1.0 Ambrosia Lake, New Mexico, Disposal Site

1.1 Compliance Summary

The Ambrosia Lake, New Mexico, Uranium Mill Tailings Radiation Control Act (UMTRCA) Title I Disposal Site was inspected on March 18, 2021. No changes were observed on the disposal cell or in the associated drainage features. Inspectors identified no immediate maintenance needs and found no cause for a follow-up or contingency inspection.

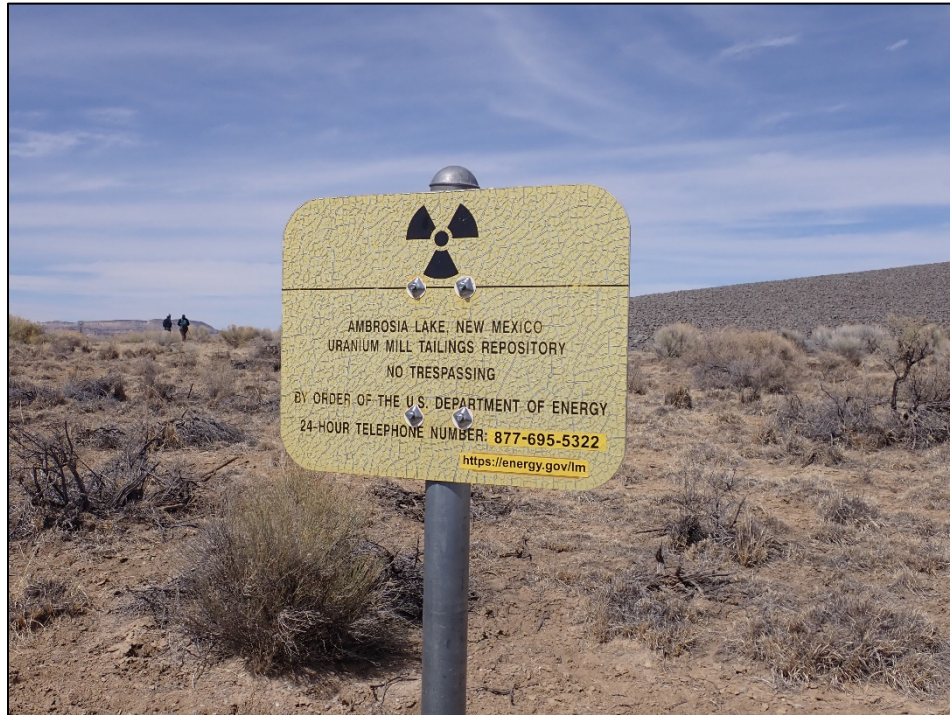
PL-1. Entrance Sign

Access to the site is from a gravel road that crosses private property and leads to the site approximately 1 mile from New Mexico Highway 509. Entrance to the site is through a locked steel gate at the intersection of the access road and Highway 509. The access road continues east past the site to private mining and grazing interests. The gate and access road are owned by Rio Algom Mining LLC. LM has been granted permanent access to the site but does not maintain the gate or the access road. The entrance sign is near the access road next to site marker SMK-1 (PL-1). The phone number on the entrance sign was updated during the annual site inspection. No maintenance needs were identified.

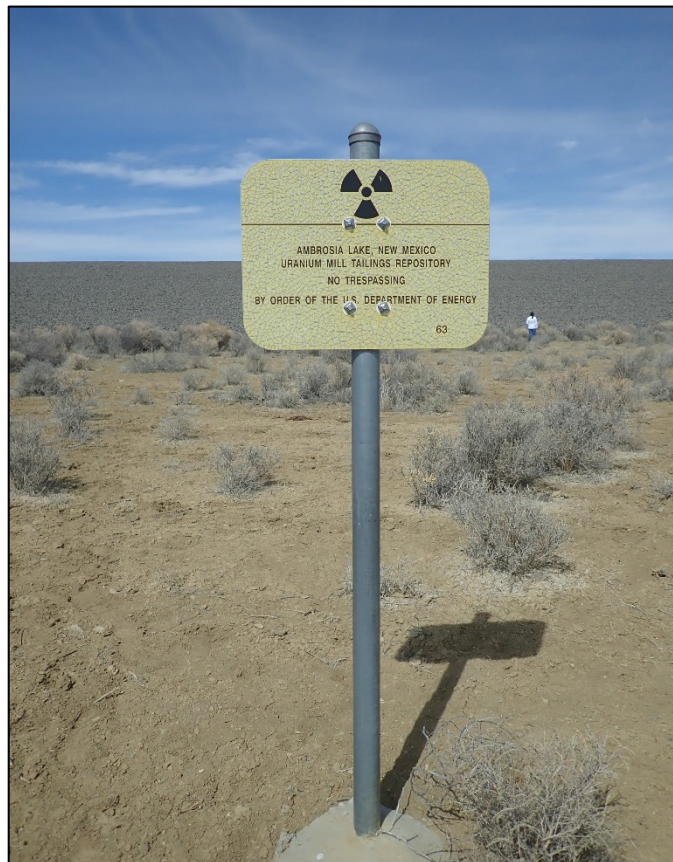
There are 70 perimeter signs, attached to steel posts set in concrete, positioned along the unfenced property boundary (PL-2). Posts for perimeter signs P1 through P15 include additional warning signs about mining restrictions. Many of the perimeter signs were cracked and weathered but remain legible. Erosion has occurred around the base of perimeter sign P12, but the perimeter sign is stable (PL-3). A new prairie dog colony was identified between perimeter signs P17 and P18. It does not threaten the integrity of either perimeter sign, no additional action is needed. No maintenance needs were identified.

PL-2. Perimeter Sign P63

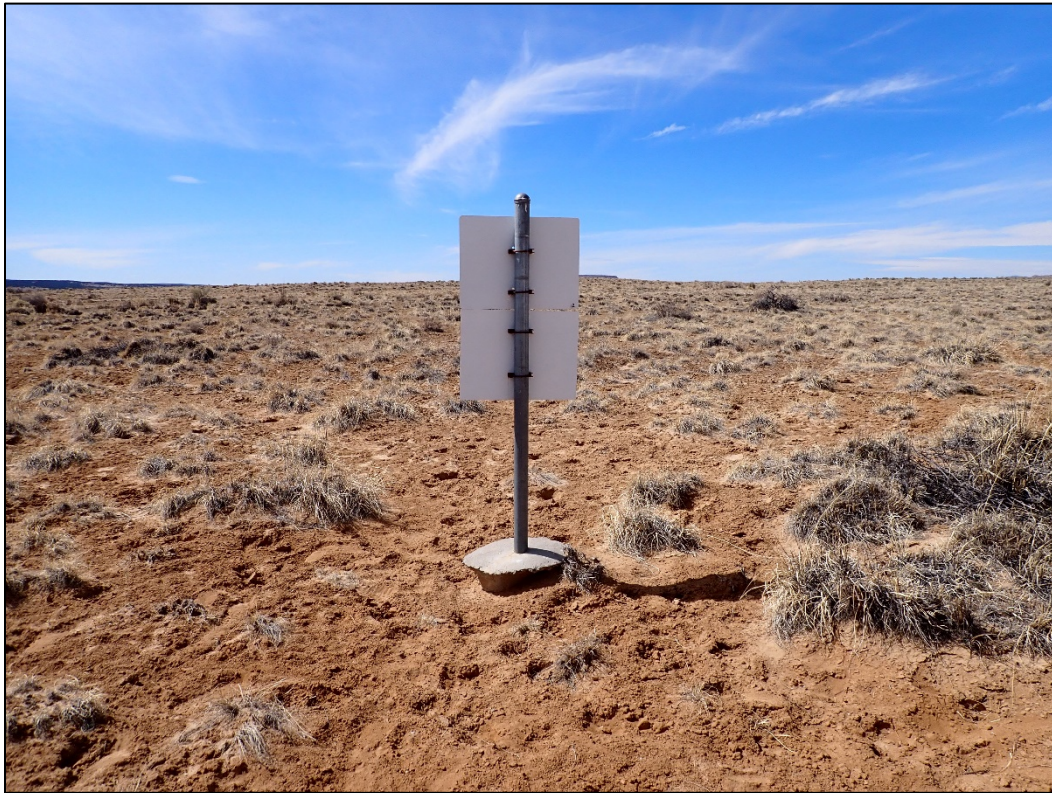
PL-3. Erosion Around Base of Perimeter Sign P12 (Stable)

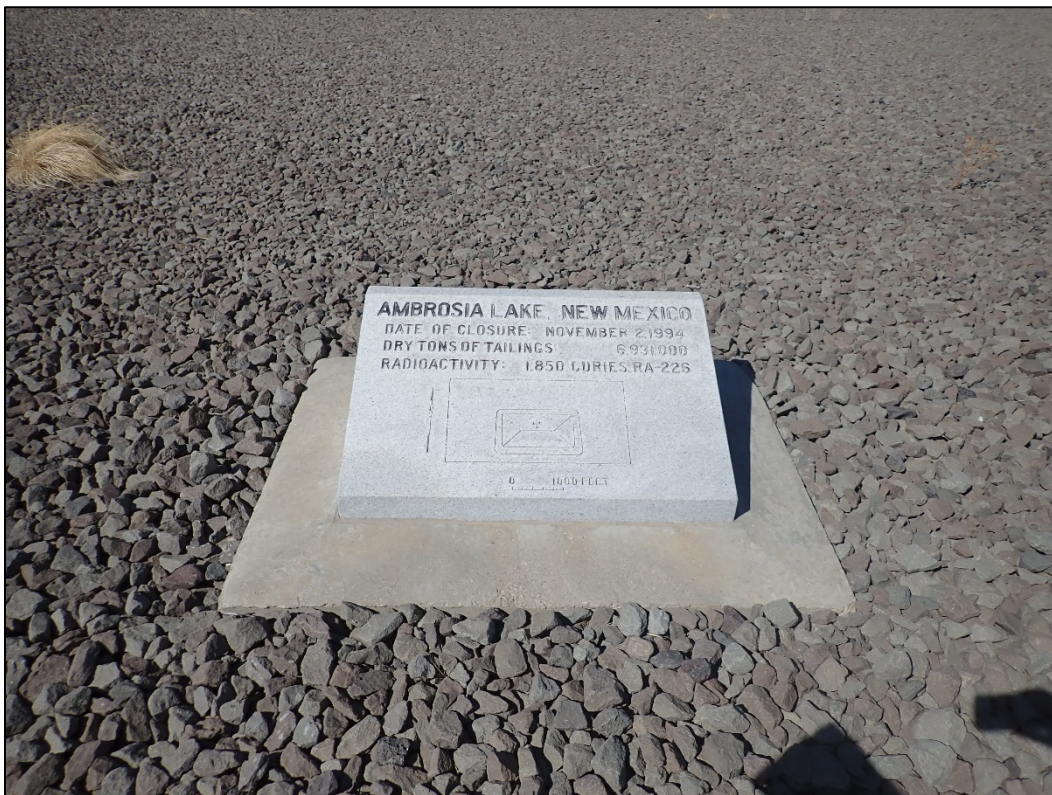
PL-4. Site Marker SMK-2

The site has two granite site markers. Site marker SMK-1 is just inside the site entrance, and site marker SMK-2 is on the top slope of the disposal cell (PL-4). No maintenance needs were identified.

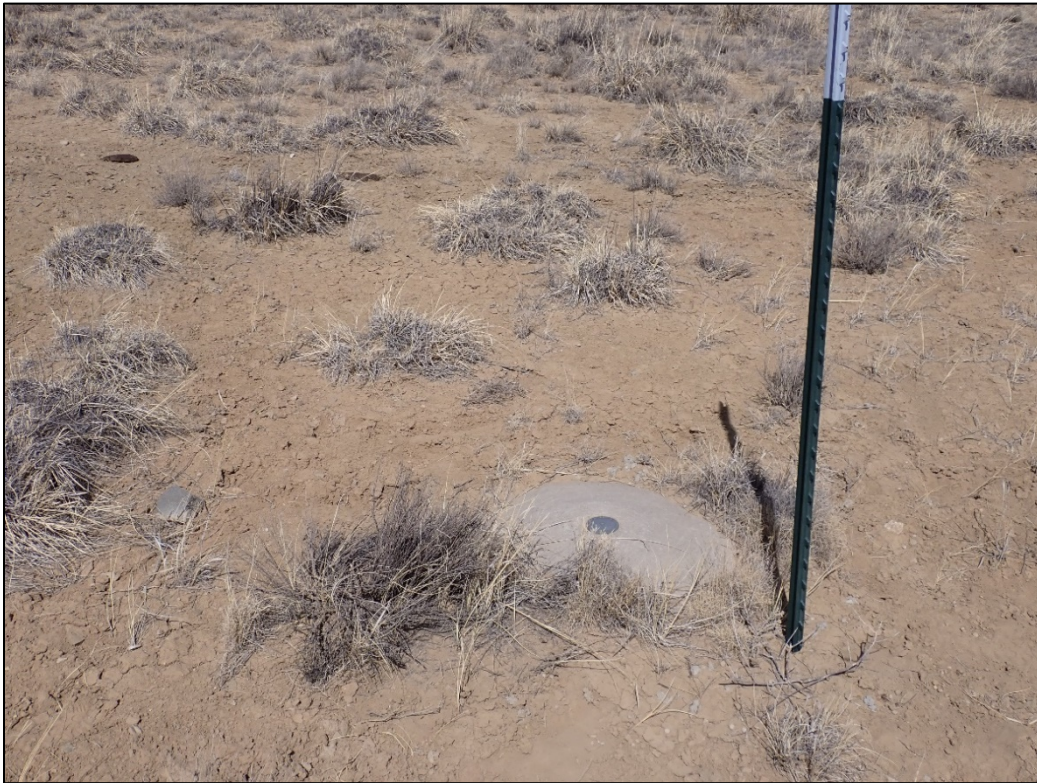
PL-5. Survey/Boundary Monument SM/BM-3

Three combined survey and boundary monuments and five additional boundary monuments delineate the property corners and boundary (PL-5). Steel T-posts were installed next to boundary monuments to help inspectors locate them. Erosion has occurred around the base of boundary monument BM-8, but the monument is stable. No maintenance needs were identified.

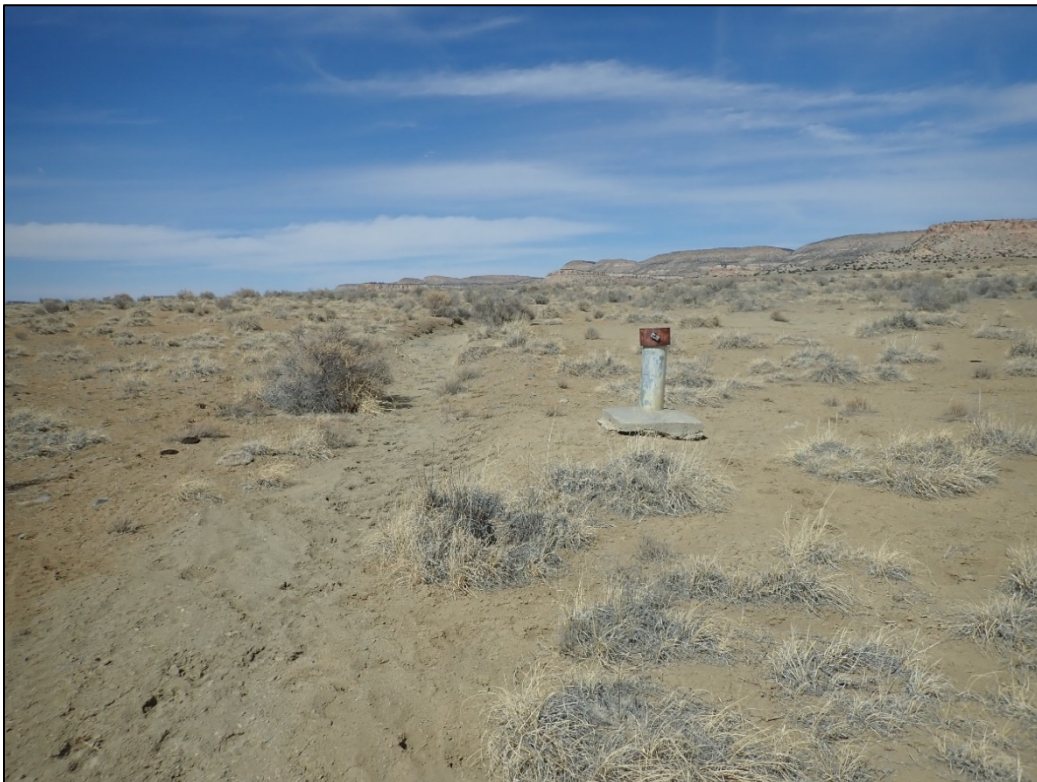
The site has three monitoring wells. A gully adjacent to well 0678 appears to be stable, and the well is not affected by the erosion (PL-6). All wellhead protectors observed during the inspection were undamaged, locked, and properly labeled. No maintenance needs were identified.

PL-6. Erosional Rills Around Monitoring Well 0678

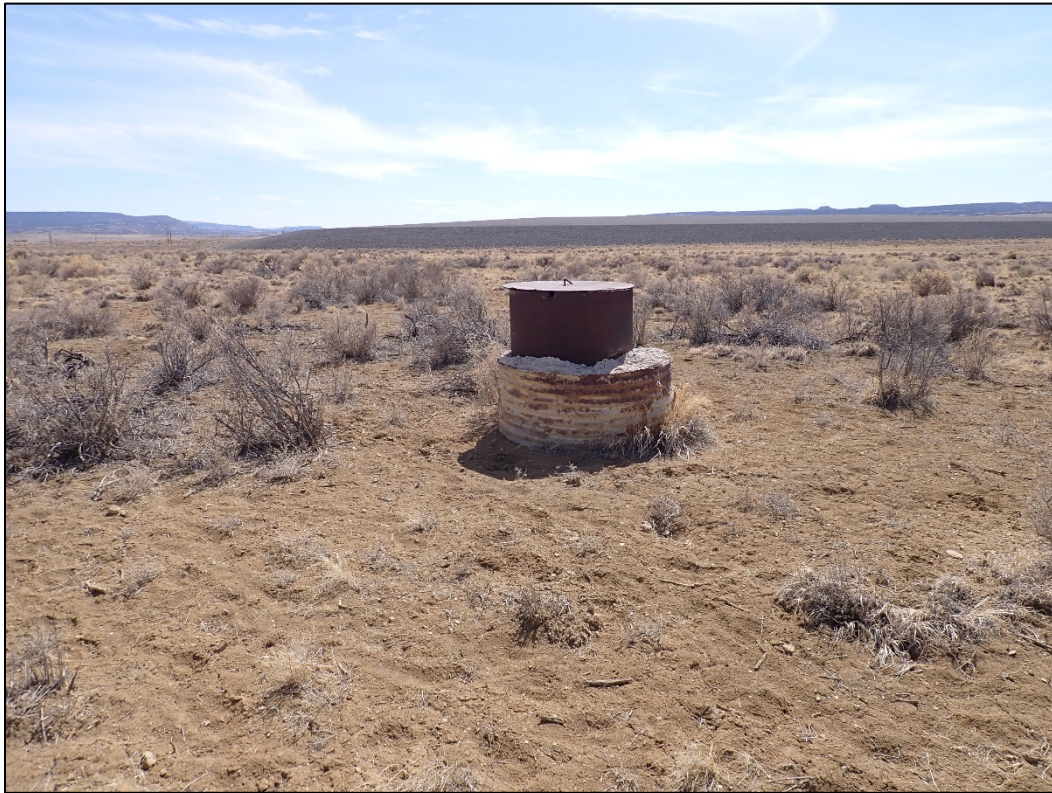
PL-7. Mine Vent Shaft

A mine vent shaft associated with an abandoned underground mine is within the site boundary in the northern portion of the site (PL-7). The vent has a spot-welded cover and a casing that rises approximately 3 feet above the ground. The vent was secure at the time of the inspection. Inspectors monitor the condition of the vent to ensure that the closure remains secure. No maintenance needs were identified.

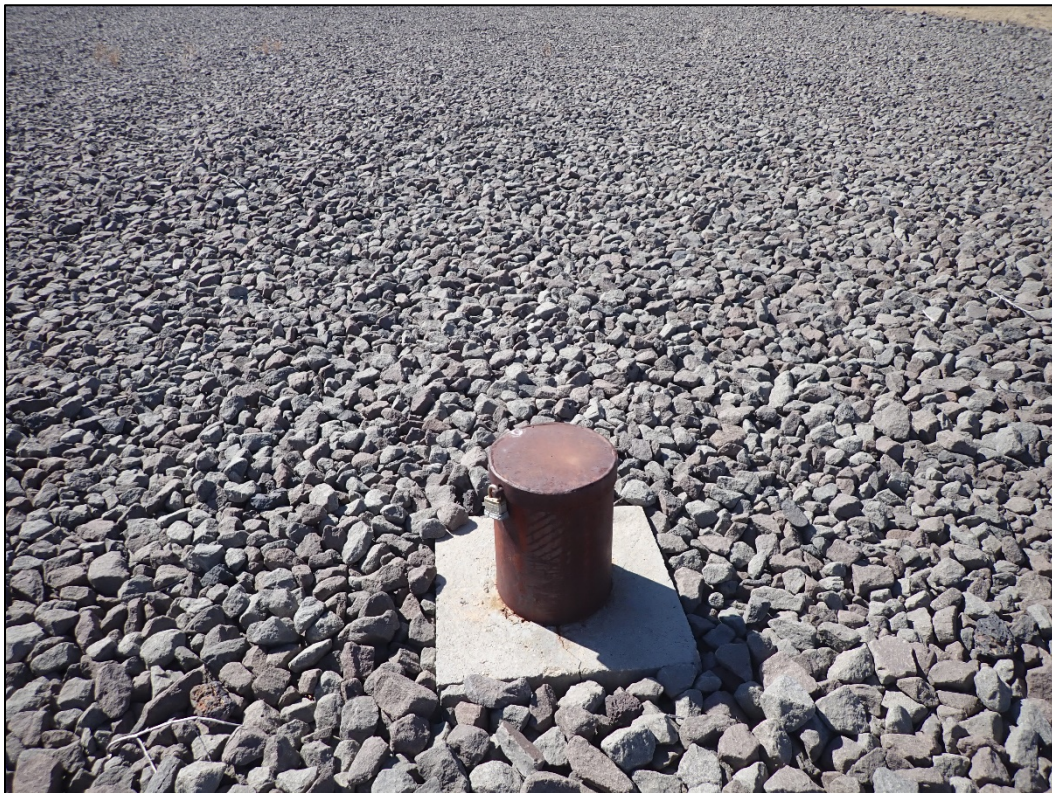
PL-8. Settlement Plate SP-4 on Disposal Cell Top

The disposal cell, completed in 1994, occupies 91 acres and is armored with basalt riprap to control erosion and deter animal and human intrusion. The top slope showed no evidence of cracking, slumping, or erosion, and there was no indication of riprap degradation. A shallow depression around settlement plate SP-4, near the northeast corner of the disposal cell cover, was first noted during the 1997 inspection and continued to grow in depth and area in subsequent years. The depression was repaired in August 2005. Visual observations during the 2017 annual inspection indicated that very minor additional settlement may have occurred since the depression was repaired. The area was inspected during the 2021 annual inspection, and settlement was shallow enough that it was determined not to have changed significantly (PL-8). Inspectors will continue to monitor this area.

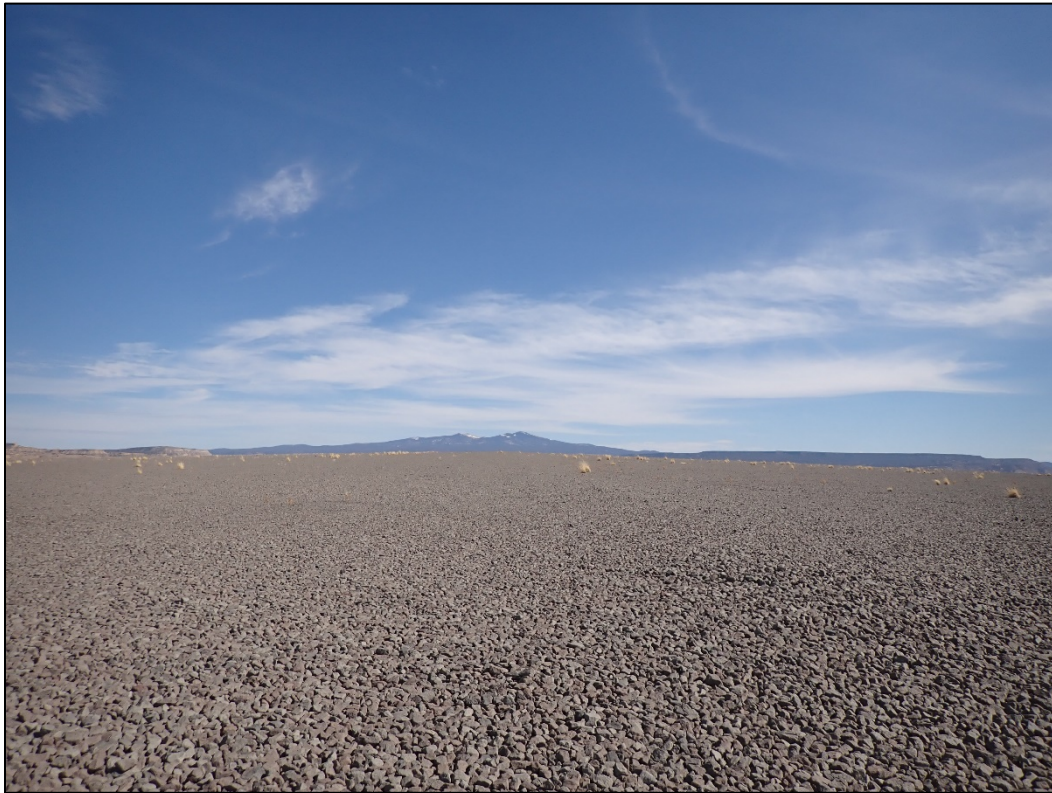
PL-9. Top Slope of Disposal Cell

Scattered annual weeds and perennial grasses and forbs are growing on the disposal cell top (PL-9). In accordance with the LTSP, deep-rooted shrubs are to be removed from the disposal cell cover. No deep-rooted shrubs were noted during the inspection. No maintenance needs were identified.

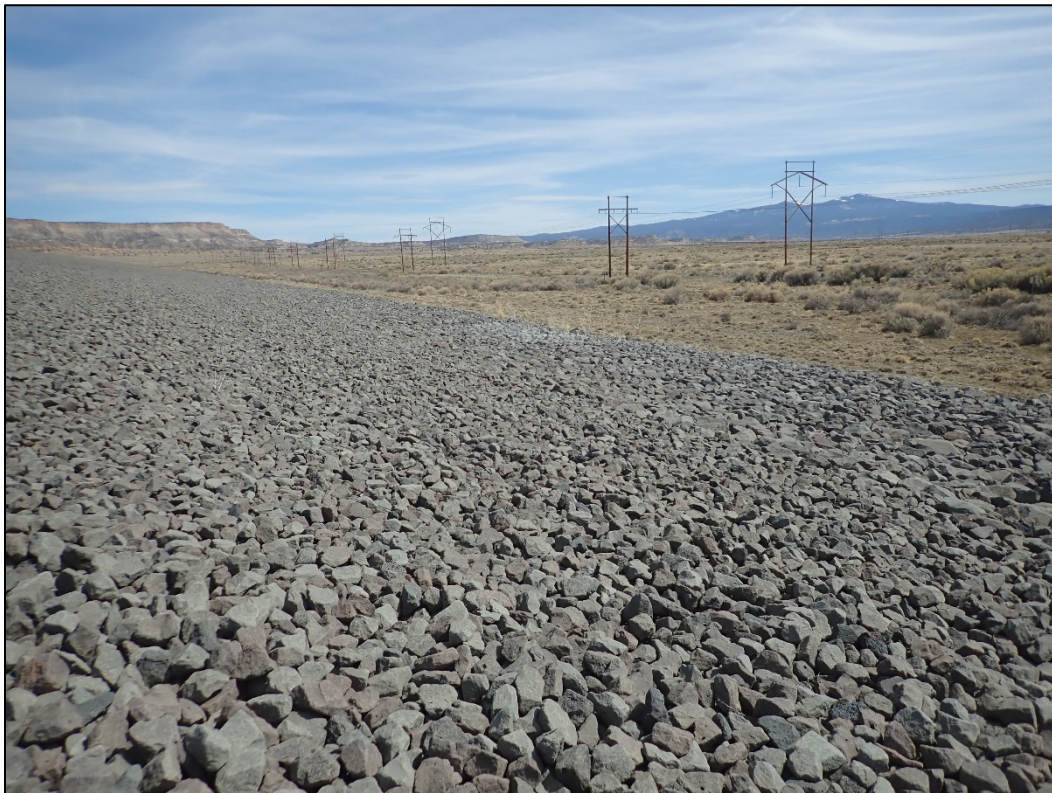
The basalt riprap-covered side slopes and apron showed no evidence of erosion, settling, slumping, or cracking. Standing water is occasionally observed in a portion of the south apron, but the area was dry during the inspection (PL-10). This location is the topographic low spot along the base of the disposal cell, and stormwater runoff collects in this area. No significant changes in the potential desiccation crack and small rills at the base of the disposal cell were observed. Inspectors will continue to monitor this area. No maintenance needs were identified.

PL-10. Ponding Areas Along South Side Slope of Disposal Cell (Dry)

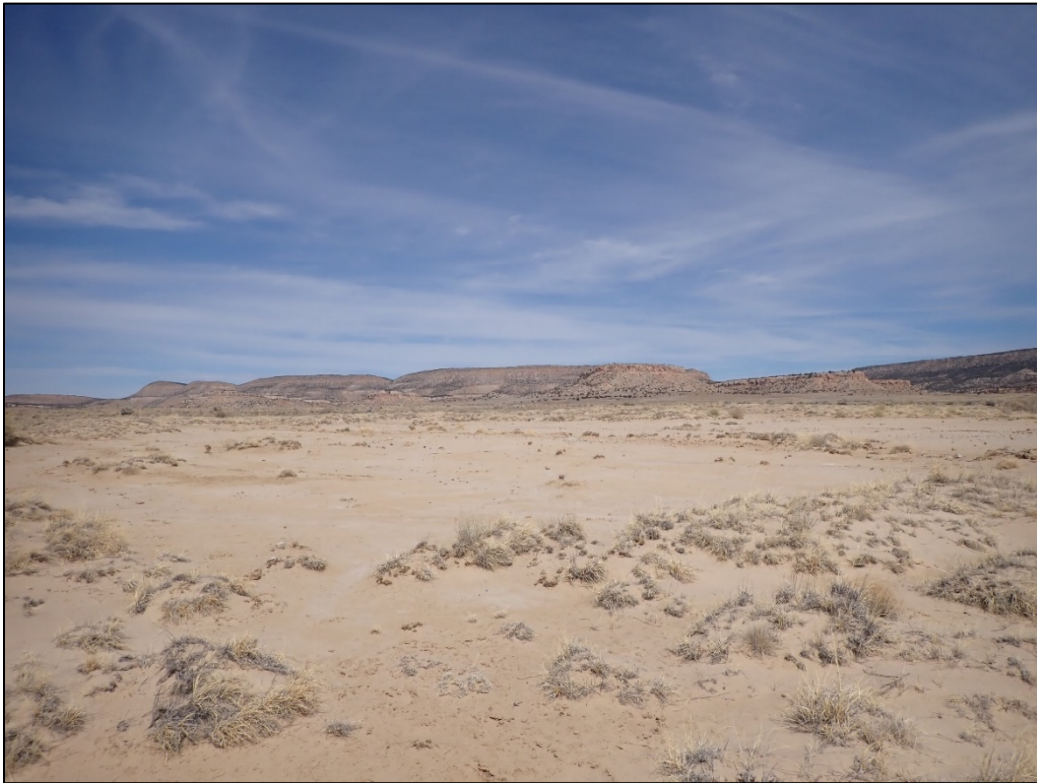
In general, site vegetation appeared to be healthy. However, some areas are windswept and have little growth, particularly in an area north of the disposal cell where mill tailings had formerly been stockpiled (PL-11). Because the site is not fenced, livestock occasionally enter it. Inspectors did not observe cattle near the disposal cell, but there was evidence of recent grazing on the site. Occasional grazing will not affect the disposal cell protectiveness or long-term performance, because livestock do not walk on riprap-armored surfaces.

PL-11. Old Stockpile Area Northwest of Disposal Cell

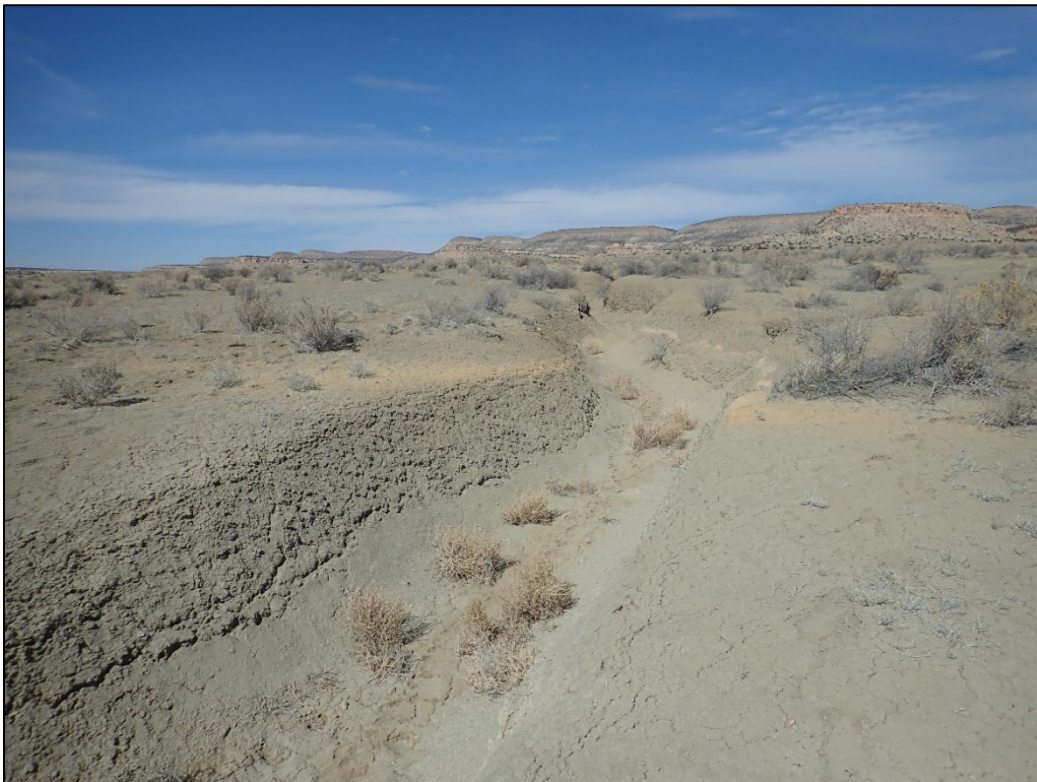
Onsite rills and gullies north and east of the disposal cell have been visually monitored for several years. While no new rills and gullies were observed during the 2021 annual inspection, existing rills and gullies continued to develop. One gully, northeast of the disposal cell, has grown to a depth of 6–8 feet and a width of 8–10 feet (PL-12). Inspectors collected GPS locations and measurements of this gully and its location has been updated on the inspection map. These erosional features do not threaten the disposal cell's performance or integrity, because headward erosion is progressing away from the disposal cell, and there is no significant sedimentation near the disposal cell. No maintenance needs were identified.

PL-12. Erosional Gully Northeast of Disposal Cell
