1.0 Ambrosia Lake, New Mexico, Disposal Site

1.1 Compliance Summary

The Ambrosia Lake, New Mexico, Uranium Mill Tailings Radiation Control Act (UMTRCA) Title I Disposal Site was inspected on March 17, 2022. No changes were observed on the disposal cell or in the associated drainage features. Inspectors identified no immediate maintenance needs and found no cause for a follow-up or contingency inspection.

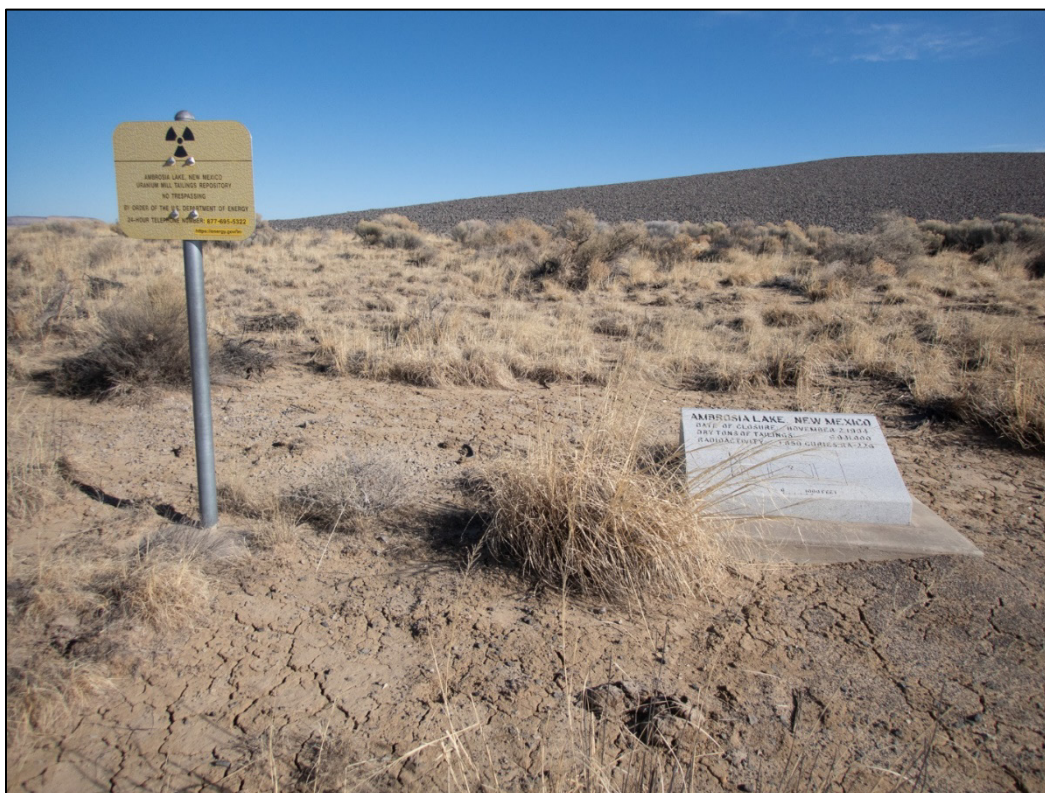
Access to the site is from a gravel road that crosses private property and leads to the site approximately 1 mile from New Mexico Highway 509. Entrance to the site is through a locked steel gate at the intersection of the access road and Highway 509. The access road continues east past the site to private mining and grazing interests. The gate and access road are owned by Rio Algom Mining LLC. LM has been granted permanent access to the site but does not maintain the gate or the access road. The entrance sign is near the access road next to site marker SMK-1 (PL-1). No maintenance needs were identified.

PL-1. Entrance Sign and Granite Site Marker SMK-1

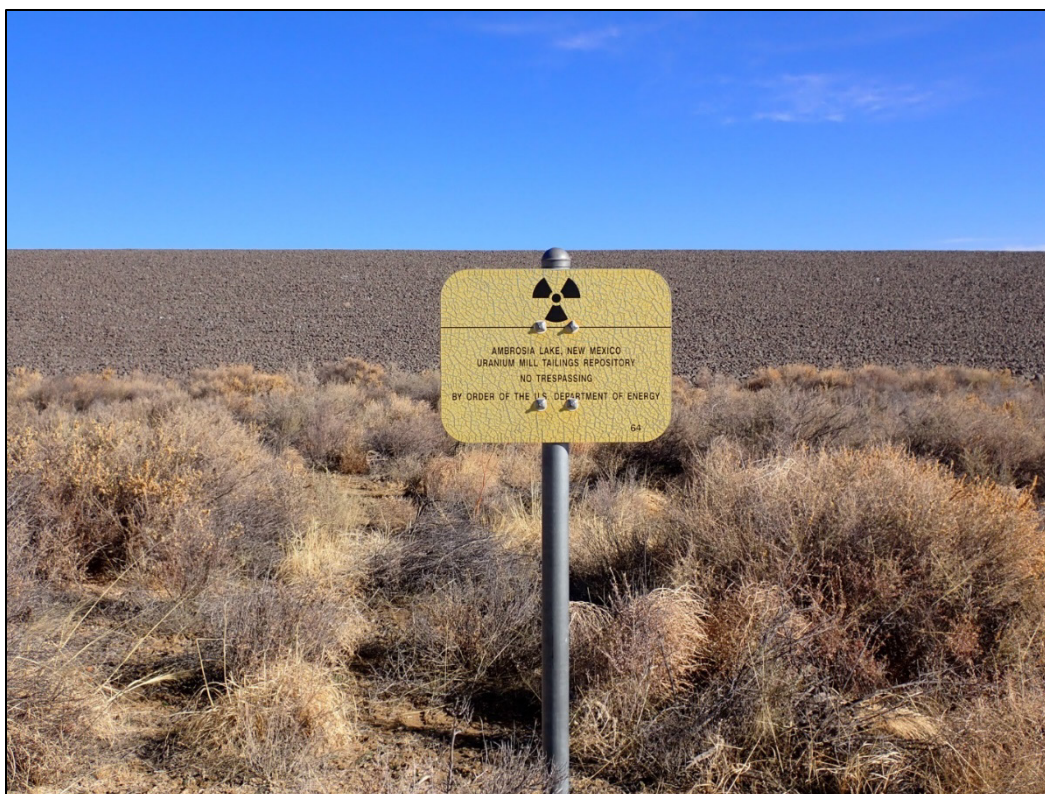
There are 70 perimeter signs, attached to steel posts set in concrete, positioned along the unfenced property boundary (PL-2). Posts for perimeter signs P1 through P15 include additional warning signs about mining restrictions. Many of the perimeter signs were cracked and weathered but remain legible. Erosion has occurred around the base of perimeter signs P12 (PL-3) and P41, but both perimeter signs are stable. Prairie dog colonies were identified near perimeter signs P17 and P18 during the 2021 inspection and observed again in 2022 (PL-4). The colony does not threaten the integrity of either of the perimeter signs, therefore, no additional action is needed. No maintenance needs were identified.

PL-2. Perimeter Sign P64

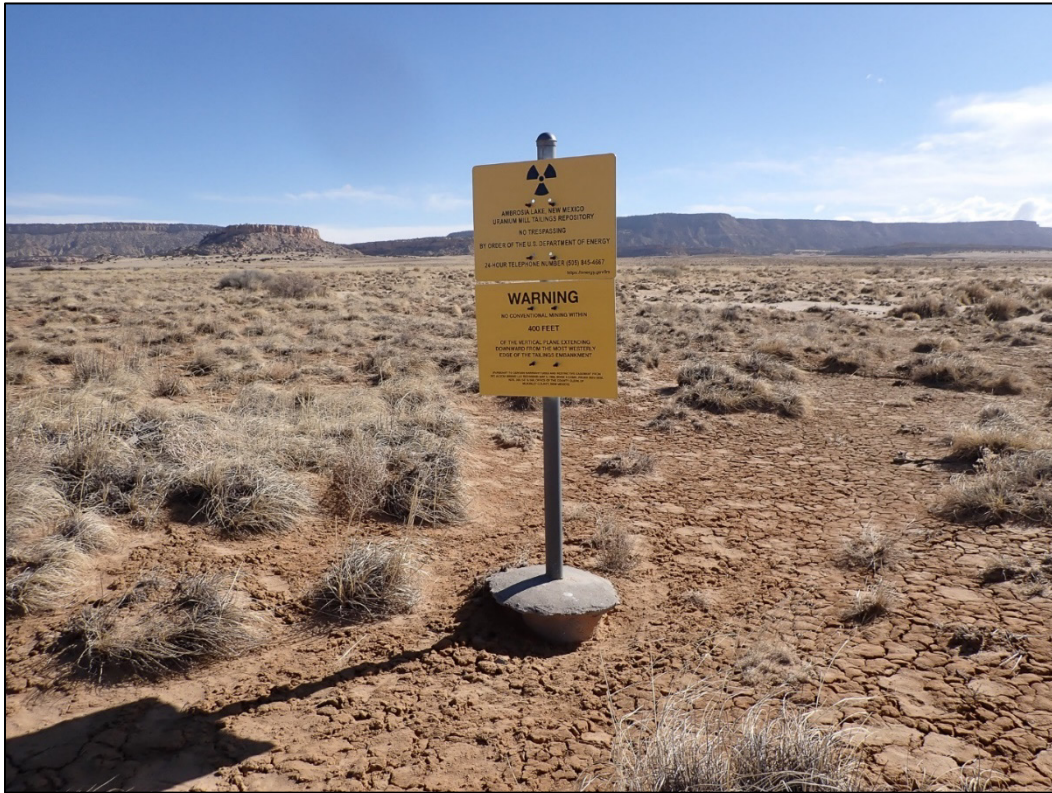
PL-3. Wind Erosion at Base of Perimeter Sign P12

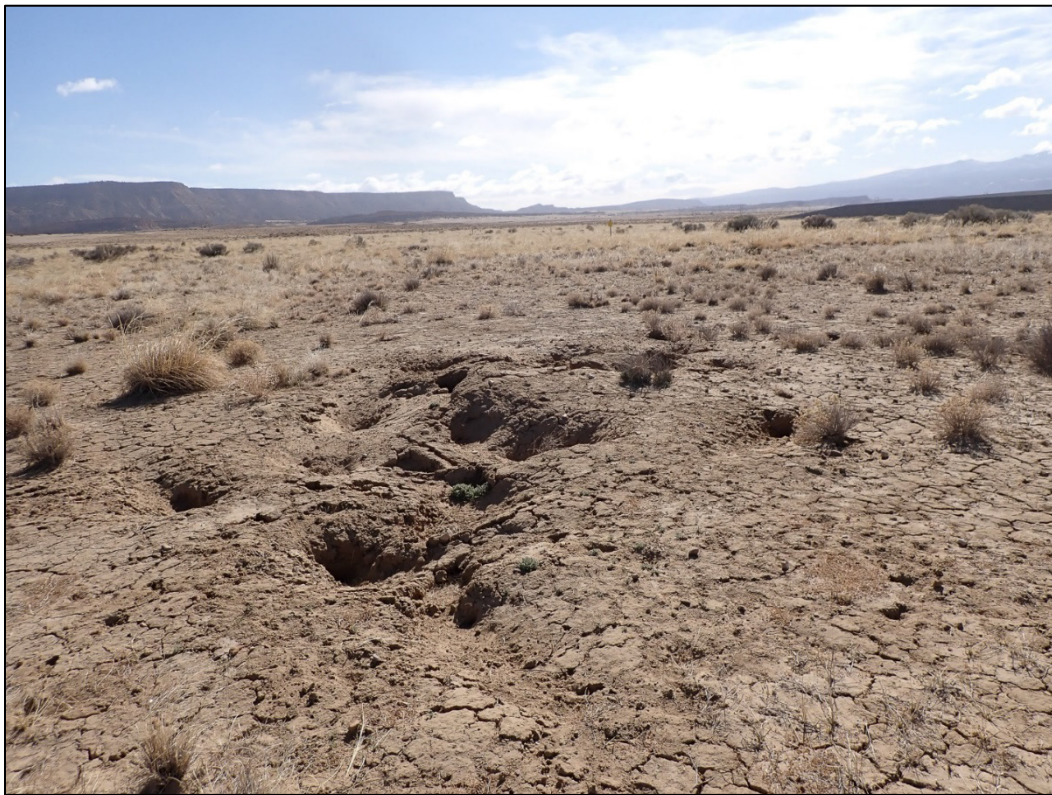
Onsite rills and gullies north and east of the disposal cell have been visually monitored for several years, and existing features have continued to develop, particularly to the northeast of the disposal cell. One gully, northeast of the disposal cell, has grown to a depth of 6–8 feet and a width of 8–10 feet (PL-12). Inspectors collected GPS locations and measurements of this gully in 2021. While no immediate maintenance needs were identified, an evaluation of the need for erosion control structures around the large gully northeast of the disposal cell will be conducted. Newly forming small rills were observed around the site during the 2022 annual inspection, near perimeter signs P17, P59, and P65.

PL-4. Prairie Dog Colony near Perimeter Sign P17

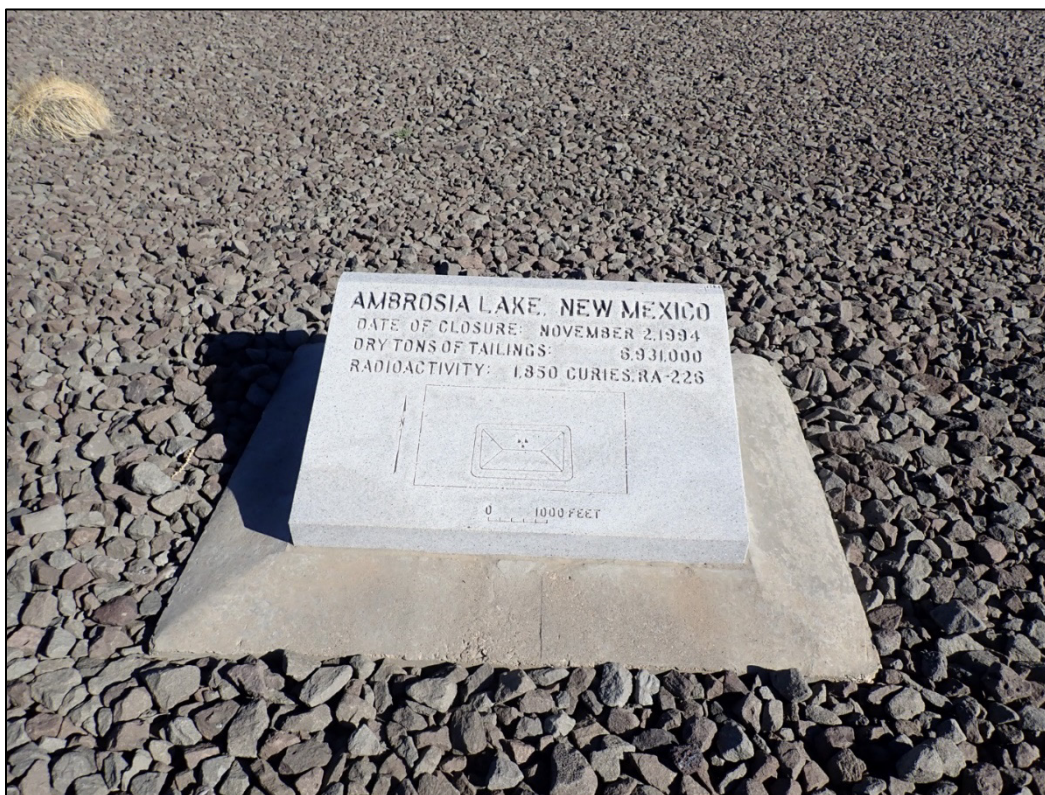
The site has two granite site markers. Site marker SMK-1 is just inside the site entrance, and site marker SMK-2 is on the top slope of the disposal cell (PL-5). No maintenance needs were identified.

PL-5. Site Marker SMK-2

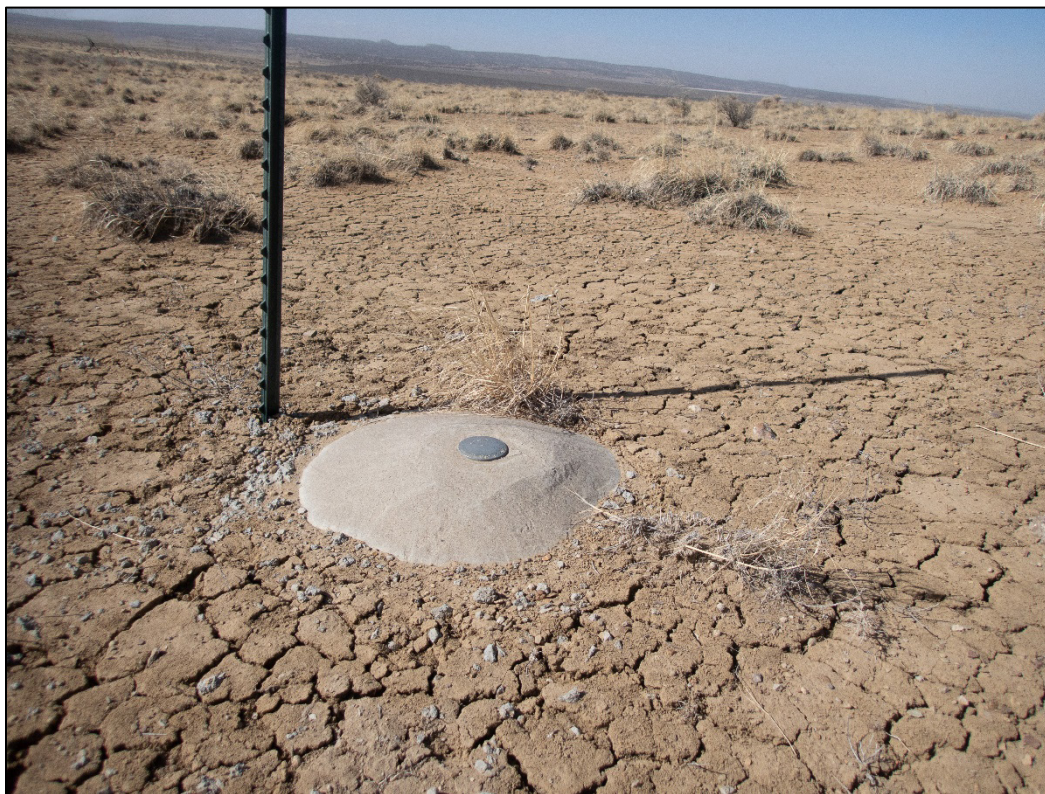
Three combined survey and boundary monuments and five additional boundary monuments delineate the property corners and boundary (PL-6). Steel T-posts were installed next to boundary monuments to help inspectors locate them. Erosion has occurred around the base of boundary monument BM-8, but the monument is stable. Prairie dog colonies were observed near boundary monuments BM-4 in 2021 (PL-7) and near BM-8 during the 2022 inspection. No maintenance needs were identified.

PL-6. Combined Survey and Boundary Monument BM-2

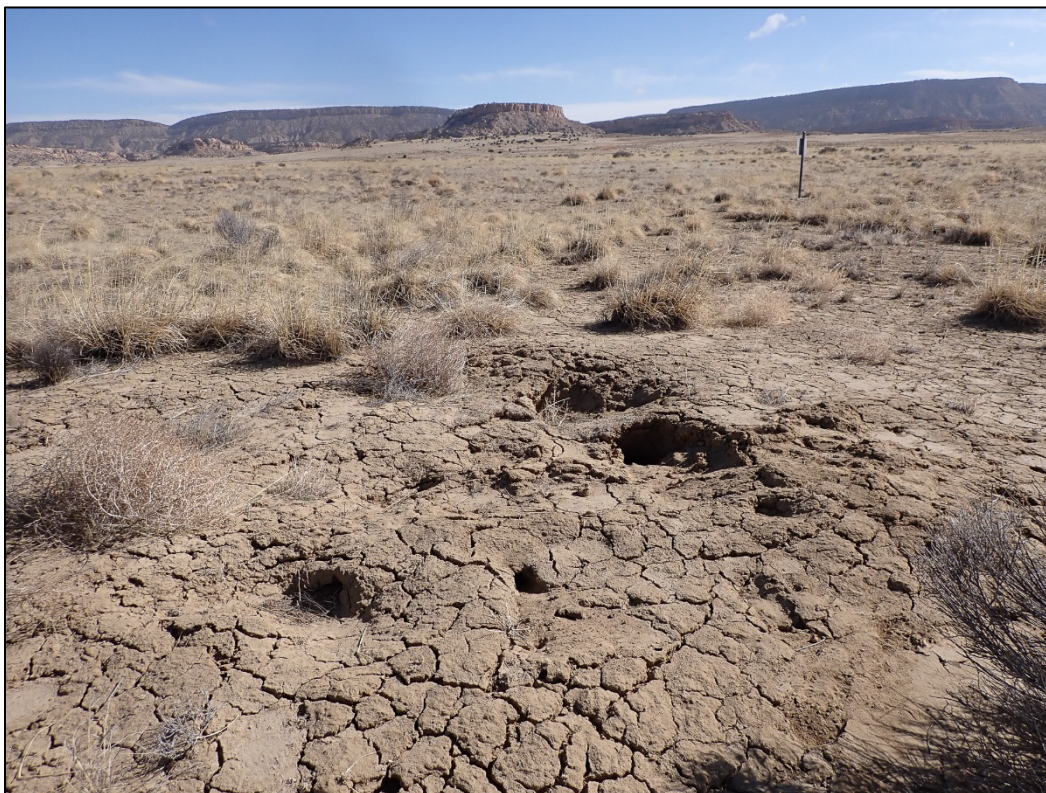
PL-7. Prairie Dog Colony near Boundary Monument BM-4 and Perimeter Sign P15

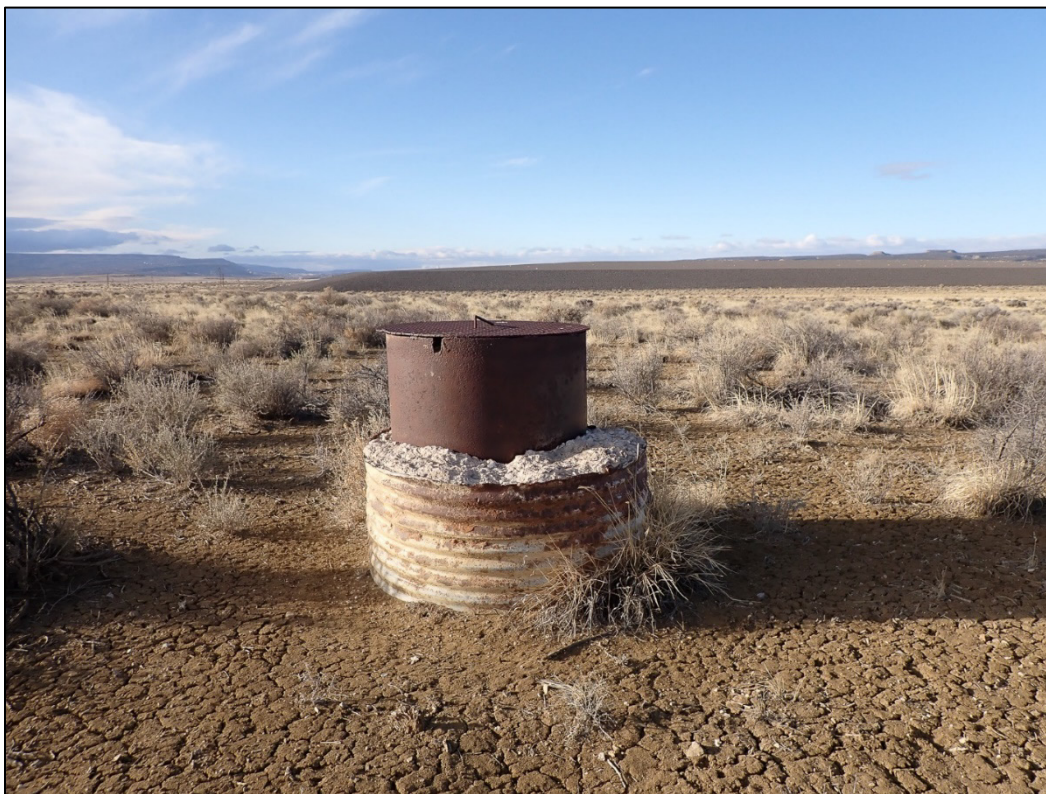
A mine vent shaft associated with an abandoned underground mine is within the site boundary in the northern portion of the site (PL-8). Inspectors monitor the condition of the vent to ensure that the closure remains secure. The vent has a spot-welded cover and a casing that rises approximately 3 feet above the ground. The vent was secure at the time of the inspection. No maintenance needs were identified.

PL-8. Mine Vent Shaft

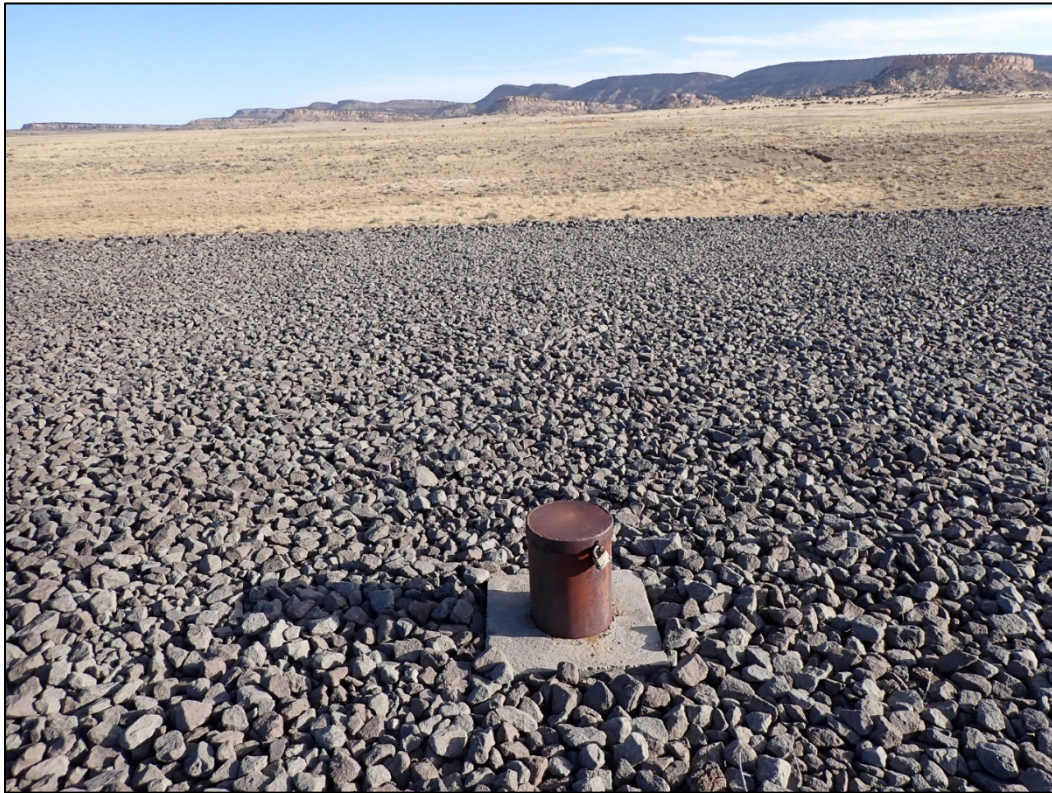
The disposal cell, completed in 1994, occupies 91 acres and is armored with basalt riprap to control erosion and deter animal and human intrusion. The top slope showed no evidence of cracking, slumping, or erosion, and there was no indication of riprap degradation. A shallow depression around settlement plate SP-4, near the northeast corner of the disposal cell cover, was first noted during the 1997 inspection and continued to grow in depth and area in subsequent years. The depression was repaired in August 2005. Continual visual observations since the 2017 annual inspection indicate that minor additional settlement has occurred since the depression was repaired. During the 2022 annual inspection, the settlement was shallow enough that it was determined not to have changed significantly (PL-9). Inspectors will continue to monitor this

area during each annual inspection and document surface topography and note any developing erosional features.

PL-9. Settlement Plate 4

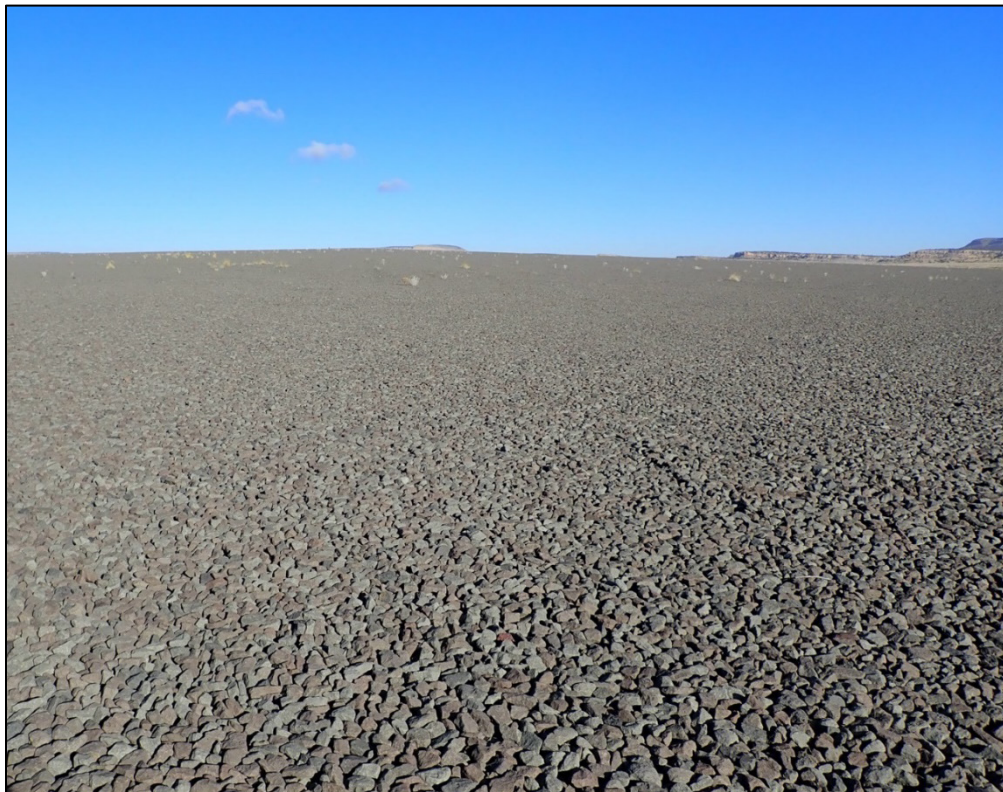
Scattered annual weeds and perennial grasses are growing on the top of the disposal cell top (PL-10). In accordance with the LTSP, deep-rooted shrubs are to be removed from the disposal cell cover. No deep-rooted shrubs were noted during the inspection. No maintenance needs were identified.

PL-10. Disposal Cell Top Slope

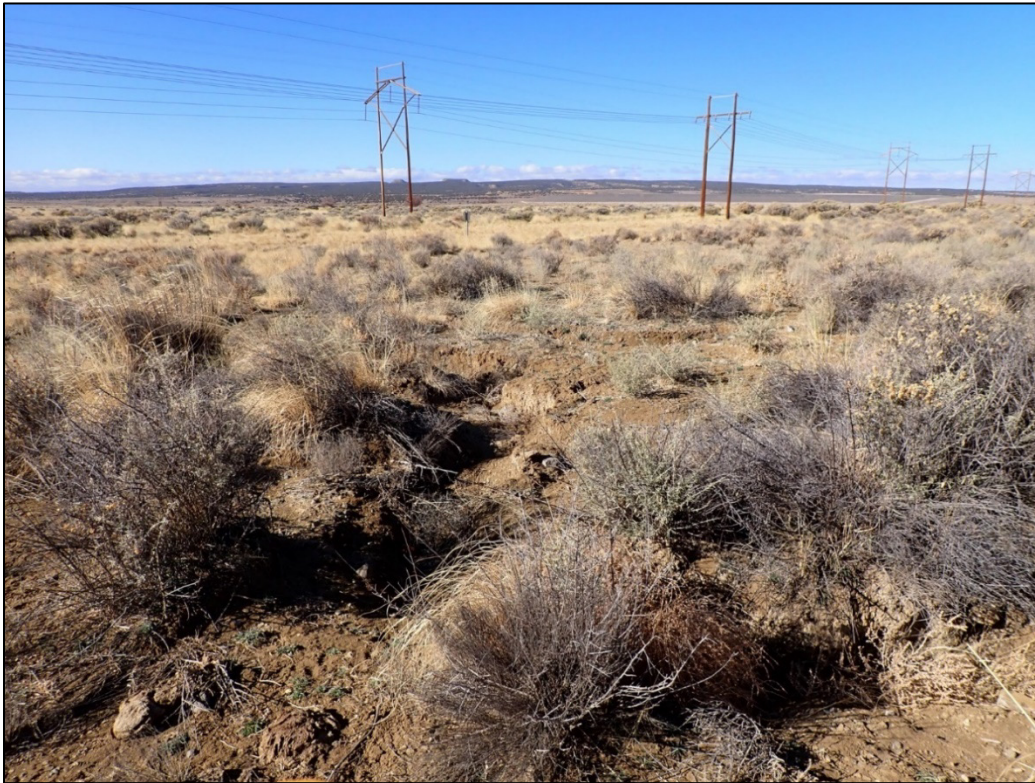
The basalt riprap-covered side slopes and apron showed no evidence of erosion, settling, slumping, or cracking. Standing water is occasionally observed in a portion of the south apron, but the area was dry during the inspection. This location is the topographic low spot along the base of the disposal cell, and stormwater runoff collects in this area. Some rilling and erosion was observed near the base of the south side slope (PL-11) near aerial survey quality control monument QC-5. Inspectors will continue to monitor this area. No maintenance needs were identified.

PL-11. Rills near Aerial Survey Quality Control Monument QC-5

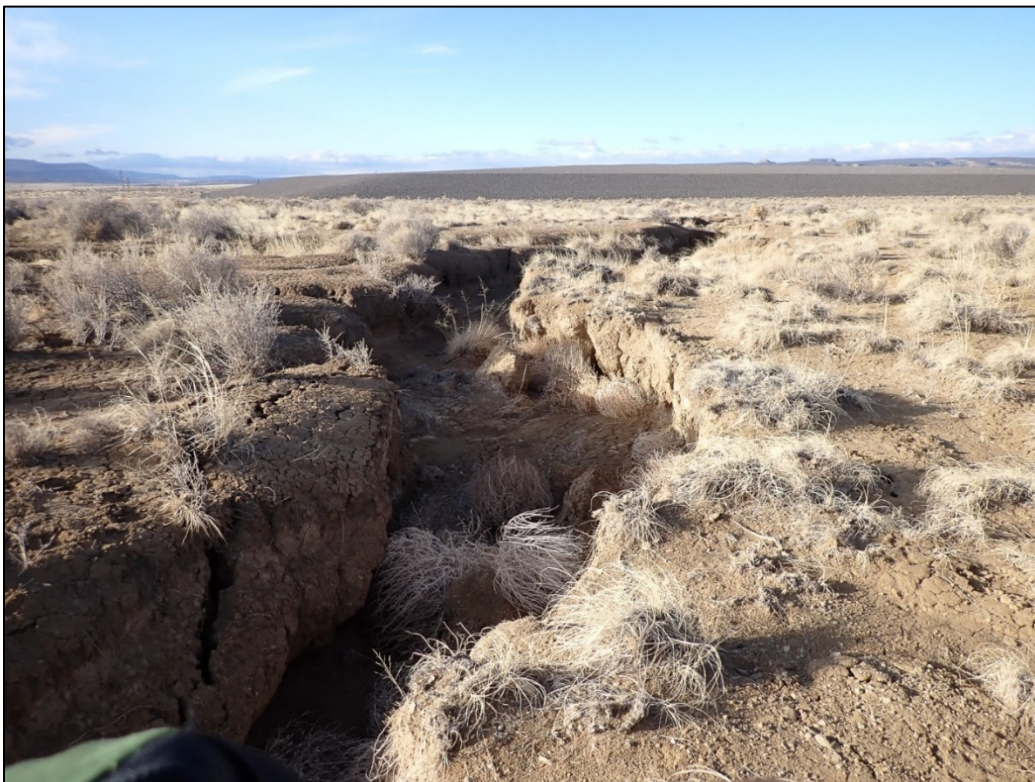
PL-12. Main Channel of Deep Gully

No immediate maintenance needs were identified during the 2022 inspection. Site engineers will evaluate the need for erosion control measures at the gully feature northeast of the cell.
