1.0 Ambrosia Lake, New Mexico, Disposal Site

1.1 Compliance Summary

The Ambrosia Lake, New Mexico, Uranium Mill Tailings Radiation Control Act (UMTRCA) Title I Disposal Site was inspected on March 19, 2024. No changes were observed on the disposal cell or in the associated drainage features. Inspectors identified no immediate maintenance needs and found no cause for a follow-up or contingency inspection.

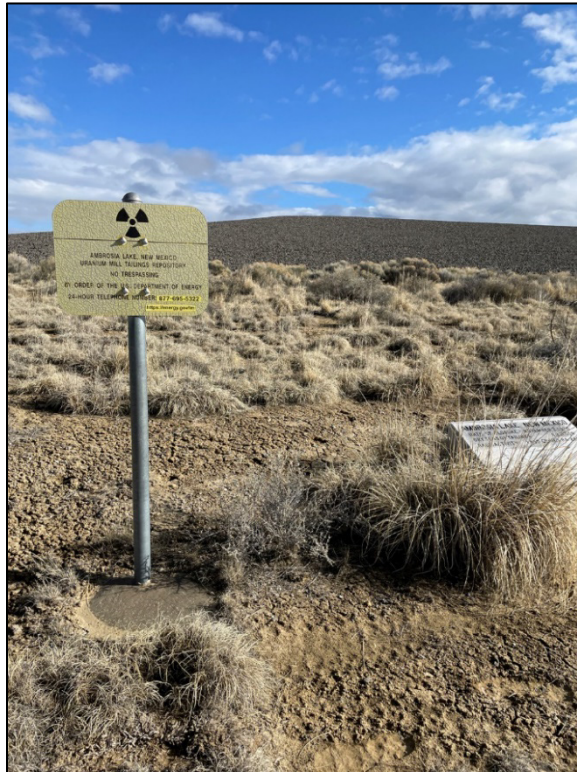
Access to the site is from a gravel road that crosses private property and leads to the site approximately 1 mile from New Mexico Highway 509. Entrance to the site is through a locked steel gate at the intersection of the access road and Highway 509. The access road continues east past the site to private mining and grazing interests. The gate and access road are owned by Rio Algom Mining LLC. LM has been granted permanent access to the site but does not maintain the gate or the access road. The entrance sign (PL-1) is near the access road next to site marker SMK-1. No maintenance needs were identified.

PL-1. Entrance Sign and Site Marker SMK-1

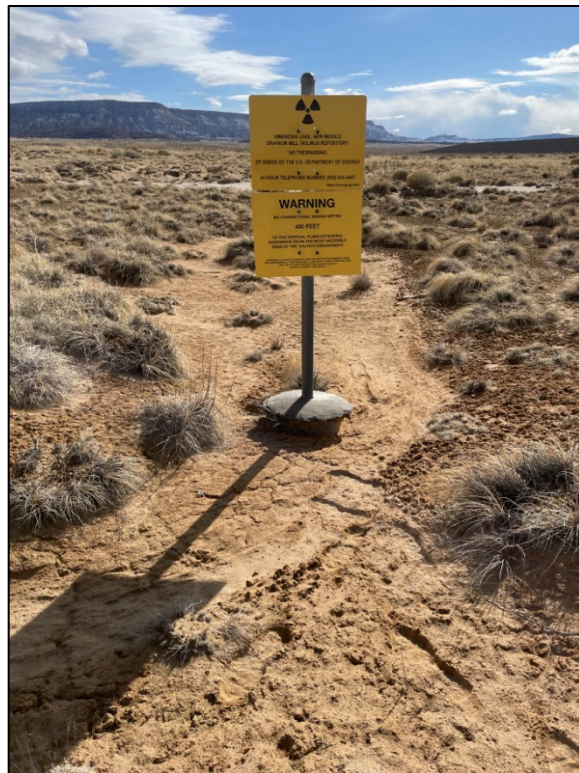
There are 70 perimeter signs, attached to steel posts set in concrete, positioned along the unfenced property boundary. Posts for perimeter signs P1 through P15 include additional warning signs about mining restrictions. Many of the perimeter signs were cracked and weathered but remain legible. Erosional gullies have formed around the base of perimeter signs P12 (PL-2), P38, and P41, but all perimeter signs are stable. Prairie dog colonies were identified near perimeter signs P17 and P18 (PL-3) during the 2021 inspection and have been observed during every inspection since. The colony does not threaten the integrity of either of the perimeter signs; therefore, no additional action is needed. No maintenance needs were identified.

PL-2. Perimeter Sign P12 with Wind Erosion at Base (Stable)

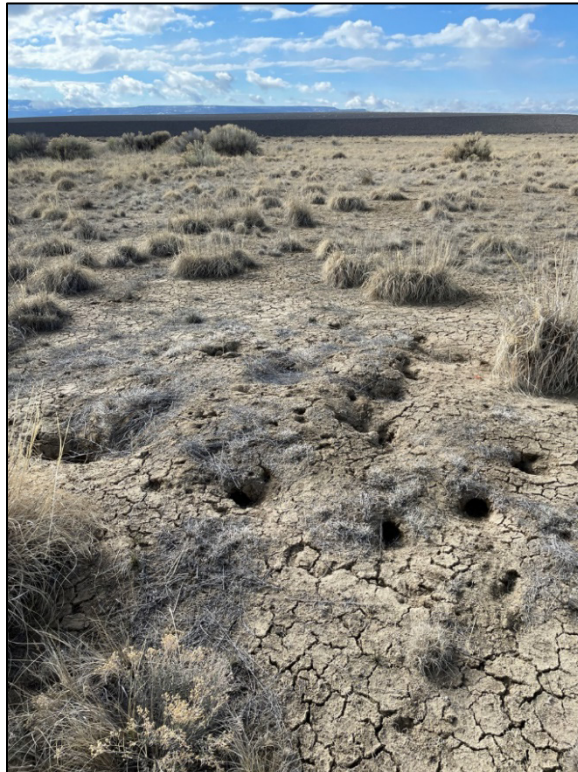
PL-3. Prairie Dog Colony near Perimeter Sign P17

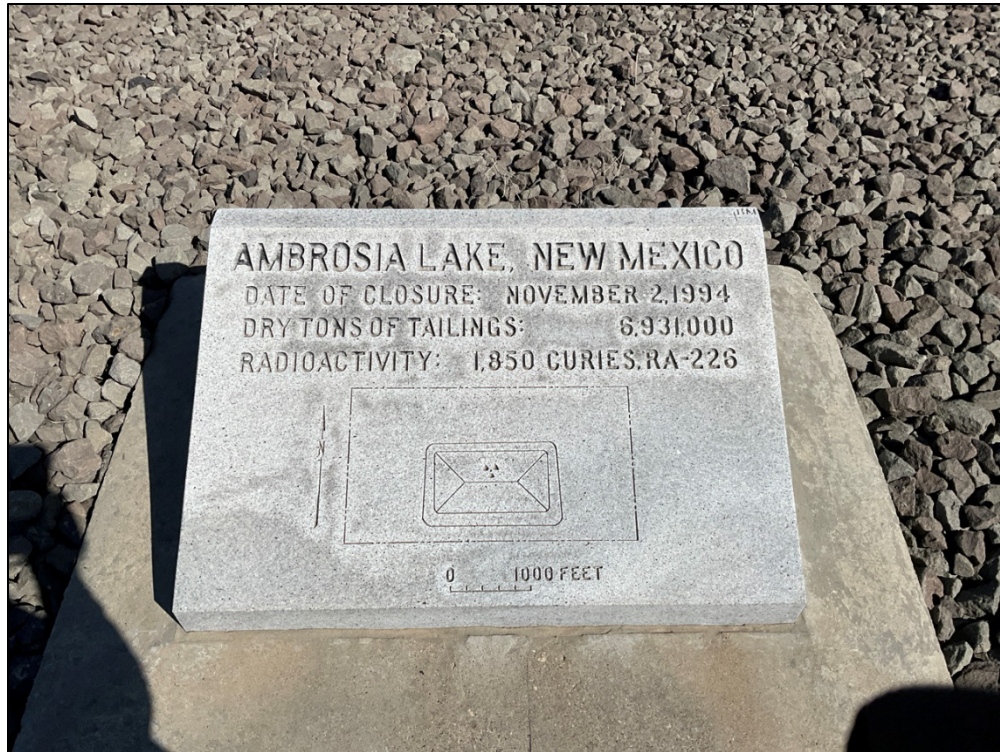
The site has two granite site markers. Site marker SMK-1 is just inside the site entrance, and site marker SMK-2 (PL-4) is on the top slope of the disposal cell. No maintenance needs were identified.

PL-4. Site Marker SMK-2

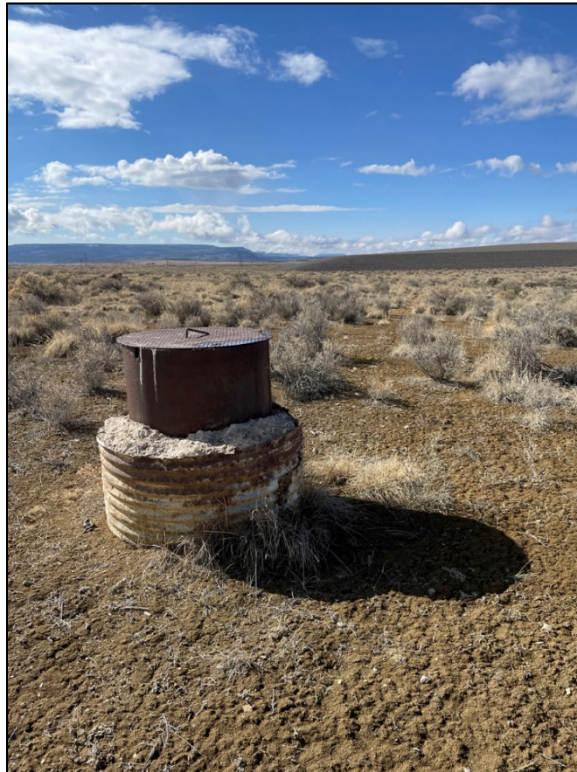
A mine vent shaft associated with an abandoned underground mine is within the site boundary in the northern portion of the site (PL-5). Inspectors monitor the condition of the vent to ensure that the closure remains secure. The vent has a spot-welded cover and a casing that rises approximately 3 feet (ft) above the ground. The vent was secure at the time of the inspection. No maintenance needs were identified.

PL-5. Mine Vent Shaft

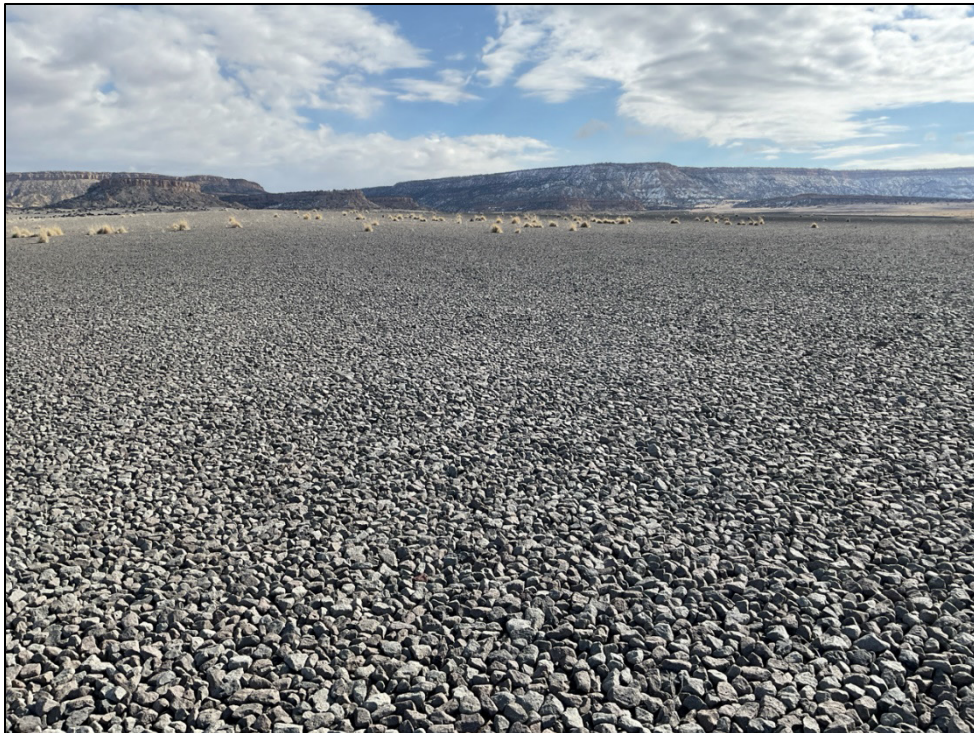
Annual weeds and perennial grasses are sporadically growing on top of the disposal cell (PL-6). In accordance with the LTSP, deep-rooted shrubs are to be removed from the disposal cell cover. No deep-rooted shrubs were noted during the inspection. Weed control is performed as necessary, and the need for weed control will be evaluated again during the next annual inspection.

PL-6. Vegetation on Disposal Cell Top Slope

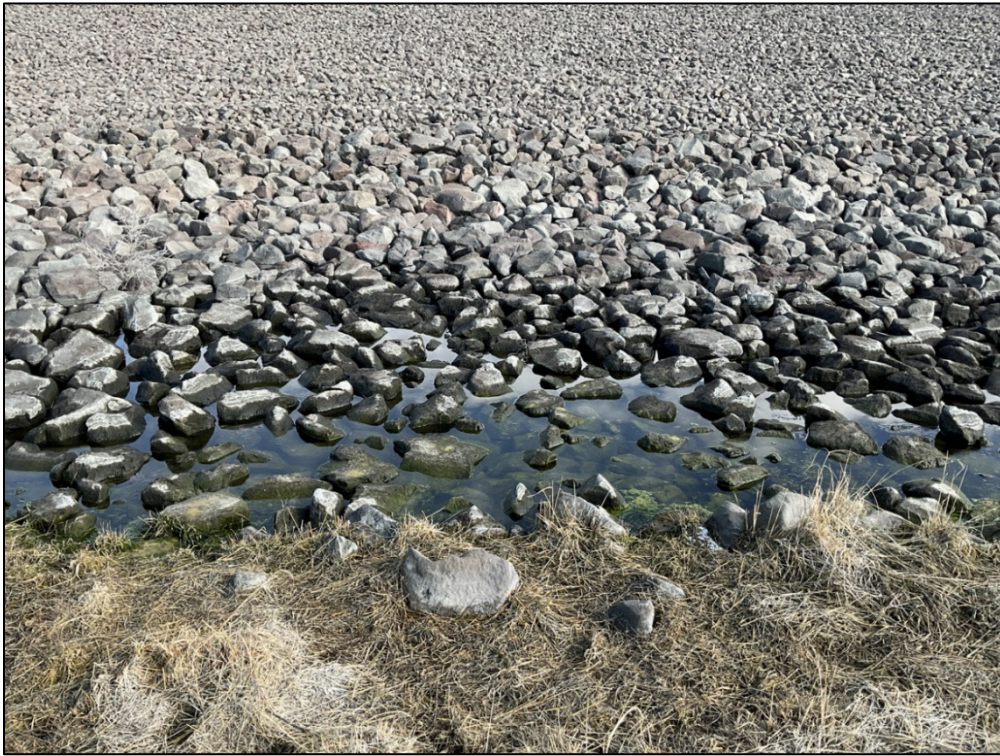
The basalt riprap-covered side slopes and apron showed no evidence of erosion, settling, slumping, or cracking. Standing water is occasionally observed in a portion of the south apron, and the area was wet during the 2024 inspection (PL-7). An additional ponding area, which was dry, exists south of the current standing water area near the apron and closer to the access road. These locations are in a topographic low spot along the base of the disposal cell, and stormwater runoff collects in these areas. During the 2022 inspection, rilling and erosion were observed on the south side slope near aerial survey quality control monument QC-5. During the 2024 inspection, these features seemed to be stable. Inspectors will continue to monitor this area. No maintenance needs were identified.

PL-7. Ponding Water on South Disposal Cell Apron

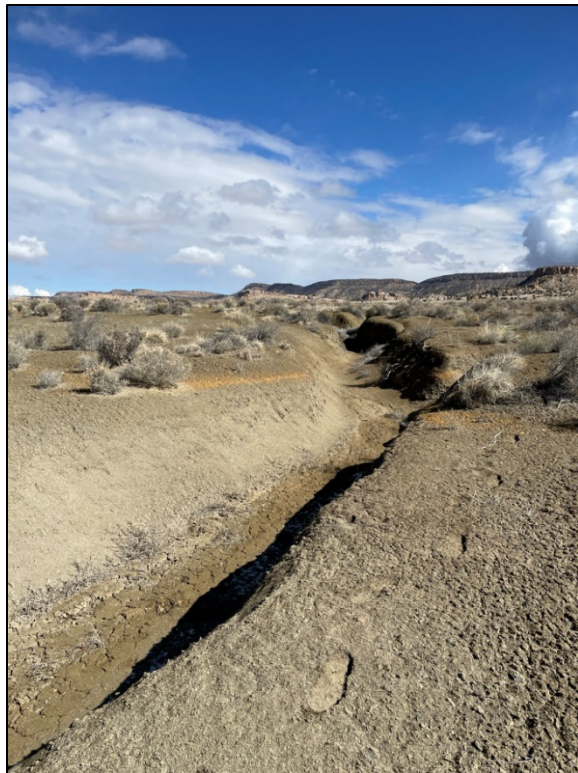
Onsite rills and gullies north and east of the disposal cell have been visually monitored for several years, and existing features have continued to develop, particularly to the northeast of the disposal cell. One gully, northeast of the disposal cell, has grown to a depth of 6–8 ft and a width of 8–10 ft (PL-8). Inspectors collected GPS locations and measurements of this gully in 2021 and 2024. While no immediate maintenance needs were identified during the 2024 inspection, an evaluation of the need for erosion control structures around the large gully northeast of the disposal cell is ongoing. Small rills observed around the site during the 2022 annual inspection near perimeter signs P17, P59, and P65 have not grown significantly. An additional small gully was observed in 2024 extending from south of the disposal cell toward perimeter sign P67 (PL-9).

PL-8. Gully Northeast of Disposal Cell

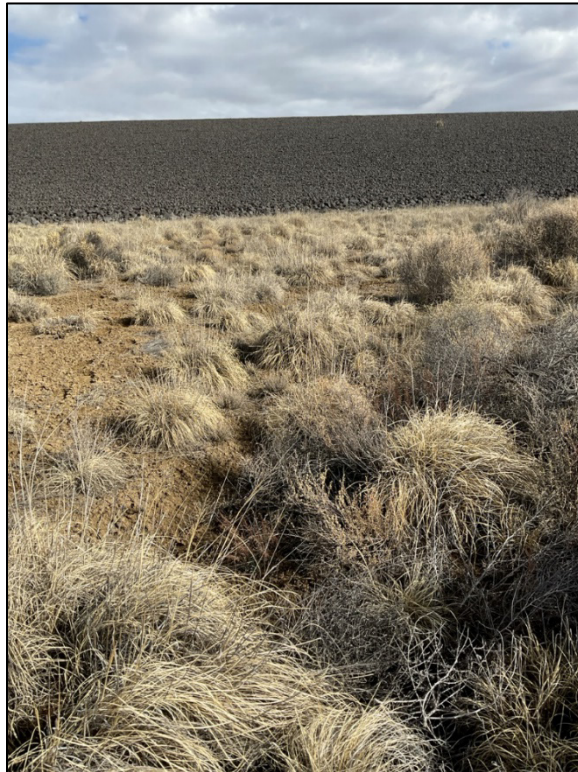
PL-9. Gully South of Disposal Cell
