10.0 Lowman, Idaho, Disposal Site

10.1 Compliance Summary

The Lowman, Idaho, Uranium Mill Tailings Radiation Control Act (UMTRCA) Title I Disposal Site was inspected on August 18, 2021. No changes were observed on the disposal cell or in the associated drainage features. Inspectors identified no maintenance needs and found no cause for a follow-up inspection. Groundwater monitoring is not required and was discontinued in 2004.

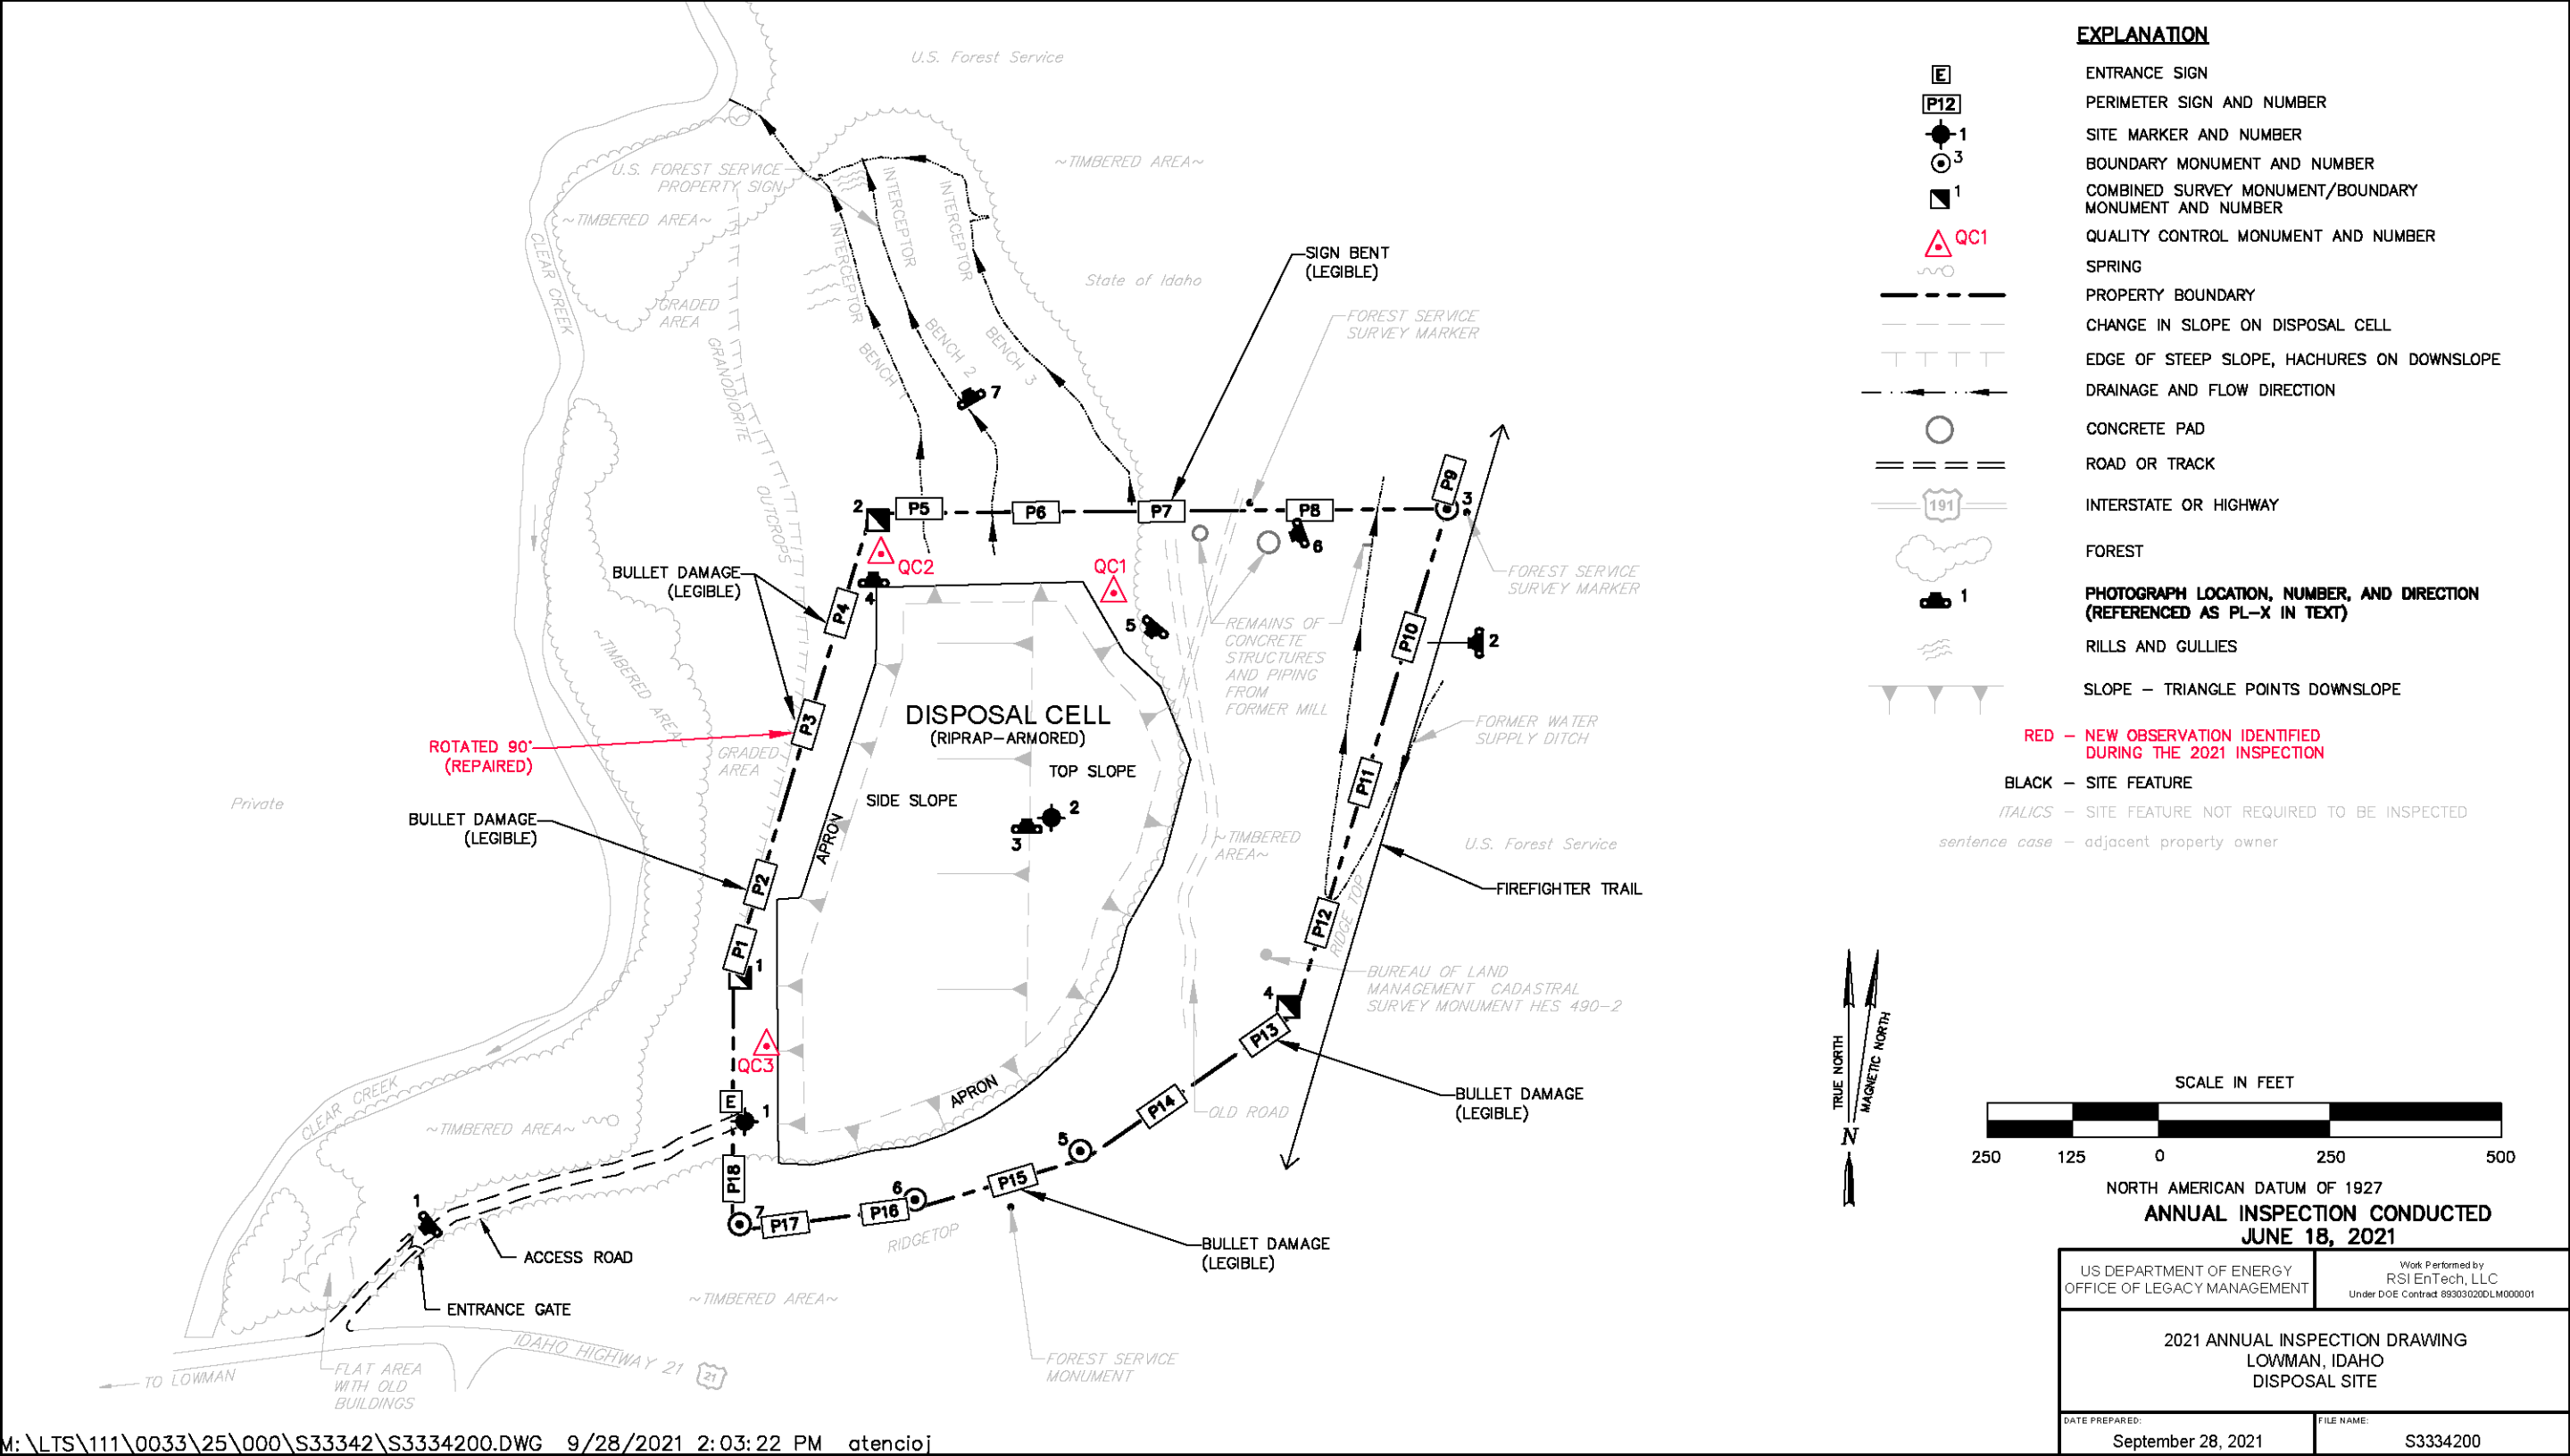
Figure 10-1. 2021 Annual Inspection Drawing for the Lowman, Idaho, Disposal Site

Figure 10-1 shows the locations of site features, including site surveillance features and inspection areas, in black and gray font. Site features that are present but not required to be inspected are shown in italic font, and new observations identified during the 2021 annual inspection are shown in red. Inspection results are described in the following subsections. Photographs to support specific observations are identified in the text and in Figure 10-1 by photograph location (PL) numbers. The photographs and photograph log are presented in Section 10.10.

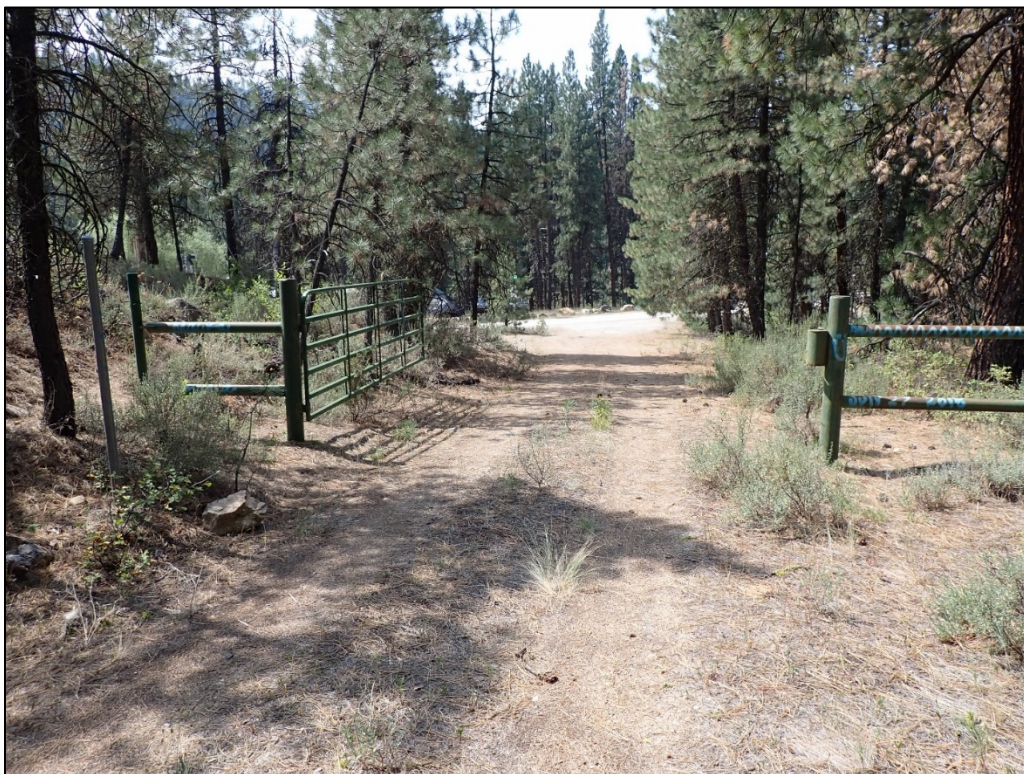
PL-1. Disposal Site Entrance Gate

Access to the site is at the end of a gravel road about 650 feet (ft) north of Idaho Highway 21. Entrance to the site is through a locked steel gate on the site access road about 150 ft from the highway (PL-1). The site is not fenced, but the topography and forest vegetation prevent vehicle access around the entrance gate and along the property boundary. The entrance gate was locked and functional, the access road was passable, and the entrance sign was present and legible. No maintenance needs were identified.

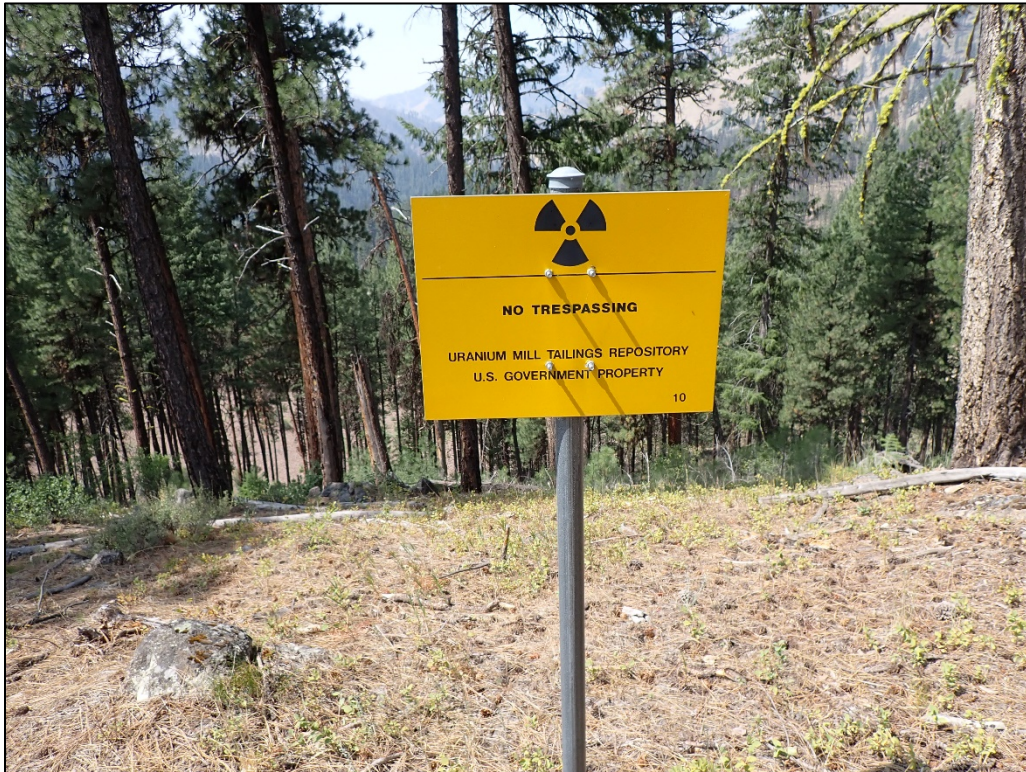
PL-2. Perimeter Sign P10

There are 18 perimeter signs attached to steel posts set in concrete positioned along the unfenced property boundary (PL-2). Several perimeter signs (P2, P3, P4, P13, and P15) have bullet damage but remain legible. Perimeter sign P3 was rotated about 90 degrees from its original position but was repaired during the inspection. Perimeter sign P7 is slightly bent from tree fall but remains legible. No maintenance needs were identified.

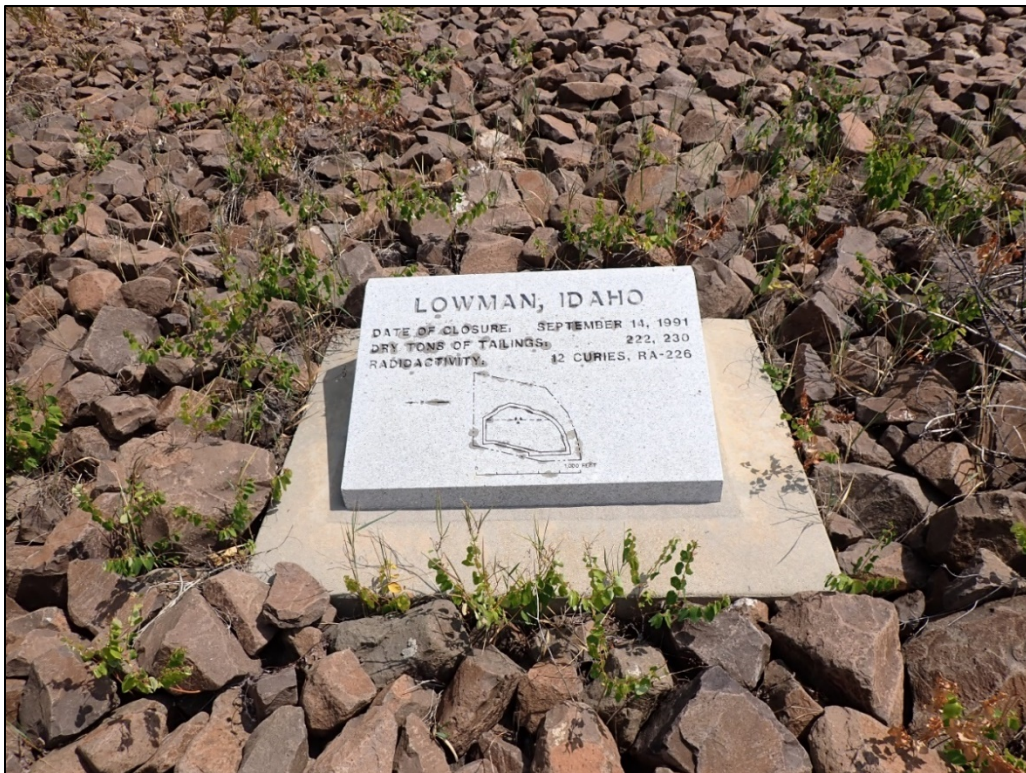
PL-3. Site Marker SMK-2

The site has two granite site markers. Site marker SMK-1 is just inside the southwest property boundary, and site marker SMK-2 (PL-3) is on the top slope of the disposal cell. Lichen is growing on the surface of both site markers, but it is easily removable by hand and does not detract from the legibility of the markers. No maintenance needs were identified.

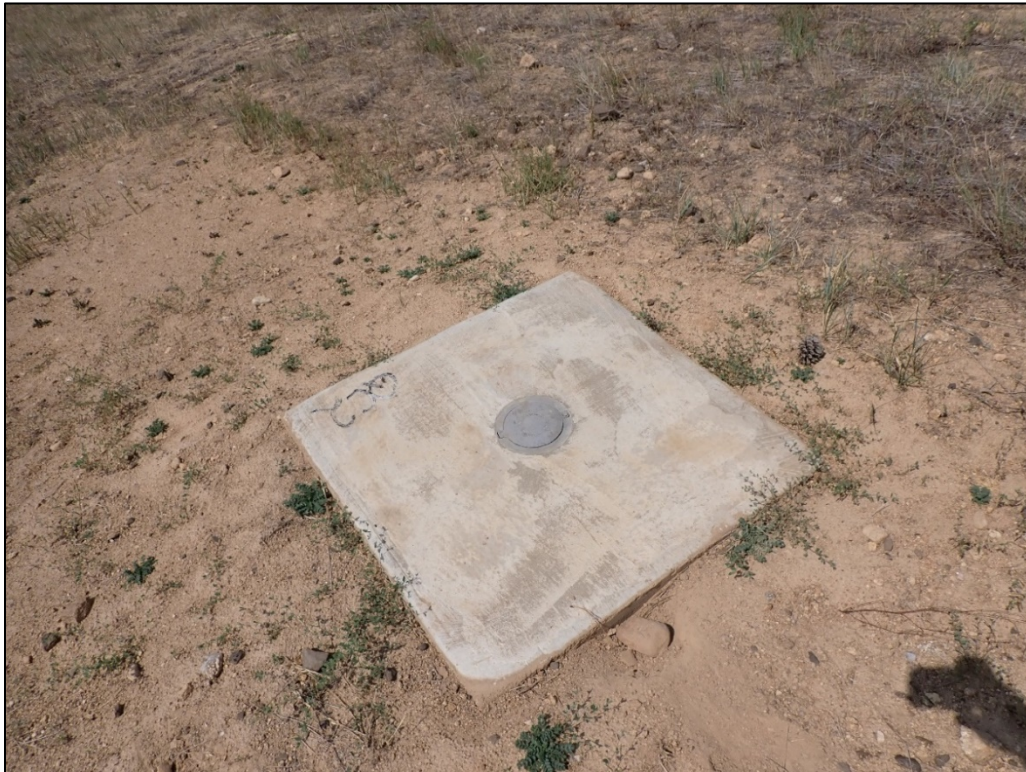
PL-4. Quality Control Monument QC-2

Three aerial survey quality control monuments, installed in October 2020, provide ground truth for aerial surveys at the site (PL-4). The quality control monuments were inspected during the 2021 annual inspection. No maintenance needs were identified.

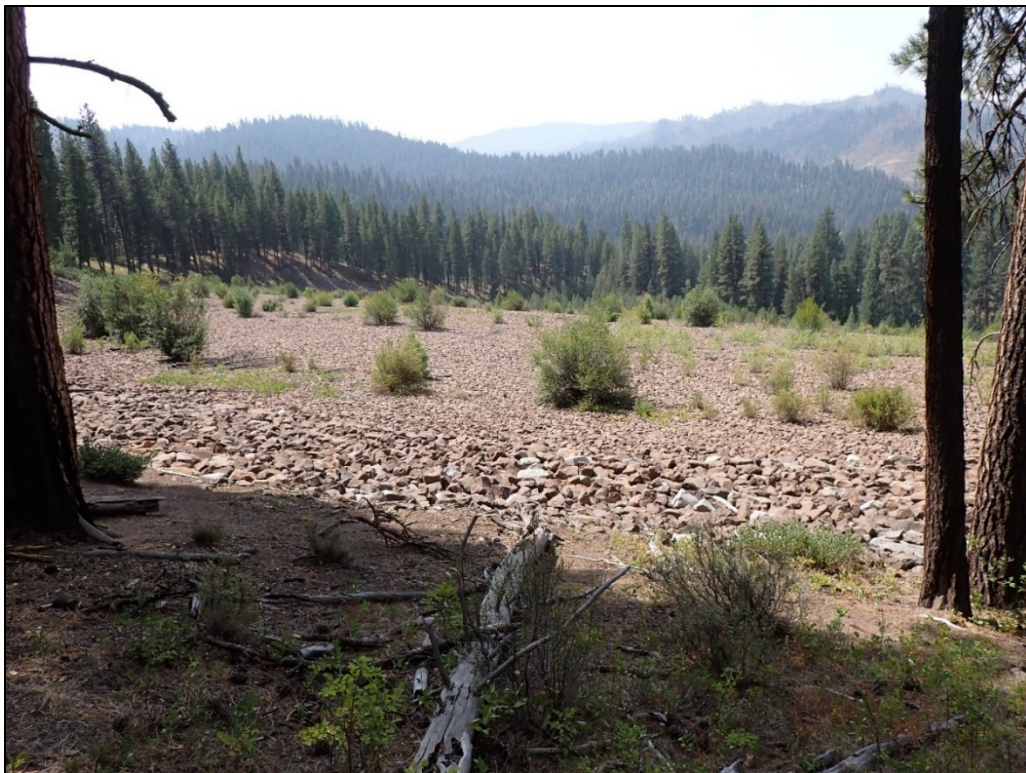
PL-5. Disposal Cell Cover

Natural vegetation continues to encroach on the top and side slopes of the disposal cell. Although the LTSP states that control of vegetation growth on the cell is not needed, LM concluded that controlling the growth of conifers—primarily ponderosa pine—would be a best management practice. Unlike the shrubs and other vegetation growing on the disposal cell, mature conifers could potentially become uprooted during windstorms and damage the surface of the disposal cell. Numerous ponderosa pine trees were observed on the disposal cell top and side slopes and were cut down and left in place in September 2018. Other plants growing on the disposal cell were not removed, as they do not present a physical threat to the integrity of the disposal cell (PL-5). No maintenance needs were identified.

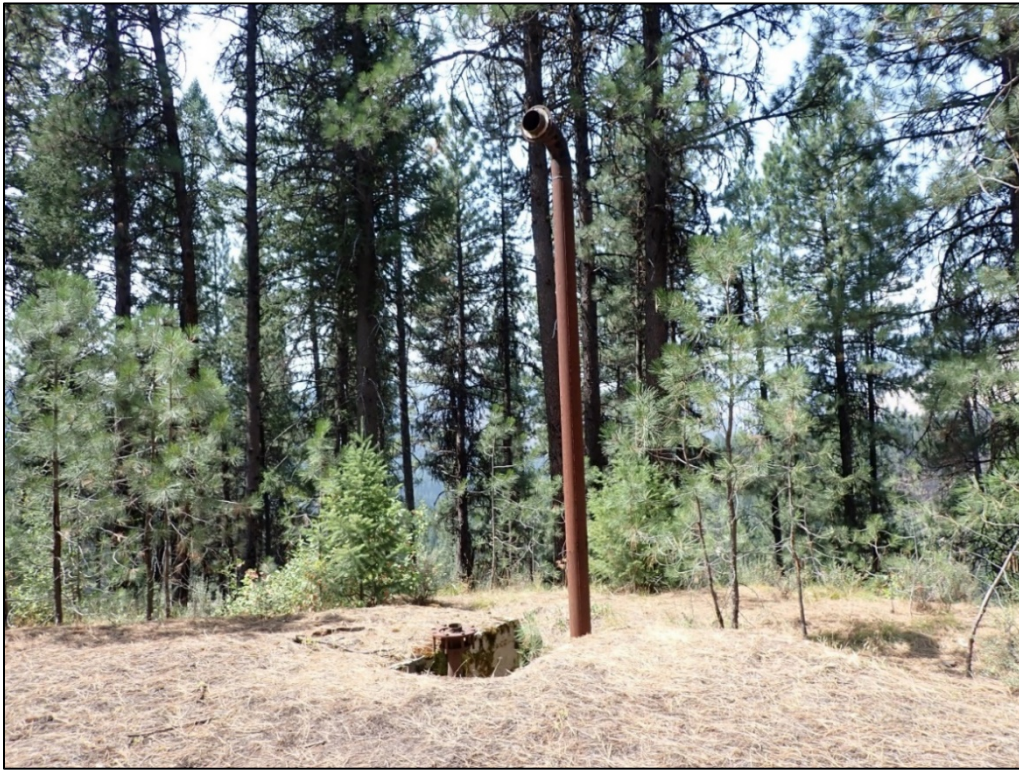
PL-6. Remains of Concrete and Piping from Former Milling Operations

The steep slopes east and south of the disposal cell are stable and vegetated with well-established ponderosa pines, shrubs, and grasses. Several features from historical milling operations remain on the steep hillside east of the disposal cell, including a water-supply ditch and the remains of a water piping system from former milling operations (PL-6). The slopes north and west of the disposal cell were highly disturbed during site remediation, but they are now stable and vegetated. No maintenance needs were identified.

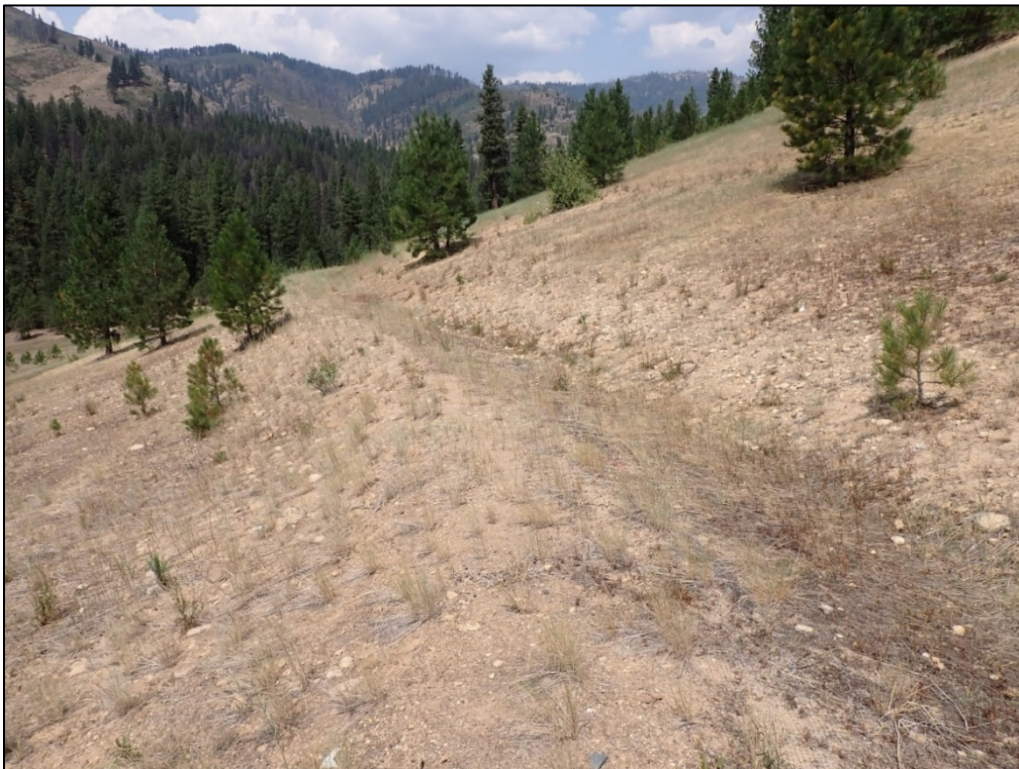
PL-7. Interceptor Bench 2

intercept stormwater runoff and route it offsite into Clear Creek. Over the years, minor erosion has breached the benches in several locations, and LM has repaired such erosion on numerous occasions, most recently in October 2016. The three interceptor benches (PL-7) and a collection ditch are inspected annually to ensure that erosion in this area does not affect overall site stability. During this year's inspection, the 2016 repairs appeared intact, and LM will continue to monitor the area as the vegetation continues to establish.
