10.0 Lowman, Idaho, Disposal Site

10.1 Compliance Summary

The Lowman, Idaho, Uranium Mill Tailings Radiation Control Act (UMTRCA) Title I Disposal Site was inspected on June 7, 2022. No changes were observed on the disposal cell or in the associated drainage features. Inspectors identified no maintenance needs and found no cause for a follow-up inspection. Groundwater monitoring is not required and was discontinued in 2004.

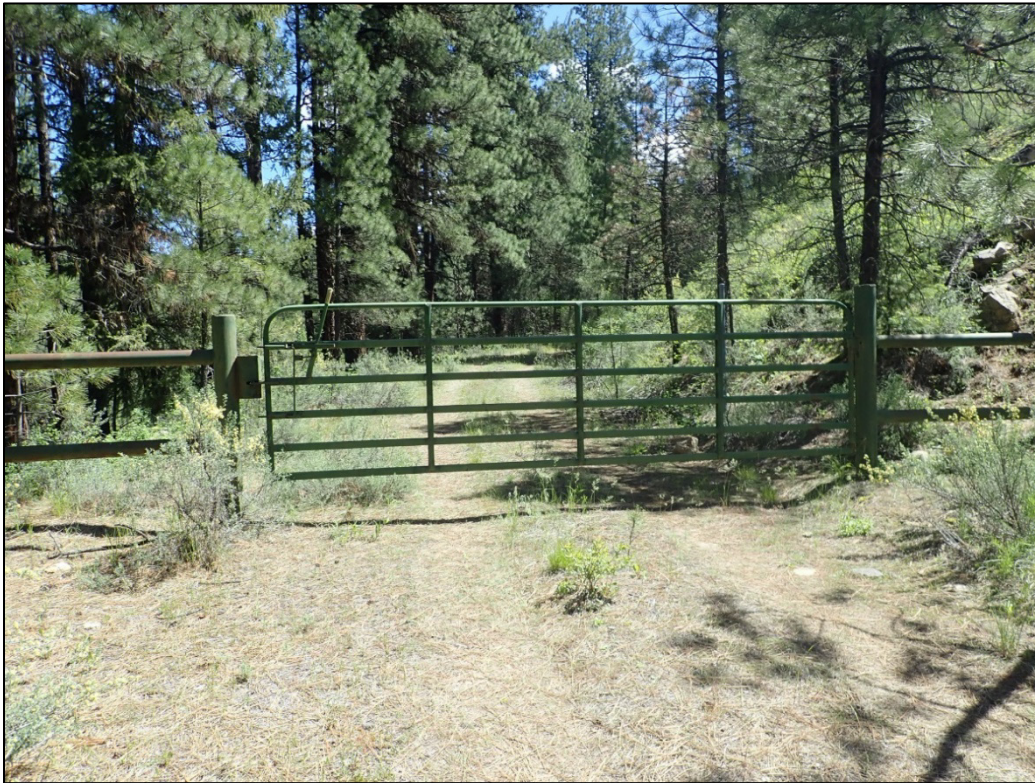
The site is about 650 feet (ft) north of Idaho Highway 21 and is accessed by a gravel road. A locked steel gate on the site access road is about 150 ft from the highway (PL-1). The site is not fenced, but the topography and mature forests prevent vehicle access around the entrance gate and along the property boundary. The entrance gate was locked and functional. The lock to the entrance gate was replaced with a new lock during the 2022 annual inspection. The access road was passable, and the entrance sign was present and legible. No maintenance needs were identified.

PL-1. Site Entrance Gate

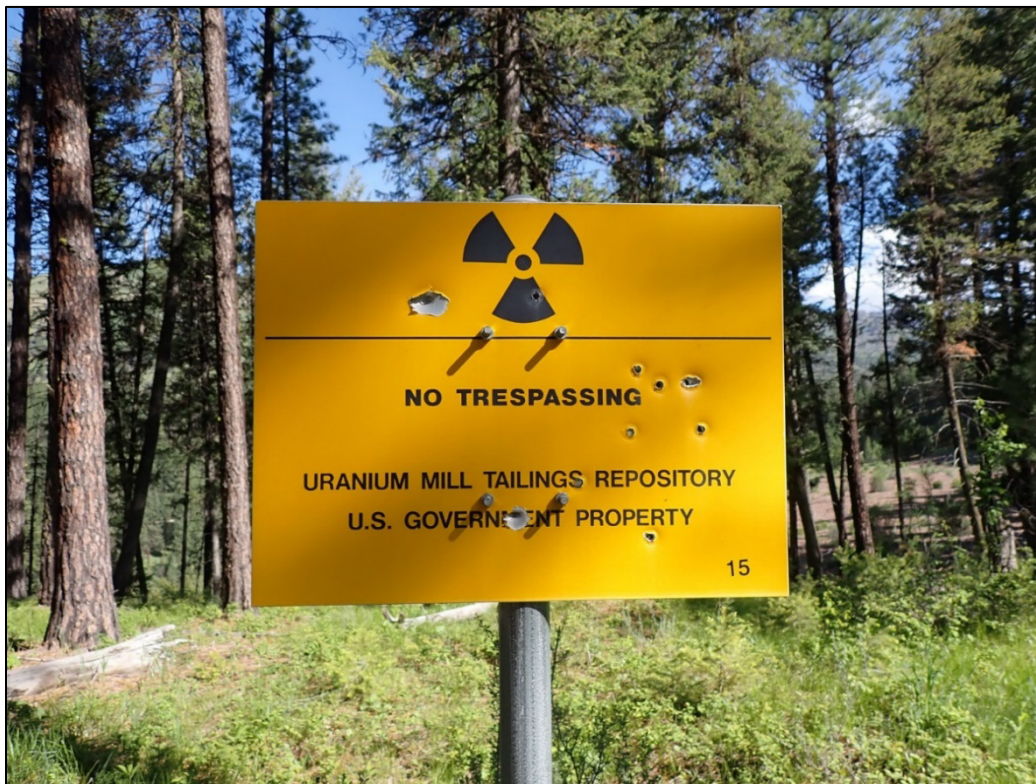
There are 18 perimeter signs attached to steel posts set in concrete positioned along the unfenced property boundary. Several perimeter signs (P3, P4, P13, and P15) have bullet damage but remain legible (PL-2). Perimeter sign P7 is slightly bent from treefall but remains legible. No maintenance needs were identified.

PL-2. Perimeter Sign P15 with Bullet Damage

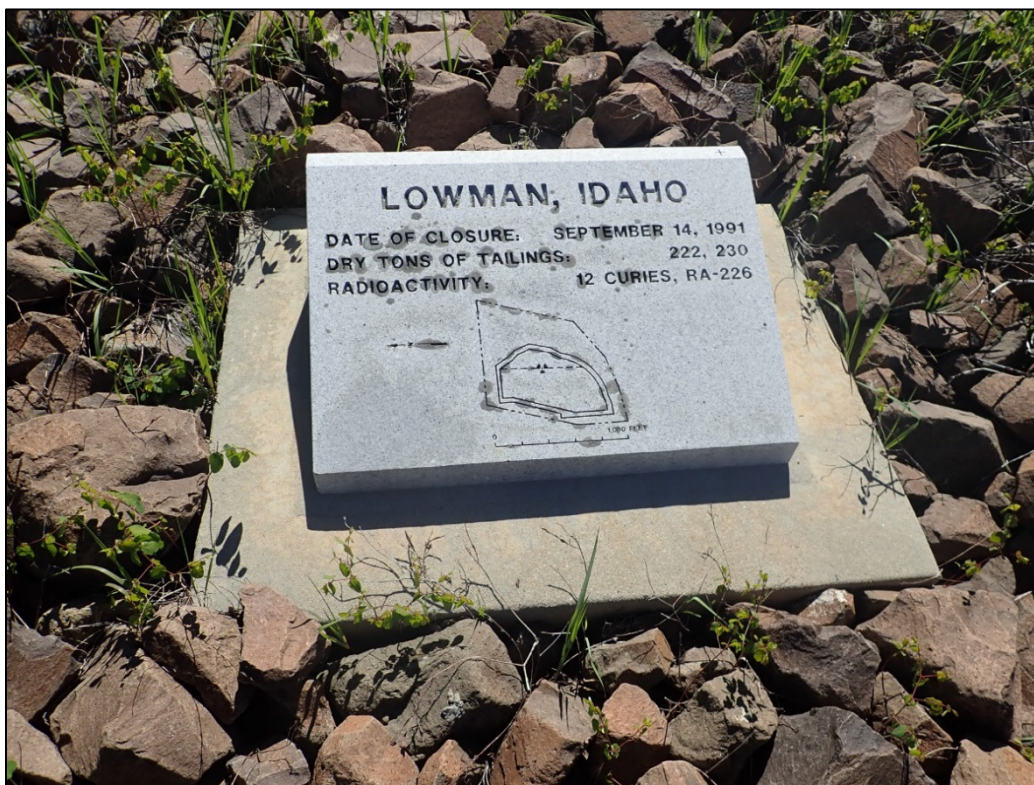
The site has two granite site markers. Site marker SMK-1 is just inside the southwest property boundary, and site marker SMK-2 (PL-3) is on the top slope of the disposal cell. No maintenance needs were identified.

PL-3. Site Marker SMK-2

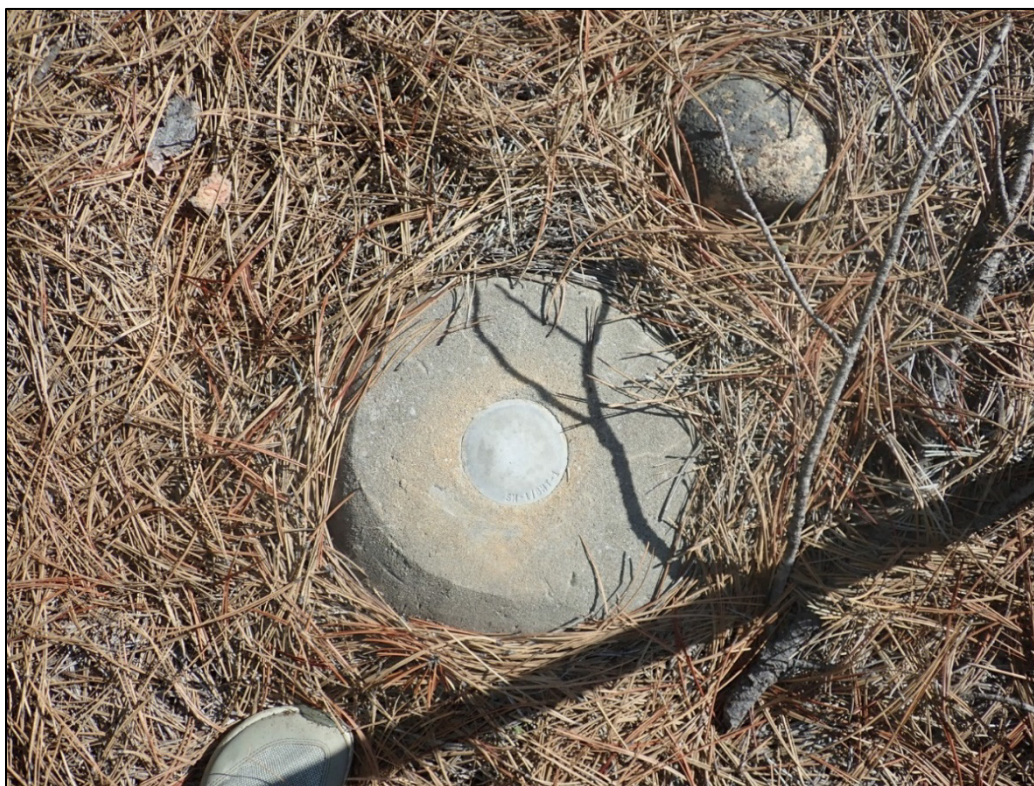
Three combined survey and boundary monuments (PL-4) and four boundary monuments delineate the property boundary. Steel T-posts are installed next to the survey and boundary monuments to help inspectors locate them. Several years ago, the U.S. Department of Agriculture (USDA) surveyed its lands managed by the U.S. Forest Service and placed boundary monuments along the shared DOE-USDA border. Inspectors noted that the survey monuments were about 5 to 15 ft outside DOE survey monuments. No maintenance needs were identified.

PL-4. Combined Survey and Boundary Monument 1

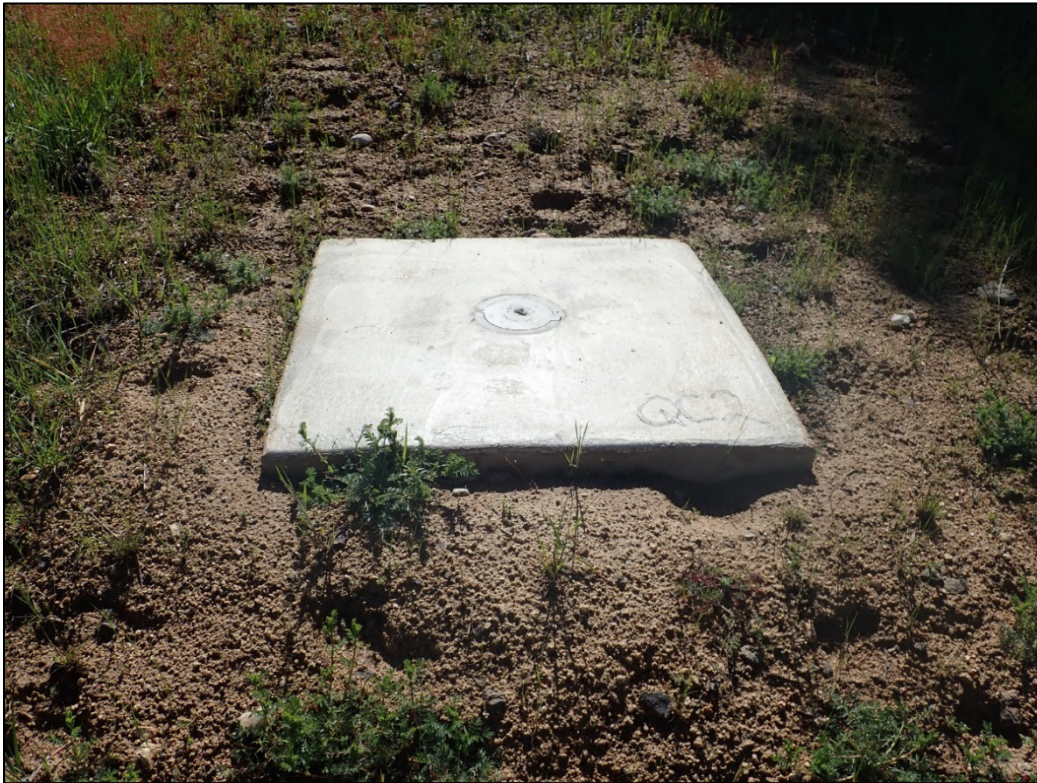
Three aerial survey quality control monuments were inspected during the 2022 annual inspection (PL-5). The baseline aerial survey is scheduled to be flown in 2023. No maintenance needs were identified.

PL-5. Quality Control Monument QC-2

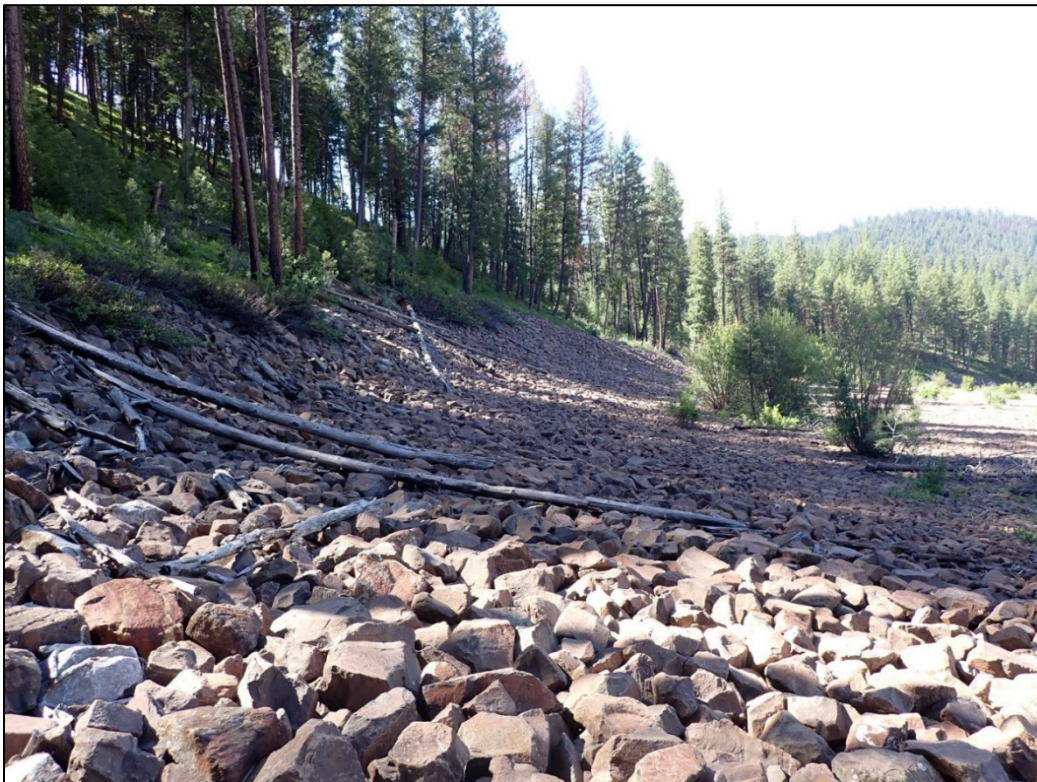
The disposal cell, completed in 1991, occupies 8.29 acres. The disposal cell top and side slopes are armored with basalt riprap to control erosion. An apron of larger riprap surrounds the disposal cell on all sides (PL-6). There was no evidence of erosion, settling, slumping, rock degradation, or other modifying processes that might affect the integrity of the disposal cell. An area of saturated soil was observed on the northwest side of the cell, confirming that the disposal cell is shedding precipitation appropriately.

PL-6. Disposal Cell Apron on Eastern Side

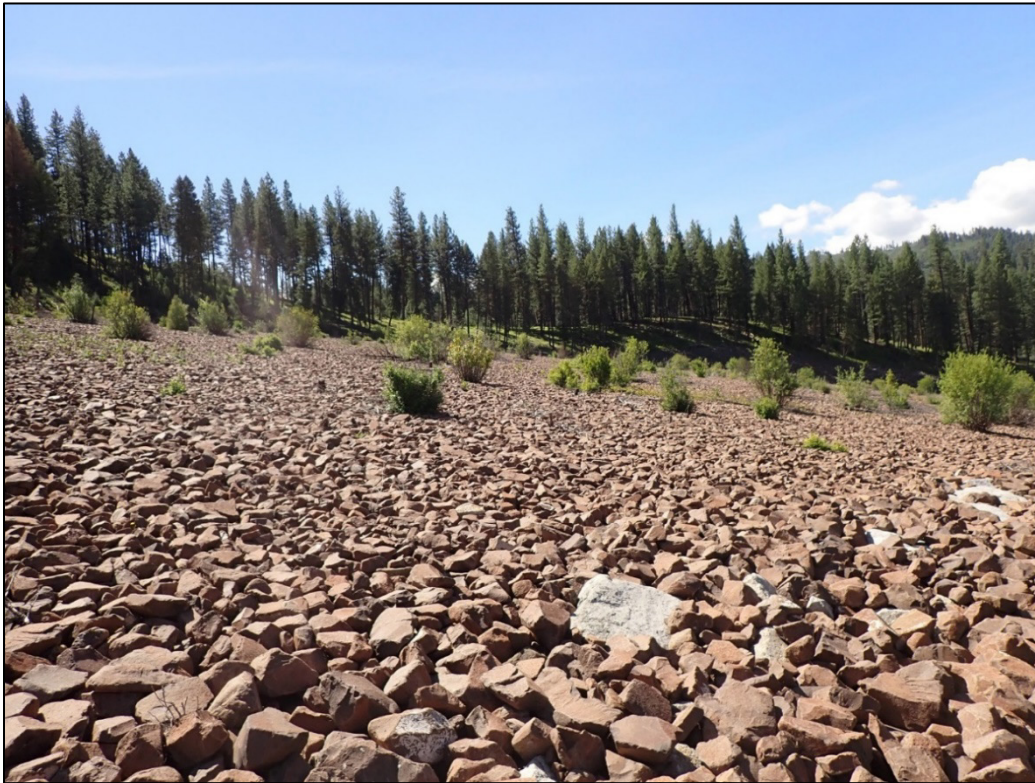
Natural vegetation continues to encroach on the top and side slopes of the disposal cell. Although the LTSP states that control of vegetation growth on the cell is not needed, LM concluded that controlling the growth of conifers—primarily ponderosa pine, but also Douglas fir—would be a best management practice. Mature conifers could potentially become uprooted during windstorms and damage the surface of the disposal cell. Other plants growing on the disposal cell do not threaten the integrity of the disposal cell and are not controlled (PL-7). Numerous ponderosa pine trees were cut down and left in place in 2018. Additional ponderosa pine and Douglas fir trees have established since then and are large enough to require evaluation and potential control. Inspectors will continue to monitor this area. No other maintenance needs were identified.

PL-7. Disposal Cell Top Slope

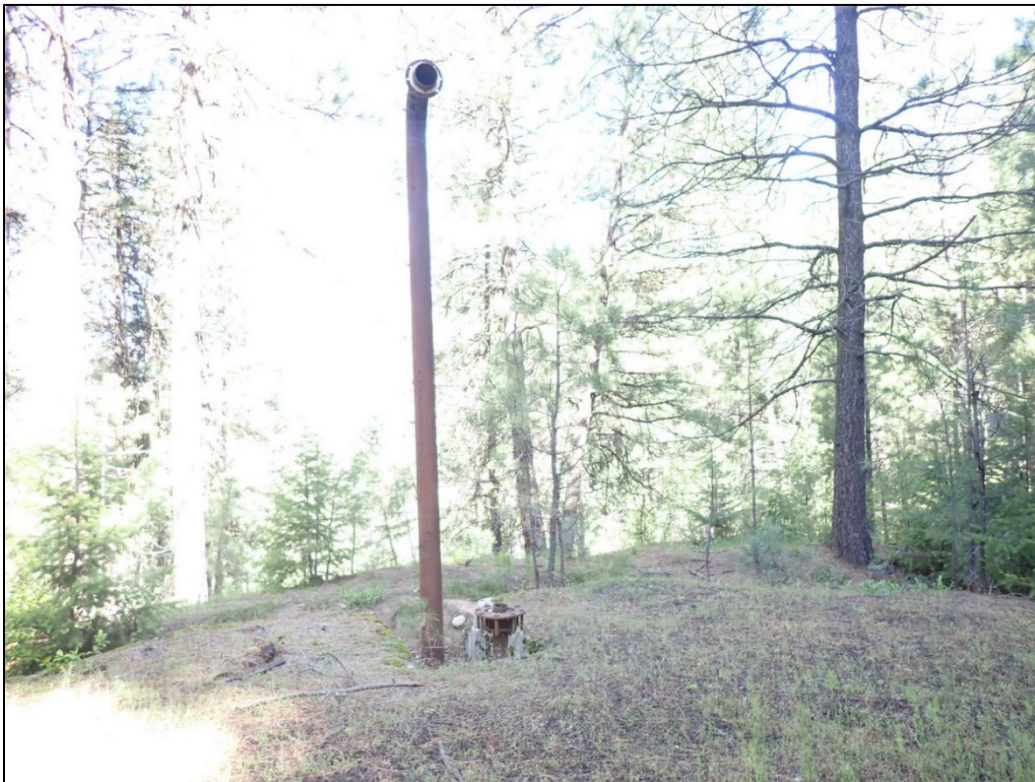
The steep slopes east and south of the disposal cell are stable and vegetated with well-established conifers, shrubs, and grasses. Several features from historical milling operations remain on the steep hillside east of the disposal cell, including a water-supply ditch and the remains of a water piping system from former milling operations (PL-8). The slopes north and west of the disposal cell were highly disturbed during site remediation, but they are now stable and vegetated. No maintenance needs were identified.

PL-8. Piping from Former Mill

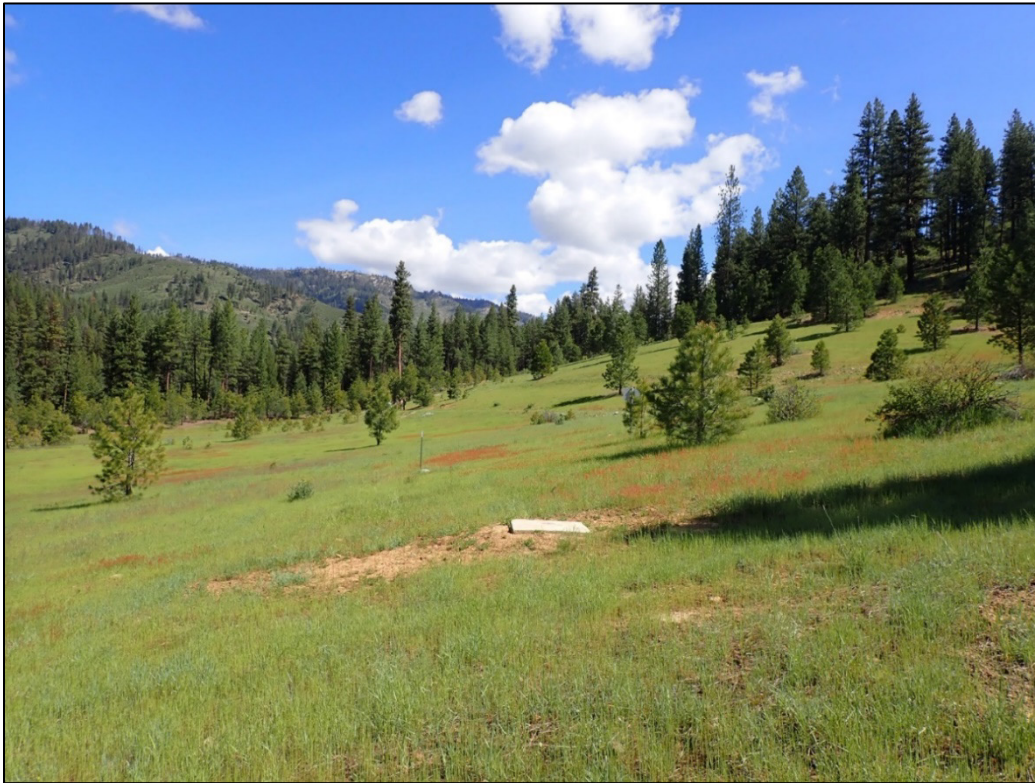
The reclaimed area north of the disposal cell and outside the site boundary is a steep area owned by the state that was disturbed during site remediation. LM installed three interceptor benches across the steep slope in this area in 1998 to intercept stormwater runoff and route it offsite into Clear Creek (PL-9). Over the years, minor erosion has breached the benches in several locations, and LM has repaired this erosion. Rock armoring has been very successful in preventing further erosion, and vegetation has become well established. No maintenance needs were identified.

PL-9. Interceptor Benches with Quality Control Monument QC-2 in Foreground
