10.0 Lowman, Idaho, Disposal Site

10.1 Compliance Summary

Figure 10-1. 2023 Annual Inspection Drawing for the Lowman, Idaho, Disposal Site

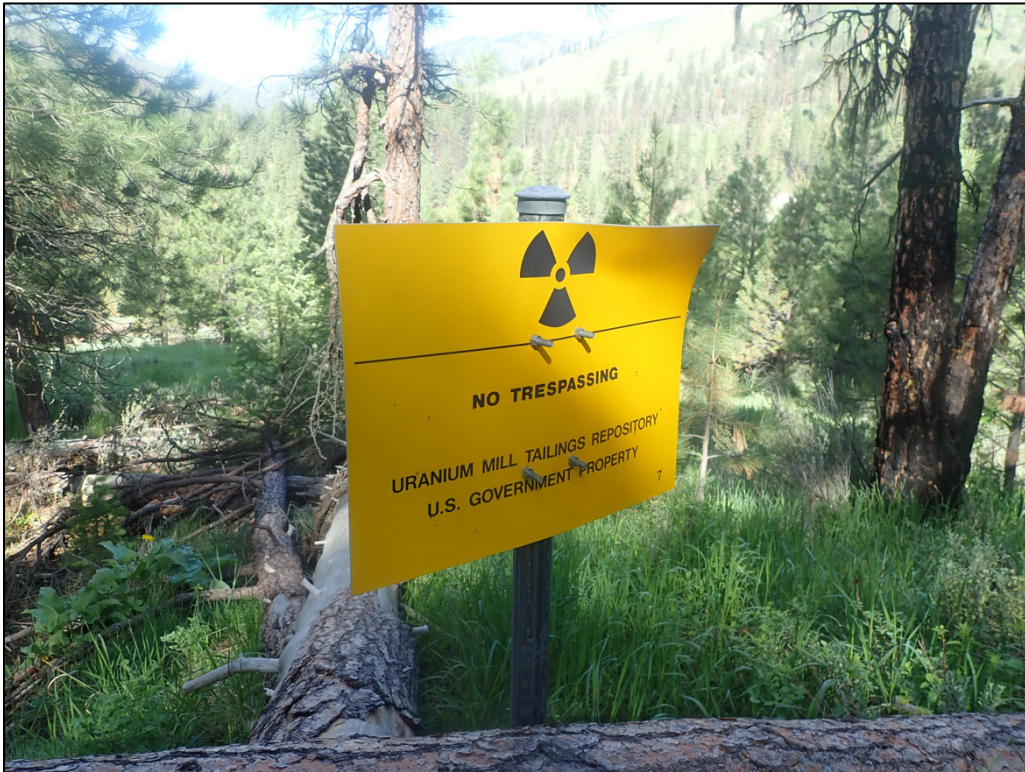
There are 18 perimeter signs attached to steel posts set in concrete and positioned along the unfenced property boundary. Several perimeter signs (P3, P4, P13, and P15) have bullet damage but remain legible. Perimeter sign P7 is slightly bent from treefall but remains legible (PL-1). No maintenance needs were identified.

PL-1. Bent Perimeter Sign P7

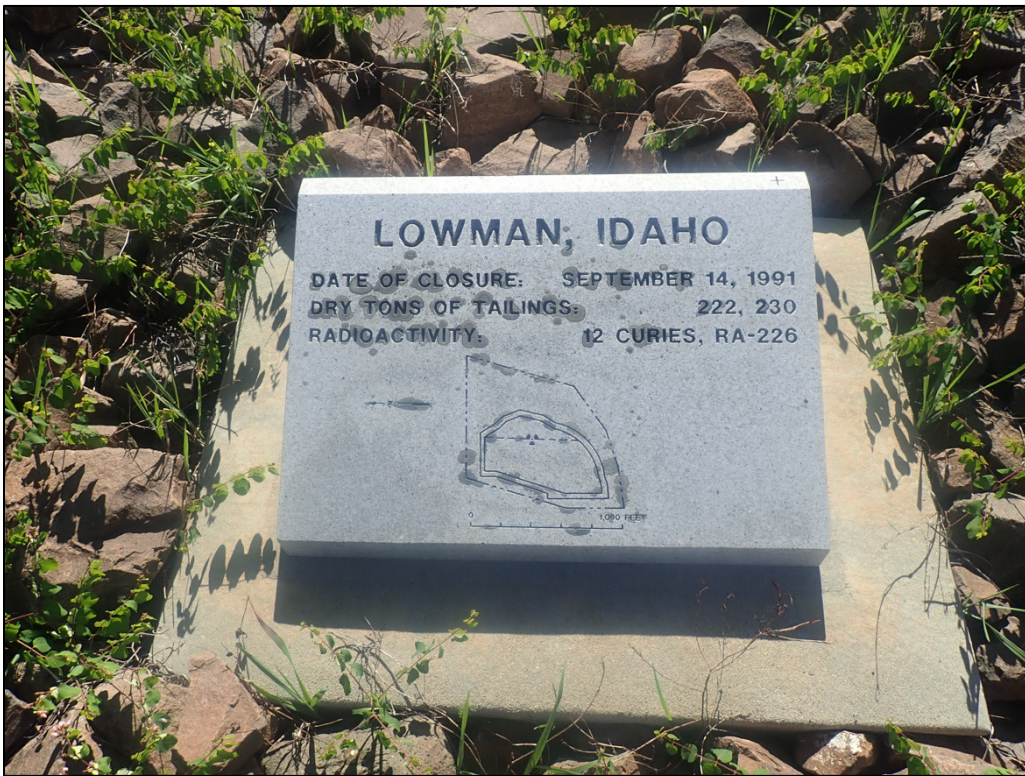
The site has two granite site markers. Site marker SMK-1 is just inside the southwest property boundary, and site marker SMK-2 (PL-2) is on the top slope of the disposal cell. No maintenance needs were identified.

PL-2. Site Marker SMK-2

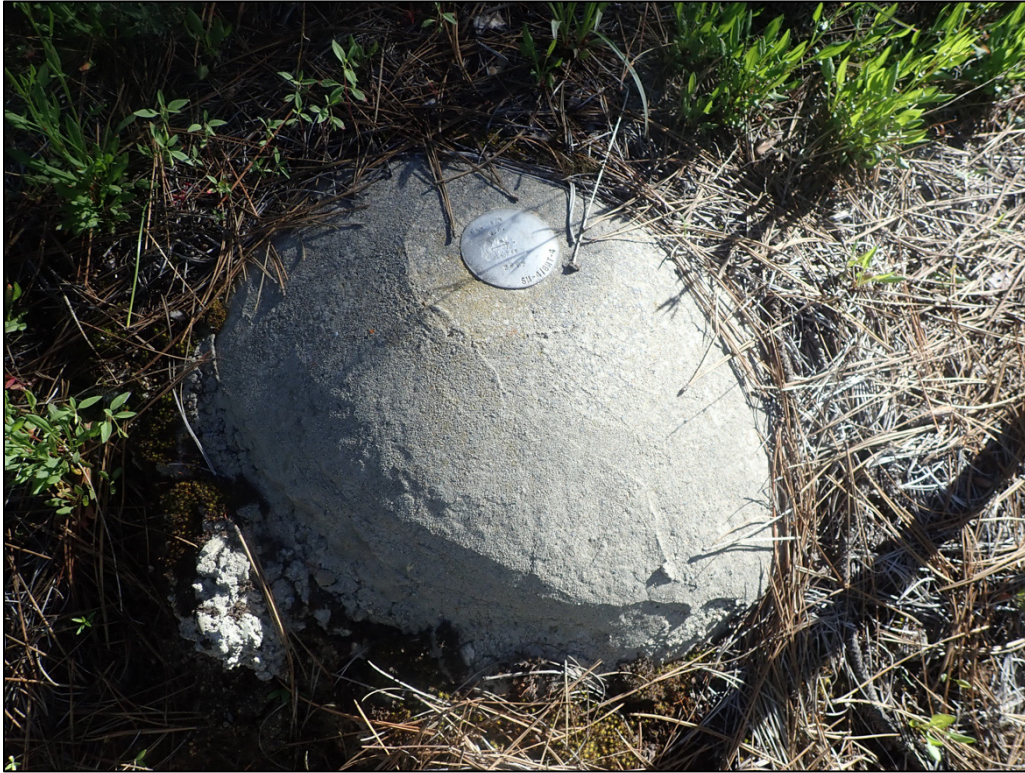
Three combined survey and boundary monuments (PL-3) and four boundary monuments delineate the property boundary. Steel T-posts are installed next to the survey and boundary monuments to help inspectors locate them. Several years ago, the U.S. Department of Agriculture (USDA) surveyed its lands managed by the U.S. Forest Service and placed boundary monuments along the shared DOE-USDA border. Inspectors noted that the survey monuments were about 5 to 15 ft outside DOE survey monuments. No maintenance needs were identified.

PL-3. Combined Survey Monument and Boundary Monument 4

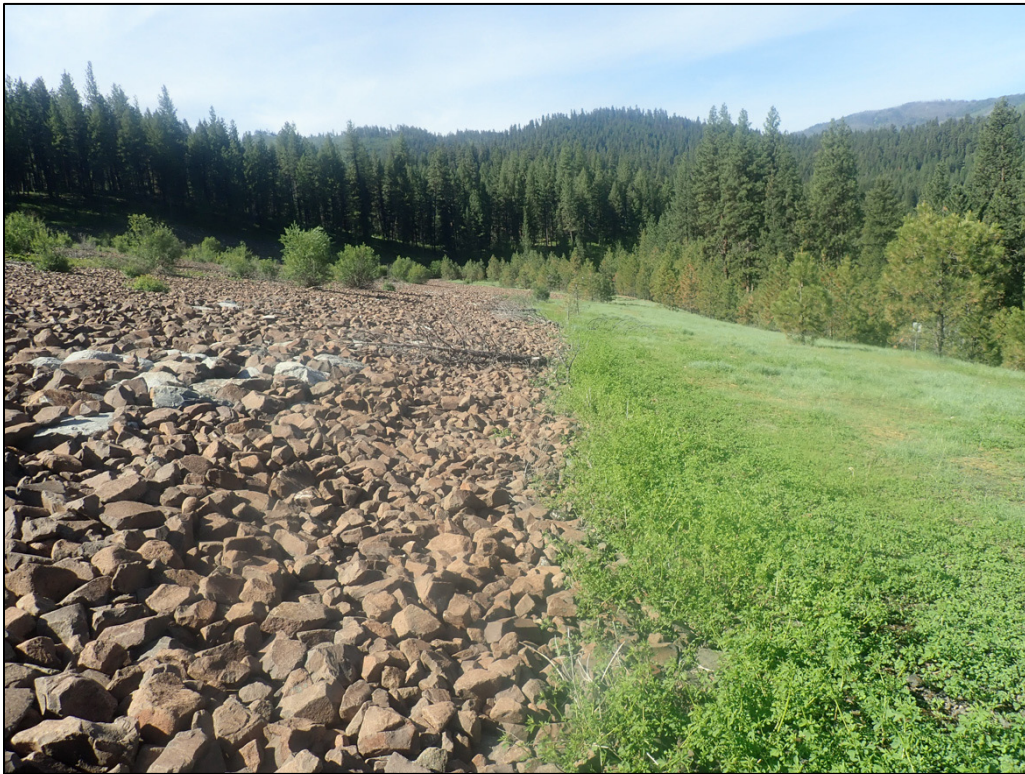
The disposal cell, completed in 1991, occupies 8.29 acres. The disposal cell top and side slopes are armored with basalt riprap to control erosion. An apron of larger riprap surrounds the disposal cell on all sides (PL-4). There was no evidence of erosion, settling, slumping, rock degradation, or other modifying processes that might affect the integrity of the disposal cell. A saturated soil area was observed on the northwest side of the cell, confirming that the disposal cell is shedding precipitation appropriately.

PL-4. Disposal Cell Apron

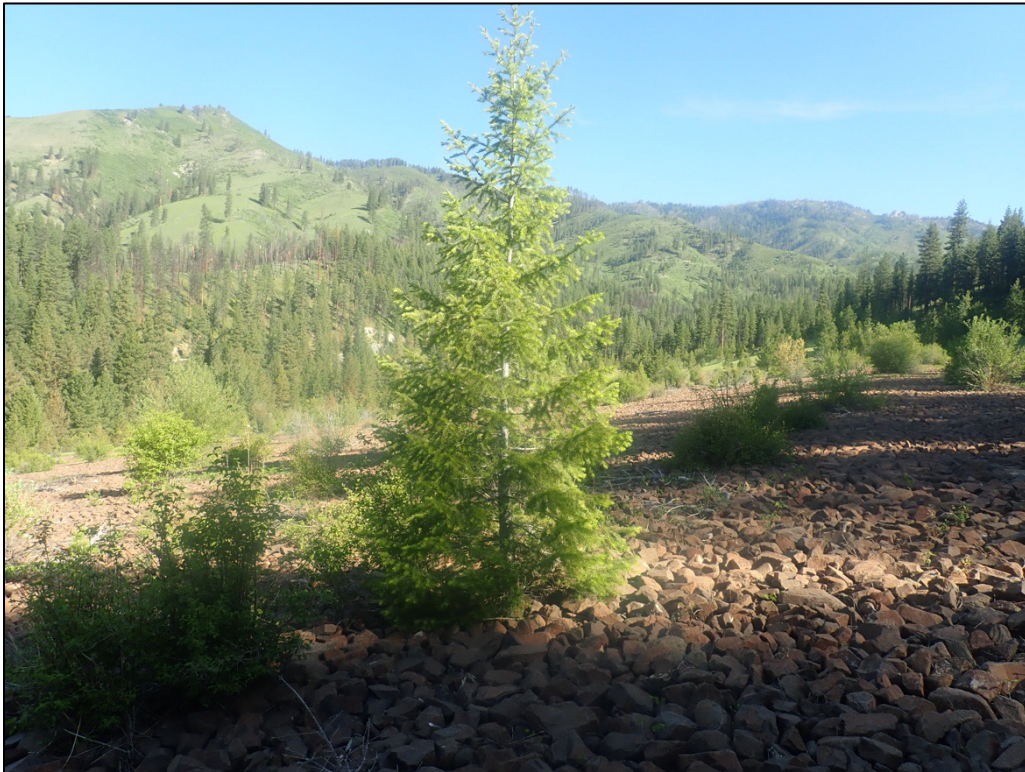
Natural vegetation continues to encroach on the top and side slopes of the disposal cell. Although the LTSP states that control of vegetation growth on the cell is not needed, LM concluded that controlling the growth of conifers—primarily ponderosa pine, but also Douglas fir—would be a best management practice. Mature conifers could potentially become uprooted during windstorms and damage the surface of the disposal cell. Numerous ponderosa pine trees were cut down in 2018. Additional ponderosa pine and Douglas fir trees have established since then and were removed following the inspection (PL-5). Other plants growing on the disposal cell do not threaten the integrity of the disposal cell and are not controlled. Inspectors will continue to monitor this area. No other maintenance needs were identified.

PL-5. Trees on Disposal Cell

Inspectors noted that treatment of the coniferous ponderosa pine and Douglas fir trees on the disposal cell cover was needed. The trees were treated following the inspection. No other maintenance needs were identified.

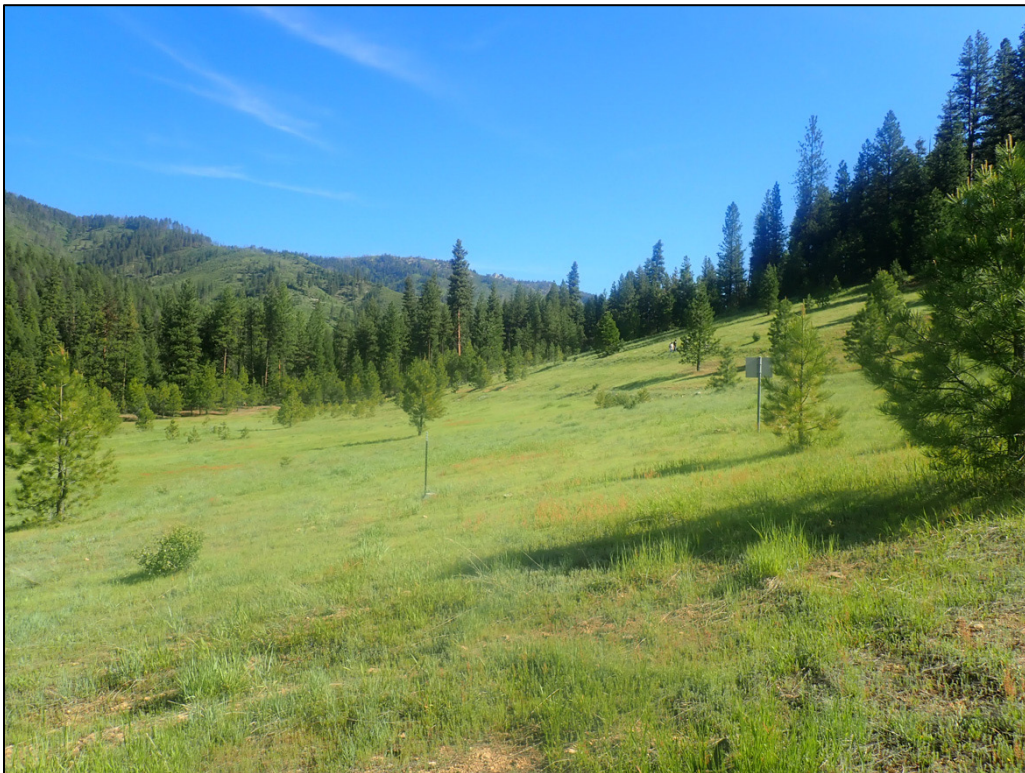
The steep slopes east and south of the disposal cell are stable and vegetated with well-established conifers, shrubs, and grasses. Several features from historical milling operations remain on the steep hillside east of the disposal cell, including a water-supply ditch and the remains of a water piping system from former milling operations. The slopes north and west of the disposal cell were highly disturbed during site remediation, but they are now stable and vegetated (PL-6). No maintenance needs were identified.

PL-6. Vegetated Area North of Disposal Cell

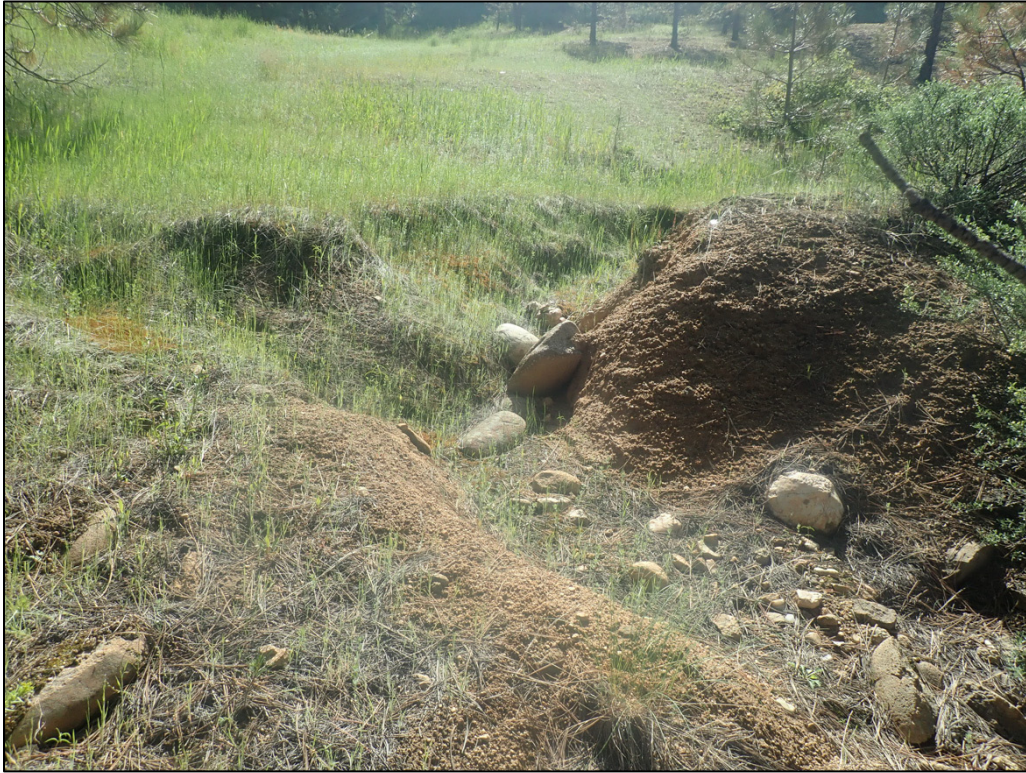
Clear Creek. Over time, minor erosion has breached the benches in several locations, and LM repaired this erosion in 2016. Rock armoring has been very successful in preventing further erosion, and vegetation has become well established. Minor erosion was noted within and around the geocell grid on the north end of the interceptor benches where they are routed into Clear Creek (PL-7). This will continue to be monitored. No maintenance needs were identified.

PL-7. Erosion on North Side of Interceptor Benches
