## 10.0 Lowman, Idaho, Disposal Site

### 10.1 Compliance Summary

The Lowman, Idaho, Uranium Mill Tailings Radiation Control Act (UMTRCA) Title I Disposal Site was inspected on May 14, 2024. No significant changes were observed on the disposal cell or in the associated drainage features. Inspectors identified minor maintenance needs that were completed following the inspection but found no cause for a follow-up inspection. Groundwater monitoring is not required and was discontinued in 2004.

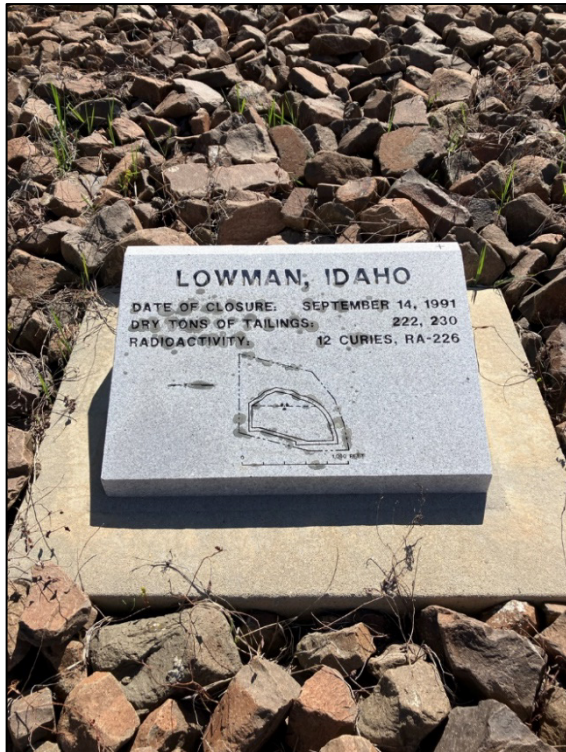
The site has two granite site markers. Site marker SMK-1 is just inside the southwest property boundary, and site marker SMK-2 (PL-2) is on the top slope of the disposal cell. No maintenance needs were identified.

*PL-2. Site Marker SMK-2*

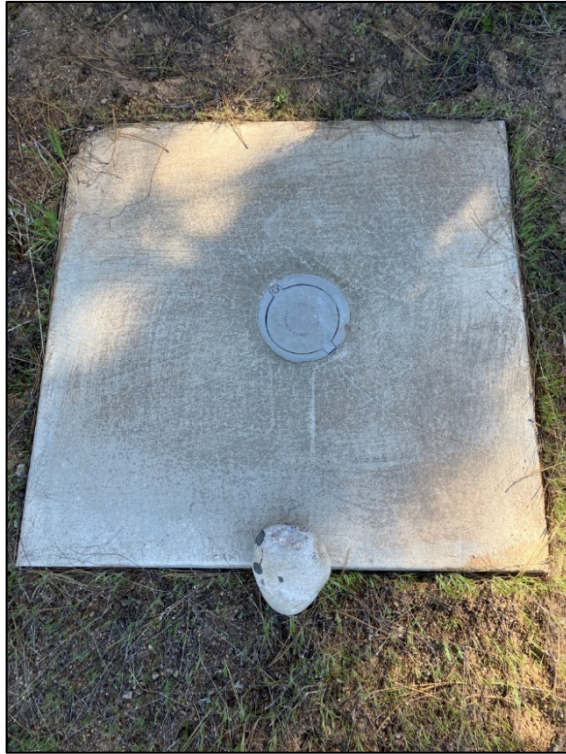
Three aerial survey quality control monuments were inspected during the 2024 annual inspection (PL-3). No maintenance needs were identified.

*PL-3. Quality Control Monument QC-1*

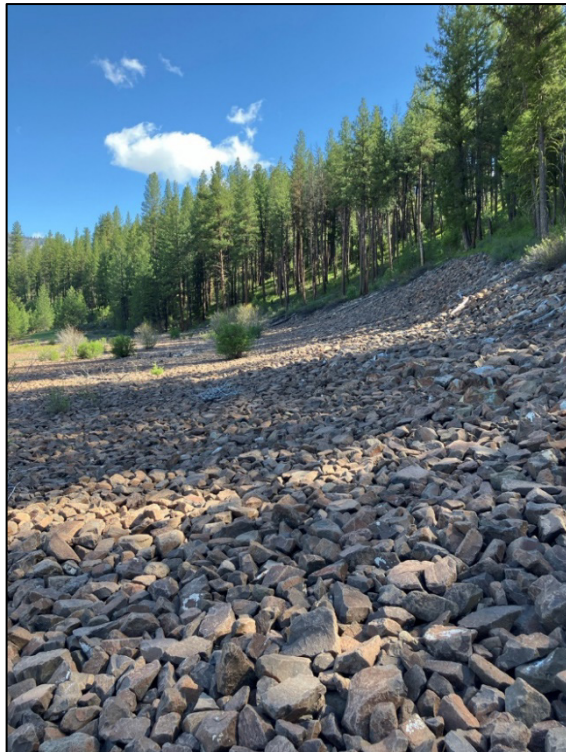
The disposal cell, completed in 1991, occupies 8.29 acres. The disposal cell top and side slopes are armored with basalt riprap to control erosion (PL-4). An apron of larger riprap surrounds the disposal cell on all sides. There was no evidence of erosion, settling, slumping, rock degradation, or other modifying processes that might affect the integrity of the disposal cell. A saturated soil area was observed on the northwest side of the cell, confirming that the disposal cell is shedding precipitation appropriately (PL-5).

*PL-4. Eastern Side of Disposal Cell*

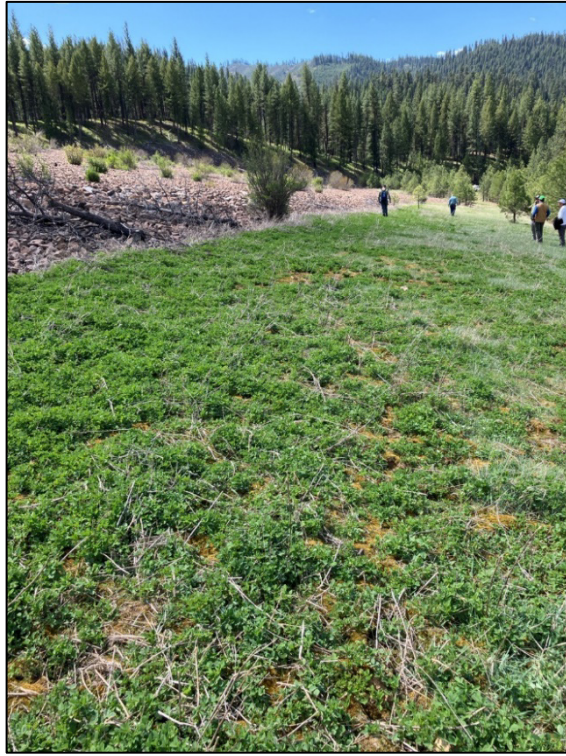
*PL-5. Vegetation Growing in Saturated Soil Area*

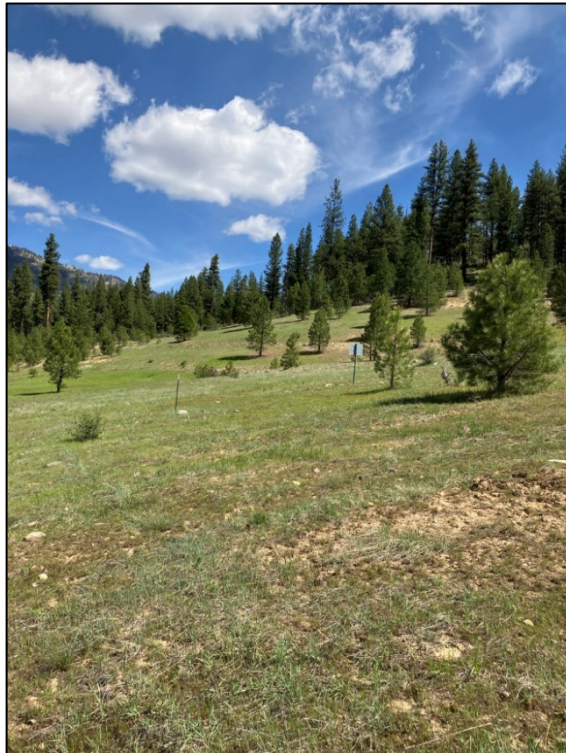
The reclaimed area north of the disposal cell and outside the site boundary is a steep area, owned by the state, that was disturbed during site remediation. LM installed three interceptor benches across the steep slope in this area in 1998 to intercept stormwater runoff and route it offsite into Clear Creek (PL-6). Over time, minor erosion has breached the benches in several locations, and LM repaired this erosion in 2016. Rock armoring has been very successful in preventing further erosion, and vegetation has become well established. Minor erosion was noted within and around the geocell grid on the north end of the interceptor benches where they are routed into Clear Creek (PL-7). This will continue to be monitored. Weeds were found growing on the North and South ends of the interceptor benches and were treated following the inspection. No other maintenance needs were identified.

*PL-6. Interceptor Benches*

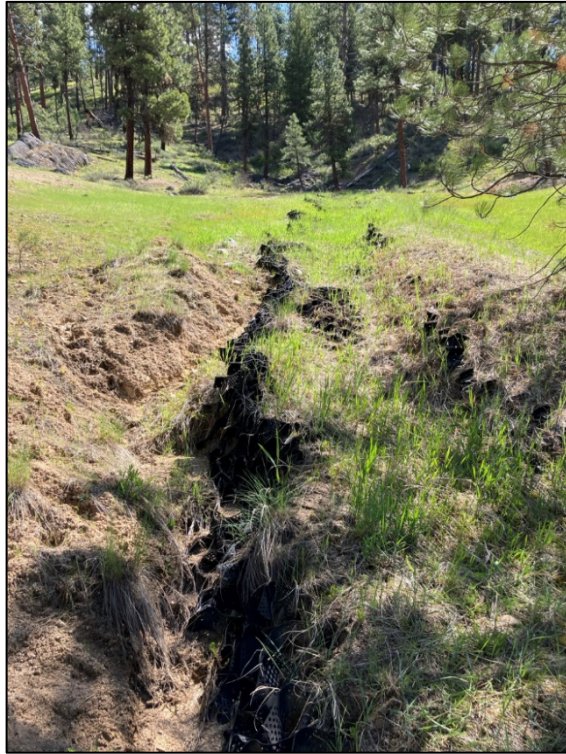
*PL-7. Erosion on North Interceptor Bench*
