4.0 Durango, Colorado, Disposal Site

4.1 Compliance Summary

4.3.1 Annual Inspection and Report

The site, located southwest of Durango, Colorado, was inspected on May 28, 2008. Results of the inspection are described below. Features and photograph locations (PLs) discussed in this

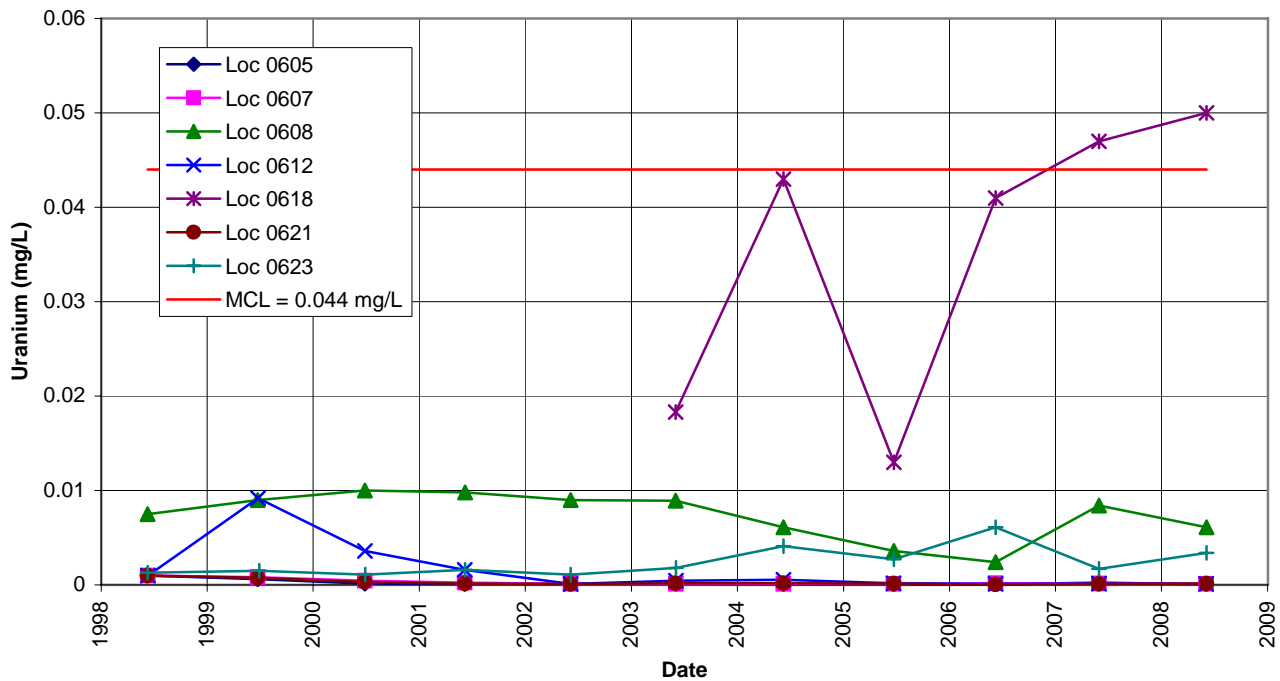
Figure 4-2. Time-Concentration Plot of Uranium in Groundwater at the Durango Disposal Site

Uranium concentrations increased in monitor wells MW-0618 and MW-0623, and selenium increased in well MW-0623. Analytical results from all other locations are on trend with previous results.

In 2008, the most significant groundwater monitoring result reported was the uranium concentration in well MW-0618, where concentrations in the last two sampling events have exceeded the MCL. The uranium concentration of 0.05 mg/L reported in 2008 from this well is consistent with the 2007 value, and shows an increasing trend from the 2005 data. However, with only six data points available, trend analysis for this well is inconclusive for this constituent, and additional monitoring is needed. As mentioned previously, an evaluation of the uranium concentrations in this well is being performed in conjunction with the treatment system closure. All other concentrations of uranium, along with all concentrations of both selenium and molybdenum, remain on trend and well below their respective MCLs.

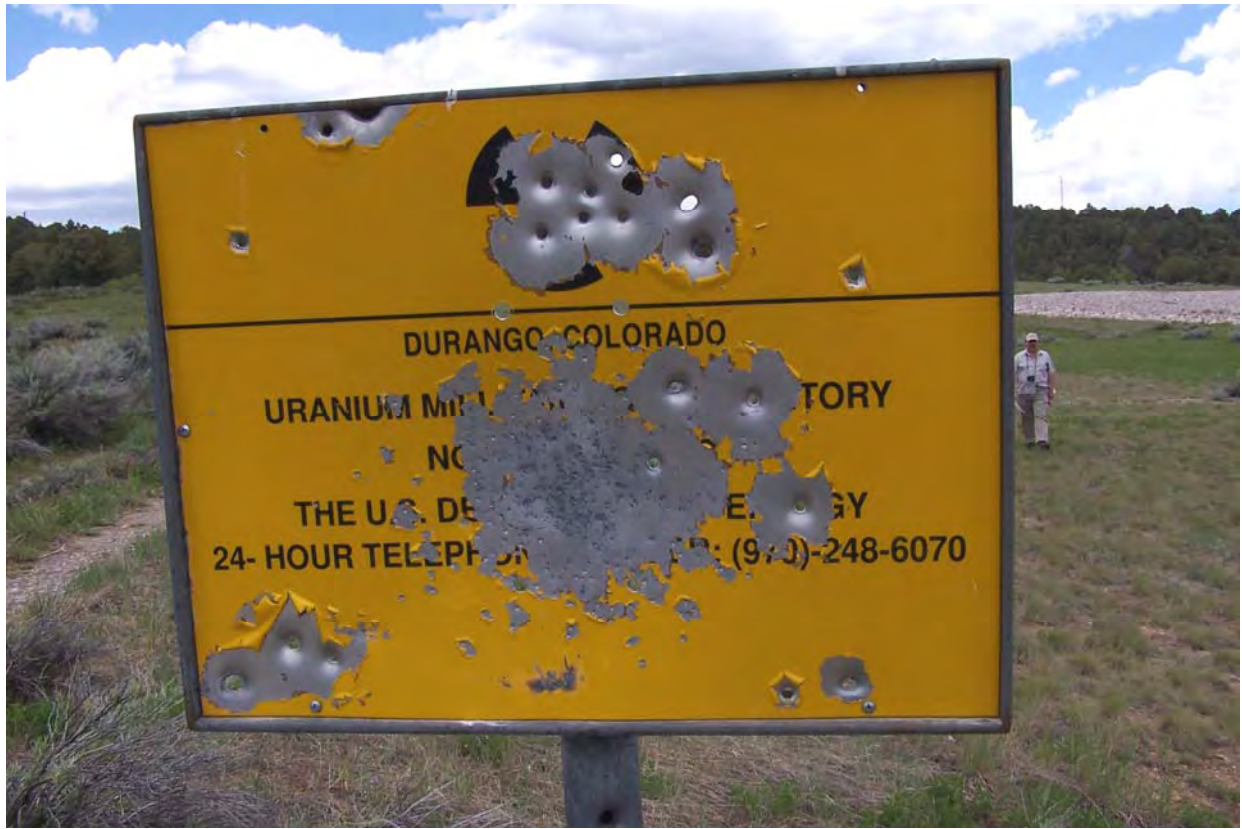
- 4A The entrance sign, which had been vandalized by buckshot and no longer legible (PL–1), was replaced. Numerous other perimeter signs have bullet holes but remain legible. Perimeter signs P1 and P82 were missing and have been replaced. Perimeter sign P2 has been stolen a number of times and is no longer being replaced as adjacent signs are within sight. The site remains well delineated by the 81 other perimeter signs. The bases of perimeter signs P41 and P44 (PL–2) are being undercut by erosion but currently remain stable.

DUR 5/2008. PL-1. Entrance sign prior to replacement.

In 2008, the entrance sign and perimeter signs P1 and P82 were replaced. Noxious weeds were treated with herbicide.

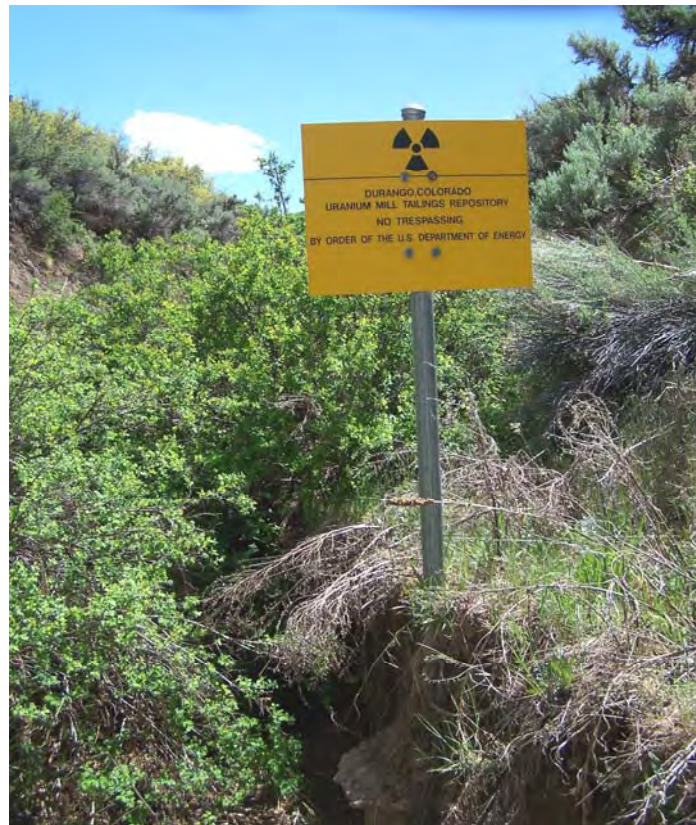
DUR 5/2008. PL-2. Undercutting at perimeter sign P44.

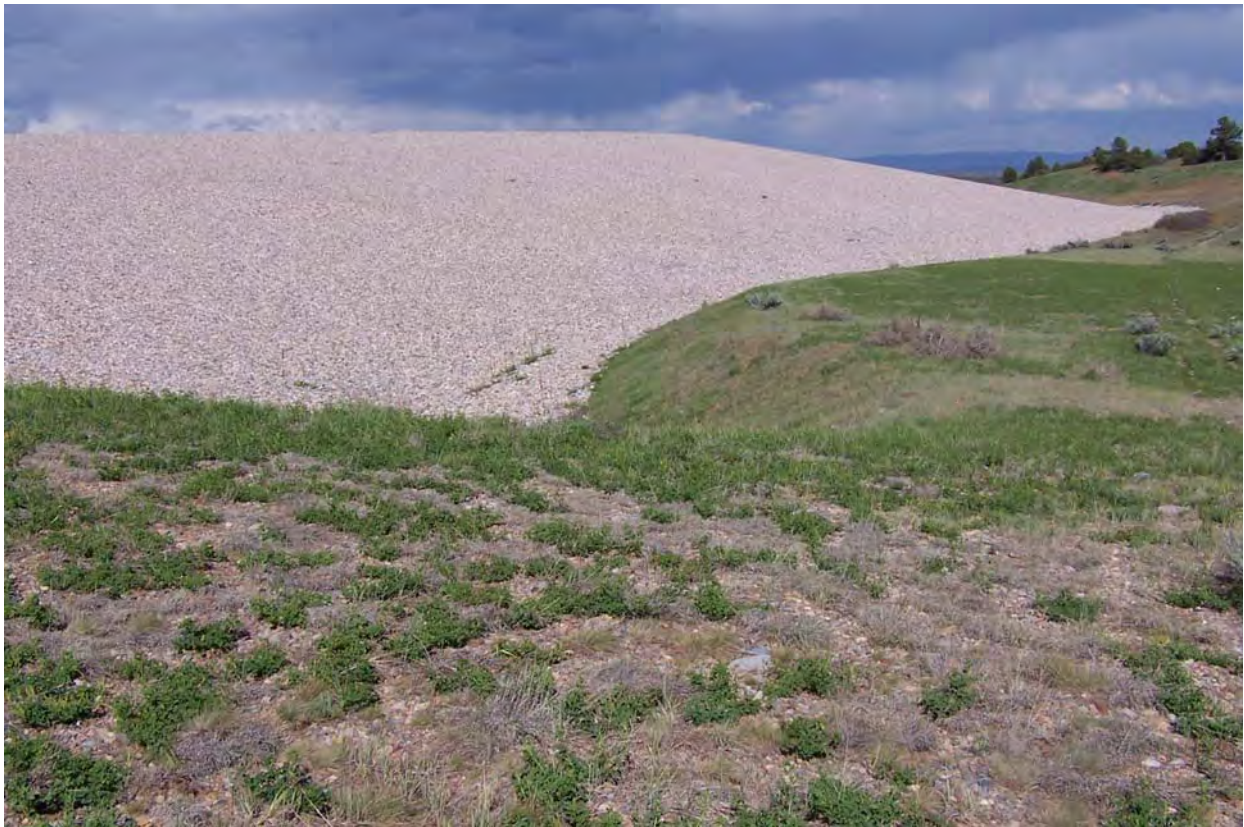
4B Deep-rooted woody shrubs and trees were treated with herbicide in 2006, and woody species observed on the cell in 2008 were all shorter than the 3.5-foot criterion (PL-3). Three noxious weed species—musk thistle, Canada thistle, and bull thistle—continue to populate the side slopes. These plants have been treated with herbicide since 2002 by a commercial applicator, and their populations have decreased significantly. They were most recently treated in June and September 2008.

DUR 5/2008. PL-3. South side slope of cell; note absence of woody vegetation.

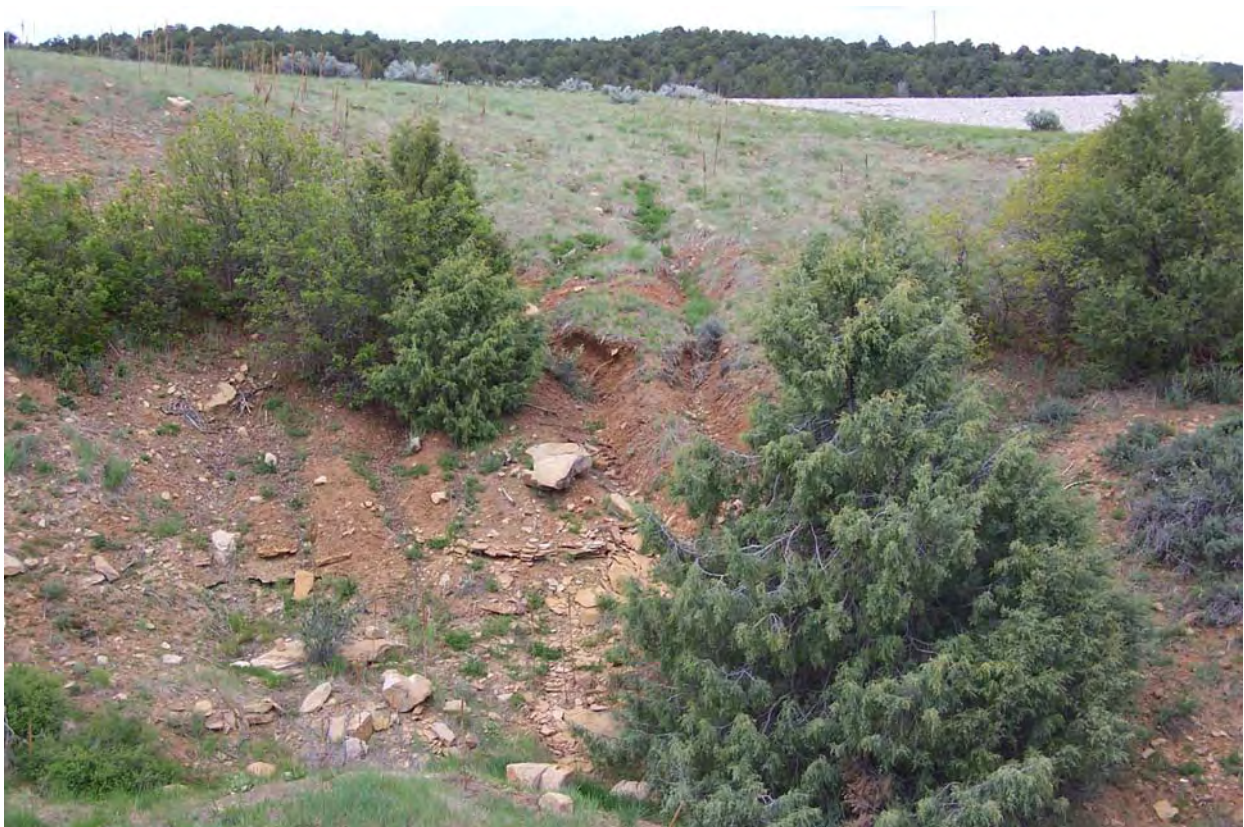
Historical rill and gully erosion has occurred at various locations on site, but most are in the process of stabilizing, and none are currently threatening the performance of the disposal cell or its associated surface water diversion structures. The establishment of vegetation and exposure of resistant bedrock in the gullies are effectively preventing further erosion in most of the gullies (PL-4). DOE will continue to monitor the site for active erosion.

DUR 5/2008. PL-4. Headcuts of gullies below southwest corner of disposal cell.
