Verification Monitoring Report for the Durango, Colorado, Processing Site

September 2009

U.S. DEPARTMENT OF
ENERGY

Legacy
Management

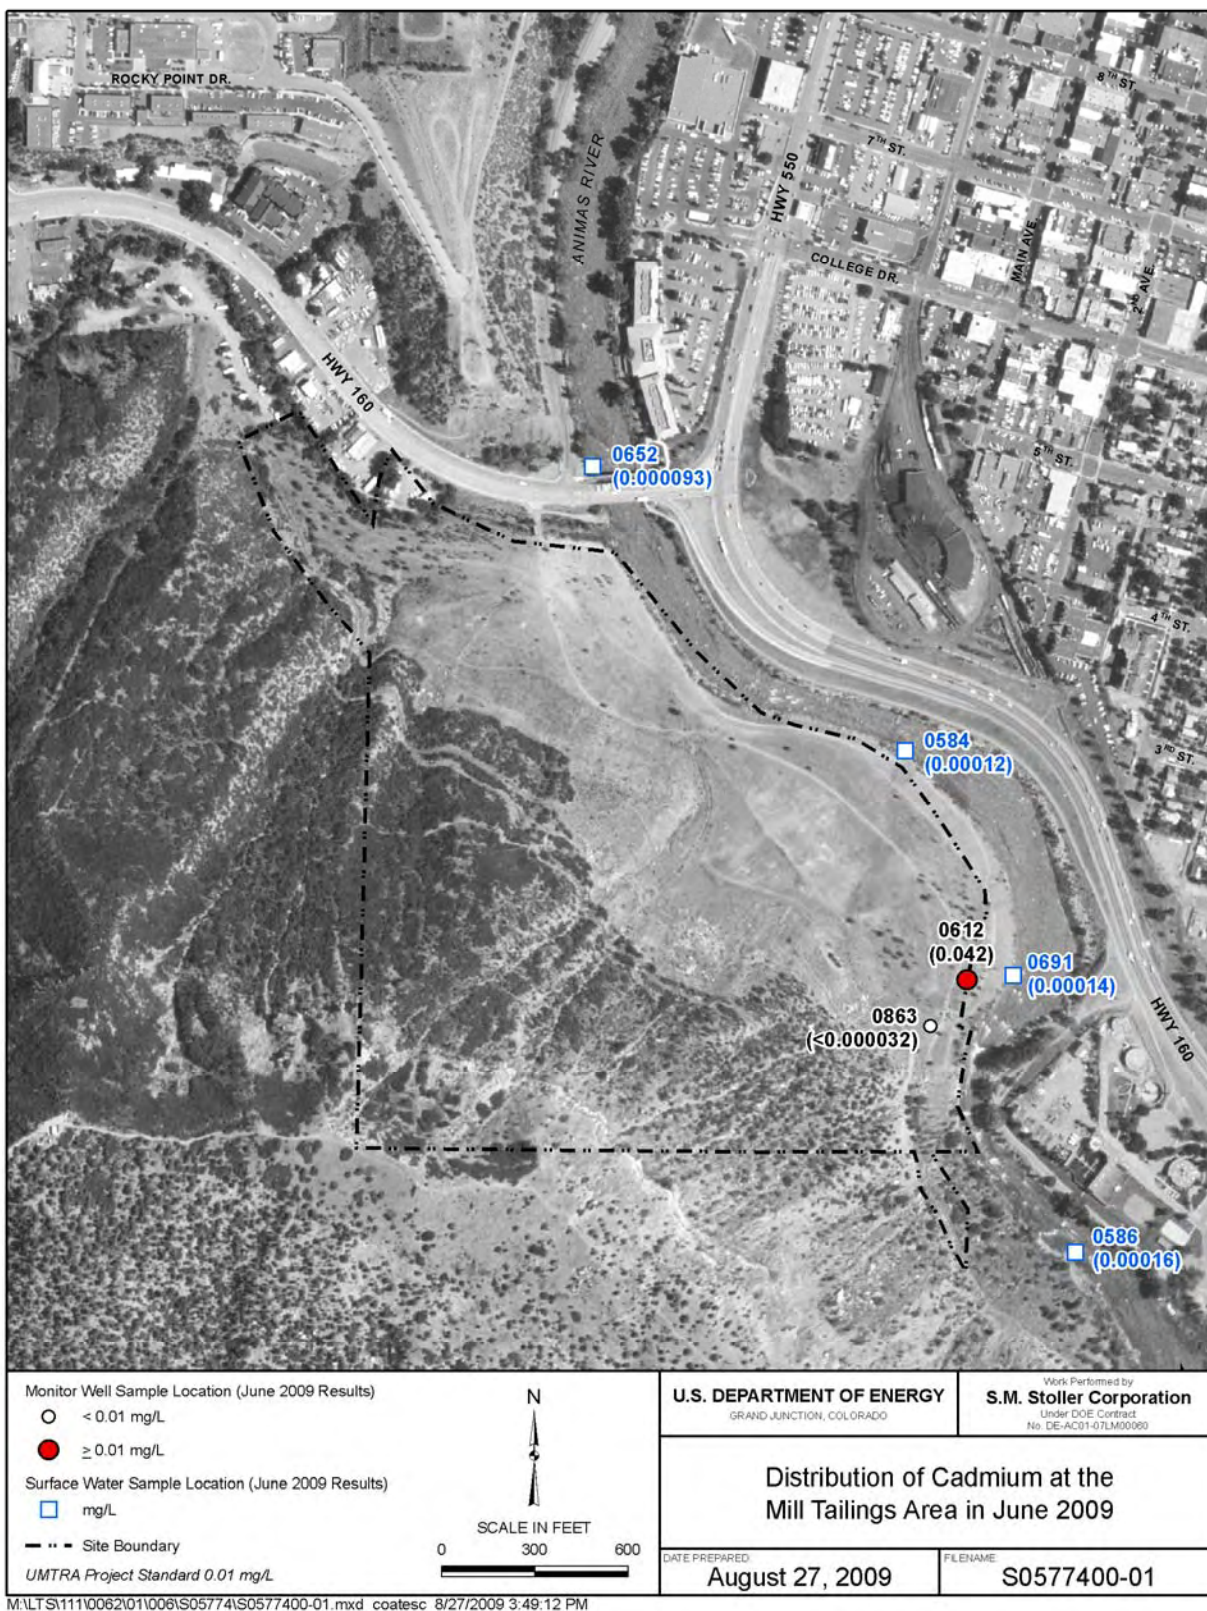
Figure 4. Distribution of Cadmium at the Mill Tailings Area

Figure 4 is a map view of the site showing the concentration of cadmium in groundwater at the compliance wells in June 2009. Figure 5 shows observed cadmium concentrations versus time at the compliance wells since completion of remedial action in 1992. Historically, and in June 2009, cadmium in excess of the MCL occurs only at well 0612, while the remaining monitor wells contained only trace levels of this constituent. Groundwater modeling predicted a flushing period of about 500 years for cadmium (Figure 6). This result is not consistent with historical trending at well 0612, which (if projected linearly from 1992 beyond June 2009) implies compliance for cadmium by about year 2021, or 19 years from the model baseline (Figure 6). Projecting this trend too far into the future may underestimate the actual restoration period because of nonlinear effects that lead to a long tail in the predicted concentrations at the

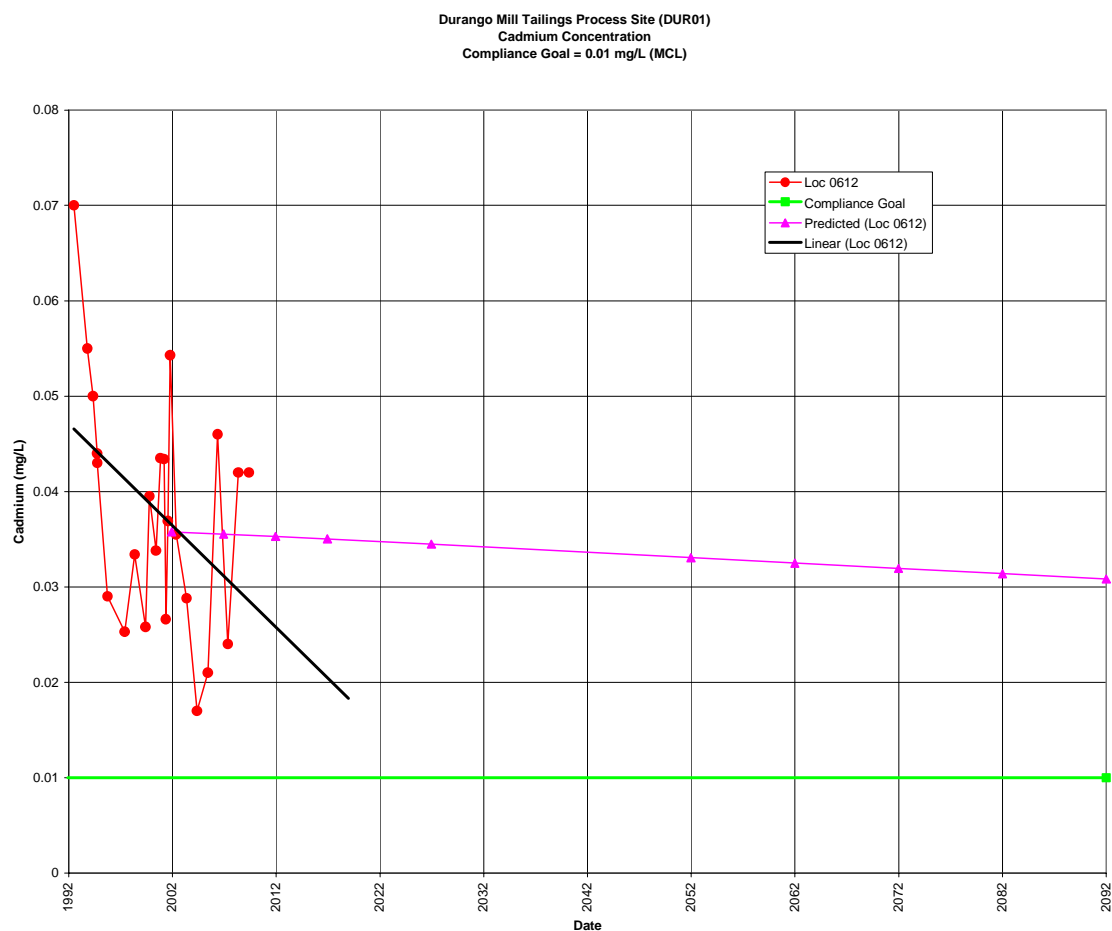
Figure 6. Predicted and Measured Cadmium Concentrations at the Mill Tailings Area

end of the process. This is commonly observed in nature and predicted by the solute transport models. Natural flushing of cadmium, however, remains a potential strategy because of the very limited distribution of cadmium at the site and the observed net decrease in concentration over time. Since it is early in the 100-year natural flushing time frame, DOE will continue to monitor cadmium concentrations in groundwater and will reevaluate the strategy later, if required.

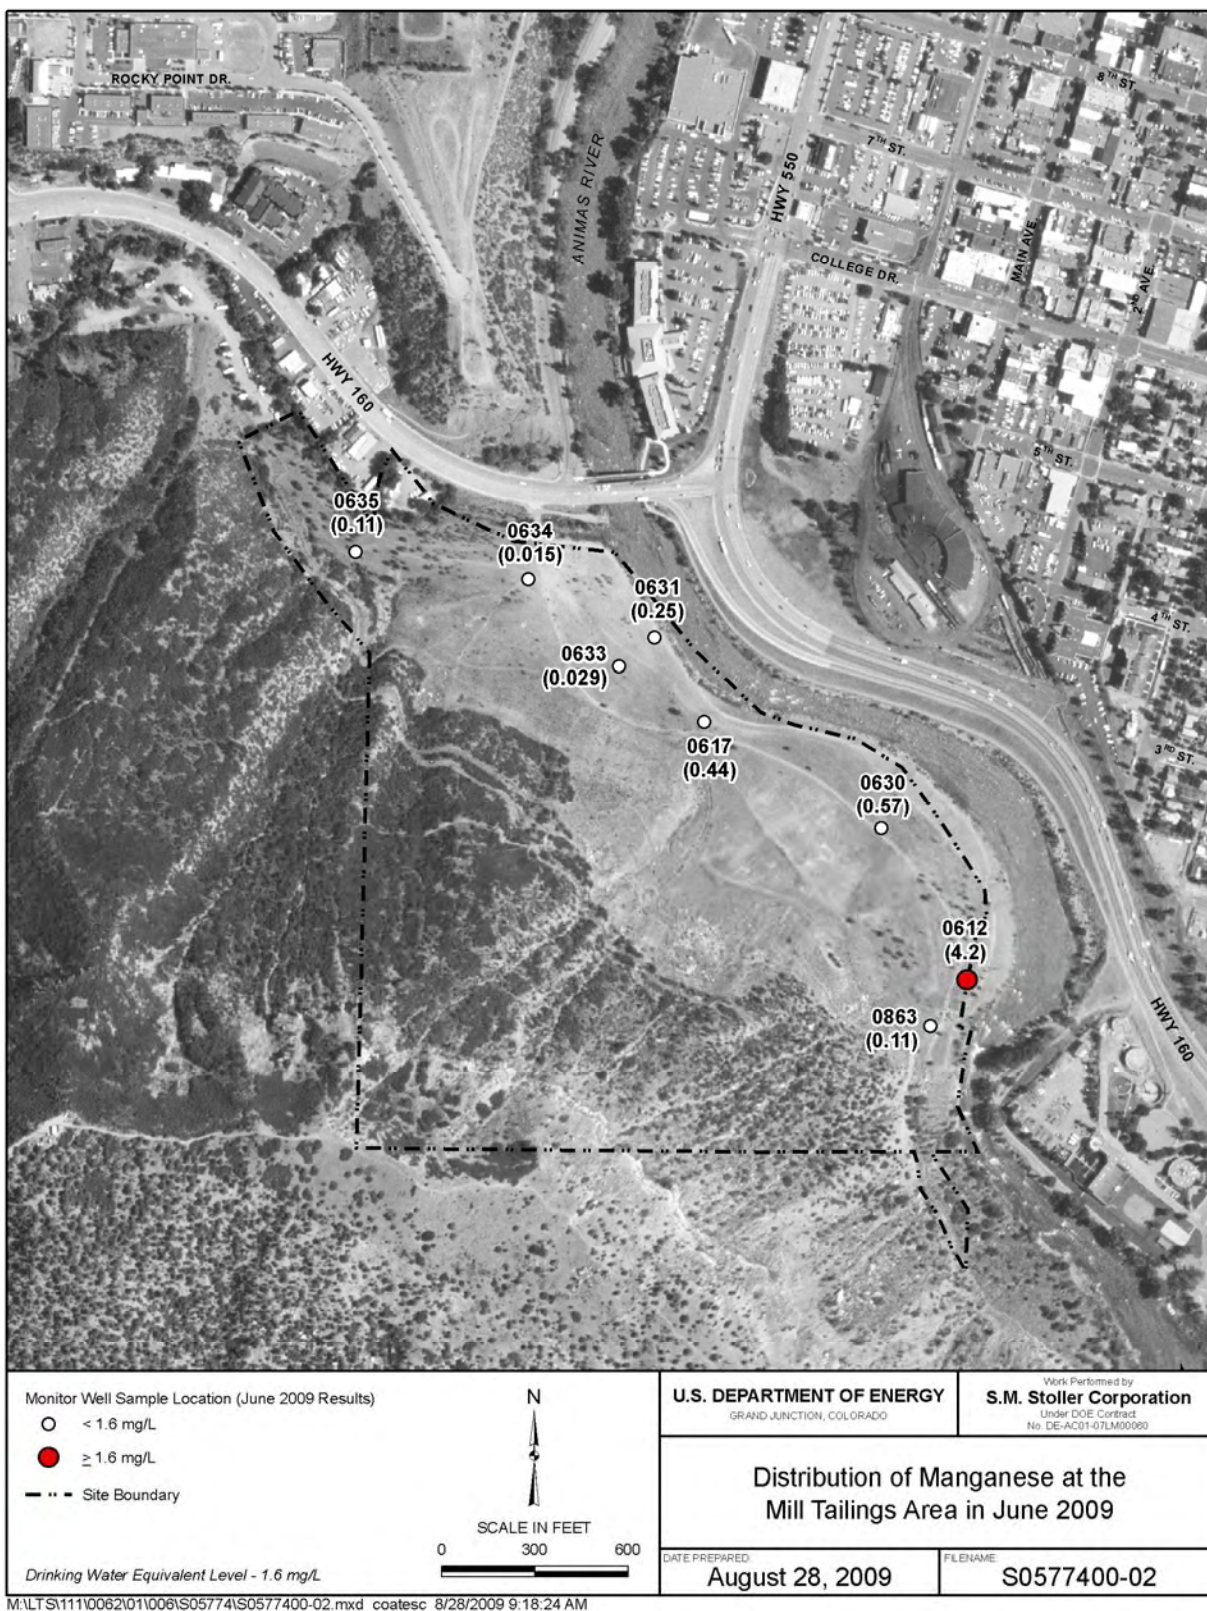
Figure 7. Distribution of Manganese at the Mill Tailings Area

Figures 7 and 8, respectively, illustrate the distribution of manganese concentrations in groundwater in June 2009 and the historical variations of manganese concentrations at the compliance wells. The June 2009 results are typical for manganese in that the compliance goal was exceeded only at well 0612 (Figure 8), where the concentration was slightly down from 2008. Projecting the linear trend of the observed concentration at well 0612 implies that natural flushing will be complete at that location in about the year 2046, well within the 100-year time allotment and in close agreement with the model prediction (Figure 9).

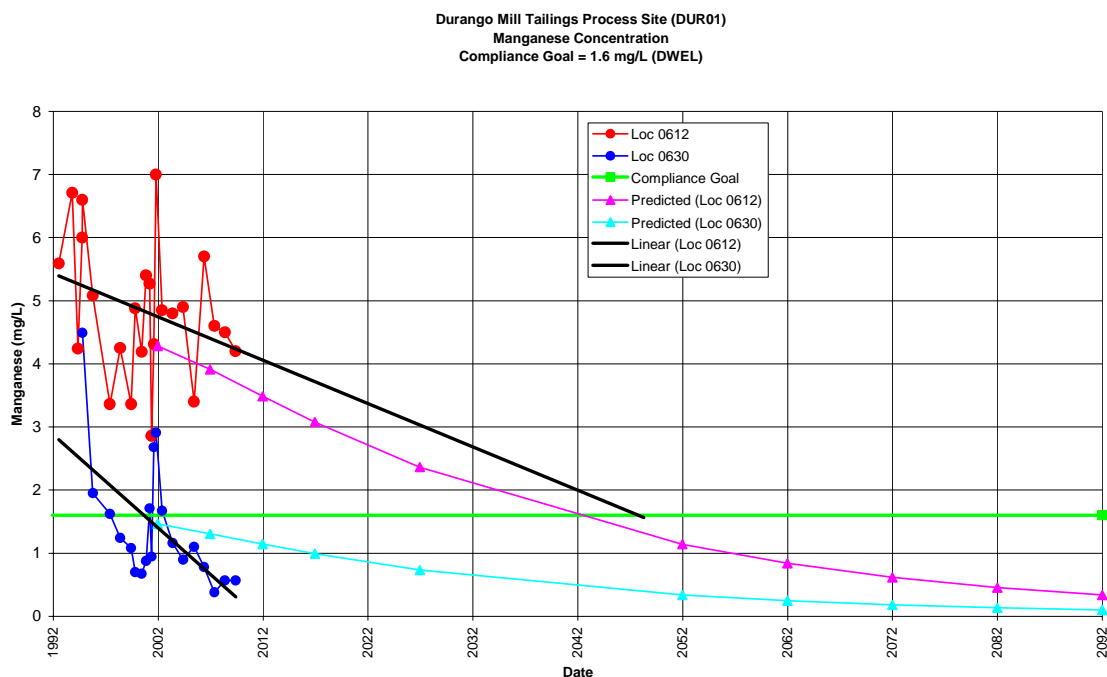
Figure 9. Predicted and Measured Manganese Concentrations at the Mill Tailings Area

The net variation in the concentration of manganese observed through the relatively brief period since 2002 is not inconsistent with the model prediction for this location. Because well 0612 is very close to the downgradient discharge boundary of the aquifer, contaminant migration from that area will not affect other regions of the aquifer. The flushing period for well 0612, therefore, represents a sitewide maximum for manganese because the compliance goal is not exceeded at any other location.

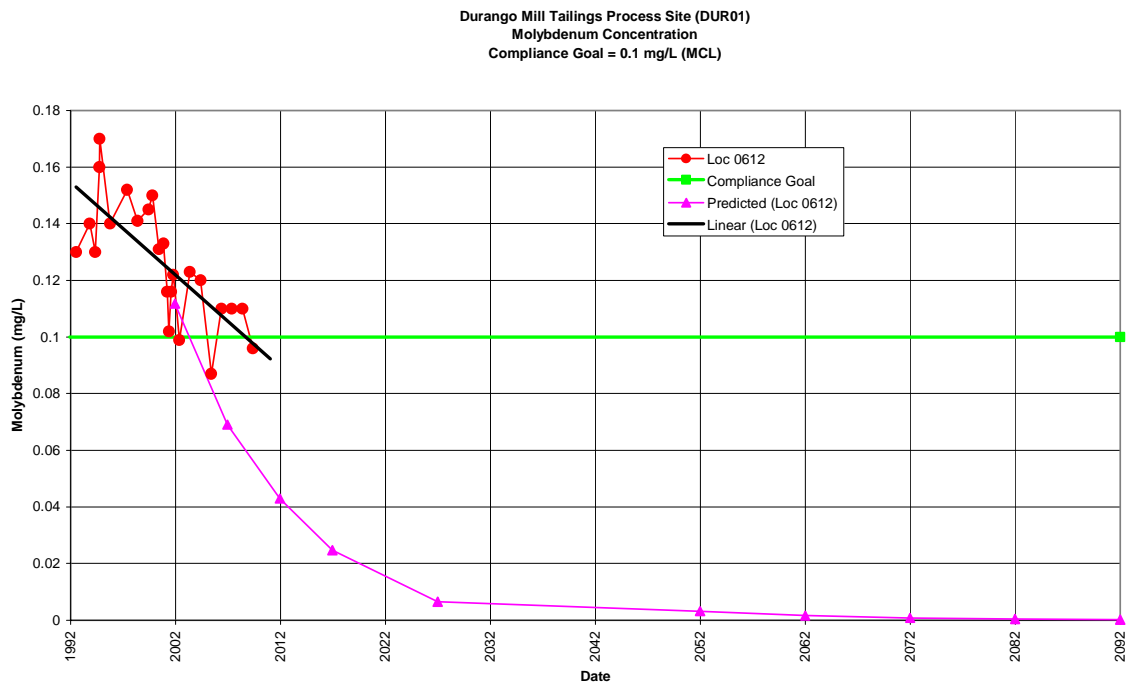
Figure 12. Predicted and Measured Molybdenum Concentrations at the Mill Tailings Area

Molybdenum concentrations in June 2009 were less than the compliance goal of 0.1 mg/L at all locations. Concentrations at well 0612, which remained slightly above the compliance goal in 2008, declined slightly to 0.096 mg/L in 2009 (Figures 10 and 11). If all wells remain below the standard for two more sampling rounds, compliance will be achieved and monitoring for molybdenum can be discontinued. The linear trend of observed concentrations at well 0612 forecasts molybdenum flushing to be complete in 2009 (Figure 12); observations bear out this prediction.

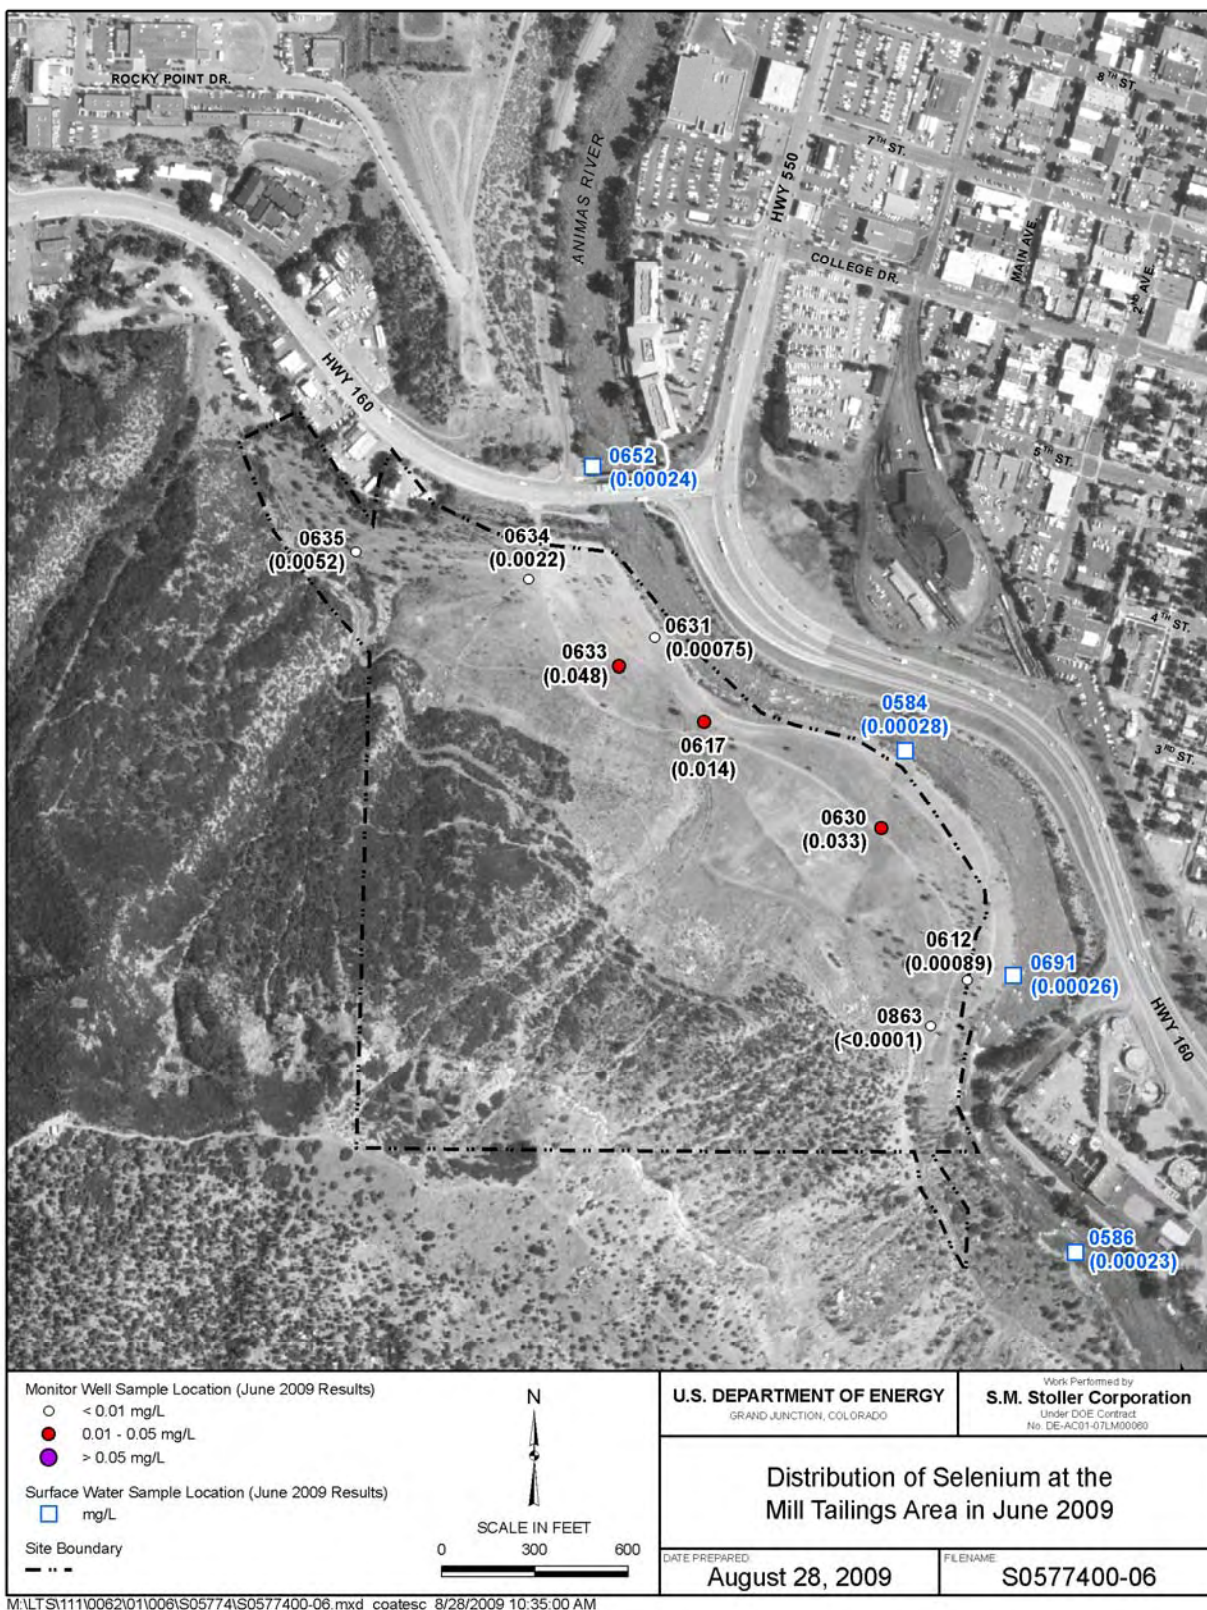
Figure 13. Distribution of Selenium at the Mill Tailings Area

Figure 13 shows, in map view, that the compliance goal for selenium (0.05 mg/L) was met at all wells in 2009. Selenium levels in well 0617, which had commonly been elevated above the standard in the past (Figure 14), have continued to remain below the compliance goal for 4 years. The model predicted that selenium concentrations would drop below the ACL by 2017 at this location (Figure 15). Observations bear this out.

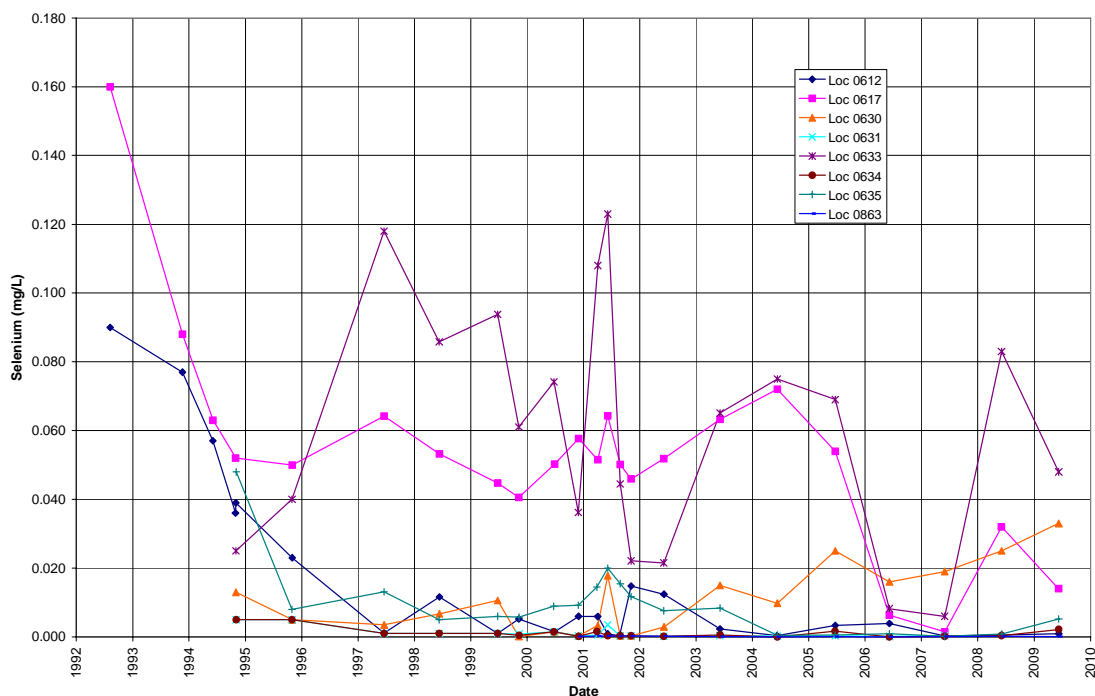
Figure 14. Historical Selenium Concentrations in Groundwater at the Mill Tailings Area

Concentrations in well 0633 declined from 0.083 mg/L in 2008 to 0.048 mg/L in 2009 (Figure 14). Well 0633 is screened 90 percent in Mancos Shale, a recognized source of readily mobilized selenium (DOE 2002). The low-level selenium contamination at the site may in part be site-related; however, some contribution from natural sources is likely, as evidenced by concentrations greater than 0.01 mg/L at background well 0622 (not shown in figures) (see DOE 2002). While the linear trend line, based on the measured concentrations at well 0633, indicates that the compliance goal should have been reached last year, achievement of compliance this year is probably within the margin of error for model predictions. If all wells remain below the standard for selenium for the next two sampling rounds, compliance will be met and analysis for selenium can be discontinued.

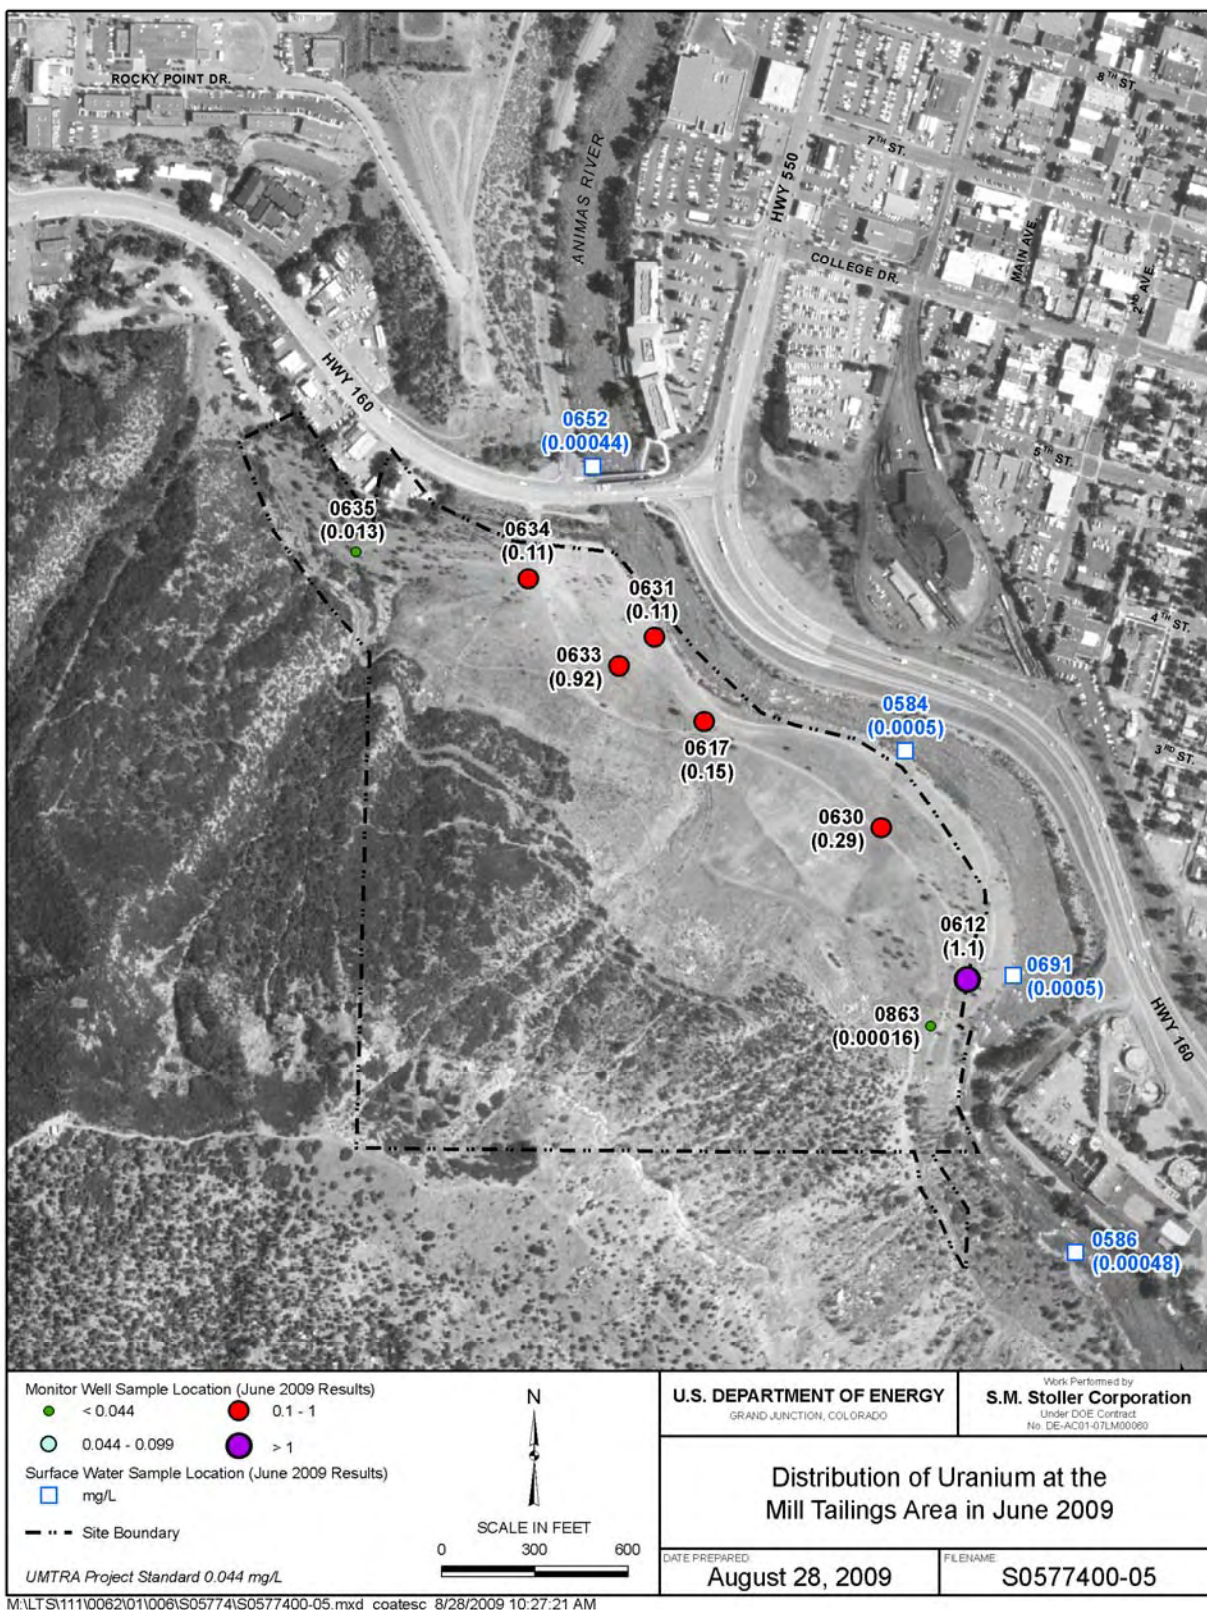
Figure 19. Distribution of Uranium at the Mill Tailings Area

The uranium compliance goal was exceeded at all locations except wells 0635 and 0863 in June 2009 (Figures 19 and 20). This is consistent with previous monitoring results. The four wells with the most elevated uranium concentrations (0612, 0617, 0631, and 0633) have shown a generally decreasing concentration trend since source removal, though concentrations at well 0633 increased about 50 percent over 2008 concentrations. Groundwater model predictions indicate that sitewide uranium flushing will be complete by about 80 years after June 2002 (Figure 21). To date, observed concentrations at the two wells that have the highest uranium concentrations (wells 0612 and 0633) are in close agreement with the model results (Figure 21). These wells are widely separated in the aquifer. The predicted flushing period for these two wells differs from the predicted sitewide flushing time because the last area to flush is south of the downgradient-most monitor well (well 0612). Linear projection of the observed concentration trends implies sitewide uranium flushing by about 2031. The model predicts similar rates of flushing initially, followed by a period of much less rapid flushing and marginal levels of contamination (concentration tailing) until the goal is attained. Uranium concentrations may remain slightly above the compliance goal during the period of reduced flushing.

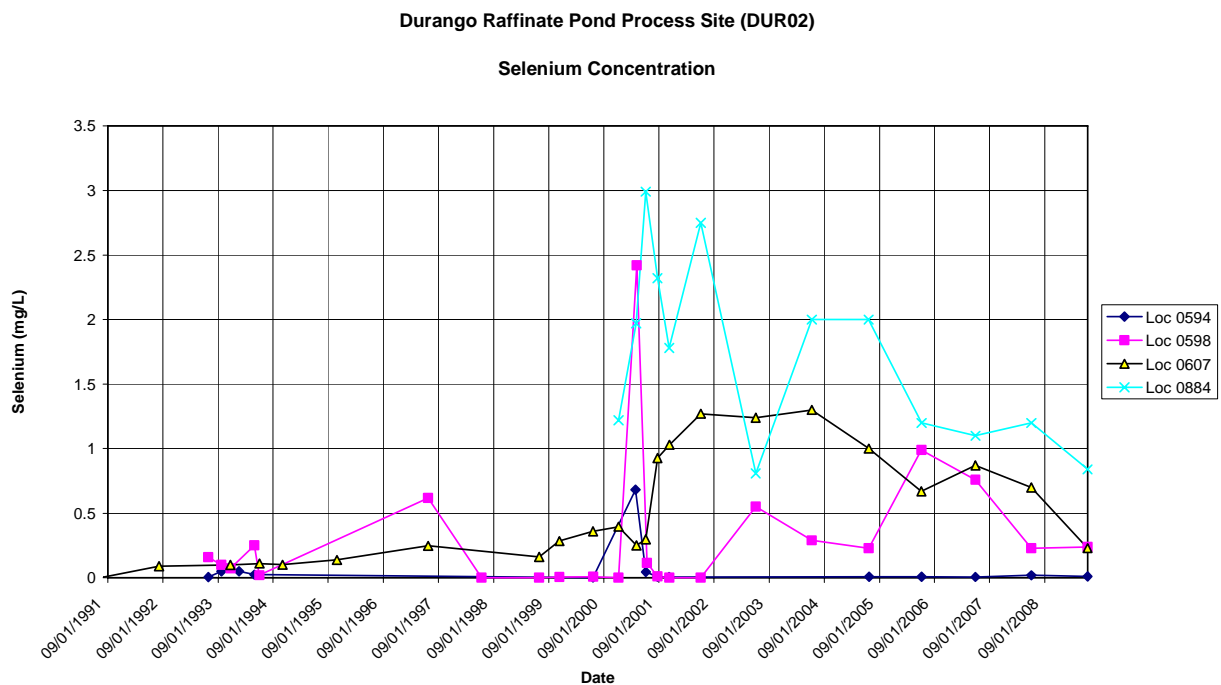
Figure 22. Historical Selenium Concentrations in Groundwater at the Raffinate Ponds Area

Historical concentrations of selenium since completion of remedial action in 1992 are shown in Figure 22. It appears that something caused increases in selenium in most wells from 2000 to 2005; concentrations have been declining over the last few years. It is not clear what caused the selenium increases or if such behavior can be expected in the future. Naturally elevated levels of selenium form the basis for the application of supplemental standards for the raffinate ponds area.

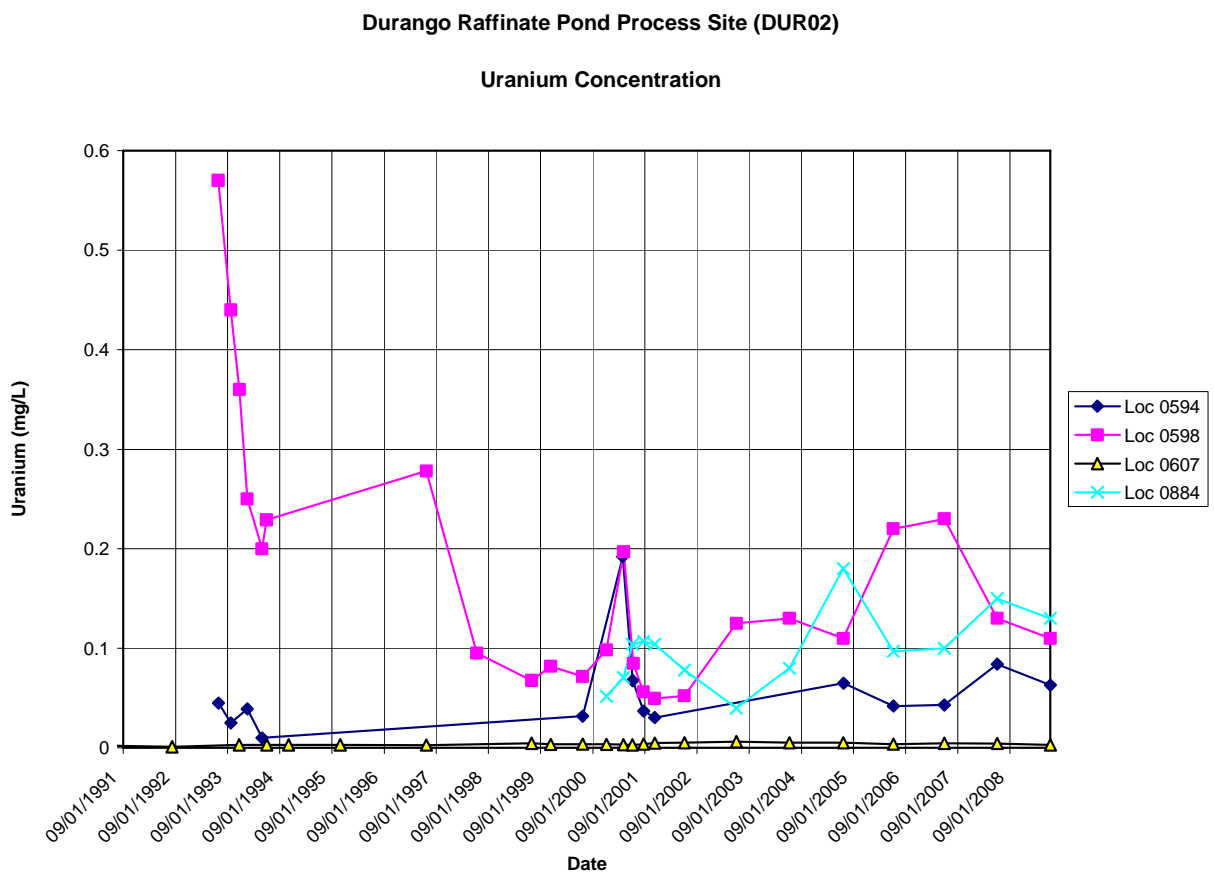
Figure 23. Historical Uranium Concentrations in Groundwater at the Raffinate Ponds Area

Historical concentrations of uranium are shown in Figure 23. Concentrations of uranium in most wells have fluctuated over the last several years but have showed no overall increasing or decreasing trends. Supplemental standards were applied to soils in the raffinate ponds area (DOE 2002), and those soils may contain residual uranium contamination that influences groundwater quality. Subpile soil analyses indicate the presence of uranium in soils remaining at the site (DOE 2002).
