4.0 Durango, Colorado, Disposal Site

4.1 Compliance Summary

4.4 Inspection Results

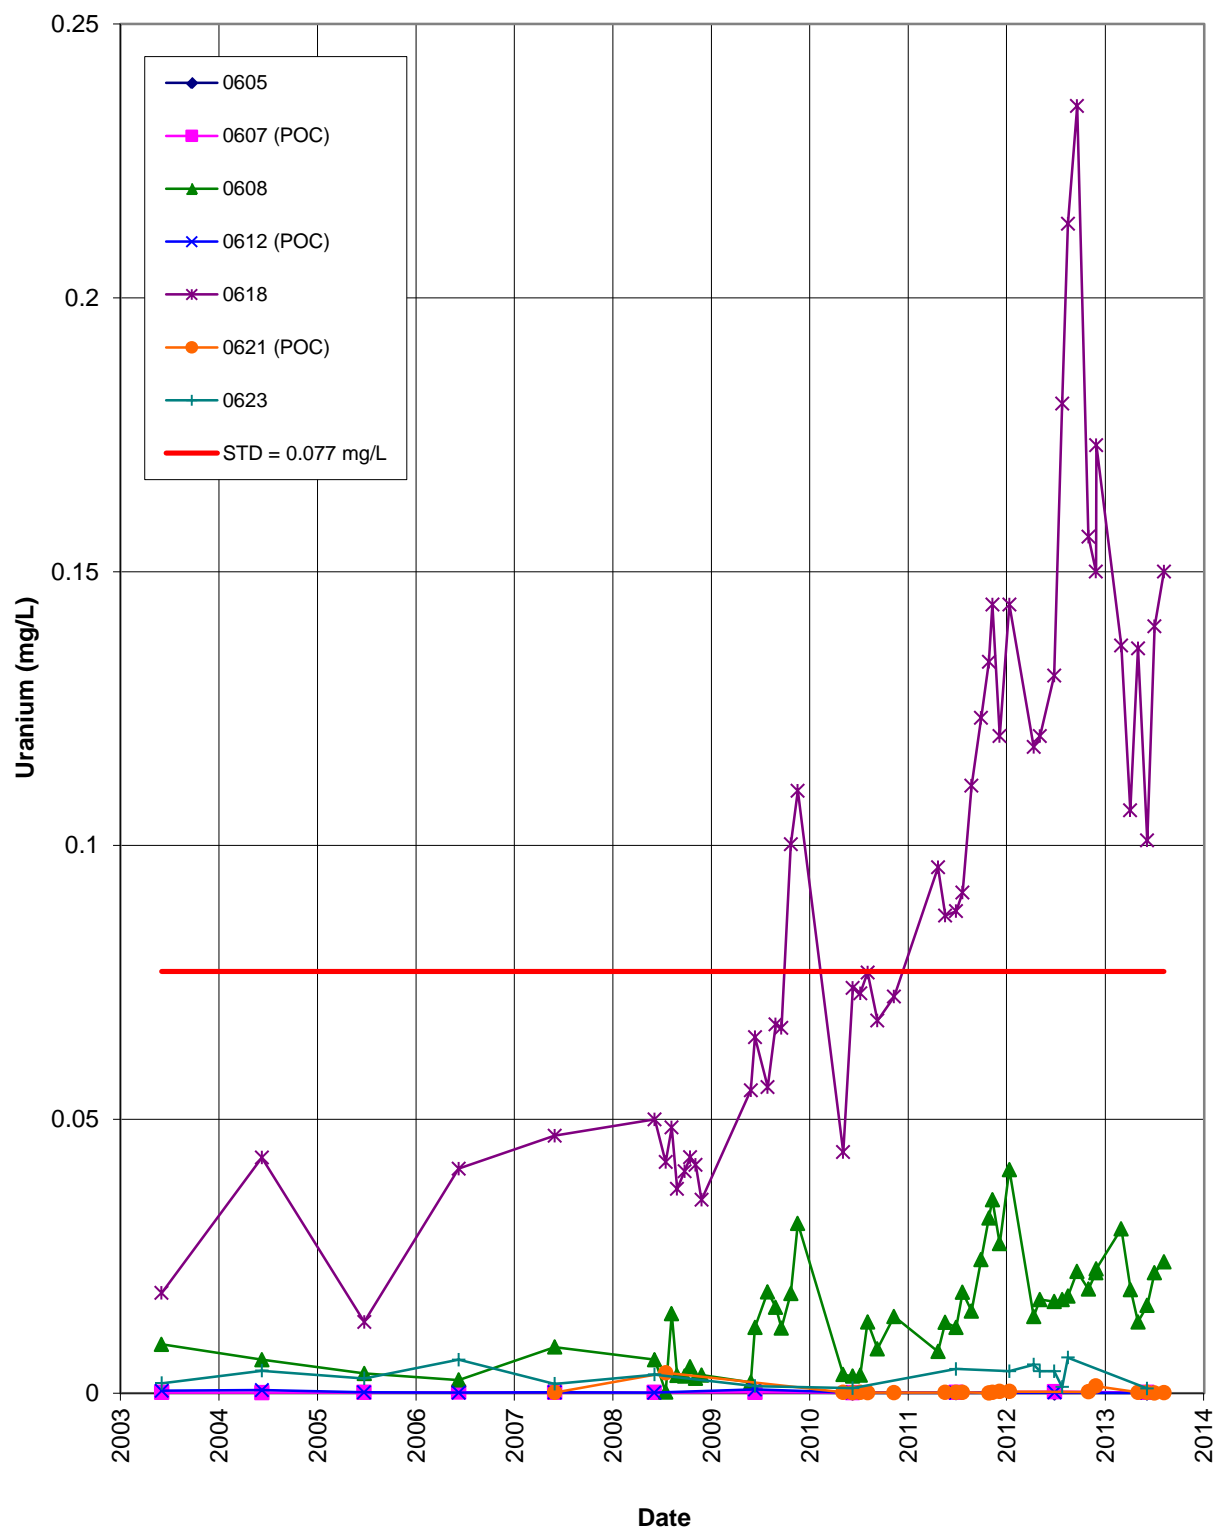
Figure 4-2. Time-Concentration Plot of Uranium in Groundwater at the Durango Disposal Site

Though not required for compliance, wells completed in the alluvial aquifer are also monitored. Uranium concentrations in well 0618 have consistently been higher than concentrations in the other wells onsite. To monitor the increased uranium observed in well 0618, wells 0608, 0618, and 0621 have been increased to monthly sampling as weather permits. Uranium concentrations in monitoring well 0618 had increased until 2009 when the well was redeveloped and the purging method and pump materials were evaluated, resulting in a decrease in concentration (0.044 milligram per liter [mg/L]) observed in May 2010. Uranium concentrations rebounded and continued to increase with a peak of 0.235 mg/L in September 2012. Uranium concentrations in well 0618 have decreased since September 2012, but still have an increasing trend overall. Because well 0618 is not a POC well and is not screened in the uppermost aquifer, the concentrations in this well do not affect compliance with the LTSP and do not pose a risk to human health and the environment. However, the potential cause of this increase is being investigated.

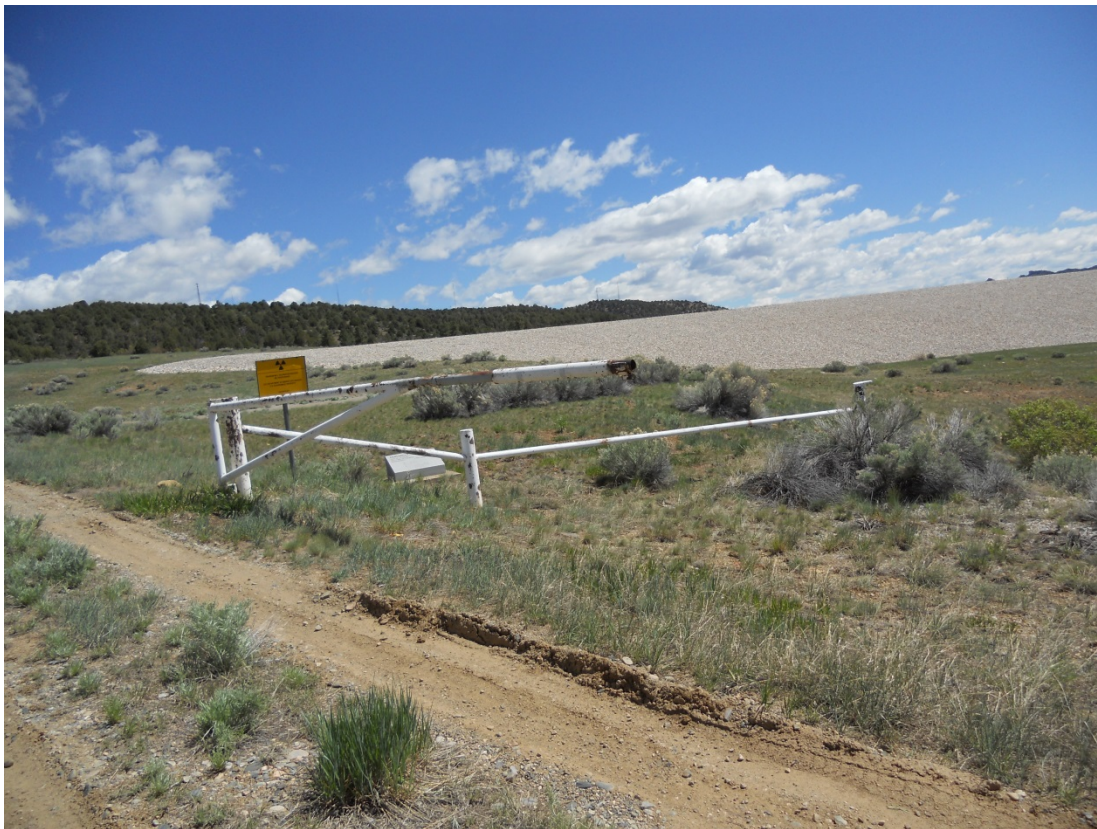
The entrance gate along County Road 212 was locked and in good condition. The older, original entrance gate was locked and in good condition, and the entrance sign was present and in good condition (PL-1).

DUD 5/2013. PL-1. Original entrance gate, site marker SMK-1, and perimeter sign E.

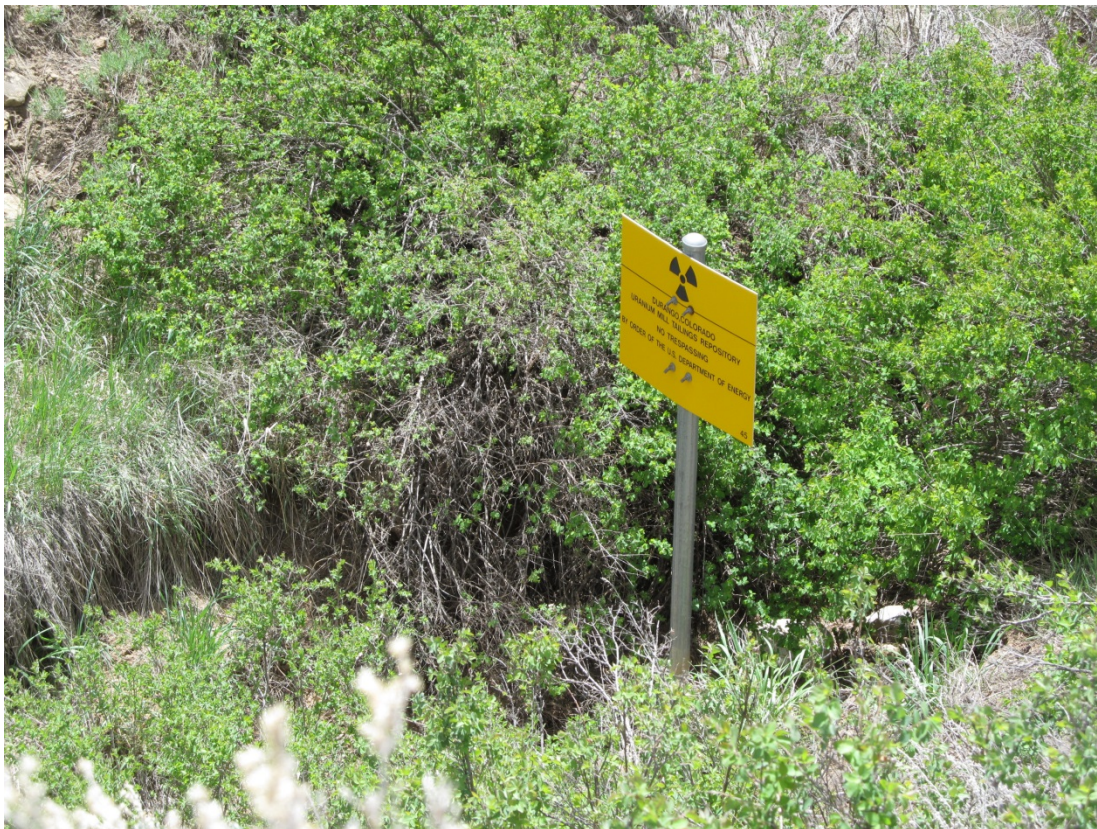
Numerous perimeter signs have bullet holes or other markings but remain legible. Perimeter sign P2 has been missing for several years and will not be replaced, as adjacent signs are within sight. In previous years, inspectors noted that the base of perimeter sign P45 was being undercut by erosion; the sign remains stable (PL-2).

DUD 5/2013. PL-2. Perimeter sign P45, in draw.

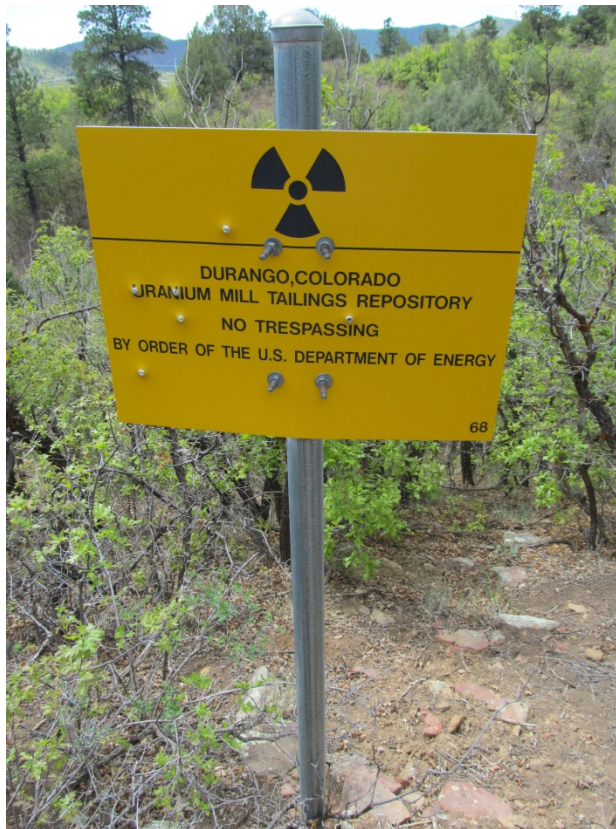
Many of the perimeter signs are difficult to find amid the pine trees, thick oak brush, and steep drainages (PL-3). Inspectors used GPS to locate the perimeter signs. All of the perimeter signs were visually located except sign P43 which the inspectors missed in the thick brush. The sign was found during the 2012 inspection; therefore, inspectors did not back track to visually verify.

DUD 5/2013. PL-3. Perimeter sign P68, showing bullet hole damage.

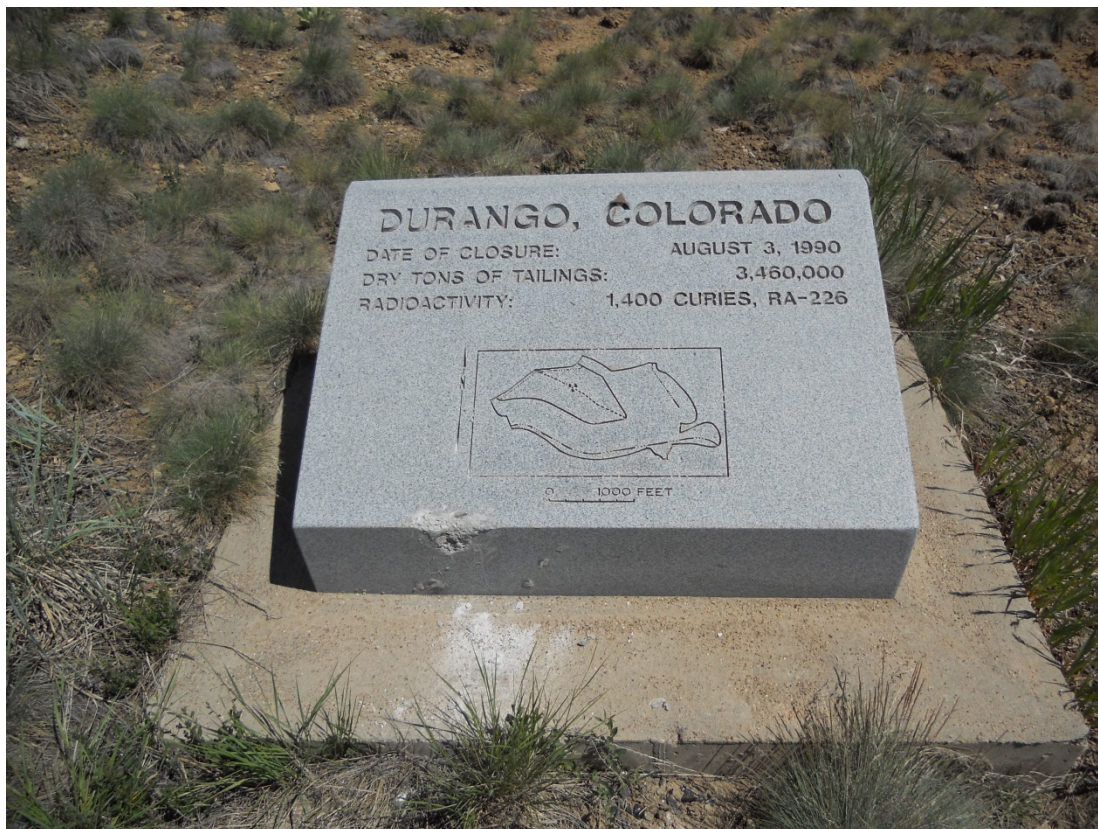
Site marker SMK-1 historically has been superficially pocked from gunfire but has remained legible. During the 2012 inspection inspectors discovered that an additional chip along the bottom edge of the marker had fallen off; however, the information on the face of the marker remains legible, and no new damage was observed (PL-4). SMK-2 remains in excellent condition.

DUD 5/2013. PL-4. Site marker SMK-1, showing damage.

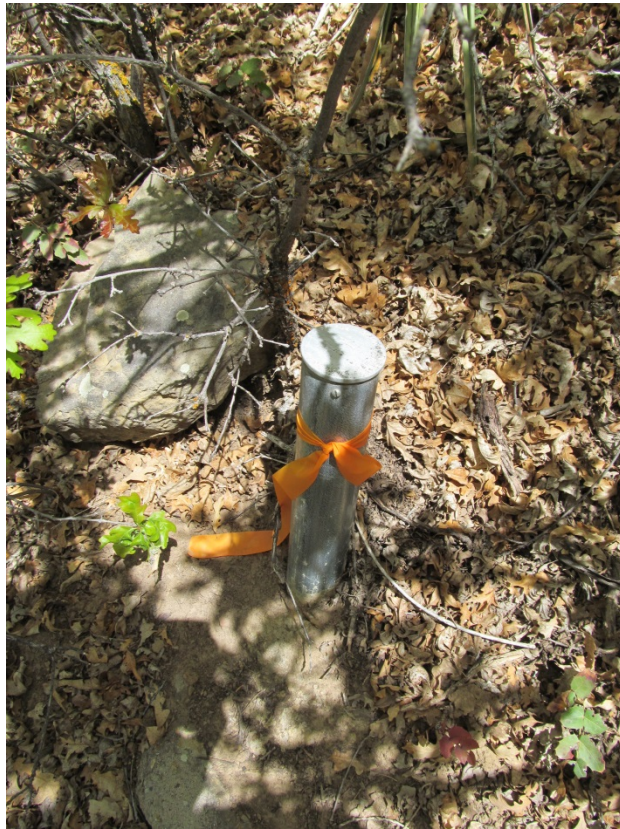
All survey and boundary monuments are in excellent condition (PL-5) except for BM-3, BM-4, and BM-6, which remain in the same condition as in previous years. Boundary monument BM-3 and two of its reference monuments are situated in a small gully and were threatened by erosion in the past; however, the monuments are now stable. One of the reference monuments for BM-4 has been bent to the ground, and the cap has been removed, but BM-4 is intact. No repair of any of these features is warranted. Boundary monument BM-6 was destroyed prior to the 2004 inspection during construction of a pipeline near the site. It was decided not to replace it because both of its witness corners are present and remain in good condition.

DUD 5/2013. PL-5. Boundary monument BM-1.

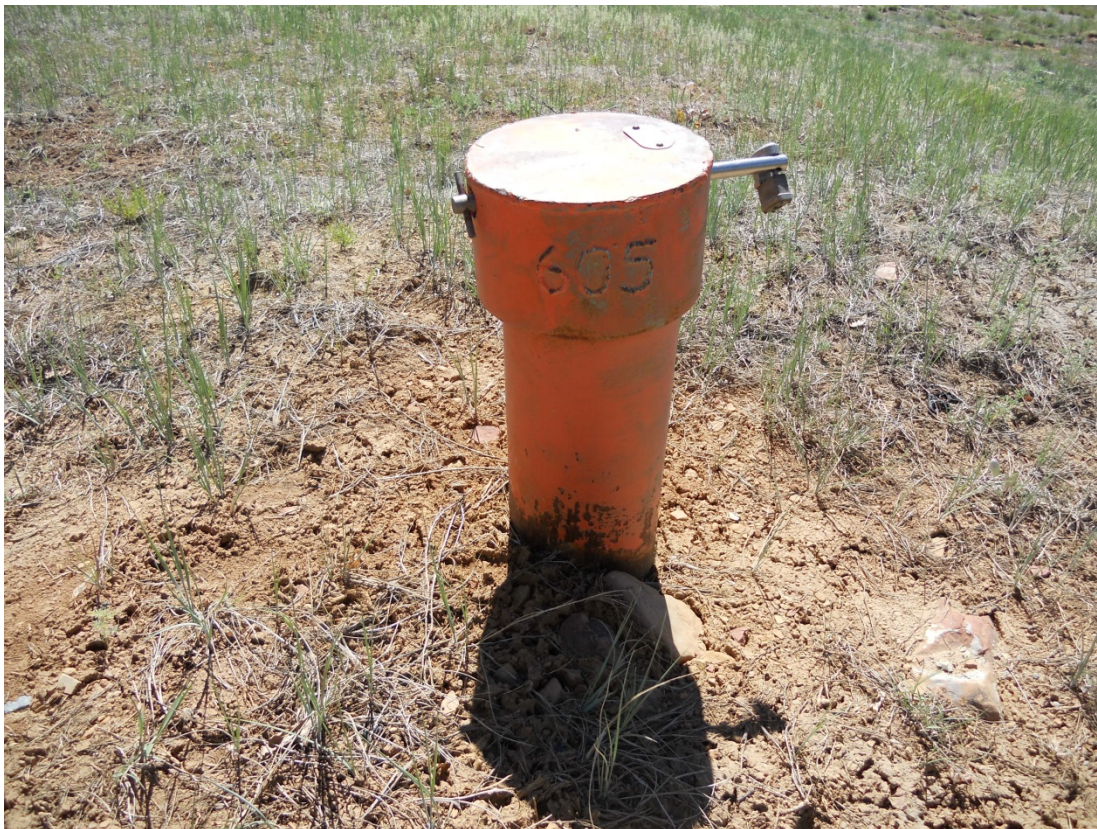
Monitoring wells specified in the LTSP (0605, 0607, 0608, 0612, 0618, 0621 and 0623) were locked and in excellent condition (PL-6).

DUD 5/2013. PL-6. Well 0605.

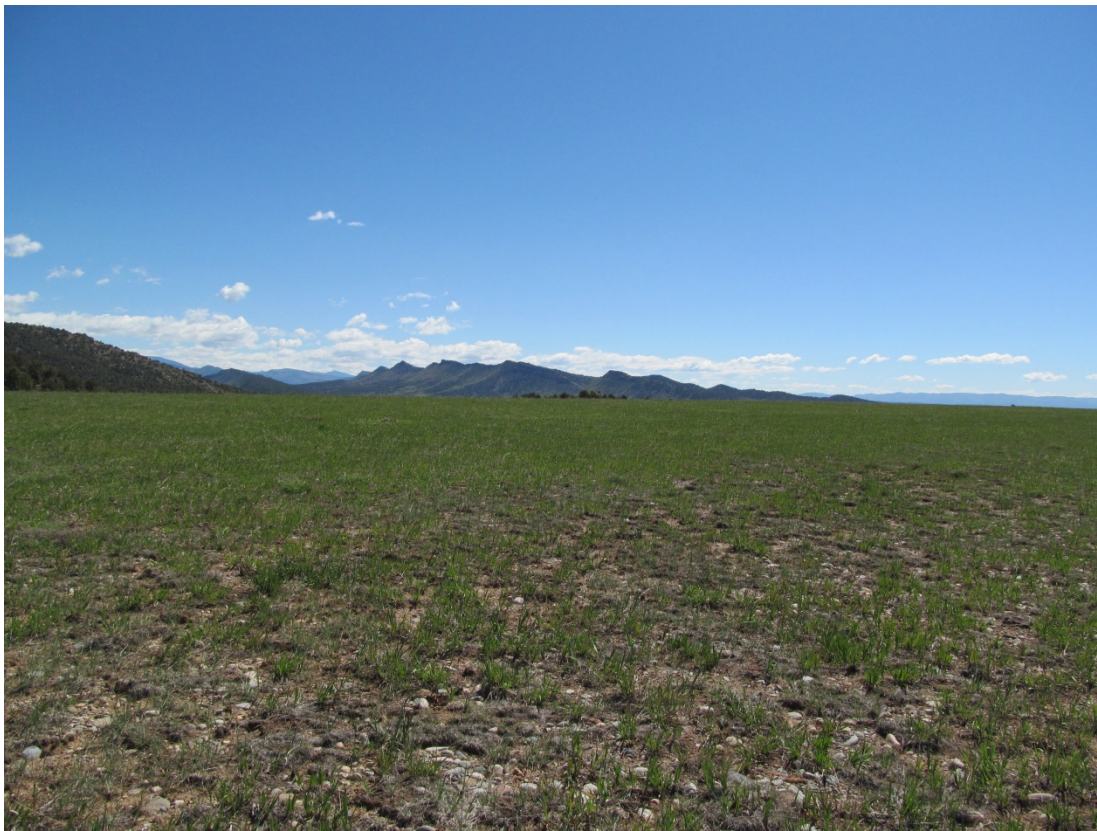
The top of the disposal cell is in excellent condition. Settling, slumping, and erosion were not observed (PL-7).

DUD 5/2013. PL-7. Disposal cell cover, view to the northeast.

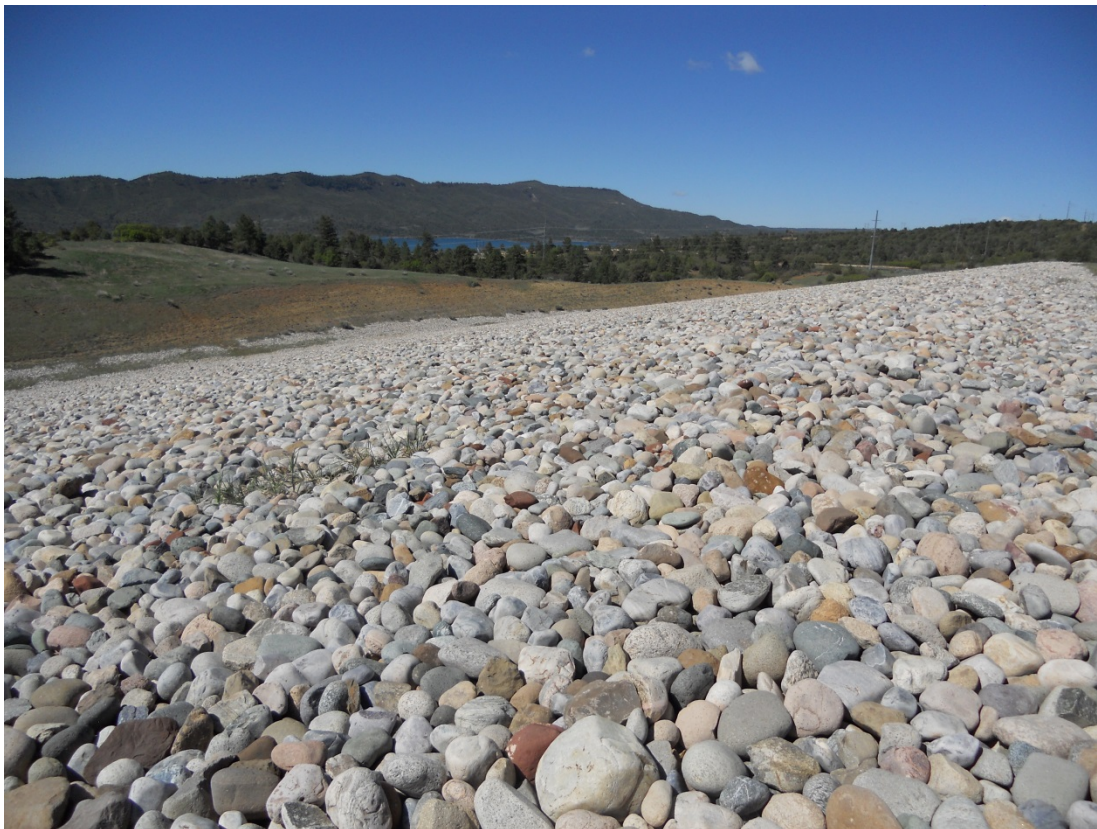
The riprap-covered side slopes of the disposal cell are in excellent condition. Disturbances resulting from natural processes, such as subsidence, rock deterioration, or slope failure, were not observed (PL-8).

DUD 5/2013. PL-8. View of south side slope of disposal cell from the southeast corner of cell top.

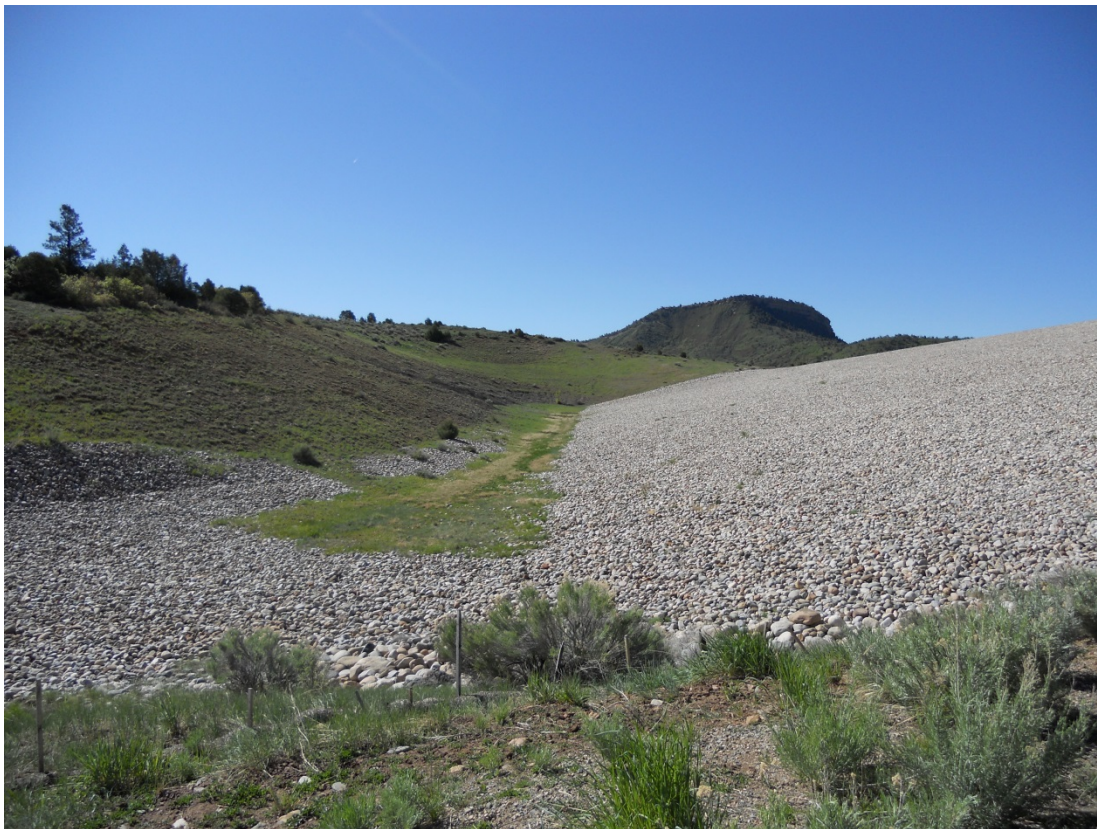
Rock-armored drainage ditches are constructed beneath the toe of the side slope on the northwest, south, and east sides of the disposal cell. These ditches direct runoff into natural drainages that carry storm water away from the disposal site. The ditches have sufficient depth and rock protection to carry runoff from a probable maximum precipitation (PMP) event. Erosion and mass wasting occurred in the past on some of the steep slopes above these channels. The eroded sediment was deposited in the rock-armored channel, creating locales favoring plant growth. The sediment deposits and vegetation will not compromise the drainage ditches' performance in a PMP event. Should sediment deposits or excessive vegetation dam a drainage ditch so as to impound water, the deposits or vegetation will be removed. Inspectors saw no evidence of recent accumulations of sediment or vegetation in the ditches (PL-9, PL-10).

DUD 5/2013. PL-9. Ditch No. 1 and the east slope of the disposal cell.

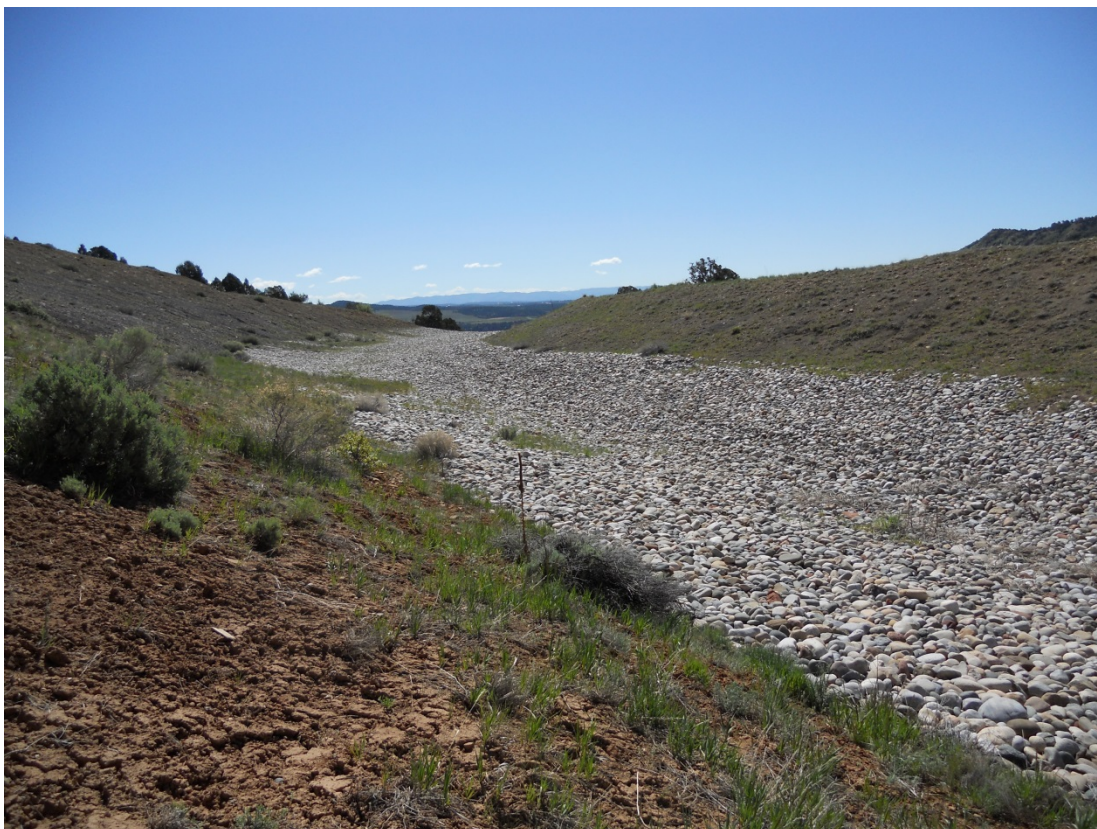
DUD 5/2013. PL-10. Portion of Ditch No. 2 downslope from disposal cell.

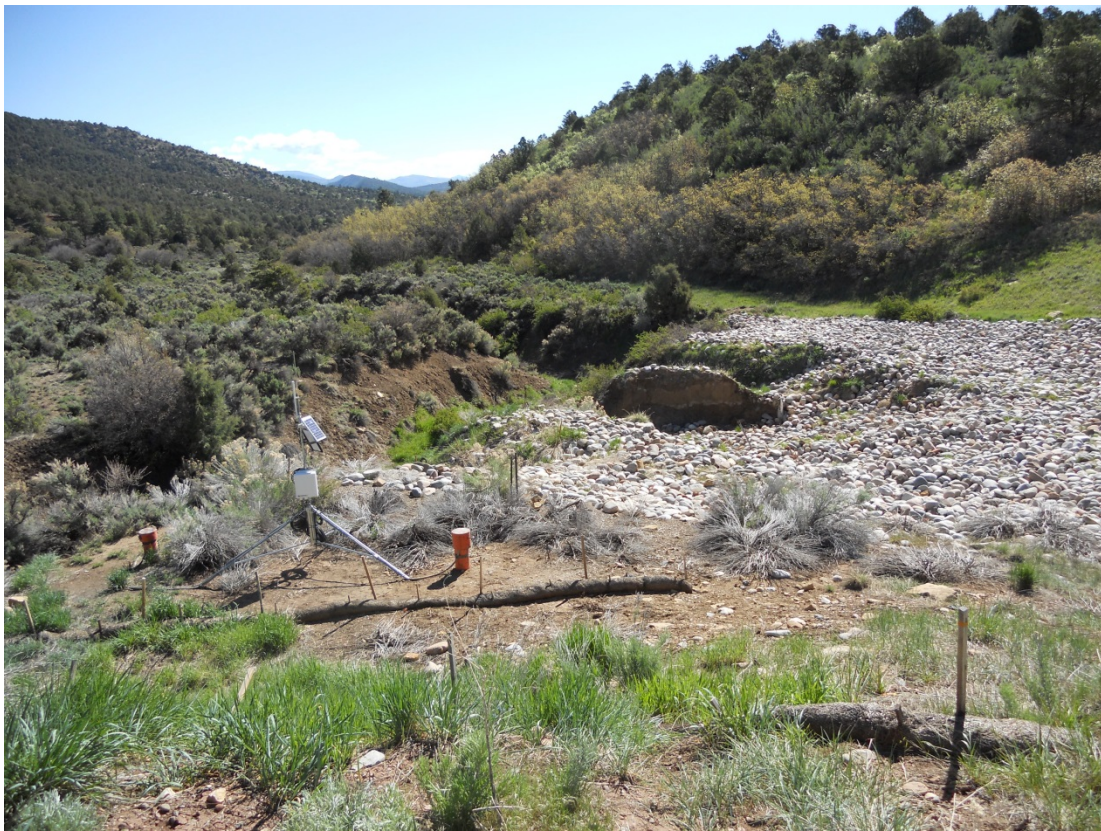
The riprap-covered outflow of Ditch No. 1 (PL-11) was designed to erode back to a rock-filled trench and self-armor in the process. The knickpoint was mapped with GPS in 1999. Significant movement of the knickpoint has not occurred since then, and mapping will not be performed again until a change is noted.

DUD 5/2013. PL-11. Northeast outflow, showing erosion areas.

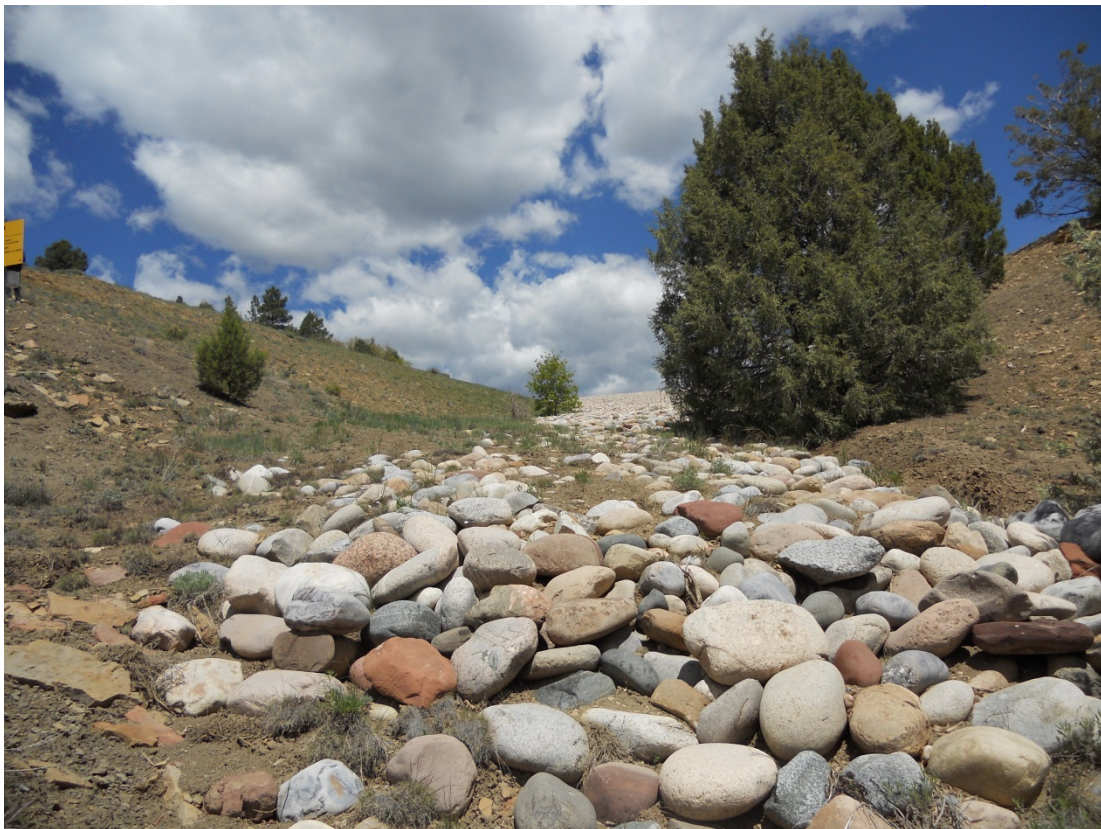
The southeast and south outflows spill into steep, natural channels that are also monitored annually. The channels at these locations are armored by riprap and bedrock. Both outflow channels were stable and in good condition at the time of the 2013 inspection (PL-12).

DUD 5/2013. PL-12. South outflow, view toward repository.

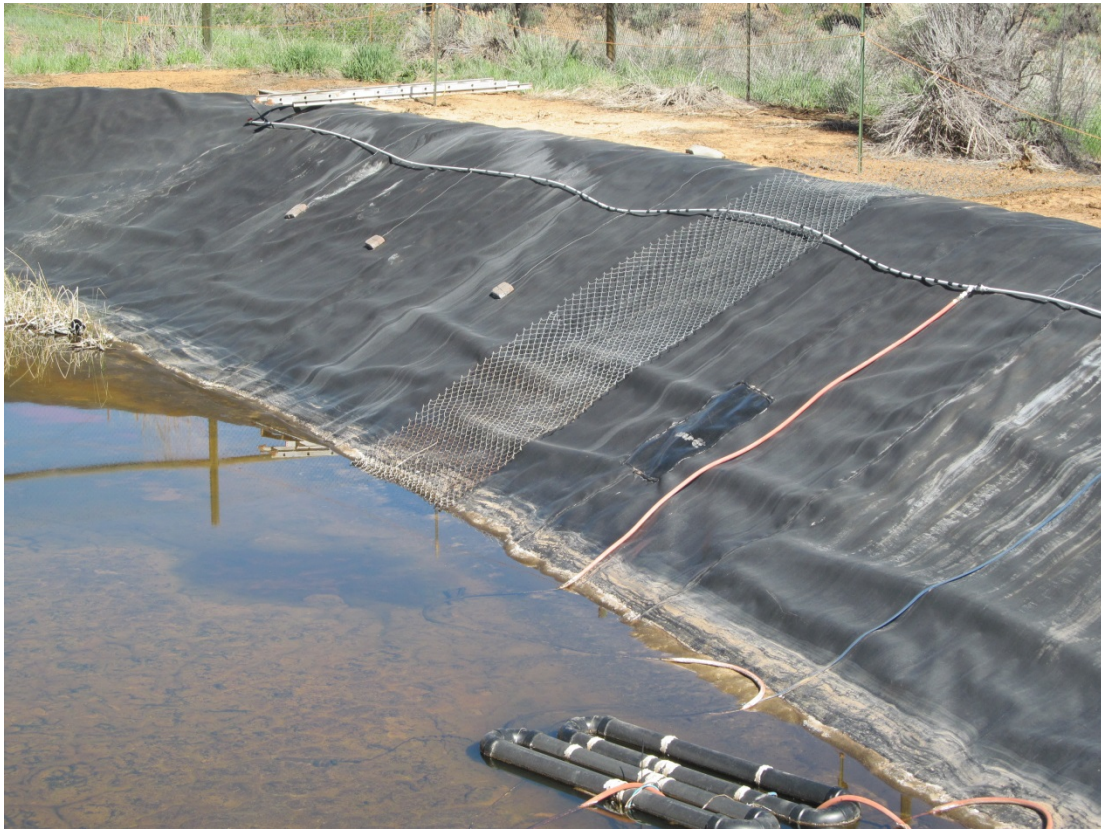
The retention pond contains precipitation and transient drainage water from the disposal cell. Because the water level in the disposal cell has dropped, the transient drainage water is no longer being drained to the retention pond. The drain valve has remained closed since November 2011. The water currently in the pond is low and therefore is not being pumped out and dispersed through drip lines onto the pond side slopes to enhance evaporation (PL-13). If precipitation increases the water level, the pumps will be turned on. The pond and evaporation system were planned to be decommissioned in 2008, but decommissioning has been delayed until the source of elevated uranium concentrations in a downgradient well can be determined.

DUD 5/2013. PL-13. Side and liner of evaporation pond.

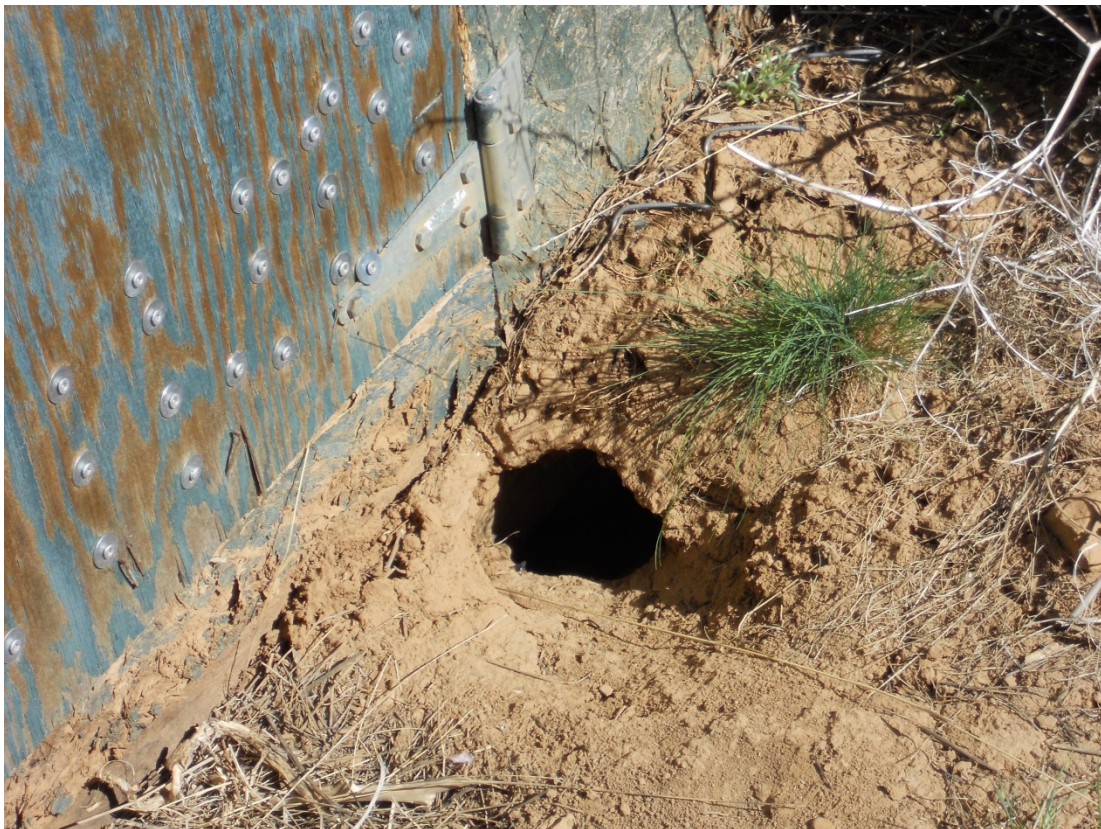
Animal burrows were noticed near the shed that houses the transient drainage system instrumentation (PL-14). Because of the proximity to the retention pond, these animal burrows will be monitored, and if the burrows pose a threat to the pond integrity, action will be taken to protect the pond.

DUD 5/2013. PL-14. Animal burrow under east side (front) of shed. Edge of pond liner is at top of photo.

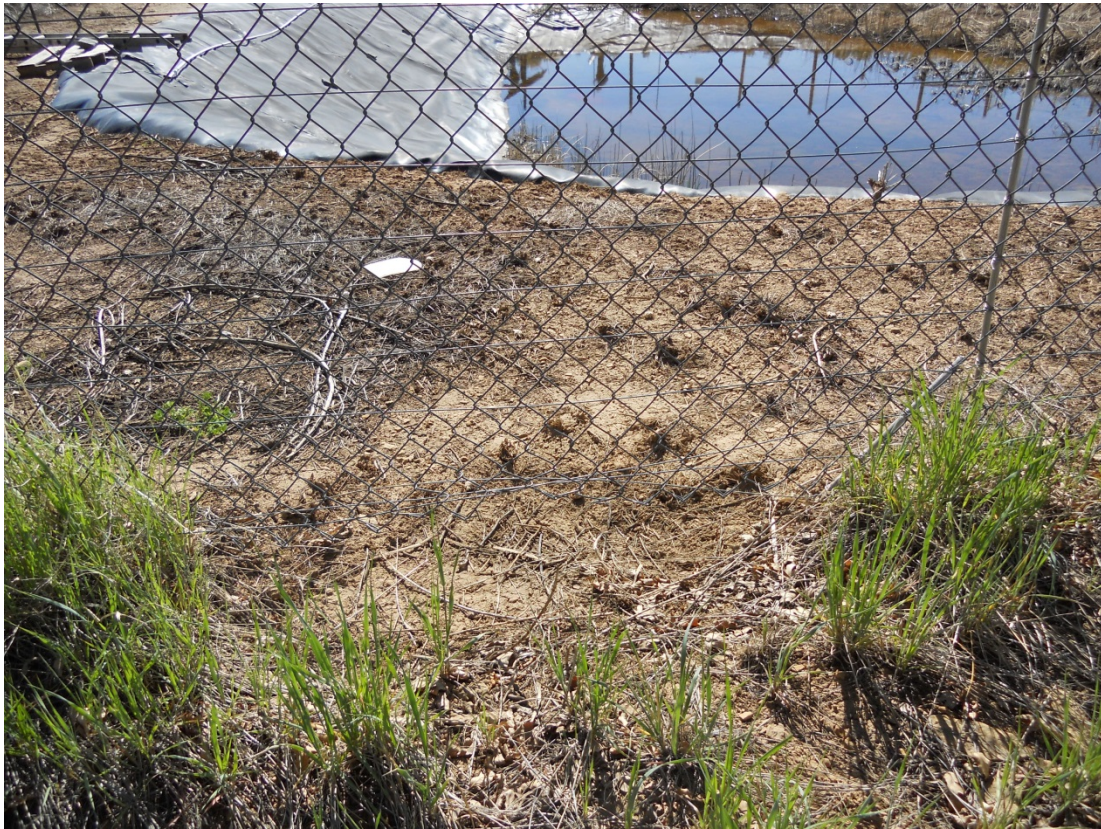
A chainlink fence surrounds the retention pond. Inspectors found a gap under the fence on the west side (PL-15). The gap was repaired after the inspection.

DUD 5/2013. PL-15. Gap under evaporation pond fence, west side.

- 4A A gap in the retention pond fence was repaired on July 2, 2013.
