4.0 Durango, Colorado, Disposal Site

4.1 Compliance Summary

Figure 4-1. 2006 Annual Compliance Drawing for the Durango, Colorado, Disposal Site

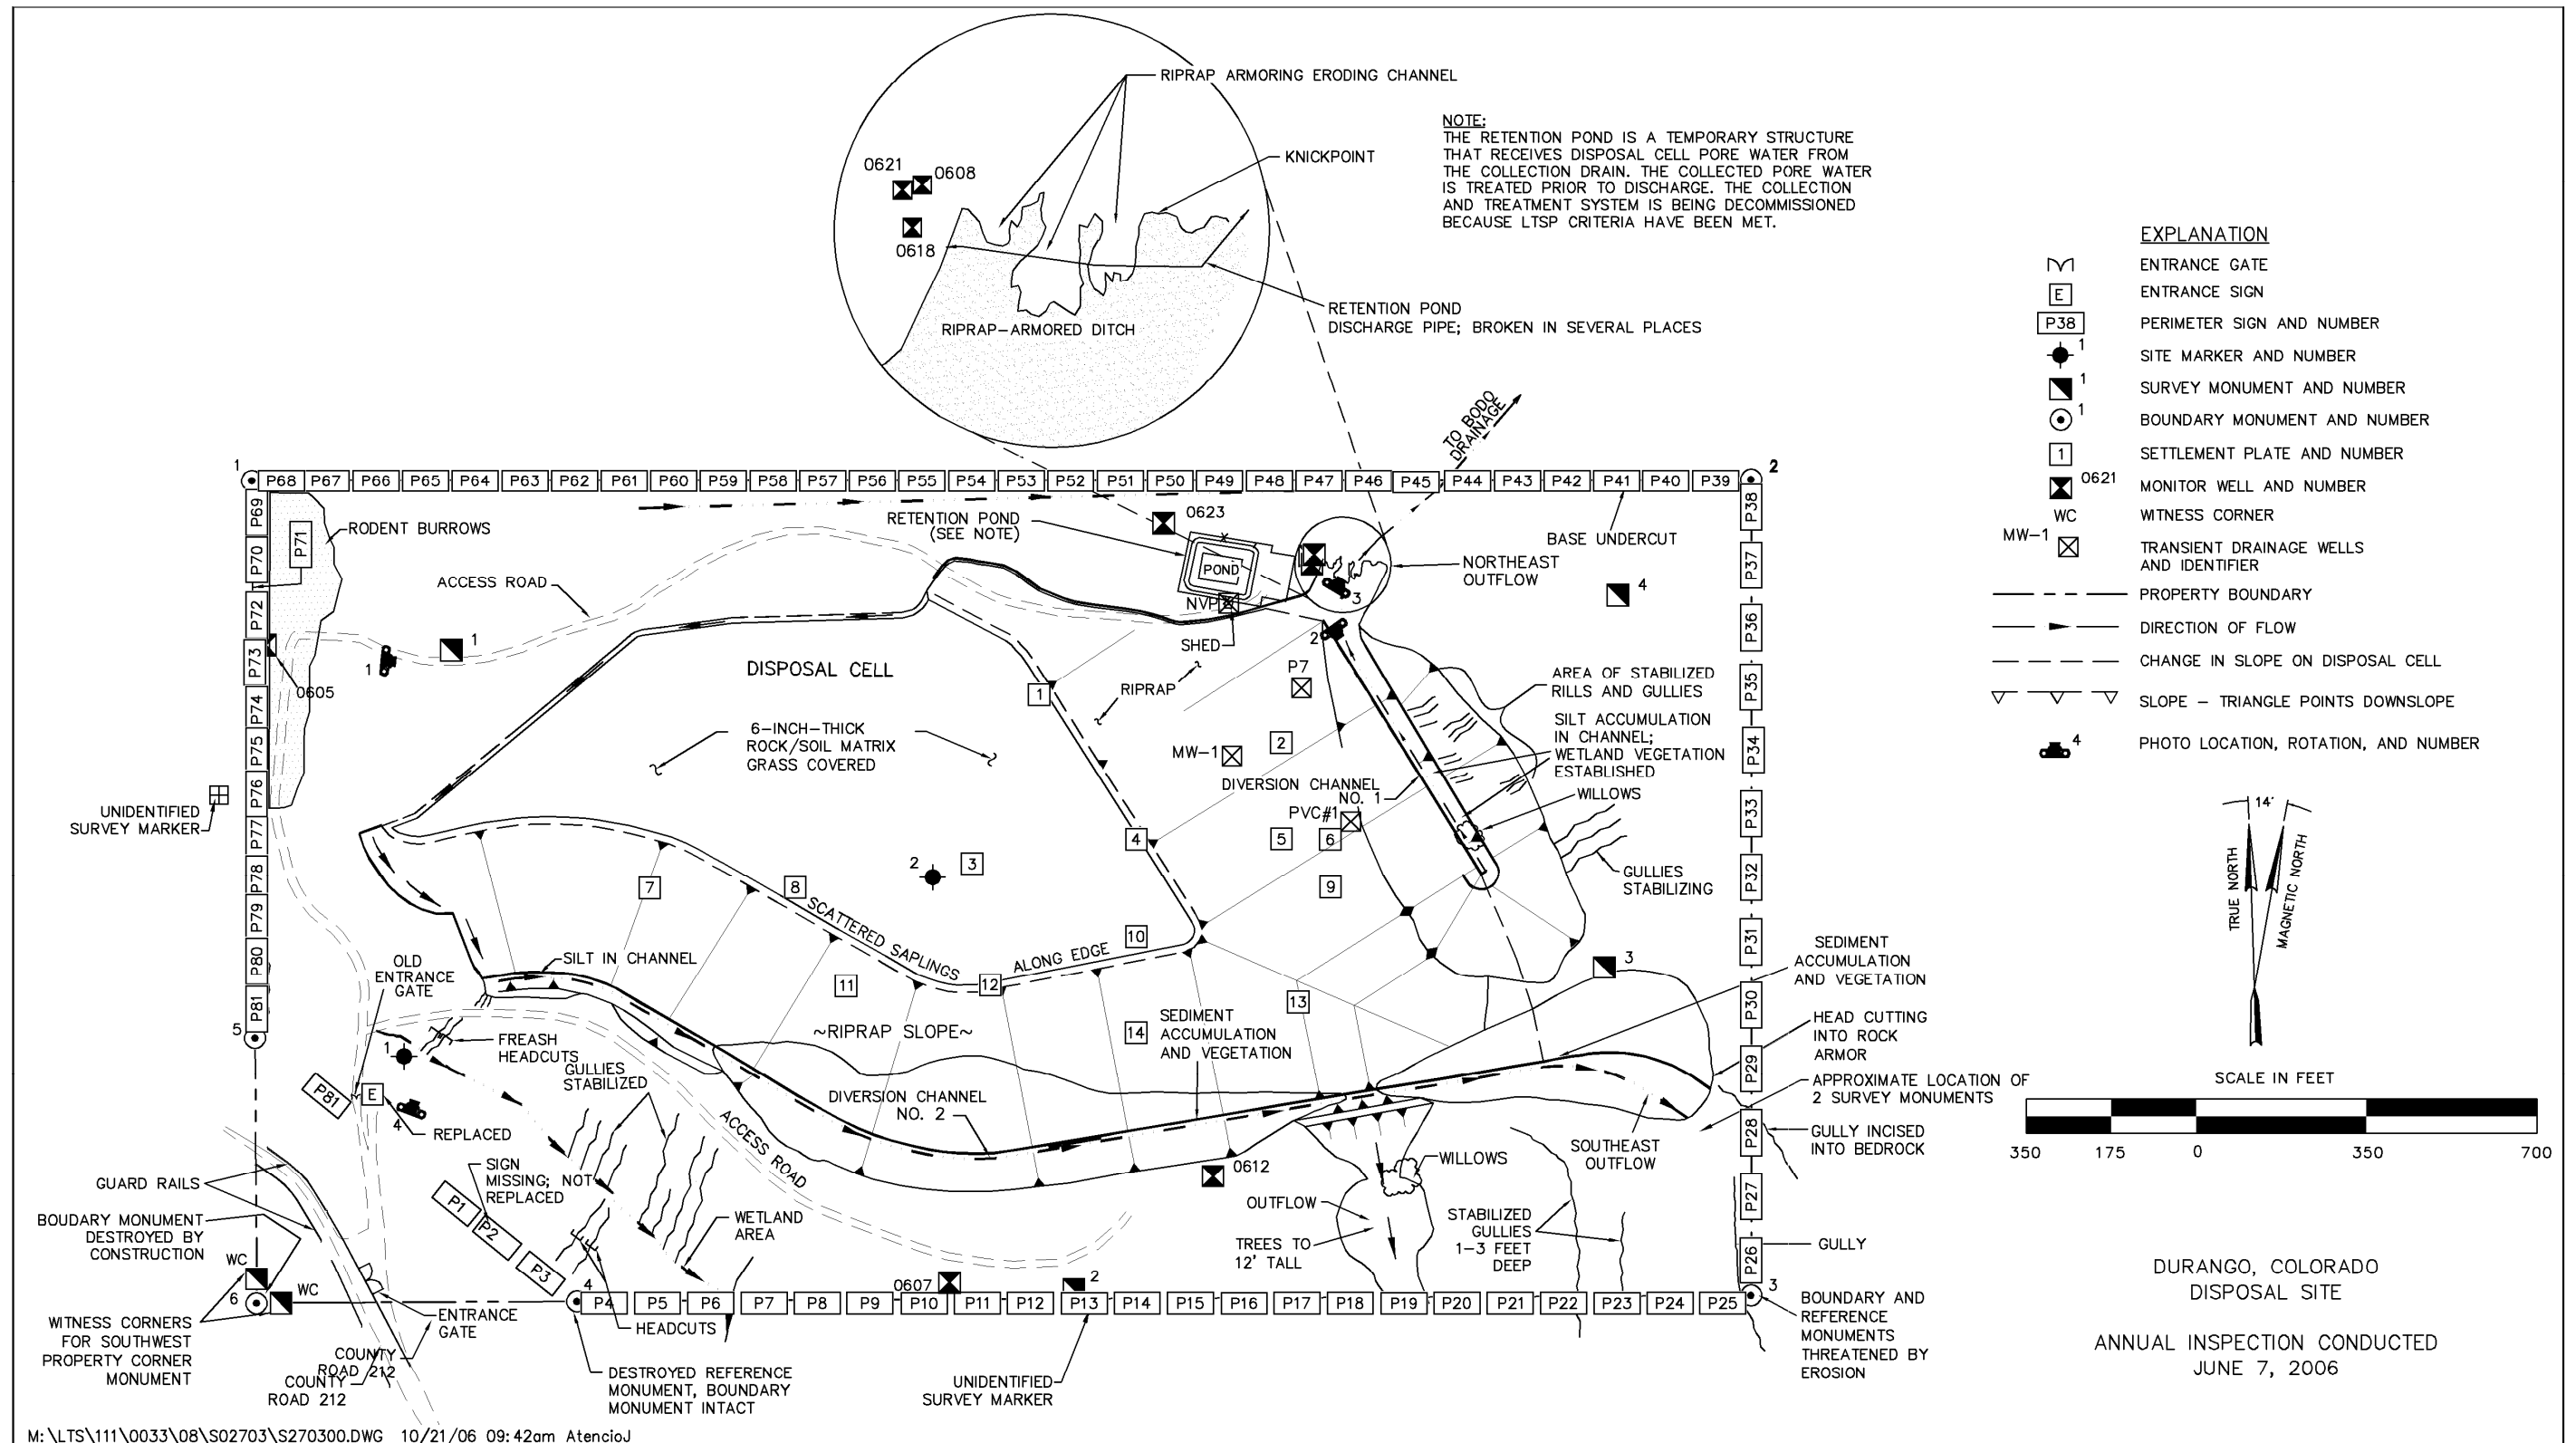
The site, located southwest of Durango, Colorado, was inspected on June 7, 2006. Results of the inspection are described below. Features and photograph locations (PLs) discussed in this report are shown on Figure 4-1. Numbers in the left margin of this report refer to items summarized in the Executive Summary table.

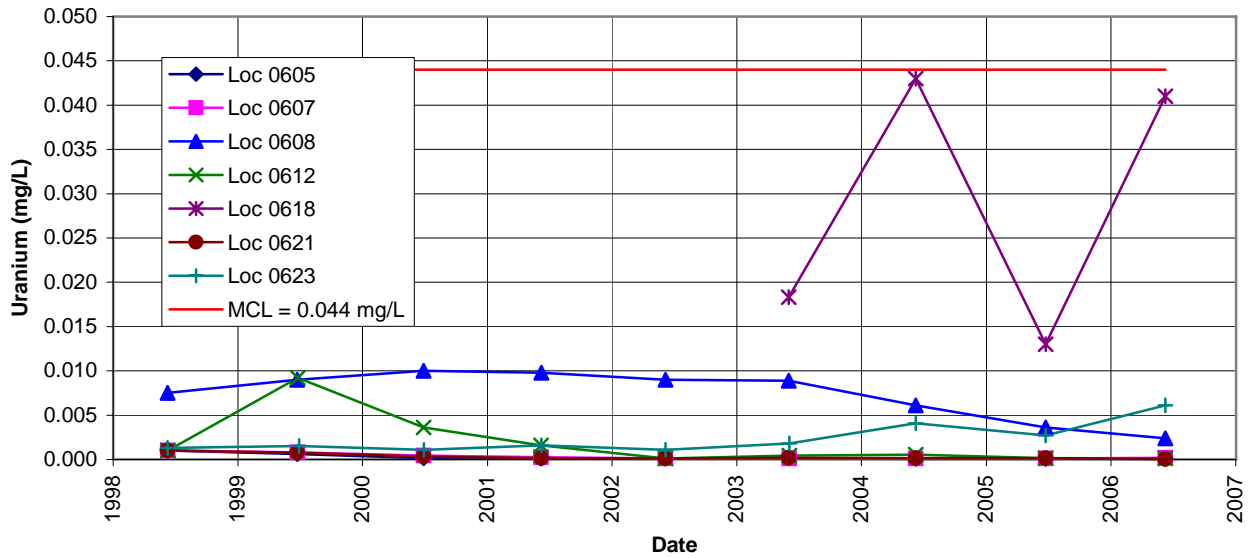
Figure 4-2. Time-Concentration Plots of Uranium in Ground Water at the Durango, Colorado, Disposal Site

As shown on Figure 4–2, the highest uranium concentrations occur in monitor well MW–0618; which continue to oscillate, but remain below the MCL. DOE had considered the concentration in 2004 to be anomalous and suspected the cause of the anomaly to be correlated with the closure

of the collection drain system. However, the uranium concentration of 0.041 mg/L reported in 2006 increased as compared with the previous year and is consistent with the 2004 result. Because only four data points are available for this well, trend analysis is inconclusive for this constituent and additional monitoring is needed.

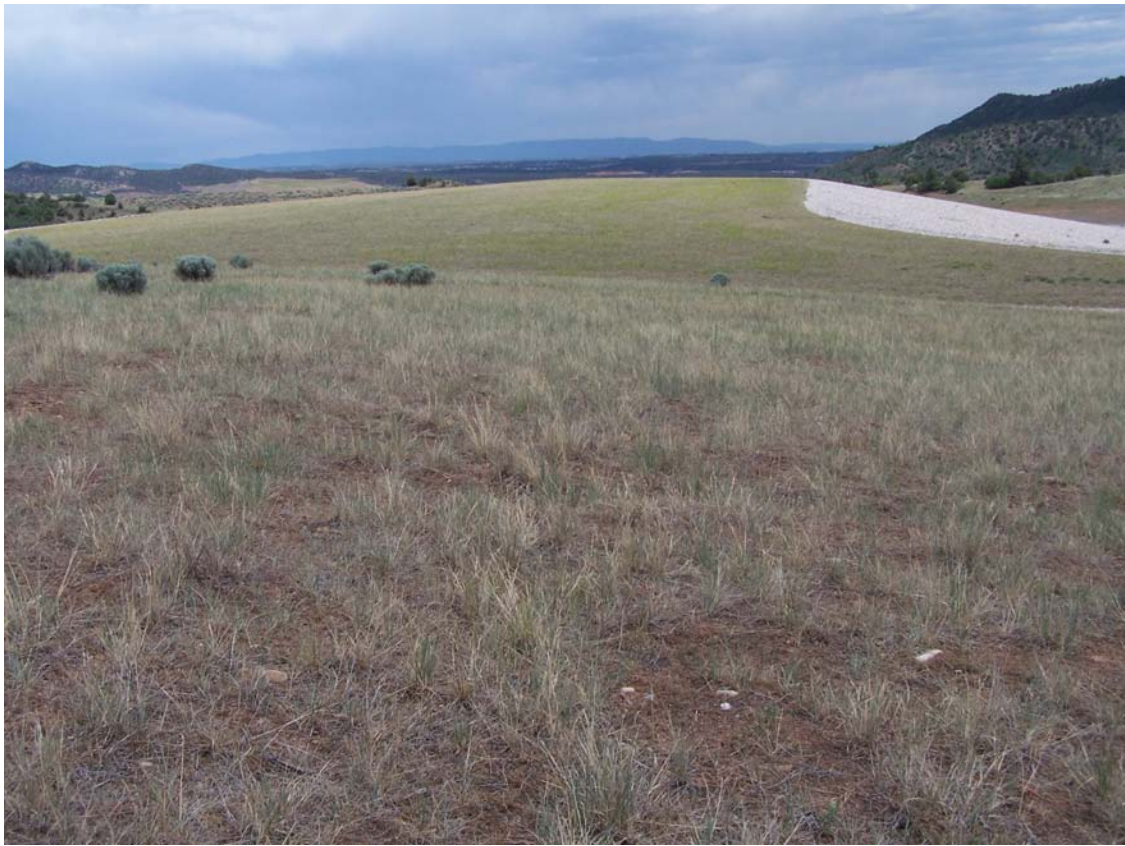
Top of Disposal Cell—The top of the disposal cell was in excellent condition (PL-1). No evidence of settling, slumping, or erosion was observed.

DUR 6/2006. PL-1. Disposal cell top.

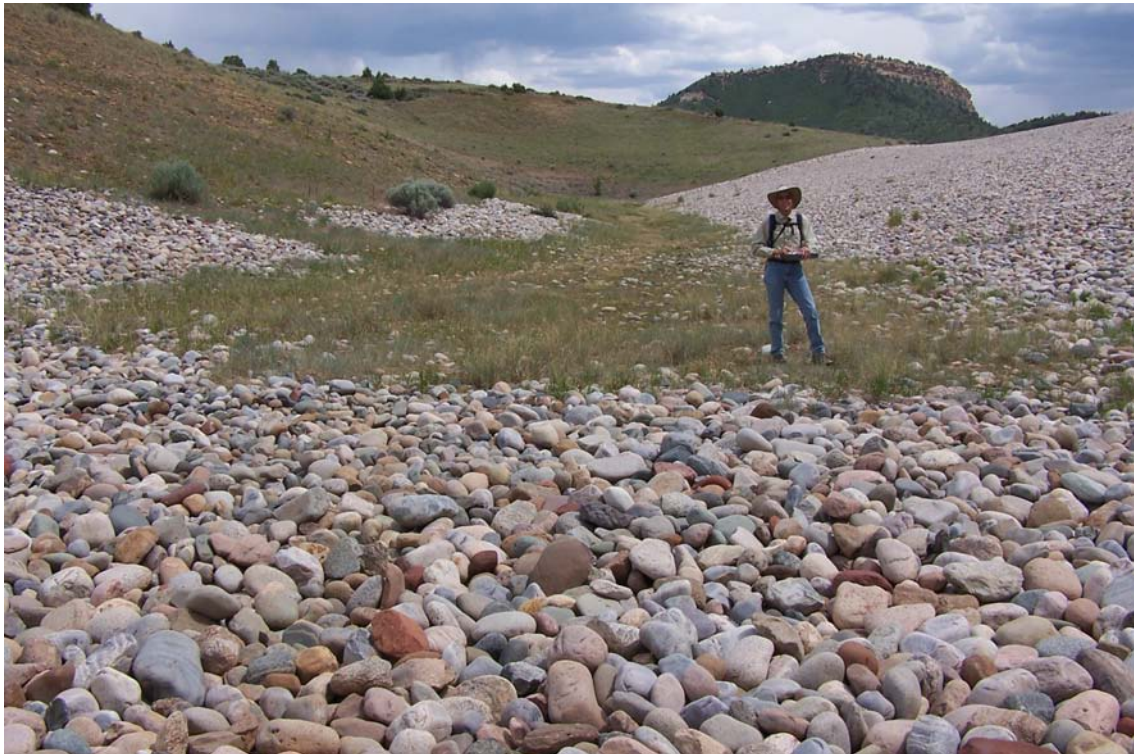
Moist sediments support wetlands vegetation and willows at places in Diversion Channel No. 1 along on the east side of the cell. The sediment deposits and plant growth will not compromise

the performance of the drainage channels in the event of a large storm. Should water be impounded in the channels, it would drain away from the disposal cell along bedding planes and permeable zones in the bedrock. However, if there is evidence of impounded water, maintenance will be conducted to remove the obstruction and restore flow out of the diversion channels. The riprap-covered outflow of Diversion Channel No. 1, referred to as the Northeast Outflow, was designed to erode back to a rock-filled trench and self-armor in the process. Significant movement of the knickpoint has not occurred since it was surveyed in 1999 (PL-3).

DUR 6/2006. PL-2. Sediment deposition in Diversion Channel No. 1.

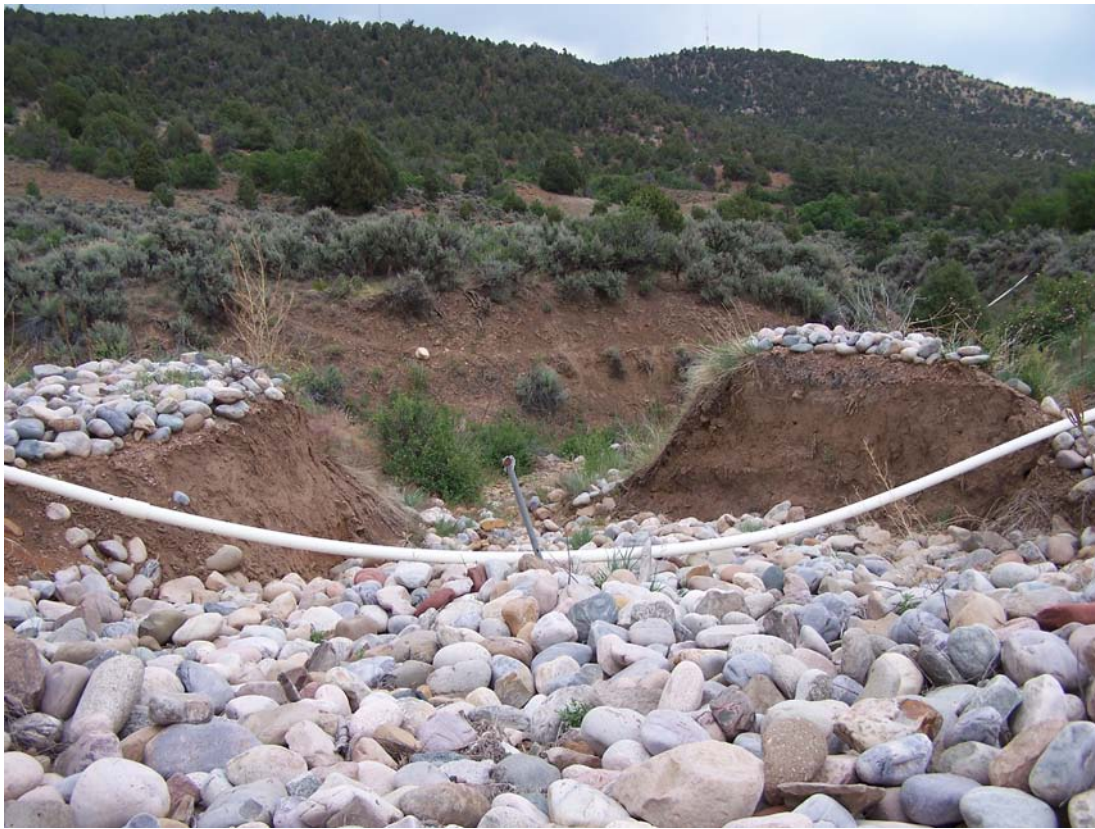
DUR 6/2006. PL-3. Northeast Outflow; no new erosion.

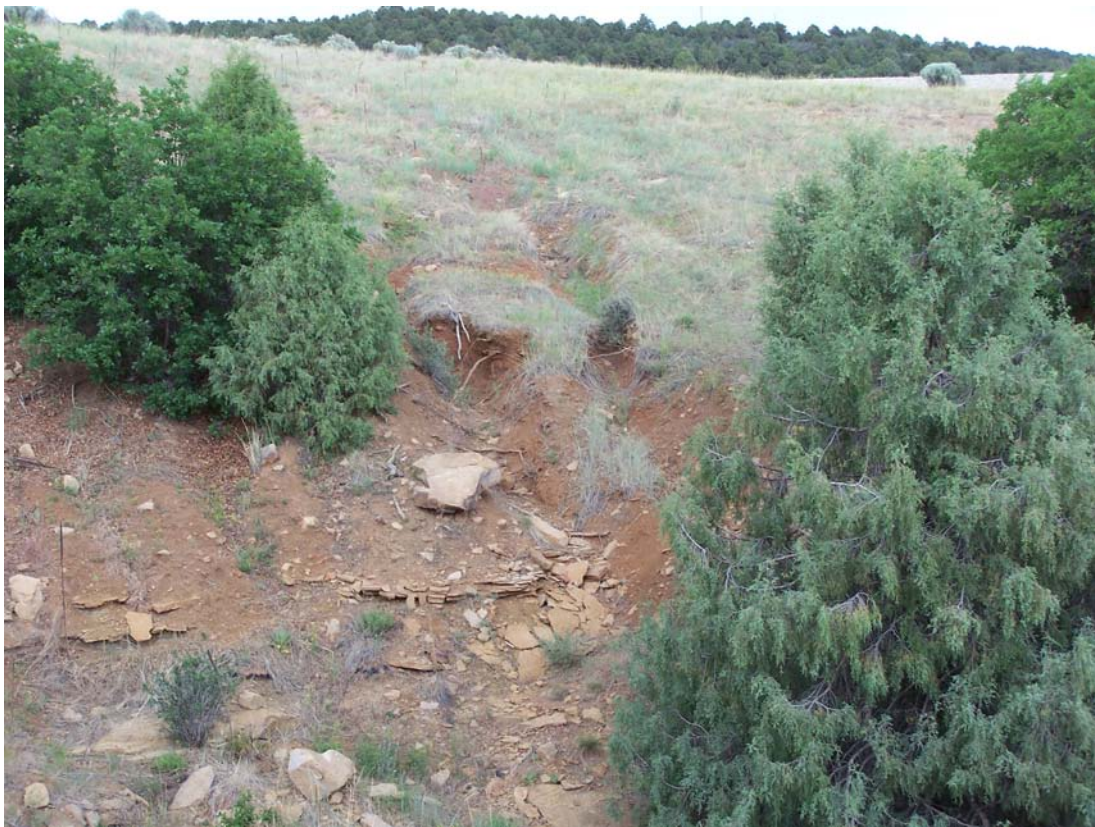
The majority of rill and gully erosion on the south and north-facing slopes in the southwest portion of the site were stable. Establishment of vegetation in these areas, previous placement of rock, and exposure of resistant bedrock in the gullies are effectively preventing further erosion. However, fresh headcuts were noted in two gullies in the southwest portion of the site (PL-4). This erosion will not impact the disposal cell or its drainage channels and will continue to be monitored. No other areas of recent erosion were observed on or around the site.

DUR 6/2006. PL-4. Fresh headcuts in gullies in the southwest portion of the site.
