4.0 Durango, Colorado, Disposal Site

4.1 Compliance Summary

The Durango, Colorado, Disposal Site, inspected on August 14, 2007, is in good condition. In June 2006, the criteria for permanent closure of the transient drainage water collection and treatment system were met; however, an increased uranium concentration reported downgradient needs to be evaluated. In 2007, a solar-powered water management system was installed to distribute retention pond water to drip lines used to enhance evaporation. Infestations of noxious weeds continue to be monitored and controlled with herbicide. Vandalism, primarily theft and damage to signs, continues at the site. No other maintenance needs or cause for a follow-up or contingency inspection was identified.

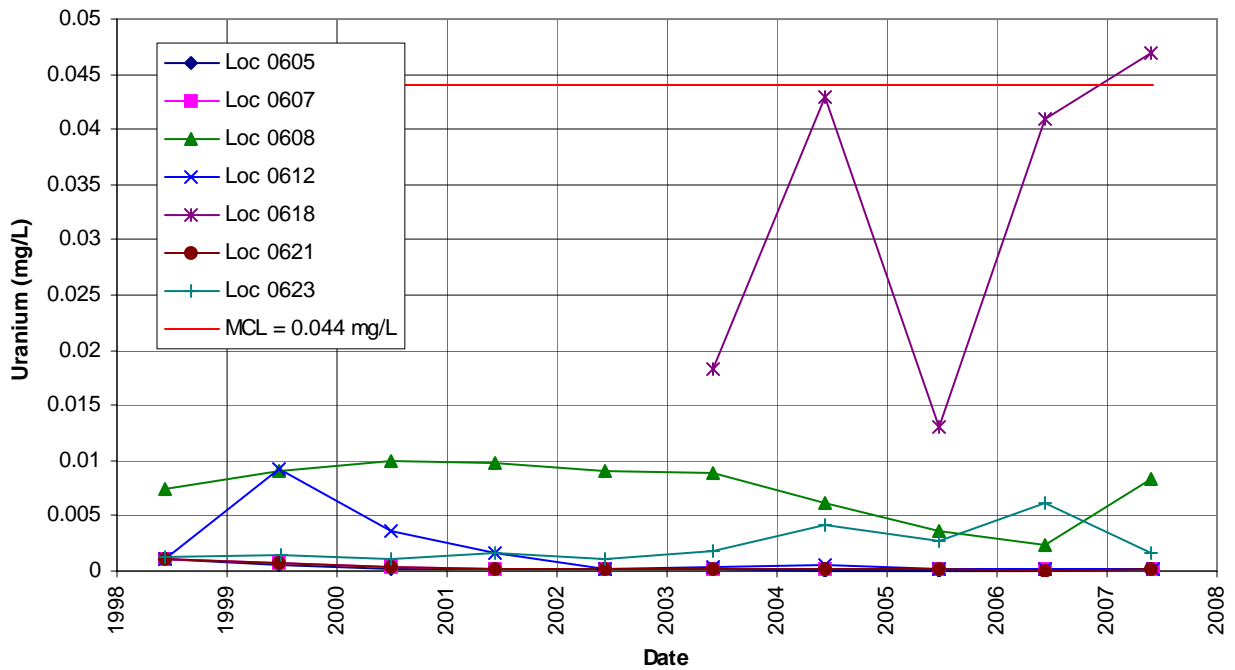
Figure 4-2. Time-Concentration Plot of Uranium in Groundwater at the Durango, Colorado, Disposal Site

As shown in Figure 4–2, the highest uranium concentrations occur in monitor well MW–0618 where for the first time since sampling began in 2003 concentrations have exceeded the MCL. The uranium concentration of 0.047 mg/L reported in 2007 is consistent with 2004 and 2006 values, but is over twice the concentrations reported in 2003 and 2005. However, with only

5 data points available for this well, trend analysis is inconclusive for this constituent and additional monitoring is needed. The uranium concentration reported in 2007 from well MW-0608 also increased, although the results (0.0084 mg/L) from this well remain below the MCL and within the historical range. These wells are adjacent to each other and completed in the alluvium, although screened at different depths (see previous text). Point of compliance well MW-0621 is also adjacent to these wells; however, completion is within the underlying bedrock (i.e., the uppermost aquifer). Analytical results reported historically from well MW-0621 for uranium continue at or near detection limits.

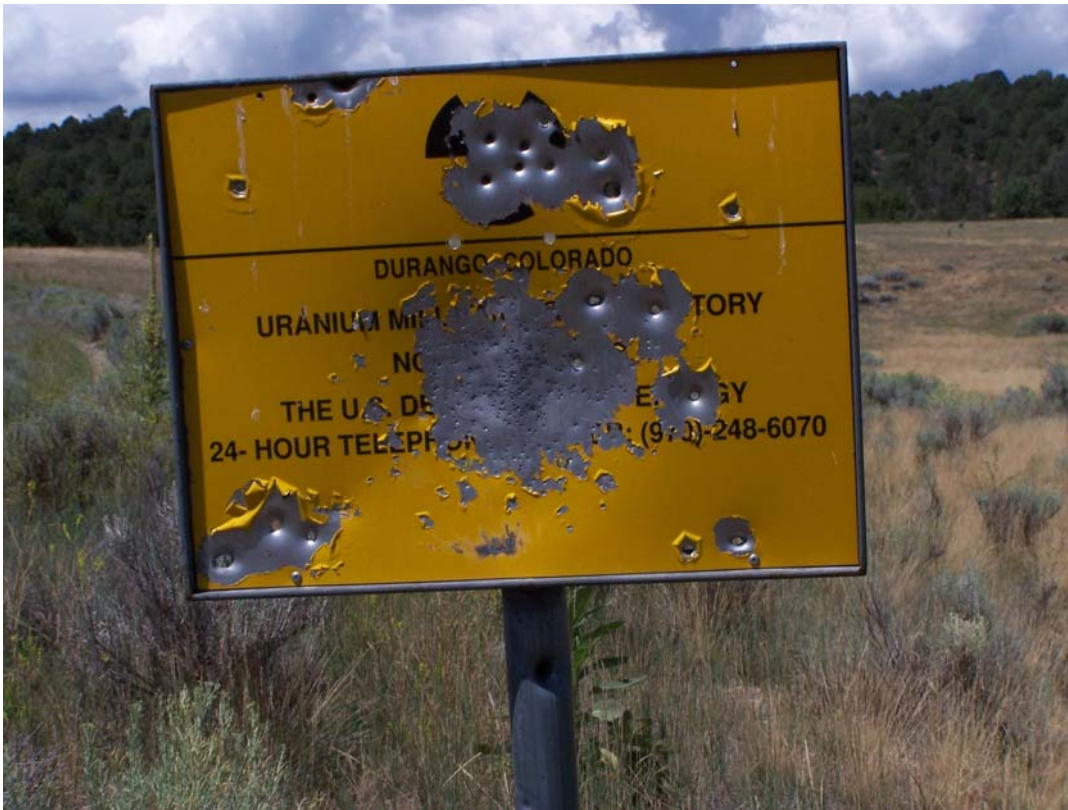
- 4A The entrance sign, which had been vandalized by buckshot to the extent that it was no longer legible (PL–1), was replaced. Numerous other perimeter signs have bullet holes but remain legible. Perimeter sign P2 has been stolen a number of times and is no longer being replaced. The site remains well delineated by the 81 other perimeter signs. The base of perimeter sign P44 is being undercut by erosion, but currently remains stable (PL–2).

DUR 8/07. PL-1. Entrance sign in need of replacement.

In 2007, the entrance sign was replaced, and noxious weeds were treated with herbicide during spring and fall applications.

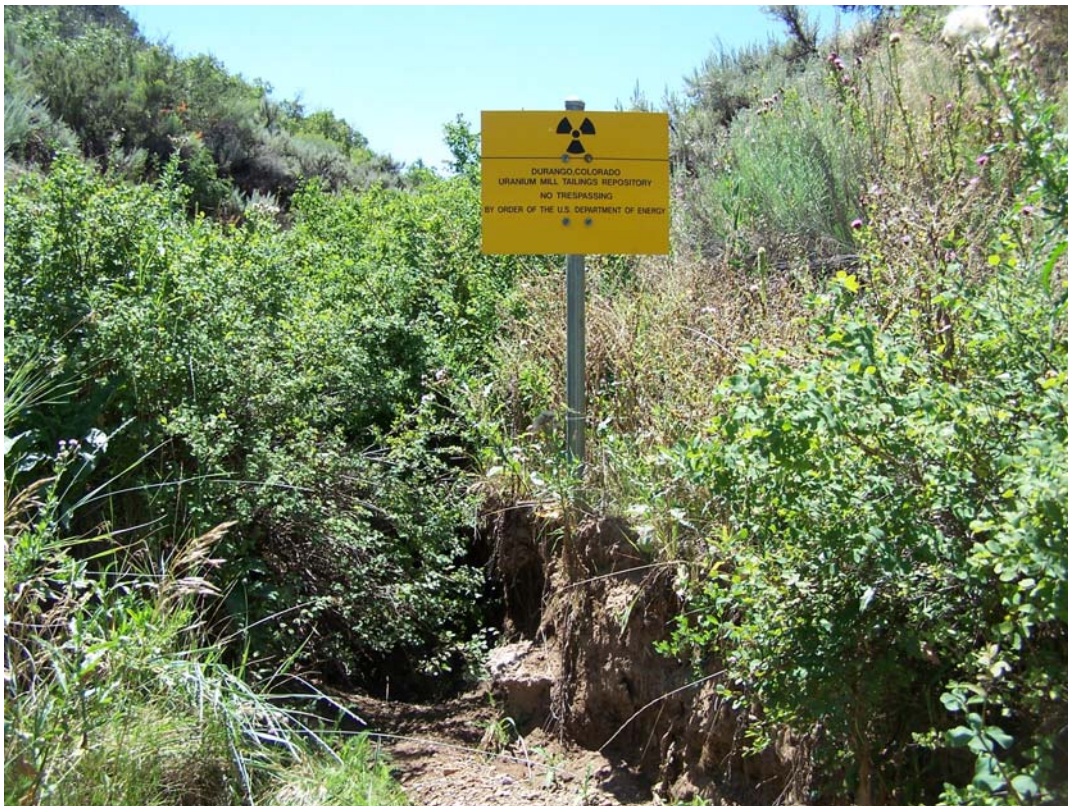
DUR 8/07. PL-2. Undercutting and deposition at perimeter sign P44.

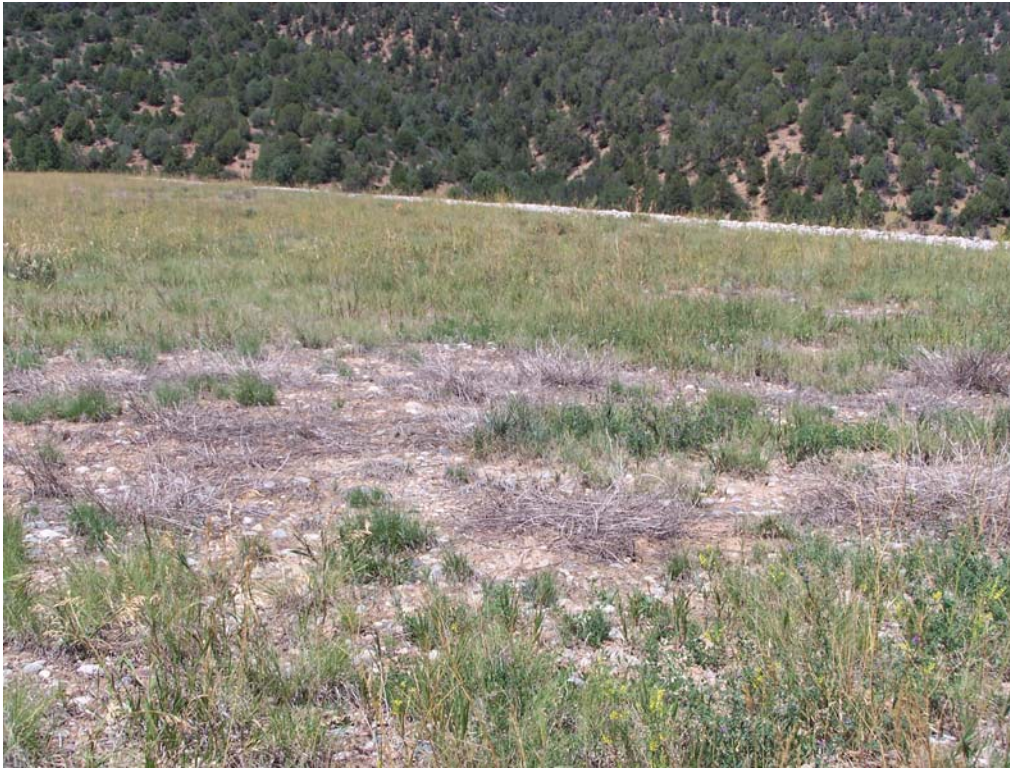
Although the aboveground height of the dryland alfalfa found growing on the cell top will never exceed the 3.5-foot criterion listed in the LTSP for woody species, it is known to be a deep-rooted plant. This species is now being controlled on the disposal cell cover (PL-3). No deep-rooted woody species were found on the cell top in 2007. The noxious musk thistle and deep-rooted alfalfa plants were treated with herbicide in September 2007.

DUR 8/07. PL-3. Dead alfalfa plants on disposal cell top, sprayed with herbicide in September 2006.

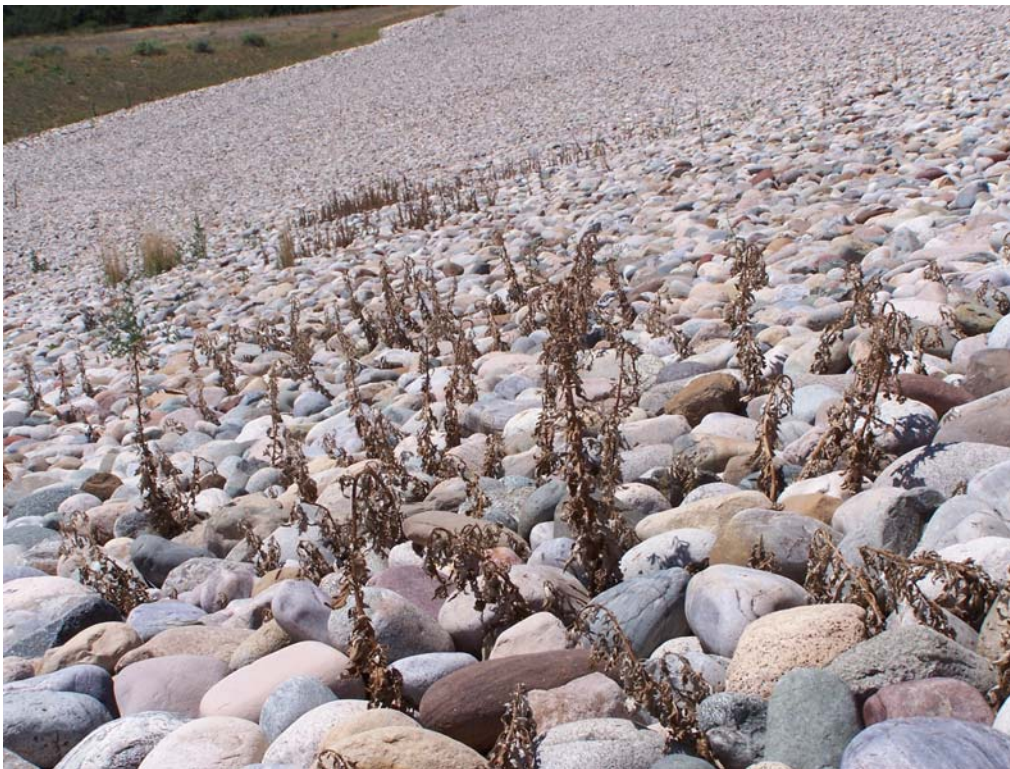
- 4B The 2006 treatment of a variety of deep-rooted woody shrubs and trees was successful, and woody species observed on the cell in 2007 were all less than 1 foot high. Two noxious weed species—musk thistle and Canada thistle—continue to populate the side slopes. They were treated in June 2007 (PL-4) and again in September 2007.

DUR 8/07. PL-4. Dead Canada thistle on disposal cell side slope, sprayed with herbicide in June 2007.

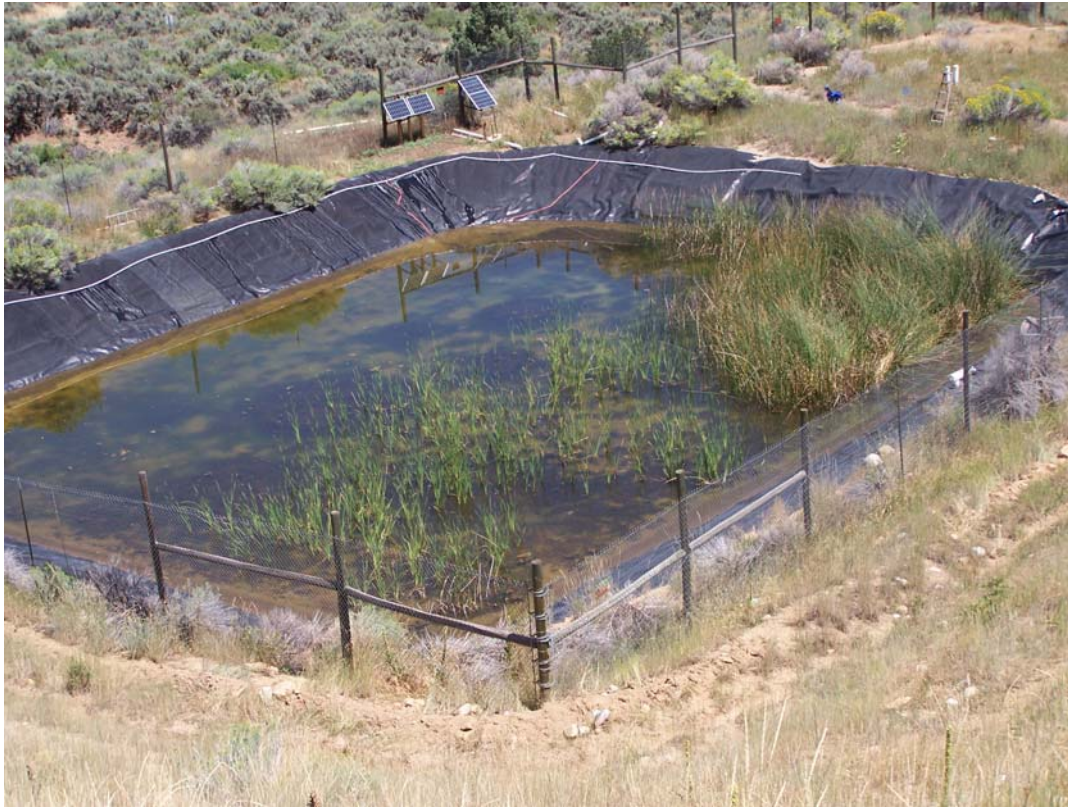
- 4C **Treatment Cells and Retention Pond**—The retention pond northeast of the disposal cell collects drainage water from the cell. Water retained in the retention pond is distributed by solar powered pumps and drip lines onto the lined pond sideslopes to enhance evaporation. This solar-powered water management system was installed in 2007 (PL-5).

DUR 8/07. PL-5. Retention pond; note drip lines along top and left banks.
