4.0 Durango, Colorado, Disposal Site

4.1 Compliance Summary

The Durango, Colorado, Uranium Mill Tailings Radiation Control Act (UMTRCA) Title I Disposal Site was inspected on June 15, 2010. The disposal cell and all associated surface water diversion and drainage structures were in good condition and functioning as designed. The water level in the disposal cell has dropped, which satisfies criteria for the permanent closure of the transient drainage water collection and treatment system. Vandalism, primarily theft and damage to signs, continues at the site. The bases of perimeter signs P41 and P44 have been undercut by erosion but remain stable. Infestations of noxious weeds and deep-rooted plants on the disposal cell continue to be monitored and controlled with herbicide. No other maintenance needs or cause for a follow-up or contingency inspection was identified.

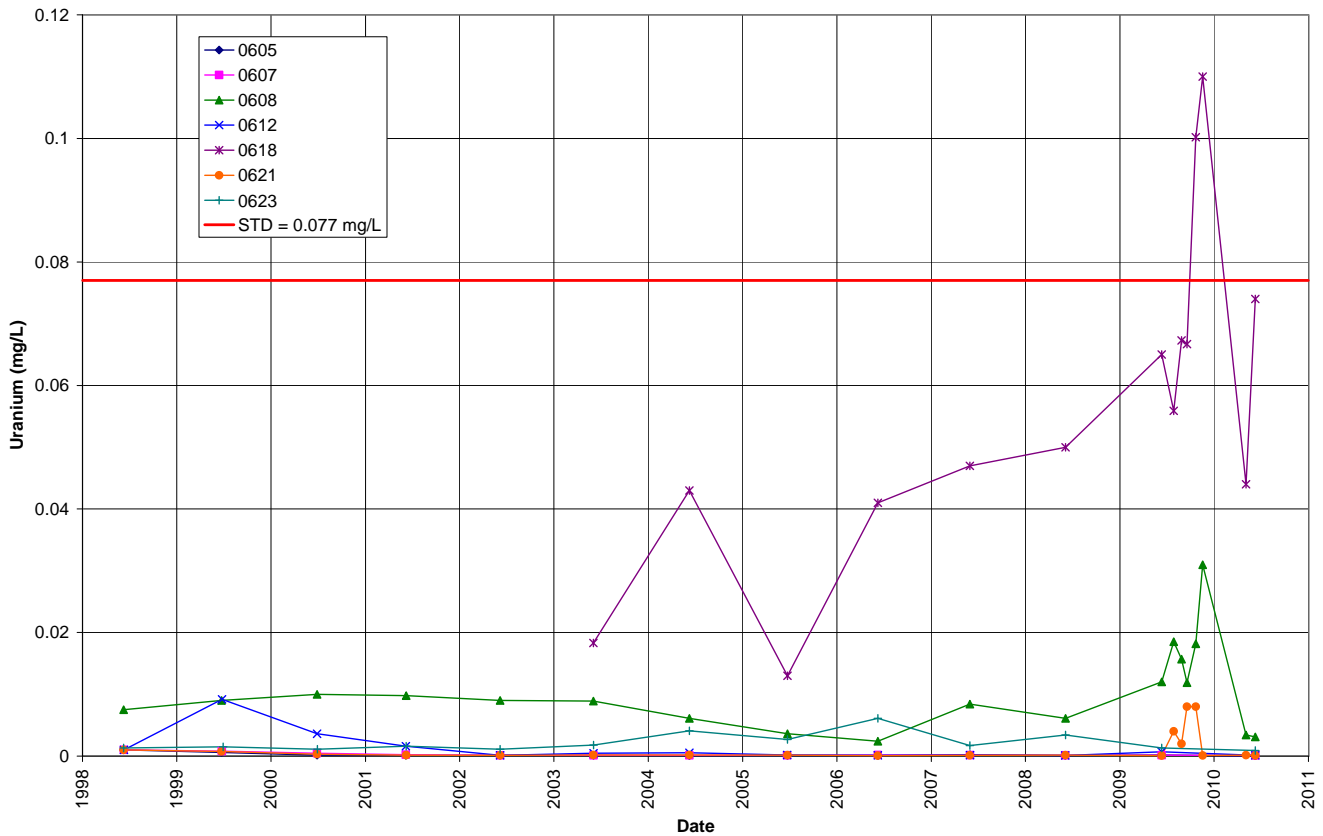
Figure 4-2. Time-Concentration Plot of Uranium in Groundwater at the Durango Disposal Site

Uranium concentrations in monitoring well MW-0618 have decreased since 2009 and are back below the standard though there was an increase observed between the May and June sampling events; concentrations in well MW-0608 decreased and remained consistent between May and June events. Selenium concentrations decreased in both of these wells, and molybdenum remained steady. Analytical results from all other locations are on trend with previous results.

In 2009, the most significant groundwater monitoring result reported was the uranium concentration in well MW-0618. The uranium concentration of 0.11 milligram per liter reported in this well in November 2009 is consistent with the increasing trend that began in 2005, and exceeded site-specific standard of 0.077 mg/L. In fall 2009, well MW-0618 was redeveloped, and the purging method and pump materials were evaluated. The uranium levels have decreased back below the standard in 2010. All other concentrations of uranium, along with all concentrations of both selenium and molybdenum, remain on trend and well below their respective standards.

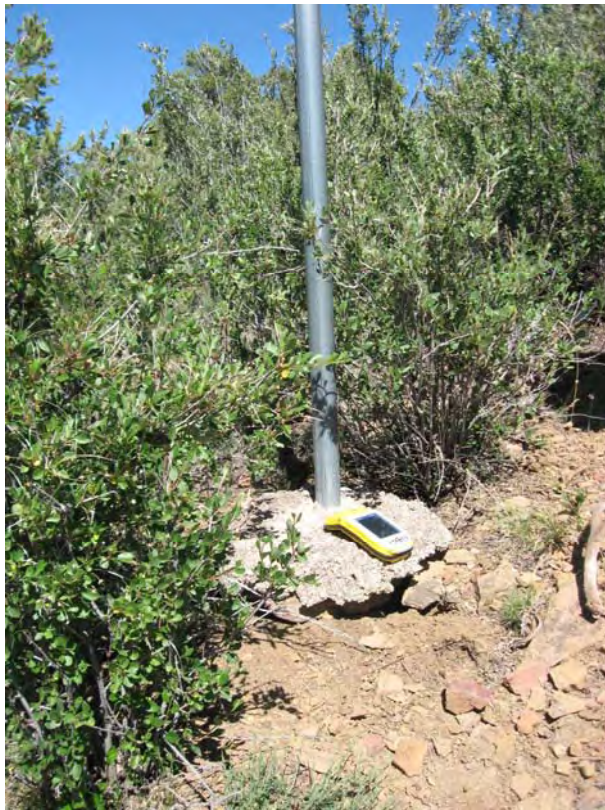
Perimeter sign P1 was replaced in 2009. Numerous other perimeter signs have bullet holes but remain legible. Perimeter sign P2 has been stolen many times, but because adjacent signs are within sight, it is no longer being replaced. The 81 remaining perimeter signs delineate the site sufficiently. The bases of perimeter signs P41 (PL–1) and P44 are being undercut by erosion but currently remain stable.

DUR 6/2010. PL-1. Undercutting at perimeter sign P41.

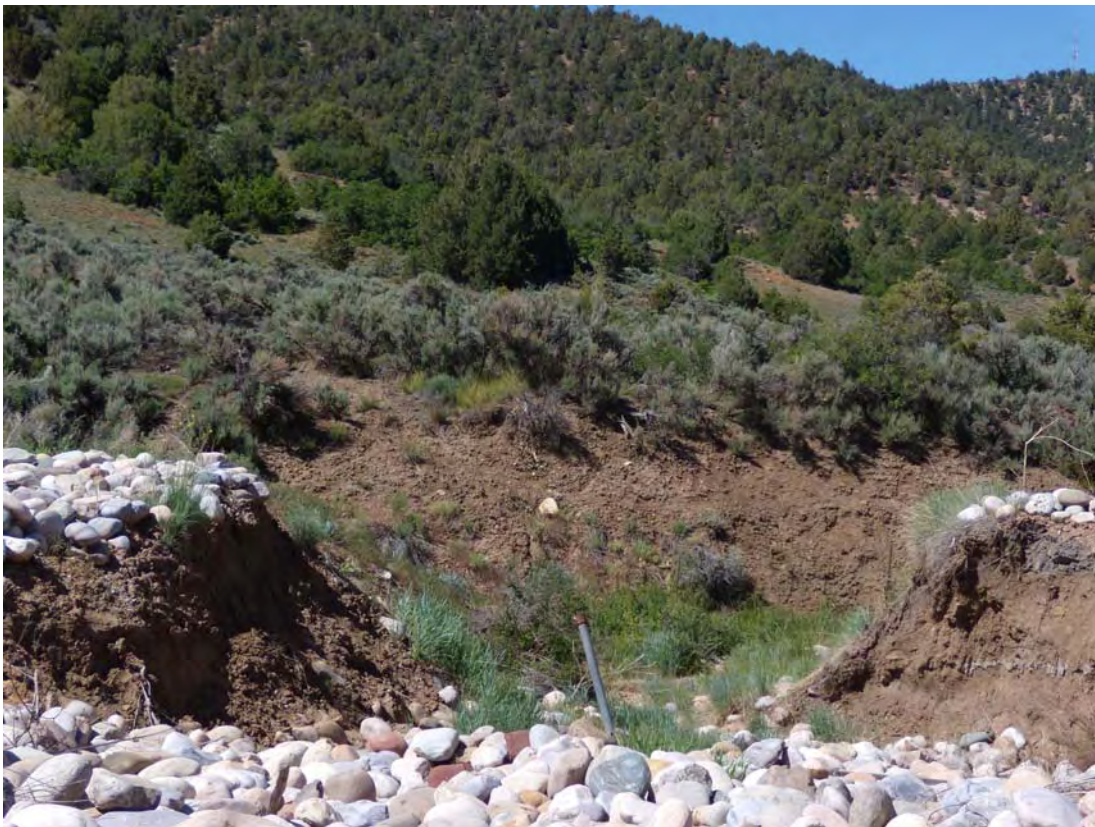
The riprap-covered outflow of Ditch No. 1 was designed to erode back to a rock-filled trench and self-armor in the process. No significant erosion has occurred in Ditch No. 1 since it was last surveyed in 1999 (PL–2).

DUR 6/2010. PL-2. Northeast outflow; no new erosion

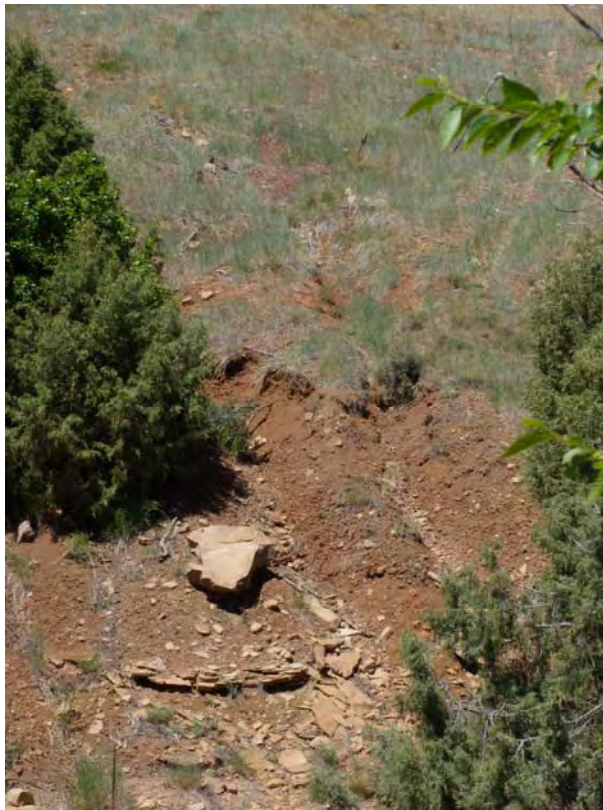
Historical rill and gully erosion has occurred at various locations on site, but most rills and gullies are stabilizing, and none are currently threatening the performance of the disposal cell or its associated surface water diversion structures. The establishment of vegetation and the exposure of resistant bedrock in the gullies are preventing further erosion in most of the gullies (PL-3). DOE will continue to monitor the site for active erosion.

DUR 6/2010. PL-3. Headcuts of gullies below SW corner of disposal cell; no change from 2009

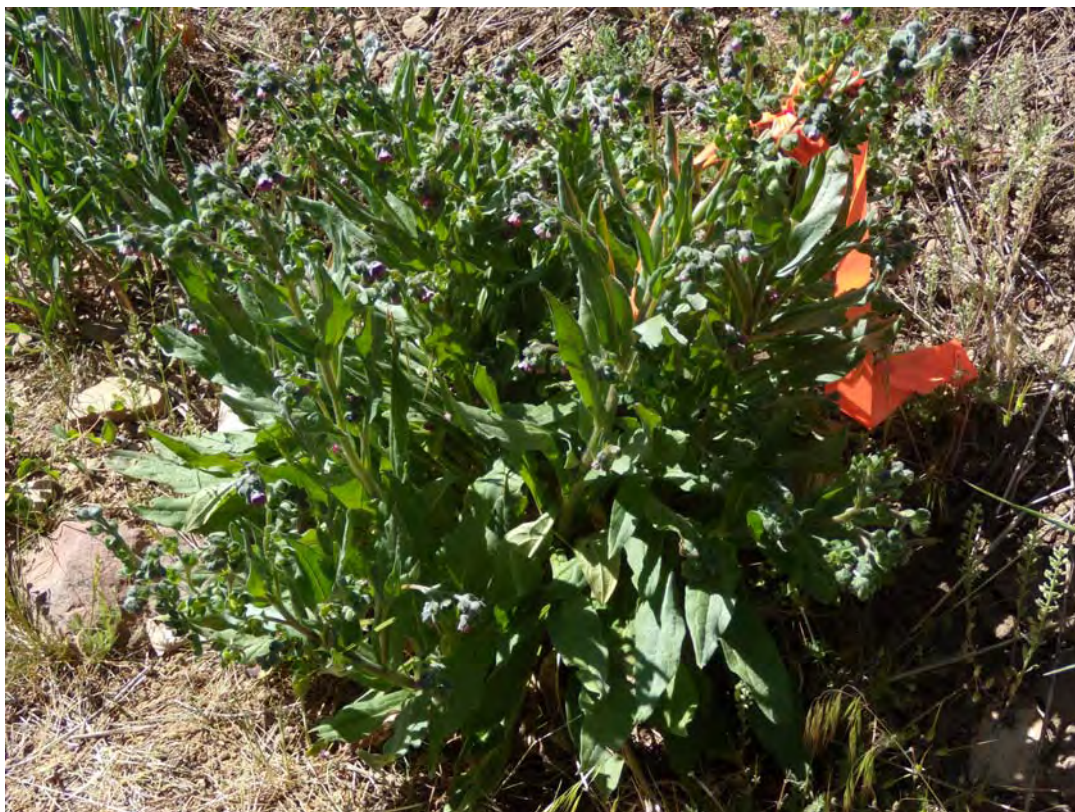
Numerous areas along the site boundary are infested with State-listed noxious weeds (PL-4). These areas were treated with herbicide in September 2010.

DUR 6/2010. PL-4. Houndstongue, a noxious weed.
