## 4.0 Durango, Colorado, Disposal Site

### 4.1 Compliance Summary

The site, southwest of Durango, Colorado, was inspected on June 10, 2011. The results of the inspection are described below. Figure 4–1 shows features and photograph locations (PLs) discussed in this report. Numbers in the left margin of this report refer to items summarized in the “Executive Summary” table.

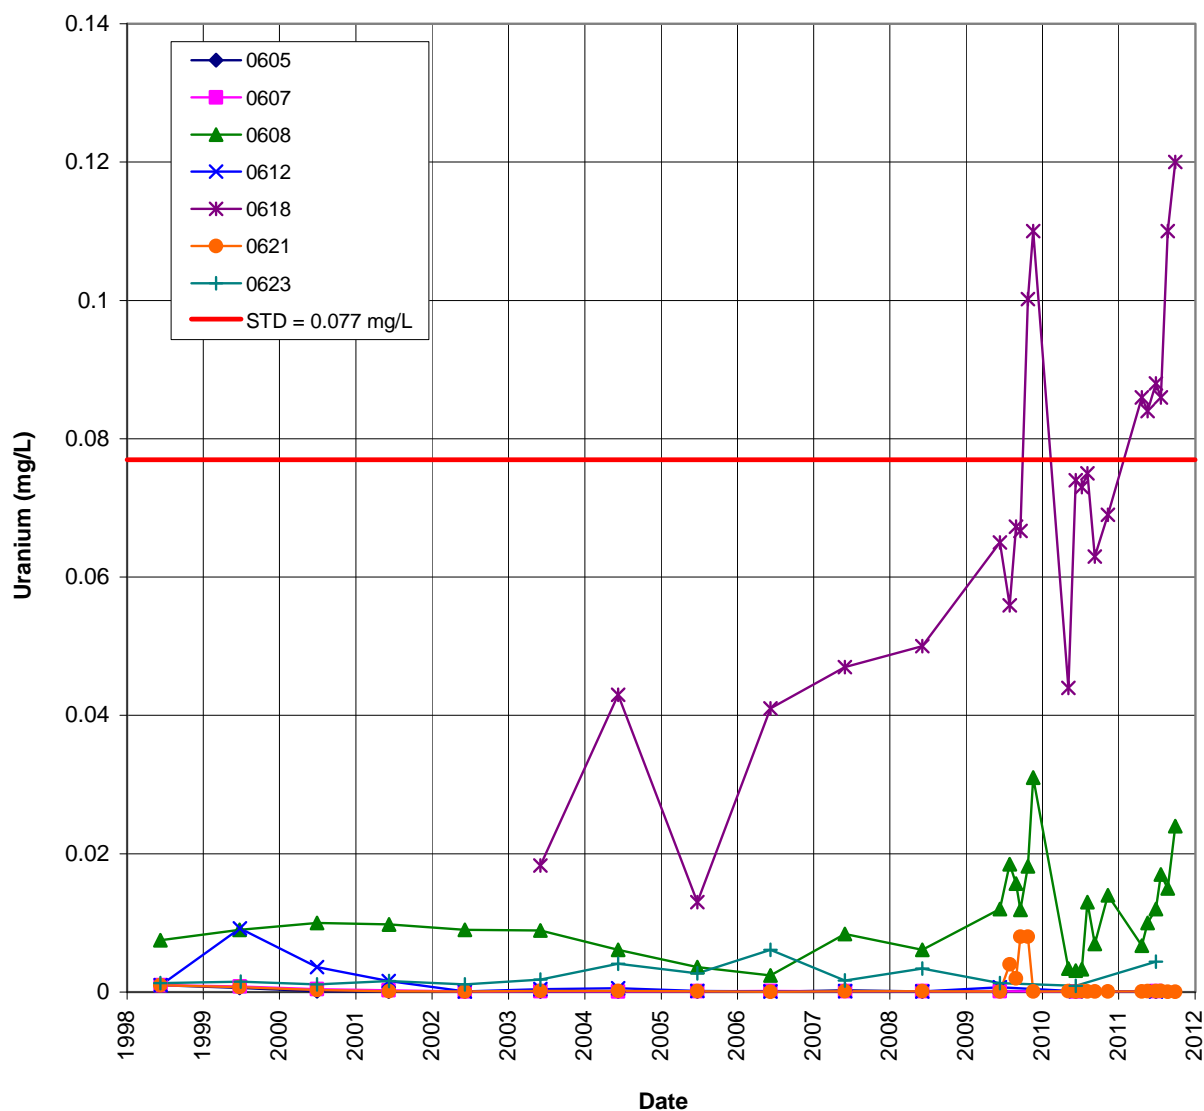
Figure 4-2. Time-Concentration Plot of Uranium in Groundwater at the Durango Disposal Site

Uranium concentrations in monitoring well 0618 had decreased since 2009 and were below the standard until an increase observed during the June 2011 sampling event. Concentrations in well 0608 have decreased slightly. Selenium concentrations decreased slightly in both of these wells, and molybdenum remained steady. Analytical results from all other locations are on trend with previous results.

In 2009, the most significant groundwater monitoring result reported was the uranium concentration in well 0618. The uranium concentration of 0.11 milligram per liter (mg/L) reported in this well in November 2009 is consistent with the increasing trend that began in 2005, and exceeded the site-specific standard of 0.077 mg/L. In fall 2009, well 0618 was redeveloped, and the purging method and pump materials were evaluated. The uranium levels had decreased below the standard in 2010. The 2011 results show an increase in uranium back above the standard as well as above levels observed in 2009 (0.12 mg/L). All other concentrations of uranium, along with all concentrations of both selenium and molybdenum, remain on trend and well below their respective standards.

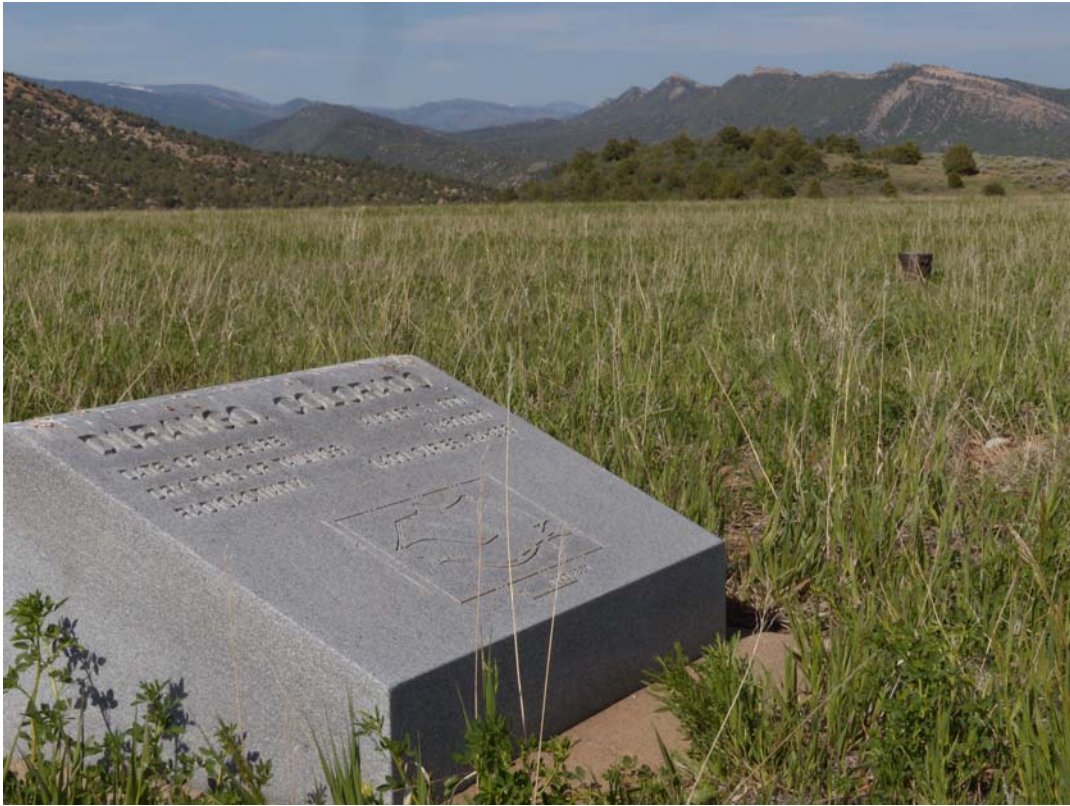
**Top of the Disposal Cell**—The top of the disposal cell (PL-1) was in excellent condition. No evidence of settling, slumping, or erosion was observed.

*DUR 5/2011. PL-1. Site marker SMK-2 and cell top.*

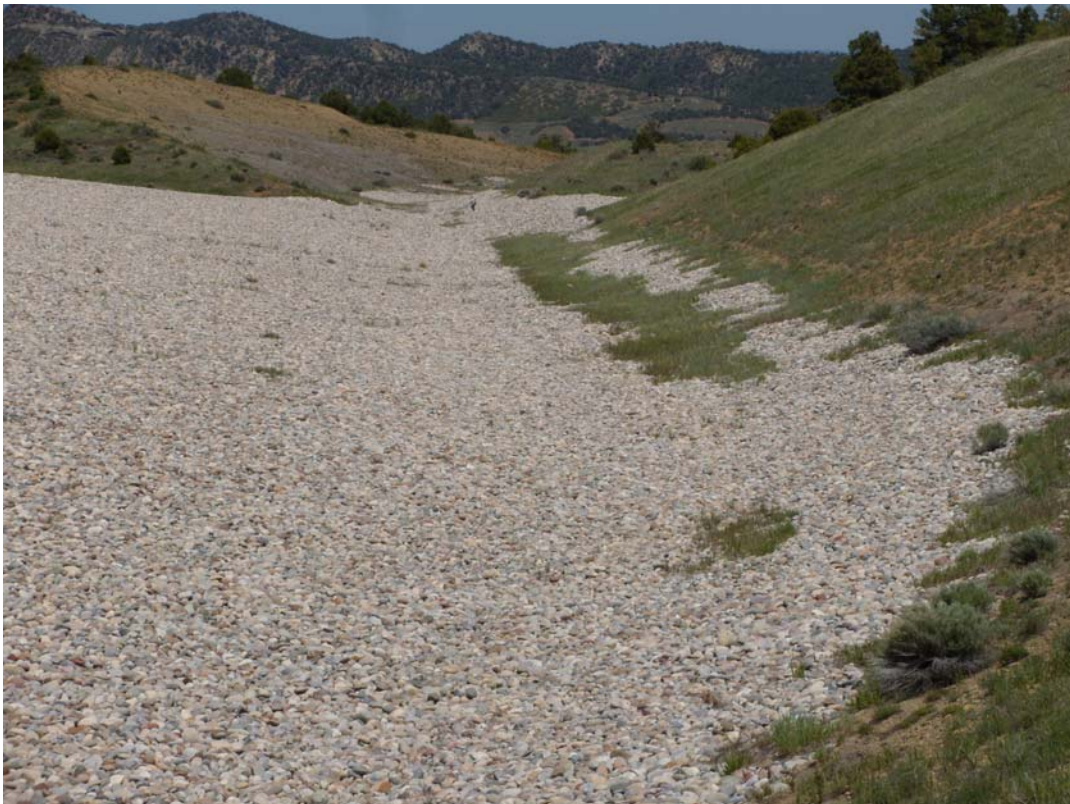
**Drainage Ditches**—Rock-armored drainage ditches beneath the toe of the side slope on the northwest, south, and east sides of the disposal cell direct runoff into natural drainages that carry storm water away from the disposal site. Past erosion and sloughing in Ditch No. 1 have allowed wetland vegetation, including willows, to take root in areas where moist sediments have accumulated. In other places, trees as tall as 15 feet grow in the drainage ditches. The sediment deposits and vegetation currently will not compromise the drainage ditches’ performance in a large storm. Should colluvial deposits or excessive vegetation dam a drainage ditch so as to impound water, the deposits or vegetation will be removed. Inspectors saw no evidence of recent accumulations of sloughed material in the ditches (PL-2).

*DUR 5/2011. PL-2. Ditch No. 2.*

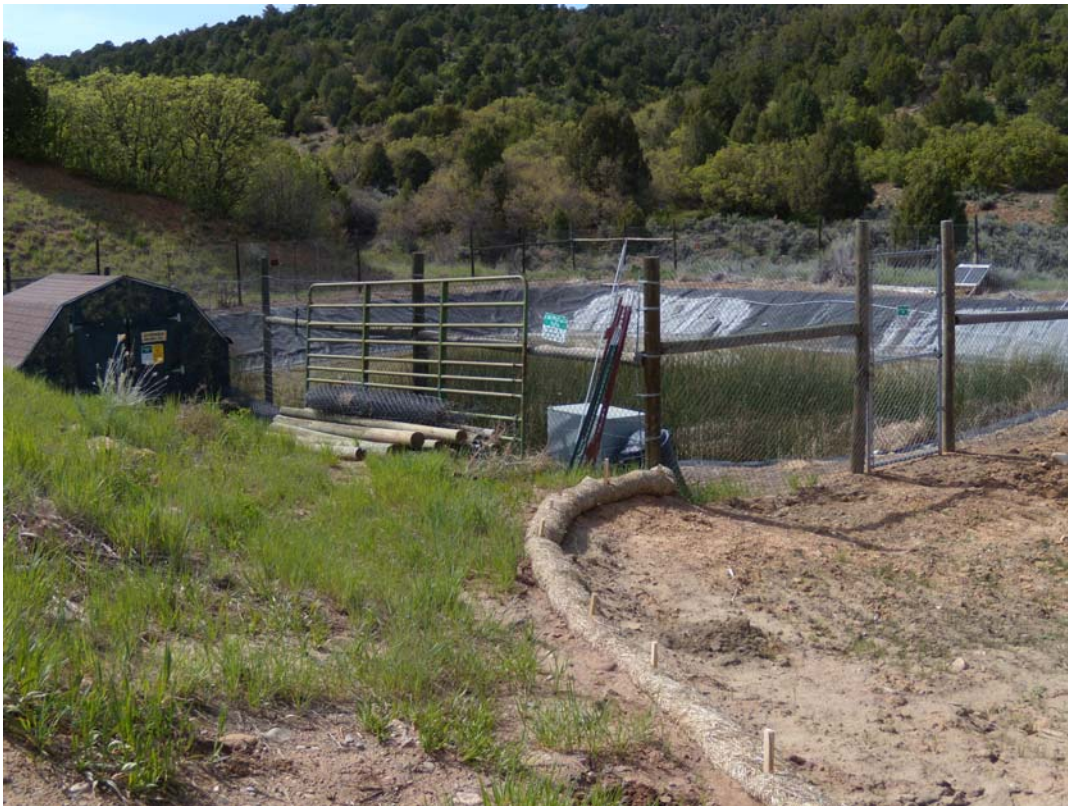
**4B** A security fence surrounds the retention pond, and a shed contains instrumentation to measure the transient drainage flow from the collection gallery. Both the fence and the shed were secure at the time of the inspection (PL-3). Inspectors noted that the shed door needed repairs, and repairs were made on September 21, 2011.

*DUR 5/2011. PL-3. New fence around east side of retention pond area.*

The shed door was repaired on September 21, 2011.

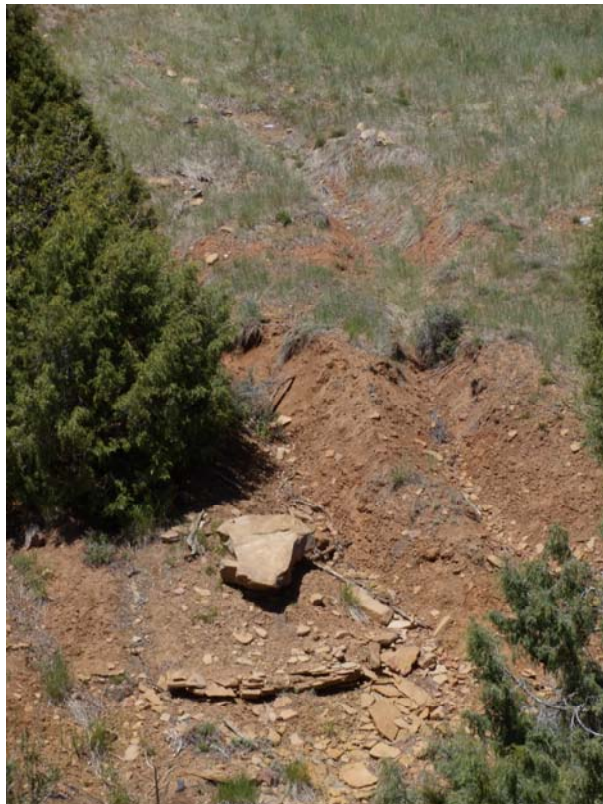
Historical rill and gully erosion has occurred at various locations on site, but most rills and gullies are stabilizing, and none are currently threatening the performance of the disposal cell or its associated surface water diversion structures. The establishment of vegetation and the exposure of resistant bedrock in the gullies are preventing further erosion in most of the gullies. No new headcutting was observed in 2011 (PL-4). DOE will continue to monitor the site for active erosion.

*DUR 5/2011. PL-4. Headcuts of gullies below southwest corner of disposal cell; no change from 2009.*
