## 11.0 Maybell, Colorado, Disposal Site

### 11.1 Compliance Summary

The Maybell, Colorado, Uranium Mill Tailings Radiation Control Act (UMTRCA) Title I Disposal Site was inspected on September 2, 2021. Standing water was observed in the disposal cell apron on the eastern toe slope. Inspectors identified several minor maintenance needs but found no cause for a follow-up inspection. Groundwater monitoring is not required.

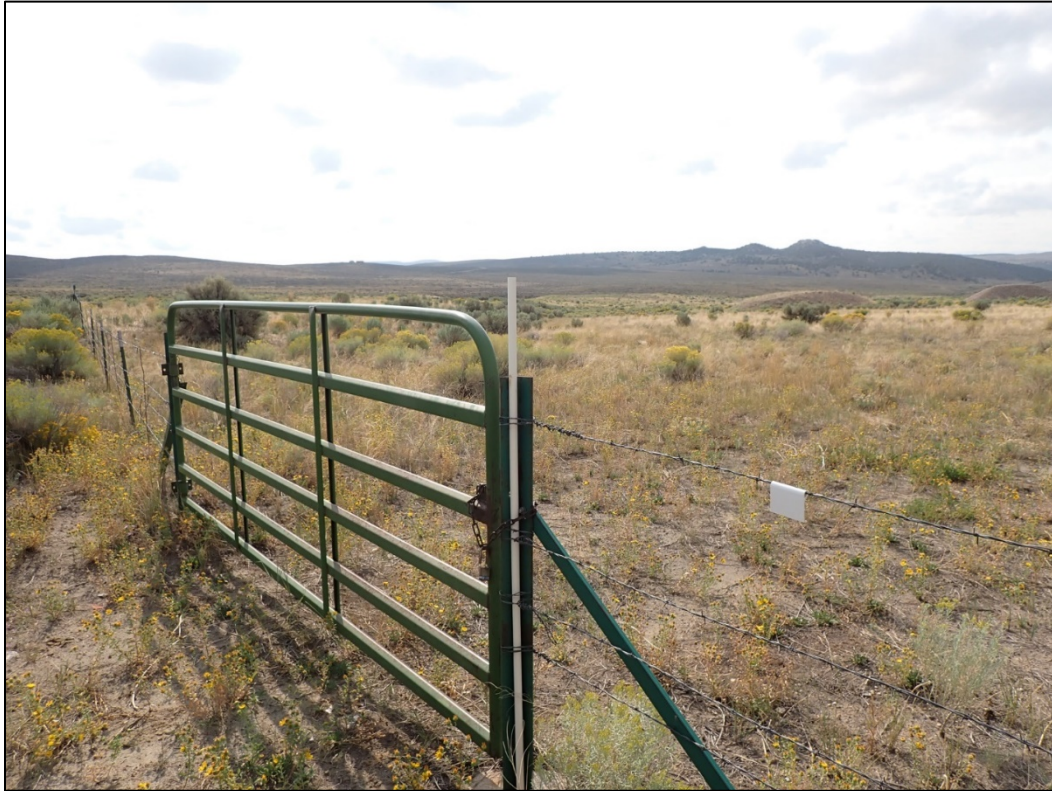
Access to the site is from the gravel-surfaced Moffat County Road 53, which runs north from U.S. Highway 40 approximately 8 miles east of Maybell, Colorado. County Road 53 ends at an unlocked gate near the northeast corner of the site (approximately 3 miles from the highway). The road continues west as a dirt two-track road directly north of the site. From the end of County Road 53 to the site entrance gate (and beyond, to the UMRCA Title II Maybell West, Colorado, Disposal Site), LM is responsible for road maintenance under a U.S. Bureau of Land Management right-of-way permit. Entrance to the site is through two locked, metal stock gates in the perimeter fence. One is the entrance gate (PL-1), which is adjacent to the site marker and entrance sign. The second gate is between perimeter signs P3 and P4 in the northwest corner of the property. Both gates were locked and functional. The entrance sign is near the entrance gate and is mounted on a T-post in the perimeter fence (PL-2). The entrance sign has bullet damage but remains legible. No maintenance needs were identified.

*PL-1. Entrance Gate*

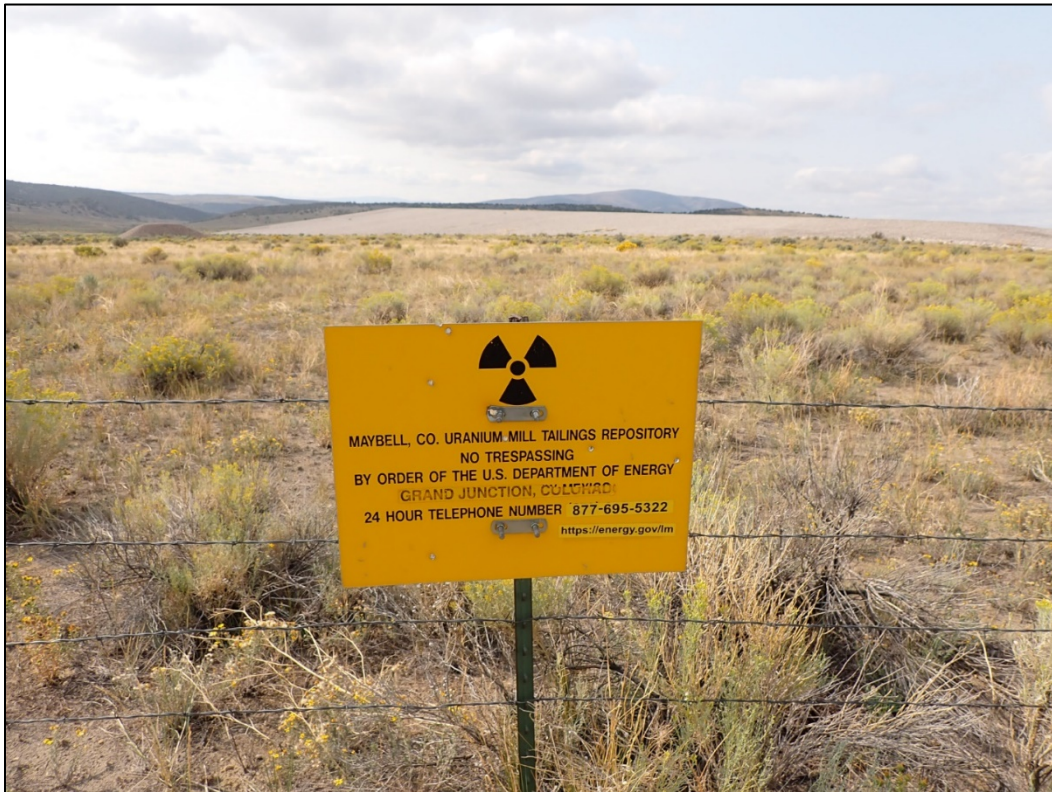
*PL-2. Entrance Sign*

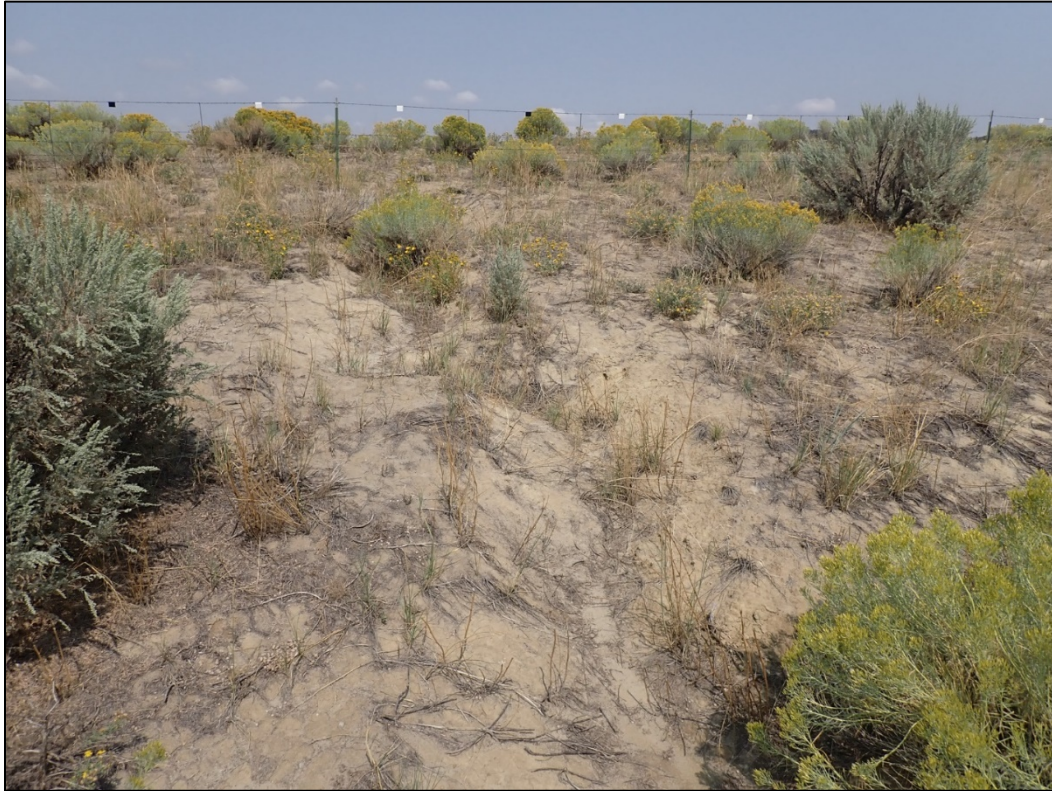
To facilitate LM's land management, a four-strand barbed-wire perimeter fence encloses the disposal cell, drainage structures, and much of the site. The site is in wintering grounds frequented by big-game animals (primarily pronghorn, deer, and elk) and is also surrounded by open range used to graze cattle. Minor damage to the perimeter fence from animal contact periodically occurs. On July 27, 2021, plastic fence flags were attached to the top strand of the perimeter fence to alert wildlife and reduce animal entanglements or strikes against fence lines (PL-3).

*PL-3. Perimeter Fence Line*

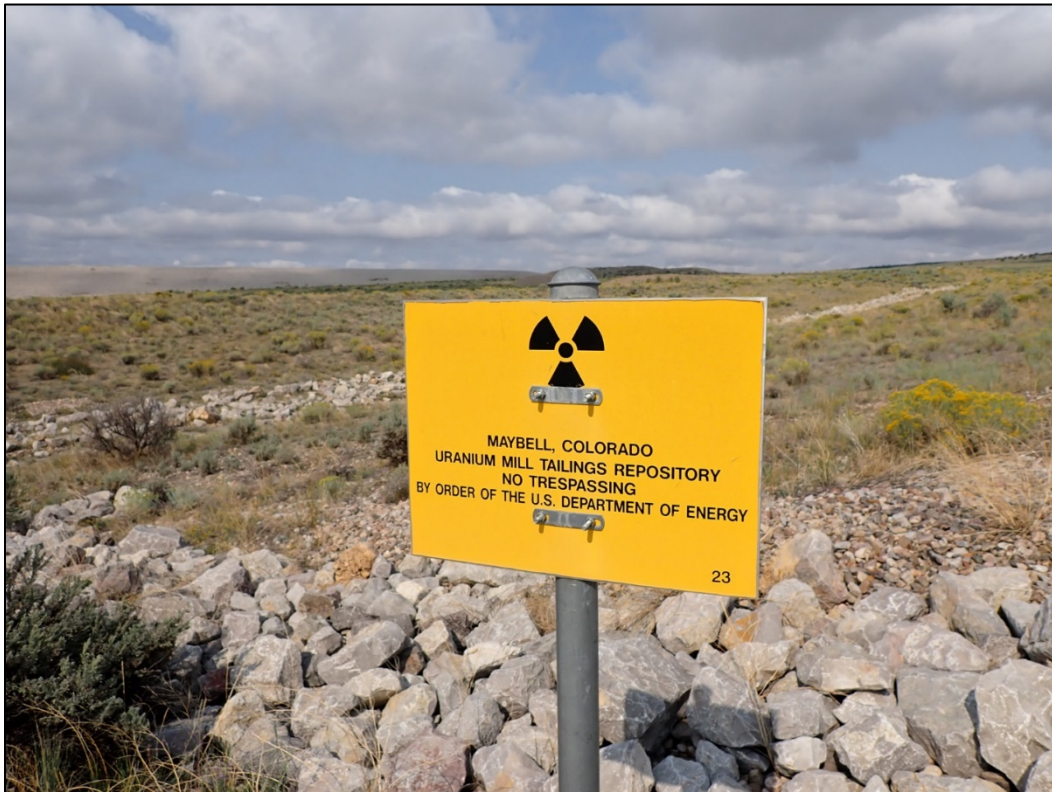
There are 26 perimeter signs. On the north, west, and south sides of the site, perimeter signs are attached to T-posts in the perimeter fence. On the east side of the site, perimeter signs are attached to steel posts set in concrete and are inside the property boundary approximately midway between the disposal cell and the perimeter fence (PL-4). Several of the perimeter signs along the dirt road north and west of the site (P5, P6, P8, and P11) have bullet damage but remain legible. Perimeter sign P16 is faded, and perimeter sign P26 was missing. Perimeter signs P16 and P26 will be replaced during the next routine maintenance event. No other maintenance needs were identified.

*PL-4. Perimeter Sign P23*

Vegetation treatment of noxious weeds and deep-rooted plants on the disposal cell was performed before the 2021 inspection. Perimeter signs P16 and P26 will be replaced during the next routine maintenance event. No other maintenance needs were identified.

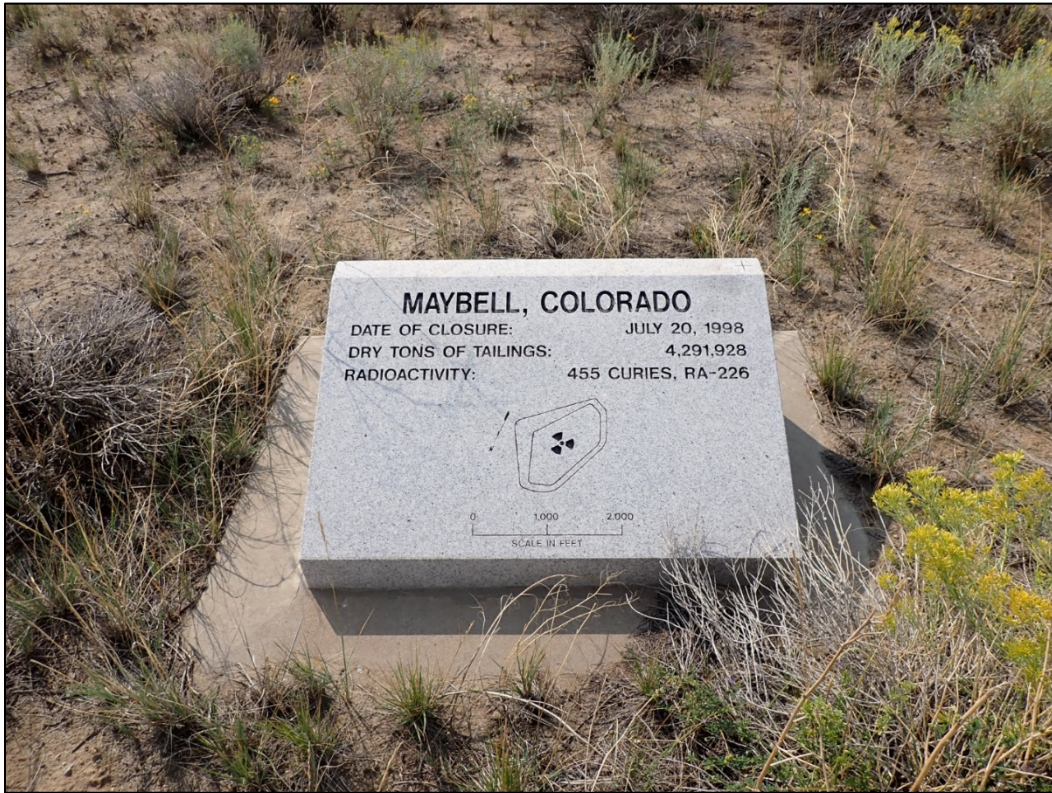
The site has two granite site markers. Site marker SMK-1 is just inside the entrance gate (PL-5), and site marker SMK-2 is on the top slope of the disposal cell. No maintenance needs were identified.

*PL-5. Granite Site Marker SMK-1*

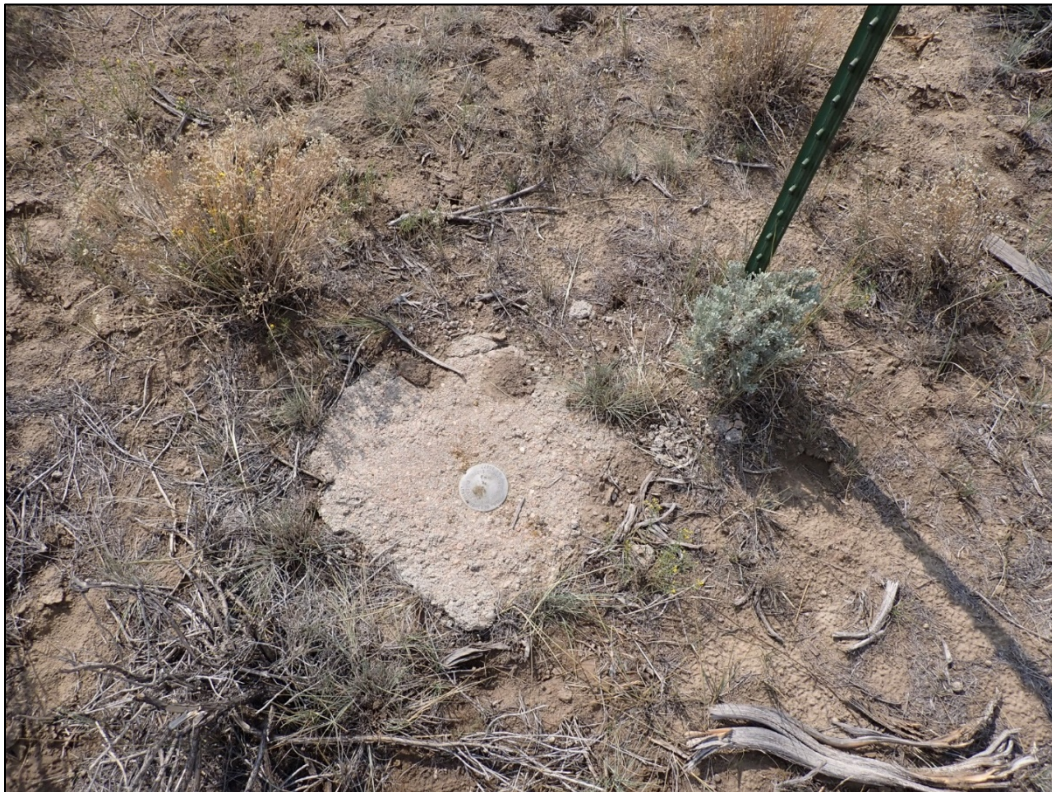
The site has two survey monuments. Survey monument SM-7 is on the bench above Johnson Wash just north of perimeter sign P21, and survey monument SM-8 is south of the disposal cell on the bench above Diversion Channel No. 2. The two survey monuments are historical site features that are difficult to locate. They were not inspected during the 2021 inspection but were confirmed to be present and intact during a site visit in 2019. Seventeen boundary monuments delineate the property boundary (PL-6). No maintenance needs were identified.

*PL-6. Boundary Monument BM-12*

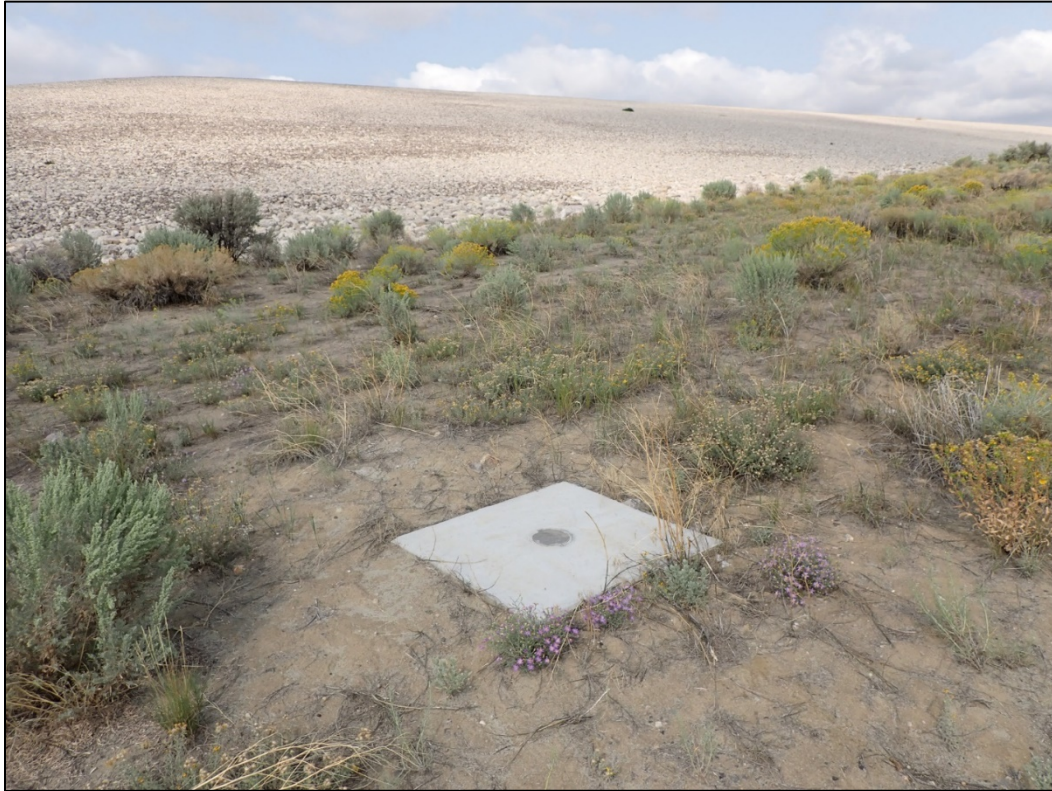
Five aerial survey quality control monuments were inspected during the 2021 inspection (PL-7). No maintenance needs were identified.

*PL-7. Quality Control Monument QC-4*

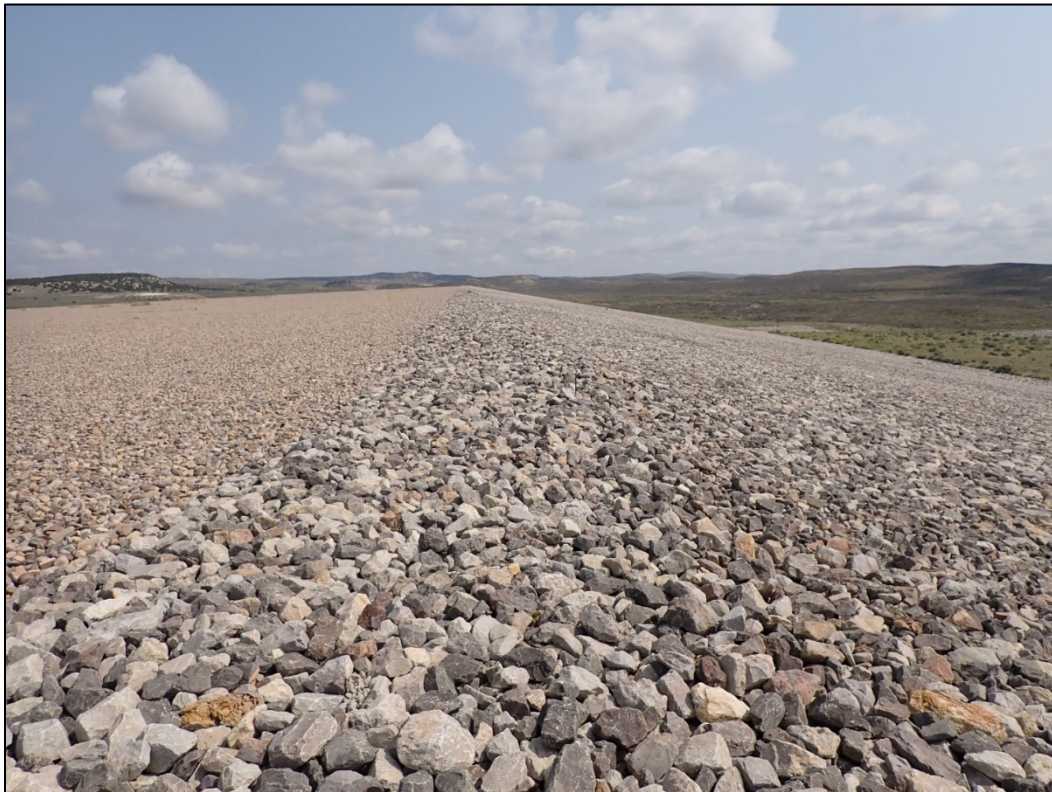
The disposal cell, completed in 1998, occupies 66 acres; it is armored with riprap to control erosion and deter animal and human intrusion (PL-8). There was no evidence of erosion, settling, slumping, rock degradation, or other modifying processes that might affect the integrity of the disposal cell. Scattered shallow-rooted plants continue to establish on the disposal cell top and side slopes; these plants do not affect the integrity of the cell. Deep-rooted plants and noxious weeds are controlled as required by the LTSP.

*PL-8. Disposal Cell Top Slope and Southeastern Side Slope Interface*

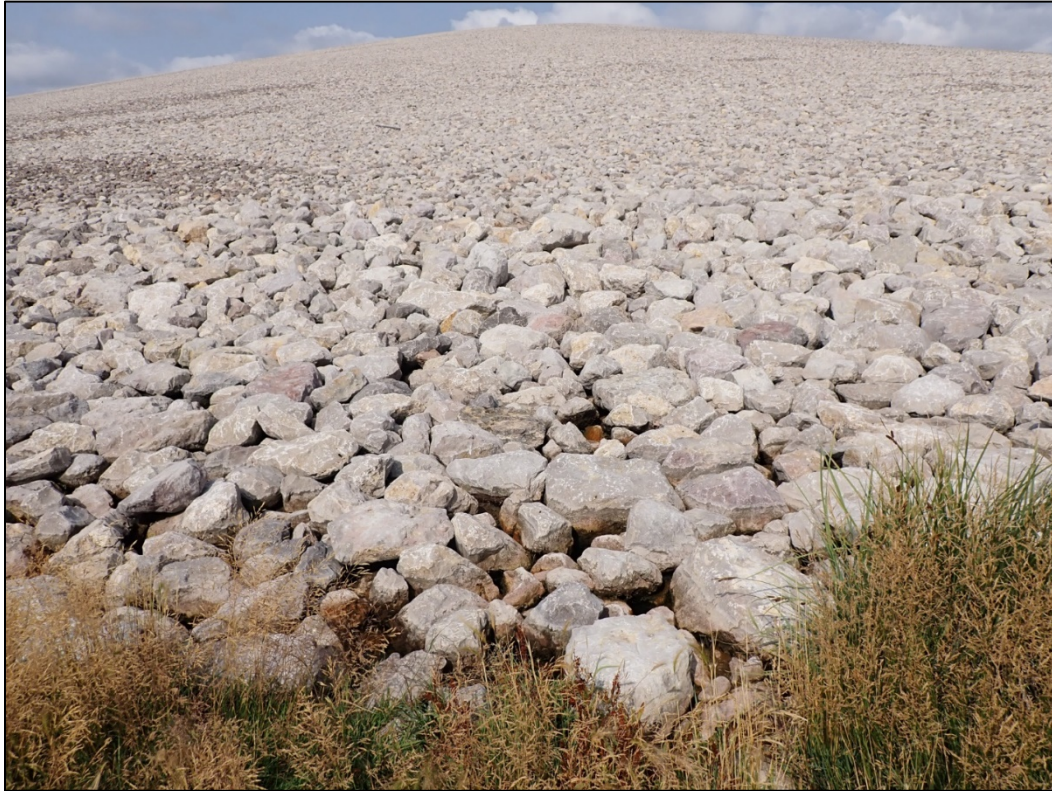
In accordance with the LTSP, inspectors looked for seeps on the east and southeast side slopes of the disposal cell, because slimes were encapsulated in this portion of the cell. No seeps were observed at the toe of the disposal cell in these areas. Stormwater runoff from the disposal cell discharges at this location, and standing water was observed in the easternmost portion of the disposal cell toe slope apron upgradient of the cobble blanket (PL-9 and PL-10). A storm was recorded in the area a few days before the annual inspection, and standing water has been observed at this location in the past. A 2003 laboratory analysis of evaporite minerals from this location confirmed that no constituents attributable to the disposal cell contents were present. No other maintenance needs were identified.

*PL-9. Standing Water in Side Slope Apron*

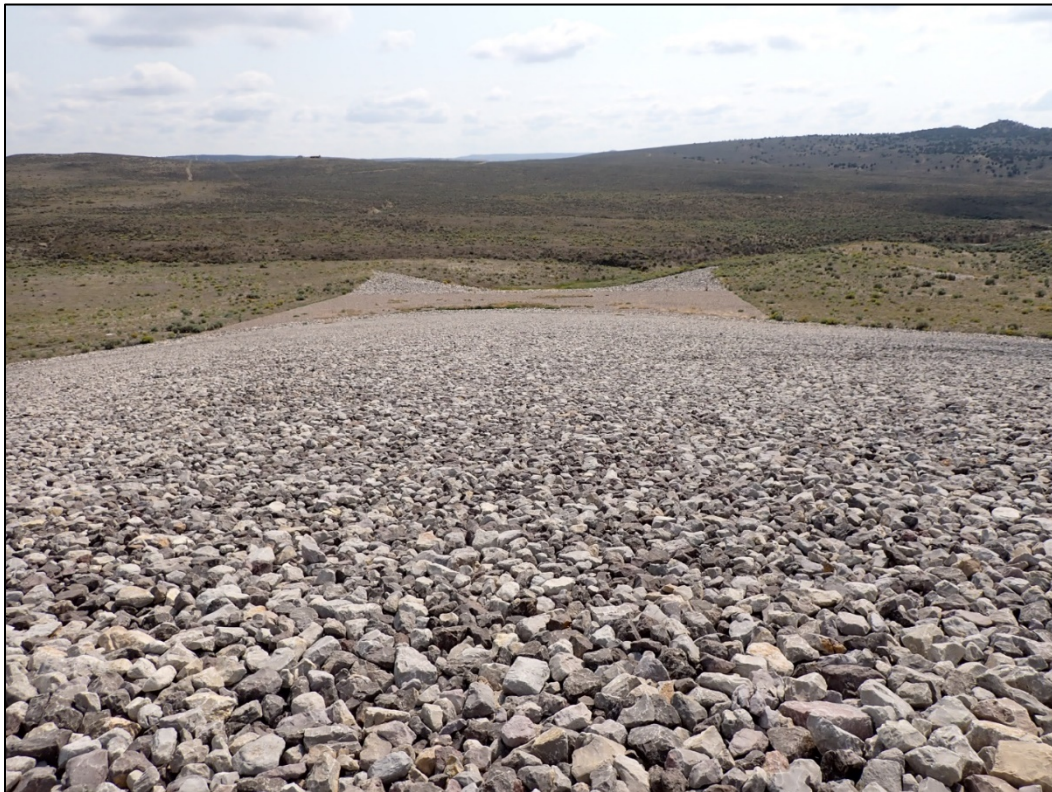
*PL-10. Disposal Cell Eastern Side Slope and Cobble Blanket*

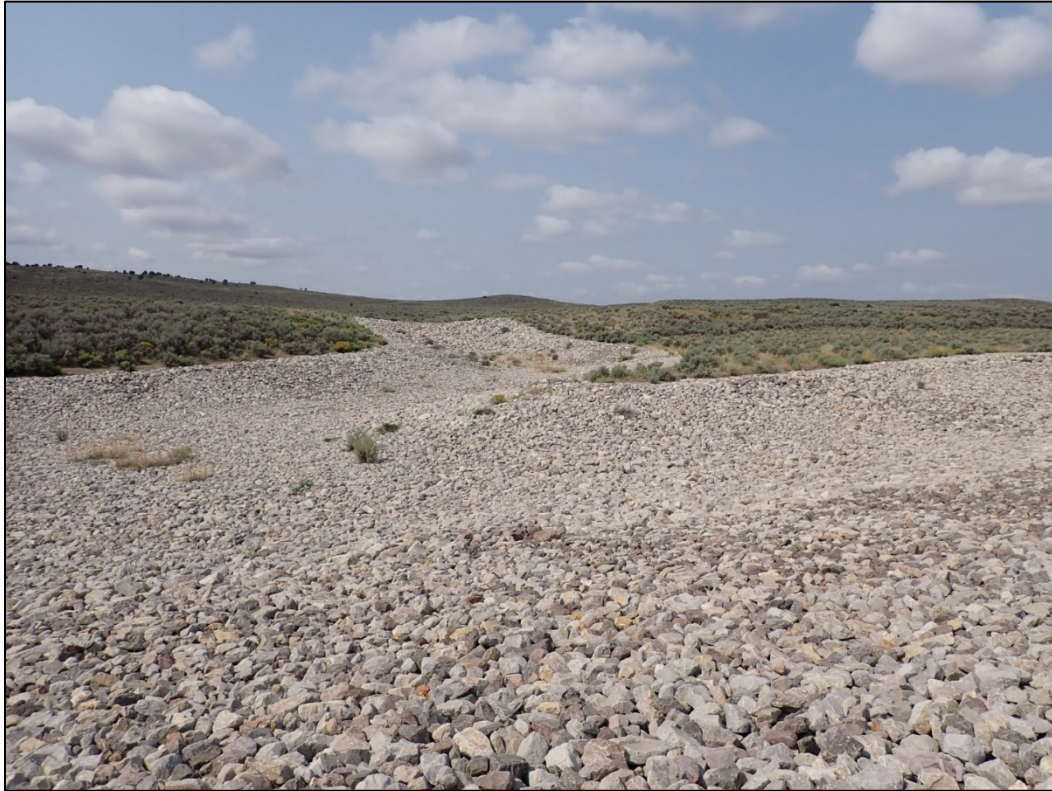
Surface conditions at the site are a combination of rock-armored drainage and diversion channels, along with contouring of soil surfaces to achieve the necessary surface water drainage control to protect the disposal cell from erosion. The rock-armored diversion channels (PL-11), swales, and gullies are performing as designed. Erosion directly downgradient of the outlets of Diversion Channel No. 1 (PL-12) and Swale No. 1 (PL-13) has exposed the underlying geofabric, but that exposure had not changed significantly since the 2020 inspection. Riprap placed in the outlets continues to protect against headcutting. Minor rills adjacent to Swale No. 1 and Gully No. 1 continue to stabilize as a result of natural armoring and increased vegetation growth. Minor erosion on the northern portion of the site directly downslope of the perimeter fence between perimeter signs P1 and P2 continues to stabilize. Minor erosion perpendicular to the perimeter fence near boundary monument BM-3 continues to be monitored, with no significant changes observed during the annual inspection. Documented erosion does not threaten the disposal cell, and there was no evidence of sediment moving offsite into Johnson Wash. No maintenance needs were identified.

*PL-11. View Southwest of Diversion Channel No. 2*

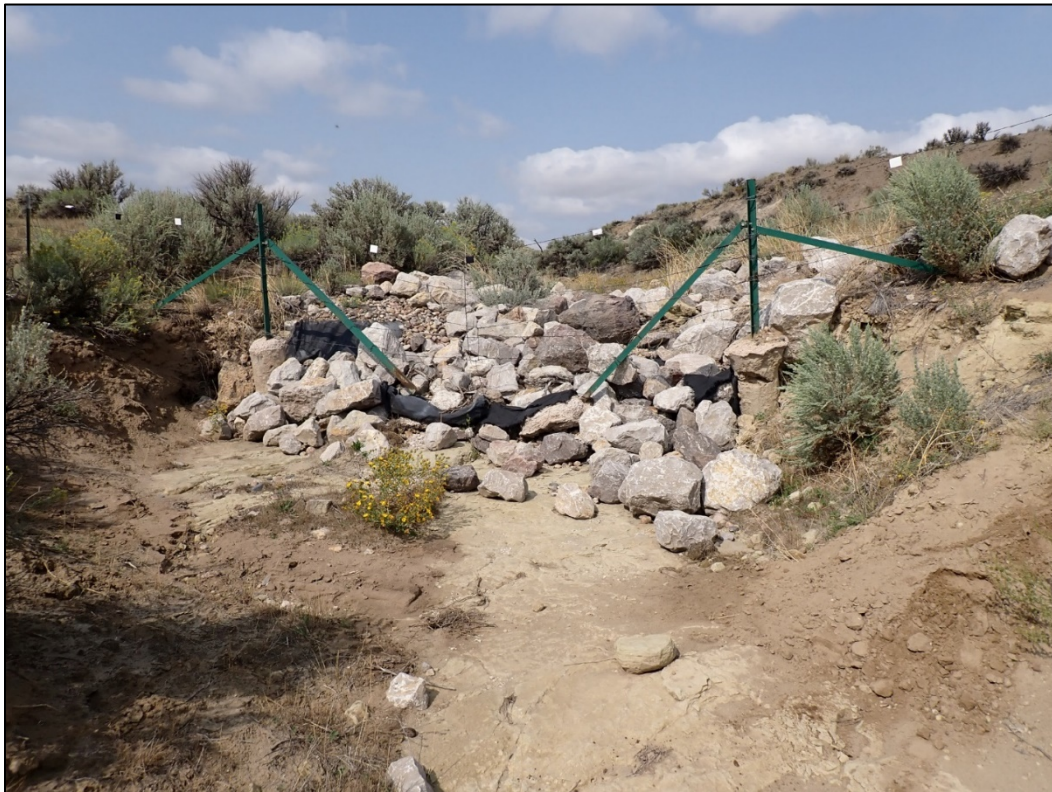
*PL-12. Exposed Geofabric in Diversion Channel No. 1 Outlet*

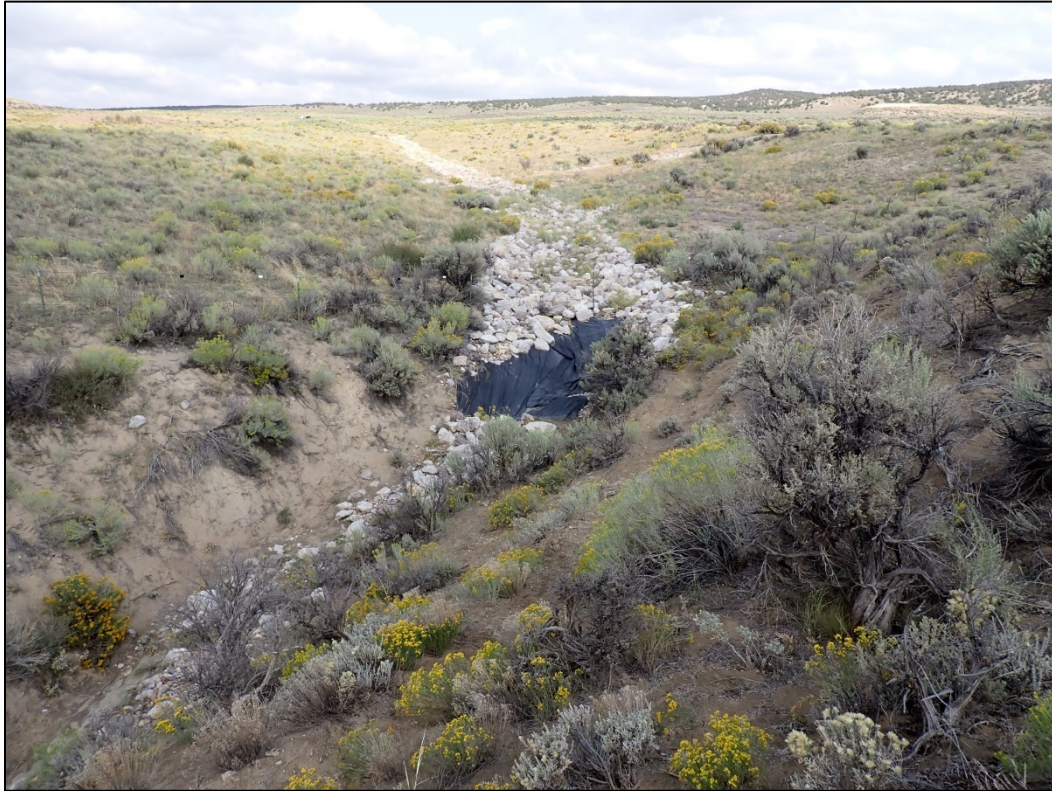
*PL-13. Exposed Geofabric in Swale No. 1 Outlet*

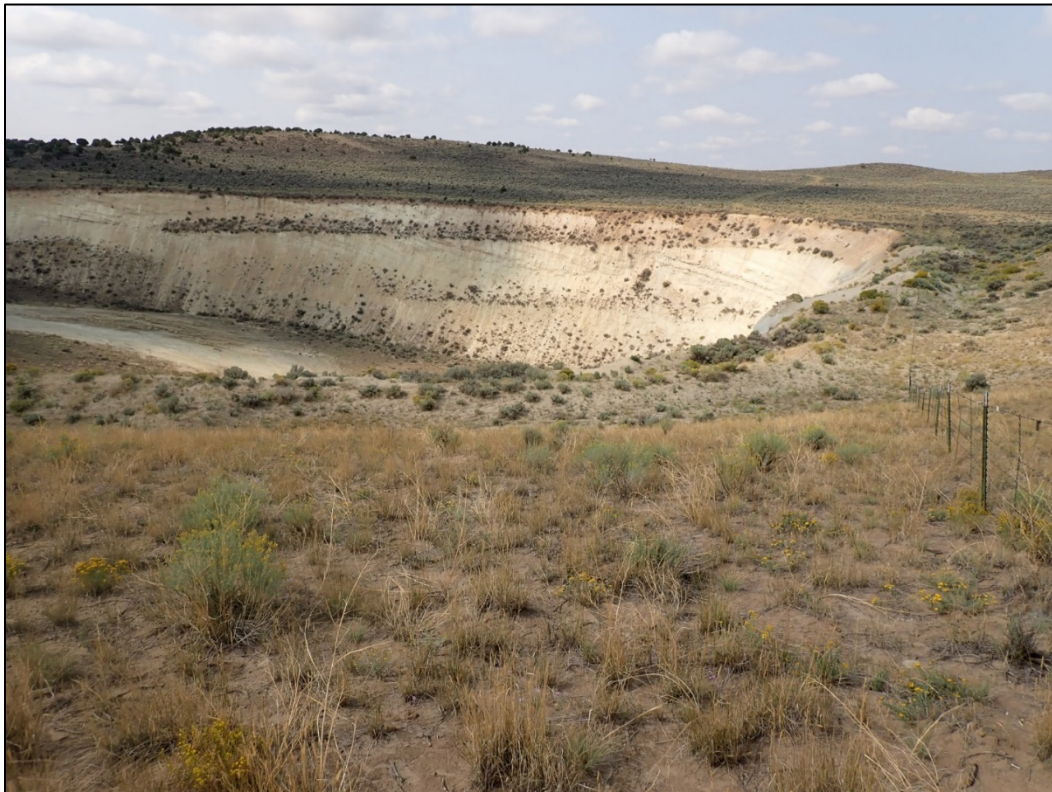
Directly south of the site is a former open-pit uranium mine known as the Johnson Pit (PL-14). Over time, slumping of the pit wall caused the pit to encroach several feet onto property now owned by DOE. This encroachment presents no threat to the integrity of the disposal cell and occurred before reclamation and transfer of the site to DOE for long-term surveillance and maintenance. This encroachment is visually monitored annually; it is periodically documented with photographs to assess whether the pit wall has slumped further and to verify the integrity and functionality of the perimeter fence. At the time of the inspection, there was no evidence of any additional encroachment of the pit onto the site. However, windblown sand continues to accumulate along the northern crest of the pit wall along the perimeter fence line (PL-15). The perimeter fence remains functional, but continued accumulation of sand will require vertically extending the fence or removing the sand. Inspectors will continue to monitor this area. No immediate maintenance needs were identified.

*PL-14. Southwest View of Johnson Pit*

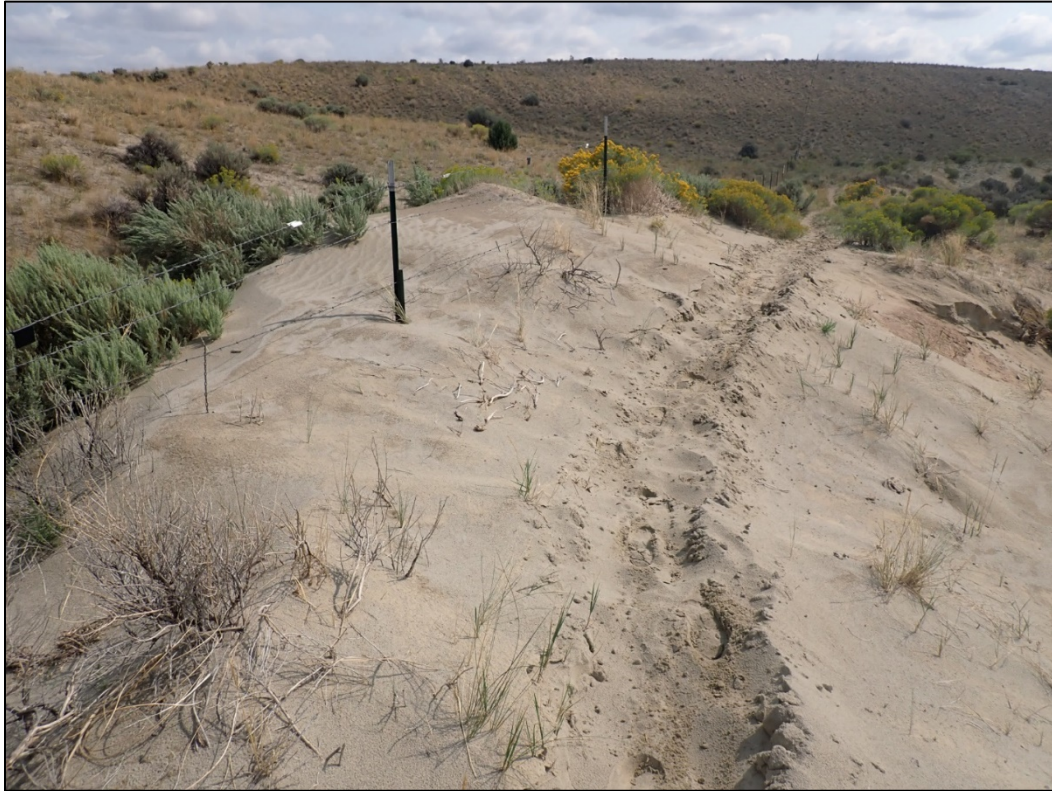
*PL-15. Sand Accumulation Along Southern Fence Line Near Johnson Pit*
