## 11.0 Maybell, Colorado, Disposal Site

The Maybell, Colorado, Uranium Mill Tailings Radiation Control Act (UMTRCA) Title I Disposal Site was inspected on September 7, 2022. Inspectors identified several minor maintenance needs but found no cause for a follow-up inspection. Groundwater monitoring is not required.

Figure 11-1. 2022 Annual Inspection Drawing for the Maybell, Colorado, Disposal Site

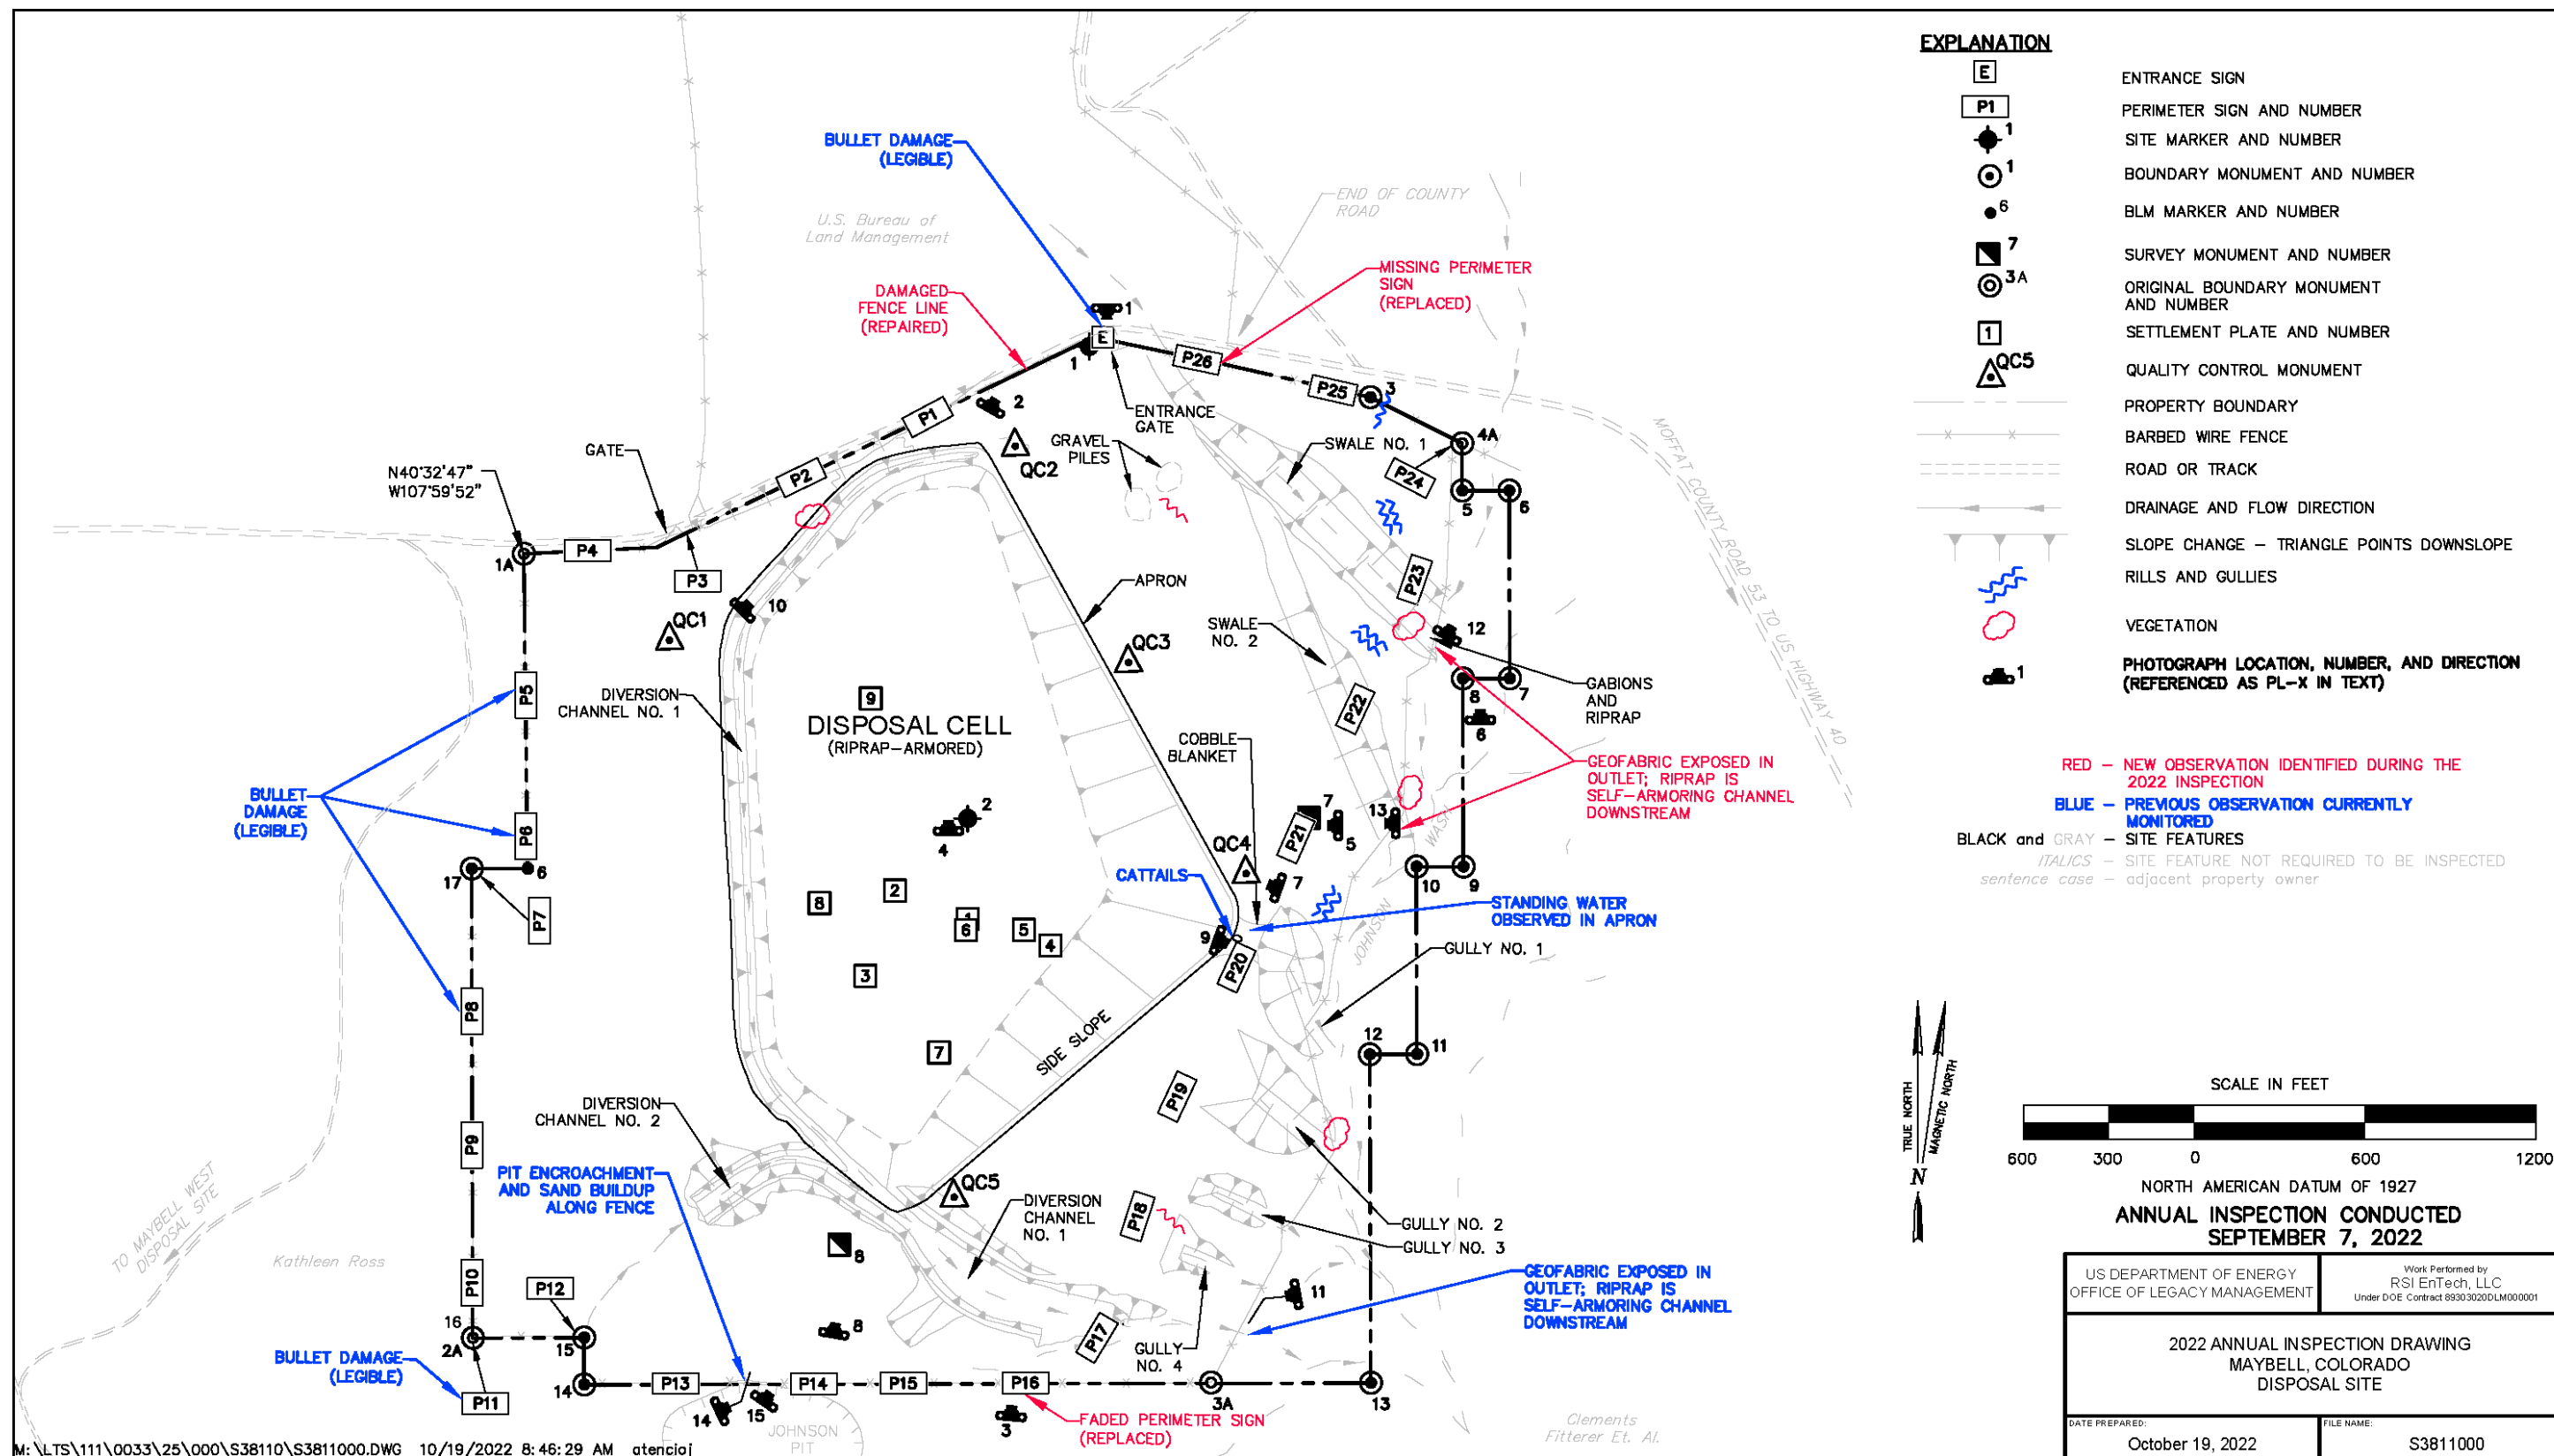
Figure 11-1 shows the locations of site features, including site surveillance features and inspection areas, in black and gray font. Some site features that are present but not required to be inspected are shown in italic font. Observations from previous inspections that are currently monitored are shown in blue, and new observations identified during the 2022 annual inspection are shown in red. Inspection results and recommended maintenance activities associated with site surveillance features are described in the following subsections. Photographs to support specific observations are noted in the text and in Figure 11-1 by photograph location (PL) numbers. The photographs and photograph log are presented in Section 11.10.

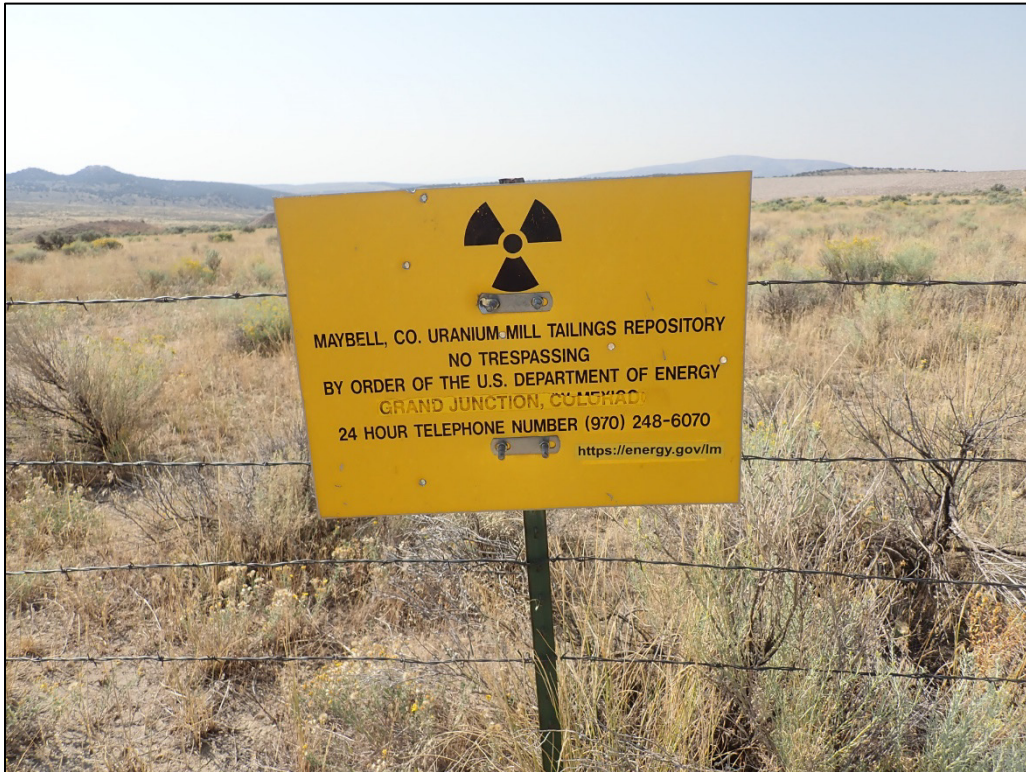
Access to the site is from the gravel-surfaced Moffat County Road 53, which runs north from U.S. Highway 40, approximately 8 miles east of Maybell, Colorado. County Road 53 ends at an unlocked gate near the northeast corner of the site (approximately 3 miles from the highway). The road continues west as a dirt two-track road directly north of the site from the end of County Road 53 to the site entrance gate (the road continues to the UMTRCA Title II Maybell West, Colorado, Disposal Site). LM is responsible for road maintenance under a U.S. Bureau of Land Management right-of-way permit. Entrance to the site is through two locked, metal stock gates in the perimeter fence. One is the entrance gate, which is adjacent to the site marker and entrance sign. The second gate is between perimeter signs P3 and P4 in the northwest corner of the property. Both gates were locked and functional and had locks replaced for additional security. The entrance sign is near the entrance gate and is mounted on a T-post in the perimeter fence (PL-1). The entrance sign has bullet damage but remains legible. No maintenance needs were identified.

*PL-1. Entrance Sign*

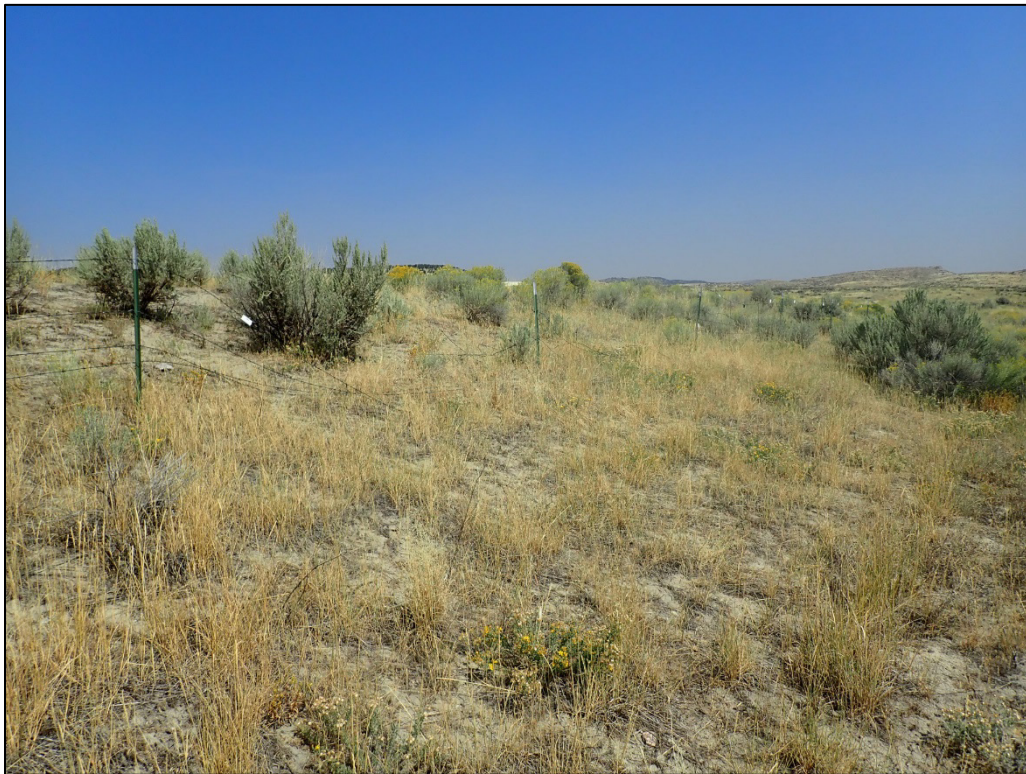
To facilitate LM's land management, a four-strand barbed-wire perimeter fence encloses the disposal cell, drainage structures, and much of the site. The site is in wintering grounds frequented by big-game animals (primarily pronghorn, deer, and elk) and is also surrounded by open range used to graze cattle. Minor damage to the perimeter fence from animal contact periodically occurs. On July 27, 2021, plastic fence flags were attached to the top strand of the perimeter fence to alert wildlife and reduce animal entanglements or strikes against fence lines. The fence has been cut between perimeter sign P1 and the entrance gate (PL-2) and was repaired following the inspection.

*PL-2. Damaged Fence near Perimeter Sign P1*

- Treatment of noxious weeds in the drainage and diversion channels.
- Replacement of perimeter signs P16 and P26.
- Repair of fence between perimeter sign P1 and the entrance gate.

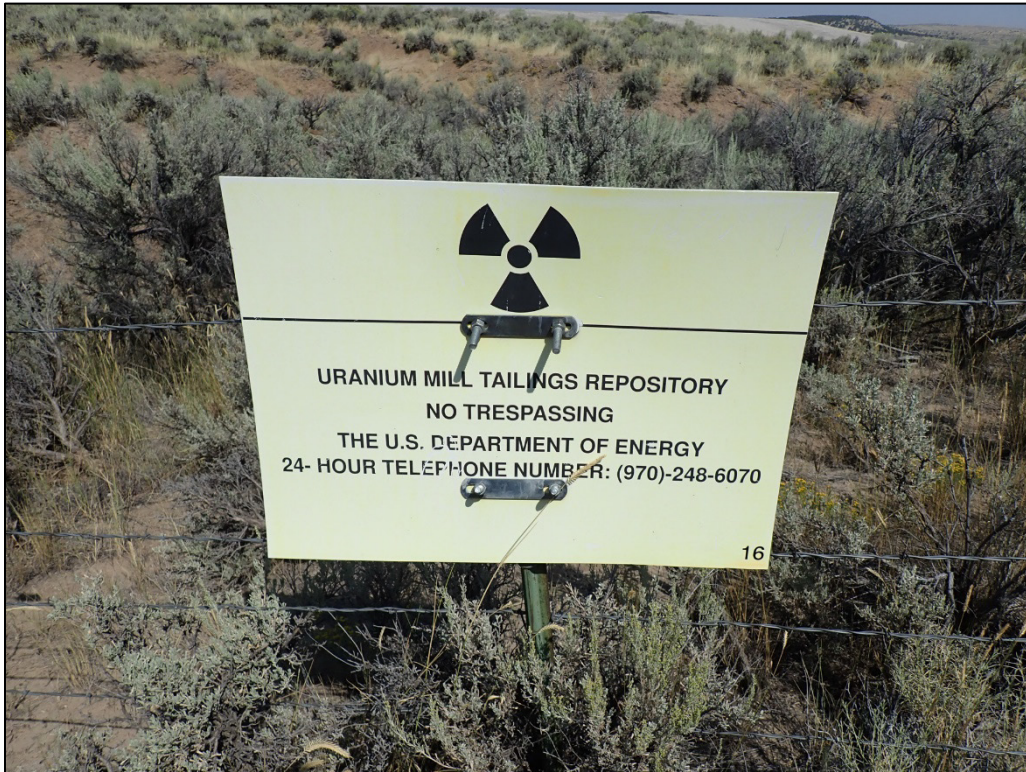
There are 26 perimeter signs. On the northern, western, and southern sides of the site, perimeter signs are attached to T-posts in the perimeter fence. On the eastern side of the site, perimeter signs are attached to steel posts set in concrete and are inside the property boundary approximately midway between the disposal cell and the perimeter fence. Several of the perimeter signs along the dirt road to the north and west of the site (P5, P6, P8, and P11) have bullet damage but remain legible. Perimeter sign P16 is faded (PL-3), and perimeter sign P26 was missing. Perimeter signs P16 and P26 were replaced following the inspection. No other maintenance needs were identified.

*PL-3. Faded Perimeter Sign P16 to Be Replaced*

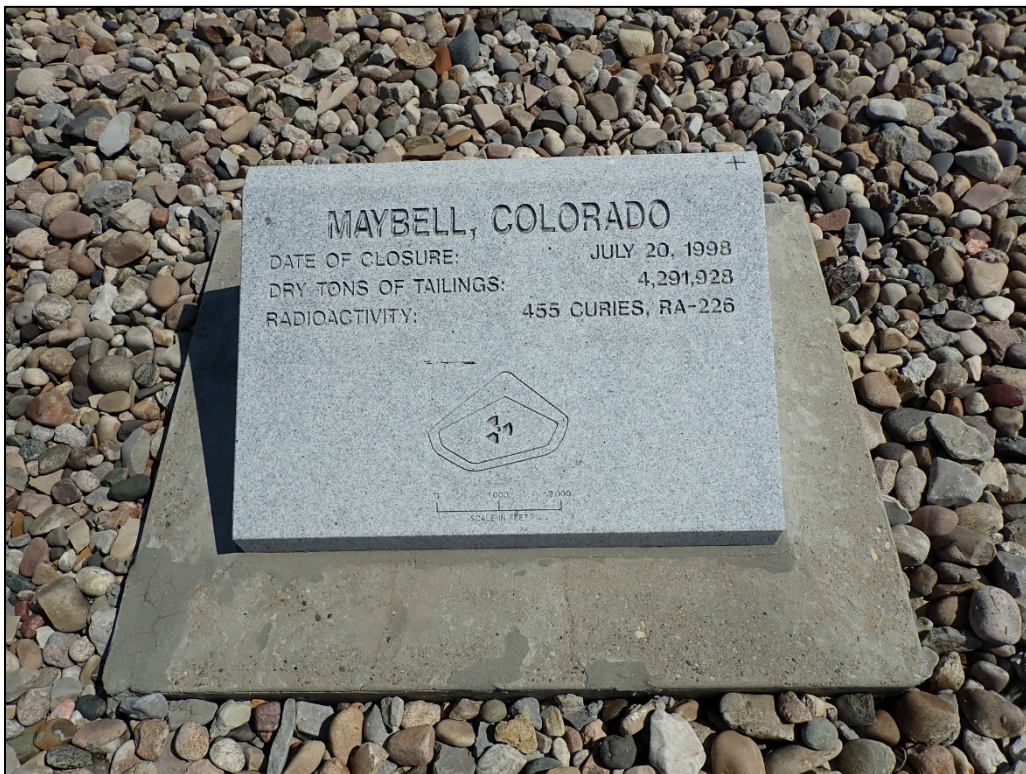
The site has two granite site markers. Site marker SMK-1 is just inside the entrance gate, and site marker SMK-2 is on the top slope of the disposal cell (PL-4). No maintenance needs were identified.

*PL-4. Site Marker SMK-2 on Disposal Cell*

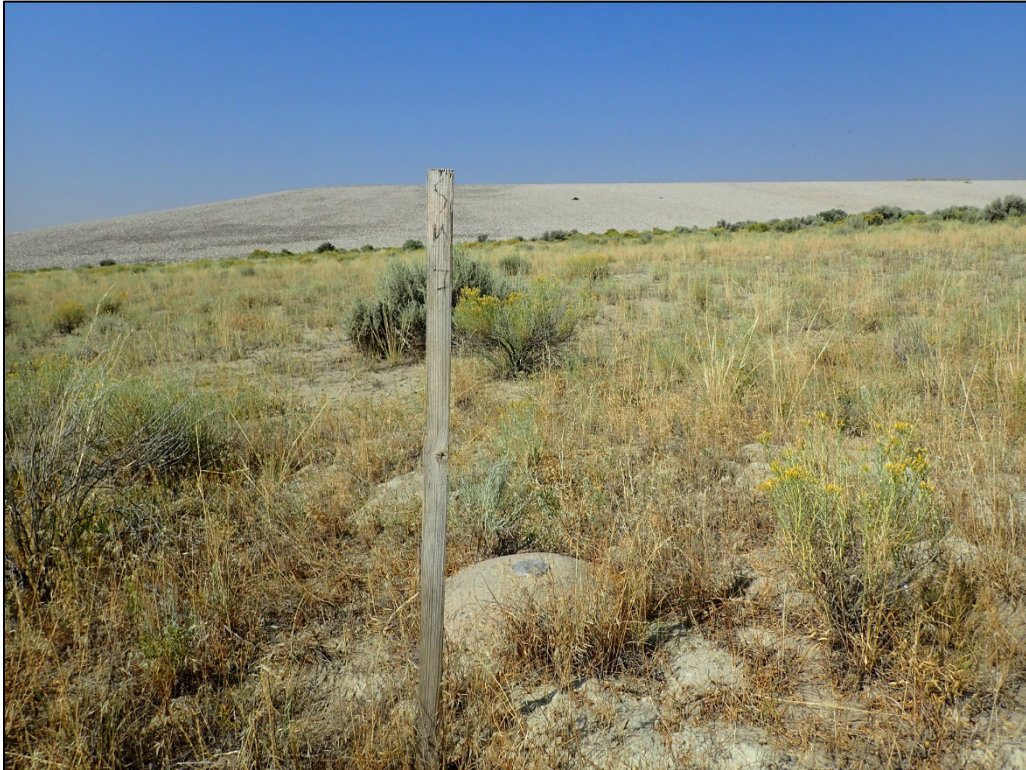
The site has two survey monuments. Survey monument SM-7 (PL-5) is on the bench above Johnson Wash just north of perimeter sign P21, and survey monument SM-8 is south of the disposal cell on the bench above Diversion Channel No. 2. The two survey monuments are historical site features that are difficult to locate. Seventeen boundary monuments delineate the property boundary (PL-6). No maintenance needs were identified.

*PL-5. Survey Monument SM-7*

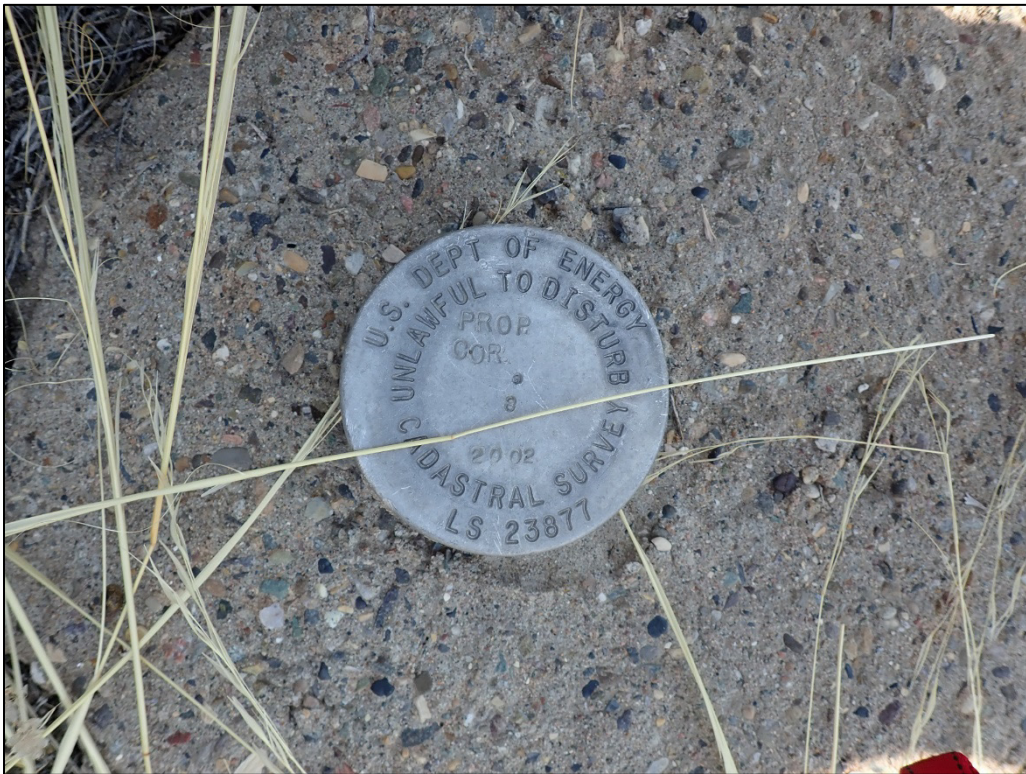
*PL-6. Boundary Monument BM-8*

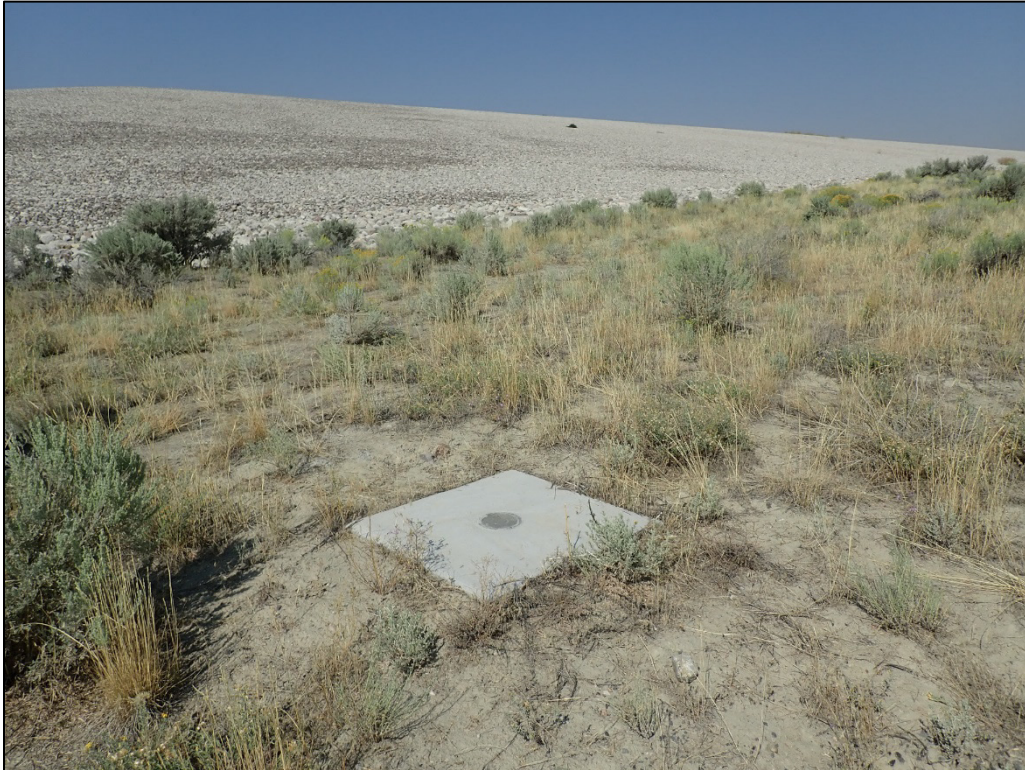
Five aerial survey quality control monuments were inspected during the 2022 inspection (PL-7). No maintenance needs were identified.

*PL-7. Quality Control Monument QC-4*

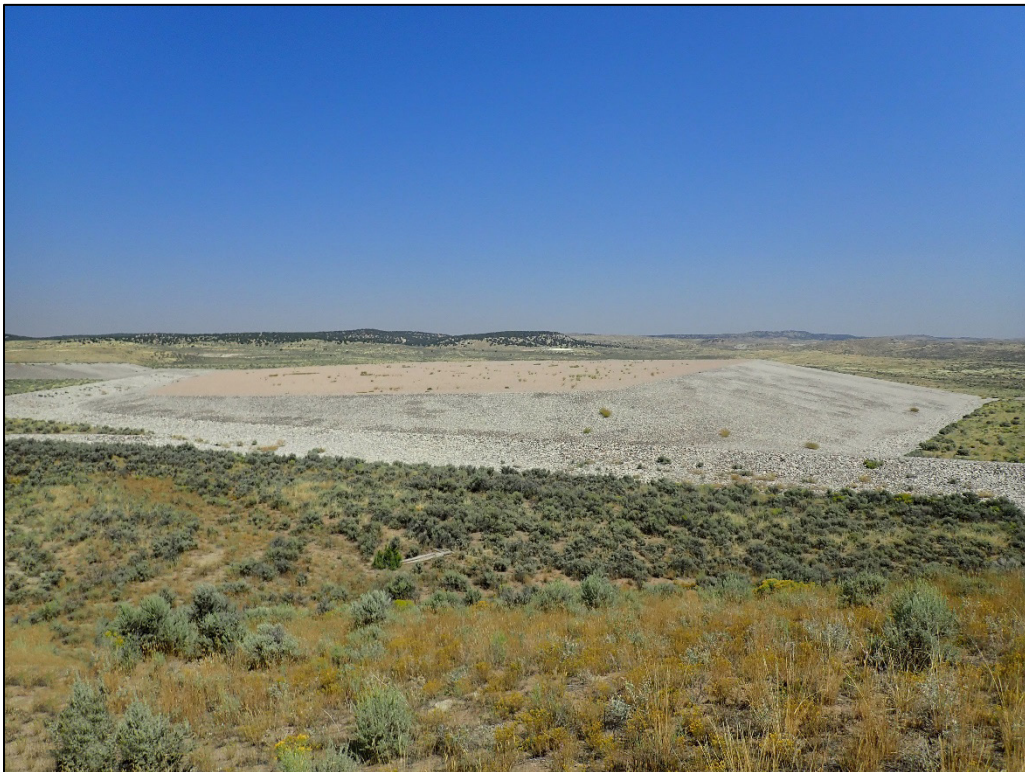
The disposal cell, completed in 1998, occupies 66 acres; it is armored with riprap to control erosion and deter animal and human intrusion (PL-8). There was no evidence of erosion, settling, slumping, rock degradation, or other modifying processes that might affect the integrity of the disposal cell. Scattered plants continue to establish on the disposal cell top slope, but they are not affecting the integrity of the disposal cell.

*PL-8. Disposal Cell Overview*

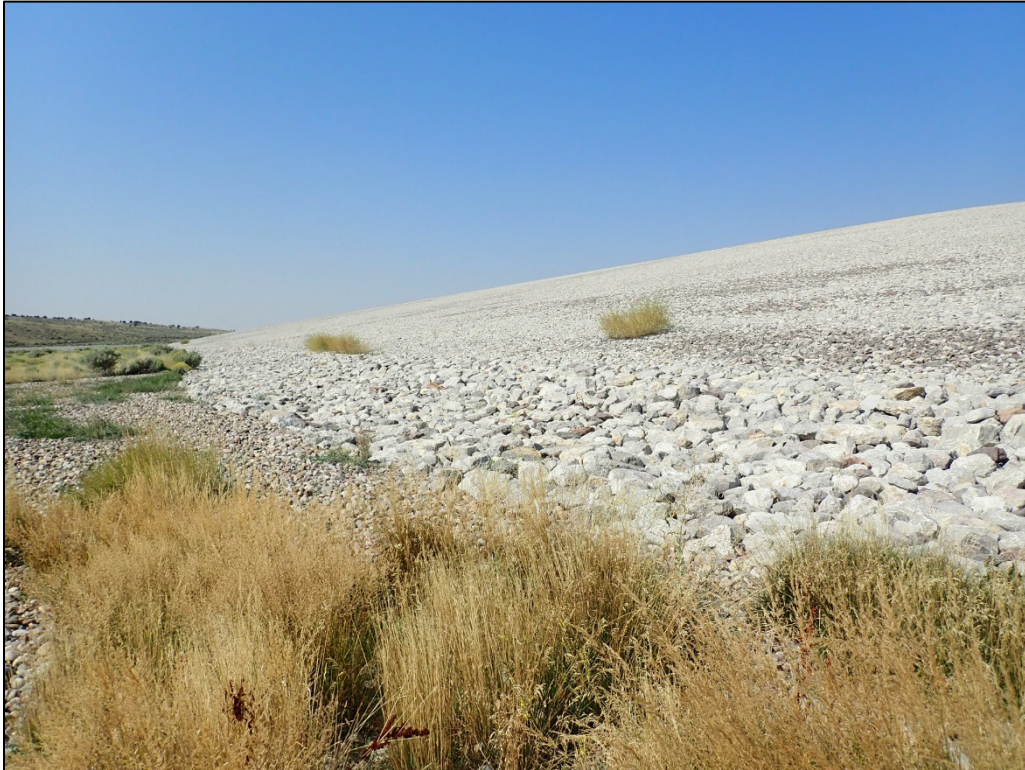
Stormwater runoff from the disposal cell discharges at this location. Cattails are present in this area indicating regular pooling of water (PL-9). During the 2021 inspection, standing water was observed in the easternmost portion of the disposal cell toe slope apron upgradient of the cobble blanket. This area was dry during the 2022 inspection. No other maintenance needs were identified.

*PL-9. Cattails Along Eastern Side Slope Apron*

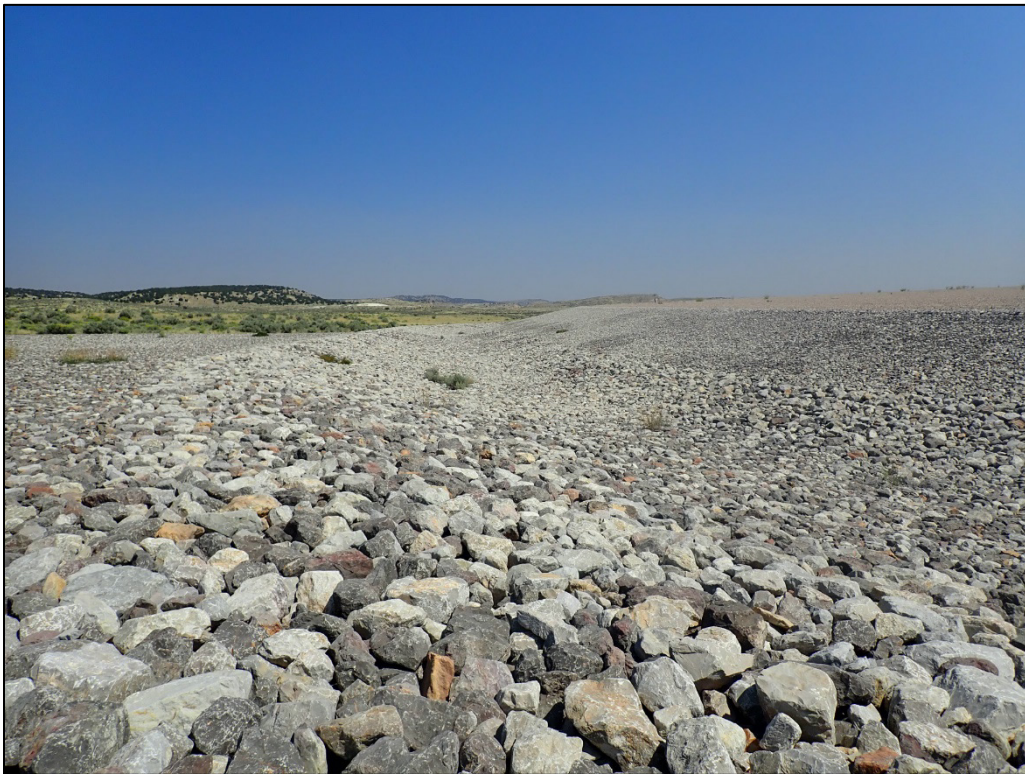
Surface conditions at the site are a combination of rock-armored drainage and diversion channels, along with contouring of soil surfaces to achieve the necessary surface water drainage control to protect the disposal cell from erosion. The rock-armored diversion channels (PL-10), swales, and gullies are performing as designed. Noxious weeds were observed growing in the diversion and drainage channels and were treated after the inspection.

*PL-10. Diversion Channel No. 1*

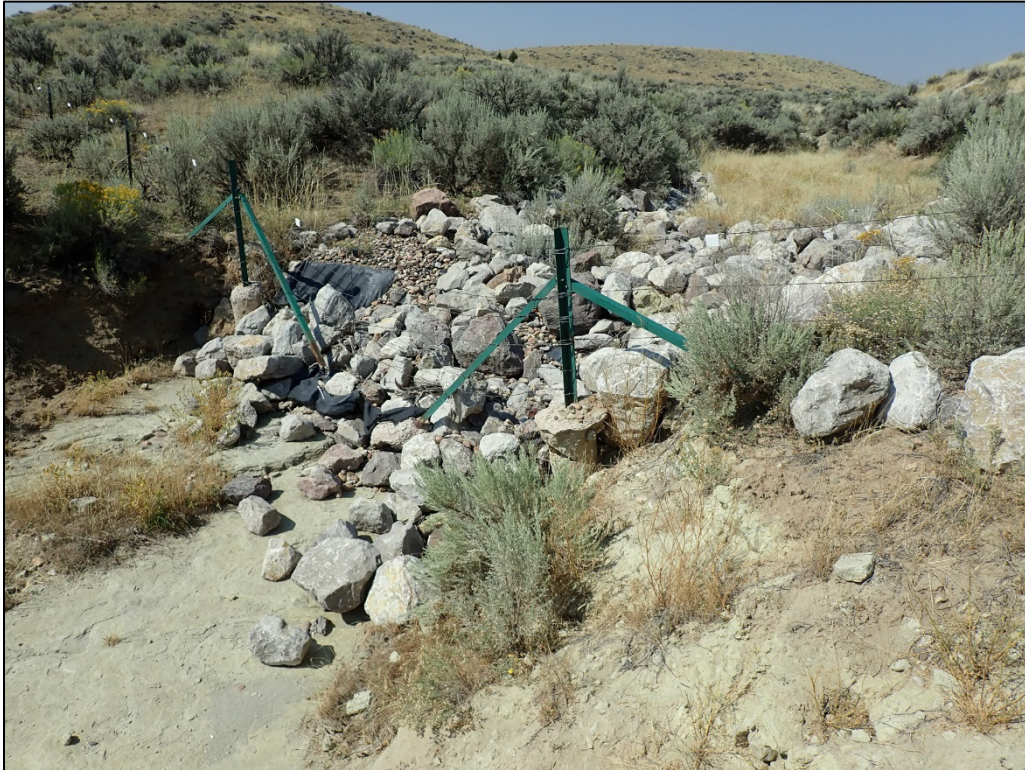
Erosion directly downgradient of the outlets of Diversion Channel No. 1 (PL-11) and Swale No. 1 (PL-12) has exposed the underlying geofabric, but that exposure has not changed significantly since the 2020 inspection. During the 2022 inspection, it was discovered that Swale No. 2 (PL-13) had erosion exposing the underlying geofabric. Riprap placed in the outlets continues to protect against headcutting. Minor rills adjacent to Swale No. 1, Swale No. 2, Gully No. 1, and Gully No. 4 continue to stabilize as a result of natural armoring and increased vegetation growth. Minor erosion on the northern portion of the site directly downslope of the perimeter fence between perimeter signs P1 and P2 continues to stabilize. Minor erosion perpendicular to the perimeter fence near boundary monument BM-3 continues to be monitored, with no significant changes observed during the annual inspection. Documented erosion does not threaten the disposal cell, and there was no evidence of sediment moving offsite into Johnson Wash. No other maintenance needs were identified.

*PL-11. Exposed Geofabric in Diversion Channel No. 1*

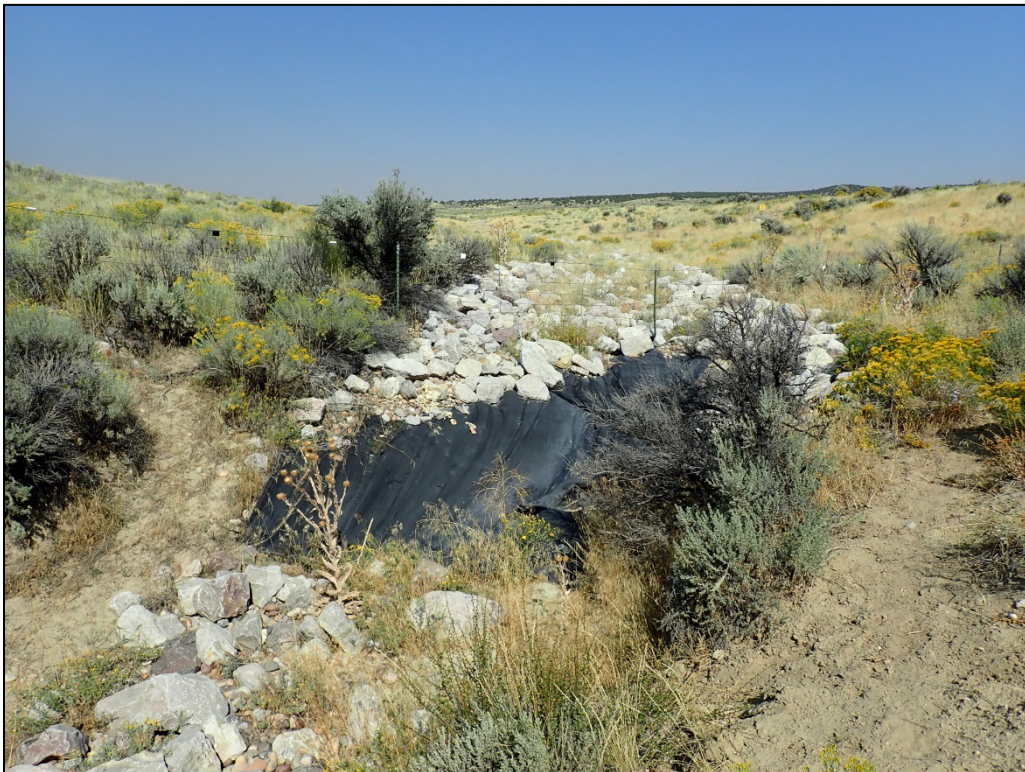
*PL-12. Exposed Geofabric in Swale No. 1*

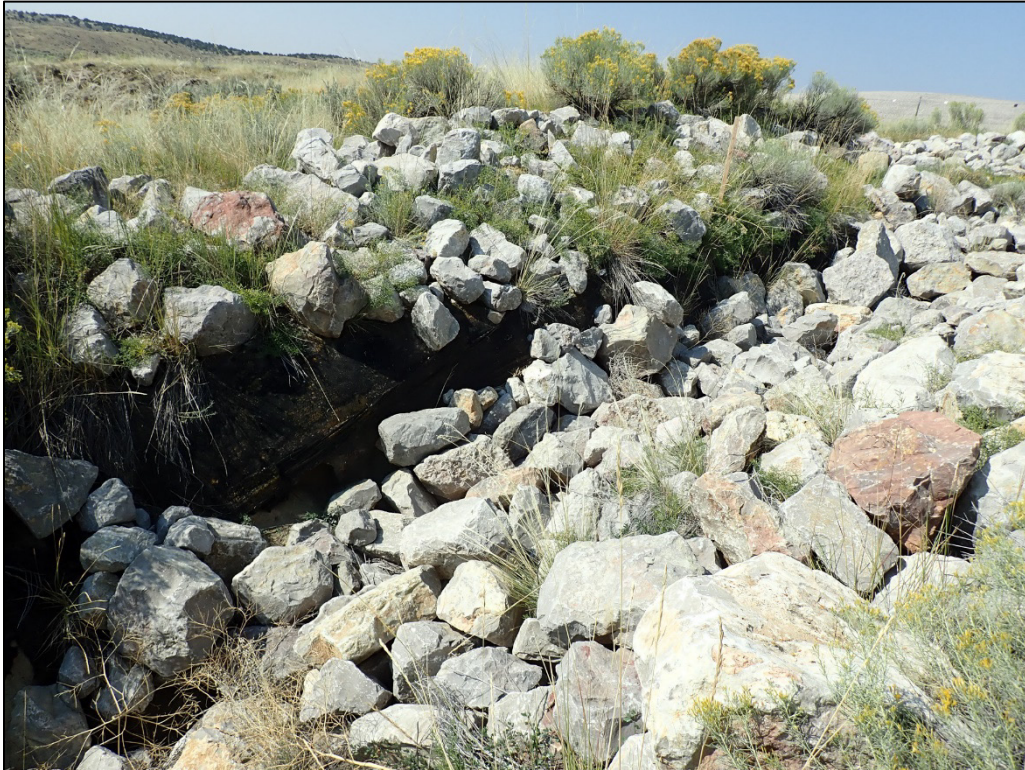
*PL-13. Exposed Geofabric in Swale No. 2*

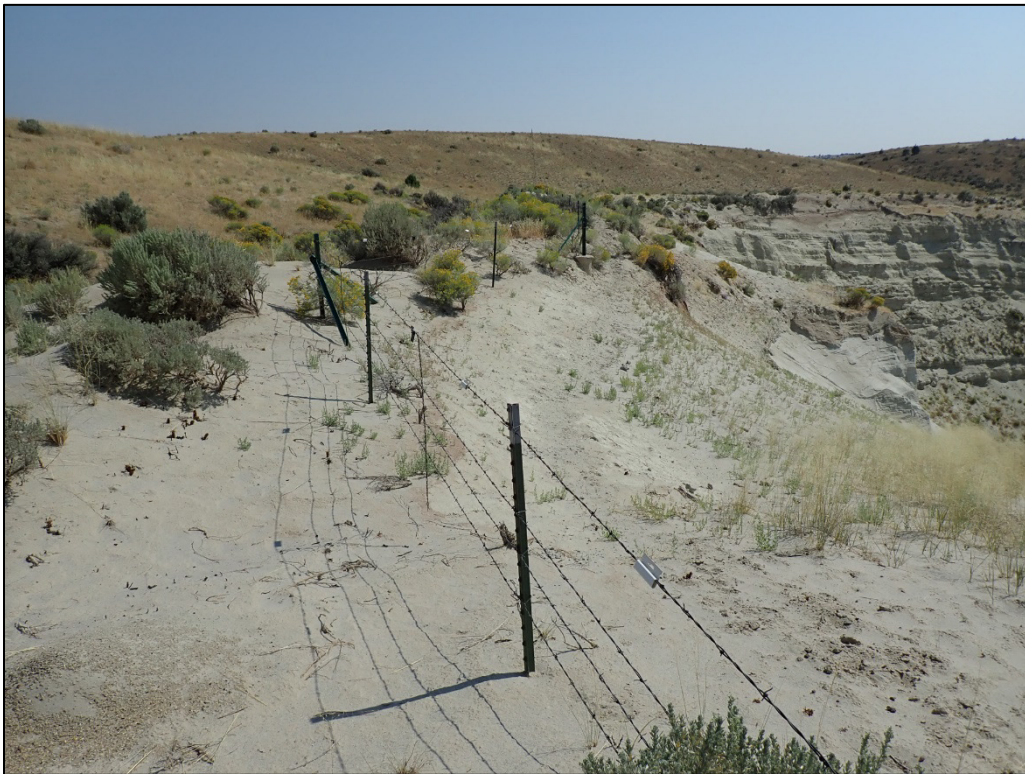
Directly south of the site is a former open-pit uranium mine known as the Johnson Pit. Over time, slumping of the pit wall caused the pit to encroach several feet onto property now owned by DOE (PL-14). This encroachment presents no threat to the integrity of the disposal cell at this time. This encroachment is visually monitored annually; it is periodically documented with photographs to assess whether the pit wall has slumped further and to verify the integrity and functionality of the perimeter fence. At the time of the inspection, there was no evidence of any additional encroachment of the pit onto the site. However, windblown sand continues to accumulate along the northern crest of the pit wall along the perimeter fence line (PL-15). The perimeter fence remains functional, but continued accumulation of sand will require vertically extending the fence or removing the sand. Inspectors will continue to monitor this area. No immediate maintenance needs were identified.

*PL-14. Encroachment of Johnson Pit*

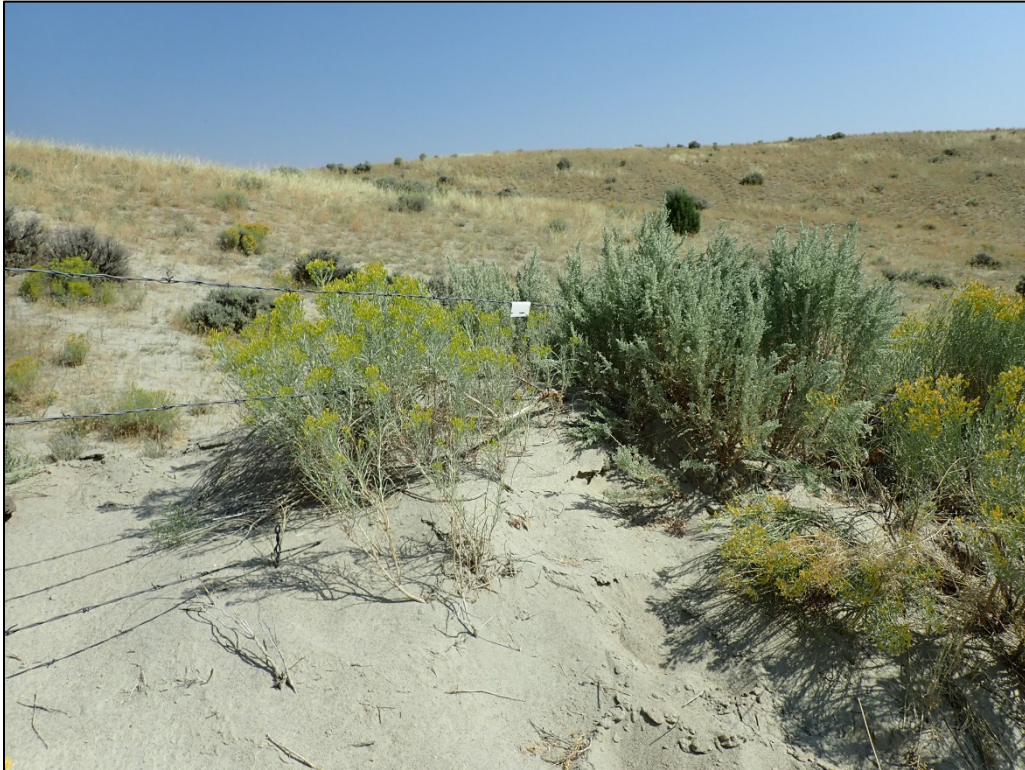
*PL-15. Sand Buildup Along Fence near Johnson Pit*
