11.0 Maybell, Colorado, Disposal Site

11.1 Compliance Summary

The Maybell, Colorado, Uranium Mill Tailings Radiation Control Act (UMTRCA) Title I Disposal Site was inspected on September 6, 2023. Inspectors identified several minor maintenance needs but found no cause for a follow-up inspection. Groundwater monitoring is not required.

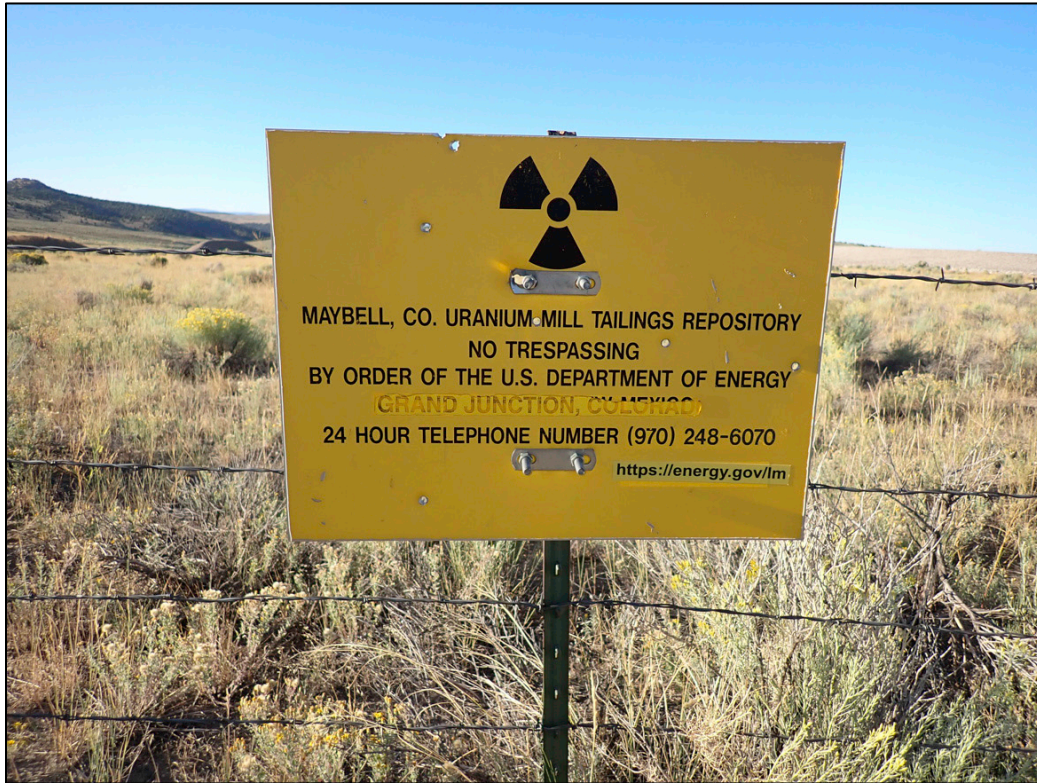
Access to the site is from the gravel-surfaced Moffat County Road 53, which runs north from U.S. Highway 40, approximately 8 miles east of Maybell, Colorado. County Road 53 ends at an unlocked gate near the northeast corner of the site (approximately 3 miles from the highway). The road continues west as a dirt two-track road directly north of the site from the end of County Road 53 to the site entrance gate (the road continues to the UMTRCA Title II Maybell West, Colorado, Disposal Site). LM is responsible for road maintenance under a U.S. Bureau of Land Management right-of-way permit. Entrance to the site is through two locked, metal stock gates in the perimeter fence. One is the entrance gate, which is adjacent to site marker SMK-1 and the entrance sign. The second gate is between perimeter signs P3 and P4 in the northwest corner of the property. Both gates were locked and functional. The entrance sign is near the entrance gate and is mounted on a T-post in the perimeter fence (PL-1). The entrance sign has bullet damage but remains legible. No maintenance needs were identified.

PL-1. Entrance Sign

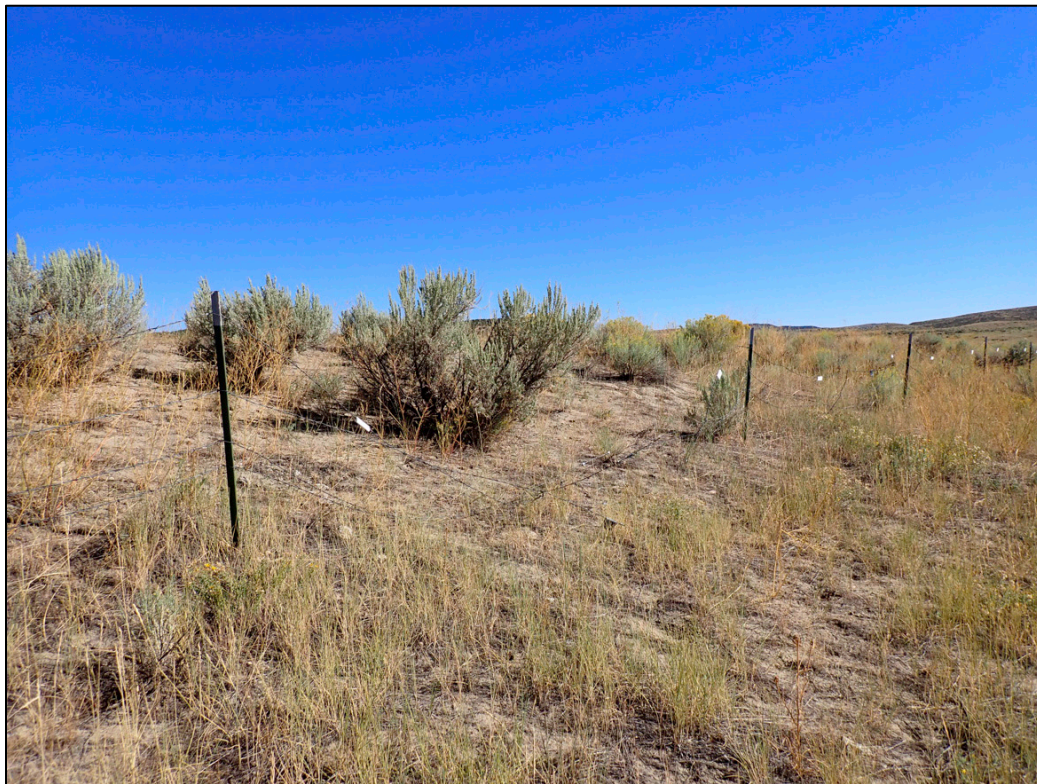
To facilitate LM's land management, a four-strand barbed-wire perimeter fence encloses the disposal cell, drainage structures, and much of the site. The site is in wintering grounds frequented by big-game animals (primarily pronghorn, deer, and elk) and is also surrounded by open range used to graze cattle. Periodically, animals cause minor damage to the perimeter fence. In 2021, plastic fence flags were attached to the top strand of the perimeter fence to alert wildlife and reduce animal entanglements or strikes against fence lines. The fence had been cut or damaged in several locations, primarily on the northern side of the property (PL-2) and was repaired following the inspection.

PL-2. Fence Damage near Entrance Sign

- Installation of additional warning signs to the entrance gate
- The damaged fence line was repaired

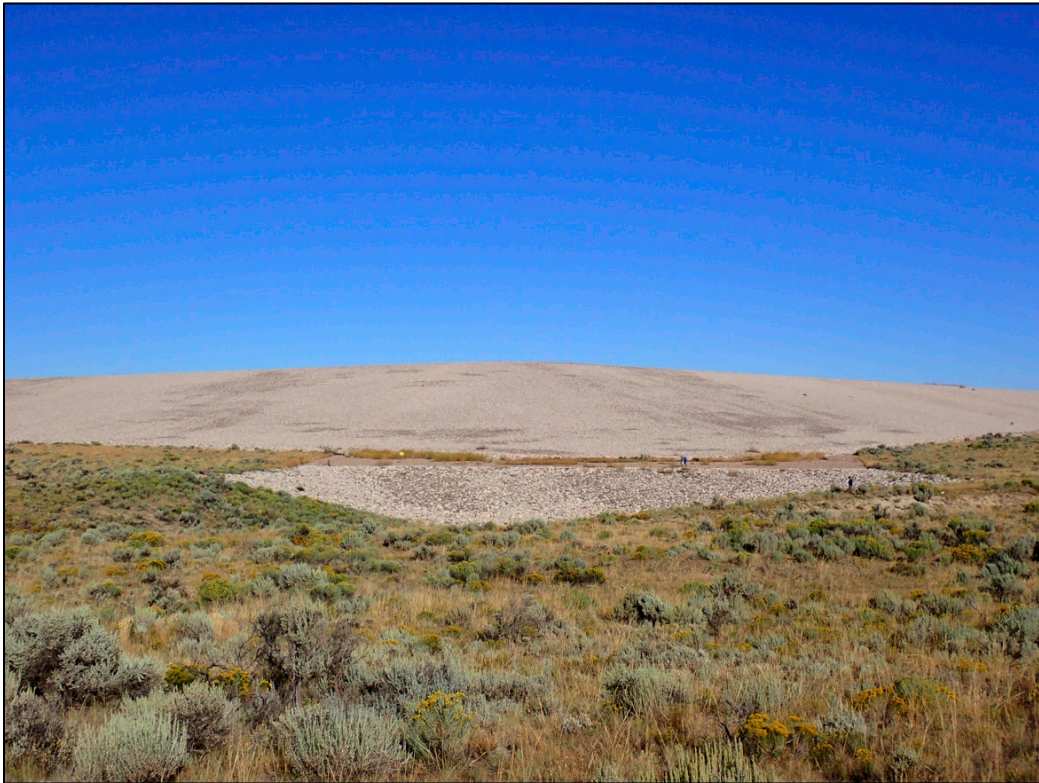
The disposal cell, completed in 1998, occupies 66 acres; it is armored with riprap to control erosion and deter animal and human intrusion (PL-3). There was no evidence of erosion, settling, slumping, rock degradation, or other modifying processes that might affect the integrity of the disposal cell. Scattered plants continue to establish on the disposal cell top slope, but they are not affecting the integrity of the disposal cell.

PL-3. Disposal Cell Overview

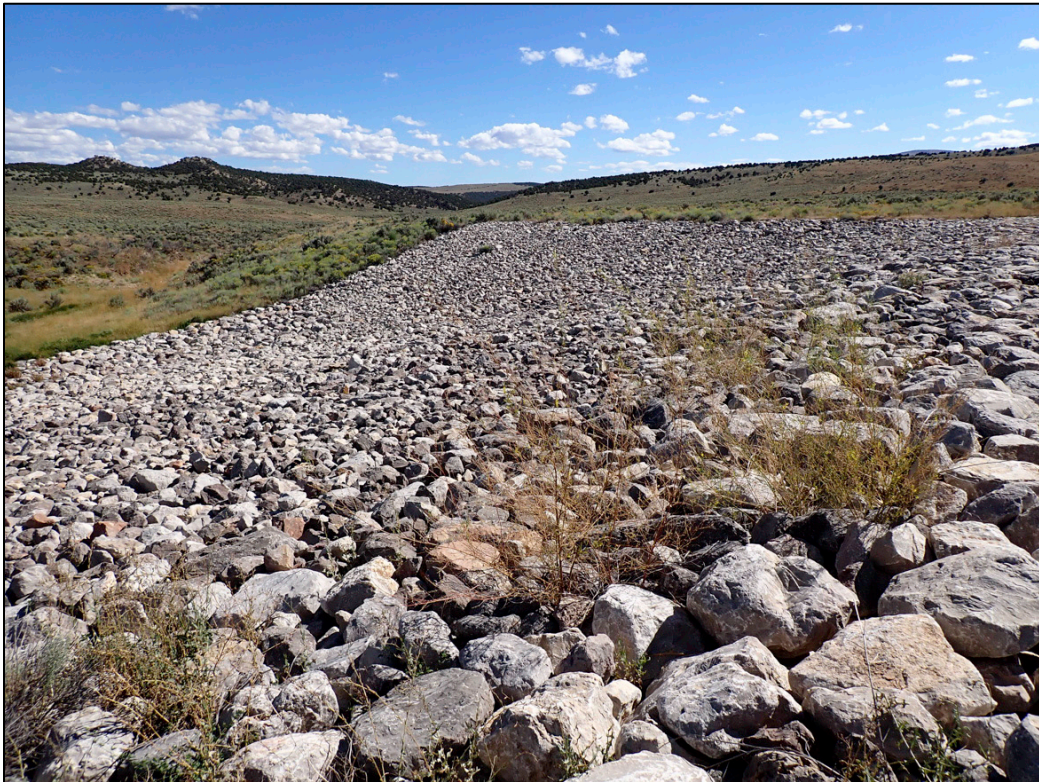
Stormwater runoff from the disposal cell discharges into the cobble blanket and continues into Gully No. 1 (PL-4). Cattails are present in this area indicating regular pooling of water. During the 2021 inspection, standing water was observed in the easternmost portion of the disposal cell toe slope apron upgradient of the cobble blanket. This area was dry during the 2023 inspection. No maintenance needs were identified.

PL-4. Cobble Blanket and Gully No. 1

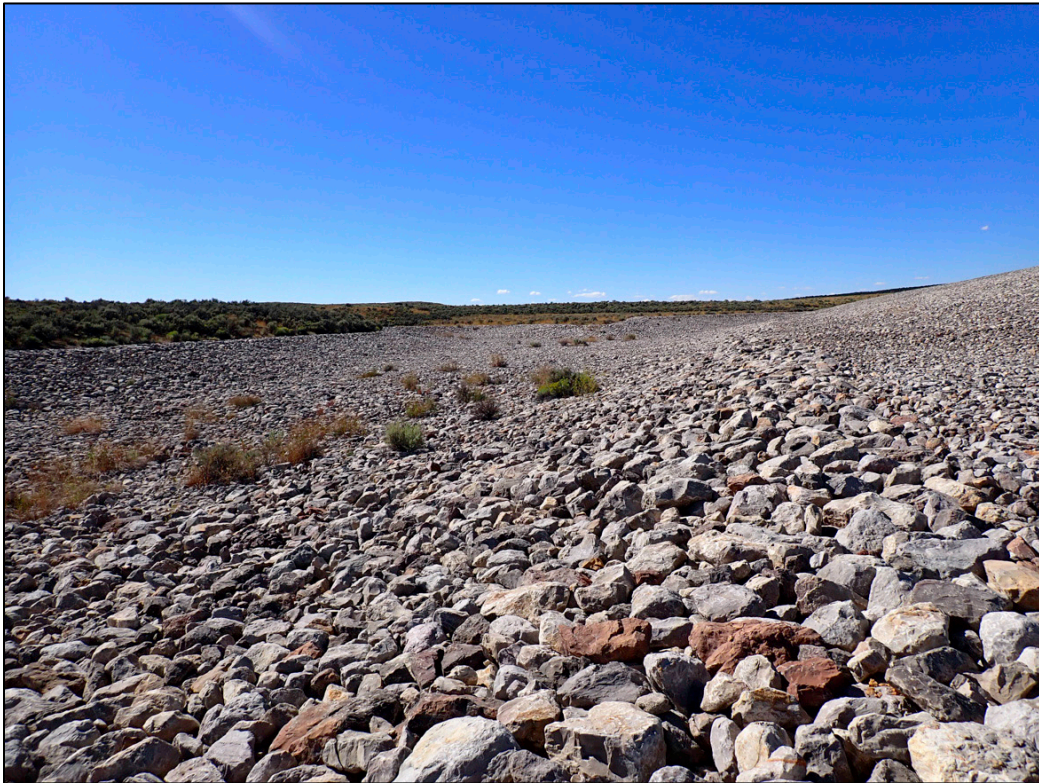
Surface conditions at the site are a combination of rock-armored drainage and diversion channels, along with contouring of soil surfaces to achieve the necessary surface water drainage control to protect the disposal cell from erosion. The rock-armored diversion channels (PL-5), swales, and gullies (PL-6) are performing as designed.

PL-5. Diversion Channel No. 1

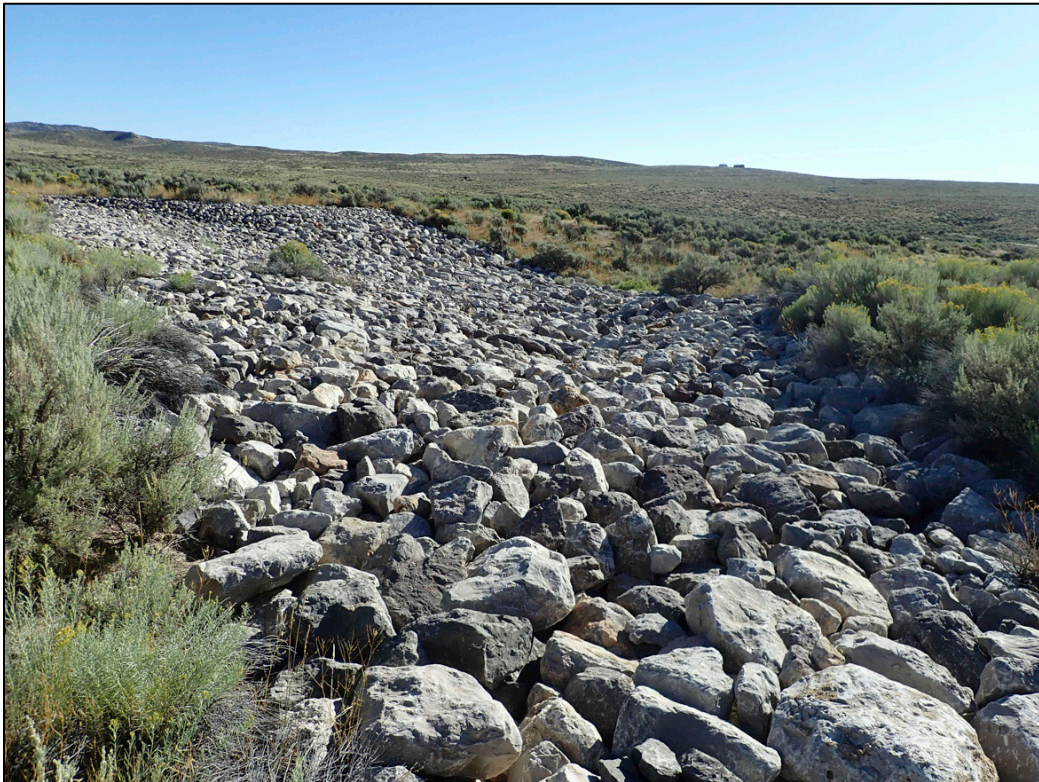
PL-6. Gully No. 4 Overview

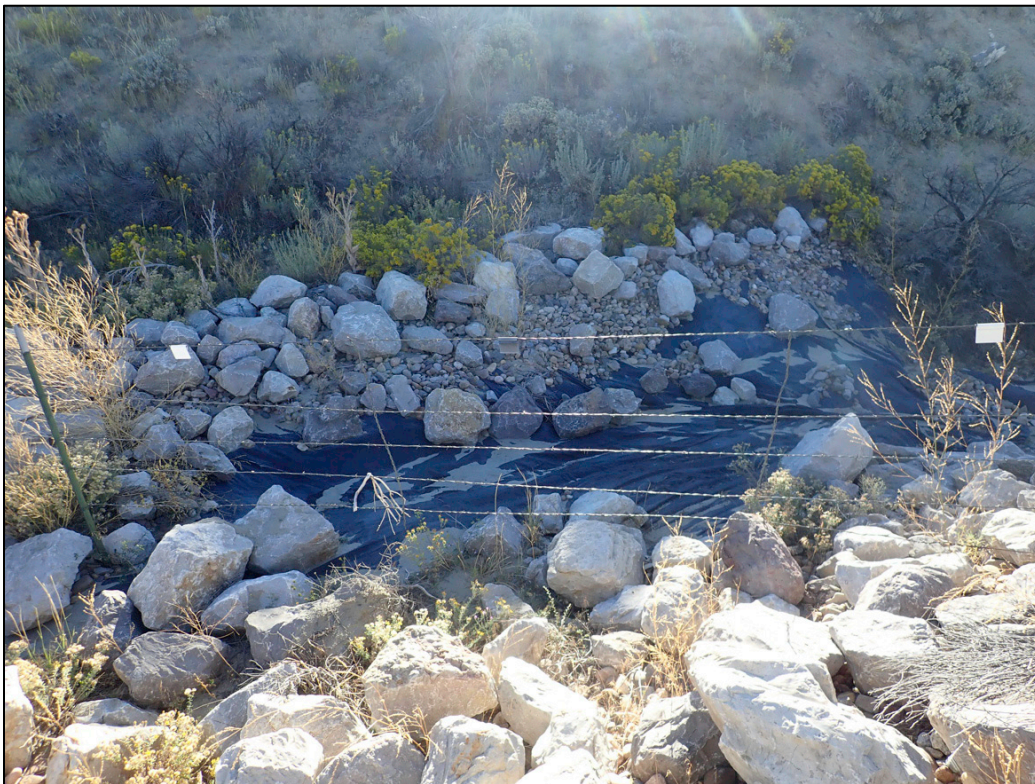
Erosion directly downgradient of the outlets of Diversion Channel No. 1 (PL-7) and Swale No. 1 (PL-8) has exposed the underlying geofabric, but that exposure has not changed significantly since the 2020 inspection. During the 2022 inspection, it was discovered that Swale No. 2 (PL-9) had erosion exposing the underlying geofabric. Riprap placed in the outlets continues to protect against headcutting. Minor rills adjacent to Swale No. 1 and Gully No. 1 continue to stabilize as a result of natural armoring and increased vegetation growth. Minor erosion on the northern portion of the site directly downslope of the perimeter fence between perimeter signs P1 and P2 continues to stabilize (PL-10). Minor erosion perpendicular to the perimeter fence near boundary monument BM-3 continues to be monitored, with no significant changes observed during the annual inspection. Documented erosion does not threaten the disposal cell, and there was no evidence of sediment moving offsite into Johnson Wash. No maintenance needs were identified.

PL-8. Exposed Geofabric in Outlet of Swale No. 1

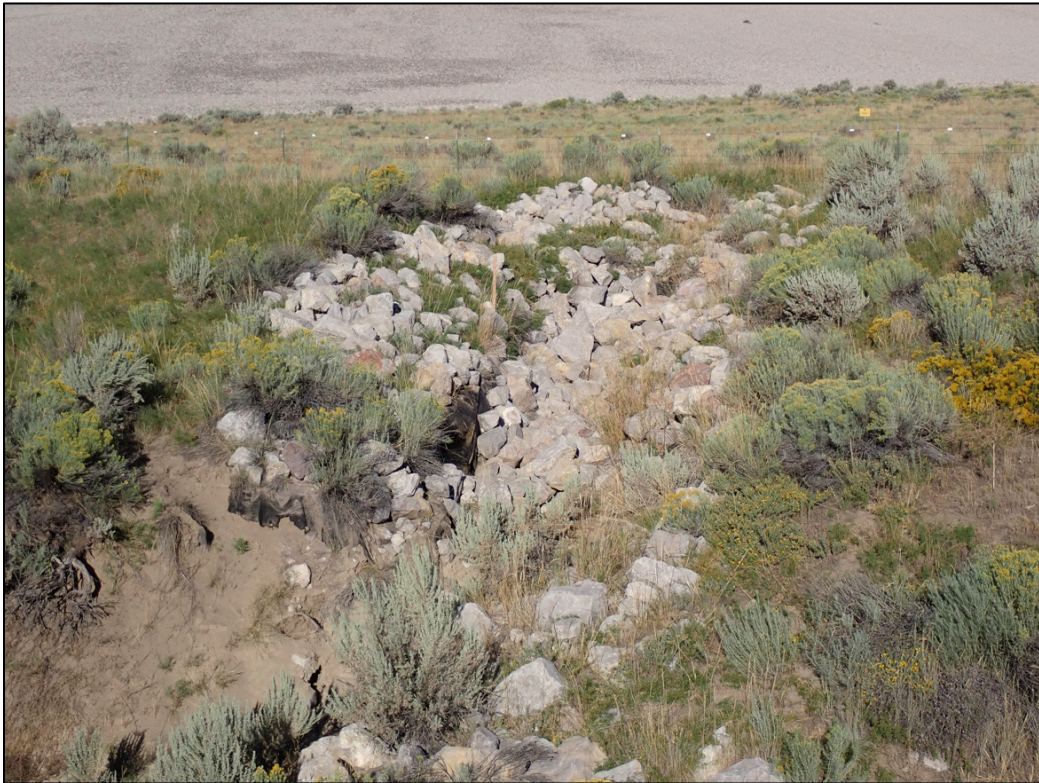
PL-9. Exposed Geofabric in Swale No. 2

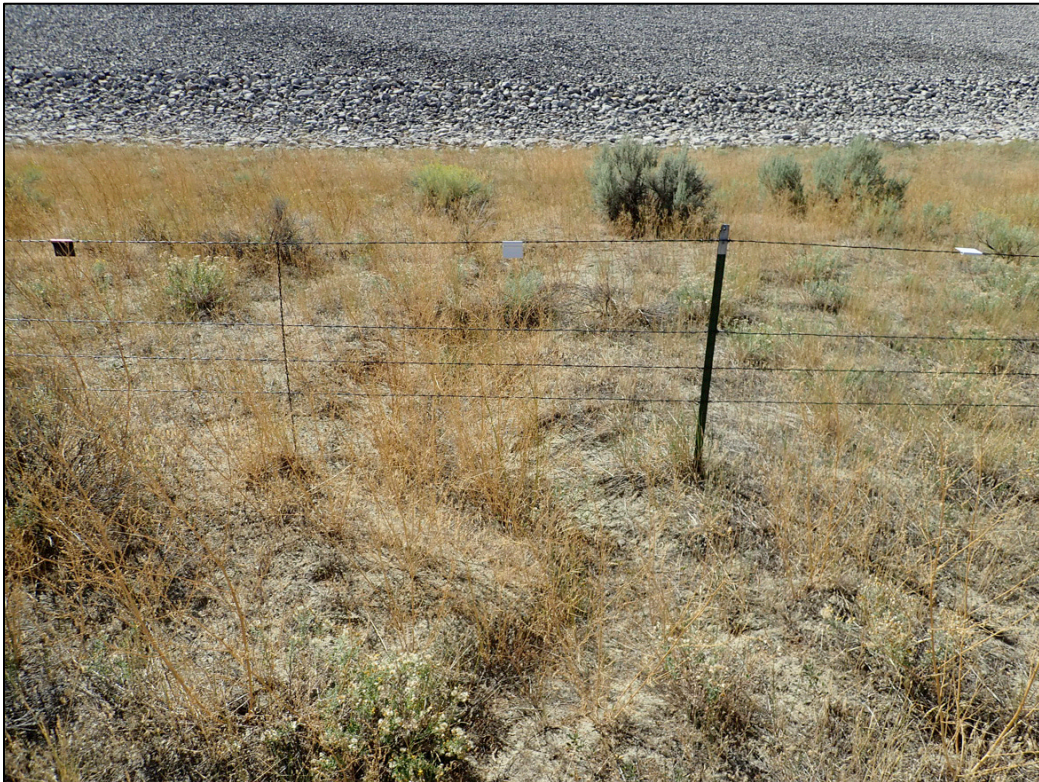
PL-10. Minor Rilling Under Fence

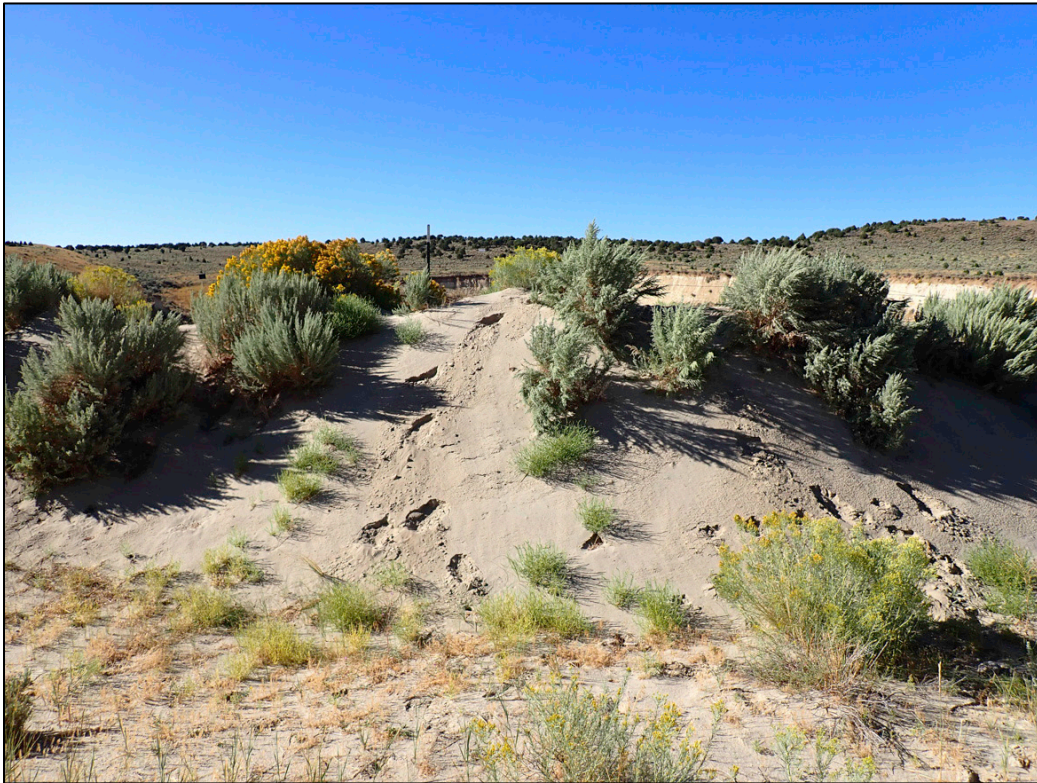
Directly south of the site is a former open-pit uranium mine known as the Johnson Pit. Over time, slumping of the pit wall caused the pit to encroach several feet onto property now owned by DOE. This encroachment presents no threat to the integrity of the disposal cell at this time. This encroachment is visually monitored annually; it is periodically documented with photographs to assess whether the pit wall has slumped further and to verify the integrity and functionality of the perimeter fence. At the time of the inspection, there was no evidence of any additional encroachment of the pit onto the site. However, windblown sand continues to accumulate along the northern crest of the pit wall along the perimeter fence line (PL-11). The perimeter fence remains functional, but continued accumulation of sand will require vertically extending the fence or removing the sand. Inspectors will continue to monitor this area. No immediate maintenance needs were identified.

PL-11. Sand Encroachment near Pit
