4.0 Annual Inspection of the Durango, Colorado, UMTRCA Title I Disposal Site

4.1 Compliance Summary

Figure 4-1. 2012 Annual Compliance Drawing for the Durango Disposal Site

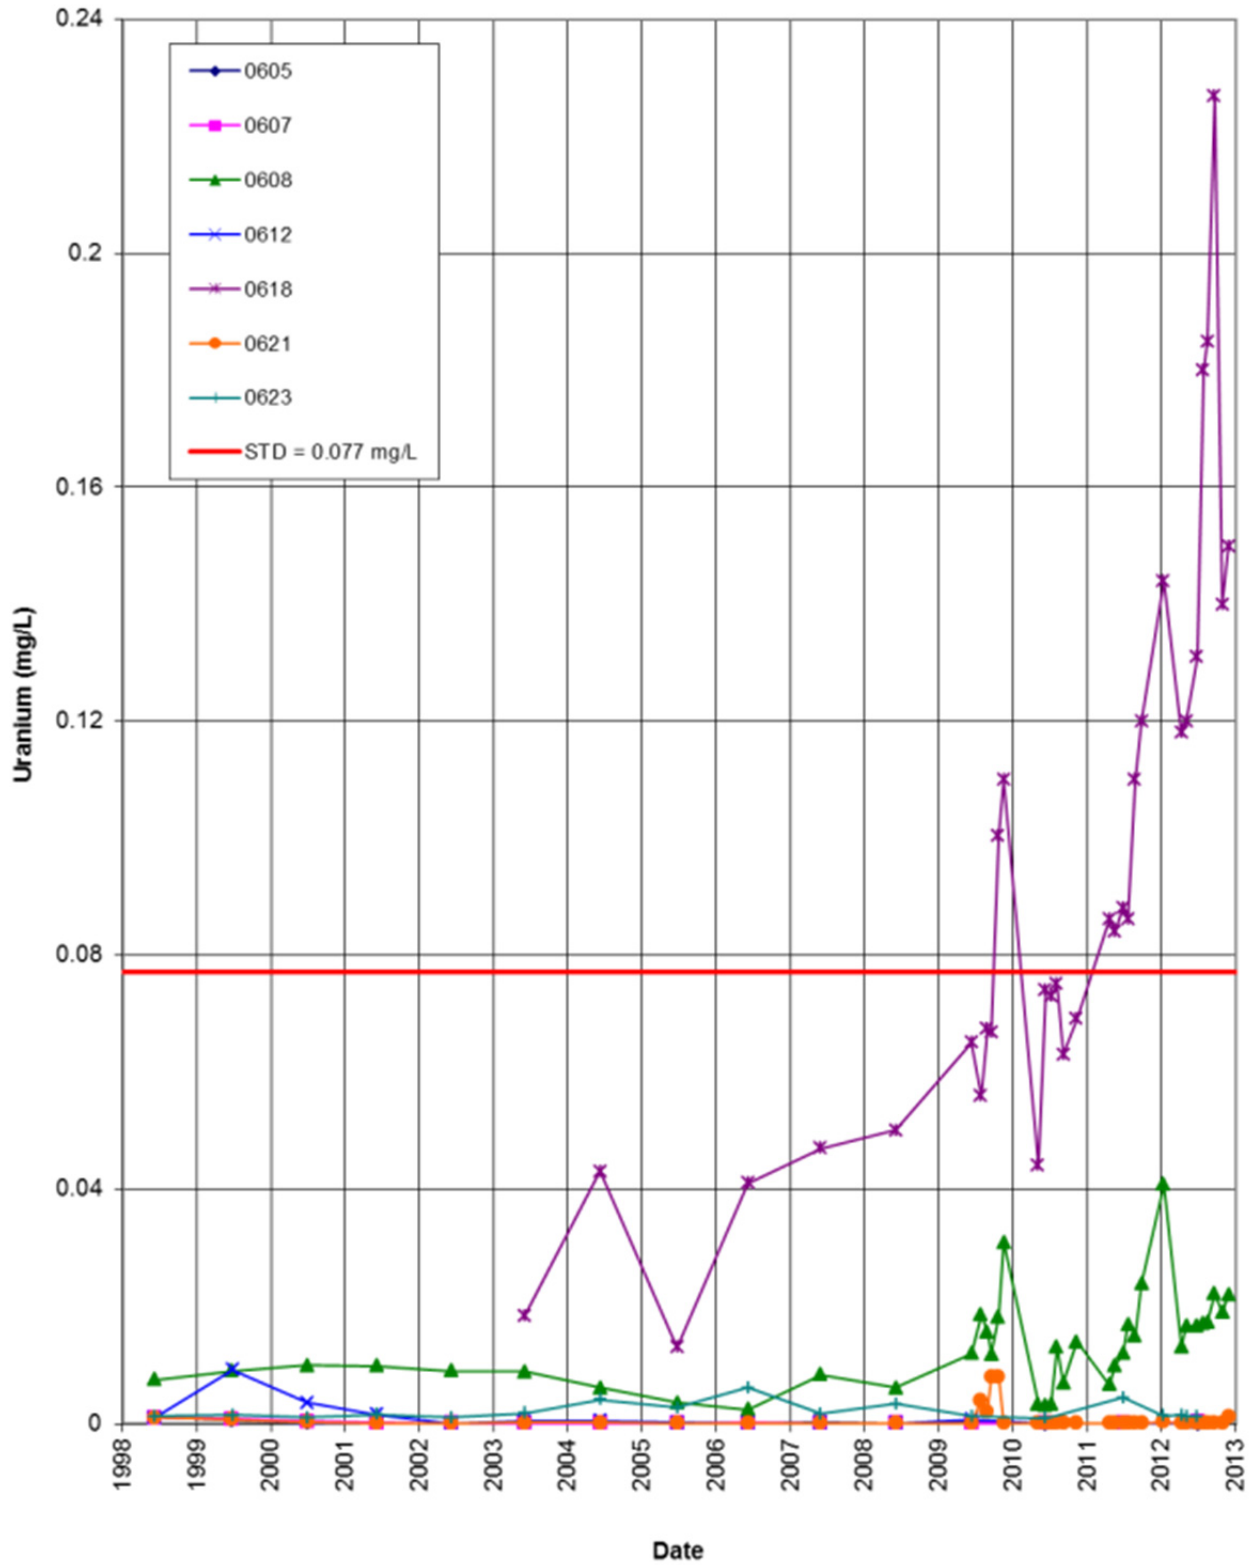
Figure 4–2. Time-Concentration Plot of Uranium in Groundwater at the Durango Disposal Site

Uranium concentrations in monitoring well 0618 had decreased since 2009, when the well was redeveloped and the purging method and pump materials were evaluated. Uranium concentrations were below the standard until an increase observed during the June 2011 sampling event. Concentrations continued to increase, and the September 2012 results of 0.227 milligram per liter (mg/L) are the highest observed in well 0618. The results for October and November 2012 have decreased, but still remain over the standard. The potential cause of this increase is being investigated; however, because well 0618 is not a point-of-compliance well, site levels remain in compliance with the LTSP. All other concentrations of uranium, along with all concentrations of both selenium and molybdenum, remain on trend and well below their respective standards.

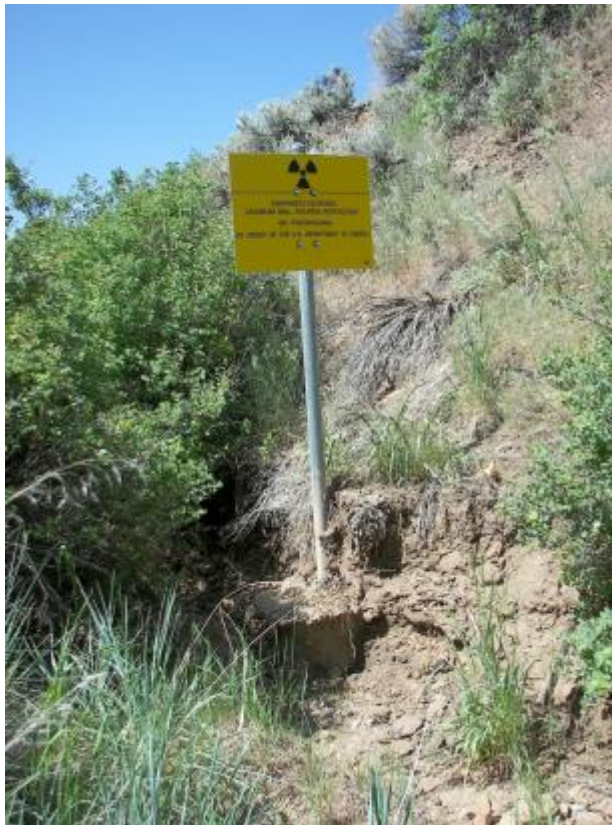
Numerous perimeter signs have bullet holes or other markings but remain legible. Perimeter sign P2 has been missing for several years and will not be replaced, as adjacent signs are within sight. In previous years, inspectors noted that the base of perimeter sign P45 was being undercut by erosion; the sign remains stable (PL–1).

DUD 5/2011. PL- 1. Perimeter sign P45, showing undercut area.

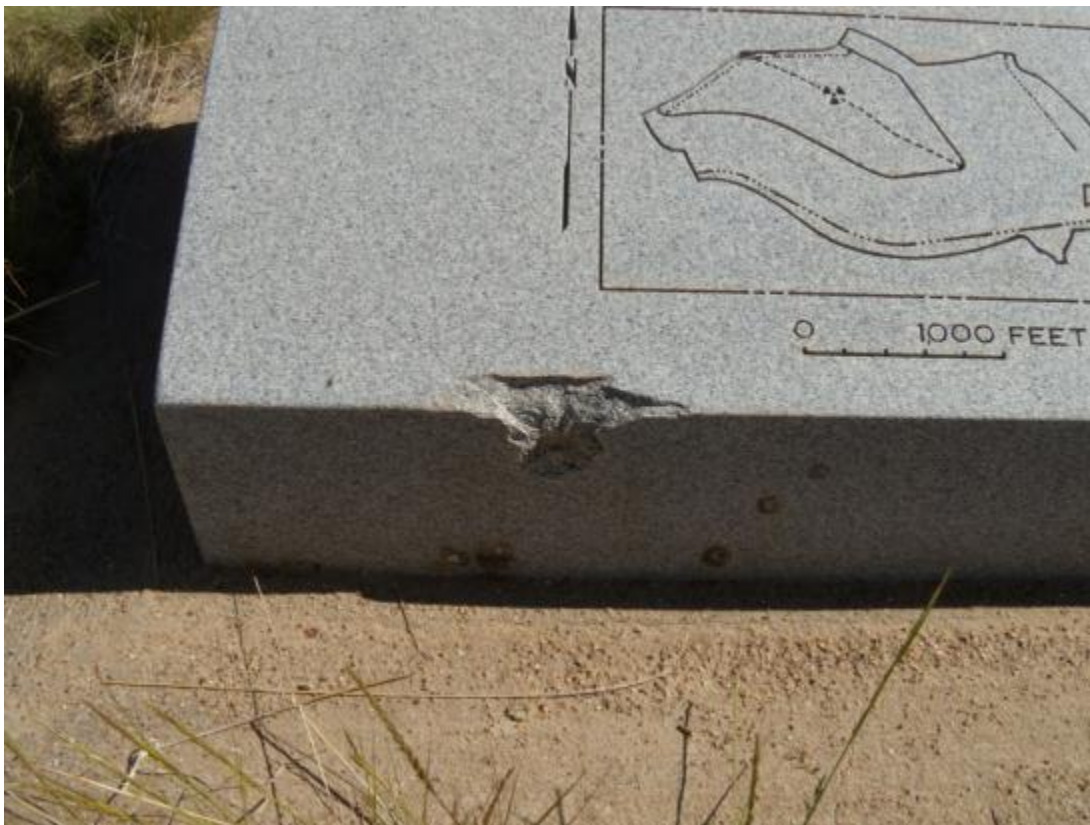
Site marker SMK–1 historically has been superficially pocked from gunfire but has remained legible. Inspectors discovered that an additional chip along the bottom edge of the marker had fallen off (PL–2); however, the information on the face of the marker remains legible. The chipped area will be protected from further erosion with a protective epoxy-glue compound. SMK–2 remains in excellent condition.

DUD 5/2012. PL-2. Chipped portion of site marker SMK-1.

- 4A Site marker SMK-1 has a new chip in it. The chipped area will be covered with a protective coating to reduce the potential for further chipping.

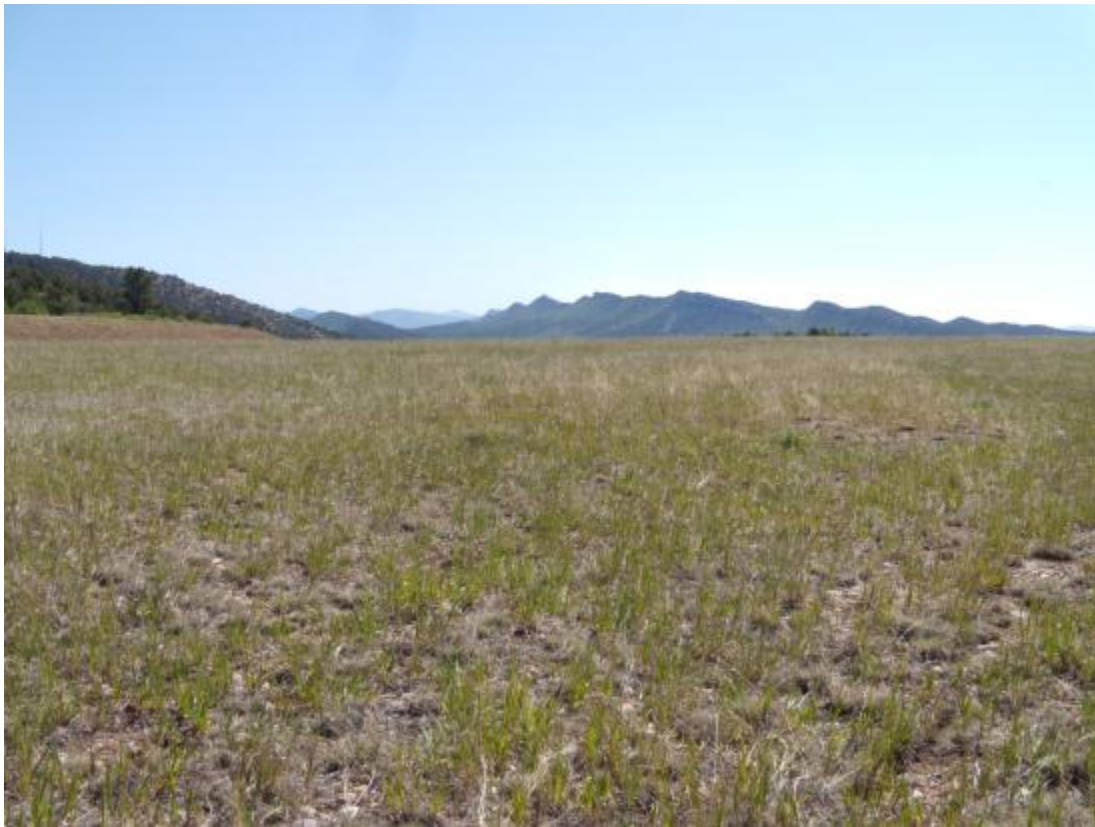
Vegetation on top of the cell remains healthy (PL-3, PL-4).

DUD 5/2012. PL-3. Vegetation on cell top, view west-southwest.

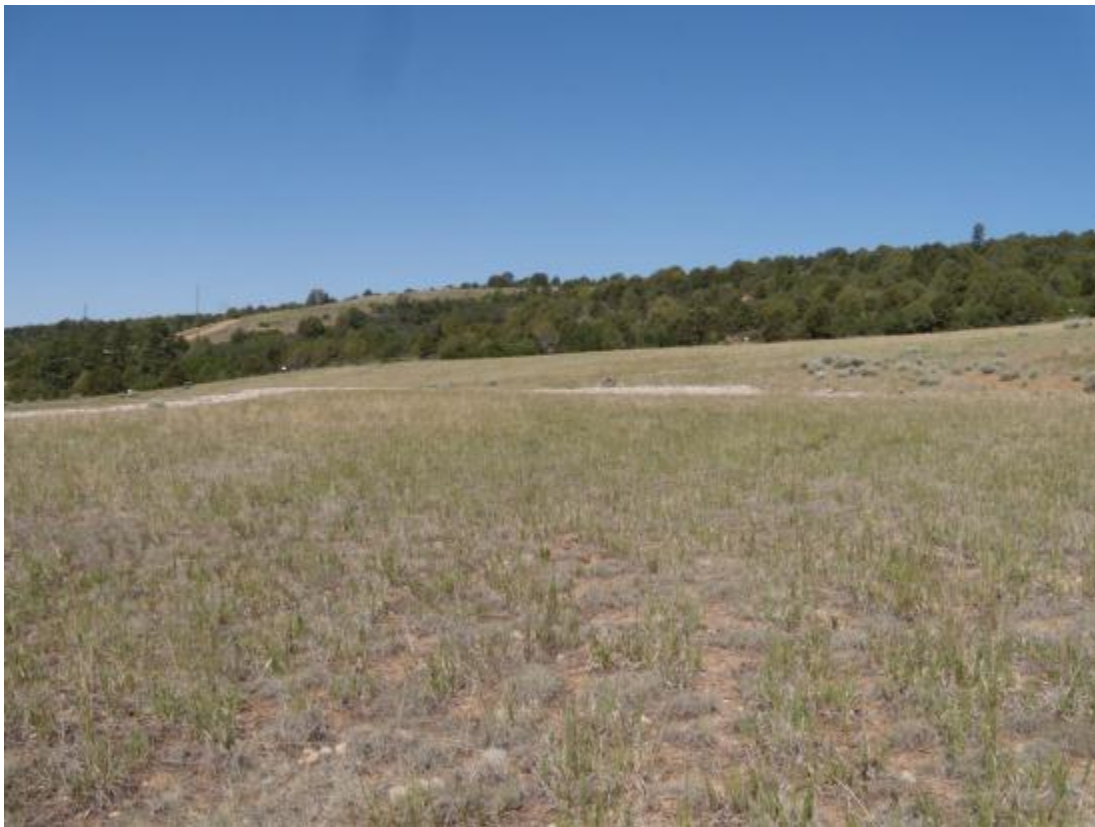
DUD 5/2012. PL-4. Vegetation on cell top, view east-northeast.

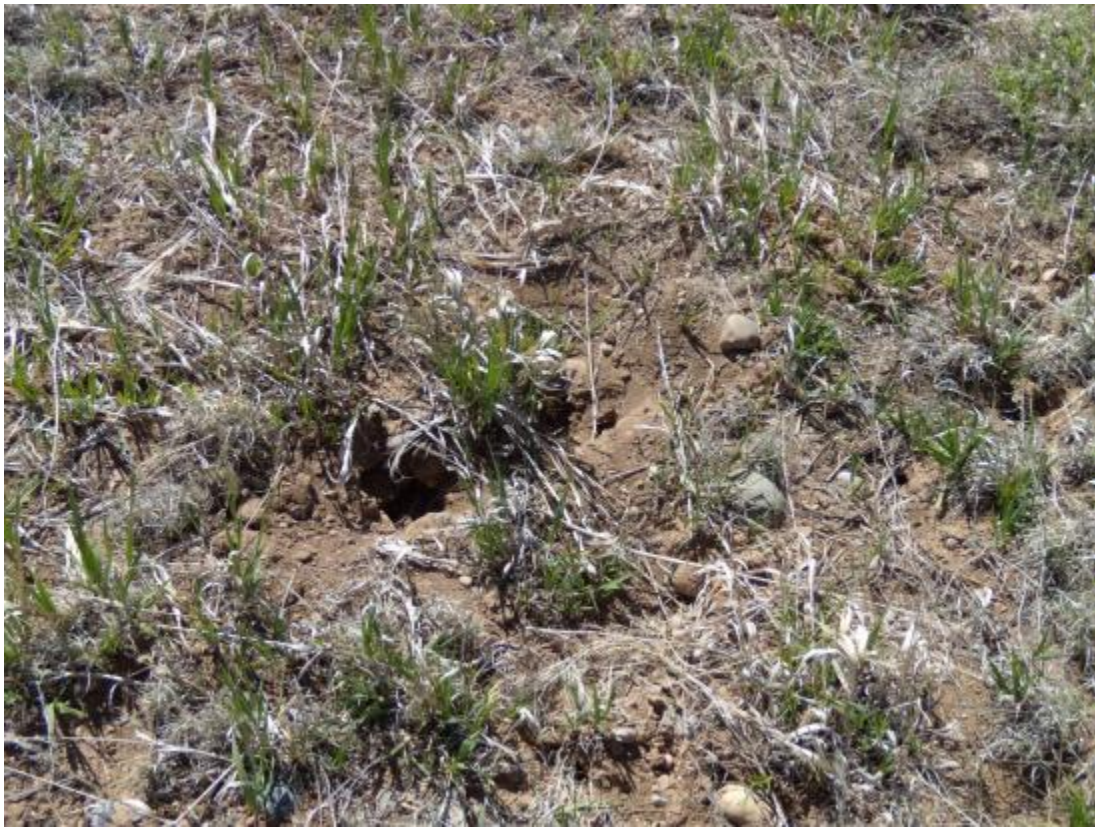
DUD 5/2012. PL-5. Revegetated area associated with removal of permeable reactive barrier treatment system.

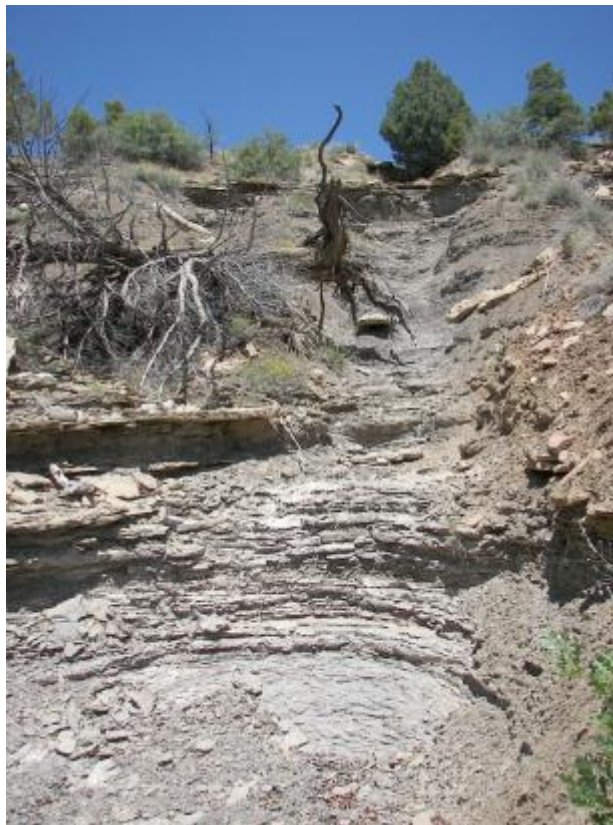
The southeast and south outflows spill into steep, natural channels and are also monitored annually. The channels at these locations are armored by riprap and bedrock. Both outflow channels were stable and in good condition at the time of the 2012 inspection (PL-6, PL-7).

DUD 5/2012. PL-6. Below the southeast outflow channel.

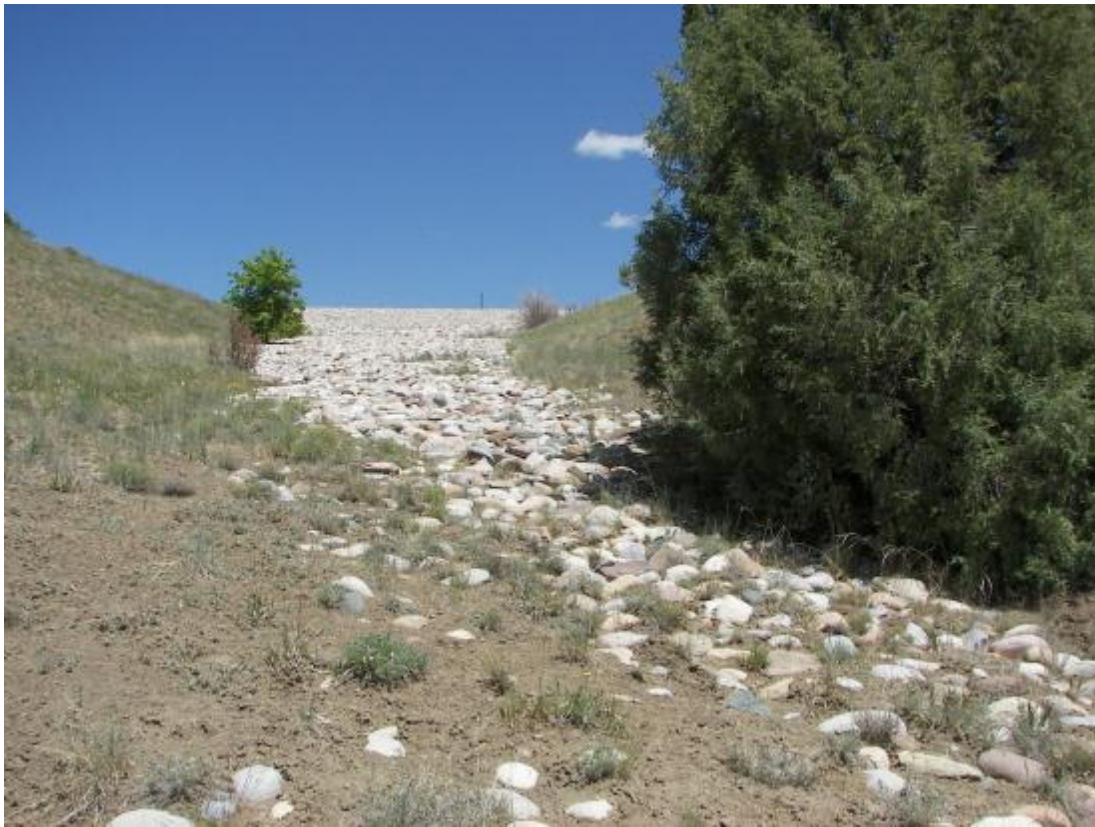
DUD 5/2012. PL-7. South outflow channel.

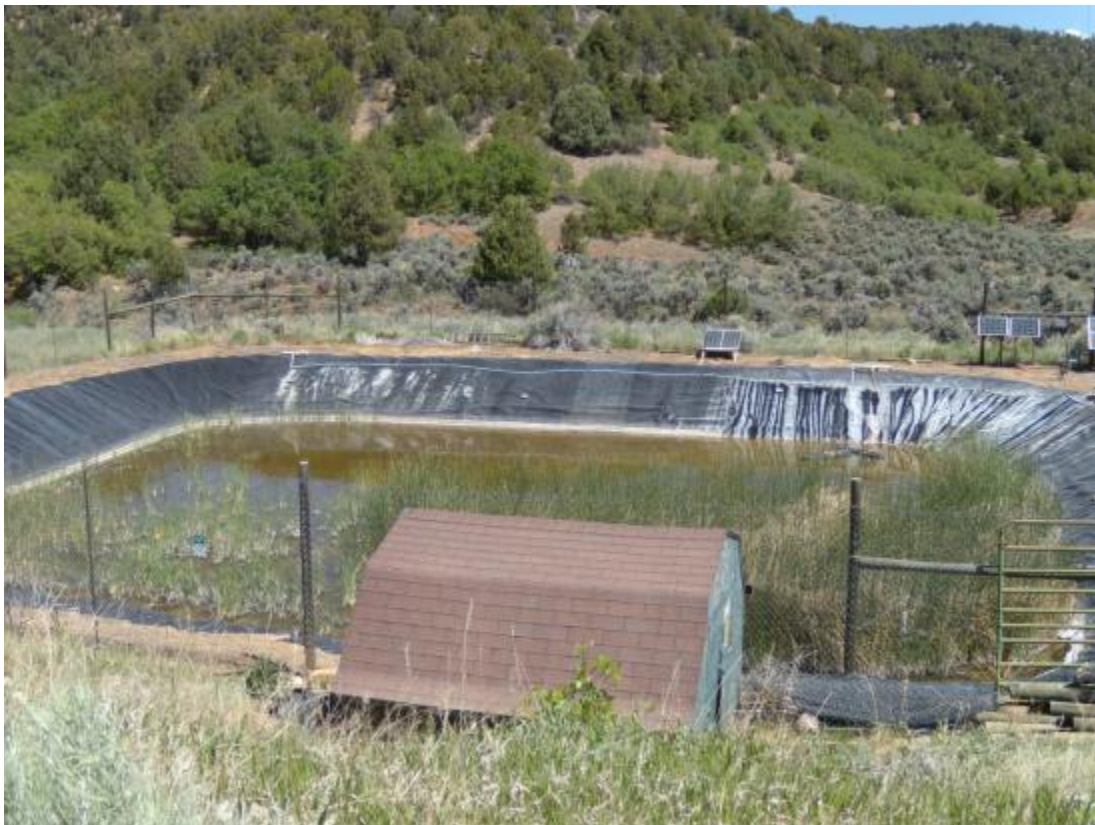
withdrawn and treated although it is pumped to the pond occasionally. The water currently in the pond is being pumped out and then dispersed through drip lines onto the pond side slopes to enhance evaporation. The pond and evaporation system were planned to be decommissioned in 2008, but decommissioning has been delayed until the source of a recent spike in uranium concentrations in a downgradient well can be determined. The tear in the pond liner discovered during the 2011 inspection had been repaired by the time of the 2012 inspection (PL-8).

DUD 5/2012. PL-8. Evaporation pond.

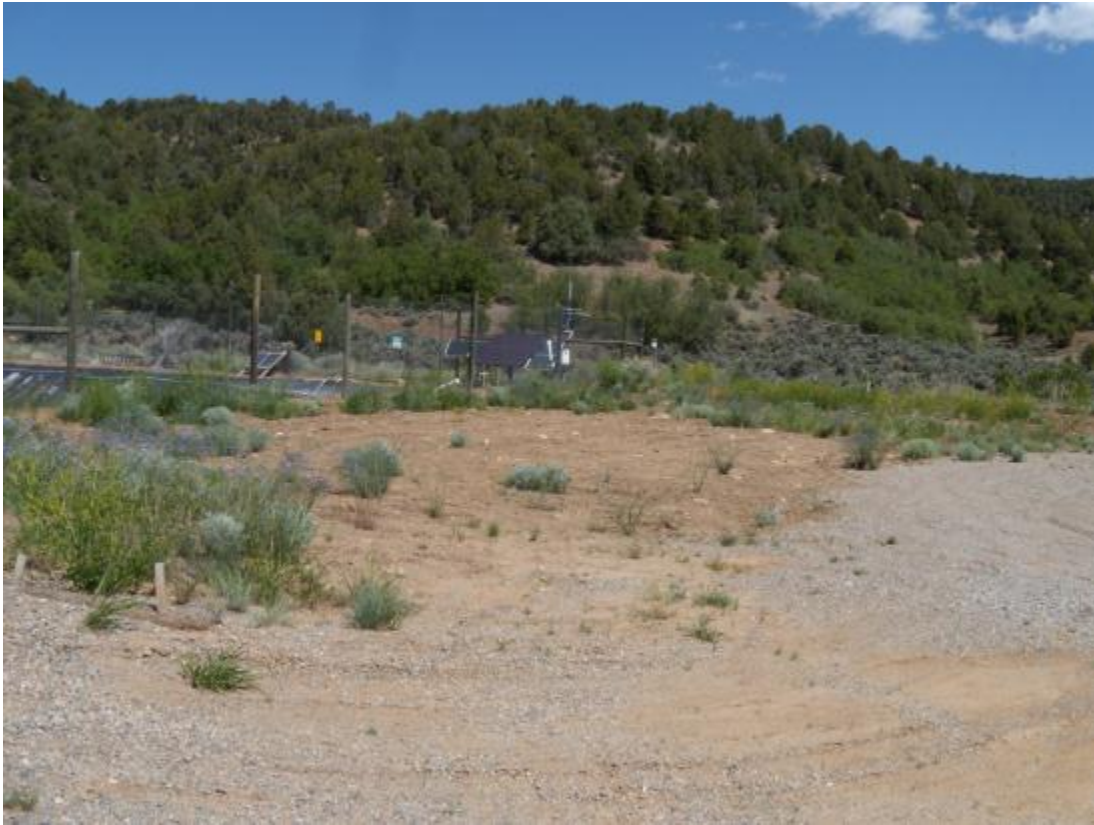
In October 2010, the permeable reactive barrier treatment system, buried in the area east of the retention pond, was decommissioned and removed. Revegetation of this area is proceeding successfully (PL-9), and sediment-control structures continue to prevent offsite sediment discharges. Inspectors will continue to monitor the integrity of the sediment-control structures until the disturbed area is considered reclaimed.

DUD 5/2012. PL-9. Revegetated area associated with removal of permeable reactive barrier treatment system.

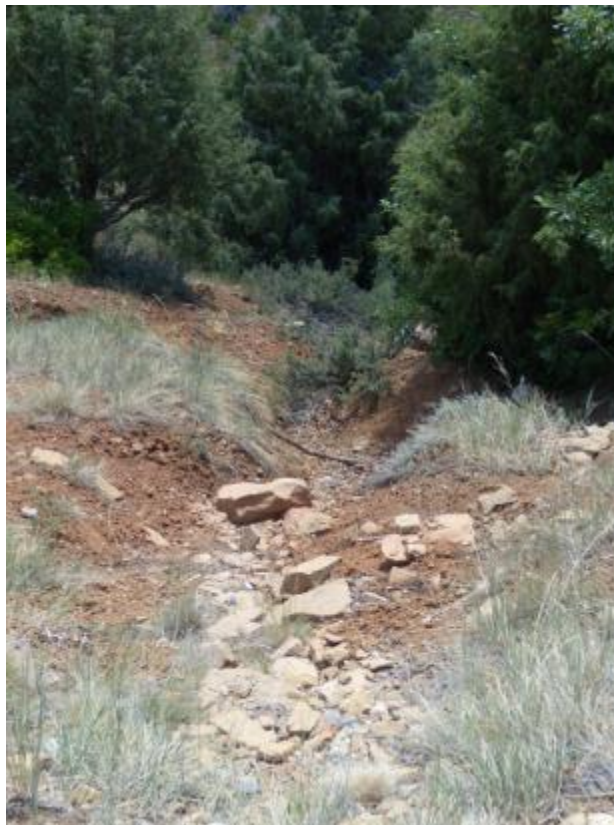
Historical rill and gully erosion on the south-facing slope along the southern boundary of the site is stable for the most part. Establishment of vegetation and exposure of resistant bedrock in the gullies are effectively preventing further erosion in most of the gullies. Inspectors noted fresh headcuts in two gullies in the southwest portion of the site in 2006. No noticeable movement in the headcuts has been observed since then, and the gullies appear to be stabilizing with rock and vegetation (PL-10, PL-11). These erosional features do not threaten cell integrity but will continue to be inspected.

DUD 5/2012. PL-10. West gully (southwest of cell) stabilizing with rock.

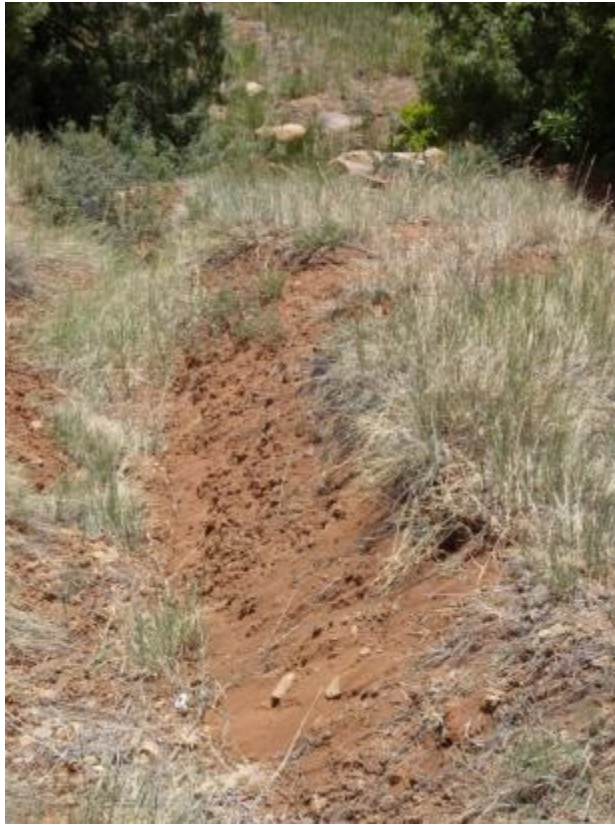
DUD 5/2012. PL-11. East gully (southwest of cell) stabilizing with vegetation.
