## 4.0 Durango, Colorado, Disposal Site

### 4.1 Compliance Summary

## **4.4 Inspection Results**

The site, southwest of Durango, Colorado, was inspected on June 3, 2014. The inspection was conducted by D. Miller and L. Sheader of Stoller Newport News Nuclear, Inc. (SN3), a wholly owned subsidiary of Huntington Ingalls Industries, Inc. SN3 is the DOE Legacy Management Support contractor. J. Dayvault (DOE Site Manager) and M. Cosby of the Colorado Department of Public Health and Environment attended the inspection.

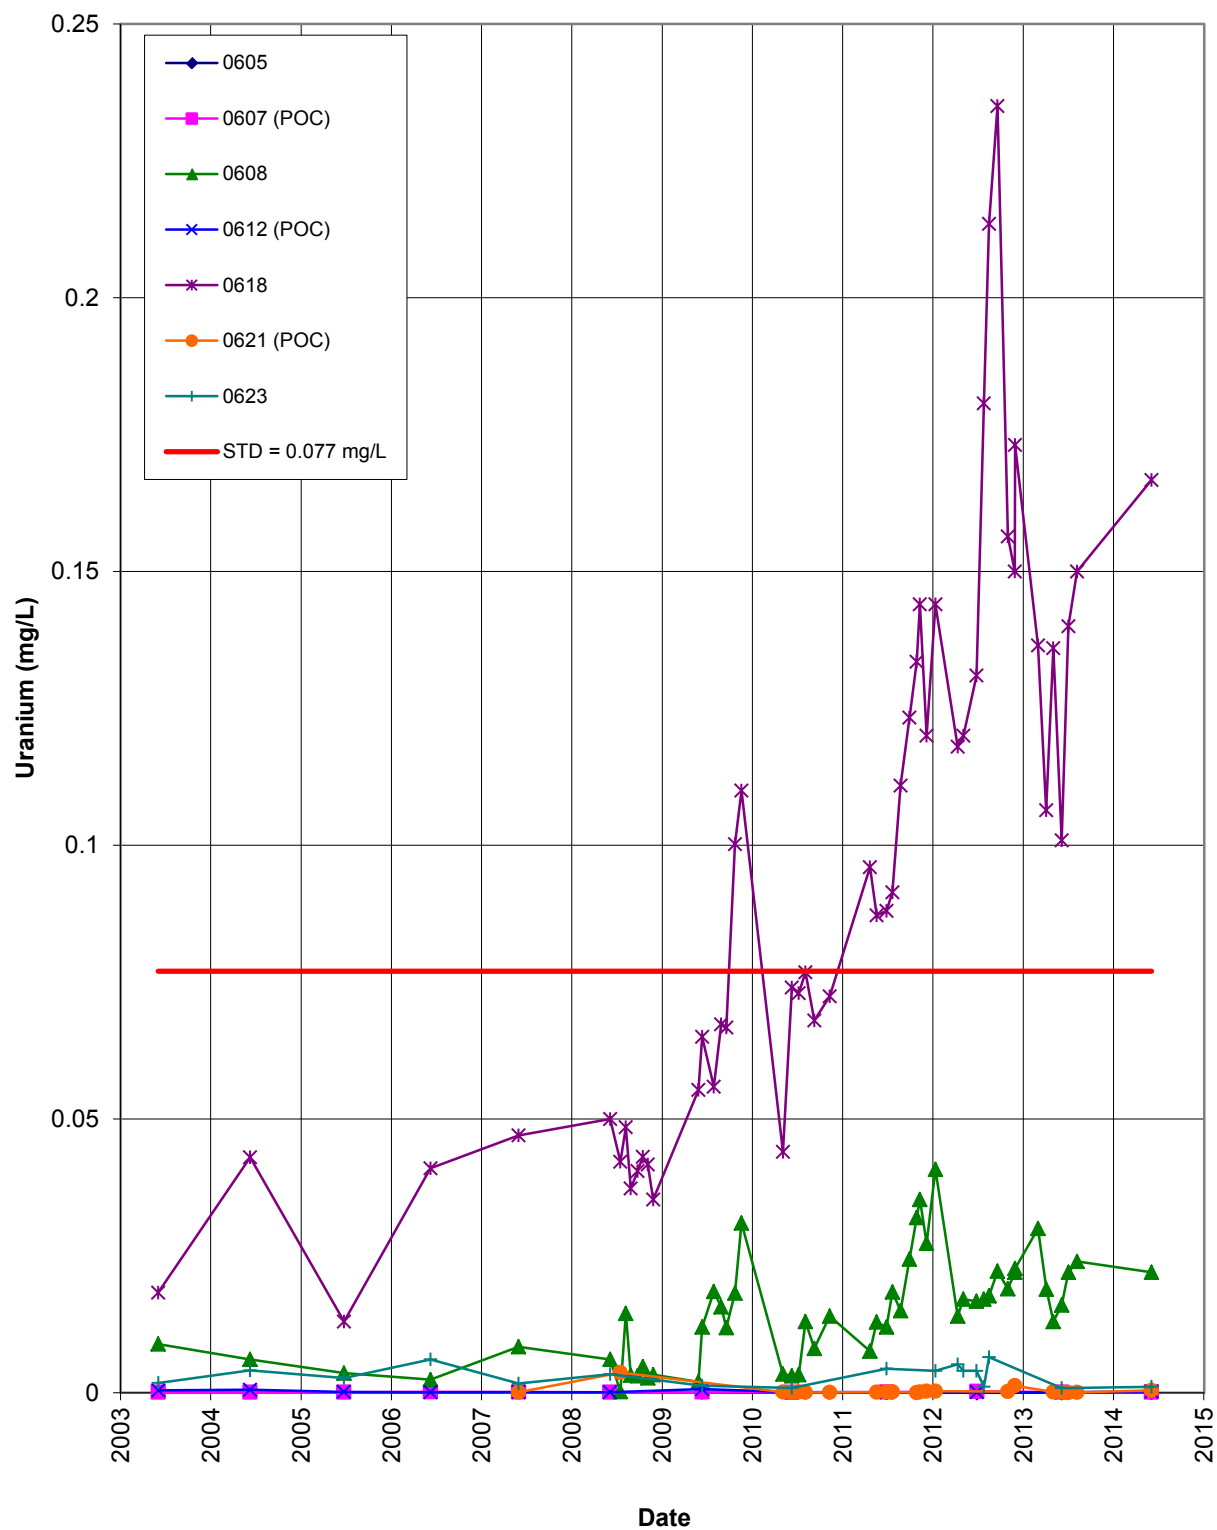
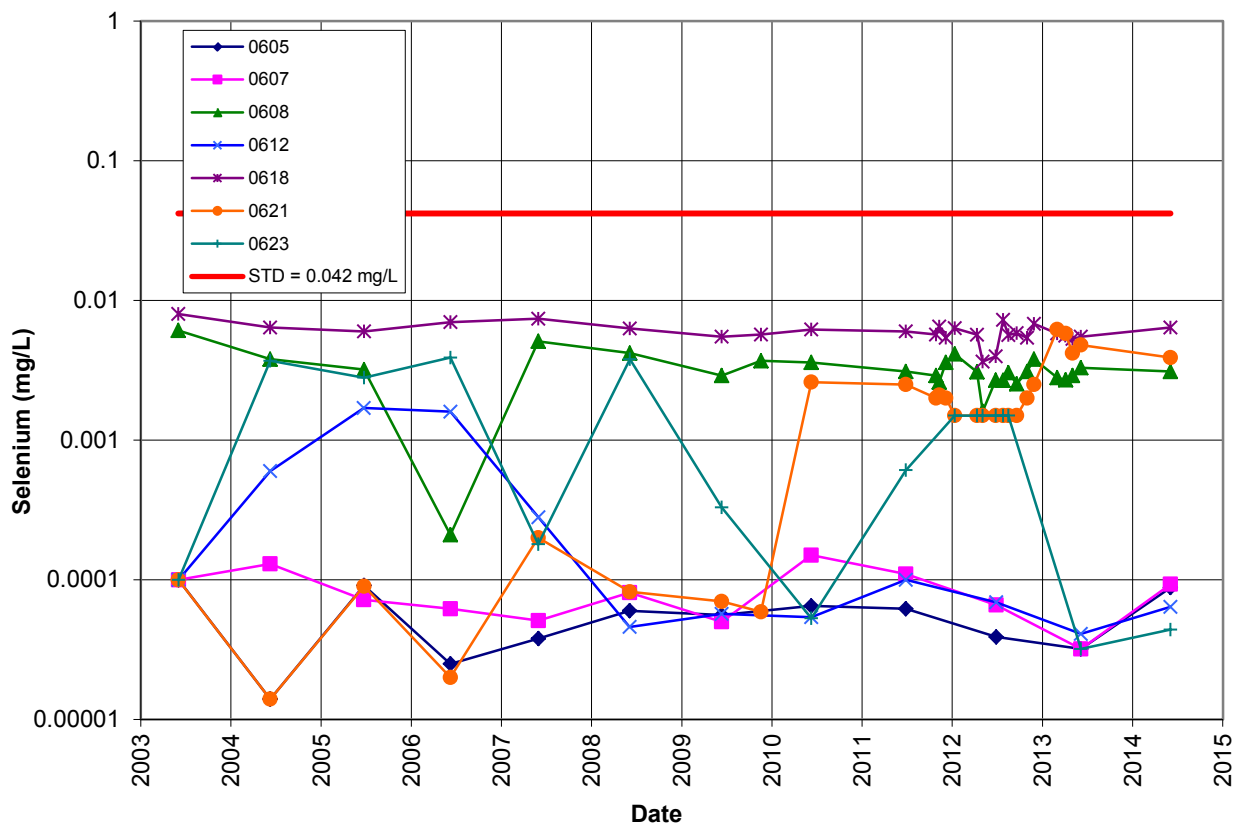
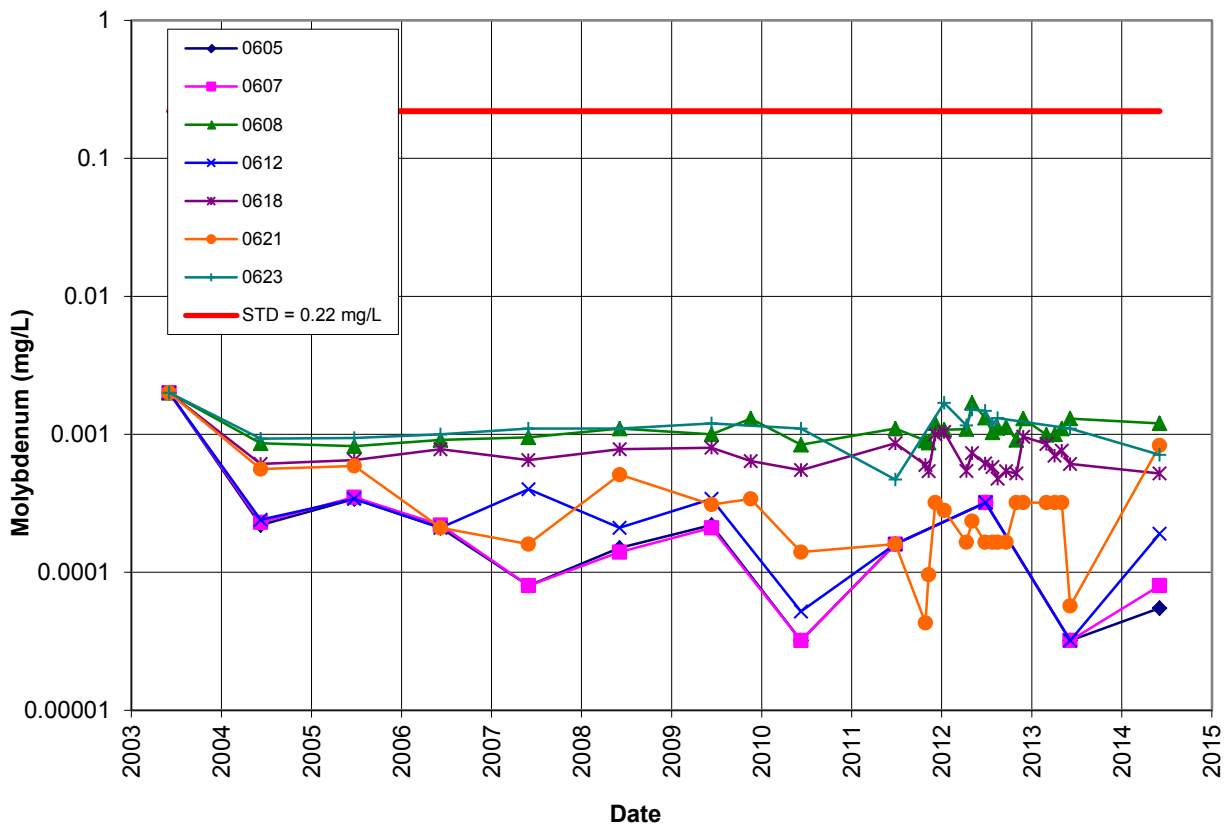
Uranium, molybdenum, and selenium concentrations in the POC wells in the uppermost aquifer are well below the respective standards with no increasing trends (Figures 4-2 through 4-4). Therefore, the aquifer is in compliance with the LTSP groundwater monitoring requirements.

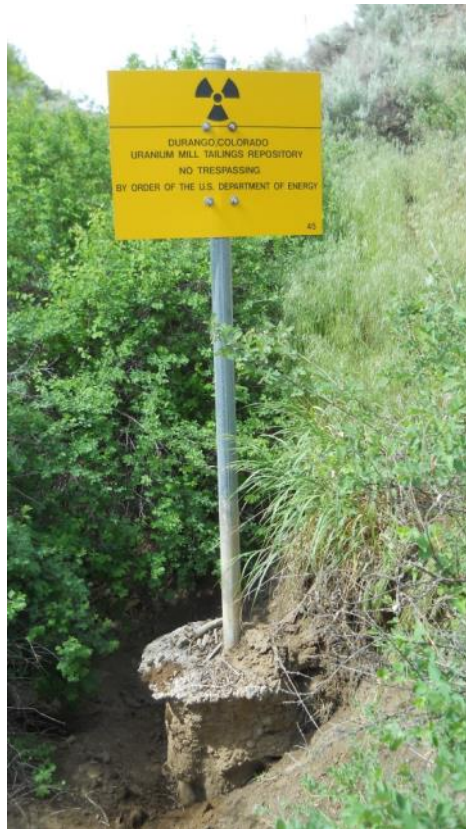
Eighty-one perimeter signs mark the unfenced site boundary. Numerous perimeter signs have bullet holes or other markings but remain legible. Perimeter signs P1 and P2 are missing. Perimeter Sign P2 has been missing for several years and will not be replaced, as adjacent signs are within sight. Perimeter sign P1 will be replaced. In previous years, inspectors noted that the base of perimeter sign P45 was being undercut by erosion; the sign remains stable (PL-1). Sign P61 is also slightly undercut and will continue to be monitored (PL-2).

*DUD 6/2014. PL-1. Perimeter sign P45 with significant undercutting.*

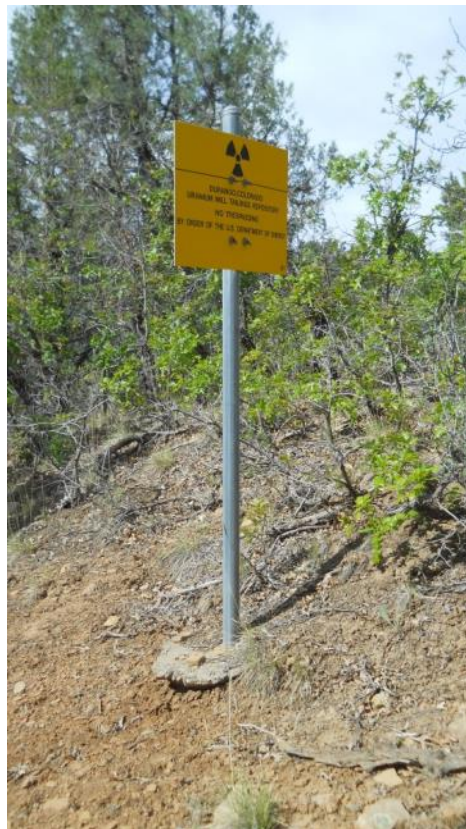
*DUD 6/2014. PL-2. Perimeter sign P61 showing minor undercutting.*

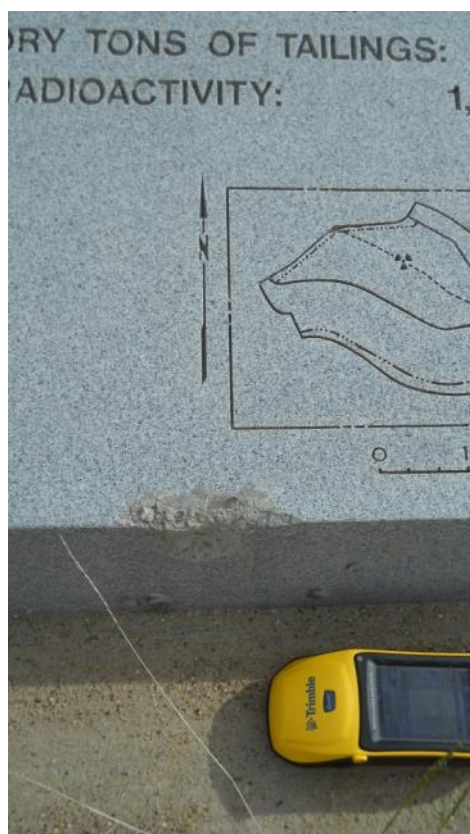
Site marker SMK-1 was historically damaged by gunfire and continues to degrade (PL-3). The site marker will be repaired.

*DUD 6/2014. PL-3. Site marker SMK-1 in need of repair.*

Alfalfa plants on the disposal cell cover were sprayed with herbicide. Missing perimeter sign P1 will be replaced and damaged site marker SMK-1 will be repaired.

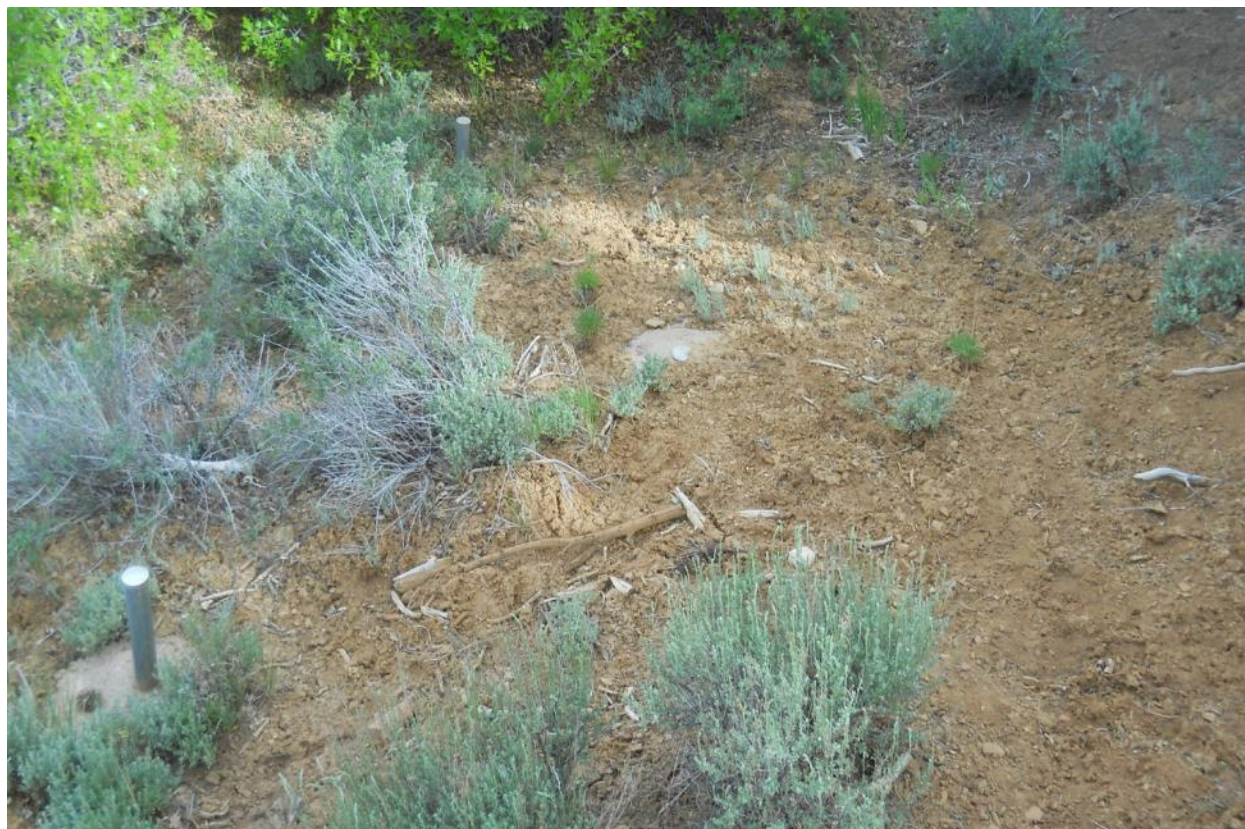
All survey and boundary monuments are in good condition except as follows. Boundary monument BM-3 and two of its reference monuments are situated in a small gully and were threatened by erosion in the past; the monuments are now stable, but slight undercutting of one of the witness corners occurred in 2014. One of the reference monuments for boundary monument BM-4 has been bent to the ground and the cap has been removed, but BM-4 is stable. Repair of any of these features is not warranted at this time. Boundary monument BM-6 was destroyed prior to the 2004 inspection during construction of a pipeline near the site. It will not be replaced because both of its witness corners are present and remain in good condition (PL-4).

*DUD 6/2014. PL-4. Witness corner for boundary monument BM-6.*

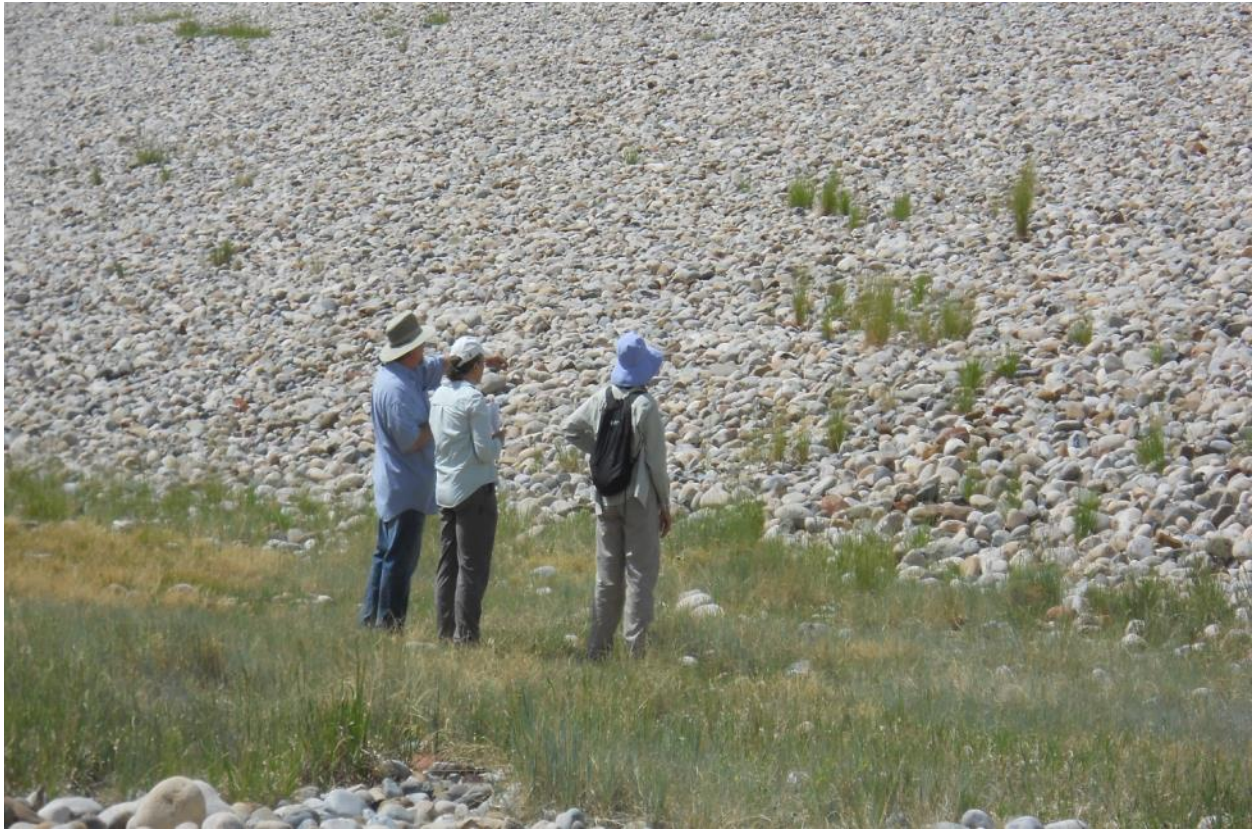
The riprap-covered side slopes of the disposal cell are in good condition. Significant disturbances resulting from natural processes, such as subsidence, rock deterioration, or slope failure, were not observed (PL-5).

*DUD 6/2014. PL-5. Inspection team at toe of disposal cell.*

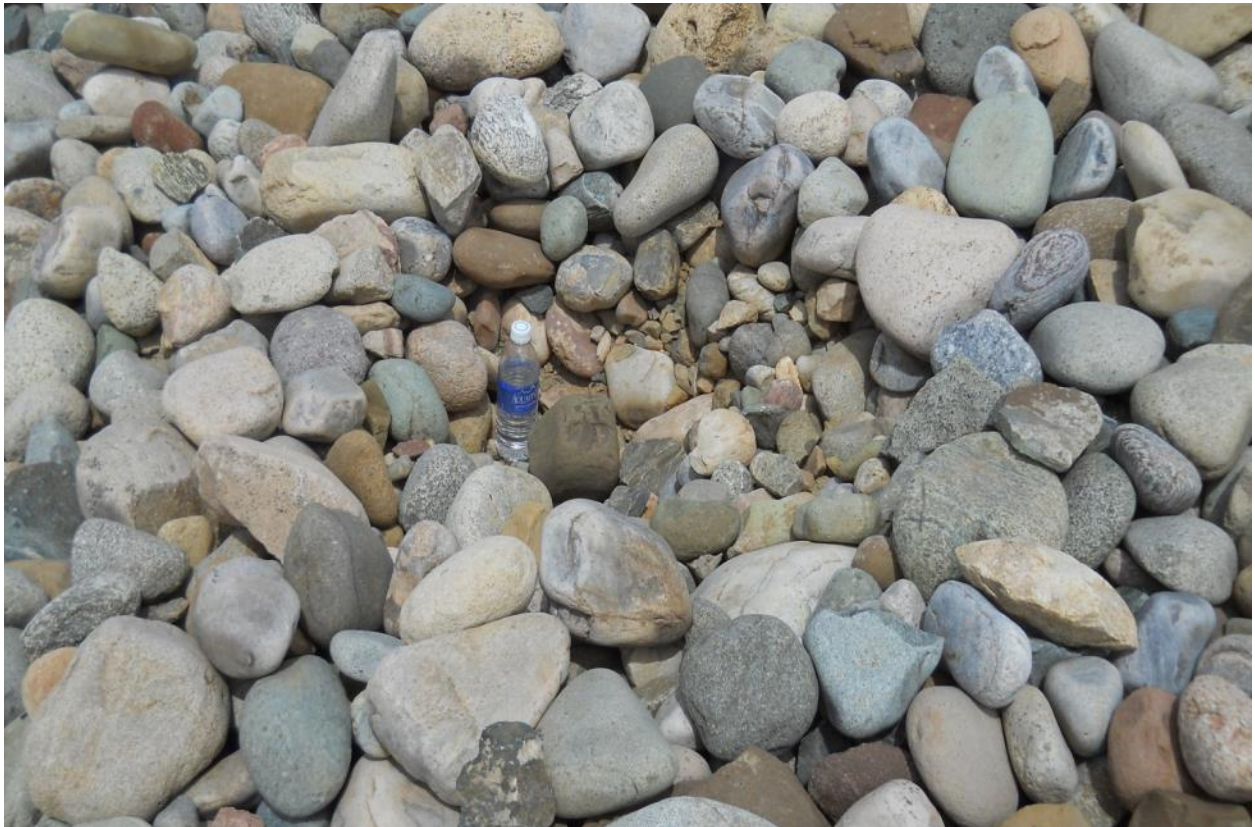
One small depression was found on the rock slope where large rocks were removed, possibly by an animal (PL-6). The location of the depression was recorded using a GPS unit, and it will be monitored during future inspections for any significant changes that may indicate slope deterioration.

*DUD 6/2014. PL-6. Large rocks moved, possibly by an animal, on cell slope.*

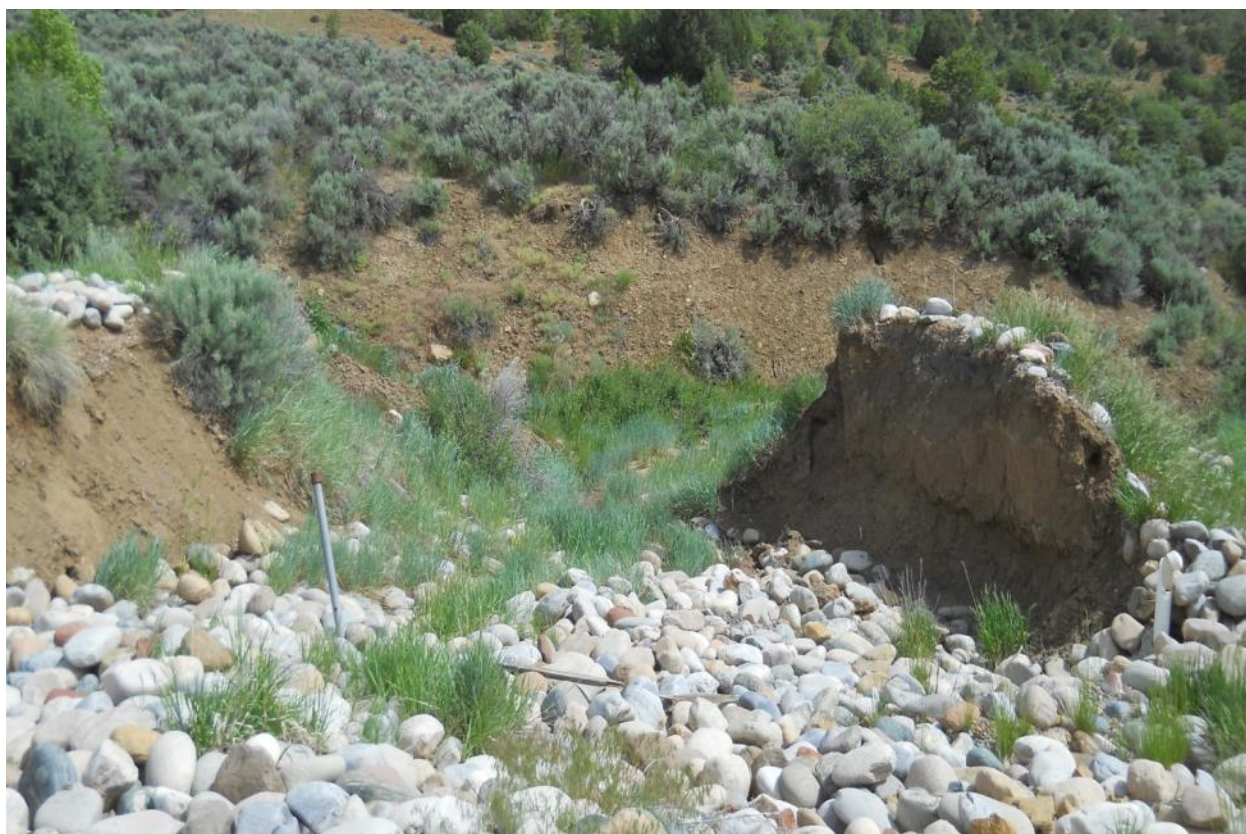
The riprap-covered outflow of Ditch No. 1 was designed to erode back to a rock-filled trench and self-armor in the process. The knickpoint was mapped with GPS equipment in 1999. Significant movement of the knickpoint has not occurred since then, and mapping will not be performed again until a change is noted. This area continues to be stable (PL-7).

*DUD 6/2014. PL-7. Northeast outflow channel.*
