4.0 Durango, Colorado, Disposal Site

4.1 Compliance Summary

4.4 Inspection Results

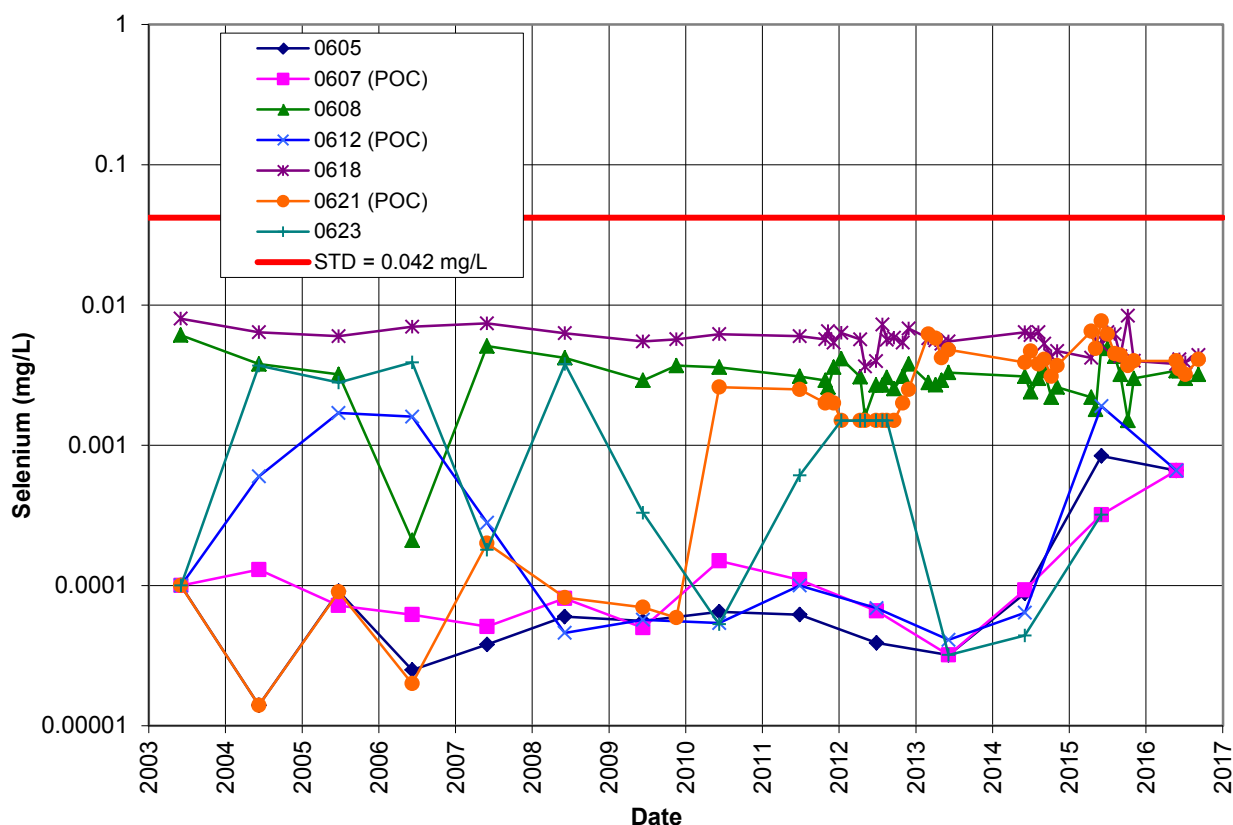
Figure 4-3. Time-Concentration Plot of Selenium in Groundwater at the Durango Disposal Site

Beginning in 2014, POC wells 0607 and 0612 have shown a slight increase in selenium concentrations (Figure 4-3). In the May 2016 sampling event, the selenium concentration continued to increase in well 0607 and it decreased in well 0612. Even so, selenium, molybdenum, and uranium concentrations in the POC wells in the uppermost aquifer are well below the respective standards (Figure 4-3 through Figure 4-5). Therefore, the aquifer is in compliance with the LTSP groundwater monitoring requirements.

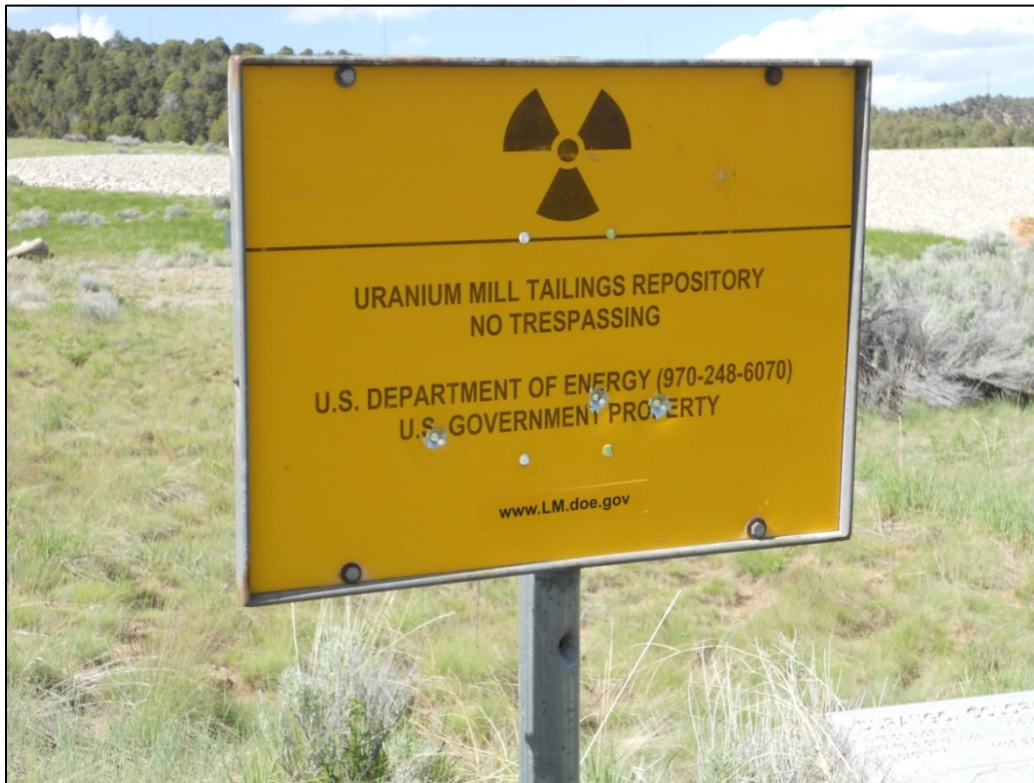
Access to the site is from County Road 212. The entrance gate along County Road 212 and the older, original site entrance gate were locked and undamaged. The entrance sign has bullet holes but was legible (PL-1). No maintenance needs were identified.

PL-1. Entrance Sign

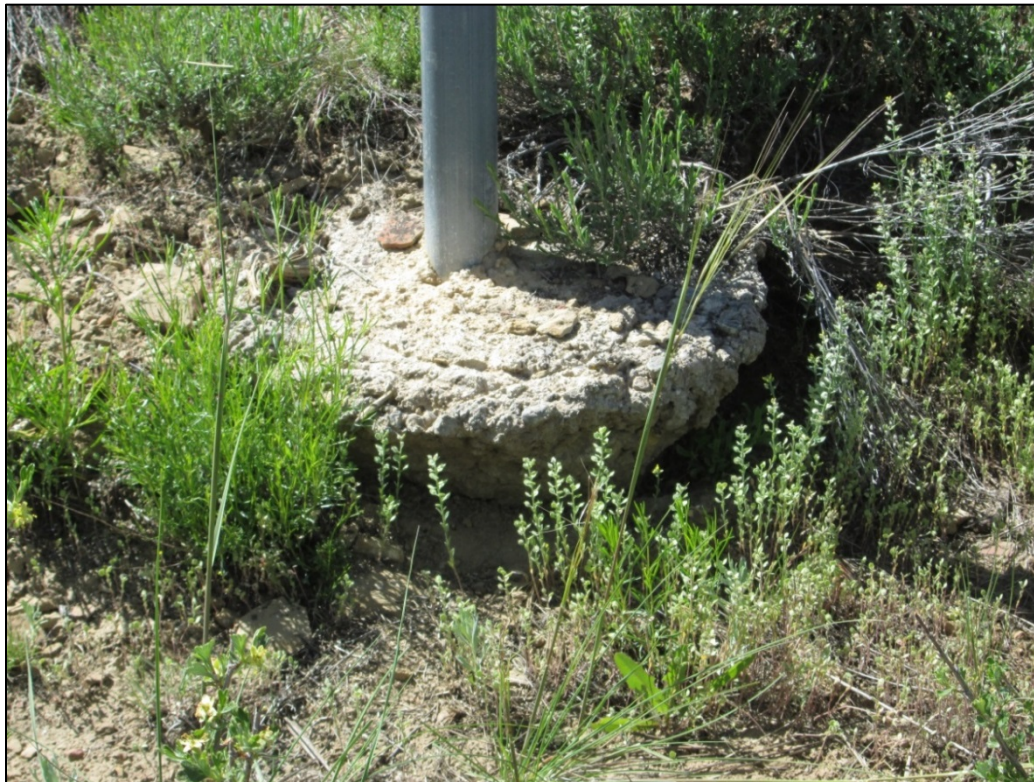
There are 82 perimeter signs, attached to steel posts set in concrete, positioned along the unfenced site boundary. Two additional perimeter signs (P83 and P84) attached to steel posts set in concrete were installed inside the site boundary in 2015. Four perimeter signs (P40–P43) are not required to be inspected in accordance with the LTSP because of difficult terrain. The concrete bases of several perimeter signs have been undercut by erosion (P28, P35, P38, P42, P45, P56, P61, P62) (PL-2); no significant changes were observed, and all signs were stable. Several perimeter signs have bullet holes or other markings. Ten of the perimeter signs were identified as needing replacement and will be replaced before the next site inspection. No other maintenance needs were identified.

PL-2. Base of Perimeter Sign P38, With 3–4 Inches of Erosion on Downslope Side

Ten perimeter signs were identified as needing replacement and will be replaced before the 2017 inspection. Shrubs and small trees growing on the side slopes of the disposal cell were identified during the site inspection and were treated with herbicide during a later visit. No other maintenance needs were identified.

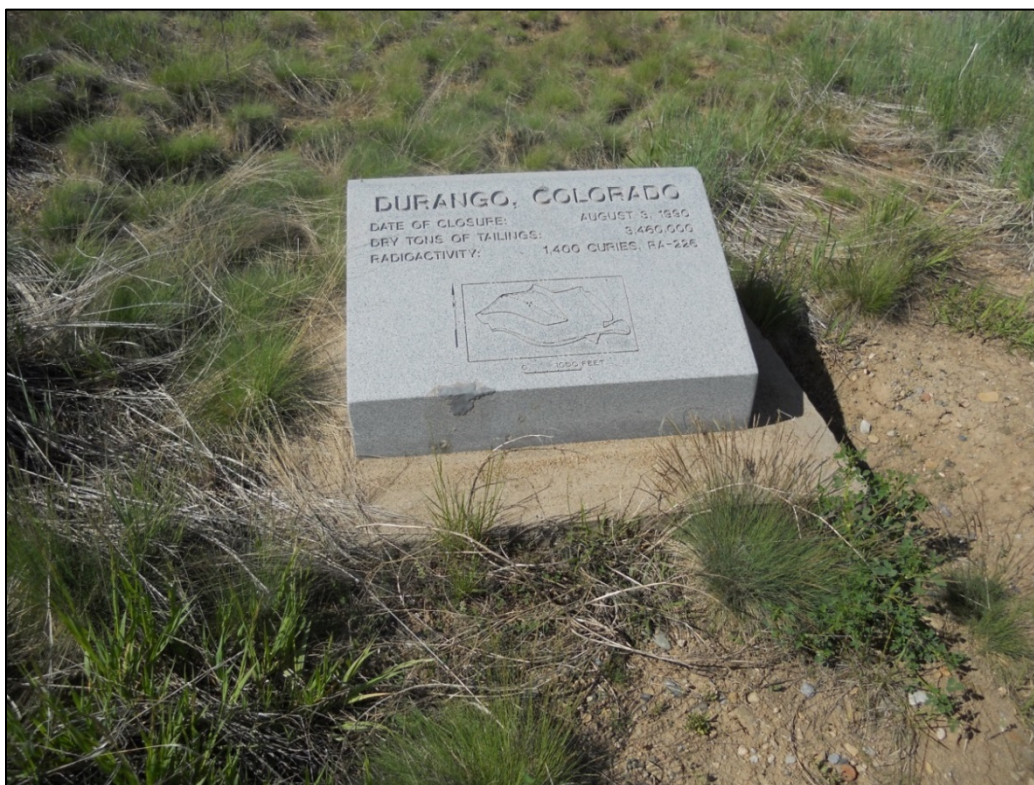
The site has two site markers. Site marker SMK-1 is just inside the original entrance gate. SMK-1 had historically been damaged by gunfire and was repaired in 2015 (PL-3). The repairs are intact, and no additional damage was observed. Site marker SMK-2 is on the top slope of the disposal cell; small burrowing animals had disturbed soils surrounding the marker's base (PL-4). The disturbance presents no threat to the integrity of the cover, but inspectors will continue to monitor it. No maintenance needs were identified.

PL-3. Site Marker SMK-1 Along Site Access Road

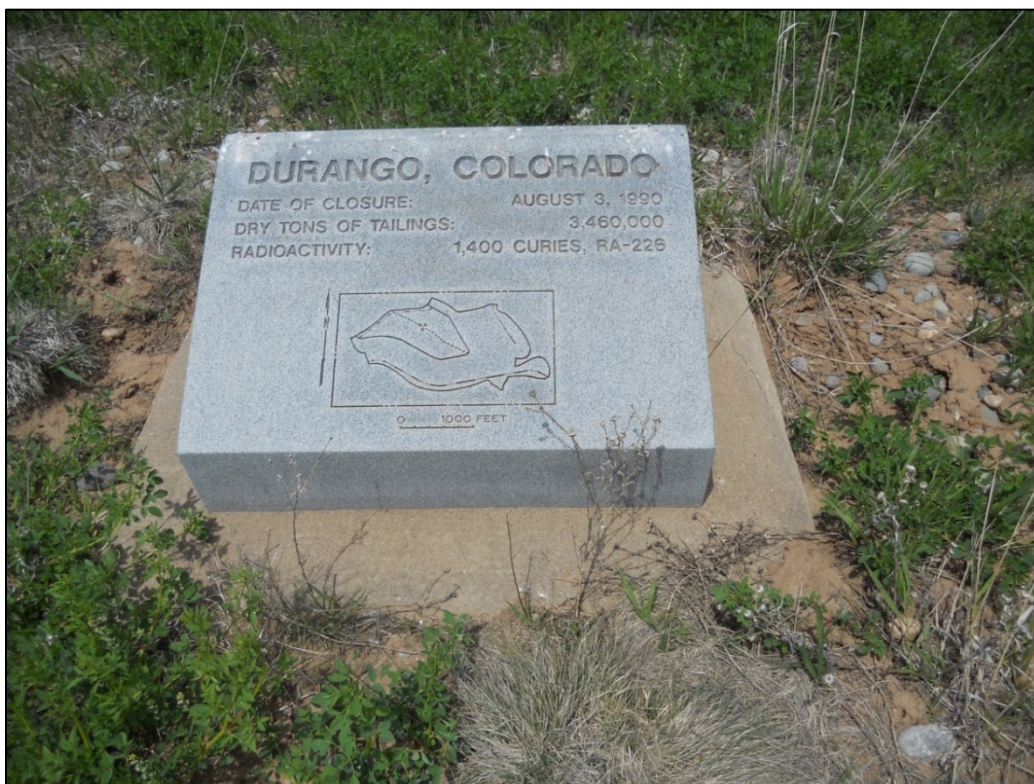
PL-4. Site Marker SMK-2 on Top of Disposal Cell

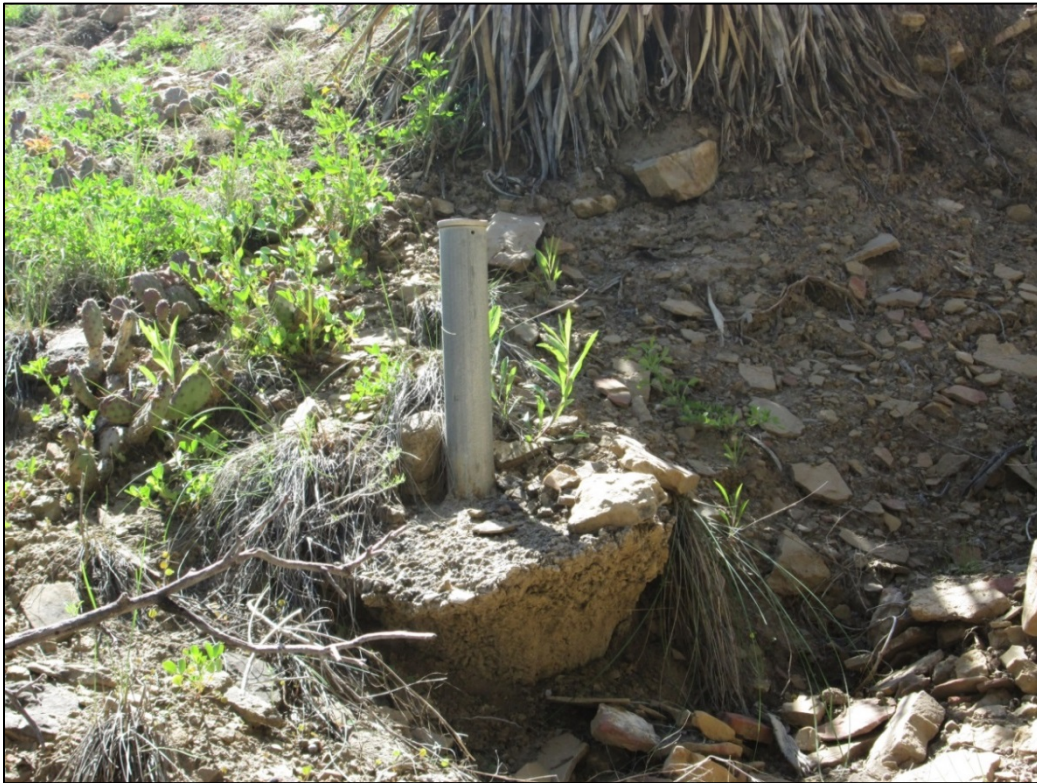
There are four survey monuments positioned around the site. All were present and undamaged. There are six boundary monuments, each with two witness corners, along the site perimeter. Most of the boundary monuments and witness corners were present and stable. One witness corner for boundary monument BM-3 was undercut by erosion (PL-5), and monument BM-3 was also undercut (PL-6). One of the witness corners for boundary monument BM-4 was bent to the ground, and its cap was missing, but BM-4 was stable. Boundary monument BM-6 has been missing for years, but both witness corners were present. Repair or replacement of these features is not warranted at this time. No other maintenance needs were identified.

PL-5. Witness Corner of Boundary Monument BM-3

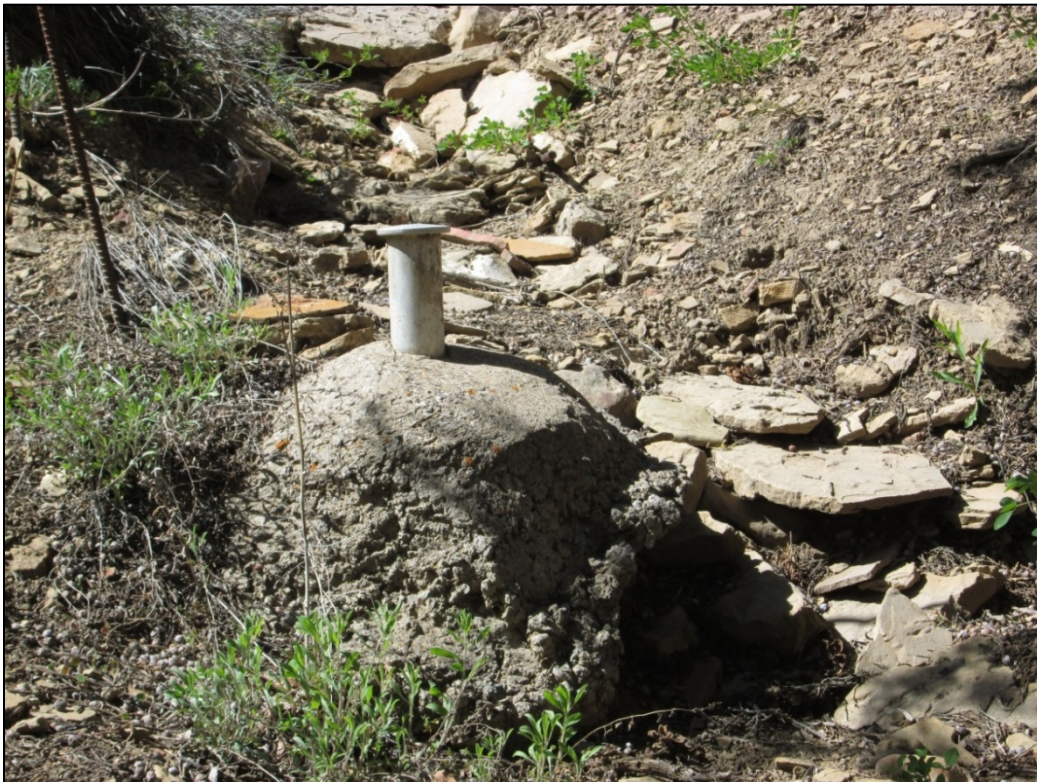
PL-6. Boundary Monument BM-3

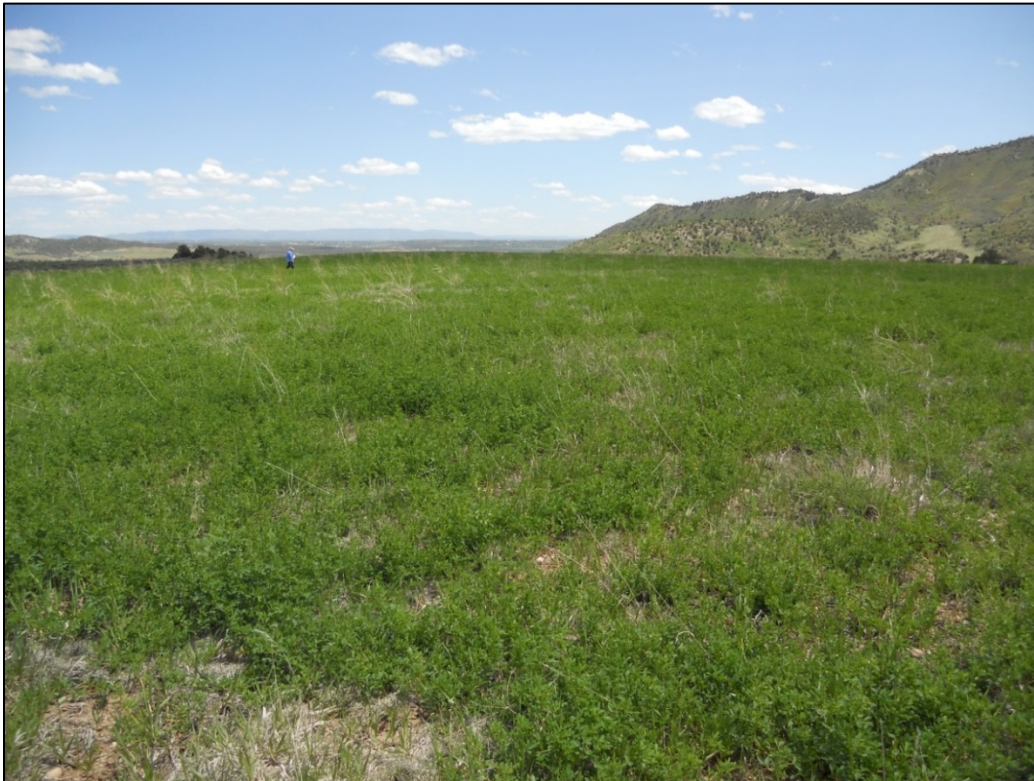
The disposal cell, completed in 1990, occupies 60 acres. It has a vegetated cover consisting primarily of perennial grasses and nonweedy broadleaf plants. There was no evidence of erosion, settling, slumping, or other modifying processes on the top of the disposal cell (PL-7). Small animal burrows were observed in some areas. The burrows do not threaten the integrity of the disposal cell. The LTSP requires that deep-rooted vegetation be controlled on the disposal cell top. No deep-rooted vegetation was observed. No maintenance needs were identified.

PL-7. Vegetated Top of Disposal Cell

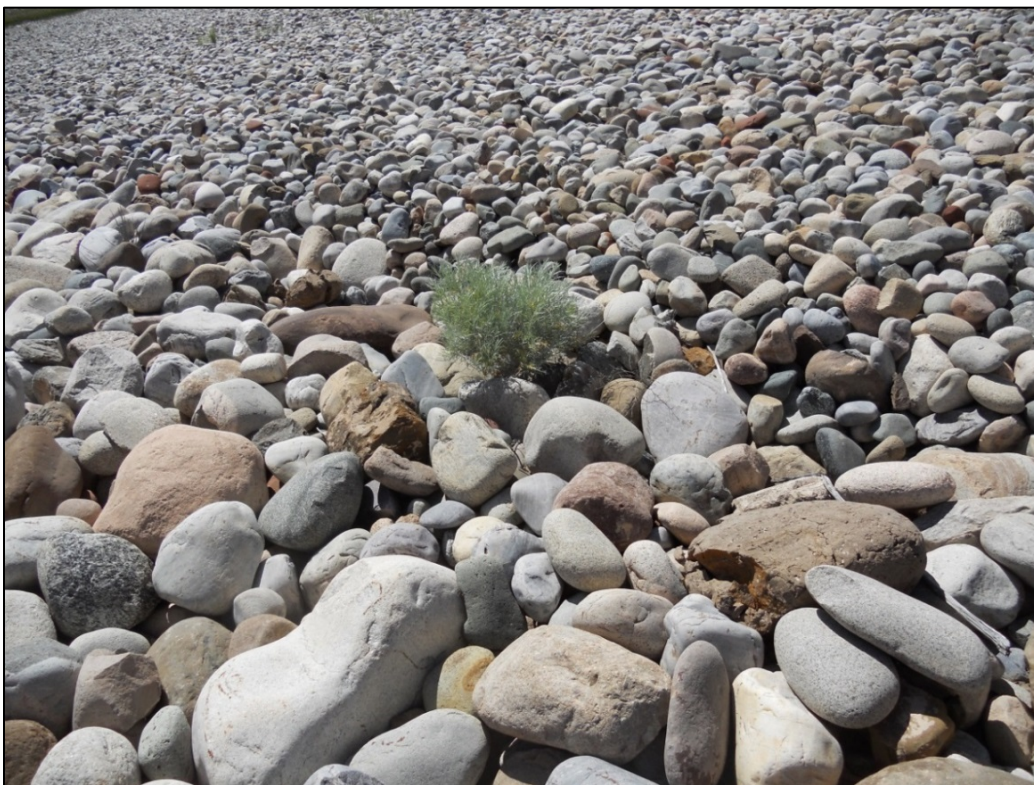
The side slopes of the disposal cell are armored with rock riprap. Along the north toe of the disposal cell, rock has moved, creating a linear depression approximately 18 feet long. The depression was first observed in 2015 (PL-8). No significant change was observed in 2016 (PL-9). Inspectors will continue to monitor and evaluate this area.

PL-8. Area of Disposal Cell Toe Where Rock Movement Has Occurred, 2015

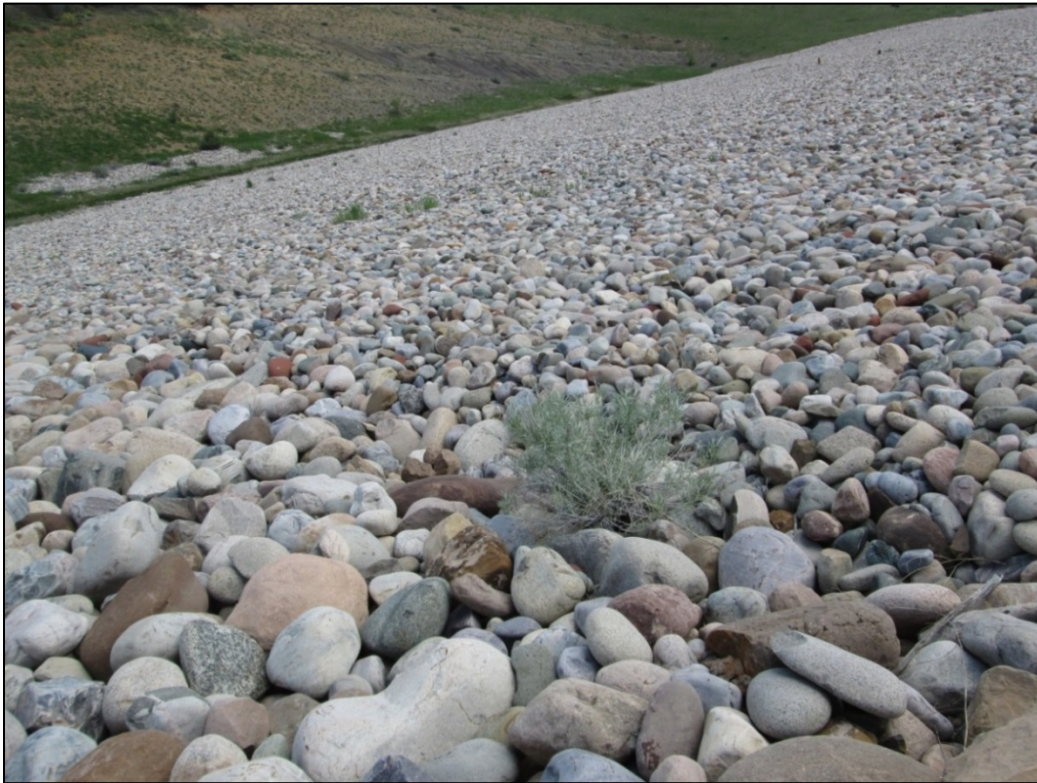
PL-9. Area of Disposal Cell Toe Where Rock Movement Has Occurred, 2016

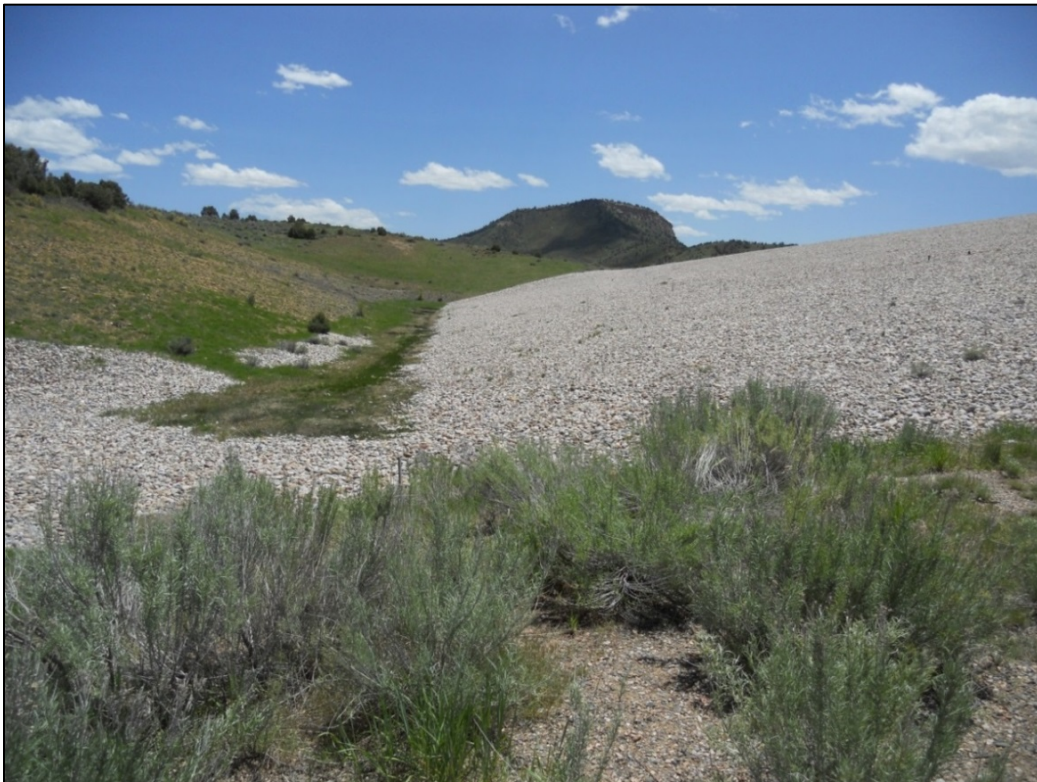
Erosion occurs on some of the steep slopes above these channels, depositing sediment in the rock-armored channel; this creates locales favoring plant growth (PL-10). As no excessive sediment deposits or vegetation were observed during the inspection, drainage ditches are expected to perform as designed. Inspectors will continue to monitor the ditches.

PL-10. Ditch No. 1 Showing Sediment Deposition and Vegetation Growth

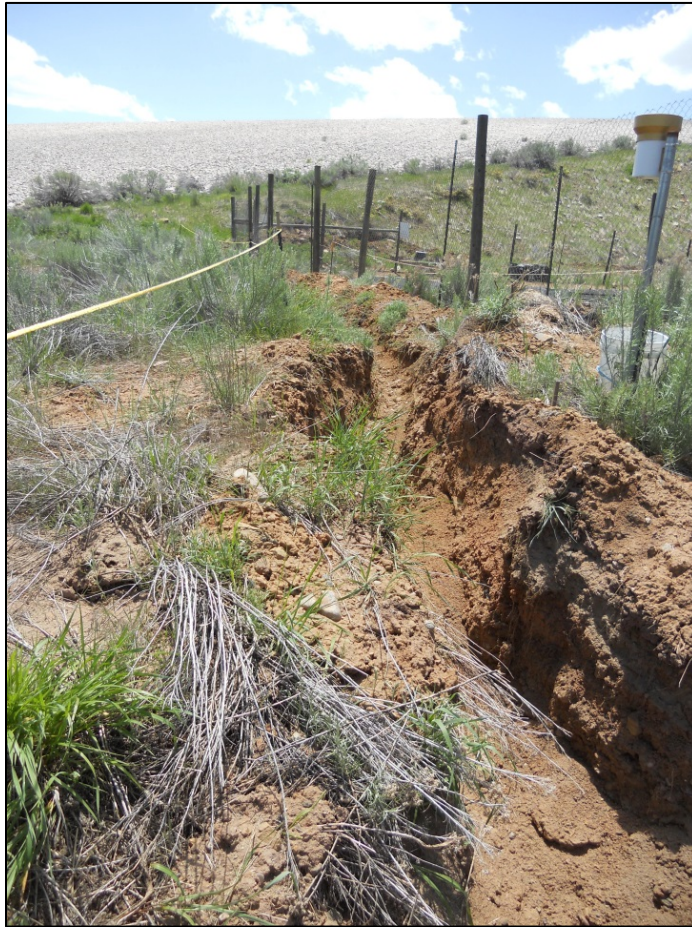
A holding pond associated with the site's transient drainage system is in the northeast corner of the site. A ditch had been constructed outside the holding pond fence to reduce surface flow into the pond (PL-11). The pond, fence, and associated structures will be removed in 2017.

PL-11. Ditch Installed Around Evaporation Pond to Reduce Inflow Before Pond Removal
