## 4.0 Durango, Colorado, Disposal Site

The Durango, Colorado, Uranium Mill Tailings Radiation Control Act (UMTRCA) Title I Disposal Site (site) was inspected on May 24, 2017. Inspectors identified minor maintenance needs, but found no cause for a follow-up inspection.

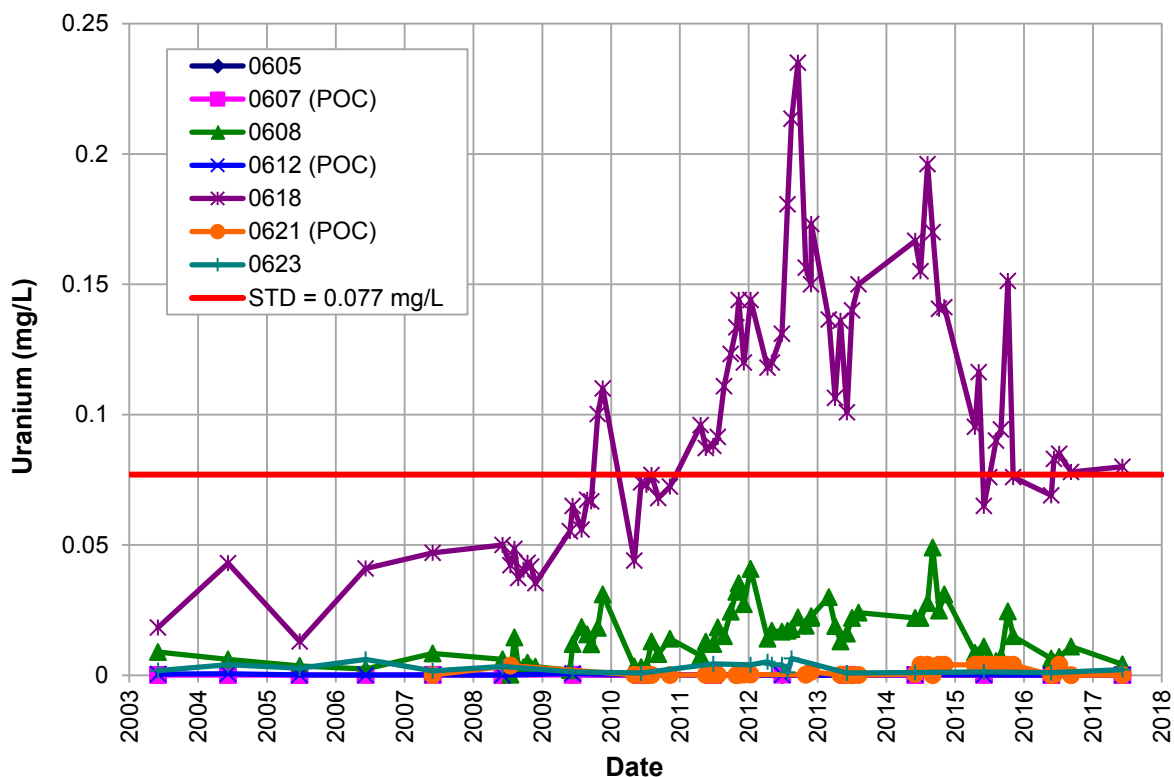
Figure 4-5. Uranium in Groundwater at the Durango, Colorado, Disposal Site

Though not required for compliance, monitoring wells completed in the alluvium are monitored as a best management practice. Uranium concentrations in monitoring well 0618 have consistently been higher than concentrations in the other wells onsite. To monitor the elevated and variable uranium concentrations observed in monitoring well 0618, monitoring wells 0608, 0618, and 0621 are sampled monthly as weather permits. Monthly monitoring was not conducted during summer 2017 while the evaporation pond removal was in progress. Sampling resumed in October 2017. Figure 4-5 shows an overall decreasing trend in uranium concentrations in well 0618 since 2014, with concentrations varying around 0.08 mg/L since 2016. Because well 0618 is not a POC well and not screened in the uppermost aquifer, the concentrations in this well do not affect compliance with the LTSP and do not pose a risk to human health and the environment. The potential cause of variability in this well continues to be investigated.

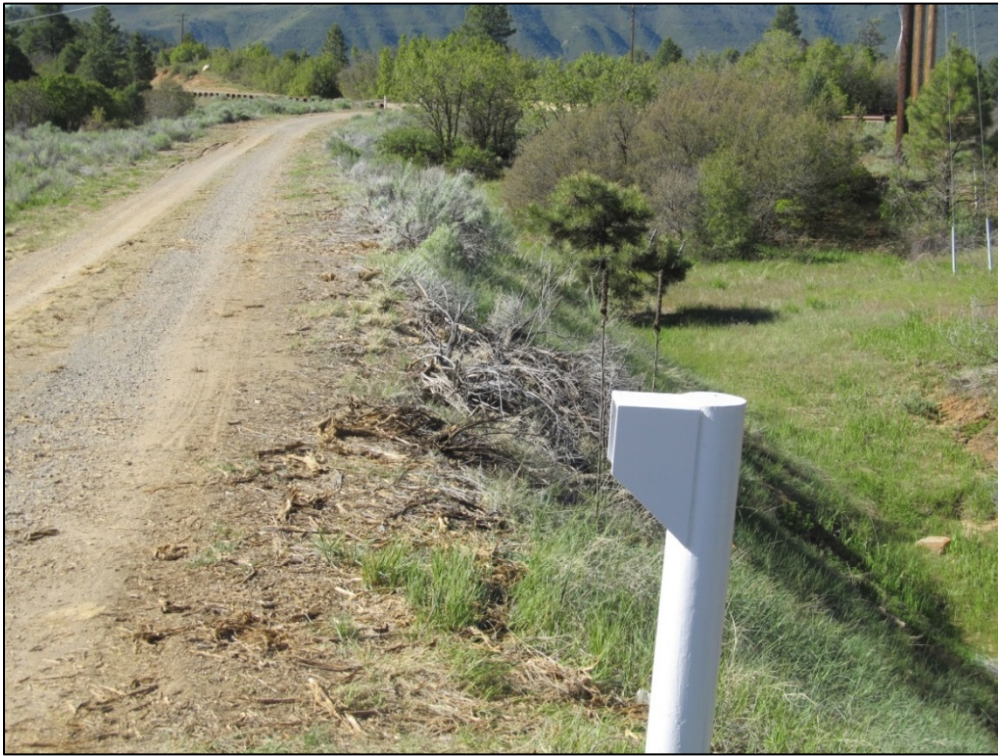
Access to the site is from La Plata County Road 212, an improved dirt road. Entrance to the site is through the locked steel entrance gate along County Road 212 and an older, original entrance gate. Both gates were locked and functional. Both entrance gates had recently been painted and vegetation along the onsite access road mowed (PL-1). The entrance sign is at the original entrance gate within the property boundary. The entrance sign was recently replaced (PL-2). No maintenance needs were identified.

*PL-1. Access Road, Recently Mowed, and Original Entrance Gate Post, Newly Painted*

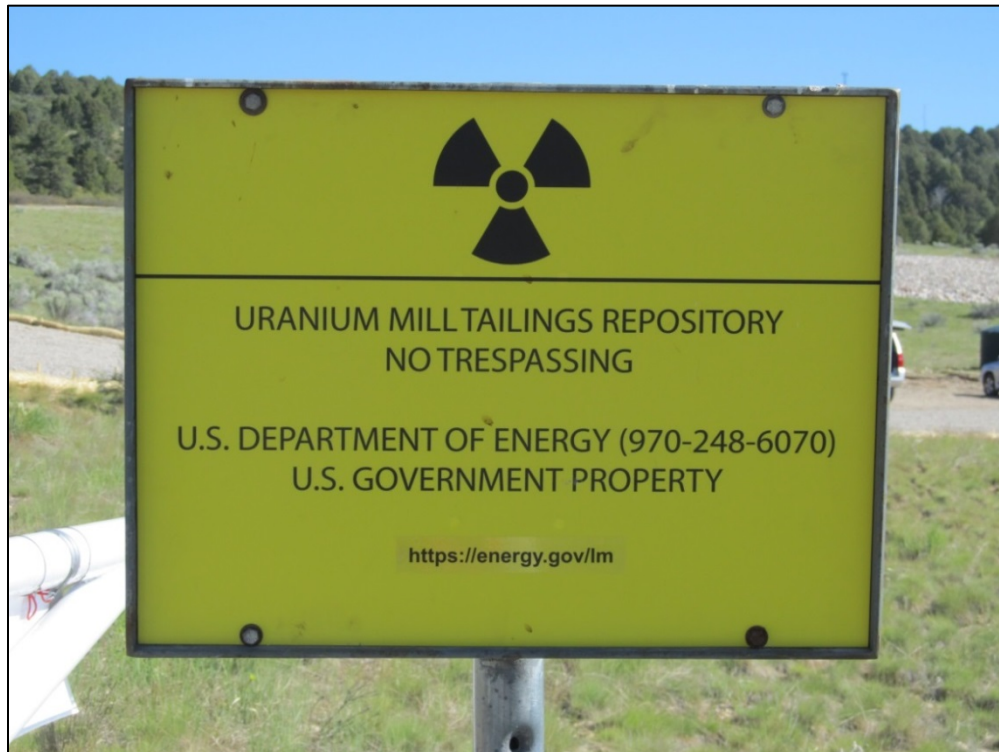
*PL-2. Entrance Sign Showing New Office of Legacy Management Website Address*

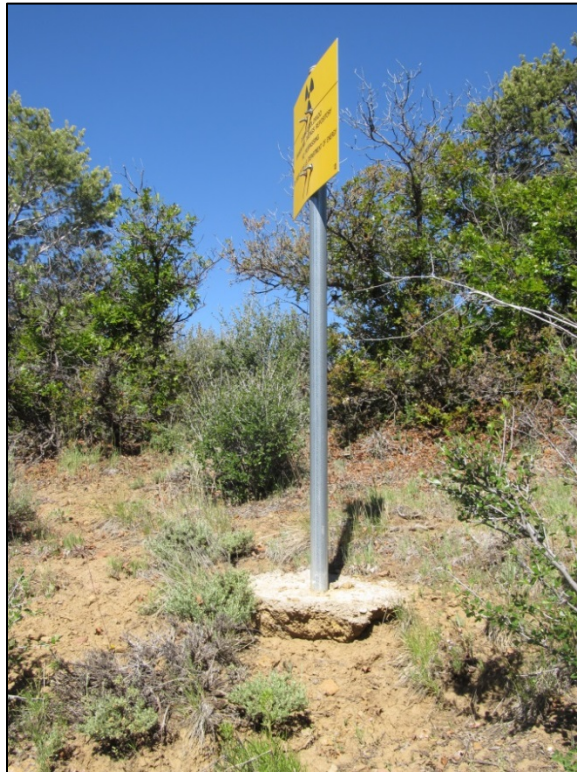
The concrete bases of several perimeter signs have been and continue to be undercut by erosion (PL-3). The concrete base of perimeter sign P45, located in the natural drainage on the north end of the site, is almost entirely free-standing (PL-4), and maintenance is required to protect against further erosion. DOE will reinforce the base of perimeter sign P45 before the 2018 annual inspection. Several perimeter signs have new bullet damage (P5, P26, P27, and P71) but remain legible. Several perimeter signs (P68, P69, P79, and P80) have bullet damage as identified in previous annual inspections but remain legible. Several perimeter signs (P18, P23, P48, P59, P66, and P69) were blocked from view by vegetation (PL-5) during the inspection; the vegetation was removed during a later site visit. No other maintenance needs were identified.

*PL-3. Perimeter Sign P13, Undercut by Erosion*

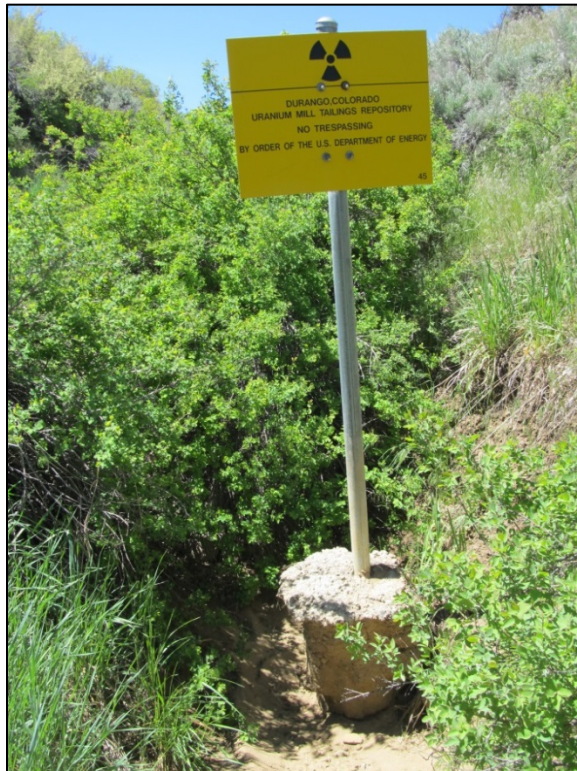
*PL-4. Perimeter Sign P45 in Drainage, Entire Base Nearly Standing Free*

The concrete base of perimeter sign P45 is significantly eroded and will be reinforced before the 2018 annual inspection. Boundary monument BM-3 and its north witness corner are undercut; both will be stabilized before the 2018 annual inspection. No other maintenance needs were identified.

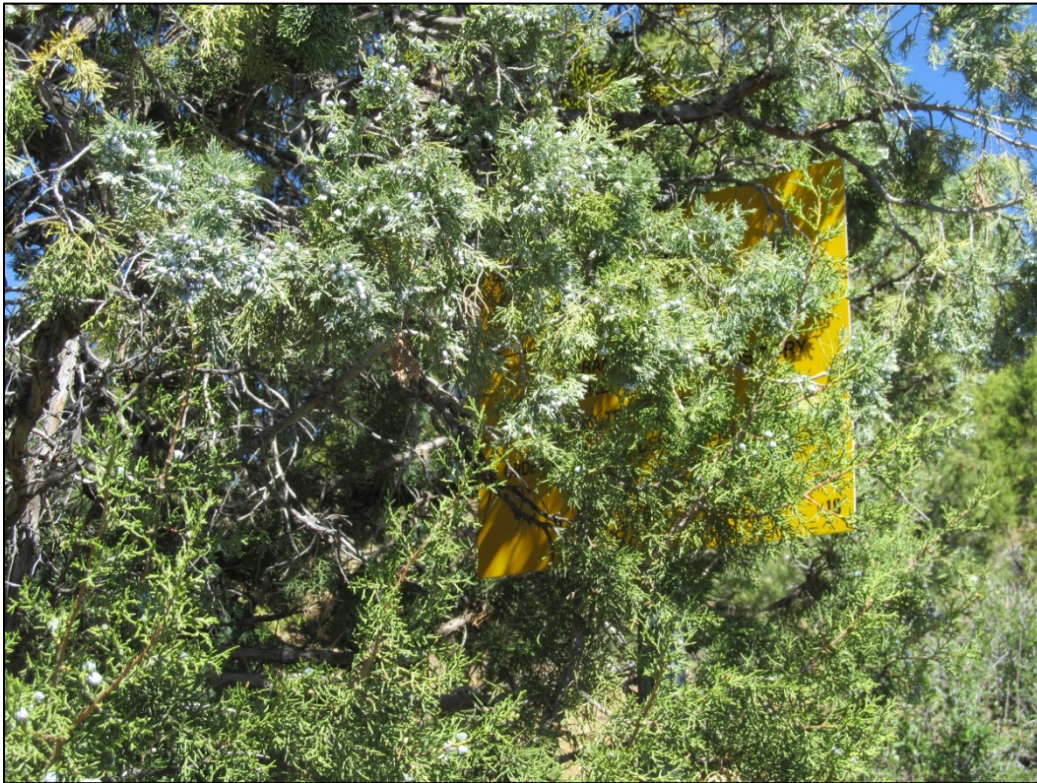
*PL-5. Perimeter Sign P18, Blocked by Vegetation (Removed)*

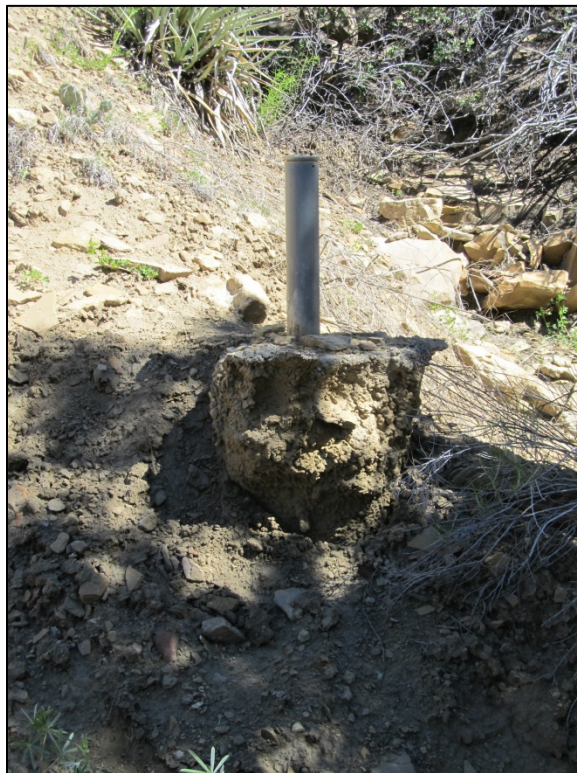
Four survey monuments and six boundary monuments (each with two witness corners) delineate the property boundary. The north witness corner for boundary monument BM-3 is undercut by erosion and in need of stabilization (PL-6). Boundary monument BM-3 also was undercut, although not as significantly. Both will be stabilized before the 2018 annual inspection. One of the witness corners for boundary monument BM-4 was bent to the ground, and its cap was missing (as it has been for years), but boundary monument BM-4 was stable. Boundary monument BM-6 has been missing since the adjacent U.S. Bureau of Reclamation pipeline was installed, but both witness corners were present, although they were somewhat hidden by vegetation. Replacement of these features is not warranted at this time. The vegetation was removed during a later site visit; no other maintenance needs were identified.

*PL-6. North Reference Marker at Boundary Monument BM-3, Erosion at Base; Needs Stabilization*

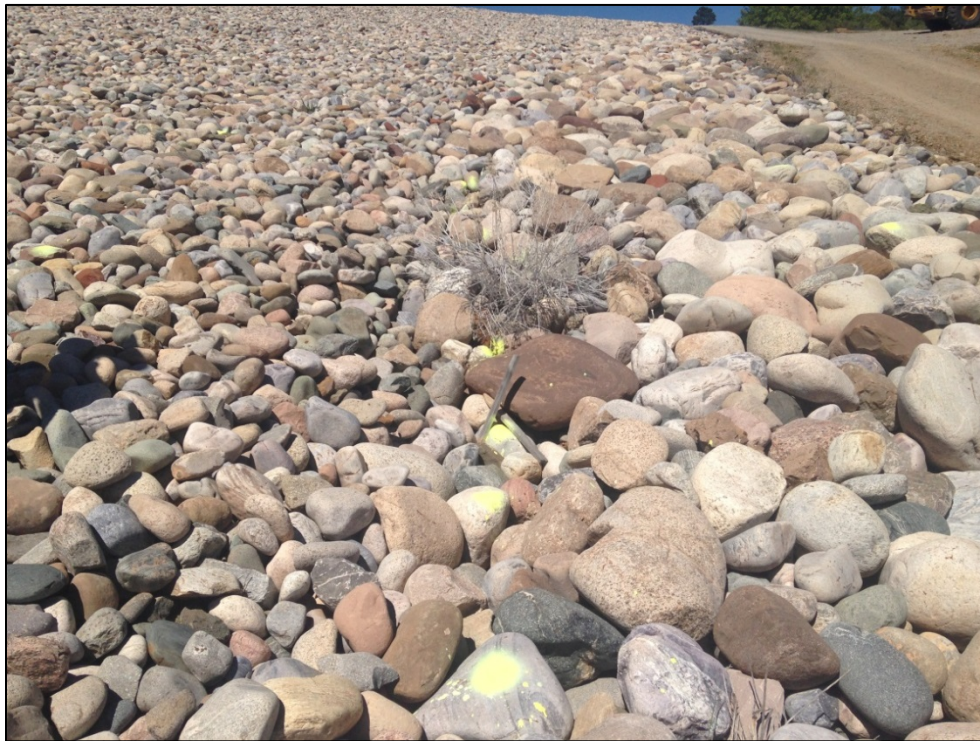
The side slopes of the disposal cell are armored with riprap. Along the north toe of the disposal cell, rock has moved, resulting in a linear depression approximately 18 feet long. The depression was first observed in 2015. No significant change was observed in 2016 or 2017 (PL-7). Inspectors will continue to monitor this area.

*PL-7. View Uphill of 18-Foot Linear Depression on Toe of Northeast Disposal Cell Side Slope  
(Yellow Paint Marks Centerline of the Depression)*

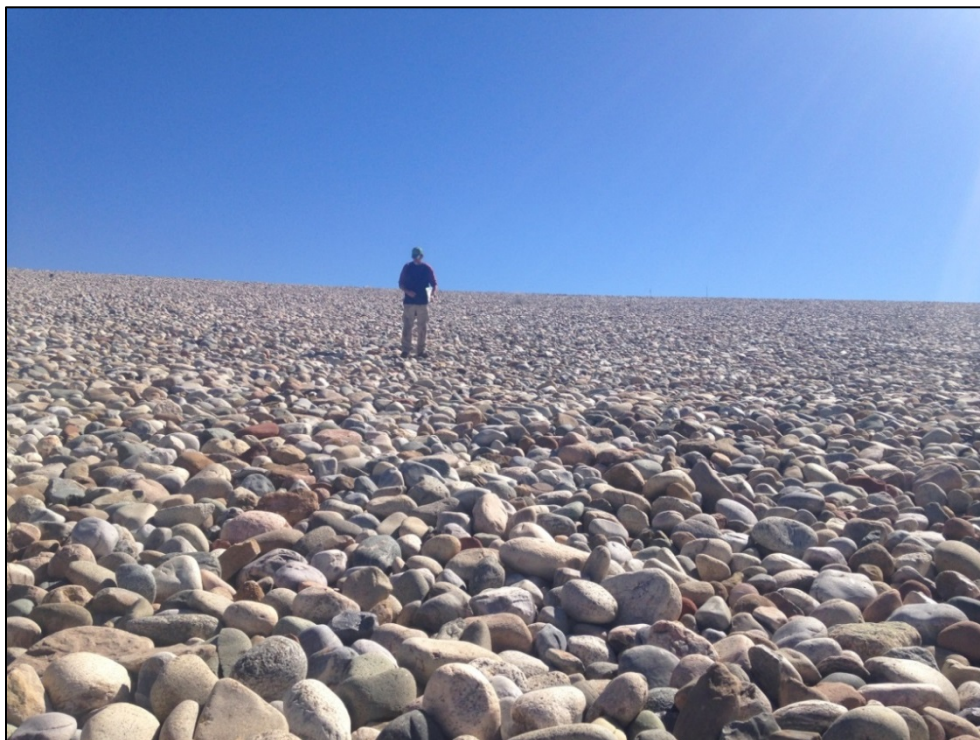
Inspectors observed subtle topographic variations in the surface of the south side slope that had not been noticed during previous inspections (PL-8). The variations, while barely perceptible, appeared as a wavelike series of gentle ridges and swales across and parallel to the slope. It was hypothesized that the variations had not previously been noted because past inspections were typically conducted in afternoons, when the light was flatter, rather than in morning light, as in 2017, when shadows provided additional contrast and revealed topographic variations. The cause of the variations is unknown, but because of their subtle nature, they likely did not form abruptly between the 2016 and 2017 inspections and have been present for some time. Inspectors found no evidence that the side slope was eroding, which would prompt concern, and determined that the observed variations did not pose concerns about disposal cell integrity. Inspectors will continue to monitor this side slope during future inspections.

*PL-8. Slight Topographic Irregularities on the South Side Slope of the Disposal Cell*

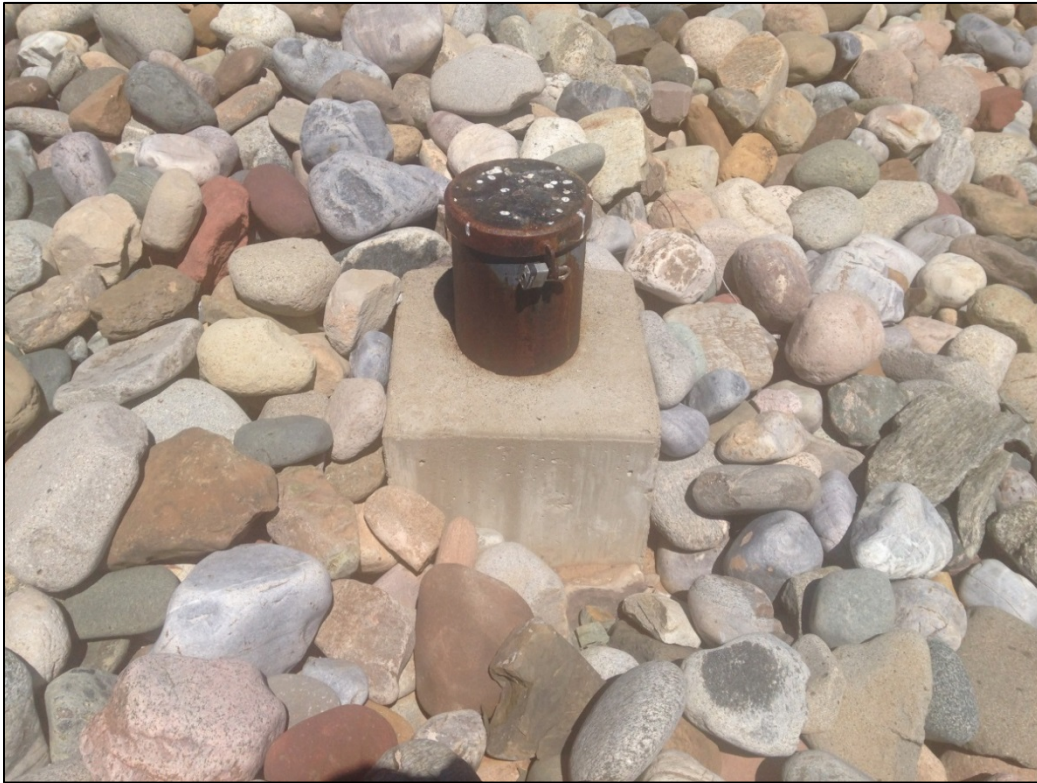
A dug-out hole was observed around settlement plate 4 on the east-facing side slope (PL-9). It was likely dug out by a large animal. Inspectors replaced the rock around the settlement plate. No maintenance needs were identified.

*PL-9. Rocks Dug Out Around Settlement Plate 4, Likely by a Large Animal*

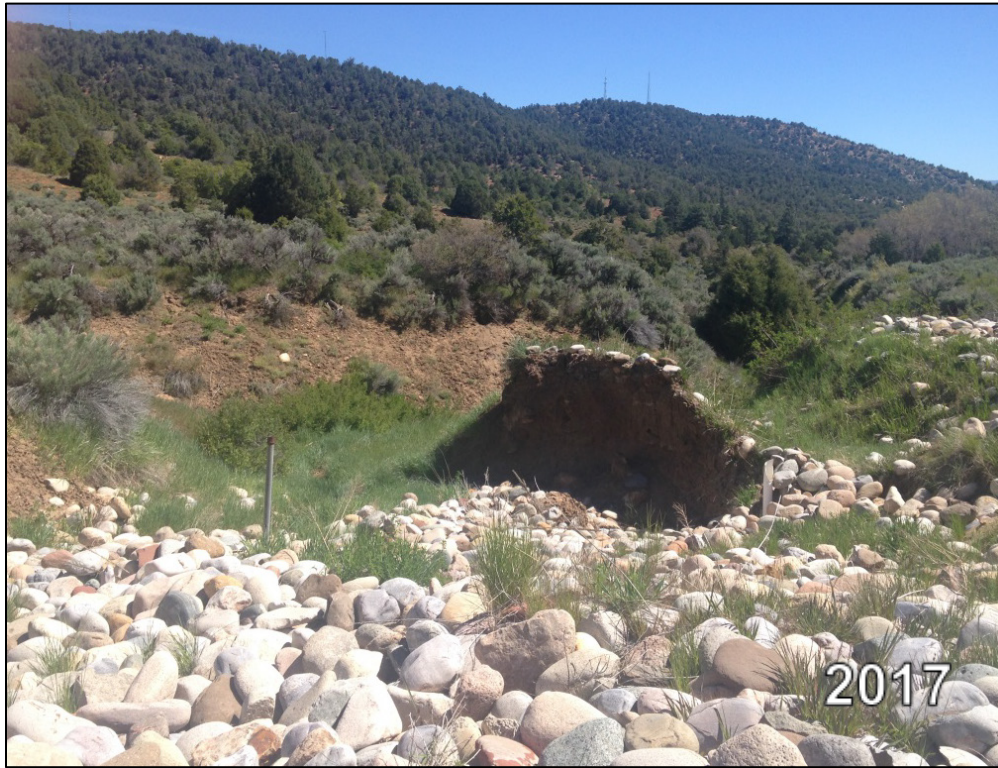
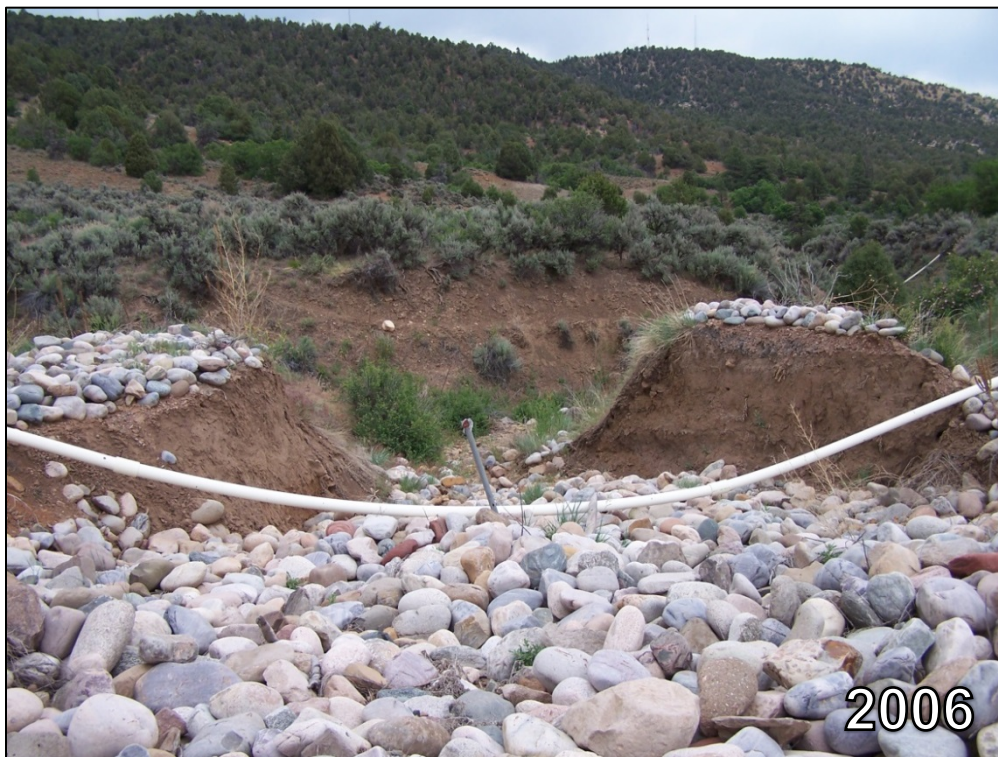
The riprap-covered outflows of the drainage ditches were designed to self-armor. The outflows and drainage ditches below them are monitored annually. The uplands above the northeast outflow are steadily eroding over time (PL-10). Erosion of the uplands does not affect the stability or effectiveness of the outflow area. No maintenance needs were identified.

*PL-10. (a) Northeast Outflow Channel Bottom Is Stable, Whereas Upland Area on Right Is Slowly Eroding, 2017*

*PL-10. (b) Northeast Outflow Channel, 2006 Photo for Comparison*

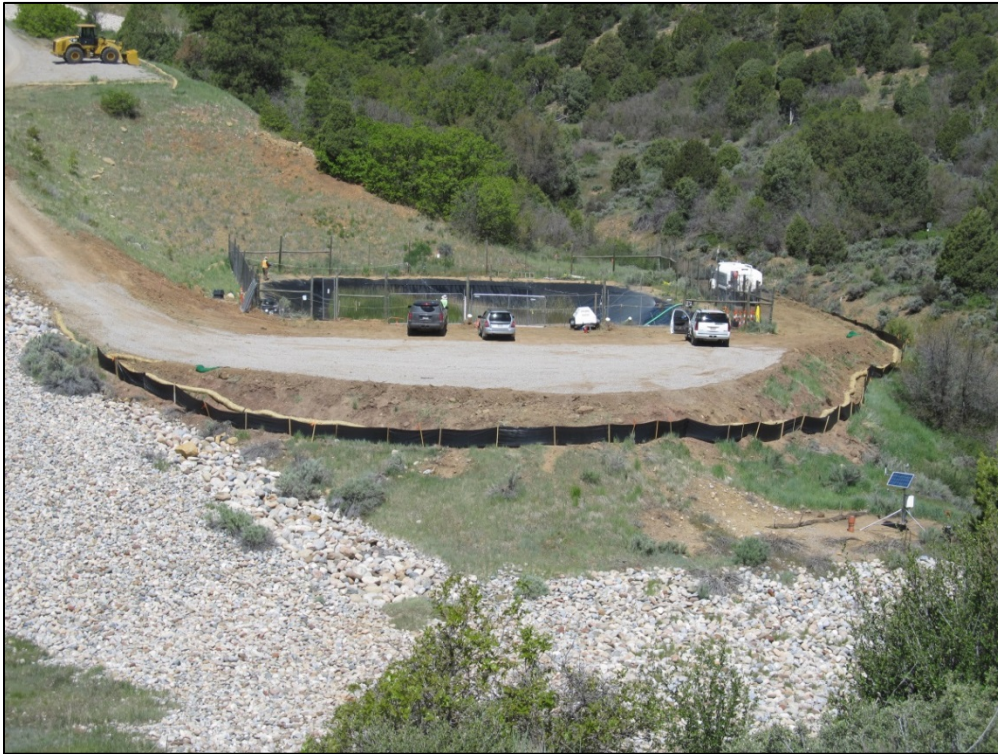
A holding pond (evaporation pond) associated with the site's transient drainage system is in the northeast corner of the site. The pond, fence, and associated structures were removed during summer 2017. At the time of the inspection, construction personnel were onsite conducting activities in preparation for the holding pond decommissioning (PL-11).

*PL-11. Holding Pond Area Showing Construction Activities*

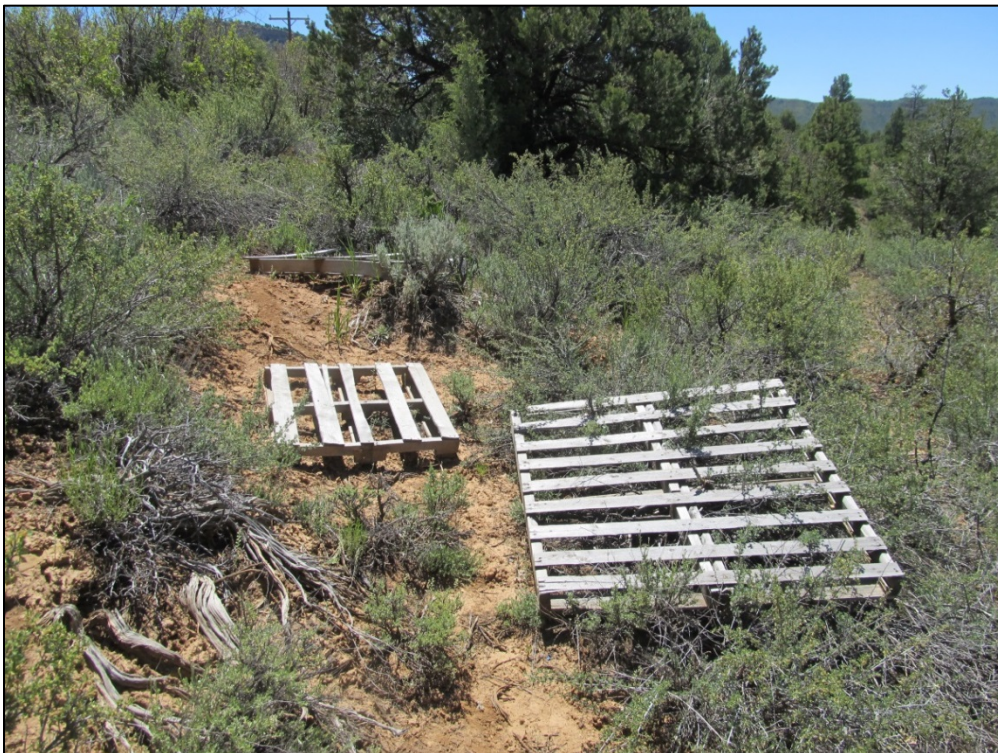
*PL-12. Trash Near Boundary Monument BM-6*

The perimeter signs identified during the 2016 annual inspection as needing to be replaced were replaced before the 2017 annual inspection. Adhesive sign identification labels were applied to 10 of the 11 signs during the 2017 annual inspection; the last adhesive label was added during a later site visit. During the 2017 annual inspection several perimeter signs (P18, P23, P48, P59, P66, P69) and the witness corners of boundary monument BM-6 were blocked from view by vegetation; the vegetation was removed during a later site visit. Trash discovered in the area near boundary monument BM-6 was also removed during a later site visit.
