4.0 Durango, Colorado, Disposal Site

The U.S Department of Energy (DOE) Office of Legacy Management (LM) conducted the Durango, Colorado, Uranium Mill Tailings Radiation Control Act (UMTRCA) Title I Disposal Site (site) annual site inspection on June 20, 2018 and the annual groundwater monitoring event in May 2018. No cause for a follow-up inspection was identified.

Figure 4-1. 2018 Annual Inspection Drawing for the Durango, Colorado, Disposal Site

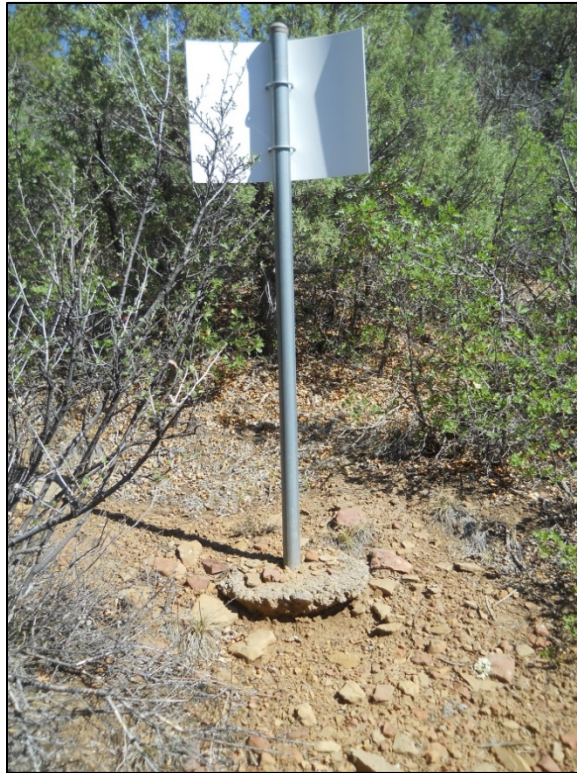
The concrete bases of several perimeter signs have been and continue to be undercut (PL-1), but the position of the signs remain uncompromised. The concrete base of perimeter sign P45, located in the natural drainage on the north end of the site, was almost entirely free-standing (PL-2). Following the inspection, LM moved perimeter sign P45 approximately 25 feet (ft) to the east, a location less prone to erosion. Vegetation was encroaching on perimeter sign P51 (PL-3) and was removed in fall 2018 following the inspection. No other maintenance needs were identified.

PL-1. Base of Perimeter Sign P62 (Undercut)

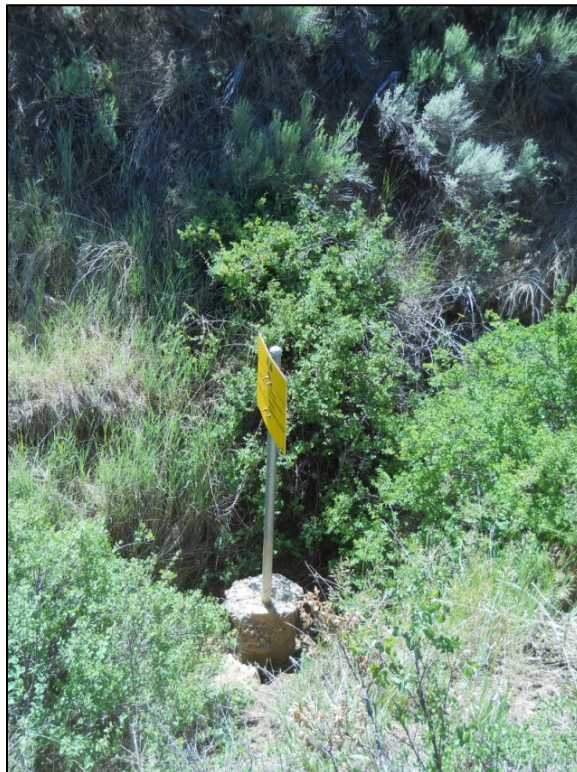
*PL-2. Perimeter Sign P45 in Arroyo
(Sign Moved Following Inspection)*

- Moving perimeter sign P45 from the arroyo in the northeast drainage to a location approximately 25 ft to the east
- Removing vegetation from around perimeter sign P51 and boundary monument BM-1
- Repairing cracks in the concrete base of site marker SMK-2 and stabilizing the surrounding soil
- Reinforcing and stabilizing the bases of boundary monument BM-3 and its north witness corner
- Removing brush and soil from around the witness corners of boundary monument BM-6
- Removing trash from the southwest corner of the site, near boundary monument BM-6
- Treating woody species on the side slopes

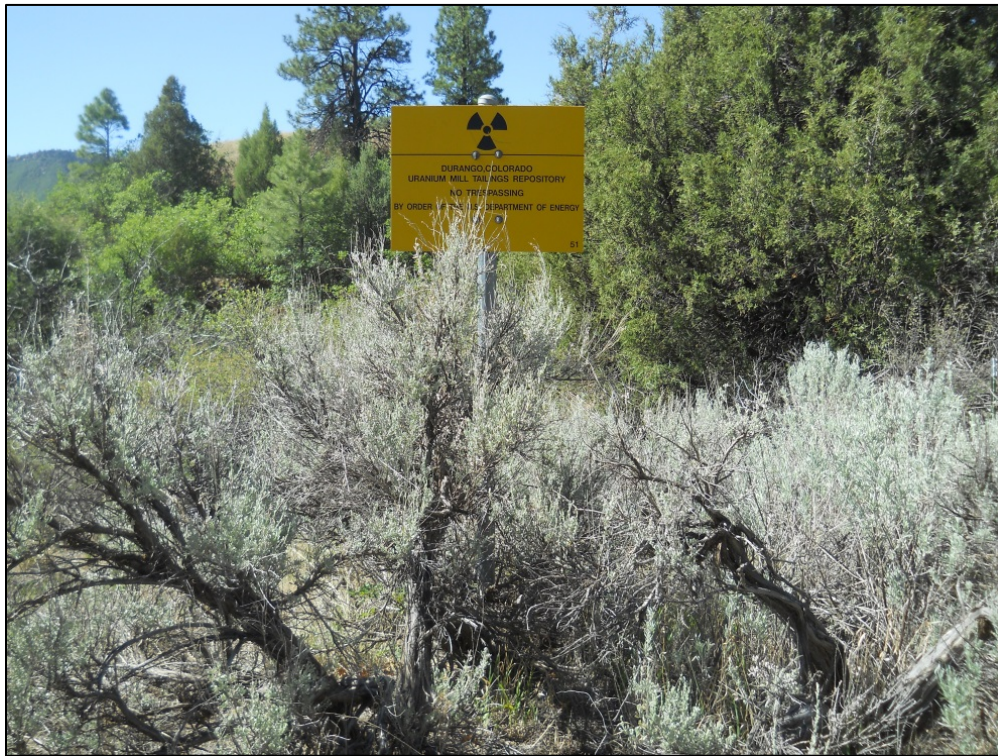
*PL-3. Vegetation Encroaching on Perimeter Sign P51
(Removed Following Inspection)*

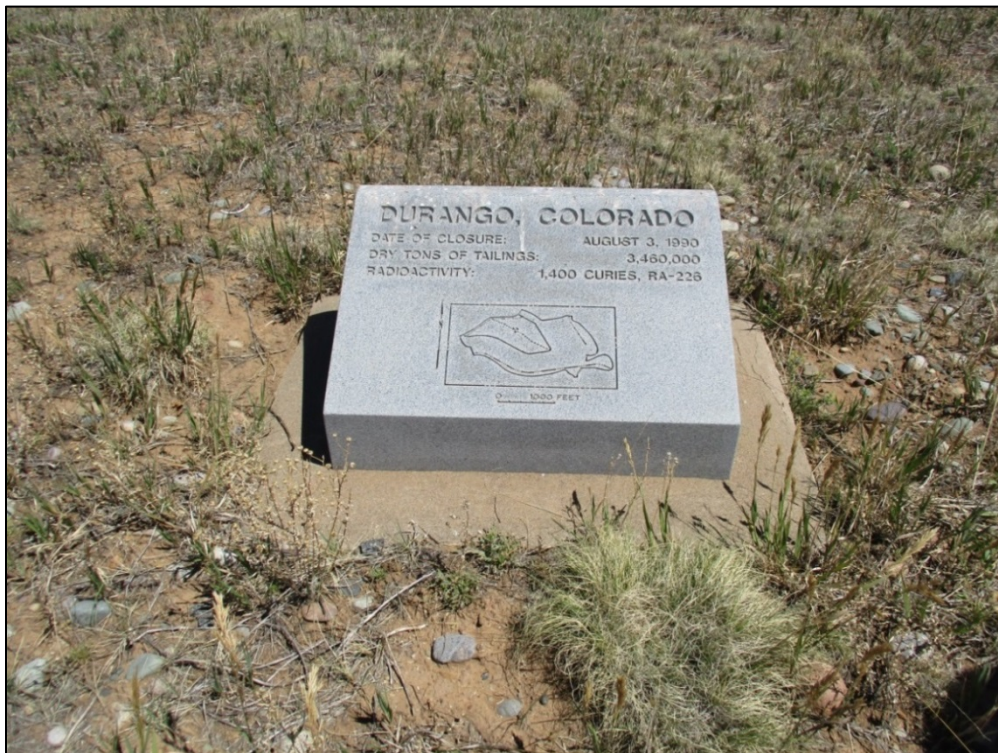
The site has two site markers. Site marker SMK-1 is just inside the original entrance gate. Site marker SMK-2 is on the top slope of the disposal cell; its concrete base exhibited minor cracking and spalling along its edges (PL-4) and soil had eroded or subsided approximately 1–3 inches around the base. Following the inspection, LM repaired and stabilized the site marker SMK-2 base. No other maintenance needs were identified.

*PL-4. Site Marker SMK-2 on Top of Disposal Cell
(Repaired and Stabilized Following Inspection)*

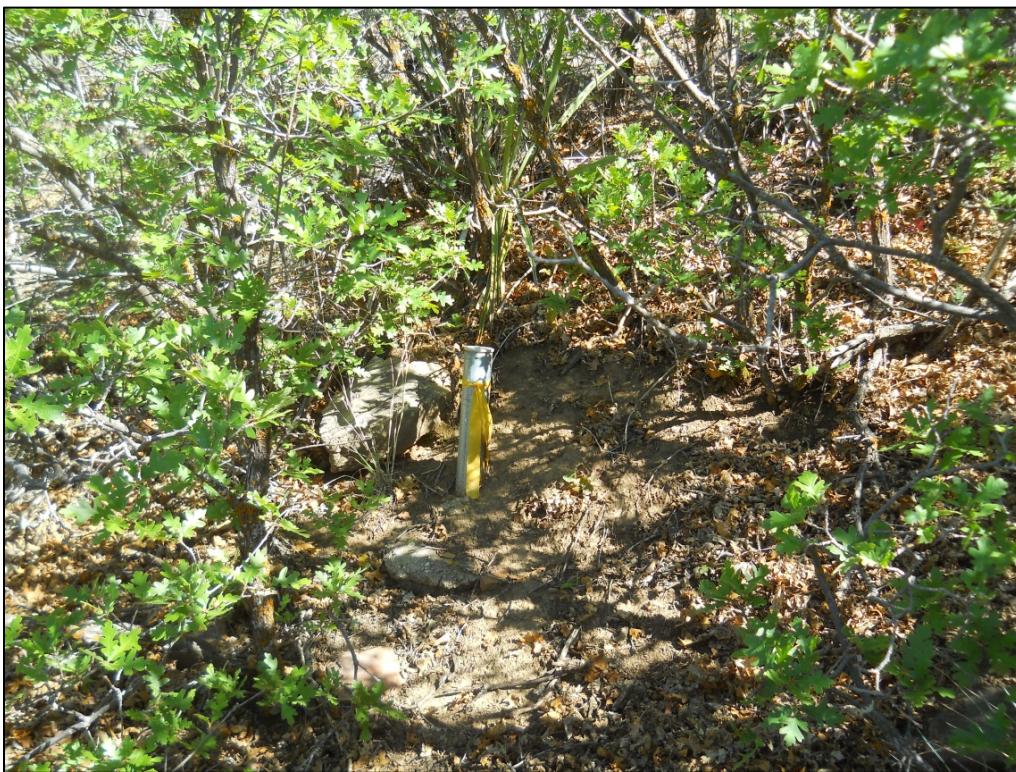
*PL-5. Brush Overgrown Around Boundary Monument BM-1
(Removed Following Inspection)*

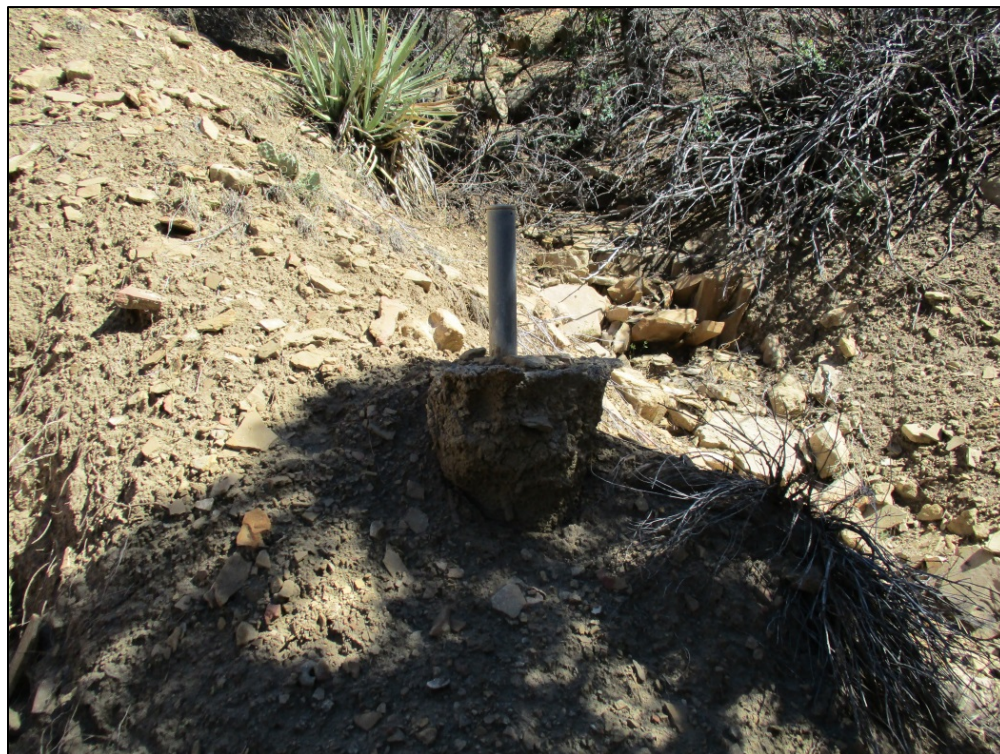
Four survey monuments and six boundary monuments (each with two witness corners) delineate the property boundary. Boundary monument BM-6 has been missing since the adjacent U.S. Bureau of Reclamation pipeline was installed, bringing the current number of boundary monuments to five. However both witness corners were present, although the southeast witness corner was beginning to be covered with soil and the northwest witness corner was blocked by vegetation. Replacement of boundary monument BM-6 is not warranted at this time. Boundary monument BM-1 was almost completely covered by vegetation (PL-5). The north witness corner for boundary monument BM-3 had been undercut by erosion (PL-6) and needed stabilization. Boundary monument BM-3 also was undercut, although not as significantly. Following the inspection, LM removed soil from the southeast witness corner to boundary monument BM-6, removed vegetation from boundary monument BM-1 and the northwest witness corner to boundary monument BM-6, and stabilized boundary monument BM-3 and its north witness corner. No other maintenance needs were identified.

*PL-6. Erosion of North Witness Corner of Boundary Monument BM-3
(Addressed Following Inspection)*

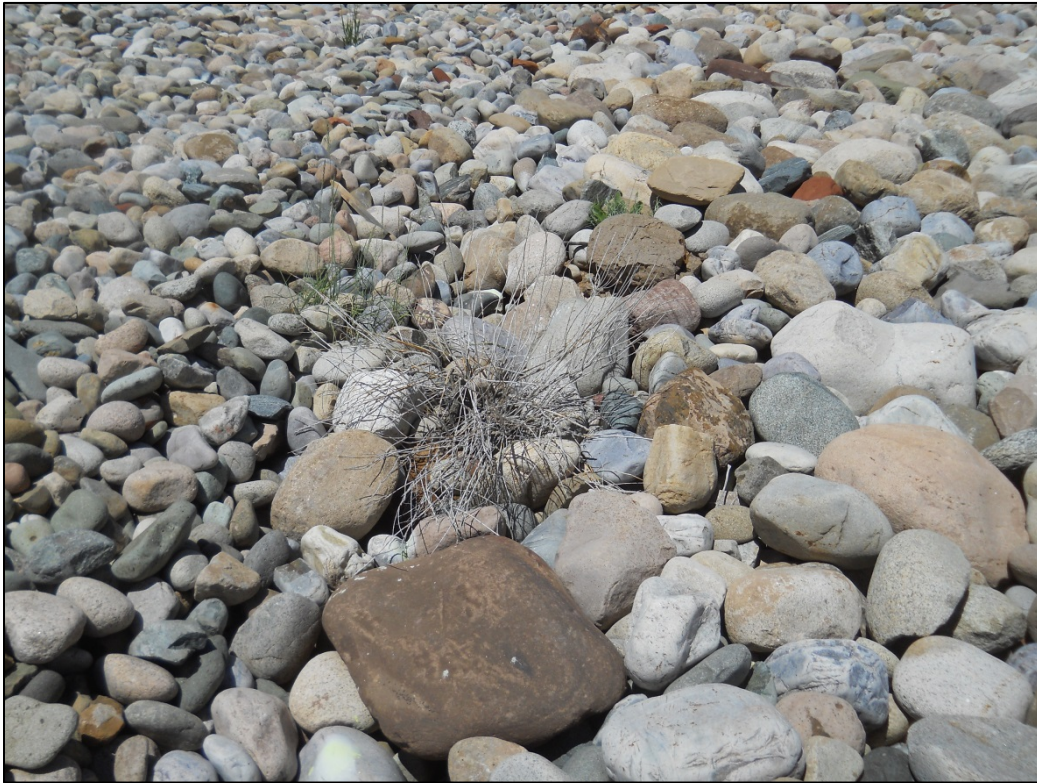
The side slopes of the disposal cell are armored with rock riprap. Along the north toe of the disposal cell, rock has moved, resulting in a linear depression approximately 18 ft long, first observed in 2015. Inspectors noted that some of the rocks in the interior of the depression that were previously marked appeared to have rotated inward (PL-7 and PL-8). Inspectors will continue to monitor this area.

PL-7. 18-Foot Linear Depression (Rocks Have Rotated Inward and Downward)

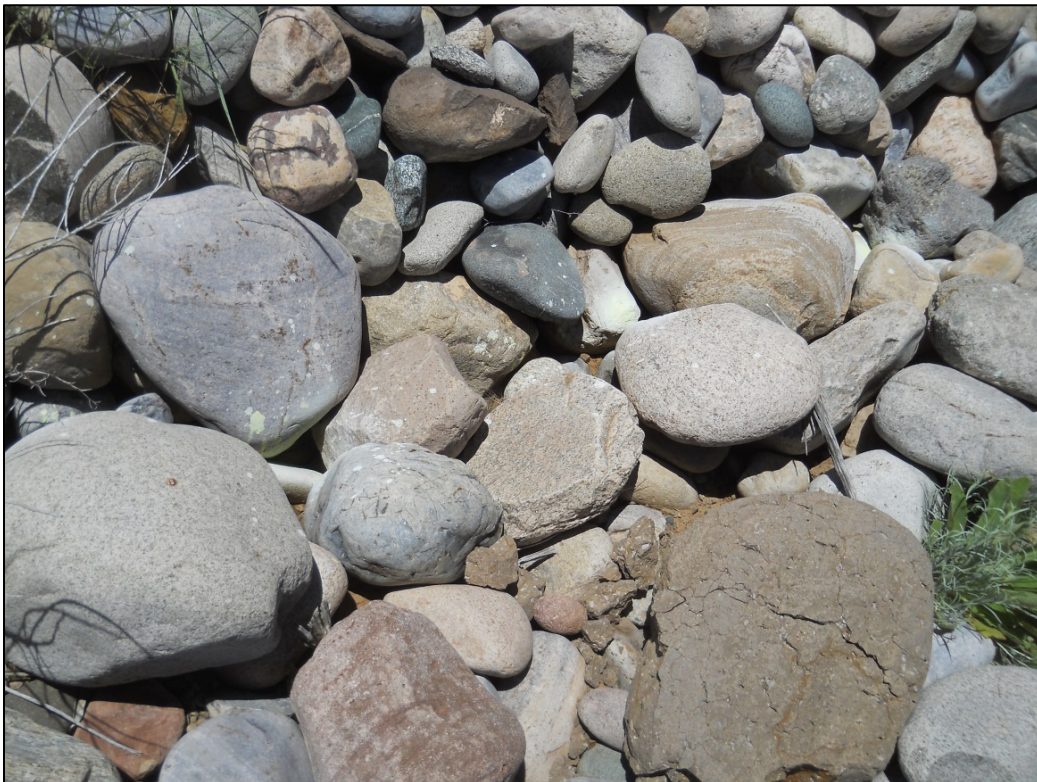
PL-8. 18-Foot Linear Depression (Rocks Have Rotated Inward and Downward)

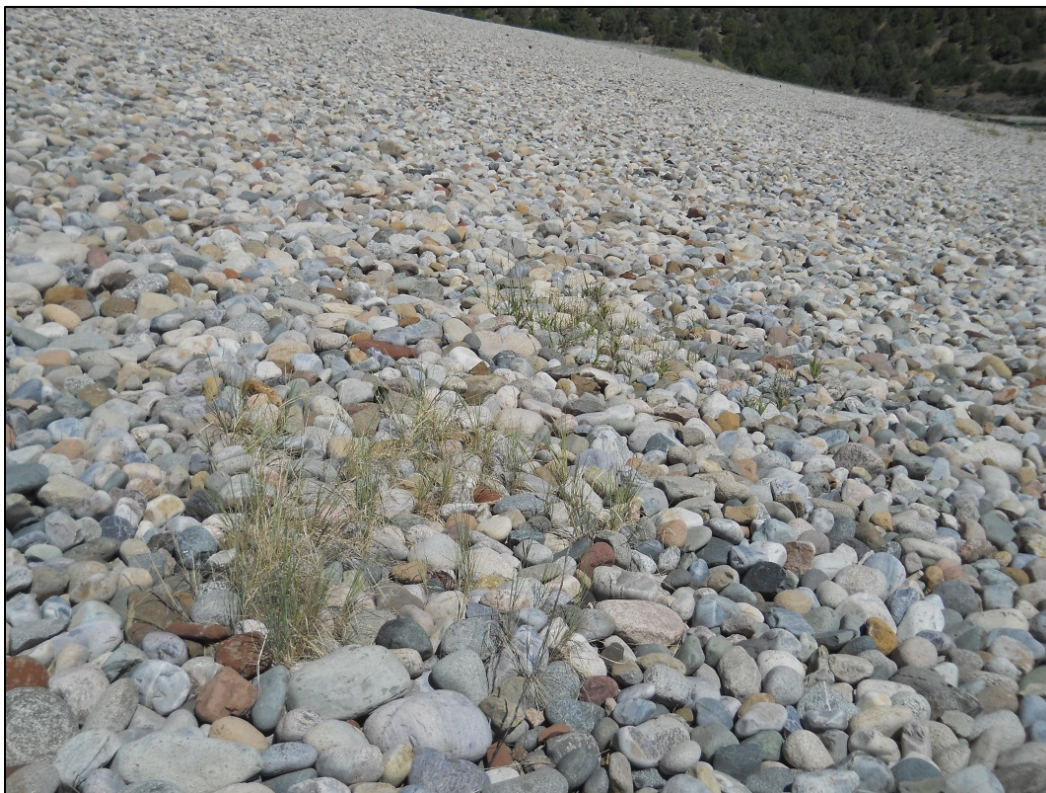
Inspectors observed a subtle topographic variation in the surface of the northeast side slope (PL-9 and PL-10). Inspectors found no evidence of significant erosion around the variation, which would prompt concern, and determined that the variation did not pose a concern regarding disposal cell integrity. Inspectors will continue to monitor the variation.

PL-9. Topographic Variation on Northeast Side Slope of Disposal Cell

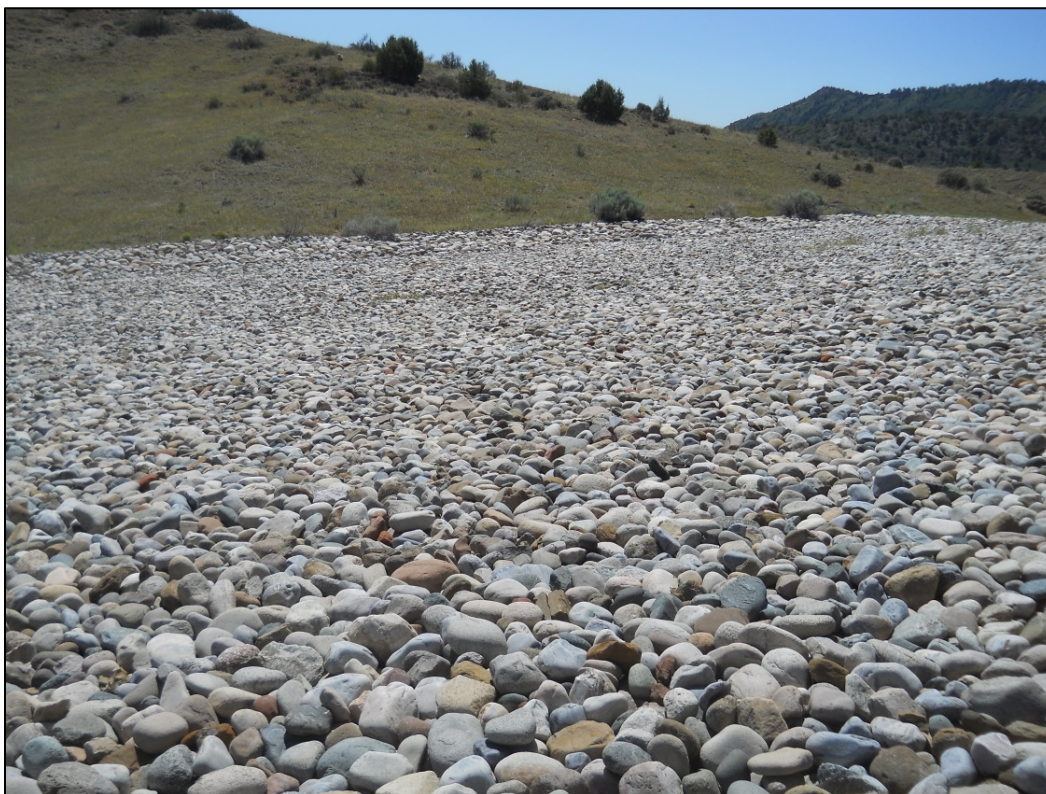
PL-10. Topographic Variation on Northeast Side Slope of Disposal Cell

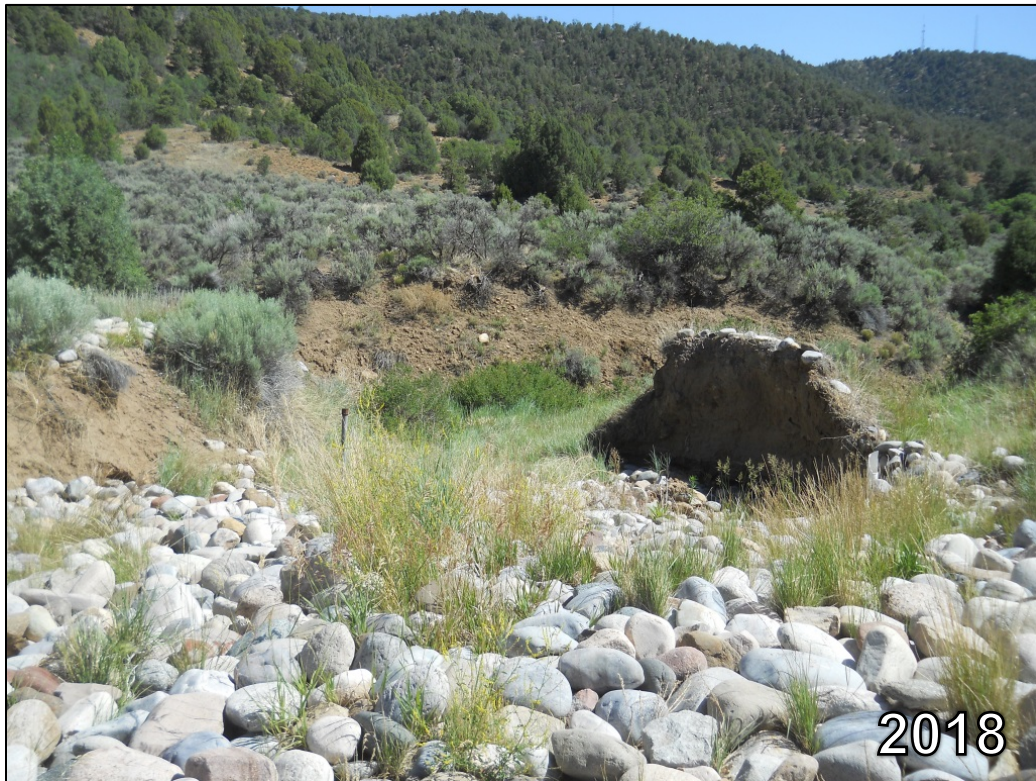
The riprap-covered outflows of the drainage ditches were designed to self-armor. The outflows and drainage ditches below them are monitored annually. The uplands above the northeast outflow are steadily eroding over time (PL-11). Erosion of the uplands does not affect the stability or effectiveness of the outflow area. No maintenance needs were identified.

PL-11 (a). Northeast Outflow, 2018

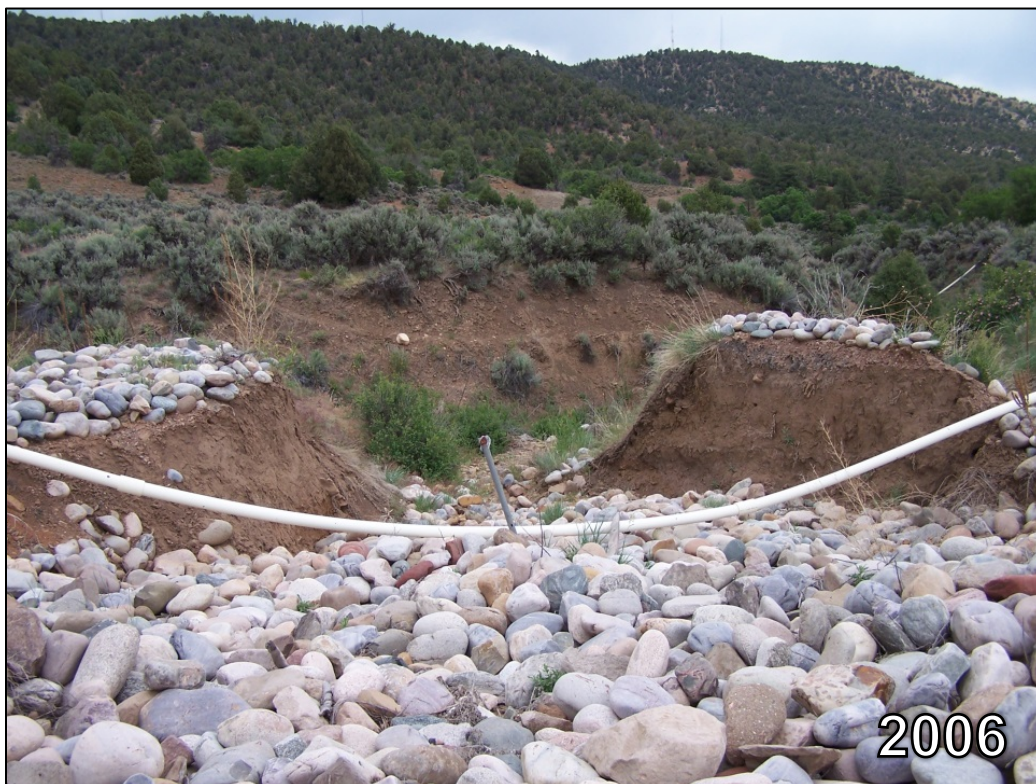
PL-11 (b). Northeast Outflow, 2006 Photo for Comparison

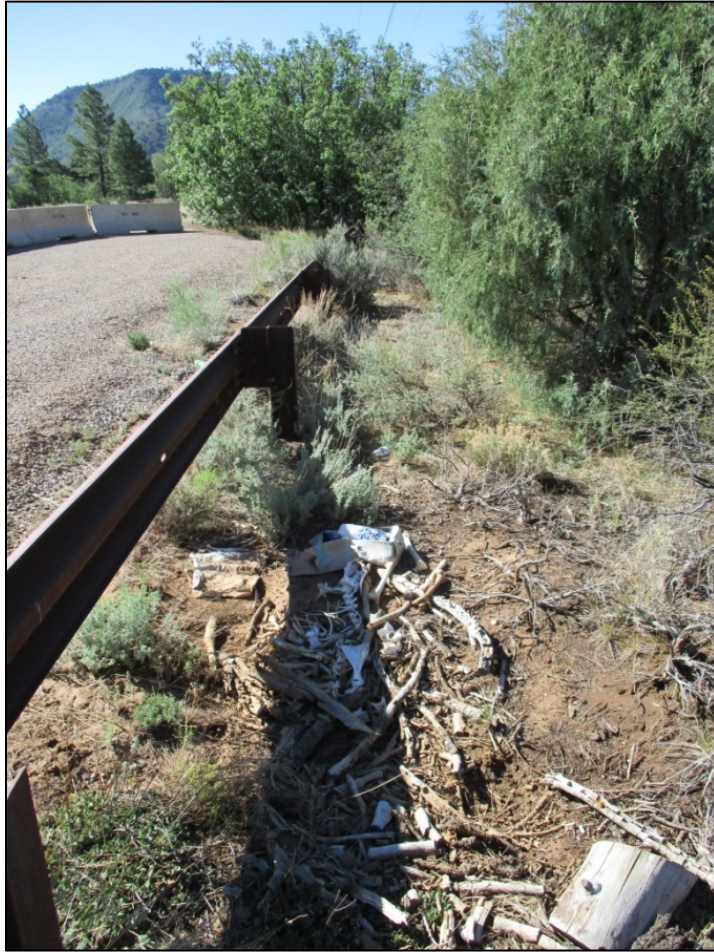
Boundary monuments and perimeter signs delineate the site boundary (property boundary) with one exception; the site boundary marked by boundary monument BM-6 is not delineated with perimeter signs because the signs cut across the corner of the site (perimeter signs P82, P1, P2, and P3). Inspectors noted no new activities or changes to the site boundary area, with the exception of debris accumulation near the southwest corner of the site near boundary monument BM-6 (PL-12). The debris was removed following the inspection. Gullies on the southeast and

*PL-12. Debris near Site Entrance Gate
(Removed Following Inspection)*
