4.0 Durango, Colorado, Disposal Site

The U.S. Department of Energy (DOE) Office of Legacy Management (LM) conducted the Durango, Colorado, Uranium Mill Tailings Radiation Control Act (UMTRCA) Title I Disposal Site (site) annual inspection on May 13, 2019, and the annual groundwater monitoring event in May 2018. No cause for a follow-up inspection was identified.

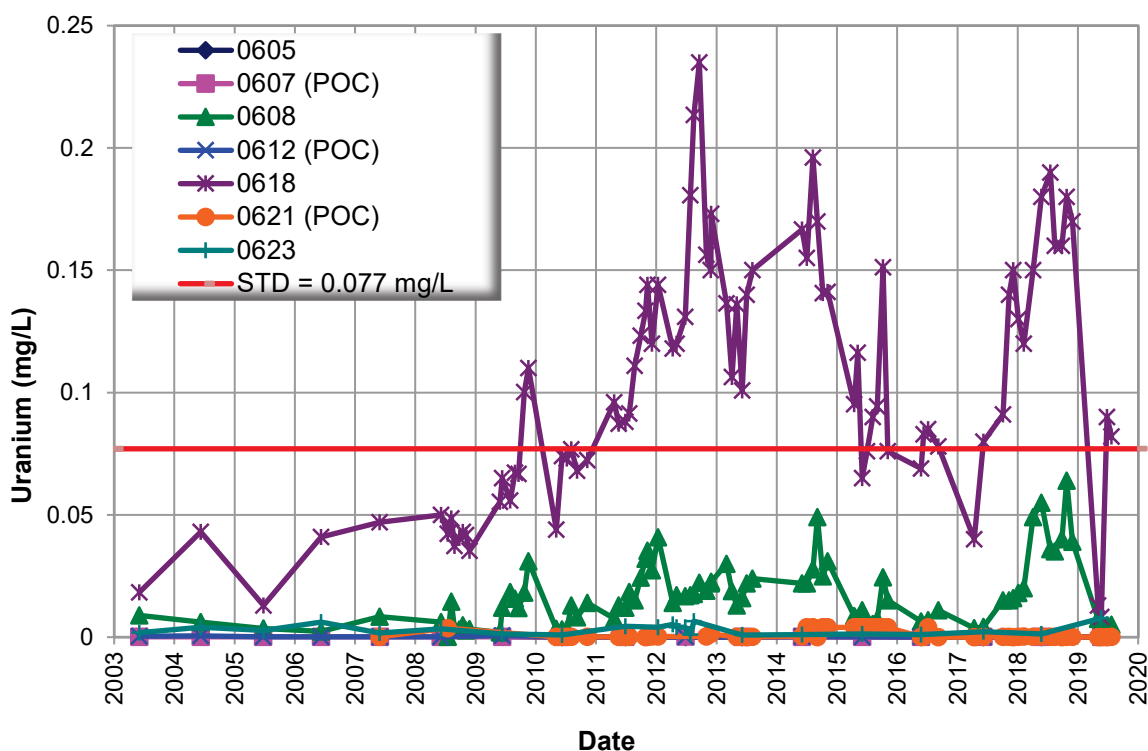
Figure 4-5. Uranium in Groundwater at the Durango, Colorado, Disposal Site

Wells completed in the alluvium are sampled as a BMP. Uranium concentrations in well 0618 have consistently been higher than concentrations in the other wells onsite. To monitor and

compare the elevated and variable uranium concentrations observed in this well, wells 0608, 0618, and 0621 are sampled monthly as weather permits. Figure 4-5 shows variable uranium concentrations between 0.04 milligrams per liter (mg/L) and 0.24 mg/L in well 0618 beginning in 2009 and continuing to the present. In 2019, uranium concentrations in well 0618 decreased from 0.18 mg/L to 0.02 mg/L—a value slightly below the minimum measured concentration—and then increased to 0.09 mg/L, which is within the range of measured historical concentrations. Investigating the cause of this variability at well 0618 continues.

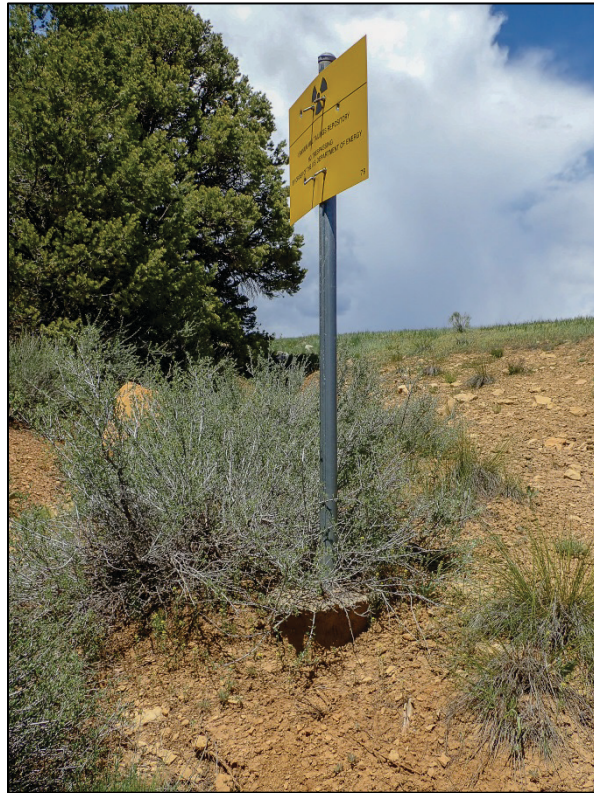
The concrete bases of several perimeter signs have been and continue to be undercut, but the positions of the signs remain uncompromised (PL-1). Following the 2018 inspection, perimeter sign P45 was moved approximately 25 feet (ft) to the east, a location less prone to erosion. Vegetation was encroaching on perimeter sign P4 (PL-2) and P18 and was removed in 2019 following the inspection. Perimeter sign P64 was a plastic sign and had faded and curled and was replaced in 2019 following the inspection. Perimeter signs P62 and P63 are also plastic and somewhat curled but still legible at this time. No other maintenance needs were identified.

PL-1. Concrete Base of Perimeter Sign P79 (Undercut by Erosion)

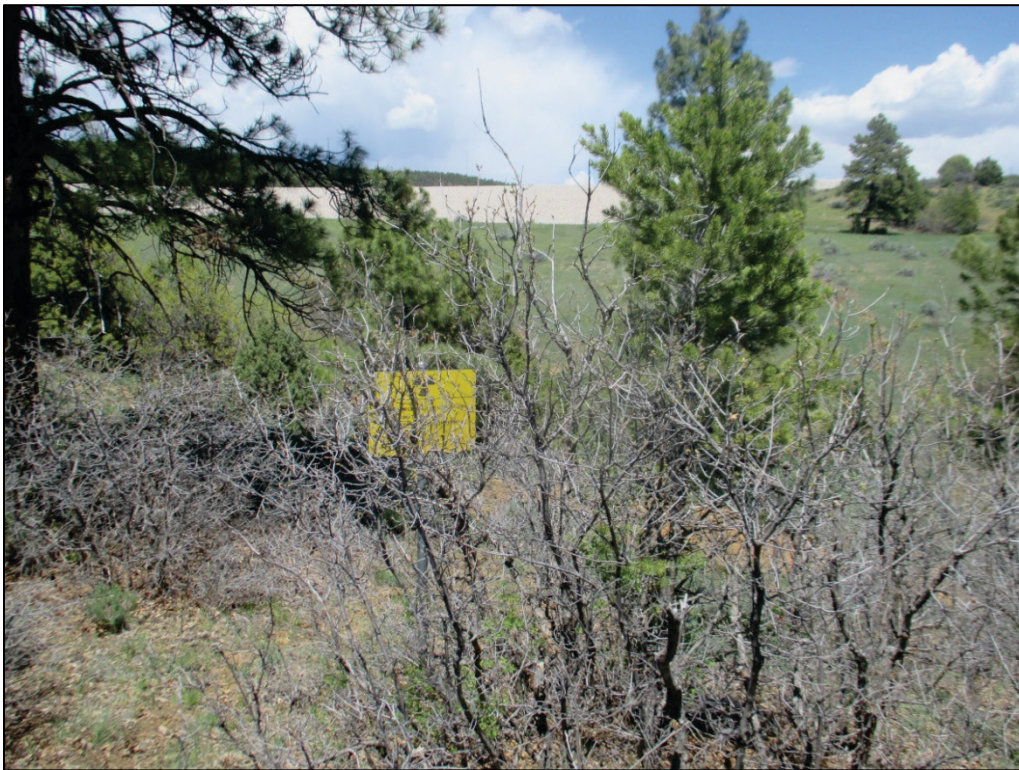
PL-2. Vegetation Blocking Perimeter Sign P4 (Removed Following Inspection)

- Removing vegetation from around perimeter signs P4 and P18 and boundary monument BM-5
- Replacing plastic perimeter sign P64, which had curled
- Filling in and stabilizing the soil around site marker SMK-1
- Treating woody species on the side and top slopes of the disposal cell
- Replacing the entrance sign, which showed outdated information
- Removing vegetation from around boundary monument BM-5 and one of its witness corners

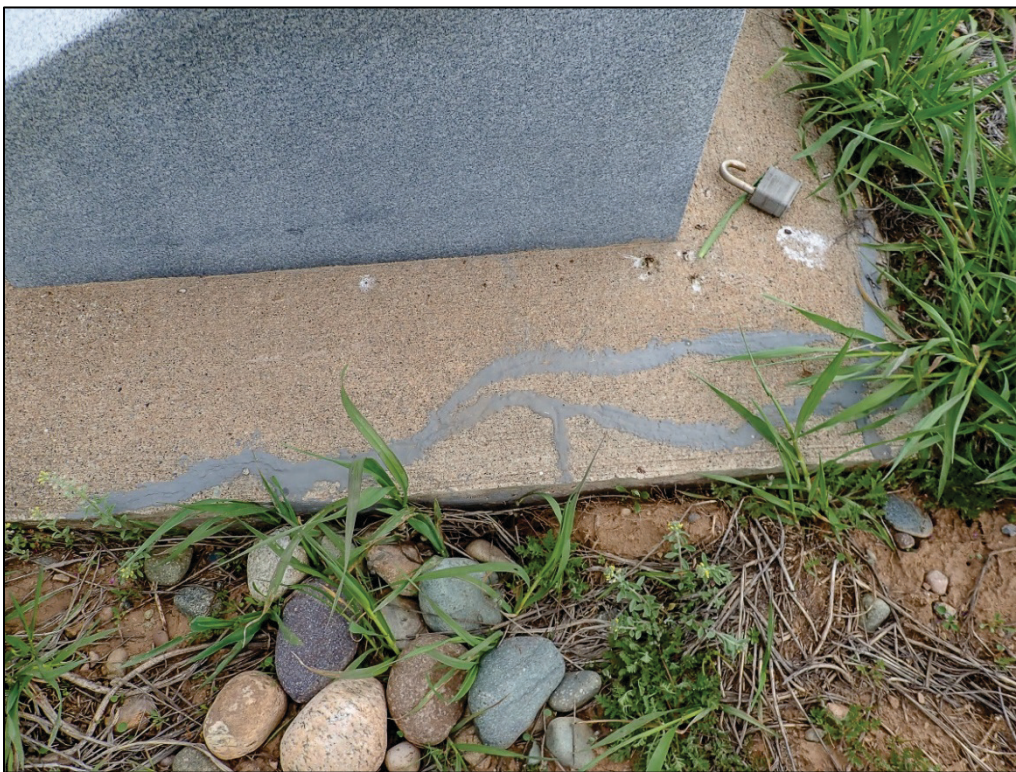
The site has two site markers. Site marker SMK-1 is just inside the original entrance gate; a deep depression to the side of SMK-1 was filled in after the inspection. Site marker SMK-2 is on the top slope of the disposal cell; minor cracking and spalling along the concrete base edges was repaired in 2018 (PL-3). No other maintenance needs were identified.

PL-3. 2018 Repairs to Base of Site Marker SMK-2

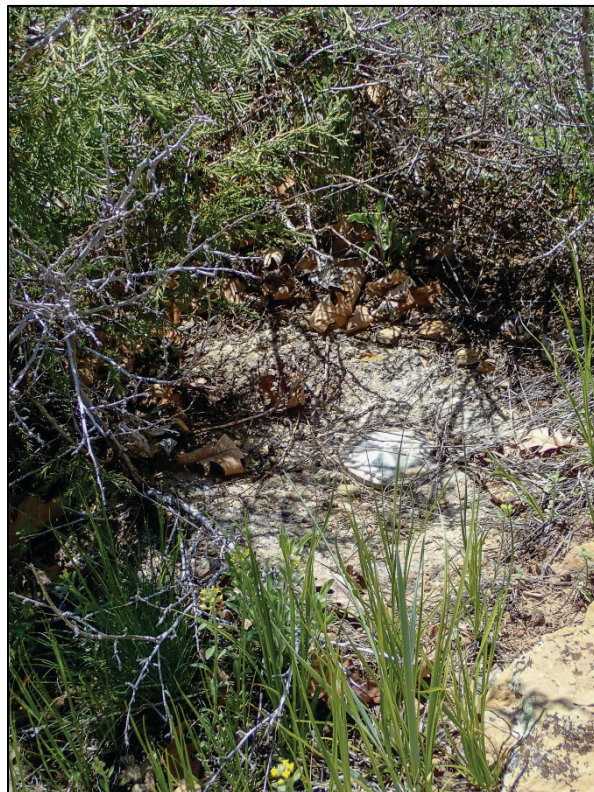
Four survey monuments and six boundary monuments (each with two witness corners) delineate the property boundary. Boundary monument BM-6 has been missing since the adjacent U.S. Bureau of Reclamation (BOR) pipeline was installed, bringing the current number of boundary monuments to five. However, both witness corners to boundary monument BM-6 were present. Replacement of boundary monument BM-6 is not warranted at this time. Boundary monument BM-5 (PL-4) and one of its witness corners was covered with vegetation, which was removed following the inspection. The north witness corner of boundary monument BM-3 was reinforced and stabilized as identified in the 2018 annual inspection (PL-5). No other maintenance needs were identified.

PL-4. Vegetation Blocking Boundary Monument BM-5

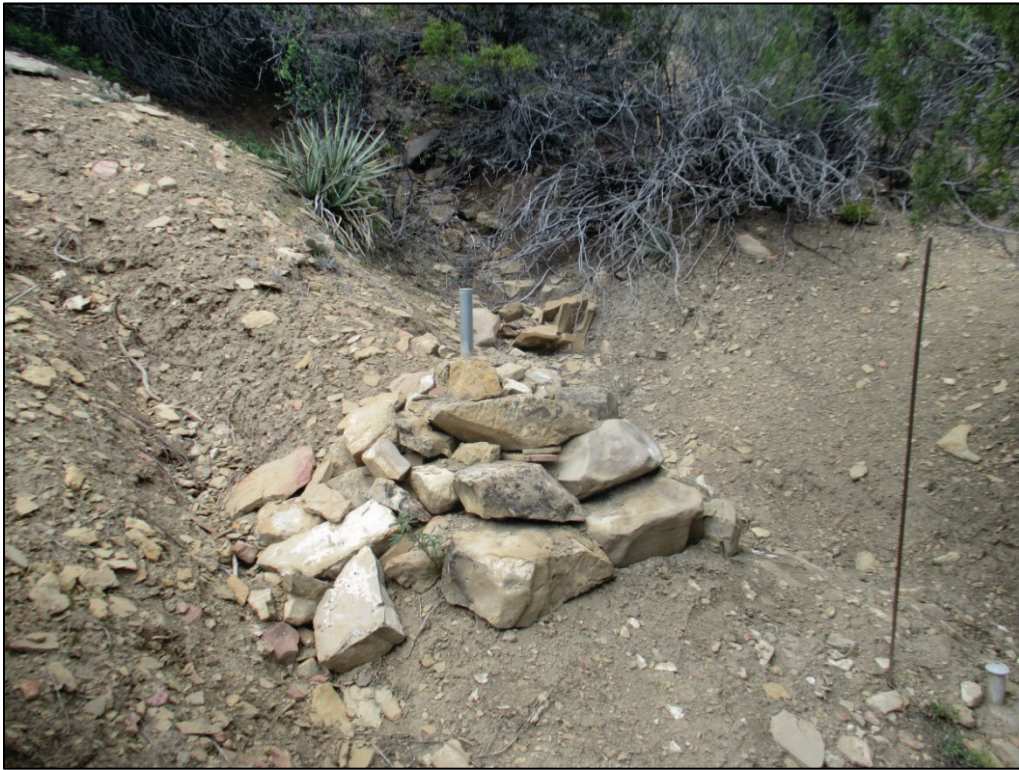
PL-5. Boundary Monument BM-3

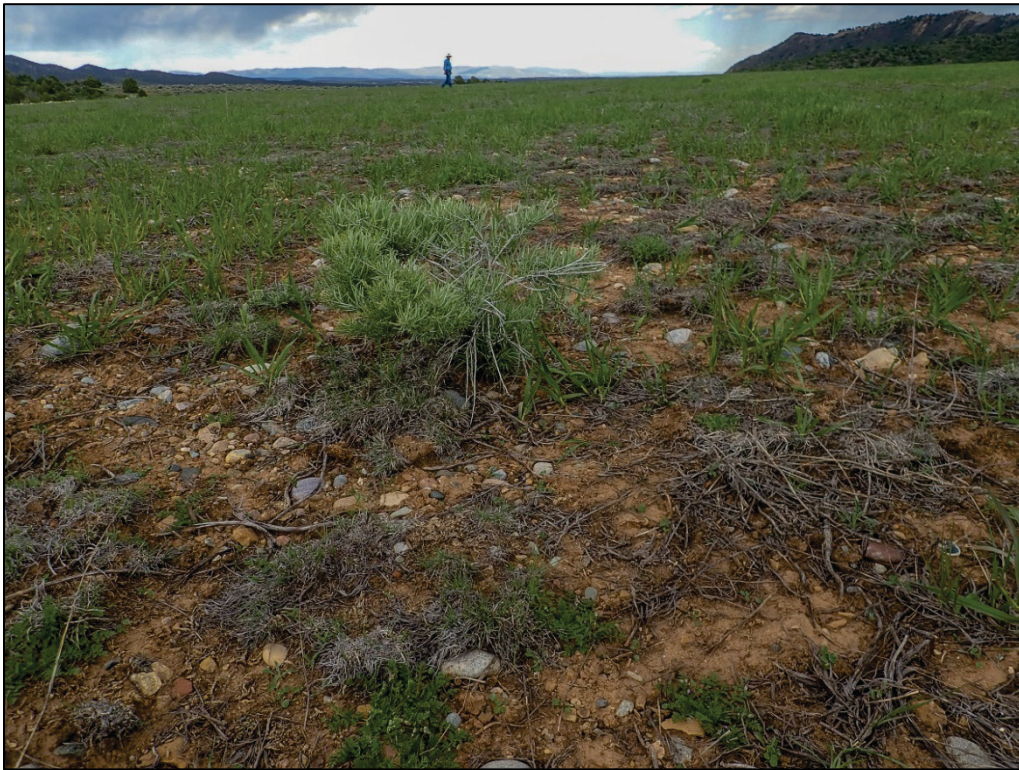
observed in 2019. A single volunteer rabbitbrush shoot (a woody species) (PL-6) was observed growing on the disposal cell top and was treated with herbicide in 2019. No other maintenance needs were identified.

PL-6. Rabbitbrush on Disposal Cell Top

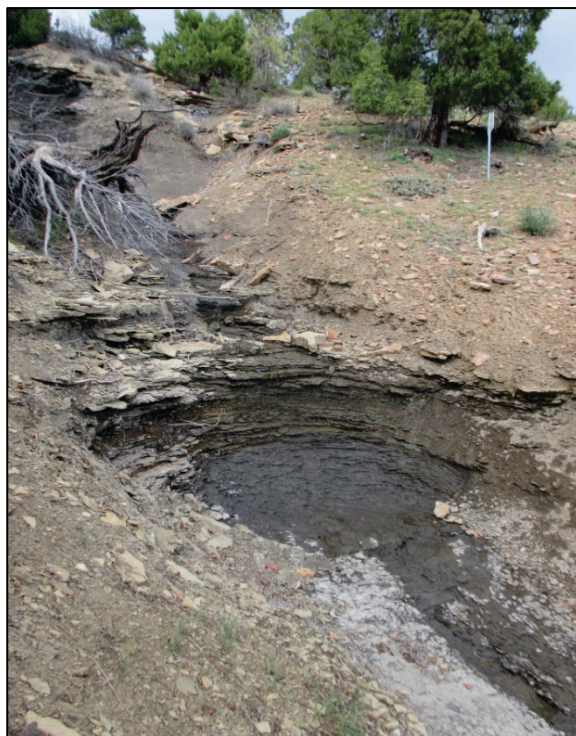
Rock-armored drainage ditches are constructed beneath the toe of the side slope on the east (Ditch No. 1), south (Ditch No. 2), and northwest and west (Ditch No. 3) sides of the disposal cell. Storm water is directed into these ditches and conveyed away from the site into natural drainages (PL-7). The ditches have sufficient depth and rock protection to carry runoff from a probable maximum precipitation event. Erosion occurs on some of the steep slopes above the ditches, depositing sediment in the riprap-armored channel. This process creates locales that favor plant establishment and enhance wildlife habitat. Sediment accumulation and associated vegetation have not adversely affected the performance of the channel.

PL-7. Water Flowing in Natural Drainage Near Perimeter Sign P23

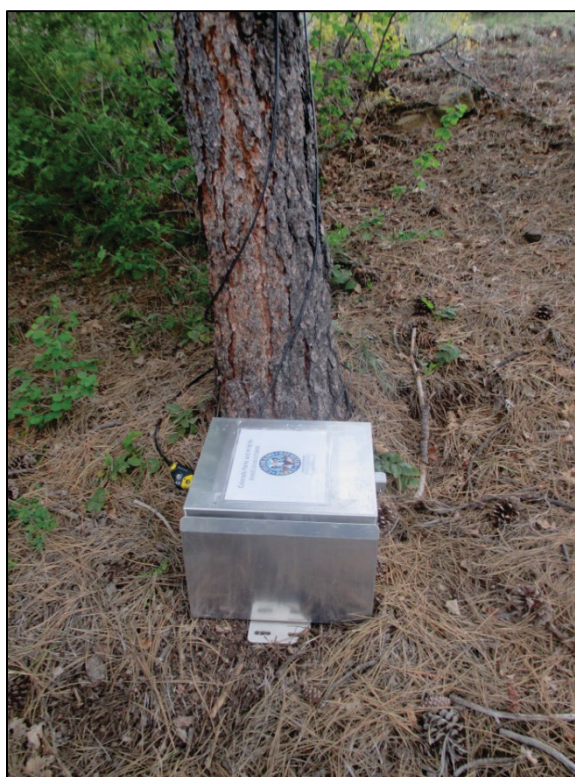
Boundary monuments and perimeter signs delineate the site boundary (property boundary) with one exception; the site boundary marked by boundary monument BM-6 is not delineated with perimeter signs because the signs cut across the corner of the site (perimeter signs P82, P1, P2, and P3). Inspectors noted no new activities or changes to the site boundary area, with the exception of a Colorado Parks and Wildlife (CPW) sound recording device placed near the road along the north side of the disposal cell (PL-8). The device was placed onsite without the

knowledge of LM or LMS personnel. LM discussed the issue with CPW. Gullies on the southeast and southwest portion of the site remain stable and do not threaten the integrity of the disposal cell or drainage ditches. No other maintenance needs were identified.

PL-8. Colorado Parks and Wildlife Sound Recorder near Small Pull-out in Road
