12.0 Mexican Hat, Utah, Disposal Site

12.1 Compliance Summary

The Mexican Hat, Utah, Uranium Mill Tailings Radiation Control Act (UMTRCA) Title I Disposal Site was inspected on August 8, 2023.

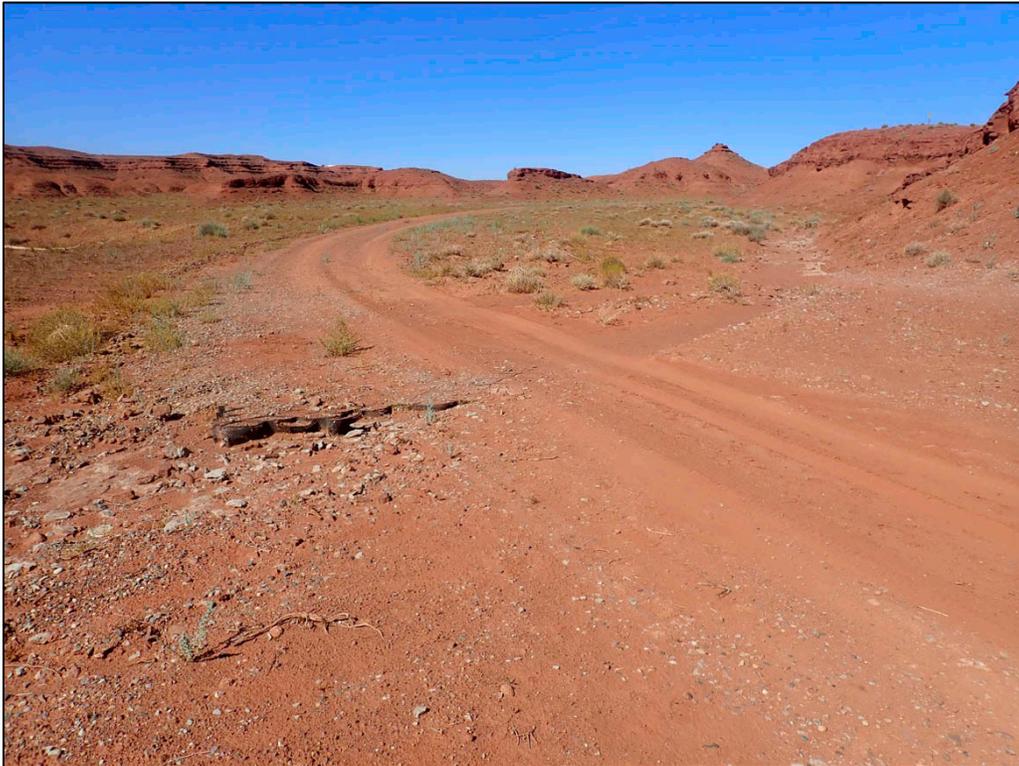
Access to the site is from a short, unmarked dirt road off U.S. Highway 163 that ends at a graded parking area. Minor erosion continues along the dirt access road, but the site remains accessible (PL-1). The steel entrance gate at the northwest corner of the site was locked and functional. The entrance sign is affixed to a steel post immediately behind the entrance gate. No maintenance needs were identified.

As part of the 2019 ICP project, road repairs were performed along the dirt access road to provide site access to haul trucks, delivery trucks, and other vehicles. Road repairs included grading the entire access road. Two incised areas were stabilized by installing geocell with standard U.S. Department of Transportation-specific rock types that allow proper drainage. The repaired areas were examined during the inspection and appeared to be performing as designed, except for minimal degradation of the access road and minor erosion to one of the drainages armored with geocell. Inspectors will continue to monitor the area.

PL-1. Exposed Geocell on Access Road

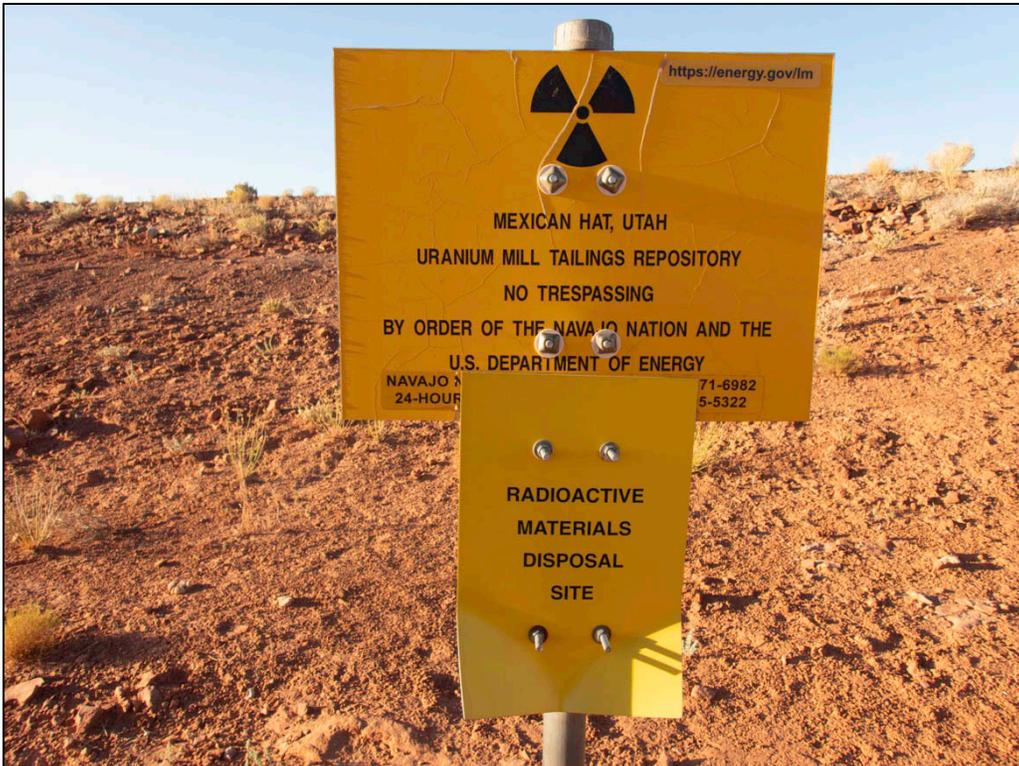
There are 43 pairs of perimeter signs, designated P1 through P43 (each pair consisting of an upper sign indicating property ownership and barring trespassing and a lower sign identifying the site as a radioactive materials disposal site), positioned along the property boundary. Each paired perimeter sign is attached to a single steel post set in concrete. Perimeter signs are typically outside the fence that encloses the disposal cell, but some are affixed directly to the fence or immediately inside the fence. The lower perimeter sign on P6 was pushed up and covering the phone numbers on the upper sign and will be repaired following the inspection (PL-2). The base of perimeter sign P7 is more exposed than on previous inspections (PL-3). The corners of the lower perimeter sign on P14 are bent, possibly from burro contact. The signpost at perimeter sign P15 had been repaired following the 2022 inspection but is missing the lower sign (PL-4). The lower sign will be added before the next inspection. The corners of the lower southeastern perimeter signs (perimeter signs P16 through P21) are bent, possibly from burro contact. Perimeter sign P25 has bullet holes but is legible. Perimeter sign P42 has bent corners and is covered in stickers but is legible. These signs will be repaired before the next inspection. All remaining perimeter signs are in good condition.

PL-2. Perimeter Sign P6 with Blocked Numbers

- Repair the gap in the fence near perimeter sign P8
- Replace the lower sign on perimeter sign P15
- Replace the illegible sign numbers on perimeter sign P6

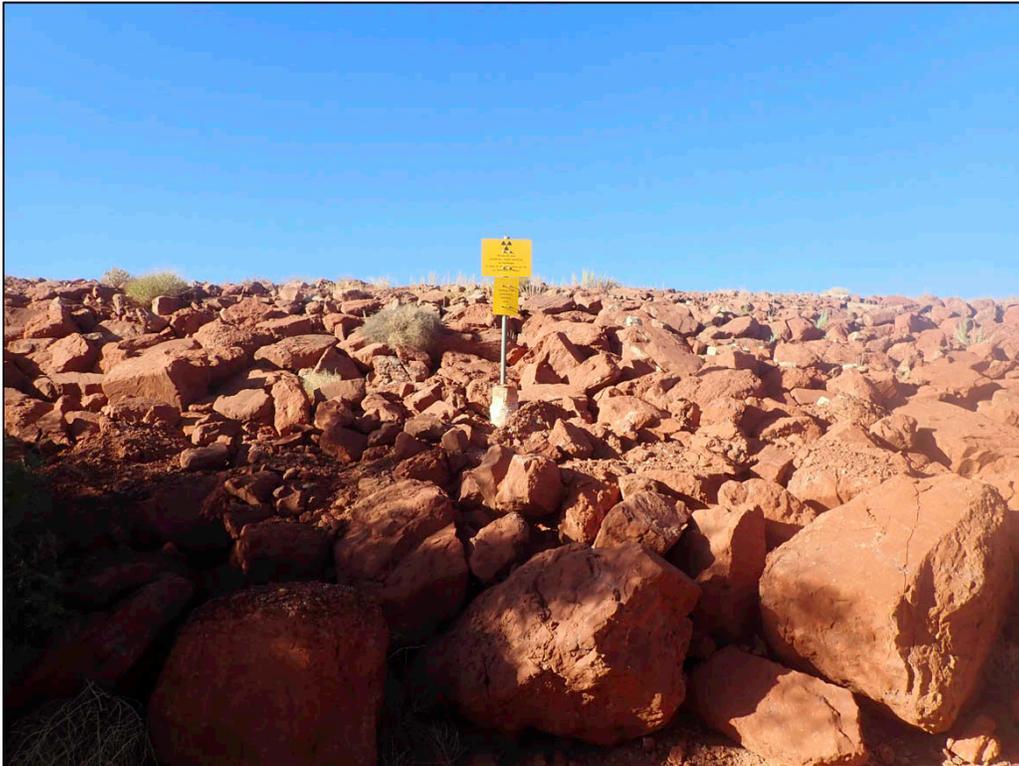
PL-3. Perimeter Sign P7 with Exposed Base

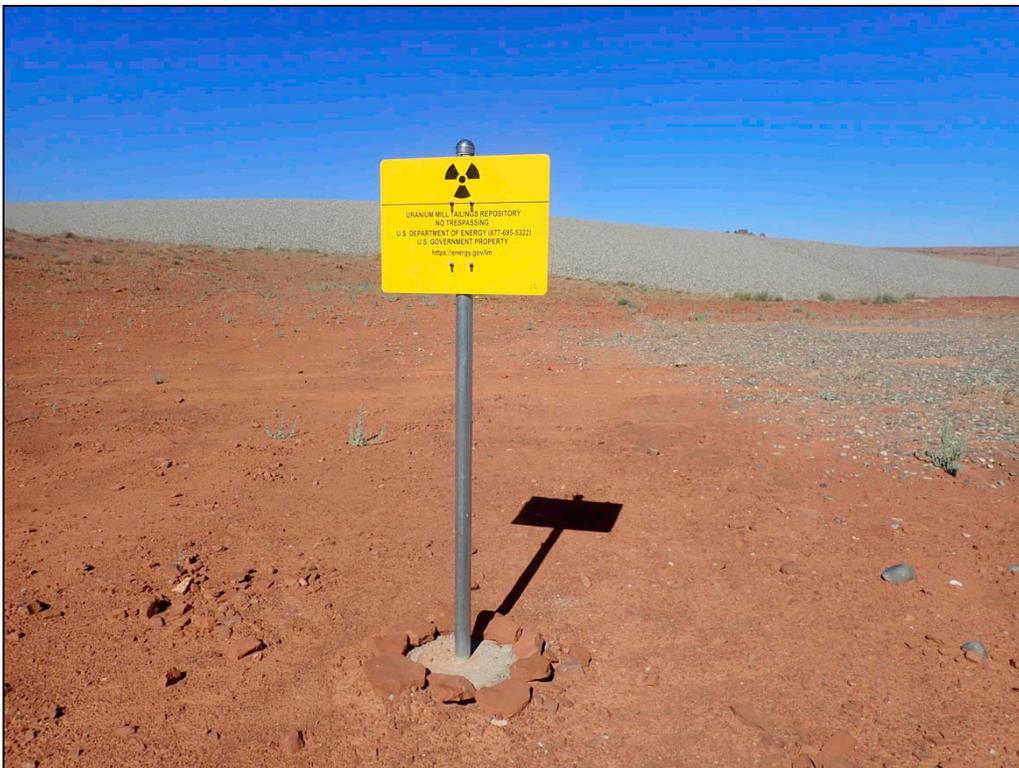
PL-4. Perimeter Sign P15 Missing Lower Sign

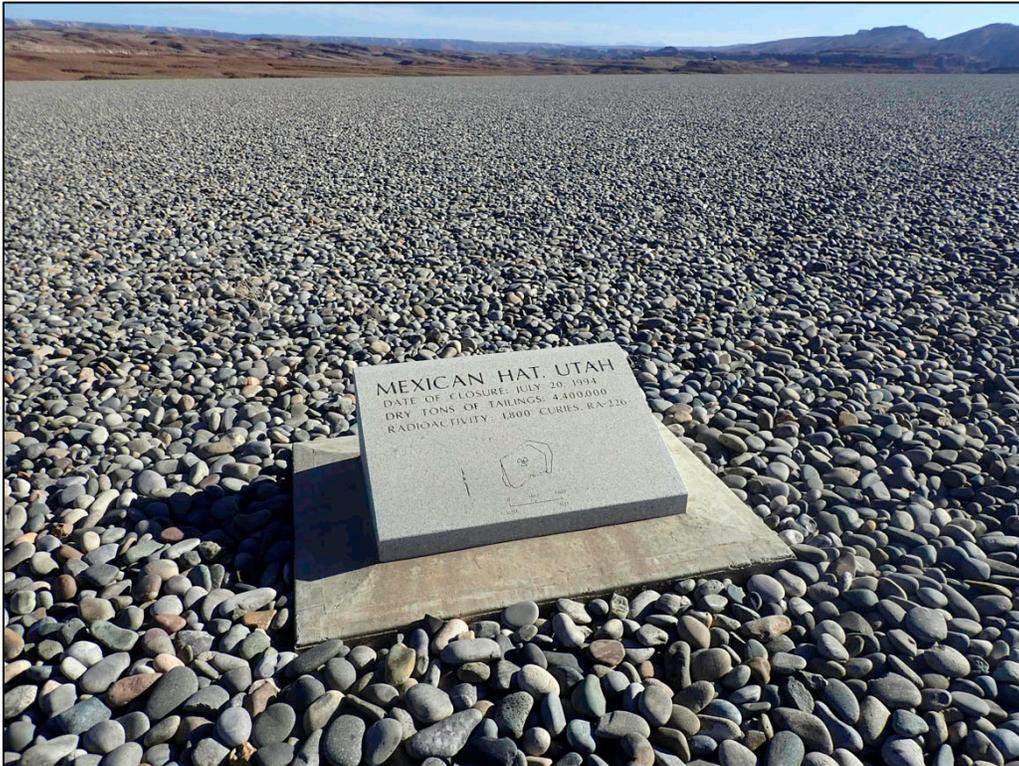
The site has two granite site markers. Site marker SMK-1 is just inside the fence near the entrance gate; the concrete base has several minor cracks, which have been noted during previous inspections. This does not compromise the integrity of the base, and repairs are unnecessary. Site marker SMK-2 is on the top slope of the disposal cell (PL-5) and is in good condition. No maintenance needs were identified.

PL-5. Site Marker SMK-2

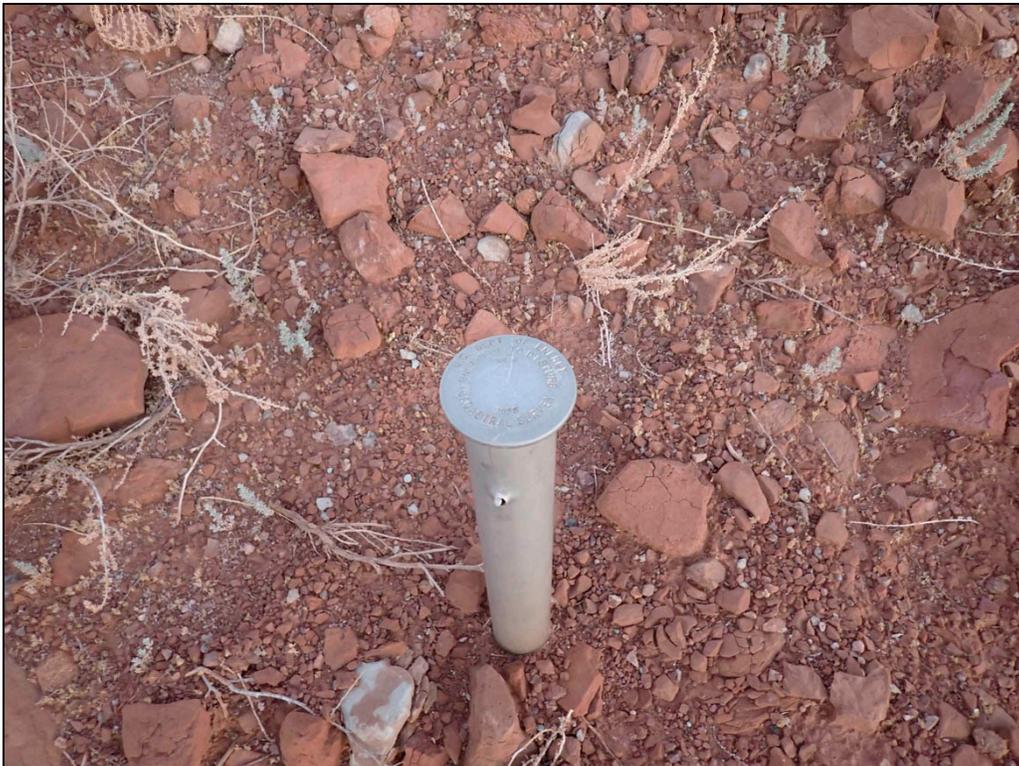
During construction of the disposal cell, four survey monuments were installed. Twelve boundary monuments delineate the property boundary. As noted previously, vandalism has resulted in bullet damage to boundary monument BM-5, but the monument remains legible and intact (PL-6). No maintenance needs were identified.

PL-6. Boundary Monument BM-5

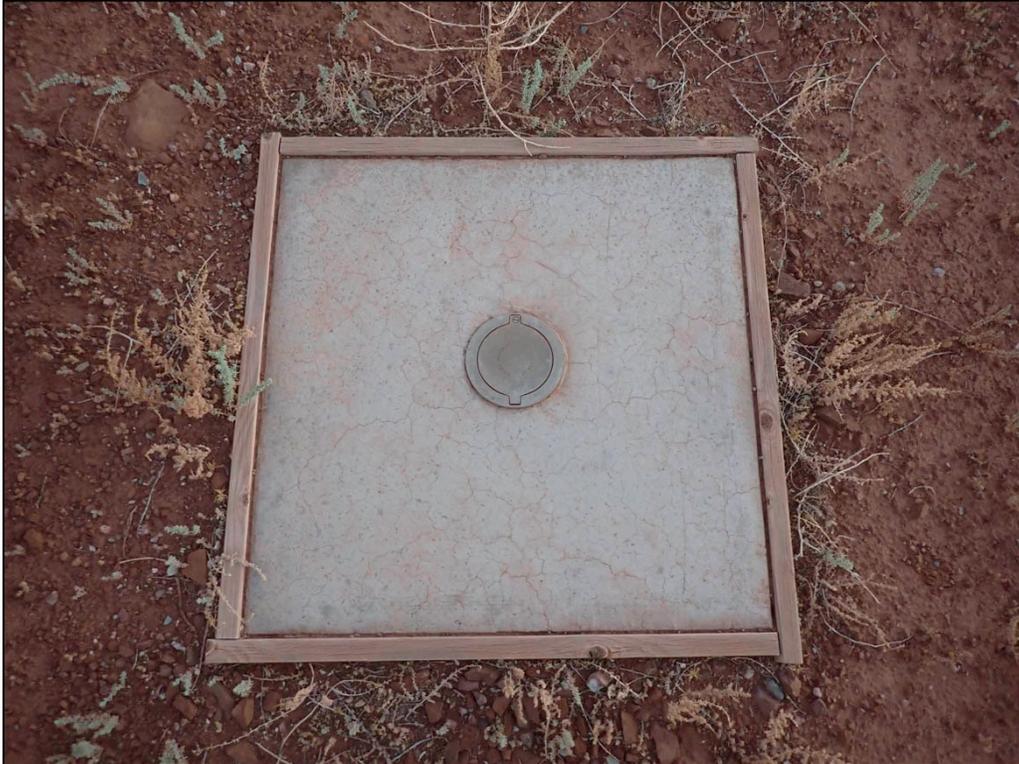
Five aerial survey quality control monuments were inspected during the 2023 annual inspection (PL-7). No maintenance needs were identified.

PL-7. Quality Control Monument QC-4

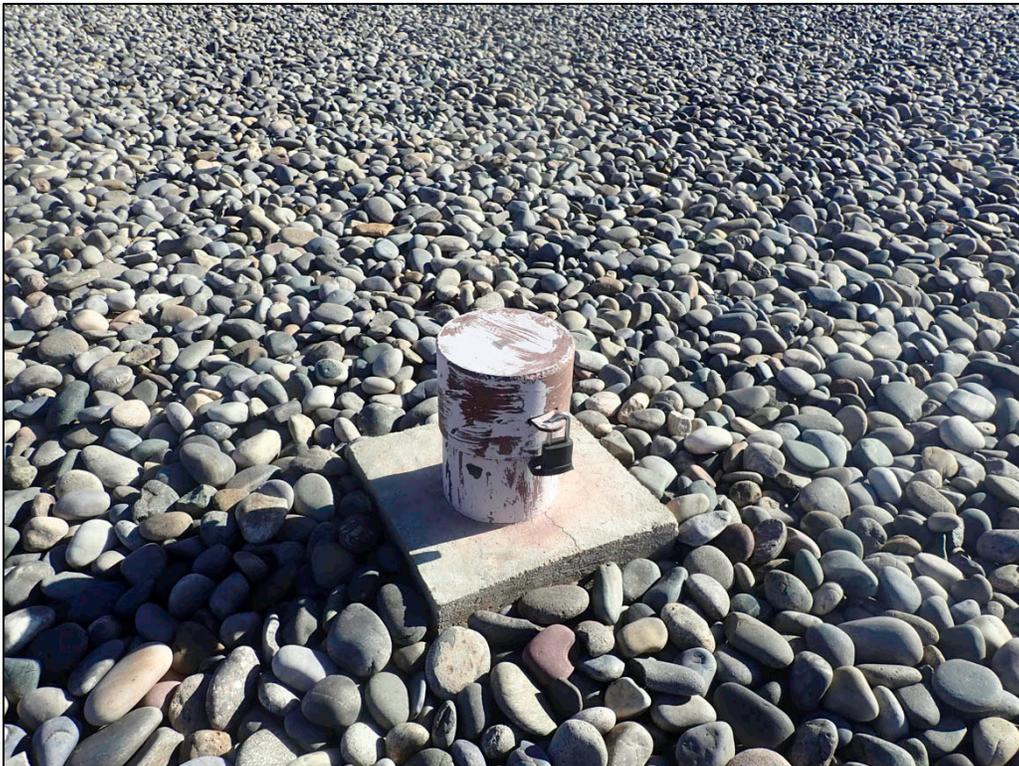
Six settlement plates were inspected during the 2023 annual inspection. All settlement plates have minor cracking in the concrete bases, but the integrity of the bases is not compromised (PL-8). No maintenance needs were identified.

PL-8. Settlement Plate SP-3

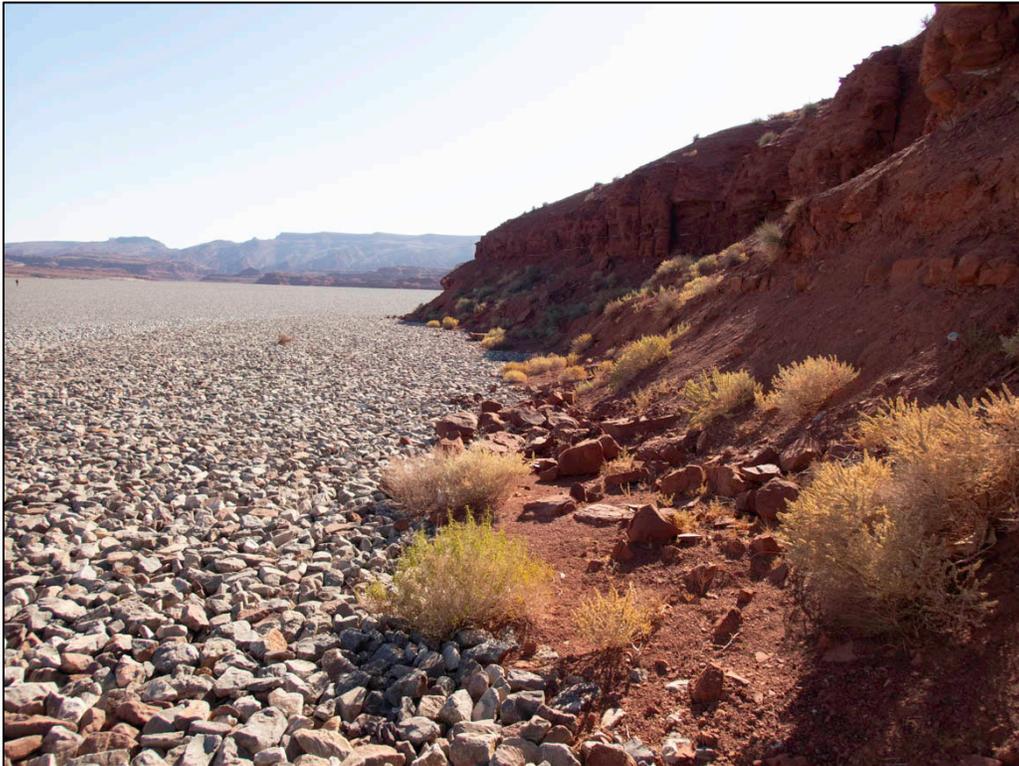
There was no noticeable increase of sloughed rock or soil along the south apron of the disposal cell (PL-9). Because the apron is adjacent to the base of a steep exposure of Halgaito Shale, it is expected that occasional sloughing of rock and soil associated with this exposure will continue. The accumulated material is not affecting the function of the apron, and this area will continue to be monitored. No maintenance needs were identified.

PL-9. Sloughing Rock Along South Apron

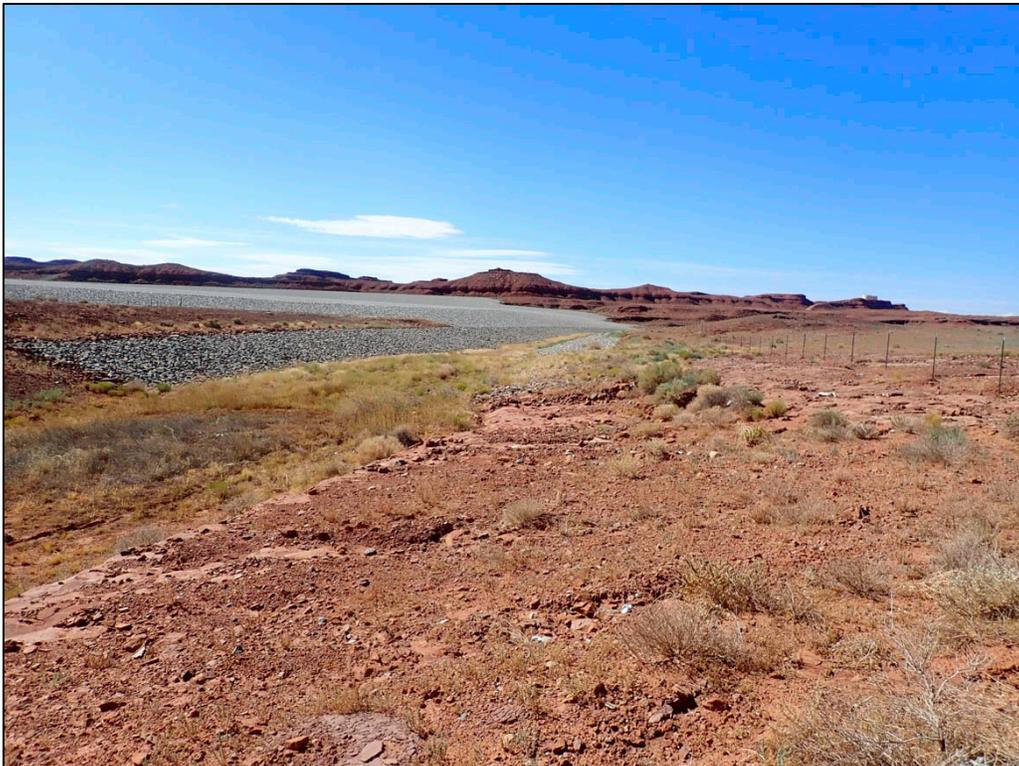
Erosion continues in upgradient offsite areas resulting in sediment being transported onto the site and into the west diversion channel. Sediment accumulation has promoted the growth of vegetation in the west diversion channel, although no more than in previous inspections (PL-10).

In accordance with the LTSP, vegetation conditions are observed during annual inspections to ensure that undesirable plant species, including deep-rooted plants on the disposal cell cover and noxious weeds, do not proliferate at the site. Except for deep-rooted vegetation, natural plant community succession is expected and will not adversely impact the performance of the disposal cell. During the 2023 inspection, three shallow-rooted plants were pulled from the top slope of the disposal cell. Vegetation is continuing to grow in the west diversion channel and will be monitored during annual inspections to ensure that it does not negatively affect the performance of this surface water diversion structure (PL-10). No other maintenance needs were identified.

PL-10. Vegetation in West Diversion Channel

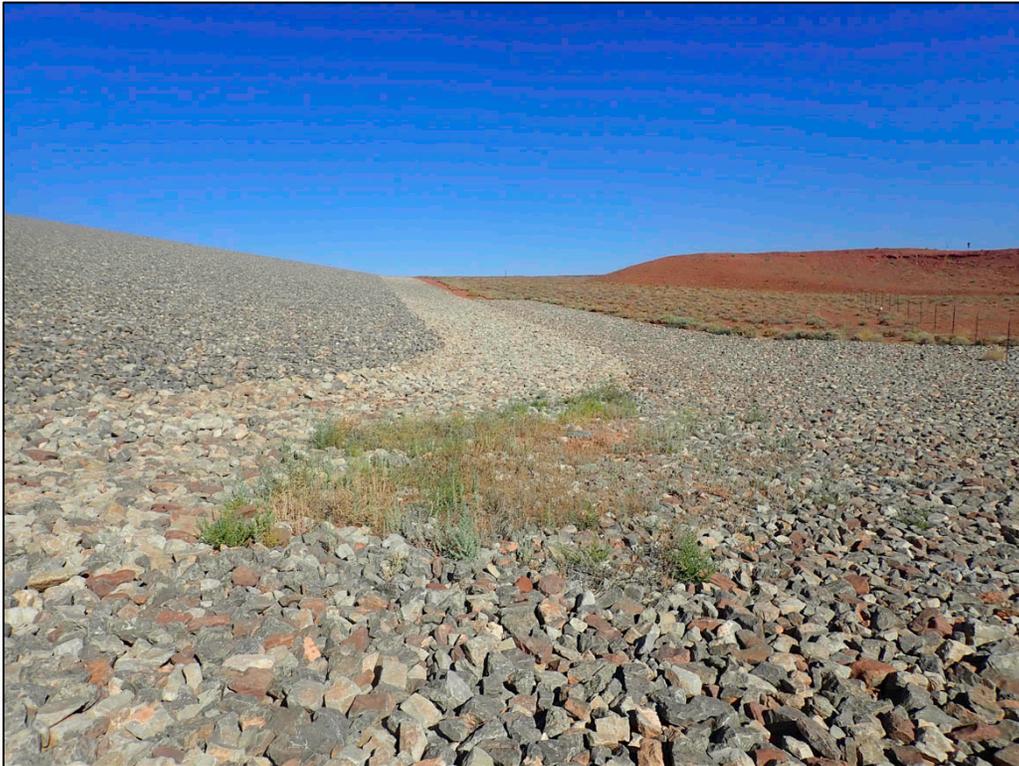
Sediment accumulation has also been observed along the transition zone from the apron to the northeast toe drain. The origin of this material is being evaluated as part of the ongoing cover degradation assessment. Possible sources of this material include a windblown material that originates offsite or radon barrier material associated with the depression features on the northeast side slope of the disposal cell, or both. Visual observations during the inspection did not identify any apparent increases in the sediment accumulation or vegetation growth in this area compared to previous visual observations (PL-11). No maintenance needs were identified.

PL-11. Vegetation in Northeast Toe Drain

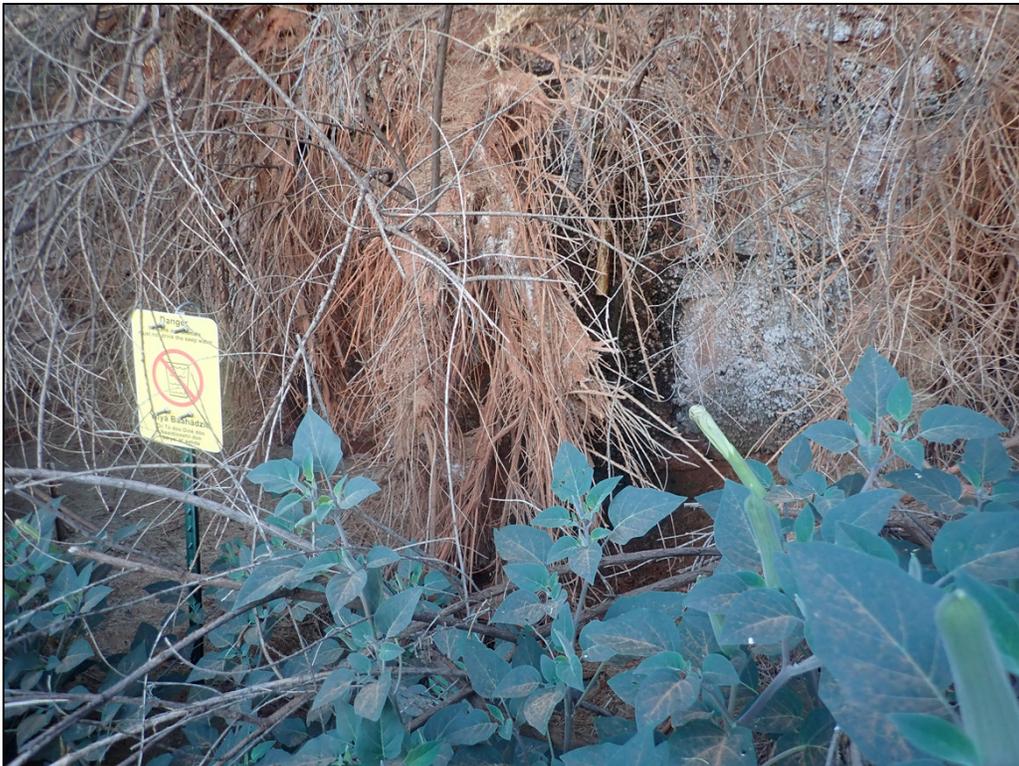
Observational documentation consists of photographing seeps (PL-12 through PL-18) and providing descriptions of the conditions observed at the seven designated seeps. Since 2010, groundwater discharge has been observed at cross-gradient seep 0248, which typically exhibits dripping conditions; during the 2023 inspection, seep 0248 was dripping and showed thick, flowering vegetation growth (PL-12). Seeps 0922 (PL-13) and 0254 (PL-14) were dry, but the ephemeral drainage nearby had standing water. Seeps 0249 (PL-15), 0264 (PL-16), and 0251 (PL-17) were dry, and ephemeral drainages near these seeps were dry.

Seep Location Number	Drainage	Location Relative to Disposal Cell	Photograph Location Number	Observed Seep Conditions
0248	Gypsum Creek	Cross gradient	PL-12	Dripping (no flow rate measured). Thick, flowering vegetation growth was noted.
0249	Gully No. 2	Downgradient	PL-15	Dry conditions (no evaporites present); seep area is covered with gray limestone that presumably is extra riprap apron material from disposal cell construction. Warning sign not posted at this location since this seep has never been documented to be discharging water.
0251	North Arroyo	Downgradient	PL-17	Dry conditions (no evaporites present).
0254	South Arroyo	Downgradient	PL-14	Dry conditions (no evaporites present). Warning sign not posted at this location due to seasonal flash flood conditions in the ephemeral drainage.
0261	Gypsum Creek	Upgradient (background)	PL-18	Seep was dripping. This seep discharges directly into Gypsum Creek, which has standing water outside the immediate seep discharge area. Warning sign not posted since this seep is a background location.

PL-12. Seep 0248 (Dripping/Wet)

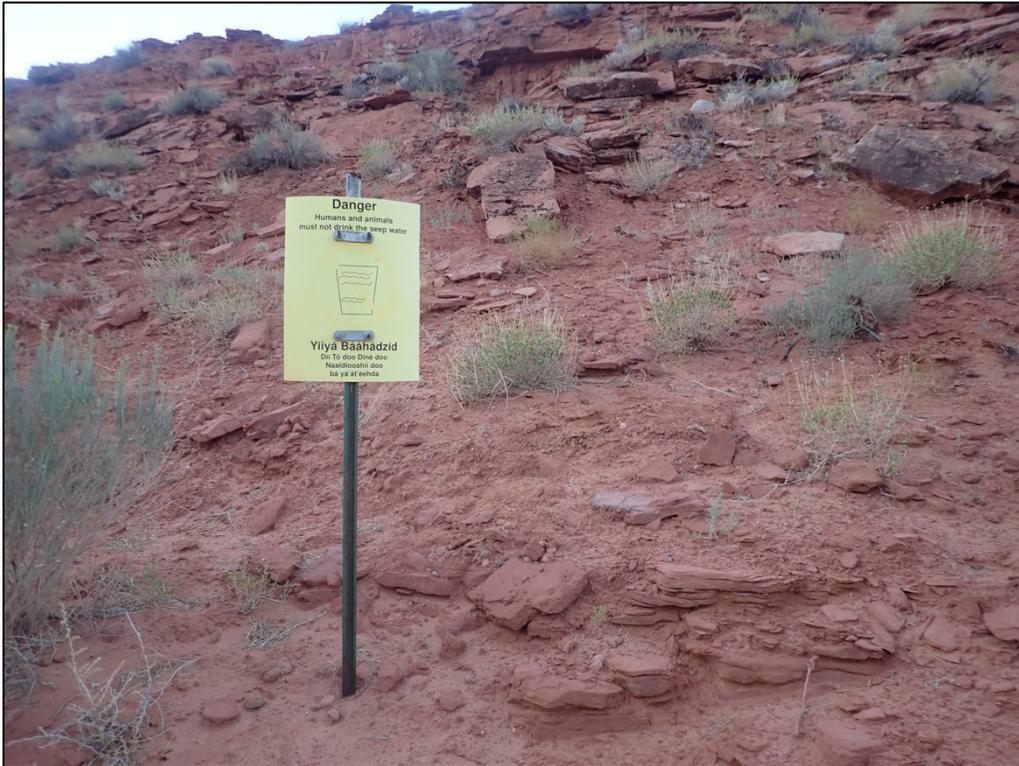
0264	North Arroyo	Downgradient	PL-16	Dry (no evaporites present in immediate area).
0922	Gypsum Creek	Downgradient	PL-13	Dry conditions (no evaporites present). Seep is along the south side of Gypsum Creek, which was noted to have standing water present.

PL-13. Seep 0922 (Dry)

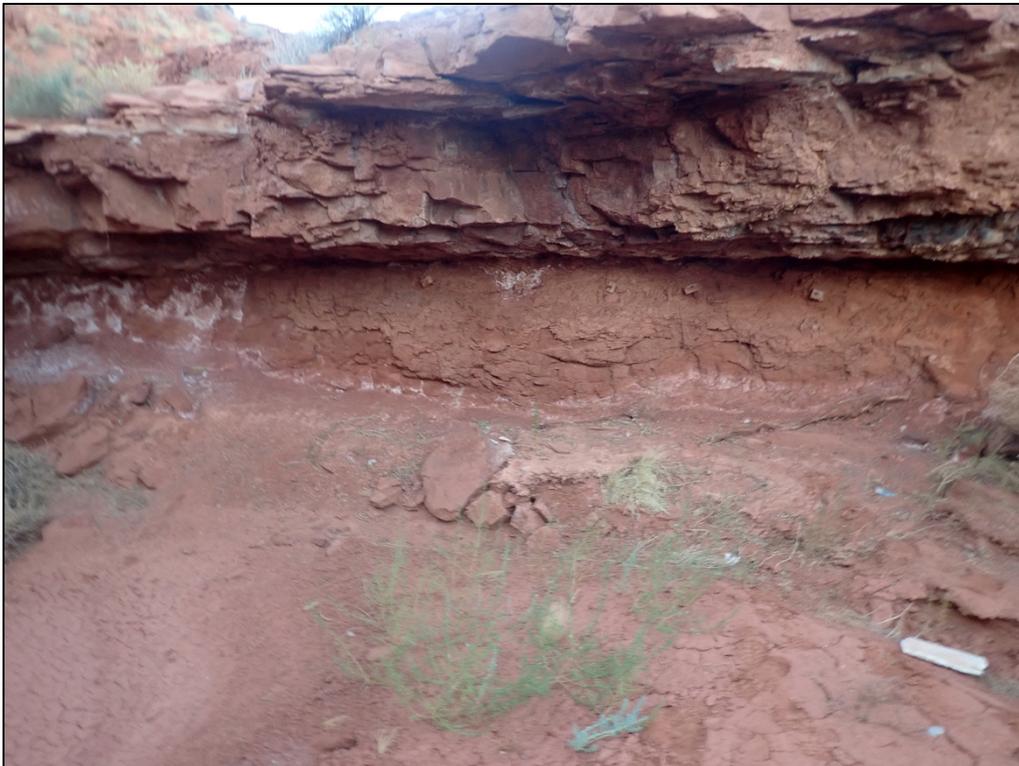
PL-14. Seep 0254 (Dry)

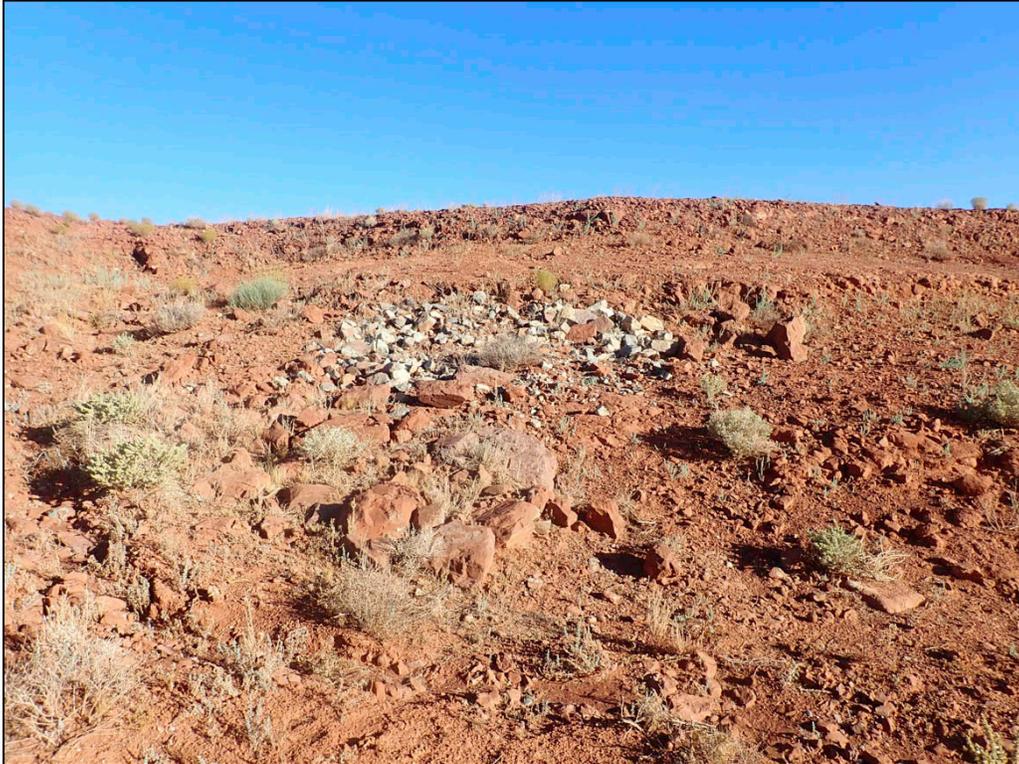
PL-15. Seep 0249 (Dry)

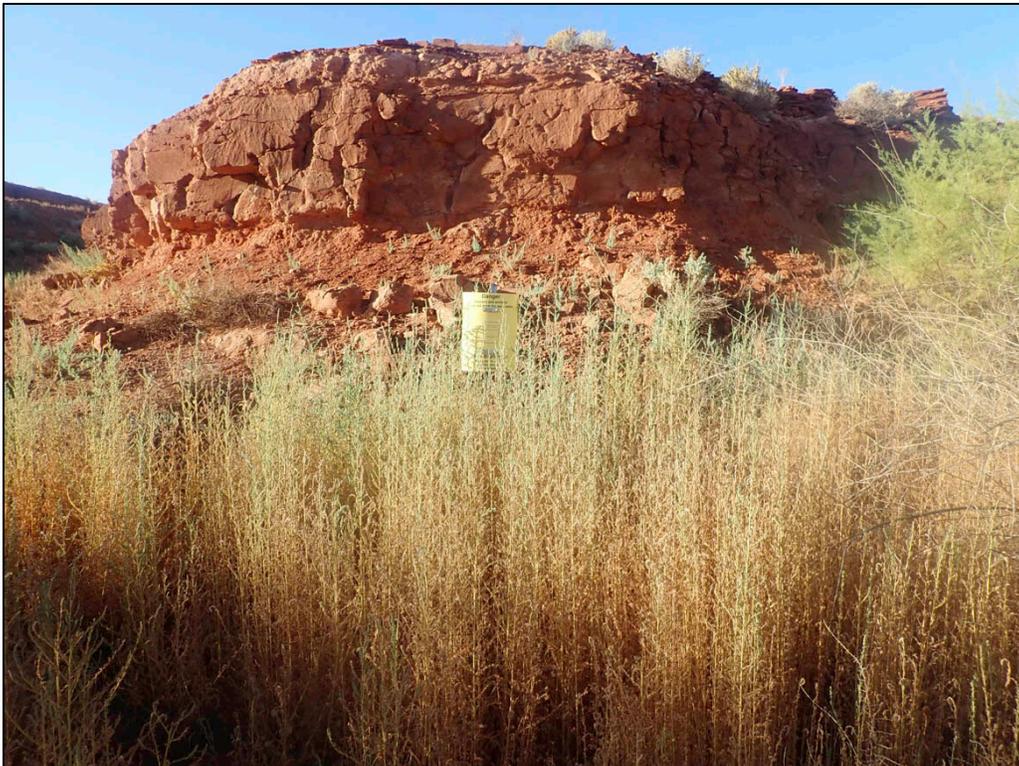
PL-16. Seep 0264 (Dry)

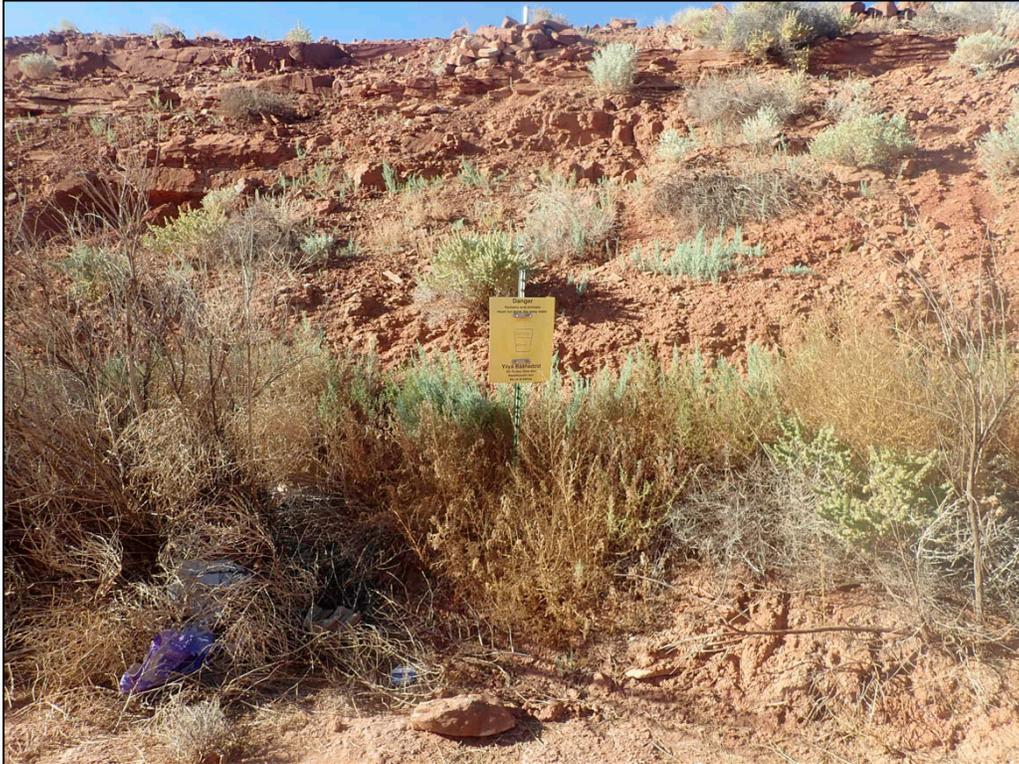
PL-17. Seep 0251 (Dry)

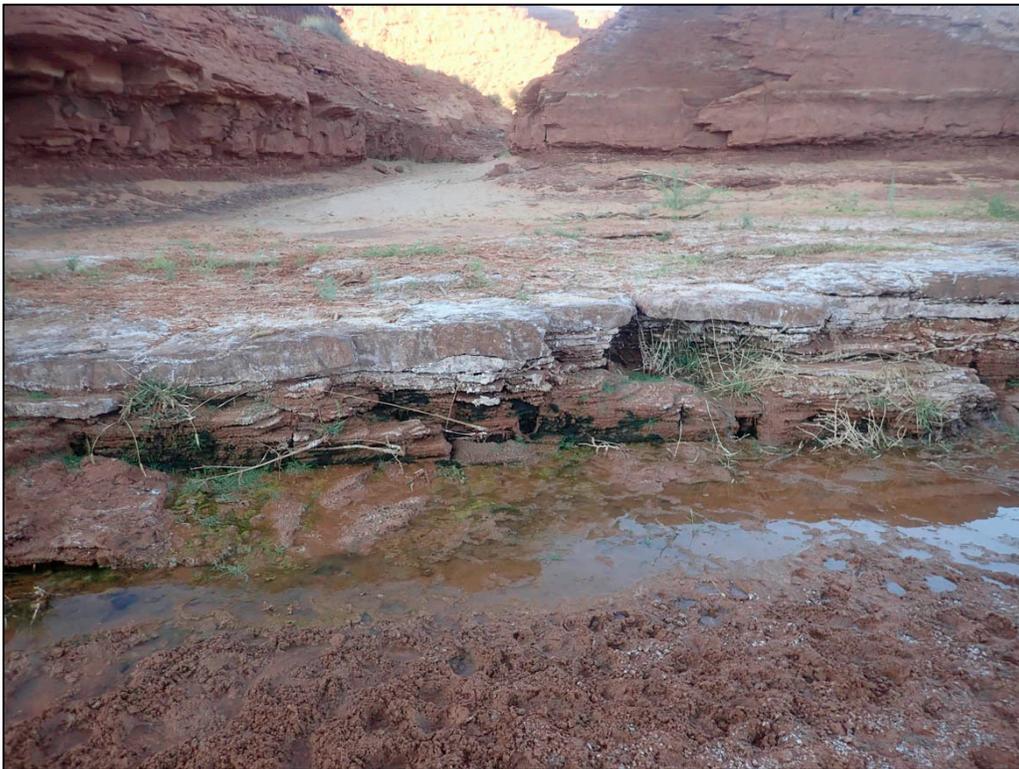
Upgradient (background) seep 0261 (PL-18), approximately 0.5 mile upstream of seep 0248 in Gypsum Creek, was observed to be dripping during the inspection.

PL-18. Seep 0261 (Background—Dripping/Wet)
