8.0 Gunnison, Colorado, Disposal Site

8.1 Compliance Summary

The Gunnison, Colorado, Uranium Mill Tailings Radiation Control Act (UMTRCA) Title I Disposal Site, was inspected on June 3, 2008. The disposal cell and all associated surface water diversion and drainage structures were in excellent condition and functioning as designed. Six riprap test areas on the cell apron and diversion ditches were visually inspected; no apparent rock degradation was noted when compared to previous photos. A deep-rooted shrub was removed from the top of the disposal cell. The perimeter fence was repaired at several locations from damage caused by significant snow accumulations during the winter. Several damaged and missing perimeter signs were replaced. Snowmelt runoff resulted in minor erosion near the southeast corner of the site; repair is not warranted at this time. No other maintenance needs or cause for a follow-up or contingency inspection was identified.

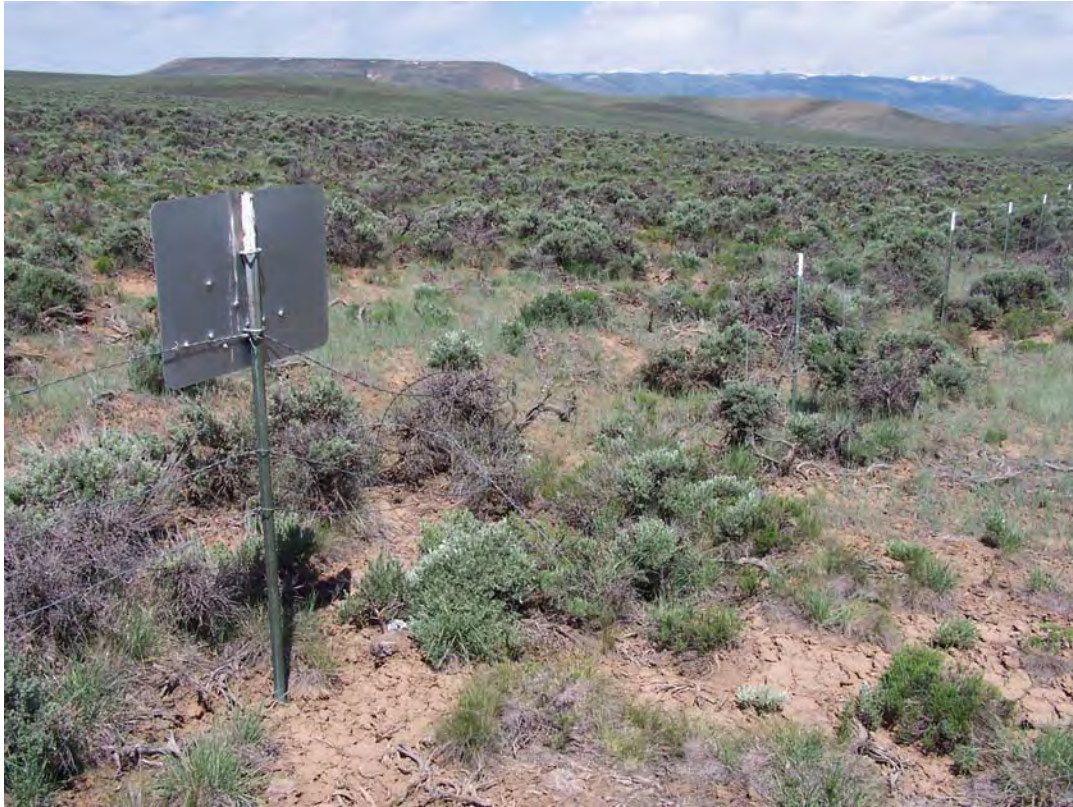
8A A three-strand, barbed-wire fence delineates the site; most of it is set along the property boundary. Fence strands were broken at several locations along the north and west sides of the site (PL–1). This damage is attributed to the above-average snow accumulation that occurred during the past winter. The broken strands were repaired on June 19, 2008.

GUN 6/2008. PL-1. Broken fence strands near perimeter sign P8.

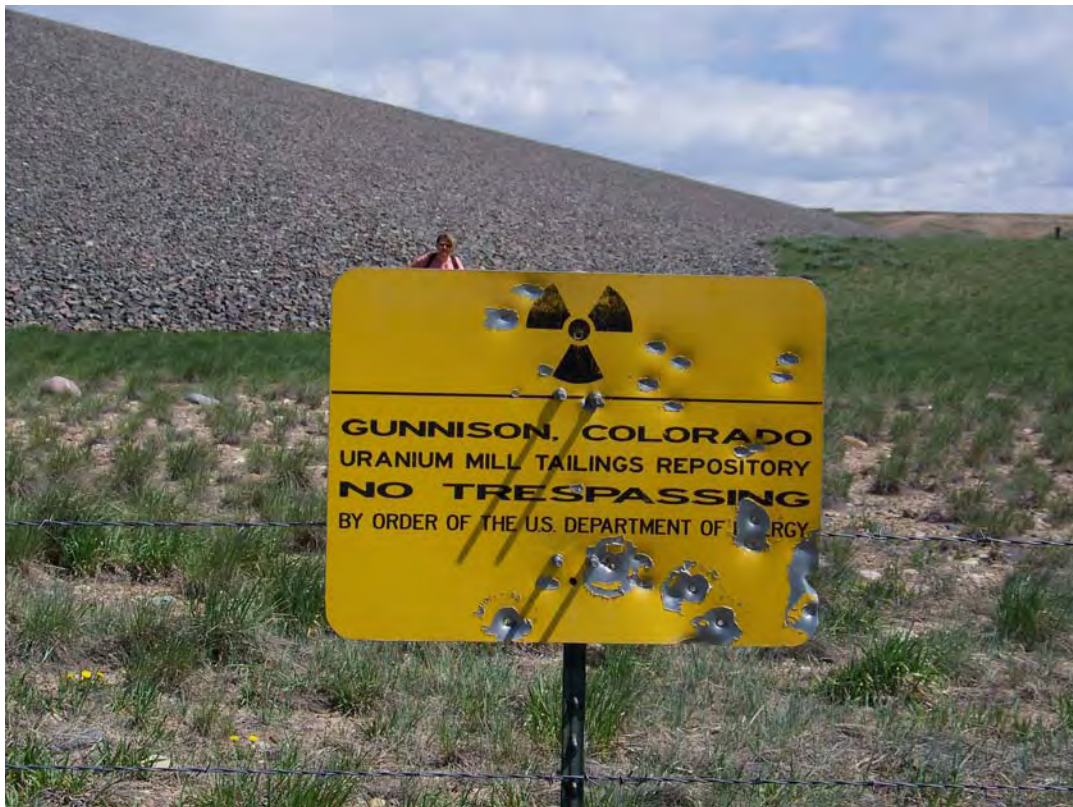
8B The entrance sign, located at the south entrance gate, is in good condition. Forty-five perimeter signs are bolted to the perimeter fence posts. Nine perimeter signs (P2, P7, P8, P9, P10, P11, P12, P13, and P42) were heavily damaged by bullets (PL–2), and one perimeter sign (P38) was missing; new signs were installed at these locations on June 19, 2008. The remaining signs were in good condition.

GUN 6/2008. PL-2. Damaged perimeter sign P42.

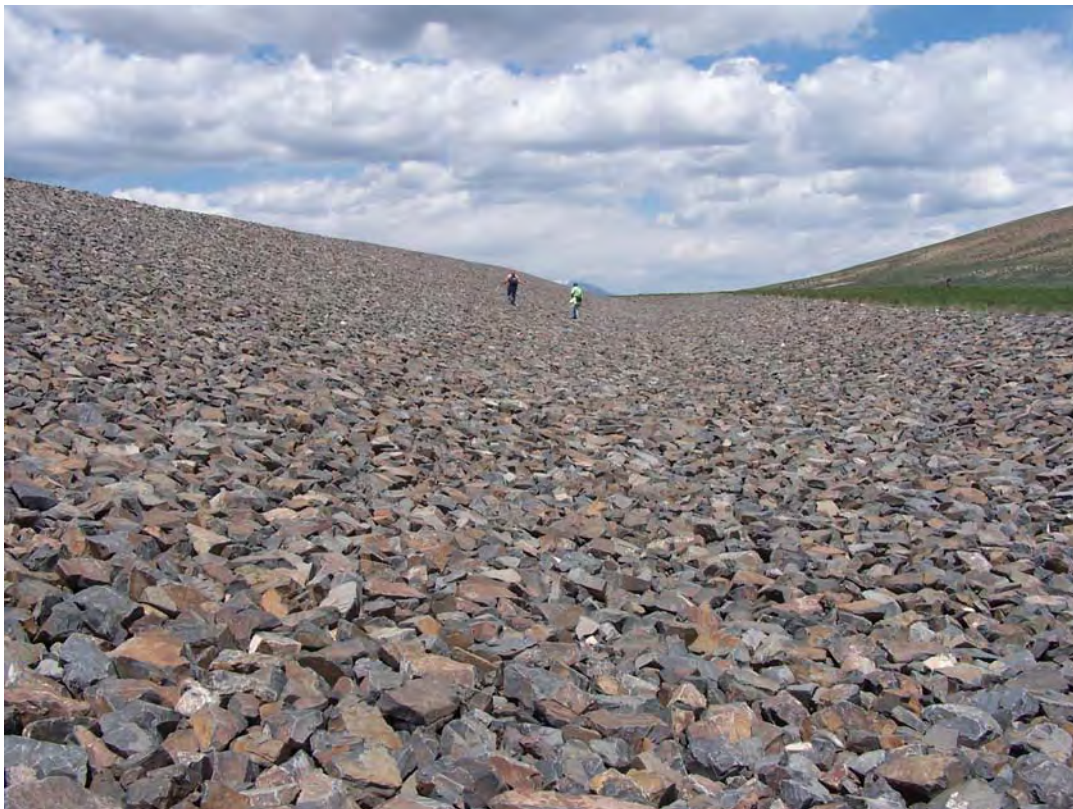
Side Slopes, Apron, and Diversion Ditches—The riprap-covered side slopes, apron, and diversion ditches were in excellent condition (PL-4 and PL-5). No evidence of slumping, settling, rock degradation, or encroachment of vegetation was observed.

GUN 6/2008. PL-4. East diversion channel along the northeast side of the disposal cell.

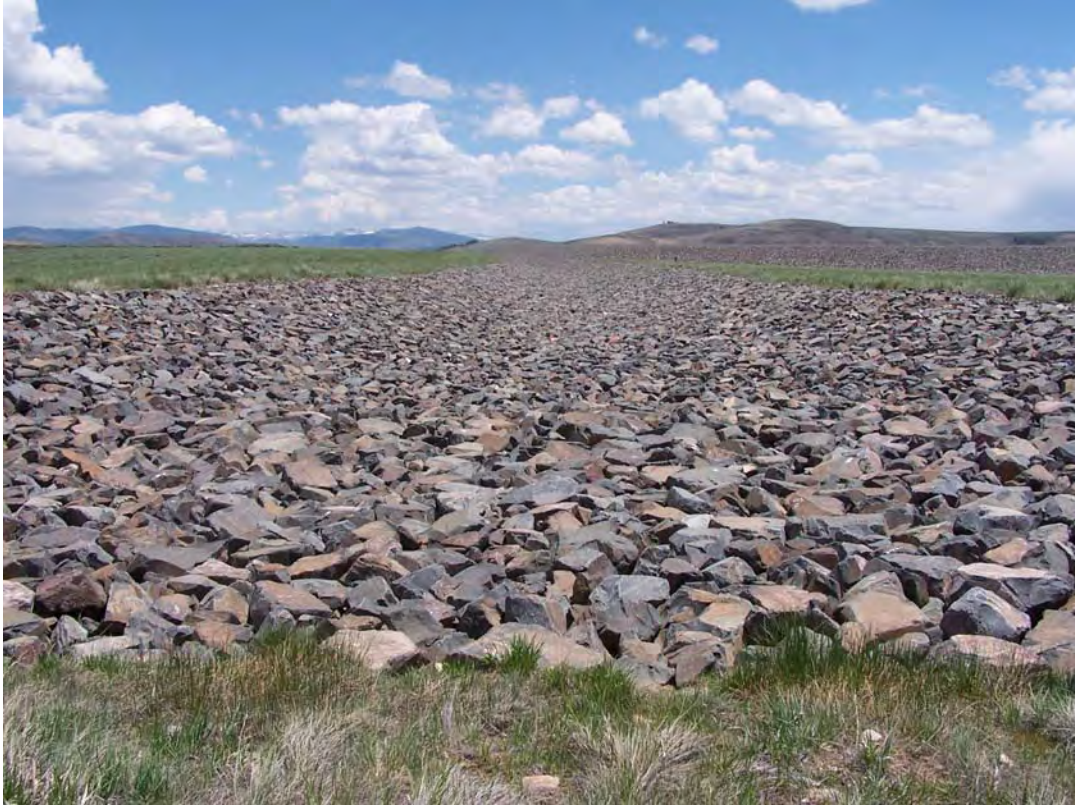
GUN 6/2008. PL-5. West diversion channel.

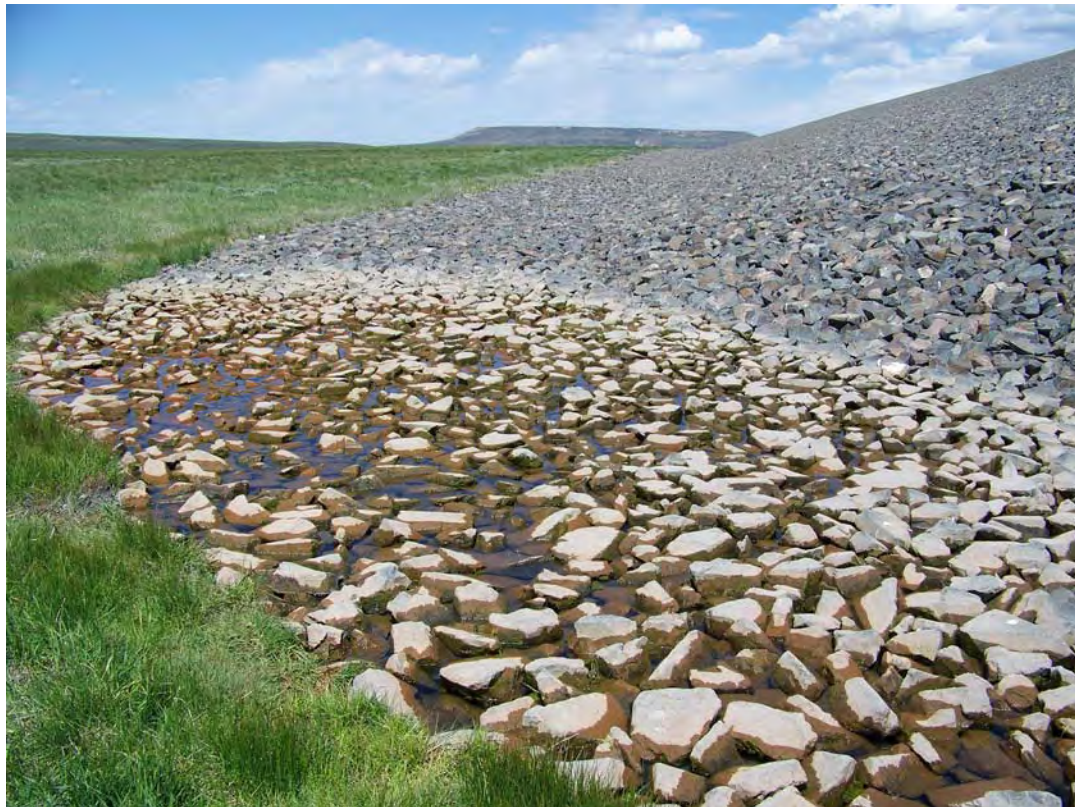
At the southeast corner of the cell apron, water draining from the cell occasionally ponds in a low-lying area along the edge of the riprap. The riparian-type vegetation that has become established in this area indicates that the area retains moisture much of the time. Water collection in this area does not pose a problem because the cell is designed to drain to the southeast, and any water that ponds is below the elevation of the entombed tailings material. Pondered water was present in the apron (PL-6), and the soil in this area was moist at the time of the inspection.

GUN 6/2008. PL-6. Ponded water at the southeast corner of the disposal cell.

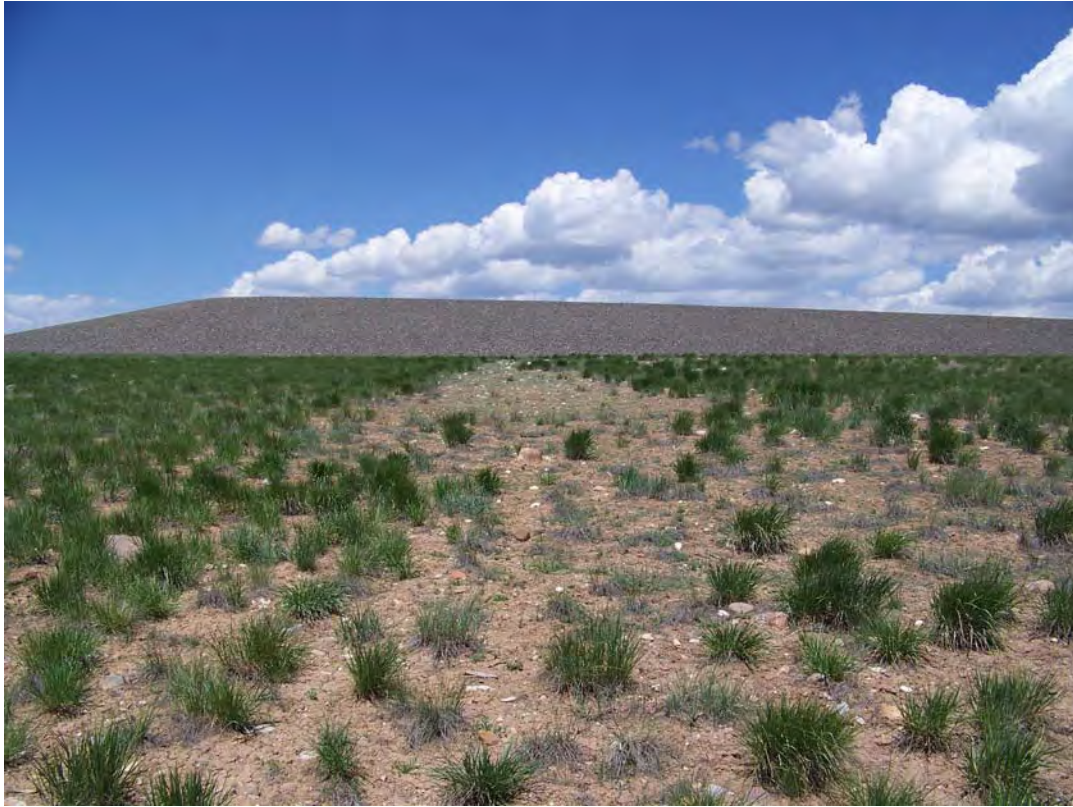
Area Between the Disposal Cell and the Site Boundary—Reclaimed and undisturbed areas occur between the disposal cell and the site perimeter. Both types of areas are in excellent condition. In general, reclaimed areas have good vegetation coverage, mostly grass. However, there are several small areas of sparse vegetation attributed to poor soil conditions (PL-7). As expected, shrubs and forbs are much less abundant and less diverse in reclaimed areas than they are in undisturbed areas. Overall, however, the vegetation at the site is healthy following a winter of above-average snowfall.

GUN 6/2008. PL-7. Poorly vegetated area near the east side of the disposal cell.
