## 8.0 Gunnison, Colorado, Disposal Site

### 8.1 Compliance Summary

#### 8.3.1 Annual Inspection and Report

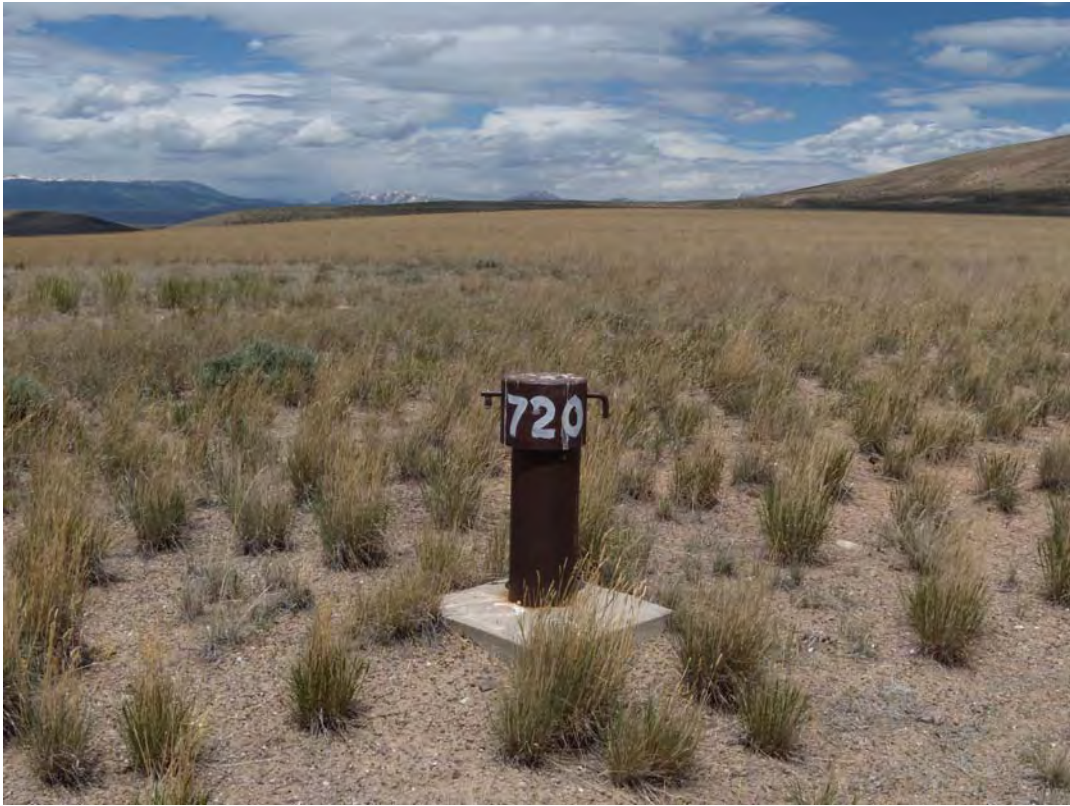
**Monitoring wells**—Sixteen wells constitute the groundwater monitoring network at the disposal site. Six of the wells are for monitoring cell performance, two are for monitoring background groundwater quality, and eight are for water level measurements. The wells were secure and in good condition (PL-1).

*GUN 6/2010. PL-1. Monitoring well 0720.*

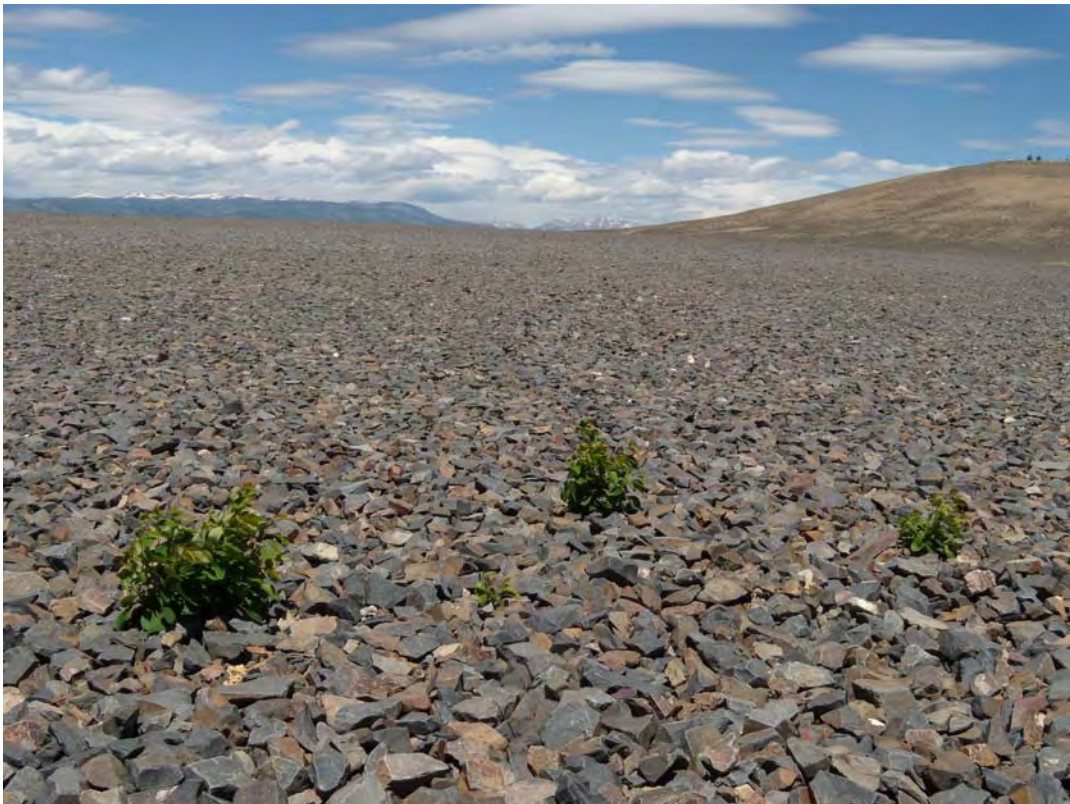
**Top of the Disposal Cell**—The top of the disposal cell was in excellent condition. There was no evidence of erosion, settling, slumping, or rock degradation. Several isolated patches of grass are randomly distributed over the disposal cell cover; however, these shallow-rooted plants are not a cause for concern. Four small cottonwood tree saplings were pulled out (PL-2); no other deep-rooted plants were observed on the disposal cell top.

*GUN 6/2010. PL-2. Cottonwood tree saplings prior to removal.*

A broken fence strand was repaired, and cottonwood tree saplings were removed from the disposal cell top.

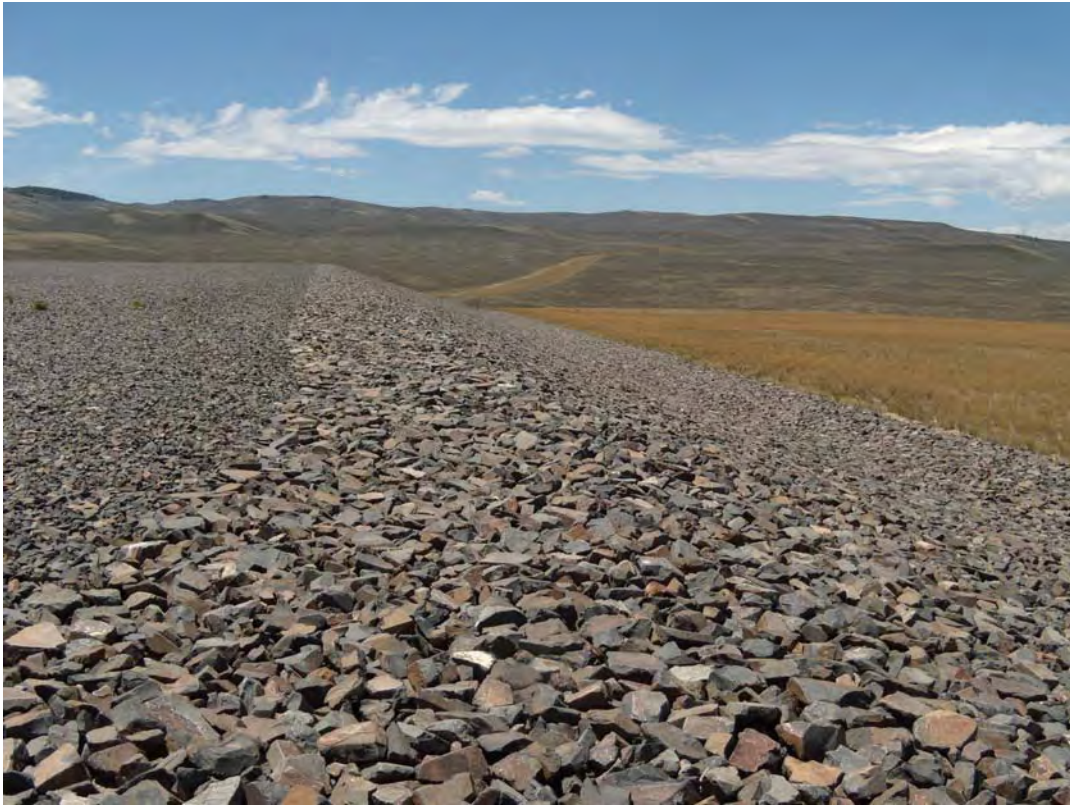
**Side Slopes, Apron, and Diversion Ditches**—The riprap-covered side slopes, apron, and diversion ditches were in good condition (PL-3). No evidence of slumping, settling, rock degradation, or encroachment of vegetation was observed.

*GUN 6/2010. PL-3. Northwest side slope of the disposal cell.*

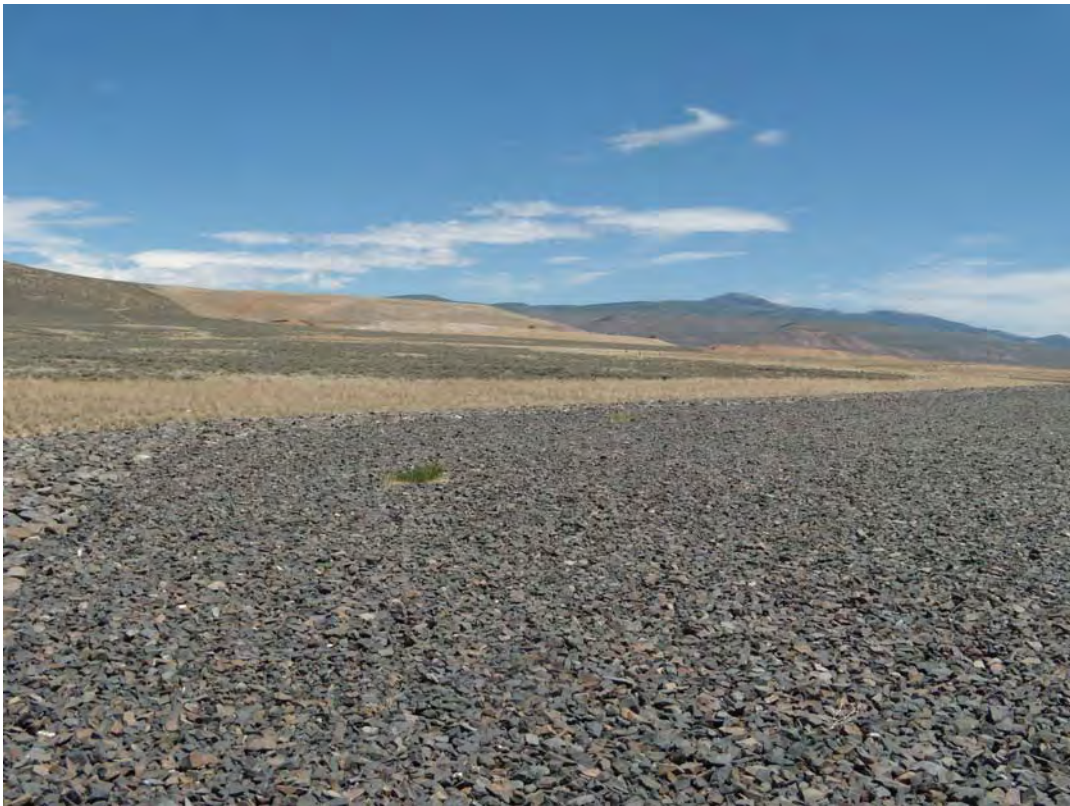
Landfill operations have encroached to within approximately 400 feet of the northeast corner of the DOE property boundary (PL-4). A diversion ditch and catchment basin were constructed on landfill property north of the site. These features were constructed to control runoff and sediment transport onto landfill property. Although landfill activities do not appear to threaten the DOE

disposal site, future inspections will continue to monitor the level of activity occurring near the DOE property boundaries and site-surveillance features (e.g., fences, monitoring wells).

*GUN 6/2010. PL-4. County landfill operations viewed from the disposal cell.*
