## 8.0 Gunnison, Colorado, Disposal Site

### 8.1 Compliance Summary

The Gunnison, Colorado, Uranium Mill Tailings Radiation Control Act (UMTRCA) Title I Disposal Site was inspected on June 2, 2009. The disposal cell and all associated surface water diversion and drainage structures were in good condition and functioning as designed. Six riprap test areas on the cell apron and diversion ditches were visually inspected; no apparent rock degradation was noted when compared to previous photos. Noxious weeds on the disposal site were treated with herbicide in October 2009. No other maintenance needs or cause for a follow-up or contingency inspection was identified.

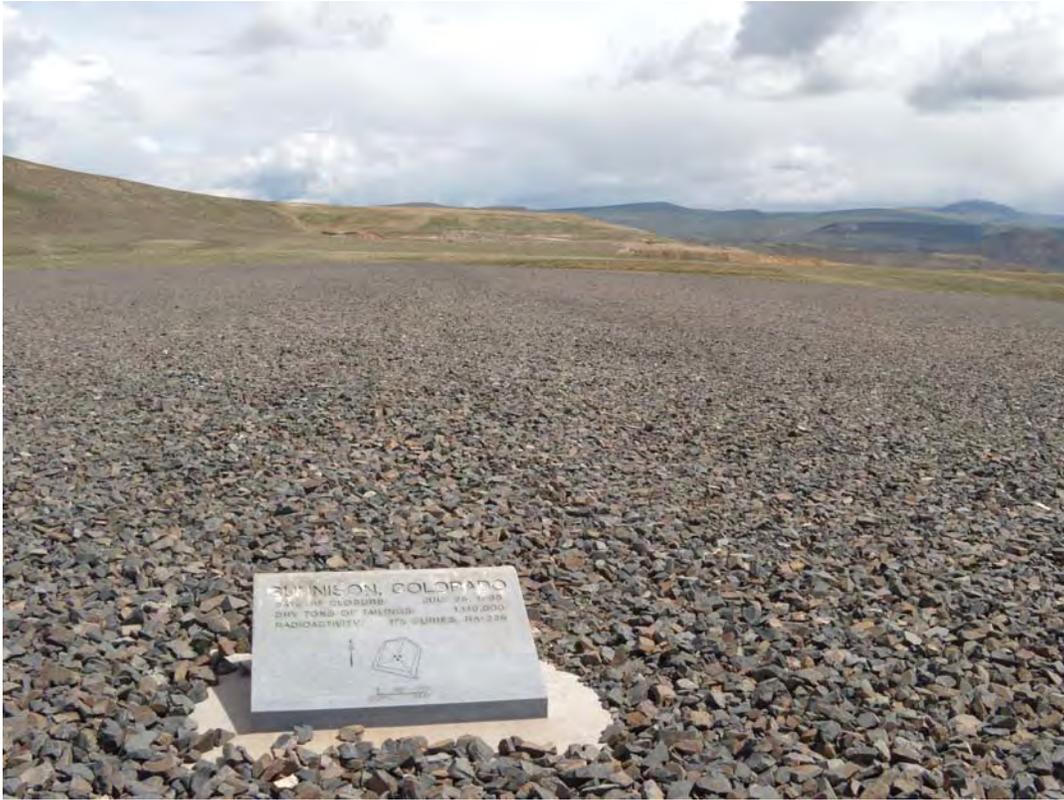
**Top of the Disposal Cell**—The top of the disposal cell was in good condition. There was no evidence of erosion, settling, slumping, or rock degradation (PL–1). Several isolated patches of grass are randomly distributed over the disposal cell cover; however, these shallow-rooted plants are not a cause for concern. Many small indentations continue to be present on the cell cover. The indentations, up to 4 inches across and up to 4 inches deep, appear to have been caused by pronghorn antelope. None of the indentations penetrate the bedding layer under the rock cover, and they are not a cause for concern.

*GUN 6/2009. PL-1. Disposal cell top with site marker SMK-2 in foreground.*

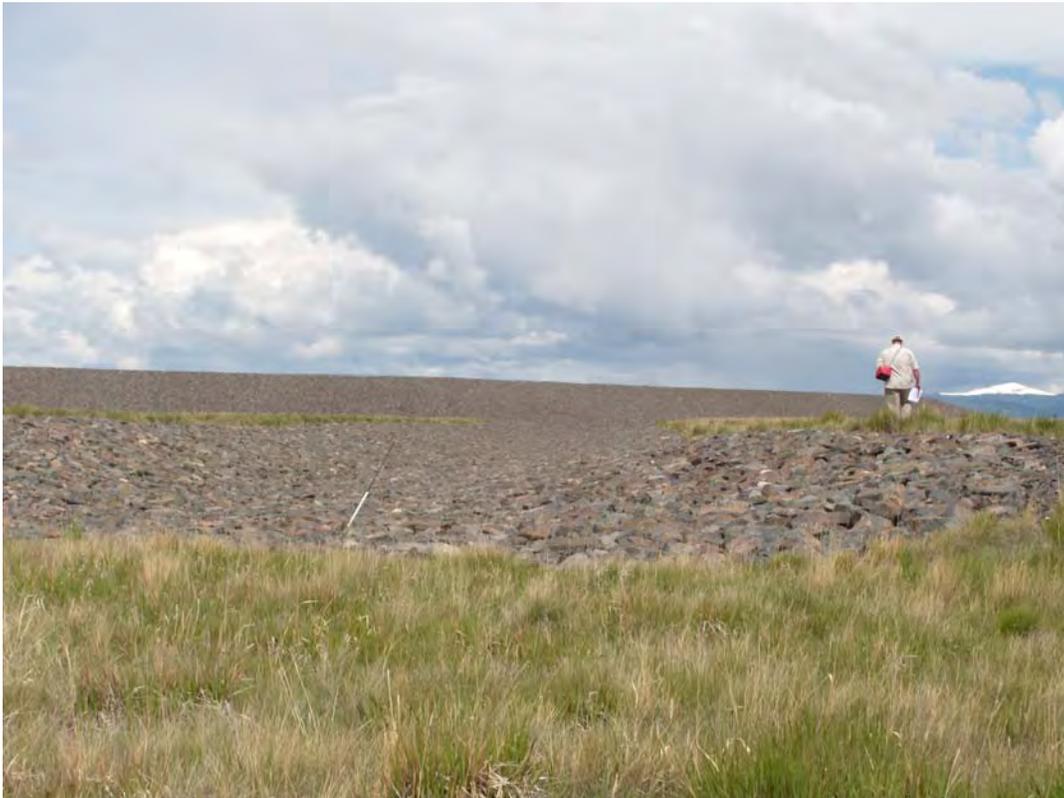
**Side Slopes, Apron, and Diversion Ditches**—The riprap-covered side slopes, apron, and diversion ditches were in good condition (PL–2 and PL–3). No evidence of slumping, settling, rock degradation, or encroachment of vegetation was observed.

*GUN 6/2009. PL-2. East Diversion Channel along the northeast side of the disposal cell.*

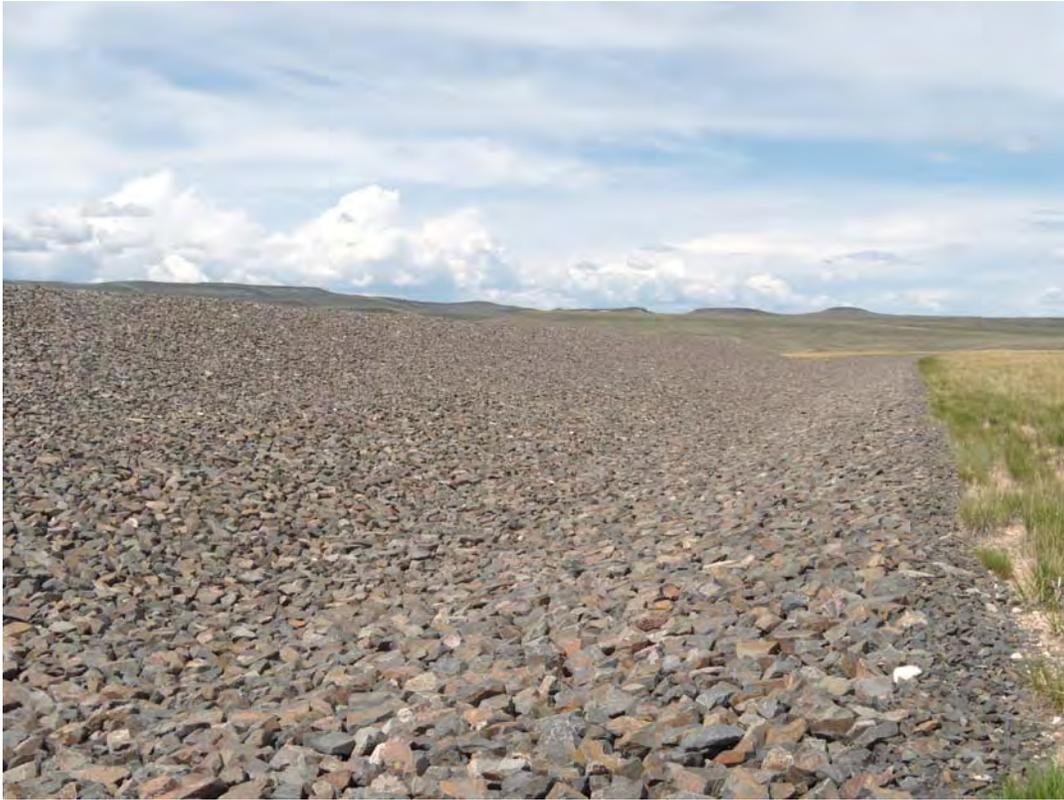
*GUN 6/2009. PL-3. Northwest side slope of the disposal cell.*

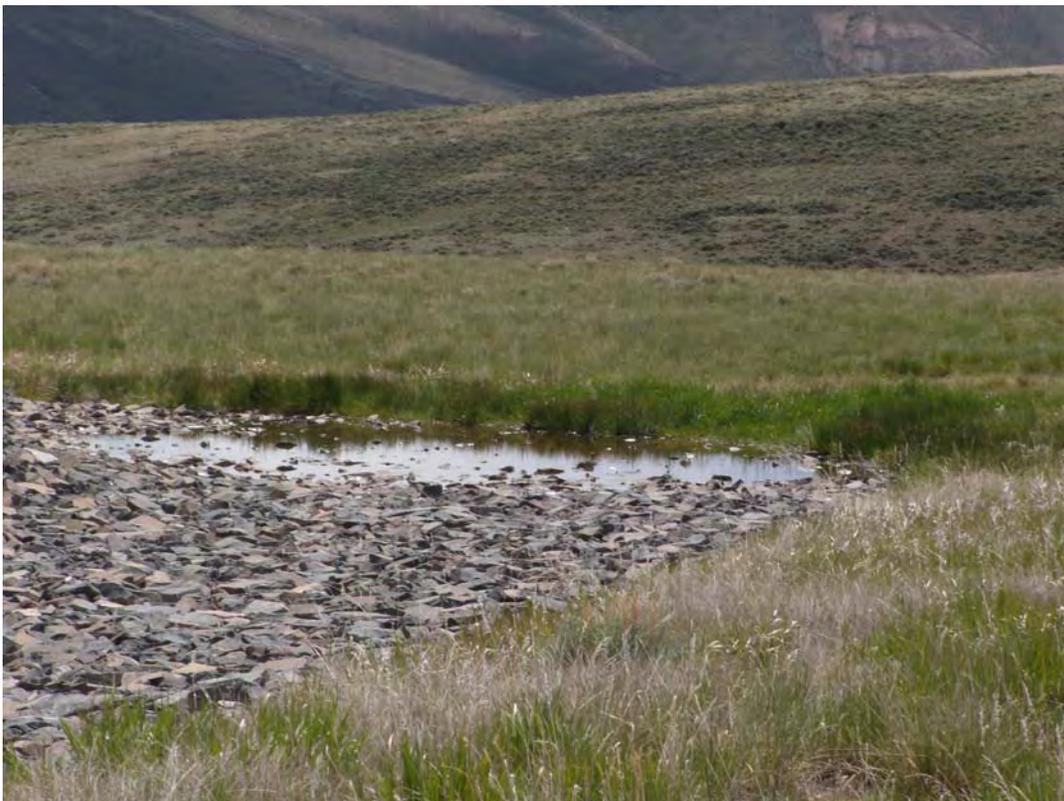
At the southeast corner of the cell apron, water draining from the cell occasionally ponds in a low-lying area along the edge of the riprap. The riparian-type vegetation that has become established in this area indicates that the area retains moisture much of the time. Water collection in this area does not pose a problem because the cell is designed to drain to the southeast, and any water that ponds there is below the elevation of the entombed tailings material. Pondered water was present in the southeast corner of the apron (PL–4).

*GUN 6/2009. PL-4. Ponded water at the southeast corner of the disposal cell.*
