8.0 Gunnison, Colorado, Disposal Site

8.1 Compliance Summary

Figure 8-1. 2014 Annual Inspection Drawing for the Gunnison Disposal Site

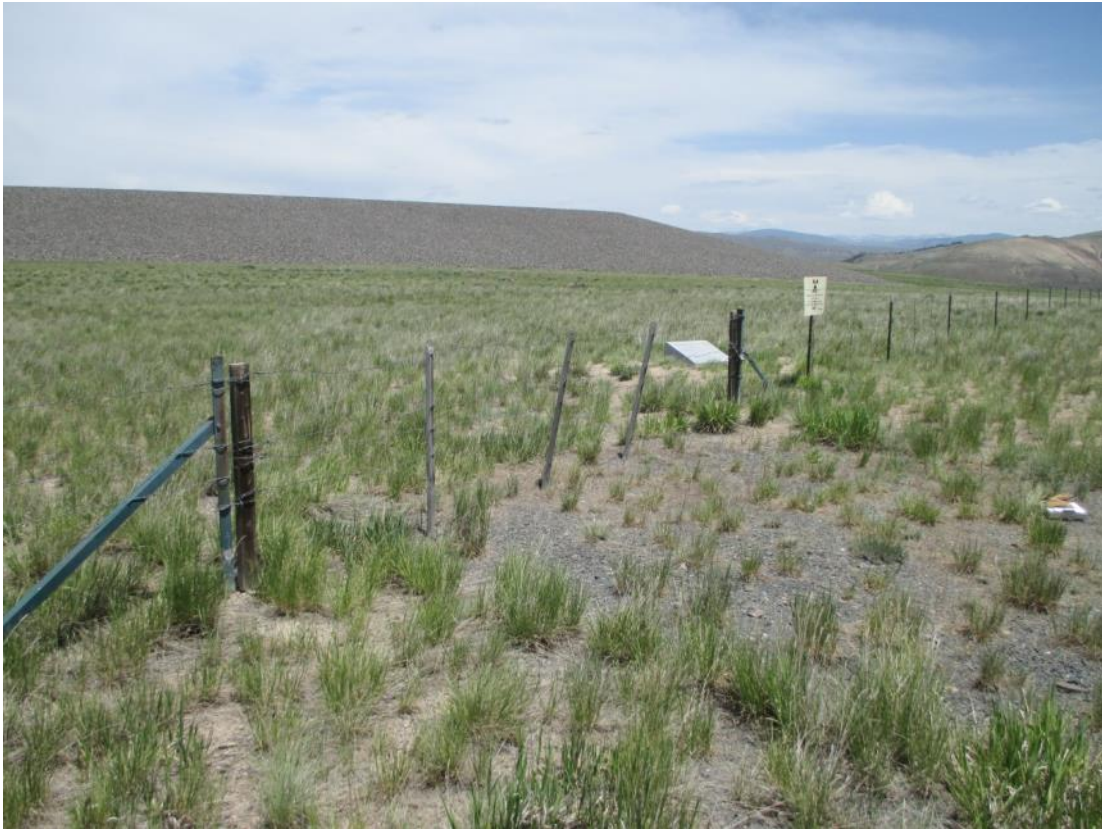
The entrance gate is a barbed-wire gate in the stock fence that surrounds the site. The entrance gate, located along the south portion of the perimeter fence, was secured by a padlock and chain to the adjoining post and was in good condition (PL-1).

GUD 6/2014. PL-1. Site entrance gate.

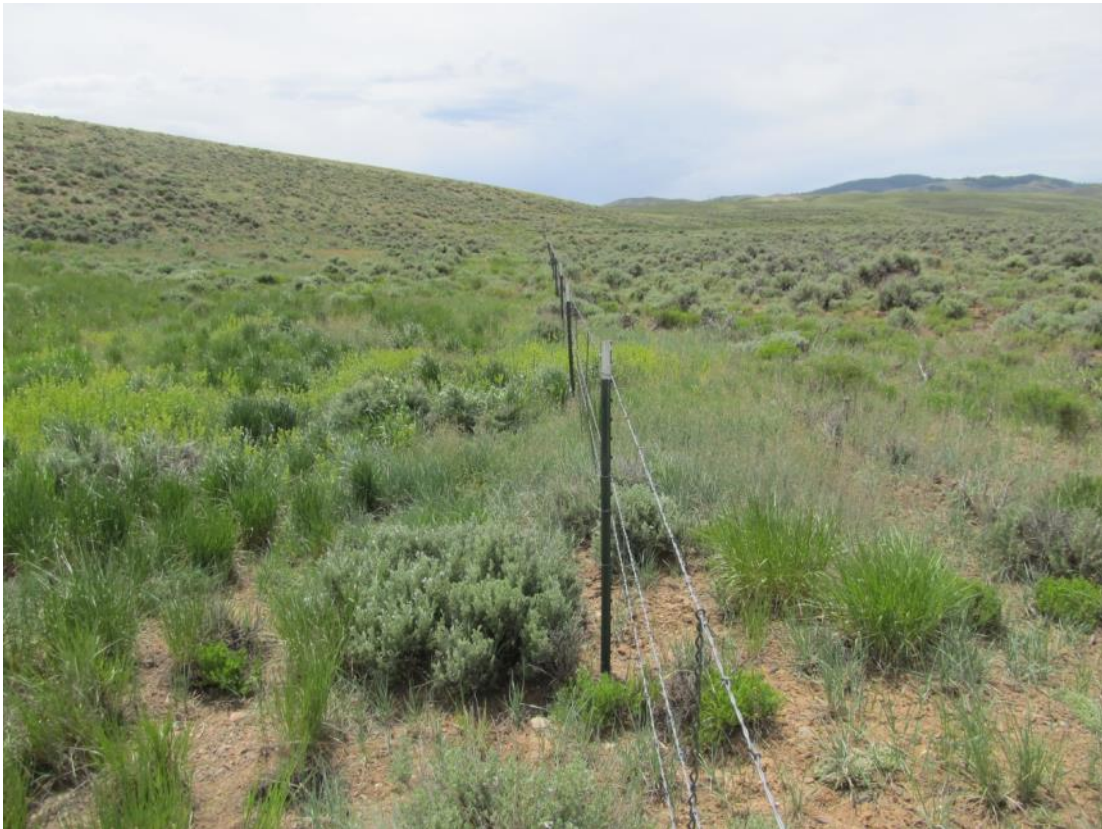
A barbed-wire fence delineates the site; most of it is set along the property boundary. The fence was in good condition (PL-2). Two locked barbed-wire gates—one on the north fence line and the other on the east fence line—provide access to offsite monitoring wells. The gates were locked and in good condition.

GUD 6/2014. PL-2. Perimeter fence along west property boundary.

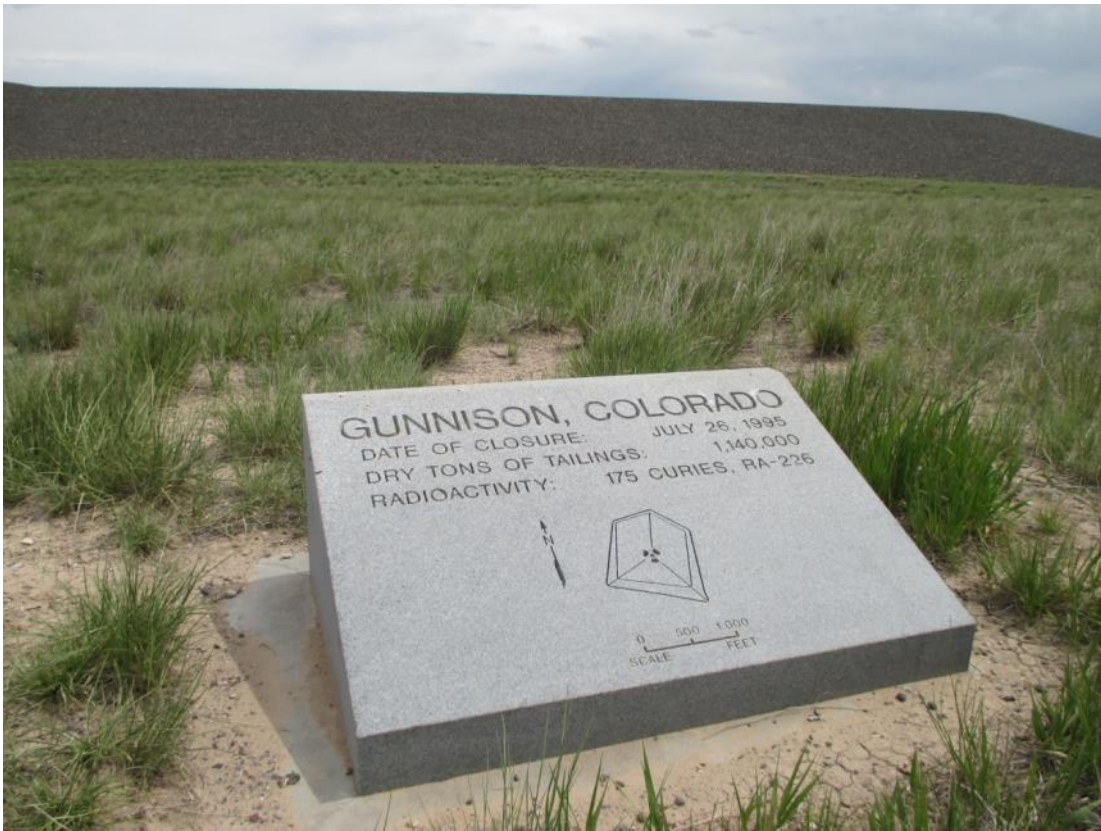
The site has two granite site markers. Site markers SMK-1 (just inside the entrance gate; PL-3) and SMK-2 (on top of the disposal cell) were in excellent condition.

GUD 6/2014. PL-3. Site marker SMK-1.

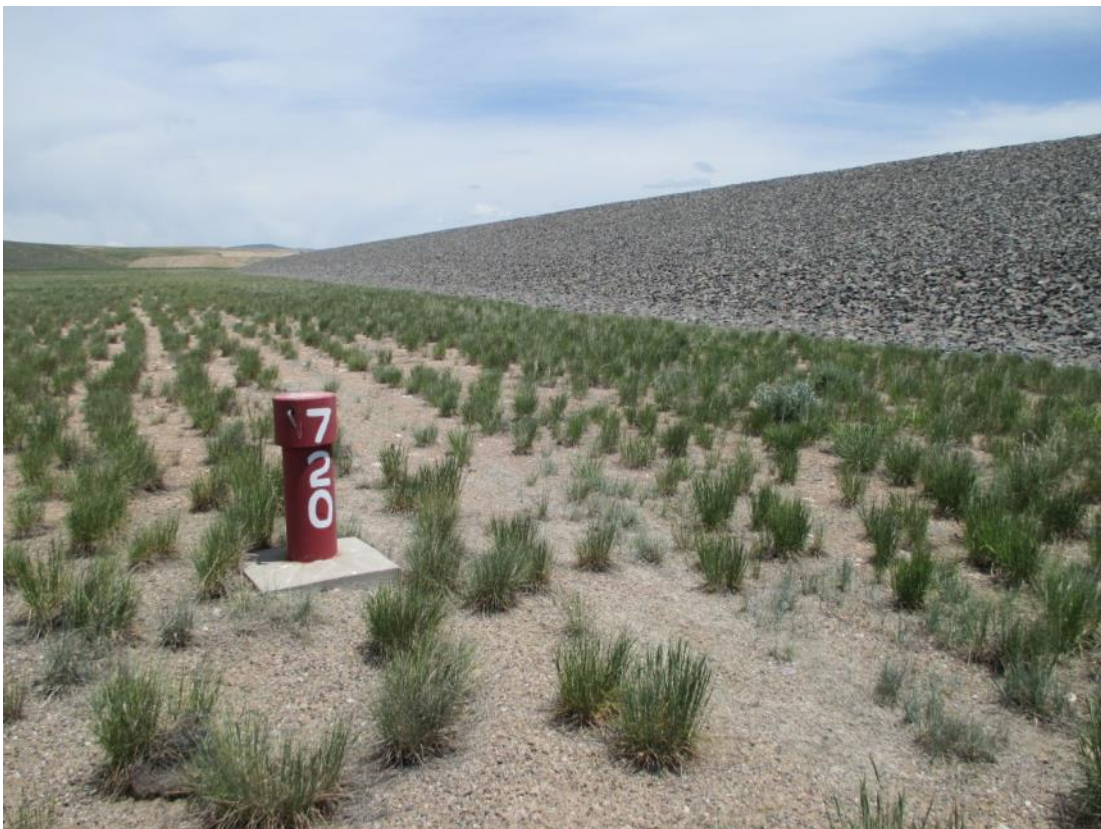
Sixteen wells constitute the groundwater monitoring network for the site. The wells were secure and in excellent condition (PL-4). The Gunnison County landfill operators have placed concrete barriers to protect monitoring well 0716, which is located on landfill property, from landfill activities (PL-5). The edge of a spoil pile is approximately 30 feet from the barriers, and it appeared to be same size as observed during the previous inspection.

GUD 6/2014. PL-4. Monitoring well 0720 near west side of disposal cell.

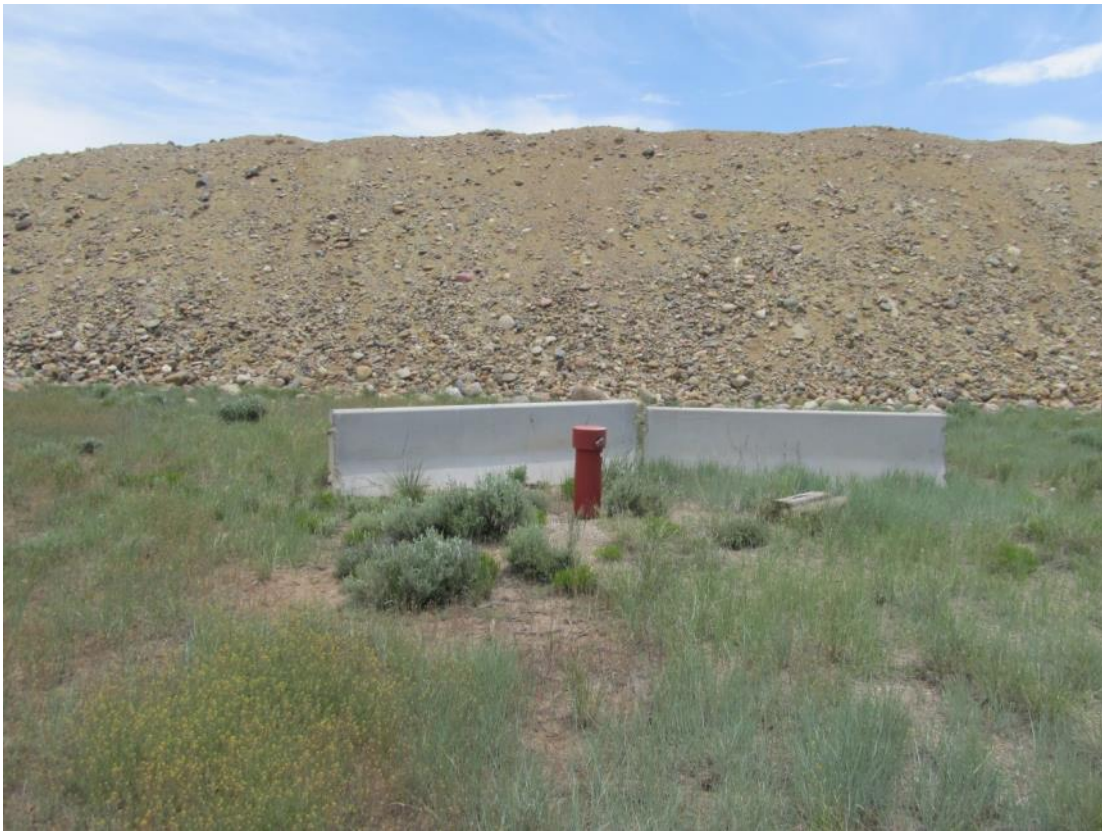
GUD 6/2014. PL-5. Monitoring well 0716 near county landfill spoil pile.

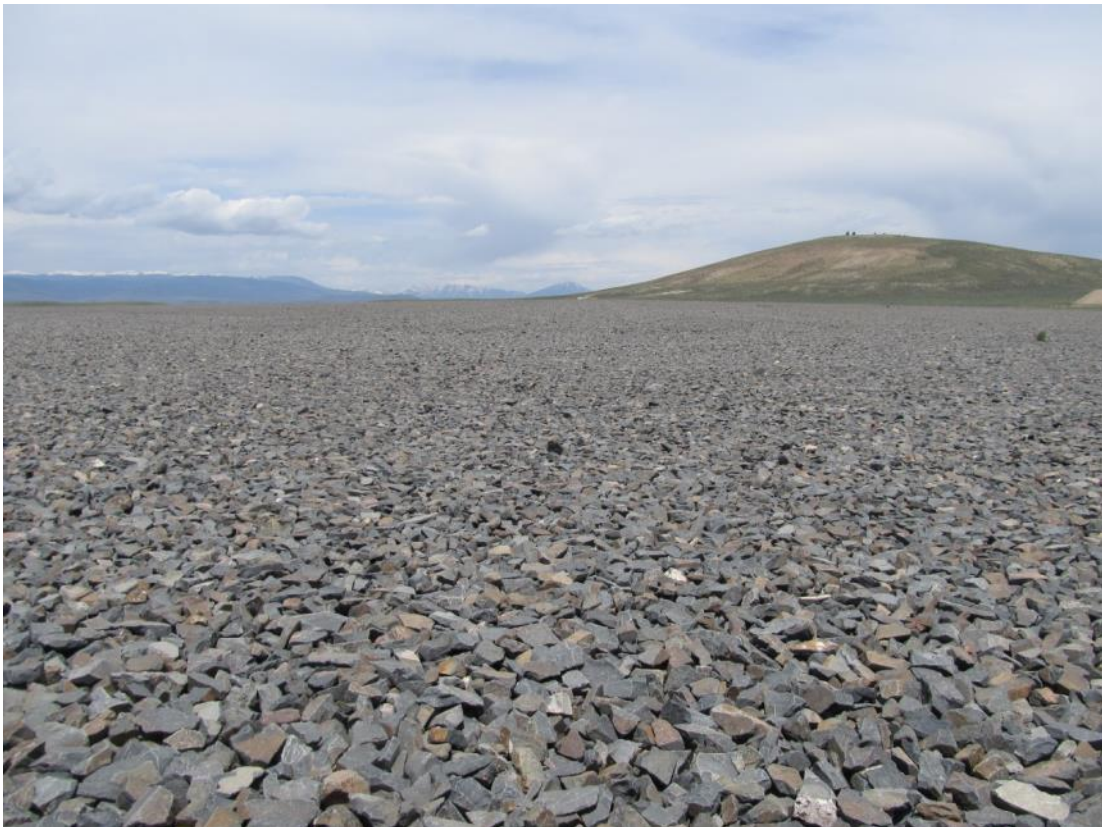
The rock-covered top of the disposal cell was in excellent condition (PL-6). There was no evidence of erosion, settling, slumping, or rock degradation. Several isolated patches of grass are randomly distributed over the disposal cell cover; however, these shallow-rooted plants are not a cause for concern. Two small tree saplings were removed from the cover; no other deep-rooted plants were observed on the disposal cell.

GUD 6/2014. PL-6. Top slope of disposal cell.

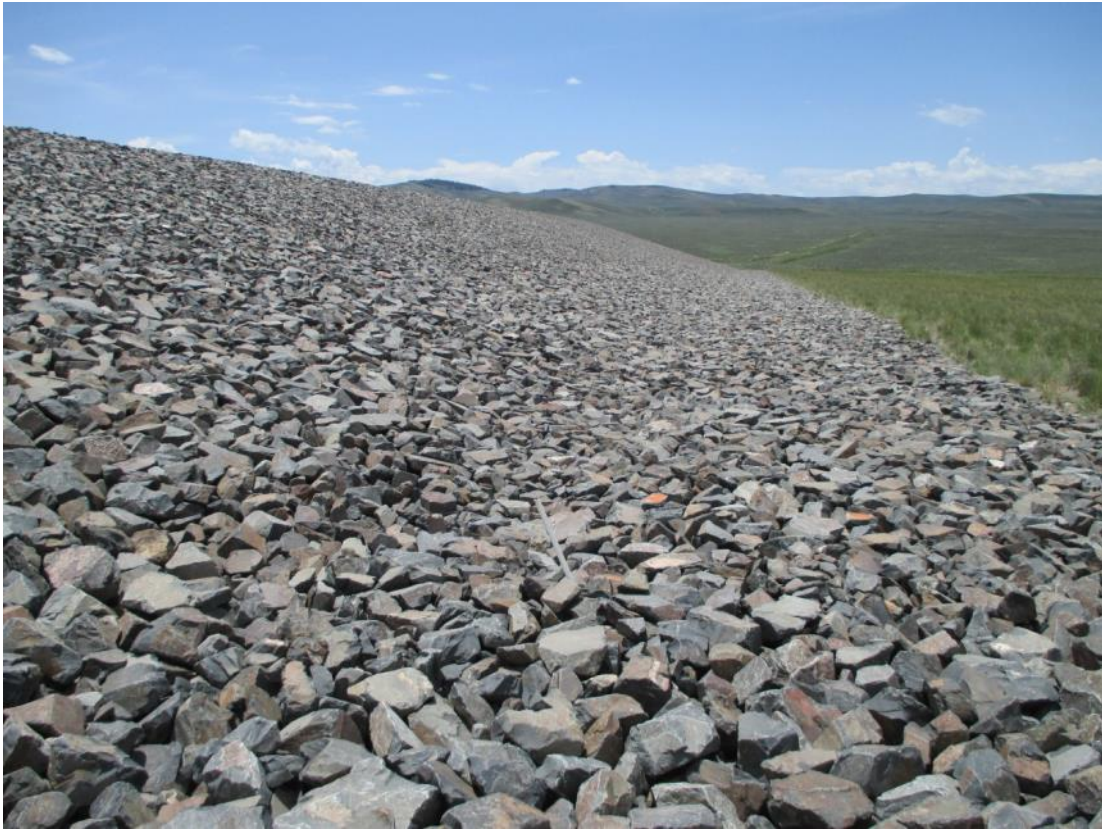
The riprap-covered side slopes, apron, and diversion channels were in good condition (PL-7 and PL-8). No evidence of slumping, settling, rock degradation, or encroachment of vegetation was observed.

GUD 6/2014. PL-7. West side slope and apron of disposal cell; Riprap Test Area No. 3 in foreground.

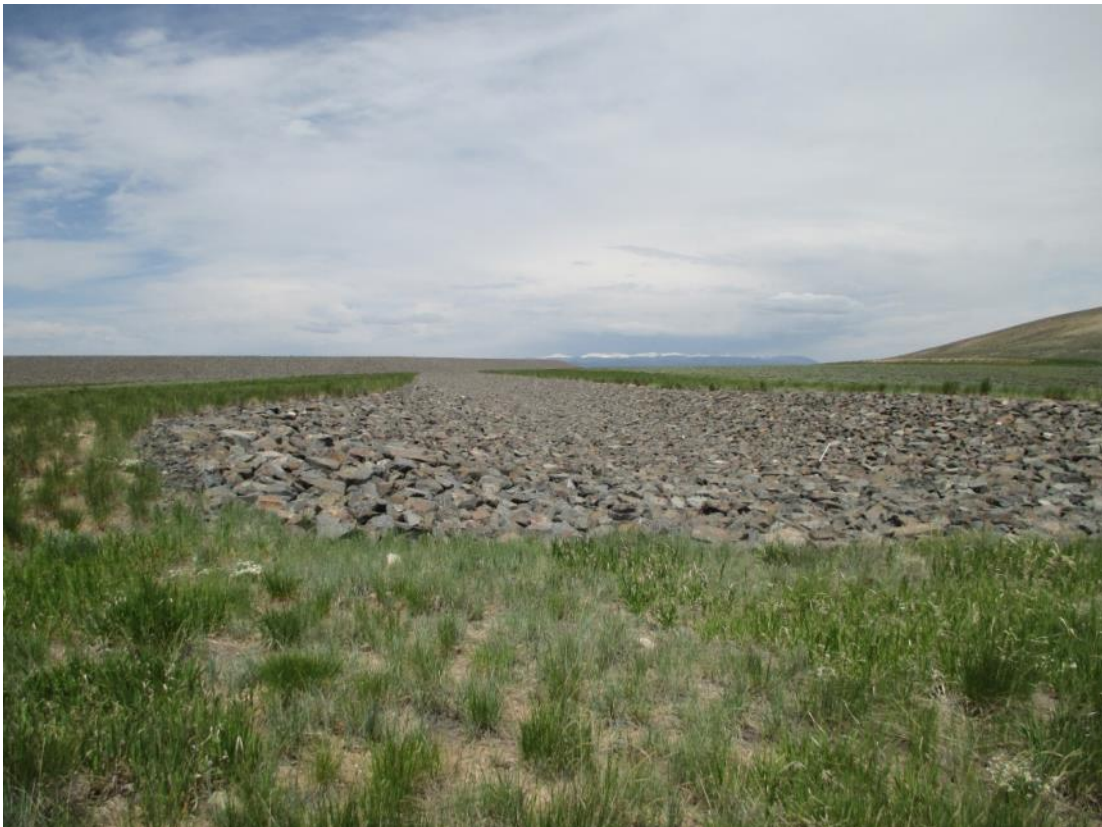
GUD 6/2014. PL-8. East diversion channel.

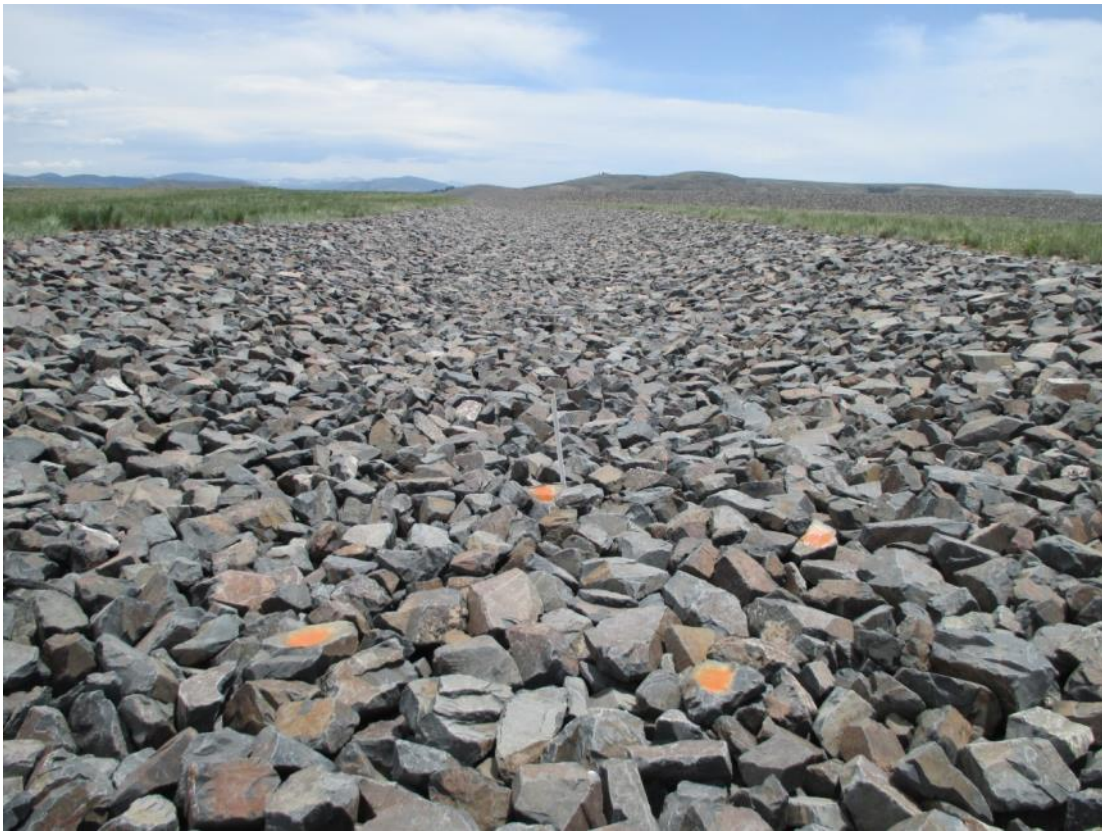
The condition of the riprap in six monitoring test areas was visually inspected. The test areas, each approximately 1 square meter in area, are in critical flow path locations in the apron and diversion channels (PL-9). The corners of each monitoring plot are marked with orange paint; the corners were repainted during the inspection. The riprap in all of the test areas was in excellent condition. When the rocks were compared to the photos taken of them in 2012, there was no evidence that individual rocks had split or otherwise been degraded. Annual photographing and comparing of these test areas was performed through 2002 in accordance with the LTSP; after that, the LTSP requires the test areas to be photographed every 5 years through 2017. The next and final set of photos will be taken in 2017.

GUD 6/2014. PL-9. West diversion channel; Riprap Test Area No. 6 in foreground.

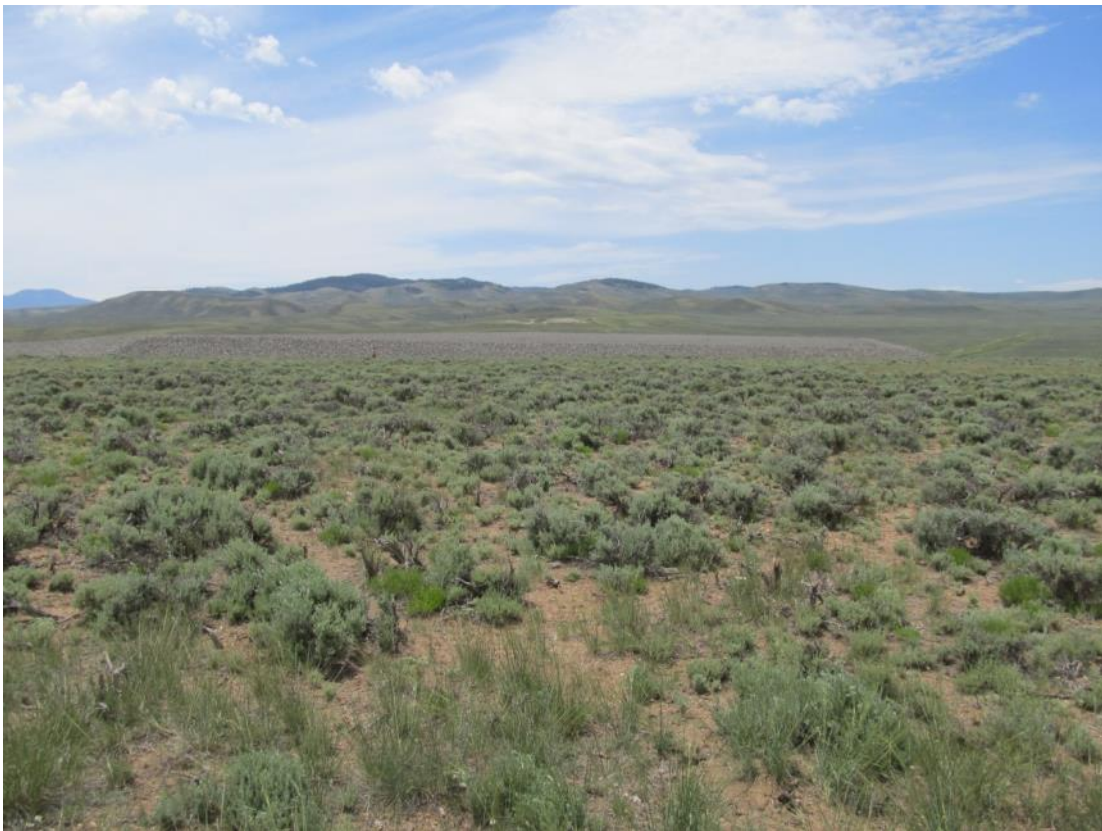
There are reclaimed and undisturbed areas between the disposal cell and the site perimeter. Both types of areas were in good condition (PL-10). No erosion concerns were observed. In general, reclaimed areas have good vegetation coverage, consisting mostly of grass. Shrubs and forbs are much less abundant and less diverse in reclaimed areas than they are in undisturbed areas.

GUD 6/2014. PL-10. Disposal cell and natural vegetation in an undisturbed area.
