8.0 Gunnison, Colorado, Disposal Site

8.1 Compliance Summary

The Gunnison, Colorado, Uranium Mill Tailings Radiation Control Act (UMTRCA) Title I Disposal Site was inspected on July 1, 2015. The disposal cell and all associated surface water diversion and drainage structures were in excellent condition and functioning as designed. Six riprap test areas on the cell apron and diversion ditches were visually inspected; no rock degradation was noted when compared to 2012 photos. Inspectors identified no maintenance needs or cause for a follow-up inspection.

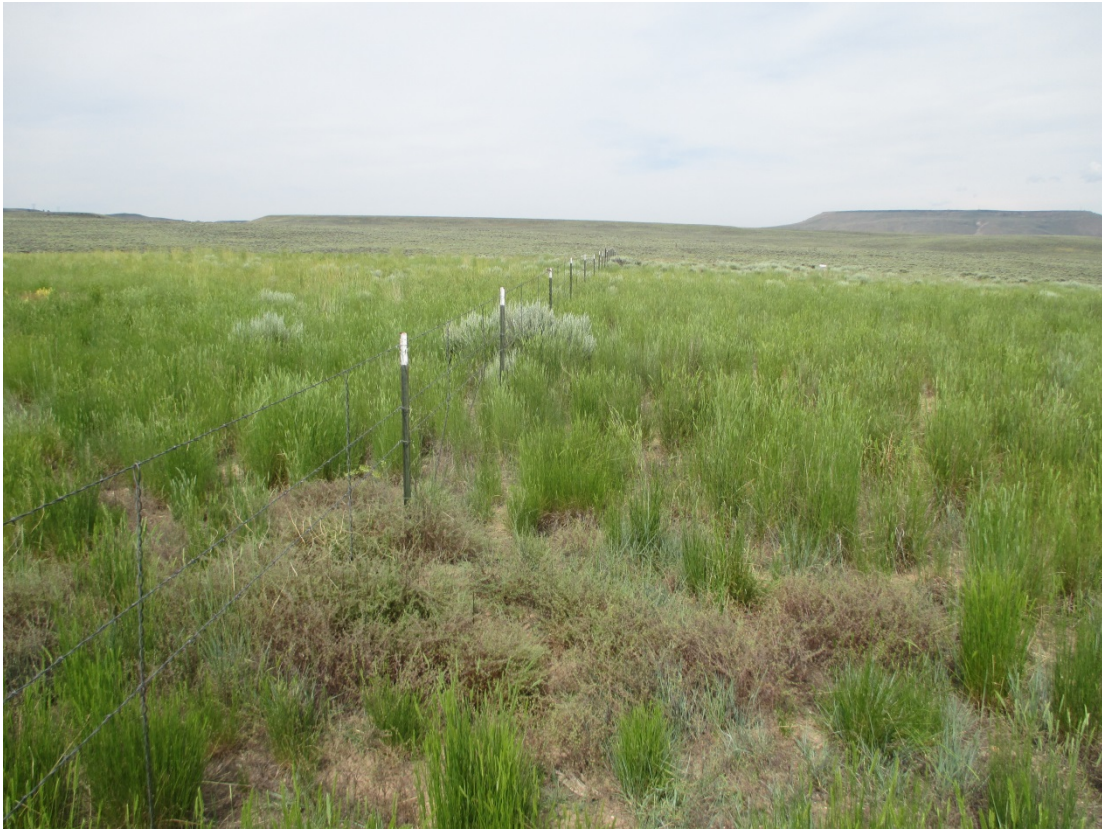
A barbed-wire fence delineates the site; most of it is set along the property boundary. The fence was in good condition (PL-1). Two locked barbed-wire gates—one on the north fence line and the other on the east fence line—provide access to offsite monitoring wells. The gates were locked and in good condition.

GUD 6/2015. PL-1. Perimeter fence.

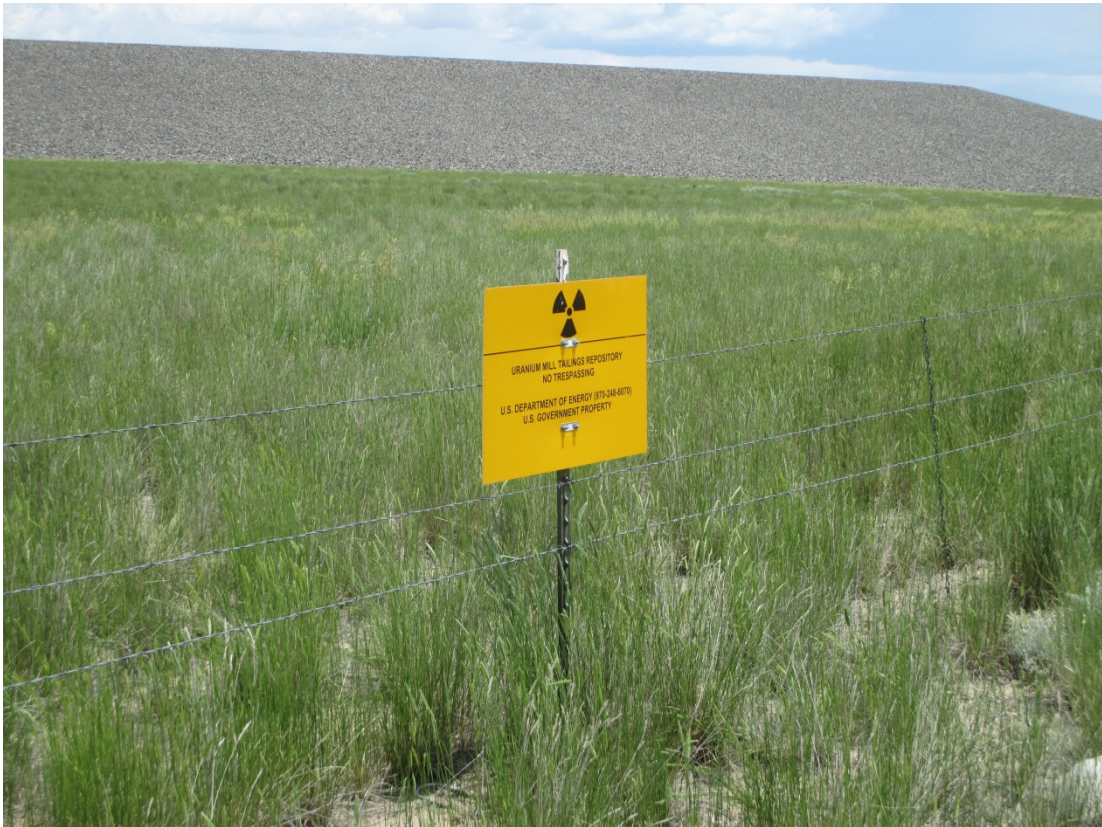
Forty-five perimeter signs are bolted to the perimeter fence posts. Several perimeter signs have bullet holes but were legible. The other signs were in good condition (PL-2).

GUD 6/2015. PL-2. Perimeter sign P1.

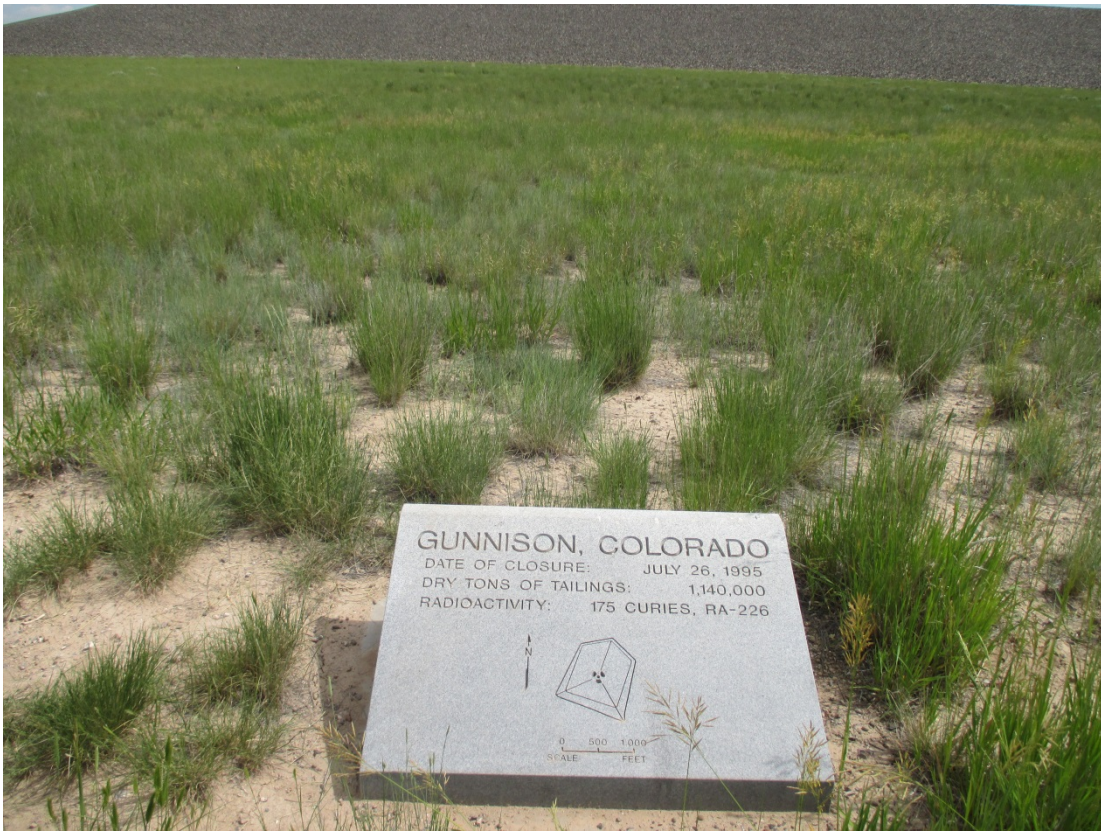
The site has two granite site markers. Site markers SMK-1 (just inside the entrance gate; PL-3) and SMK-2 (on top of the disposal cell) were in excellent condition.

GUD 6/2015. PL-3. Site marker SMK-1.

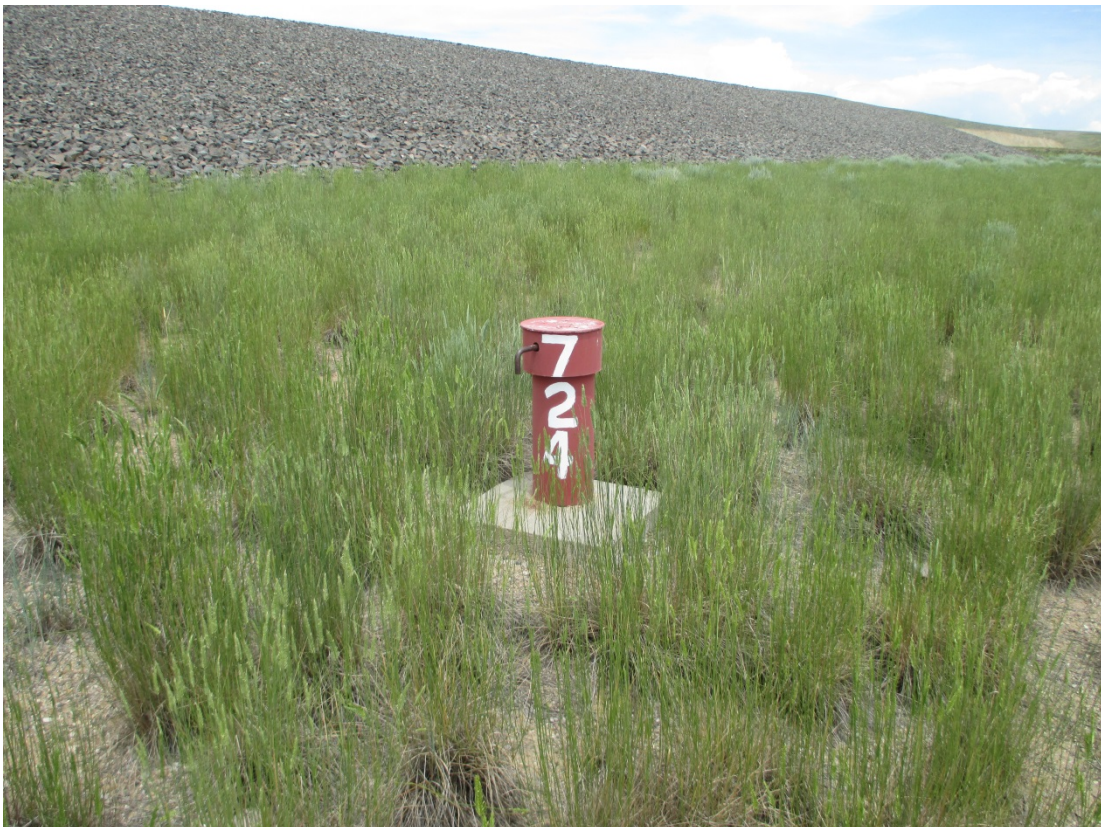
Sixteen wells constitute the groundwater monitoring network for the site. The wells were secure and in excellent condition (PL-4). The Gunnison County landfill operators have placed concrete barriers to protect monitoring well 0716, which is located on landfill property, from landfill activities (PL-5). The edge of the spoil pile was approximately 10 feet from the barriers, and was

GUD 6/2015. PL-4. Monitoring well 0724 near east side of disposal cell.

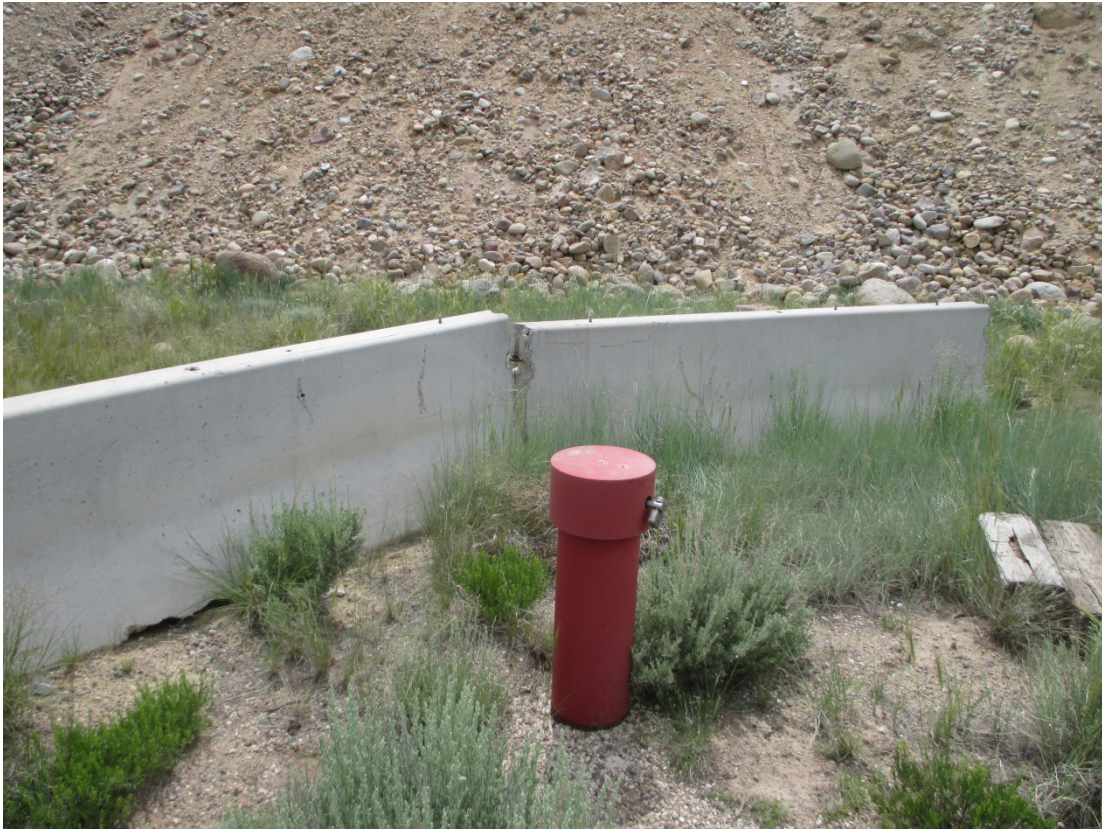
GUD 6/2015. PL-5. Monitoring well 0716 protected by jersey barriers.

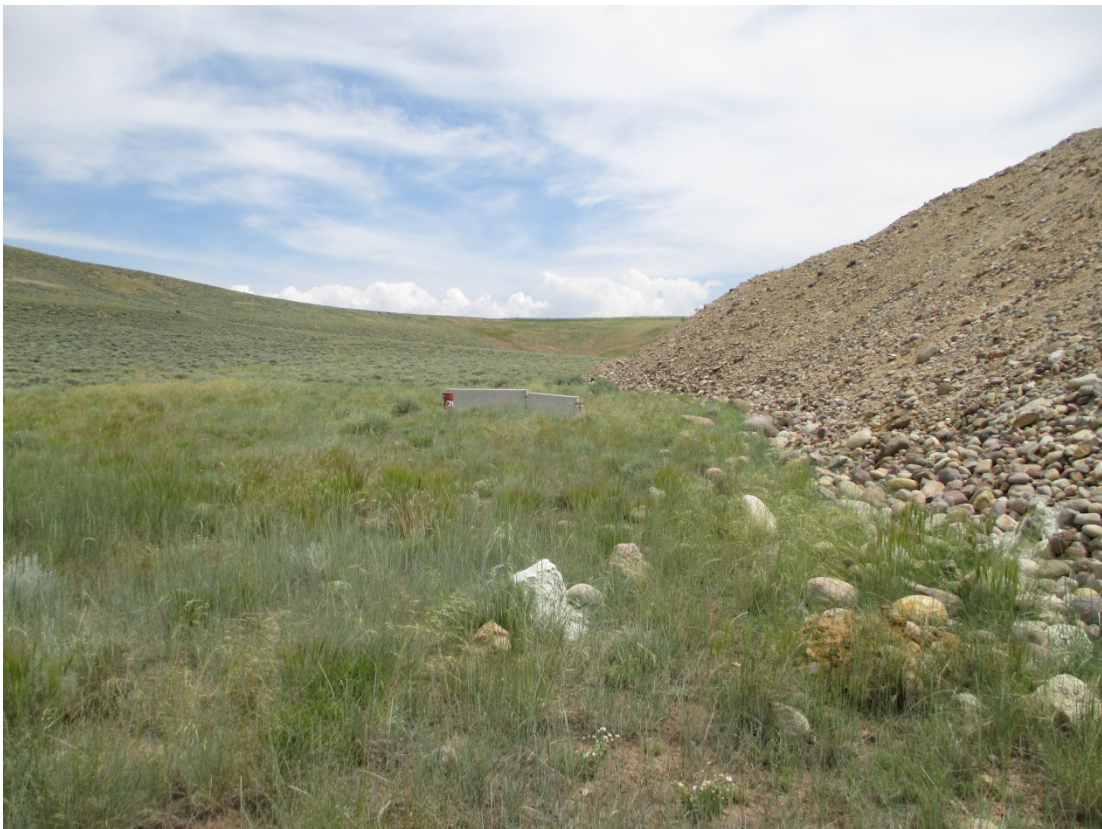
observed to be encroaching on the monitoring well (PL-6). In previous inspections the pile was observed to be approximately 30 feet from the barriers. The Office of Legacy Management will contact the Gunnison County Landfill to notify them of the proximity of the spoils pile to monitoring well 0716.

GUD 6/2015. PL-6. Monitoring well 0716 near west edge of landfill cover material spoil pile.

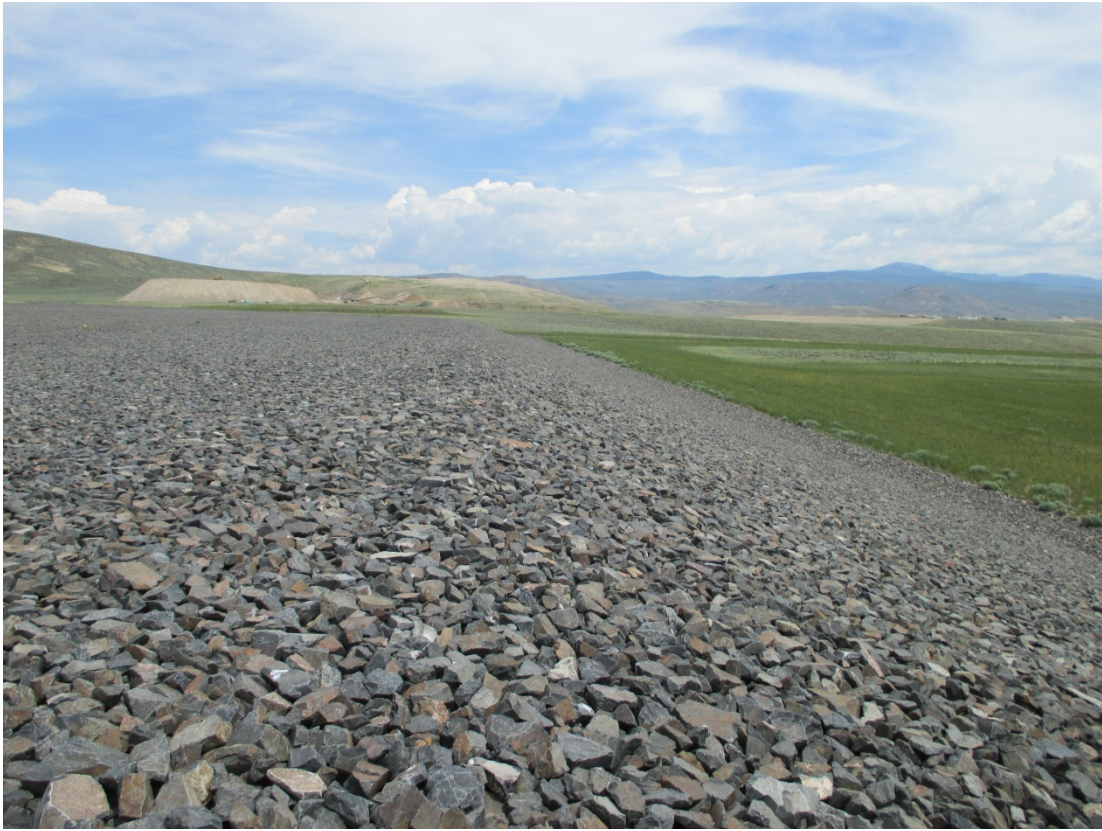
The riprap-covered side slopes, apron, and diversion channels were in good condition (PL-7 and PL-8). No evidence of slumping, settling, rock degradation or encroachment of vegetation was observed.

GUD 6/2015. PL-7. Side slope near the southeast side of disposal cell.

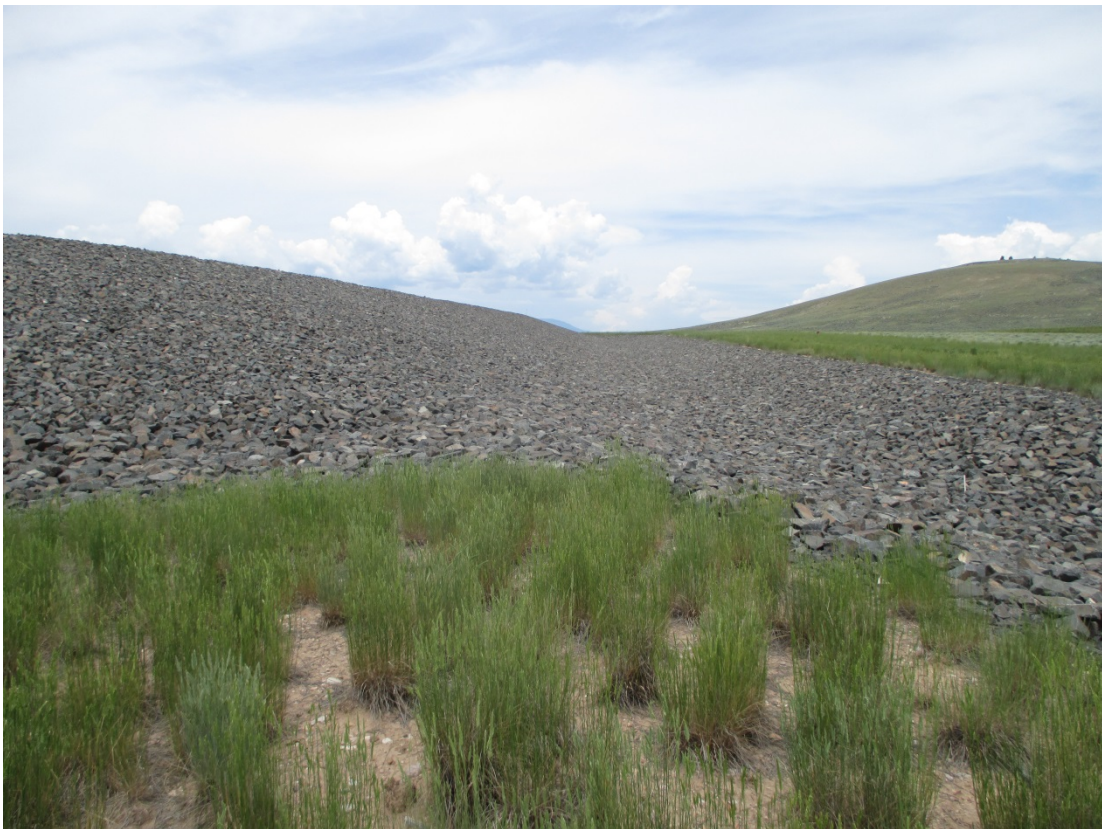
GUD 6/2015. PL-8. Diversion channel along the northeast side of disposal cell.

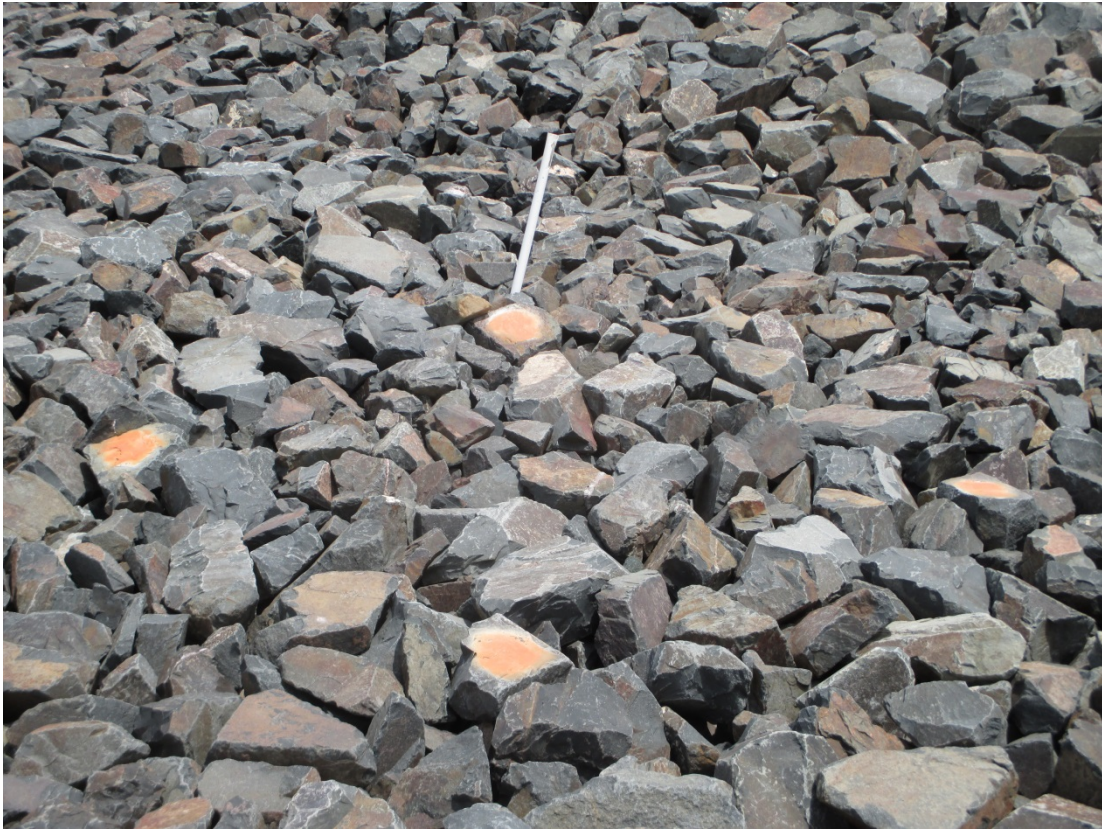
- 8A The condition of the riprap in six monitoring test areas was visually inspected. The test areas, each approximately 1 square meter in area, are in critical flow-path locations in the apron and diversion channels (PL-9). The corners of each monitoring plot are marked with orange paint; the corners were repainted during the inspection. The riprap in all of the test areas was in excellent condition. When the rocks were compared to the photos taken in 2012, there was no evidence that individual rocks had split or otherwise been degraded. Annual photographing and comparing of these test areas was performed through 2002 in accordance with the LTSP; after that, the LTSP requires the test areas to be photographed every 5 years through 2017. The next and final set of photos will be taken in 2017.

GUD 6/2015. PL-9. Riprap test area No. 3.

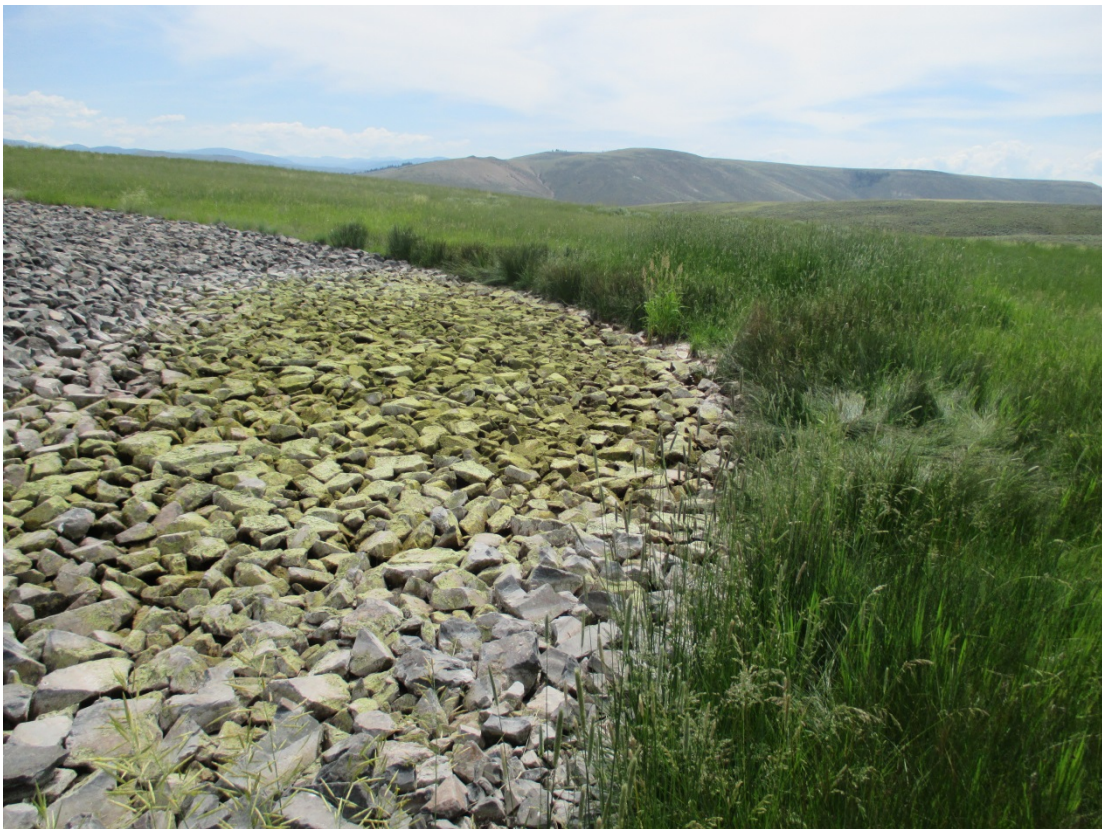
Precipitation runoff from the cell occasionally ponds in a low-lying area along the southeast corner of the cell. The riparian-type vegetation that has become established there indicates that the area retains moisture much of the time. Water collection in this area does not pose a problem because the cell is designed to drain to the southeast, and any water that ponds there is below the elevation of the encapsulated tailings material. Standing water and moss rock cover was observed within the southeast side of the apron during this inspection (PL-10); however, it is not cause for concern given the recent increased number of rain events.

GUD 6/2015. PL-10. Standing water and moss coverage along the southeast side of disposal cell apron.

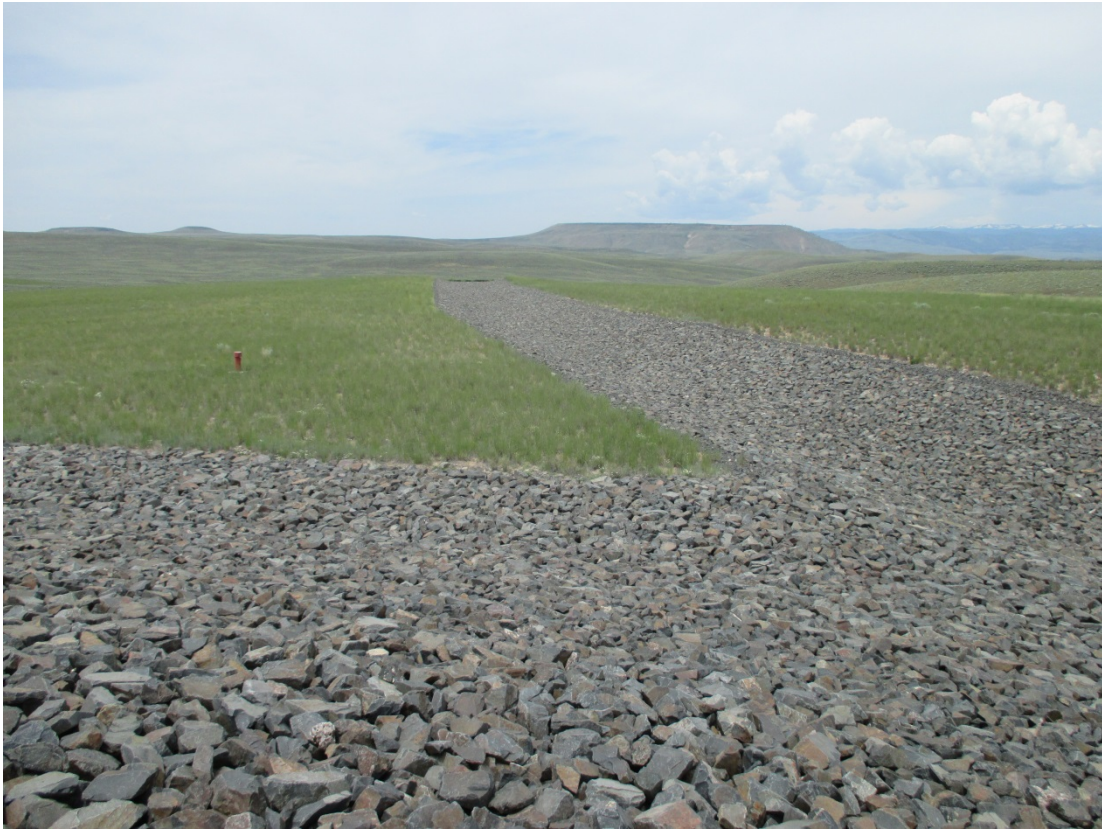
There are reclaimed and undisturbed areas between the disposal cell and the site perimeter. Both types of areas were in good condition (PL-11). No erosion concerns were observed. In general, reclaimed areas have good vegetation coverage, consisting mostly of grass. Shrubs and forbs are much less abundant and less diverse in reclaimed areas than they are in undisturbed areas.

GUD 6/2015. PL-11. Revegetated area near the northwestern side of disposal cell.
