8.0 Gunnison, Colorado, Disposal Site

The U.S. Department of Energy (DOE) Office of Legacy Management (LM) conducted the Gunnison, Colorado, Uranium Mill Tailings Radiation Control Act (UMTRCA) Title I Disposal Site (site) inspection on September 4, 2019. No cause for a follow-up inspection was identified.

The site, 6 miles southeast of Gunnison, Colorado, was inspected on September 4, 2019. The inspection was conducted by J. Lobato and D. Atkinson of the Legacy Management Support

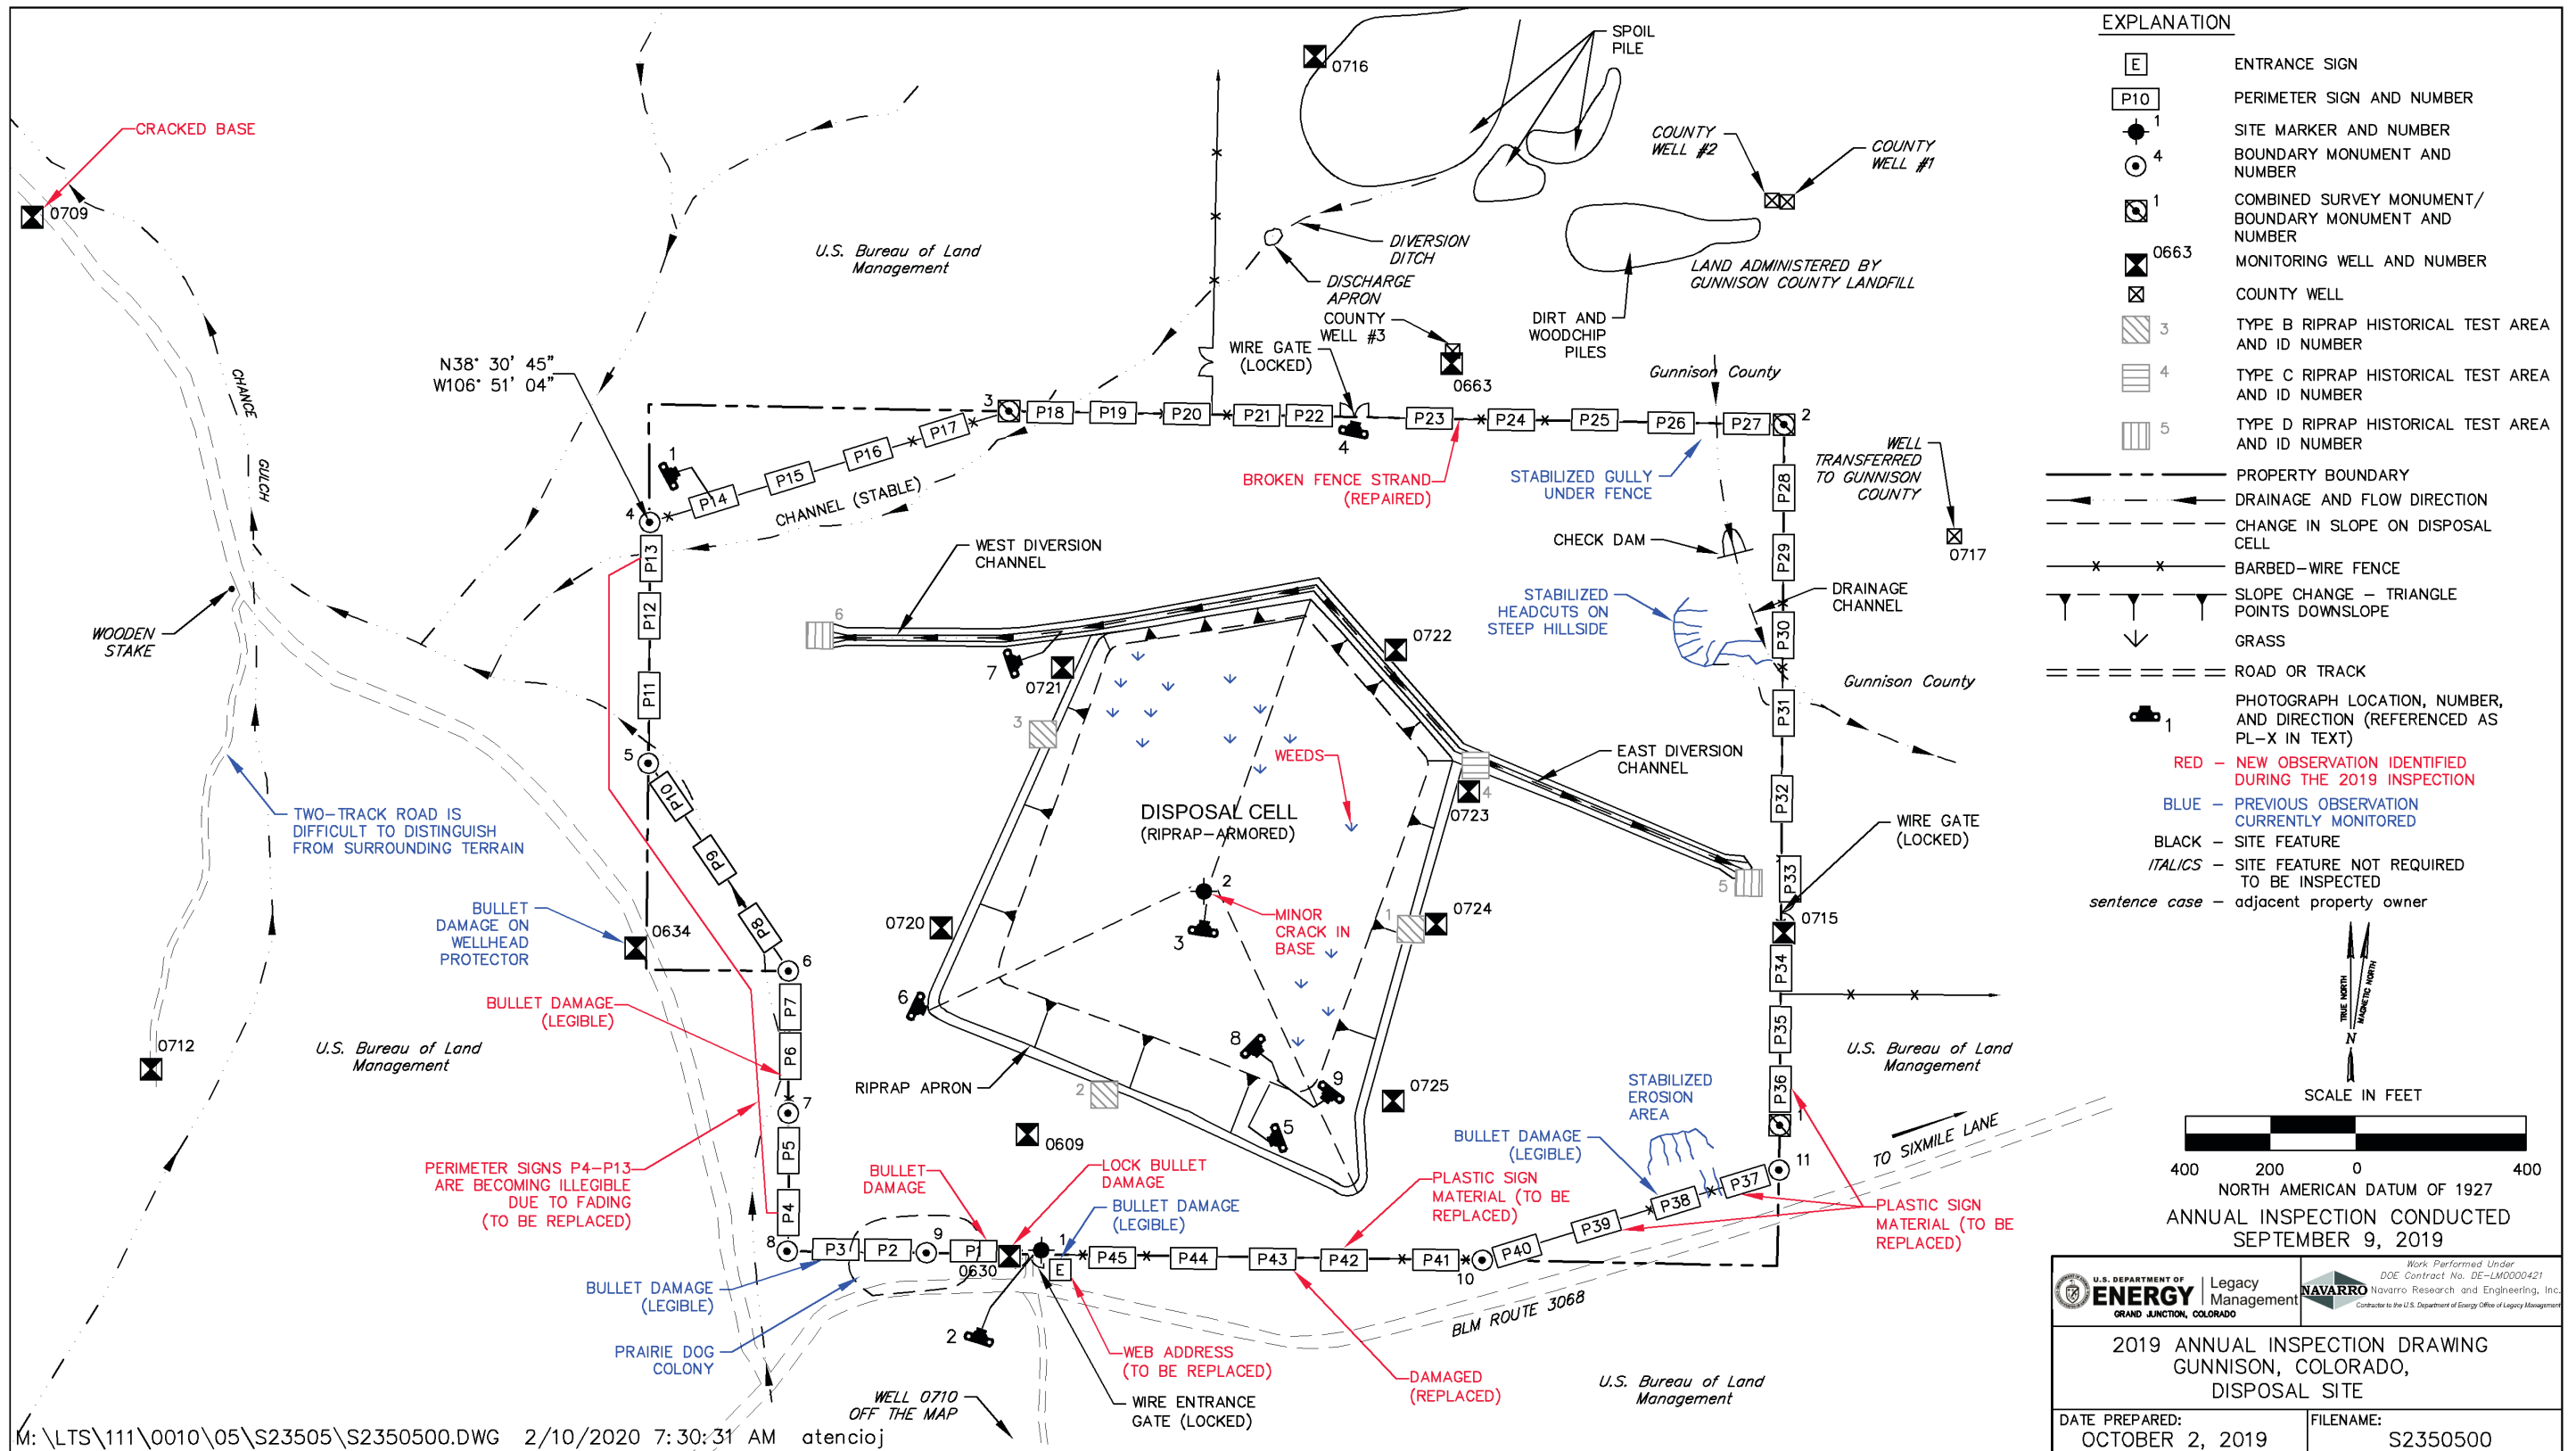
Figure 8-1. 2019 Annual Inspection Drawing for the Gunnison, Colorado, Disposal Site

Figure 8-1 shows the locations of site features in black, including site surveillance features and inspection areas. Site features that are present but not required to be inspected are shown in italic font. Observations from previous inspections that are currently monitored are shown in blue text, and new observations identified during the 2019 annual inspection are shown in red. Inspection results and recommended maintenance activities associated with site surveillance features are included in the following subsections. Photographs to support specific observations are identified in the text and in Figure 8-1 by photograph location (PL) numbers. The photographs and photograph log are presented in Section 8.10.

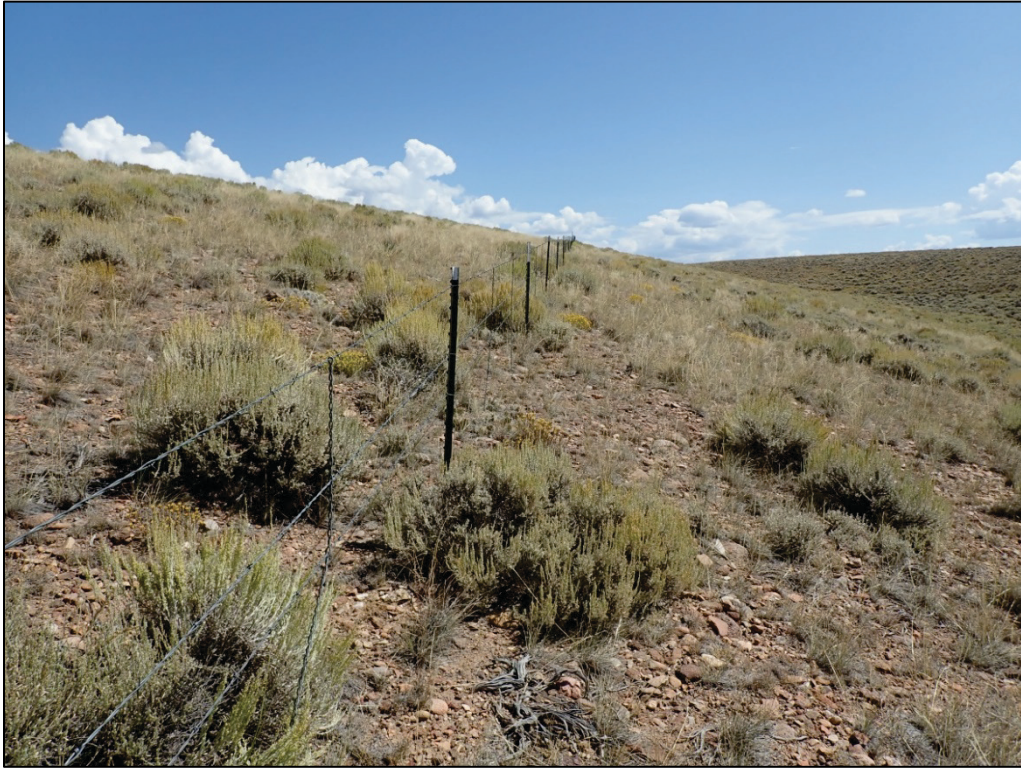
PL-1. North Fence Line

A three-strand barbed-wire perimeter fence encloses the site; most of it is set along the property boundary (PL-1). The perimeter fence was intact except for one location along the north fence line (near boundary sign P24) with a broken strand that was repaired during the inspection.

A broken fence strand along the north fence line (near boundary sign P24) was identified and repaired during the inspection. Perimeter signs P42, P39, P37, and P36 are constructed of plastic and will be replaced with metal signs at the next inspection. Perimeter signs P4–P13 along the west fence line are becoming illegible due to fading and will be replaced within the next couple of years. No other maintenance needs were identified.

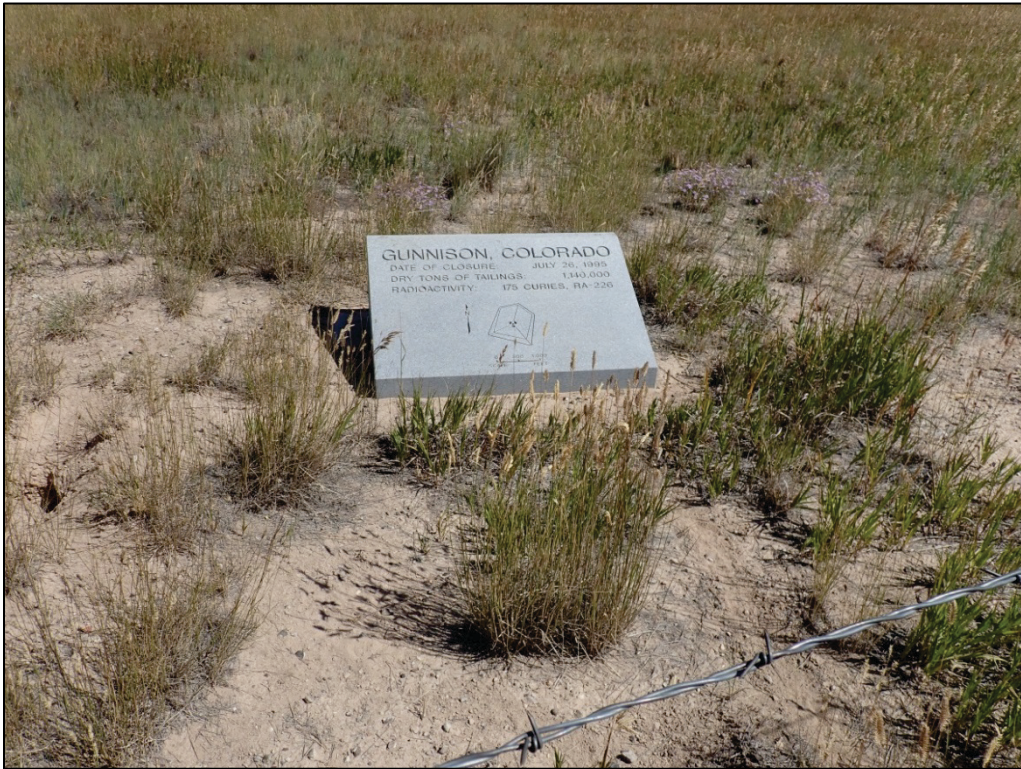
PL-2. Site Marker SMK-1

The site has two granite site markers. Site marker SMK-1 is just inside the entrance gate (PL-2), and site marker SMK-2 is on the top slope of the disposal cell. The base of SMK-2 has a small, insignificant crack and remains stable (PL-3). No maintenance needs were identified.

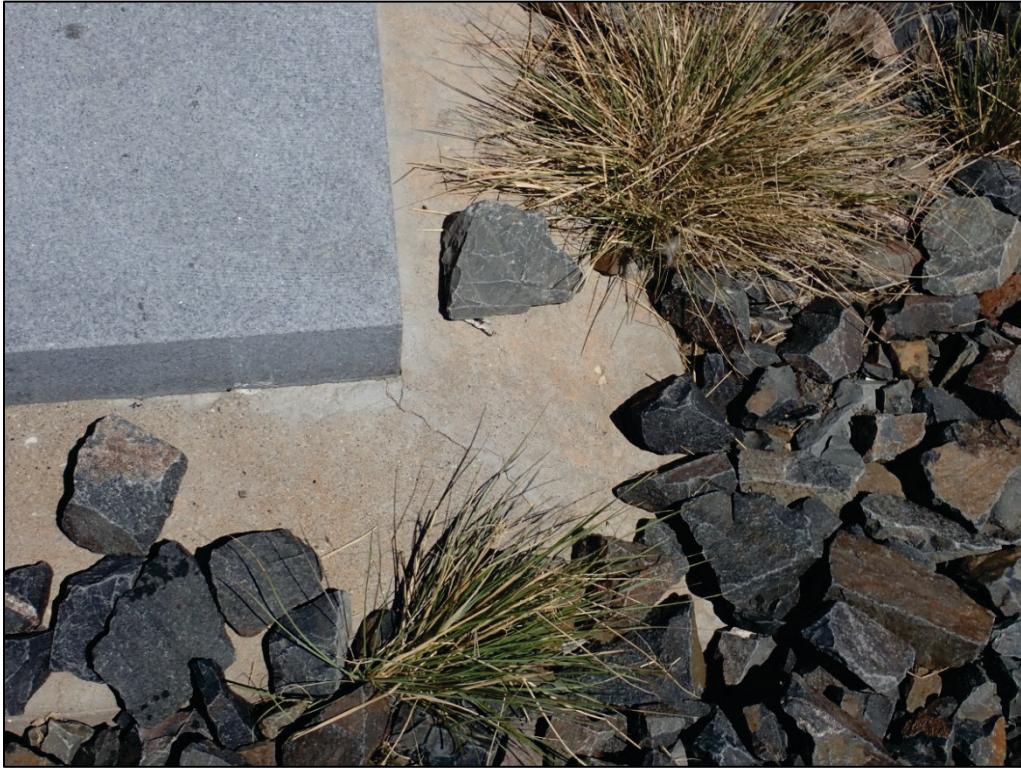
PL-3. Small Crack in Base of Site Marker SMK-2

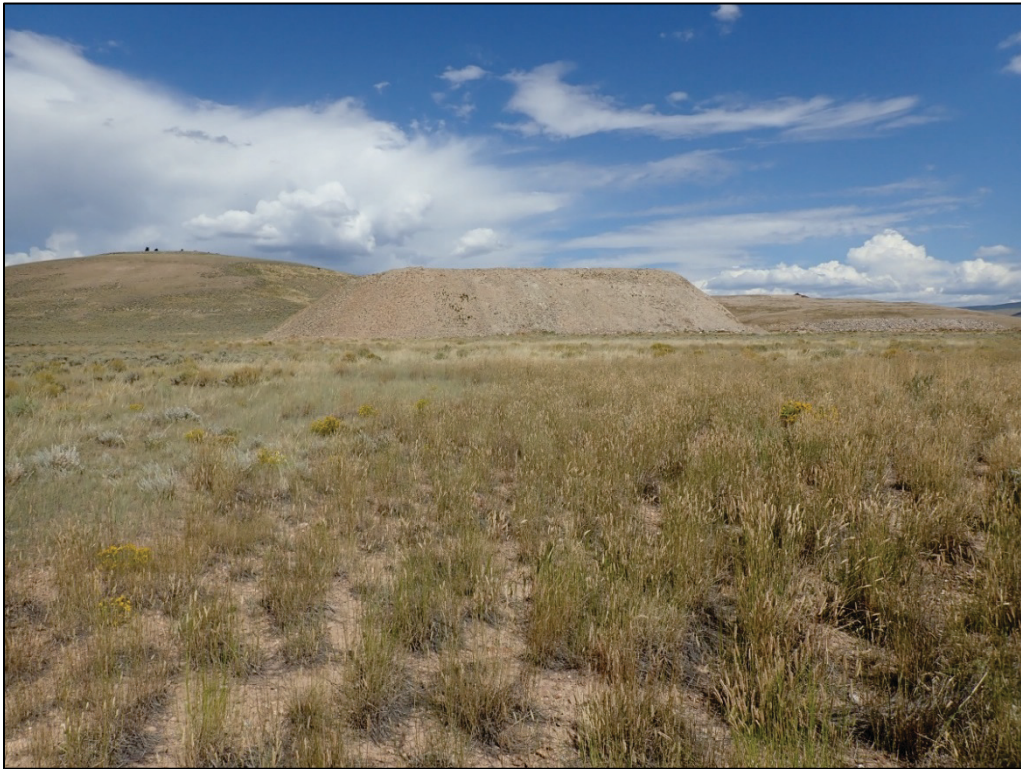
PL-4. Gunnison County Landfill Operations

The site has 16 groundwater monitoring wells. The wellhead protectors were locked and properly labeled. Bullet damage is present on the lock of monitoring well 0630 and on the wellhead protector of monitoring well 0634. However, both wells are secure, and no maintenance is required. Gunnison County landfill operators have placed concrete barriers to protect monitoring well 0716, which is on landfill property, from landfill activities. The edge of an adjacent spoil pile (PL-4), although close to the concrete barriers, does not impair access to monitoring well 0716. The base of monitoring well 709 is cracked but remains stable. Inspectors will continue to monitor these features. No maintenance needs were identified.

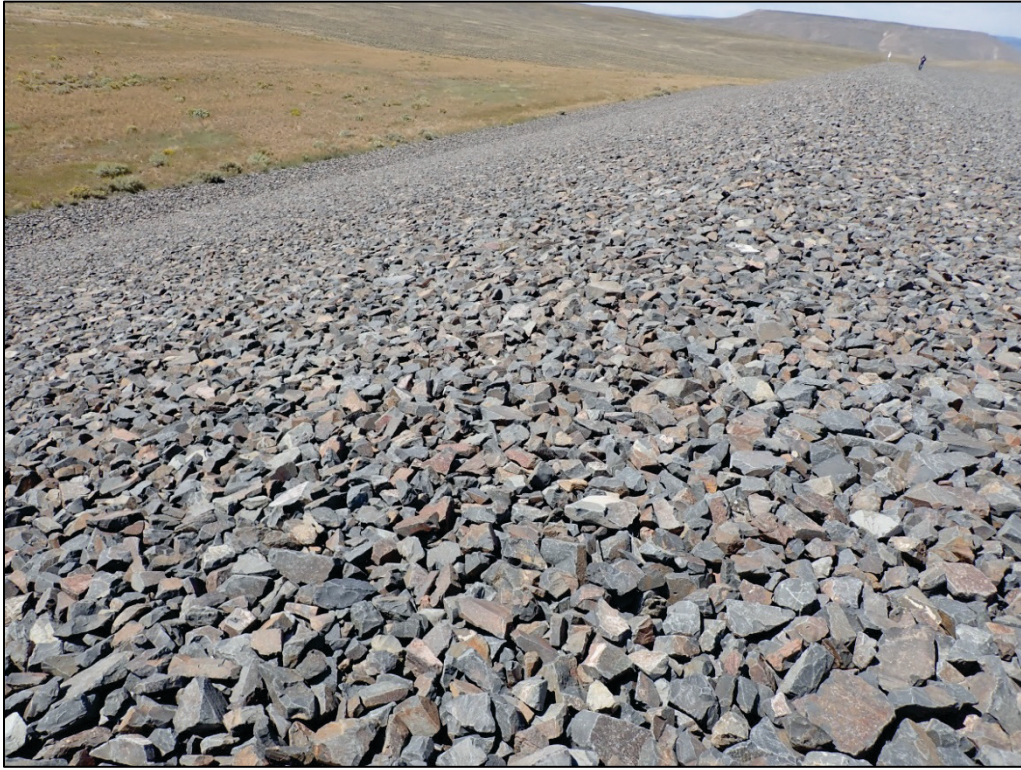
PL-5. South Side Slope of Disposal Cell

Basalt riprap armors the disposal cell side slopes (PL-5), an apron to collect and divert precipitation runoff from the disposal cell (PL-6), and two diversion channels to protect the disposal cell from precipitation run-on (PL-7). There was no evidence of settling, slumping, erosion, or any other modifying process that might affect the integrity of the disposal cell side slopes, apron, or diversion channels. Six rock-monitoring test areas were last inspected during the 2017 annual inspection; monitoring is no longer required in accordance with the LTSP because no rock degradation had been observed.

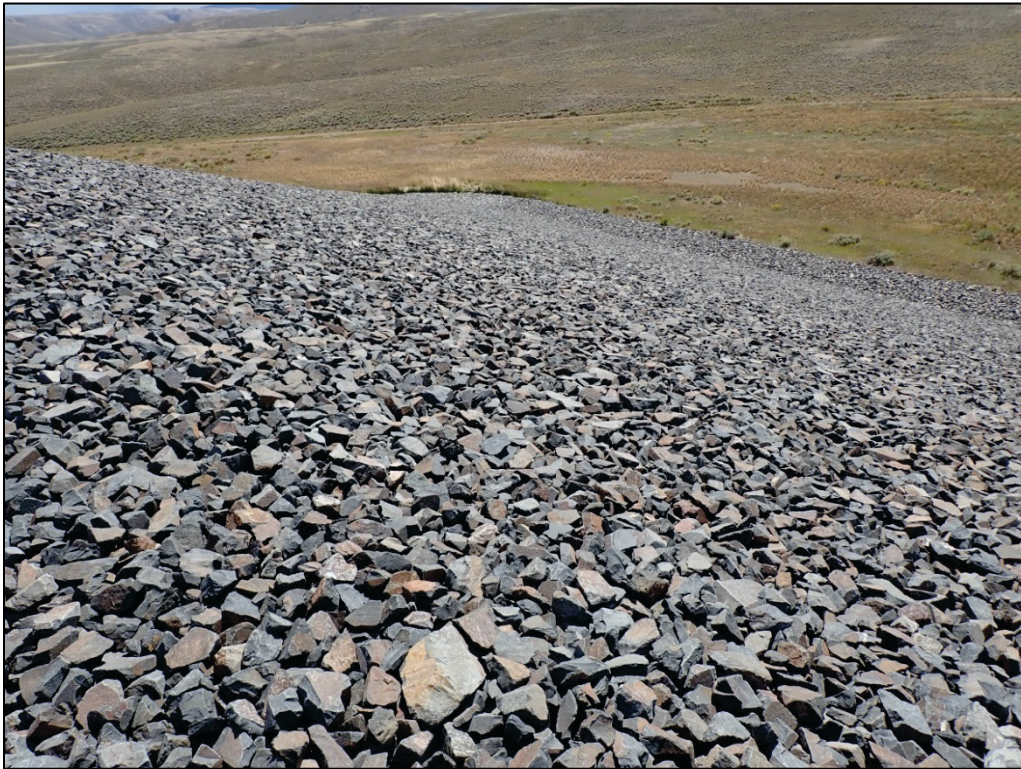
PL-8. Southeast Corner of Disposal Cell

Precipitation runoff from the disposal cell occasionally ponds in a low-lying area at the southeast corner of the disposal cell; standing water was not present at the time of the inspection (PL-8). The riparian-type vegetation that has become established there indicates that the area retains moisture. Water collection in this area does not pose a problem because the disposal cell surfaces

are designed to drain to the southeast, and any water that ponds there is below the elevation of tailings placed under the engineered cover. No maintenance needs were identified.

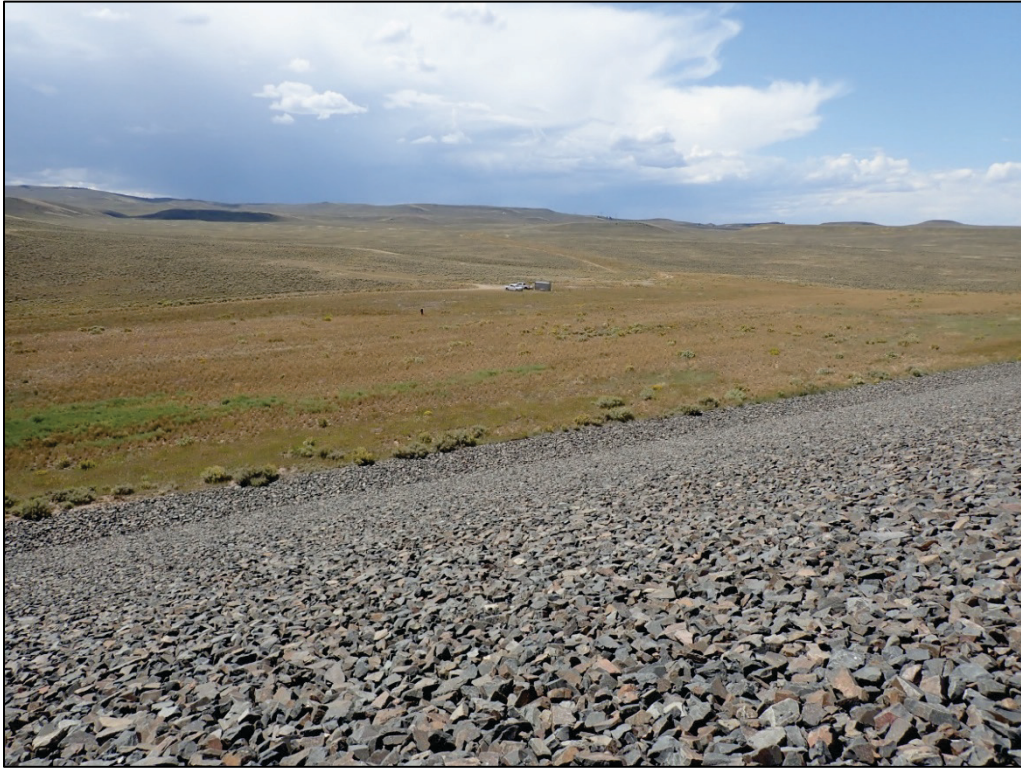
PL-9. Reclaimed Area Along South Fence Line

Reclaimed and undisturbed areas comprise the area between the disposal cell and the site boundary (PL-9). In general, the vegetation in the reseeded, reclaimed areas consists of well-established grass; native plants are much less abundant and less diverse in reclaimed areas than they are in undisturbed areas. Former erosion areas continue to be stable and are naturally revegetating with native plant species. No maintenance needs were identified.
