11.0 Maybell, Colorado, Disposal Site

11.1 Compliance Summary

The Maybell, Colorado, Uranium Mill Tailings Radiation Control Act (UMTRCA) Title I Disposal Site was inspected on July 31, 2008. The disposal cell and all associated surface water diversion and drainage structures were in excellent condition and functioning as designed. The Long-Term Surveillance Plan (LTSP) was revised and submitted to NRC to reflect a correction made to the property boundary along the north and northwest portion of the site; relocation of boundary monuments is planned for 2009. Several breaks were found in the perimeter fence, and cattle were grazing on site; the local rancher was contacted, the cattle were removed, and repairs to the fence were made. Additional fence damage caused by wildlife will be repaired in 2009. A mining claim stake found at the base of the disposal cell is considered a “nuisance claim” because protection of the disposal cell is provided through the NRC general license. Groundwater monitoring is not required at this site. Deep-rooted plants on the disposal cell top will be cut and treated in 2009. Noxious weeds found growing on the disposal cell were treated with herbicide. I

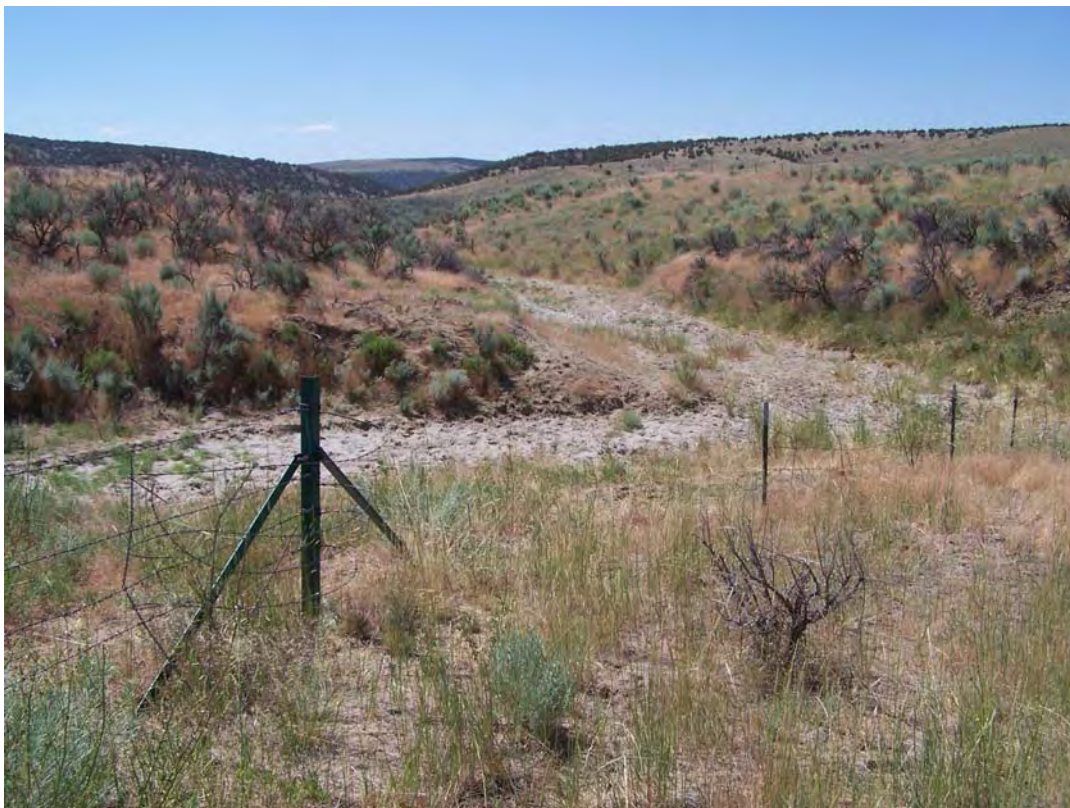
11A A standard four-strand barbed-wire stock fence surrounds the disposal cell and drainage structures. Several breaks were found in the perimeter fence (PL–1), and cattle were observed grazing on site. The local rancher was contacted, the cattle were removed, and the fence was repaired. Reinforcement of the perimeter fence will be made in 2009 (before the cattle return to the area) in an effort to ensure that cattle do not access the site in the future. Loose wires and bent posts were also noted at several other locations along the perimeter fence. This damage was likely caused by wildlife (e.g., deer, elk, antelope) crossing back and forth across the fence, and snowpack. The Maybell Disposal Site is located in wintering grounds frequented by big game animals, and damage to the perimeter stock fence is to be expected. Repairs to the fence will be made in 2009.

MAY 7/2008. PL-1. Opening in perimeter fence.

In 2008, several breaks in the perimeter fence along the east property boundary were repaired, and noxious weeds on the disposal cell were treated with herbicide.

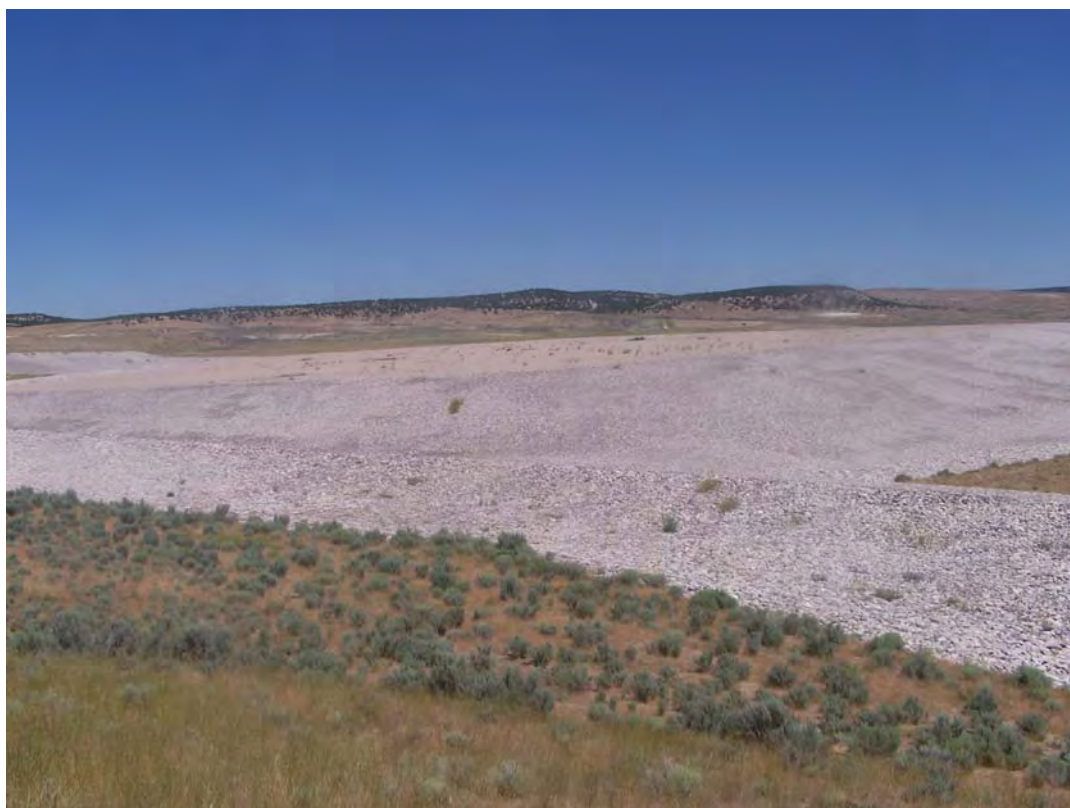
Disposal Cell—The disposal cell is armored with rock for erosion protection and was in excellent condition (PL-2). No evidence of slumping, settling, erosion, or rock degradation was noted.

MAY 7/2008. PL-2. View of the disposal cell from the southeast corner.

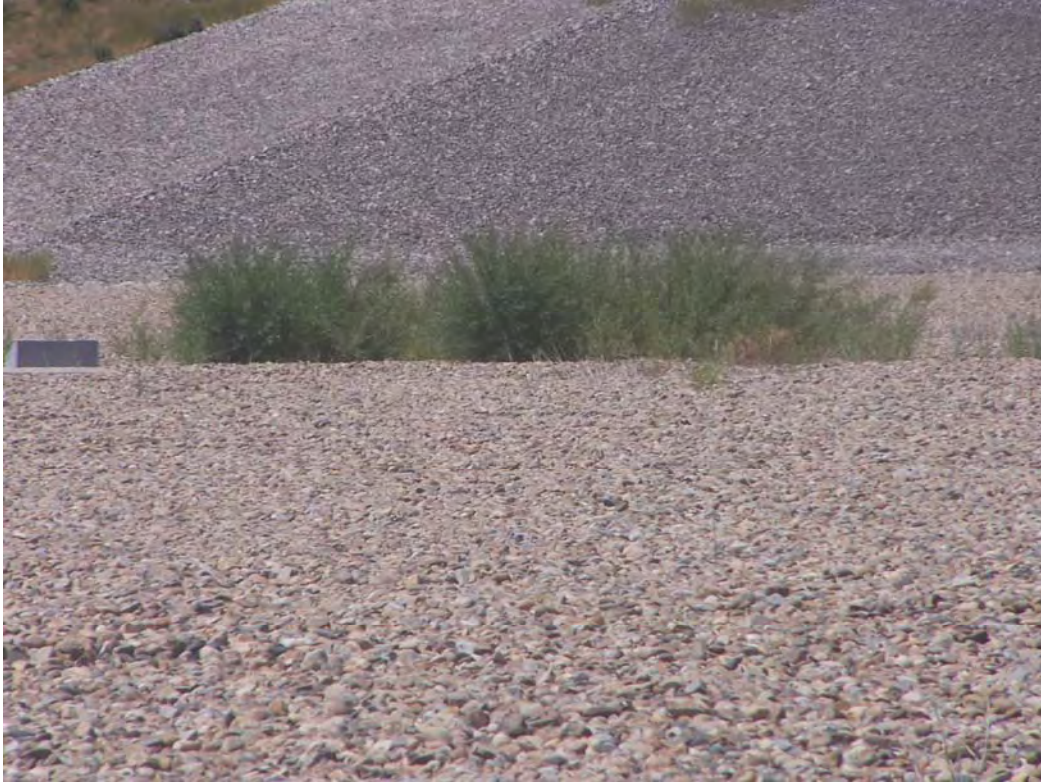
11C Minor accumulations of various plants were observed on the cell top and side slopes. Species include thistle, yellow sweet clover, dogbane, and various grasses and annual weeds. Occasionally, deep-rooted woody plants, such as sagebrush or rabbitbrush, are found growing on the disposal cell and are cut and treated with herbicide. In 2008, a small patch of willows, a deep-rooted woody plant, was found growing on the top of the cell (PL-3) and will be cut and treated in 2009. Several small patches of Canada thistle, a noxious weed, found on the disposal cell cover were treated with herbicide in 2008.

MAY 7/2008. PL-3. Patch of willow next to site marker on the disposal cell top.

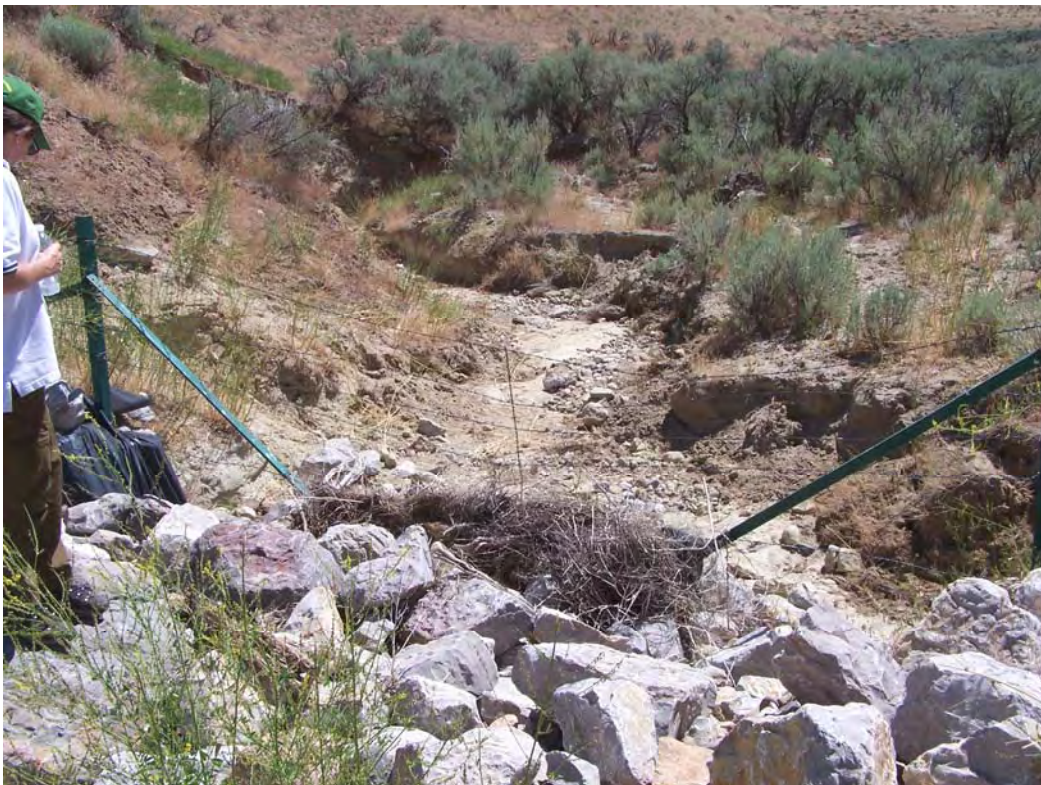
Other Areas Inside the Site Boundary—The rock-armored diversion channels, swales, and gullies were in excellent condition. Recent erosion was observed at the discharge point in Diversion Channel No. 1 downgradient of the rock armoring. However, the armoring remains protective (PL-4). Minor rills were noted adjacent to Swale No. 1 and Gully No. 1 (PL-5). Regional drought conditions in recent years resulted in very little water drainage from the disposal site, but above-average precipitation has been received at the disposal site over the last 2 years. At the time of the 2008 inspection, several of the armored drainages had standing water or moisture present from a recent precipitation event. Erosion on site will continue to be monitored during annual site inspections.

MAY 7/2008. PL-4. Erosion (headcutting) at discharge point of Diversion Channel No. 1.

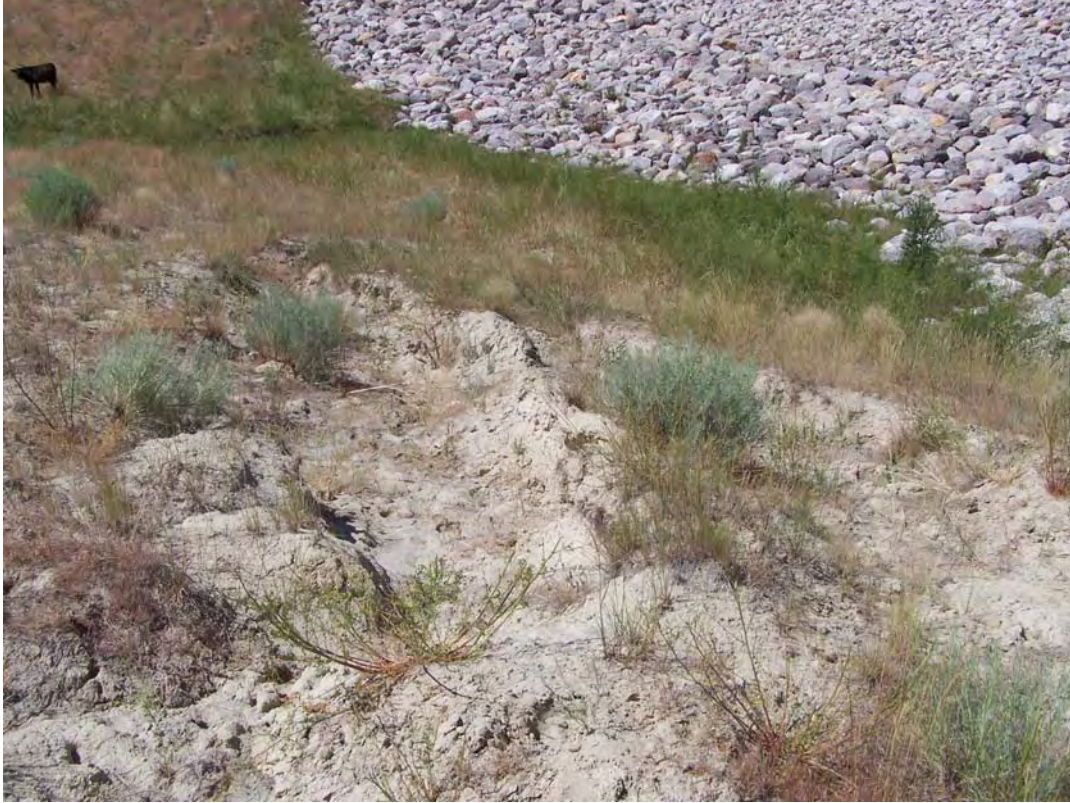
MAY 7/2008. PL-5. Rills adjacent to Gully No. 1.

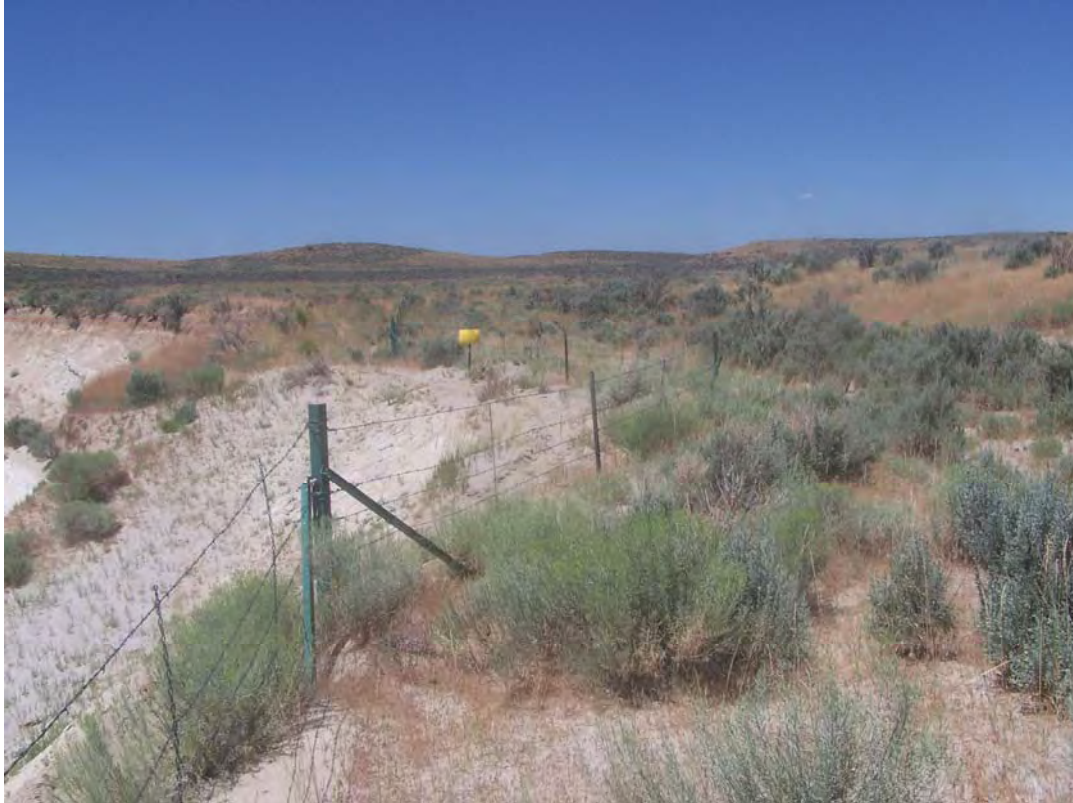
Directly south of the site is a former open pit uranium mine referred to as the Johnson Pit. Minor encroachment (approximately 5 feet) of the Johnson Pit onto DOE property has occurred (PL-6). No evidence of additional recent encroachment was observed. The perimeter fence in this location diverts approximately 15 feet off of an east-west line to accommodate this minor encroachment. The encroachment of the Johnson Pit onto DOE property does not adversely affect the disposal cell or any of its associated surface water diversion structures.

MAY 7/2008. PL-6. Encroachment of the Johnson Pit along the south boundary.
