13.0 Naturita, Colorado, Disposal Site

13.1 Compliance Summary

13.3.1 Annual Inspection and Report

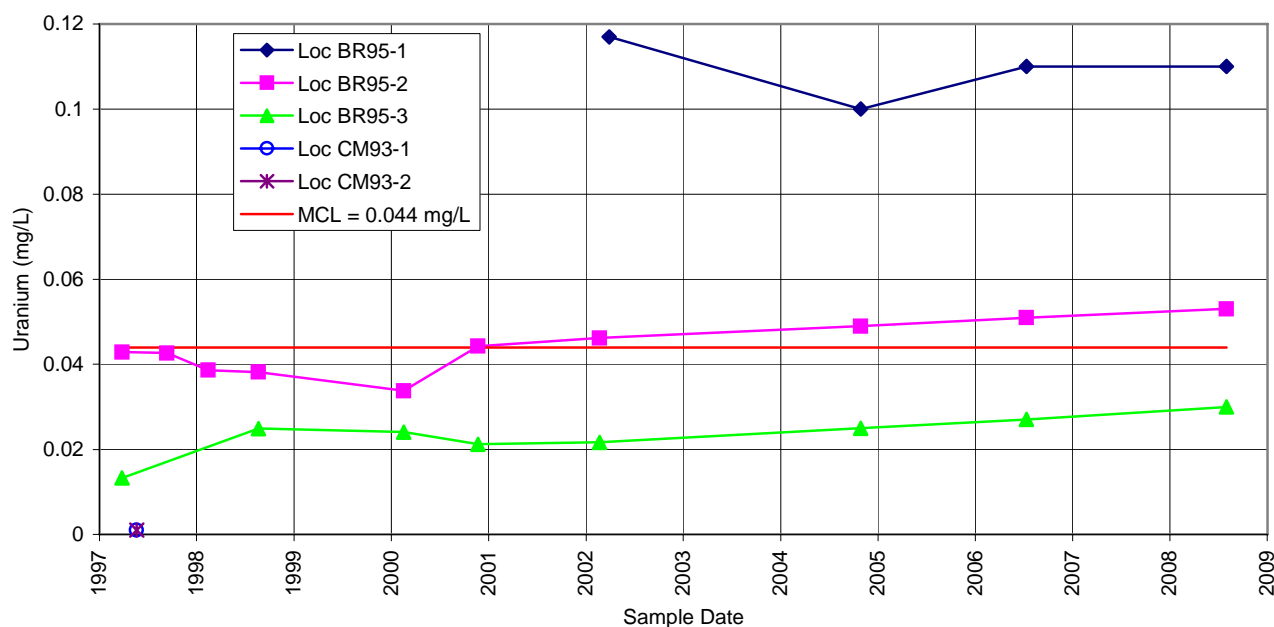
Figure 13–2. Time-Concentration Plots of Uranium in Groundwater at the Naturita Disposal Site

Groundwater Monitoring Results—Results of the most recent 2008 sampling event are consistent with those reported in previous years (1997, 1998, 2000, 2002, 2004, and 2006). Uranium concentrations continue to remain stable, ranging from 0.03 to 0.11 milligrams per liter (mg/L). Although concentrations in wells BR95–1 and BR95–2 exceed the MCL of 0.044 mg/L, comparable concentrations of uranium have been detected in samples collected from these wells since the beginning of the monitoring period and have not changed appreciably (see Figure 13–2 below). Concentrations of uranium in this range are not unexpected at the contact between the Salt Wash Member and the Summerville Formation because uranium mineralization is present in the Salt Wash Member. An indication of the intrinsic mineralization of this groundwater is the high level of uranium in seep water approximately 0.5 mile north-northwest of the disposal cell—2.0 mg/L in October 2000 and 2.59 mg/L in April 2001 (Umetco results for Seep 1). This seep is cross gradient from the disposal cell and represents natural discharge from the Salt Wash/Summerville contact. Therefore, the concentrations of uranium reported from wells BR95–1 and BR95–2 are considered to be naturally occurring (background) and not site-related.

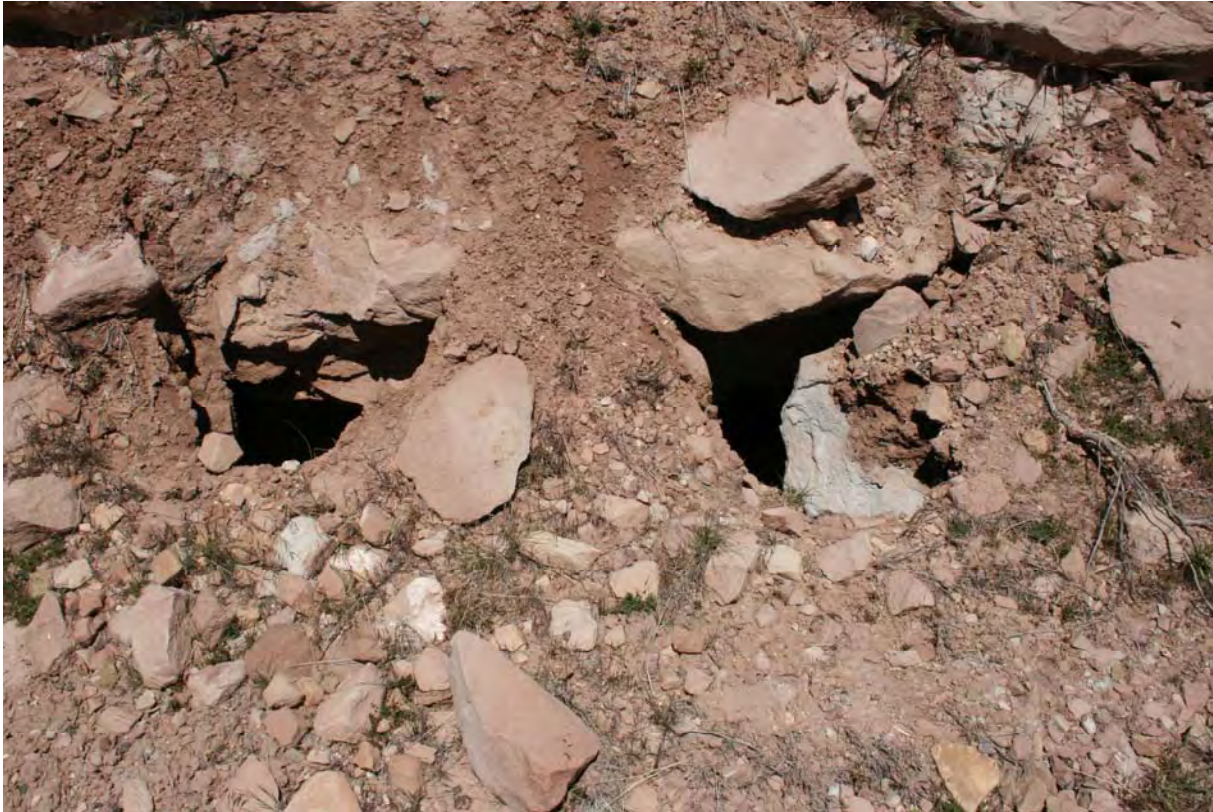
13A The access road, which was regraded after the 2005 inspection, was generally in good condition. However, a small hole has begun to erode along the west side of the road (PL–1). This eroded roadside area was identified in 2007 and will be repaired before the next inspection. In September 2005, fallen rocks were removed from the road, the road was regraded, and several loads of gravel were used to fill gullies. No significant erosion of these gullies was evident in 2008. However, boulders have fallen onto the road again (PL–2); these boulders will be removed from the access road before the next annual site inspection.

NAD 5/2008. PL-1. Hole eroded along west side of access road near top of hill that leads into cell.

In 2008, the barbed-wire perimeter fence was repaired, and pedestrian fence ladders were installed at three key locations. Herbicide was applied where necessary to control noxious weeds. Several additional maintenance issues identified during the 2008 inspection will be addressed before the 2009 annual inspection. Minor erosion observed along the access road on the northwest side of the cell will be repaired. Also, boulders that have accumulated on the road south of that location (above the lower gate) will be removed.

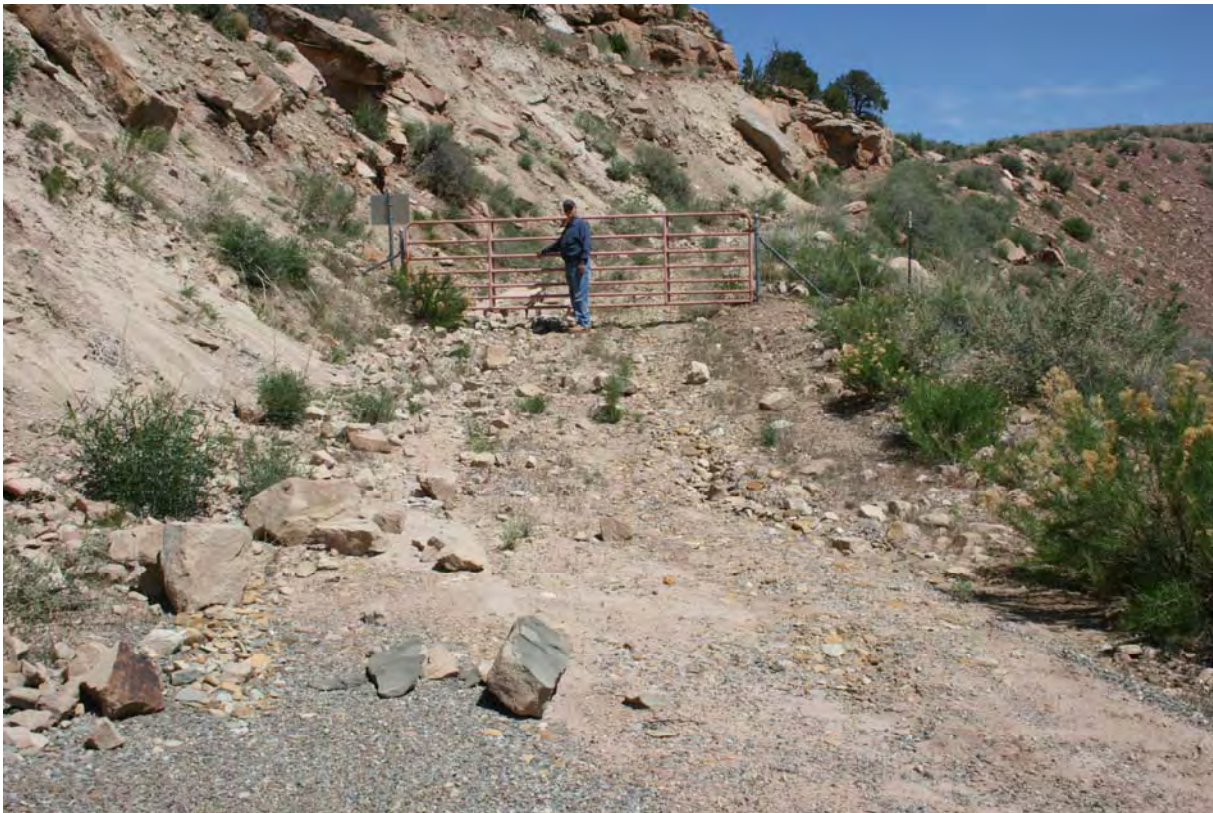
NAD 5/2008. PL-2. Rocks on access road between upper and lower gates.

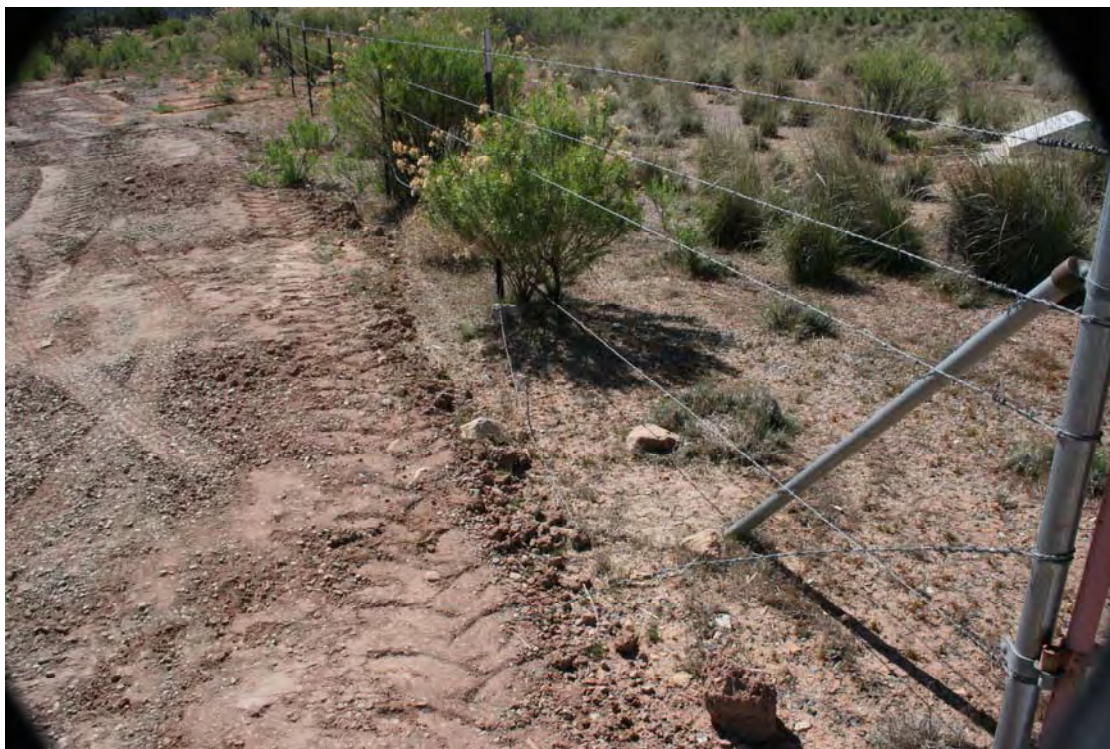
13B A barbed-wire stock fence encloses the site. Except for several small sections with broken or loose wire strands, the fence was in good condition. Broken strands were observed near perimeter signs P1 (PL–3) and P25. Two other fence sections have loose strands; the first located between perimeter signs P5 and P6, and the second south of perimeter sign P21. These broken and loose strands were repaired in September 2008.

NAD 5/2008. PL-3. Broken strand of fence near perimeter sign P1.

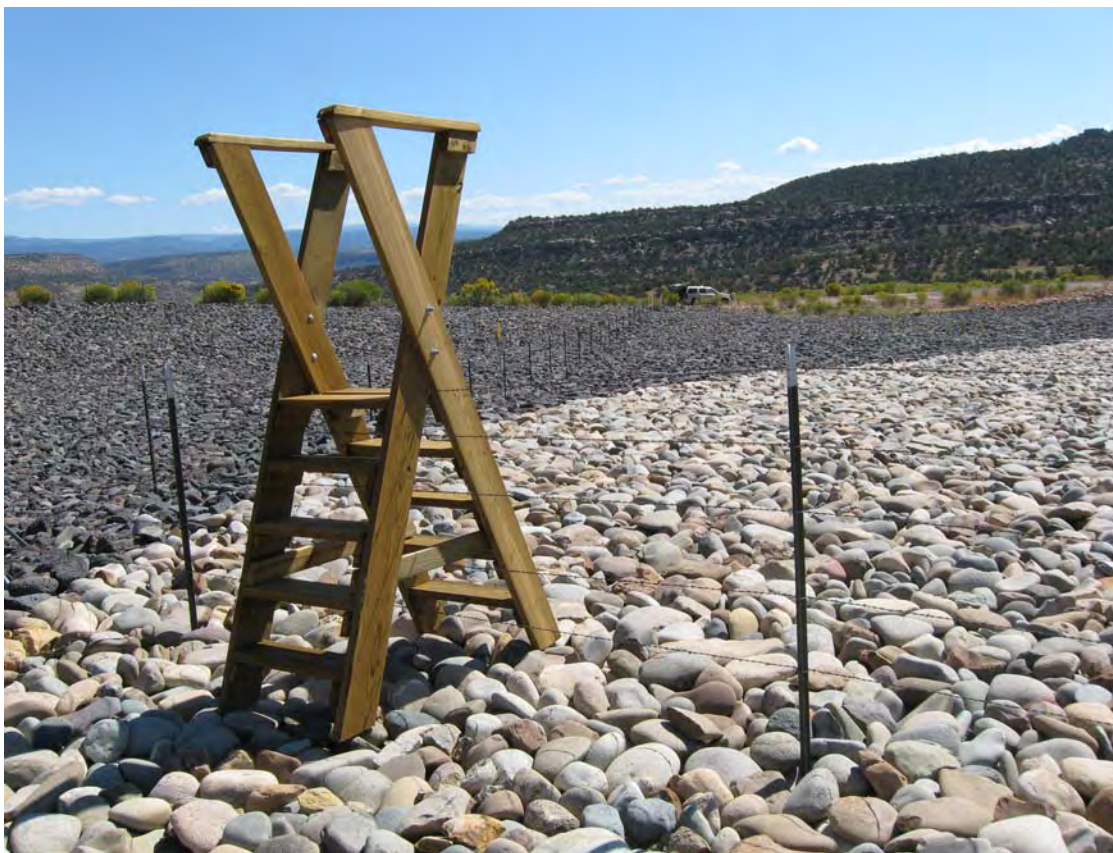
13C In August 2008, as a safety precaution, pedestrian fence ladders were installed at three locations around the perimeter of the site near boundary monuments BM–9, BM–15, and BM–16 (PL–4). These structures will allow inspectors to safely cross barbed-wire fences to access the site.

NAD 8/2008. PL-4. New pedestrian fence ladder installed near boundary monument BM-16.

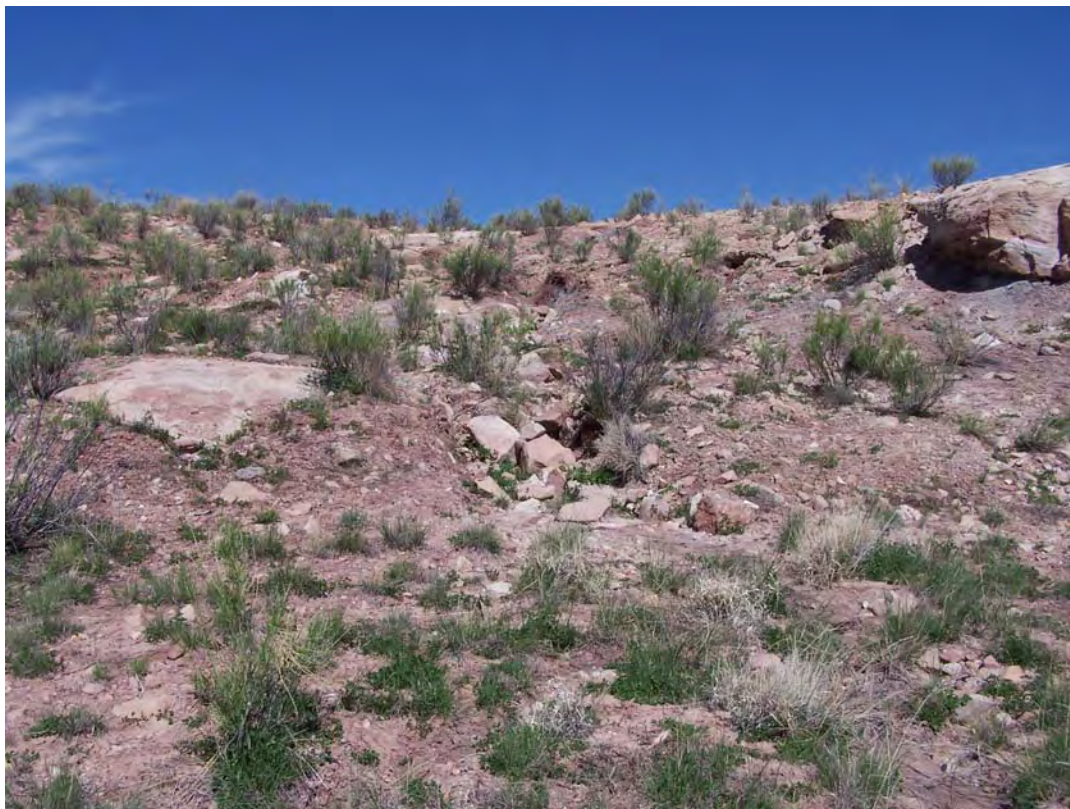
Interceptor Channel—A riprap-armored interceptor channel, upgradient and northwest of the disposal cell, diverts storm water and snowmelt run-on to the northeast across County Road EE22. Some erosion has occurred outside the property uphill from perimeter sign P23 (PL-5) and between perimeter signs P22 and P23, resulting in deposition of sediment in the channel. The rills appear to have eroded more since 2007, and vegetation has increased slightly in the accumulated sediment area inside the channel. Otherwise, the channel was in excellent condition, and the sediment and vegetation do not impair the function of the channel. A culvert was not installed where the channel crosses the road, so the road could be damaged in the event of heavy storm water flow. However, to date, storm water has not affected the road.

NAD 5/2008. PL-5. Rills west of upper interceptor channel up to 3 feet deep.

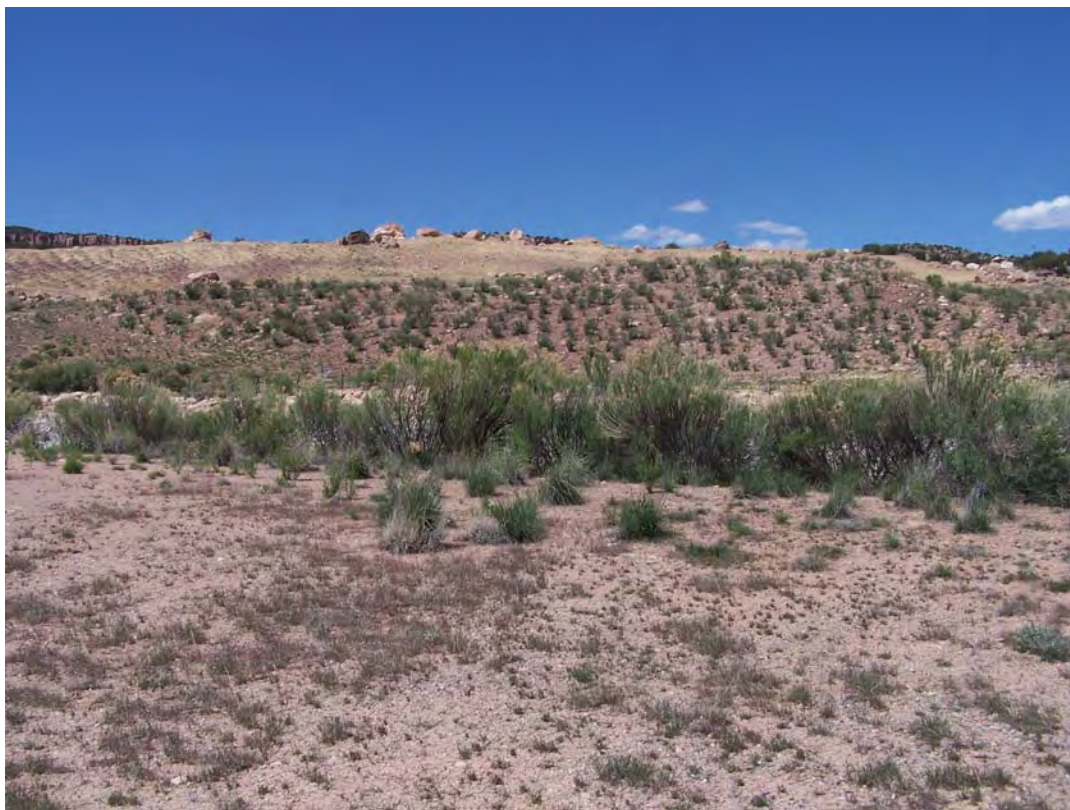
One outlying area that should be monitored in future inspections is the large Umetco borrow area northwest (and uphill of) the Naturita Disposal Site, which was recently reclaimed (PL-6). Sediment could erode from this freshly disturbed region onto the site if heavy rains occur before vegetation reestablishes.

NAD 5/2008. PL-6. Umetco reclamation area looking west-southwest from upper access road.
