14.0 Rifle, Colorado, Disposal Site

14.1 Compliance Summary

The Rifle, Colorado, Uranium Mill Tailings Radiation Control Act (UMTRCA) Title I Disposal Site was inspected on August 6, 2008. The disposal cell and all associated surface water diversion and drainage structures were in good condition and functioning as designed. Erosion repair of the interceptor trench, undertaken in fall 2005, continues to perform as designed—no new erosion was observed. Pore water continues to be removed from the disposal the cell to maintain the water level below the action level. Monitoring indicated the pore water level remained below the action level except for a brief period in May before pumping resumed in early June. The third-year survey of the standpipes and nine settlement plates conducted in December 2007 continues to indicate negligible movement in the disposal cell cover. No cause for a follow-up or contingency inspection was identified.

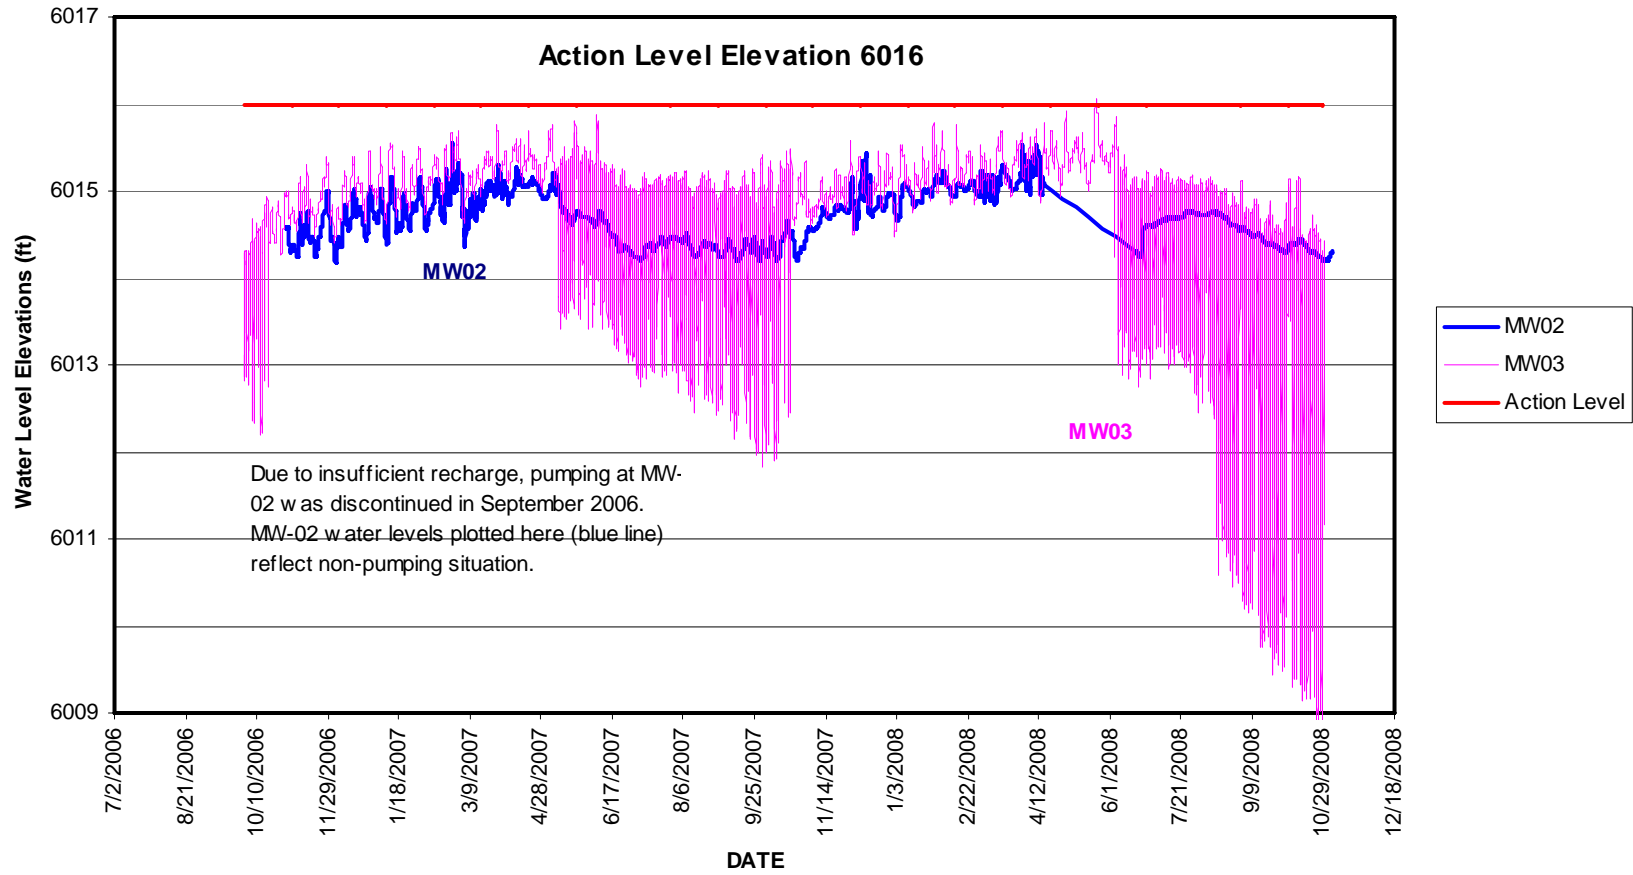
Figure 14-2. Disposal Cell Pore Water Levels in Standpipes MW-02 and MW-03 at the Rifle Disposal Site.

Datalogger information indicates that the water level in MW-03 increased from 6,013 feet to 6,015 feet within several days of shutting off the pumps in November 2007. Water levels continued to rise slowly, approaching the action level of 6,016 feet over the winter (Figure 14-2). On May 21 and 22, 2008, the action level was reached; recorded measurements ranged from 6,016.01 to 6,016.05 feet. Water levels then decreased back below the action level before pumping of MW-03 resumed in early June 2008. A similar response has been observed in past years during the winter shutdown. Shortly after pumping resumed, the water level decreased to slightly below 6,015 feet. Water levels remained below the action level for the remainder of 2008. Water levels continued to decrease in both standpipes to about 6,014.5 feet as pumping continued during the summer of 2008. About 145,000 gallons of water were produced during the 2008 season.

To date, approximately 4.35 million gallons of water have been pumped from the disposal cell. This includes the volume pumped during the construction of the disposal cell and the volume pumped since dewatering was initiated again in 2001. The recovery of the water levels in the standpipes to approximately 6,015 ft after pumping is discontinued, and the even slower recovery afterward toward the 6,016-foot action level over the next 6 months, suggests that a large reservoir of water remains in the disposal cell.

Per the LTSP requirement, DOE intends to remove enough water from the disposal cell to lower water levels in the standpipes to below the 6,014-foot elevation. At that time, pumping will be discontinued, and water levels will be monitored to ensure that they remain at or below that elevation. If water levels rise again, pumping will resume.

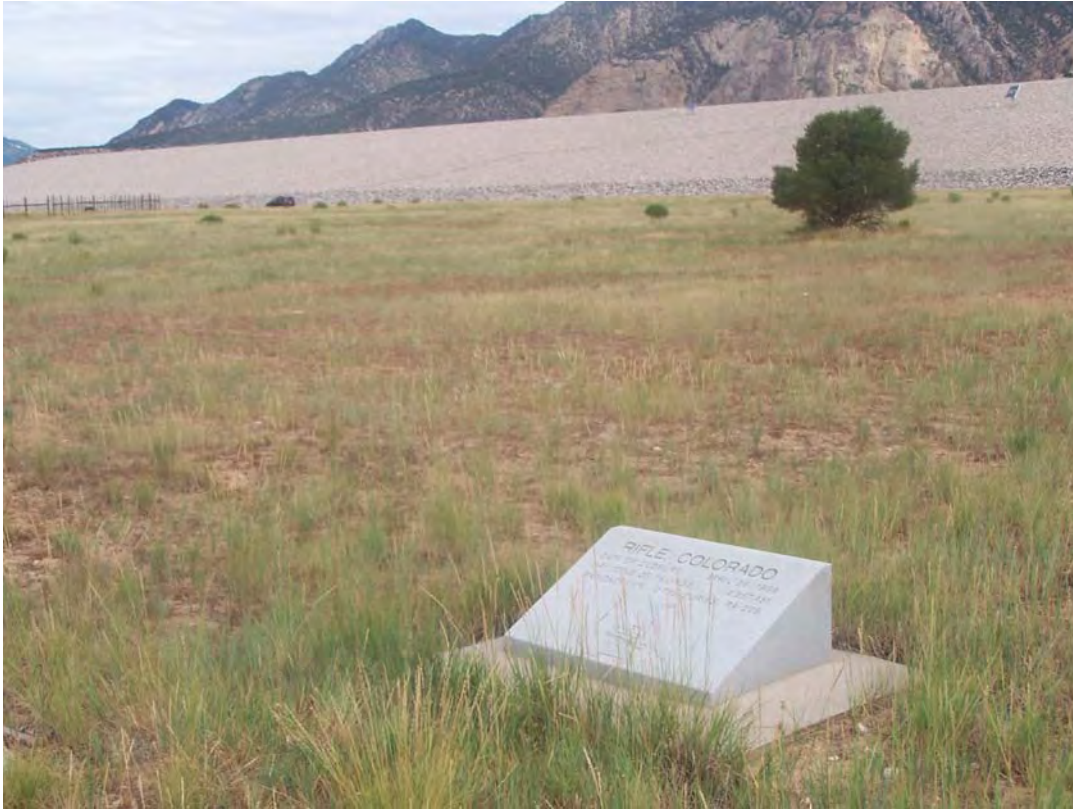
Markers and Monuments—Two granite site markers, one just inside and left of the entrance gate (SMK–1) (PL–1) and the other on the disposal cell (SMK–2), were undisturbed and in good condition.

RFL 8/2008. PL-1. Site marker SMK-1 and the south slope of the disposal cell.

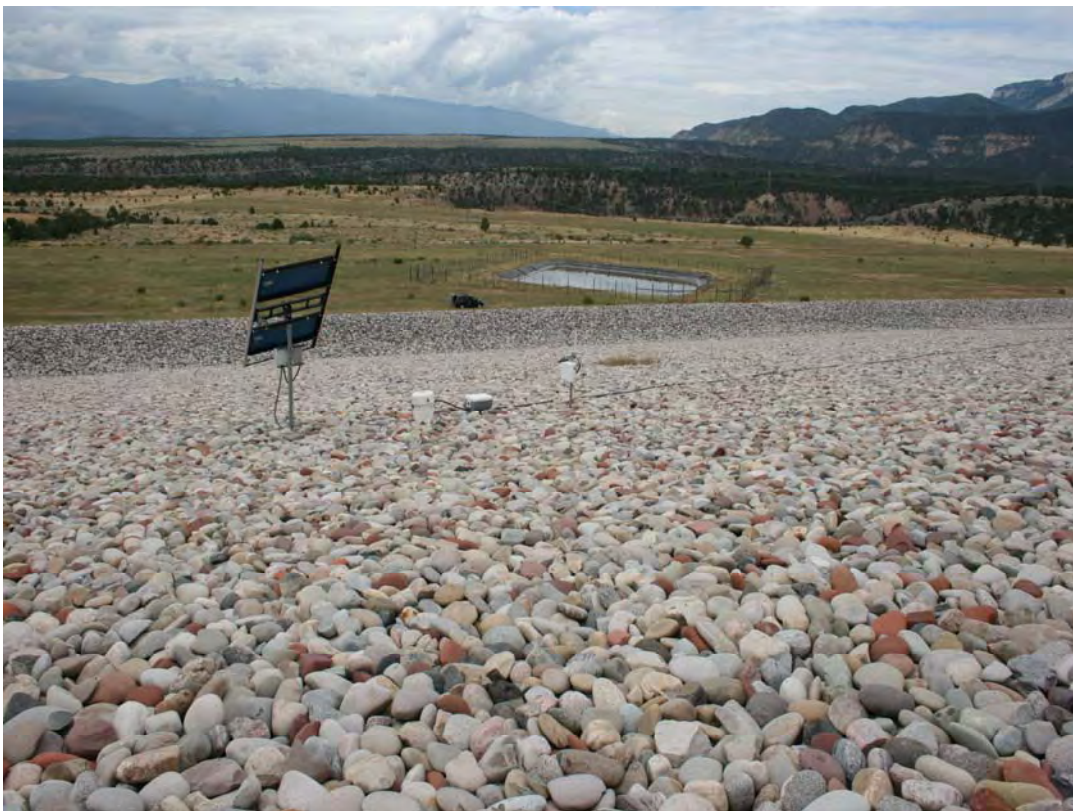
Evaporation Pond—An evaporation pond was constructed adjacent to the cell in 2001 to receive water pumped from standpipes MW-02 and MW-03 (PL-2). A datalogger, also with a remote data transfer system, measures water level fluctuations in the evaporation pond. The lined pond, surrounding security fence, and locked gate were in excellent condition. The small-diameter plastic above ground water line to the pond was also in good condition. The evaporation pond continues to function as designed because water in the pond is evaporating as fast, or faster, than influent arrives.

14C At the time of the 2008 inspection, telemetry from the site indicated that MW-03 was pumping at about 2.5 gallons per minute (as compared with 4 gallons per minute recorded in 2007). On August 14, a week after the inspection, a second pump was placed in MW-03 to increase the flow rate. The rate increased only by about 1 gallon per minute, probably because the power supplied by the solar collector limited production. It was noted that the solar collector for MW-03 was tracking the position of the sun for optimal performance.

RFL 8/2008. PL-2. Solar cell at MW-03 and evaporation pond.

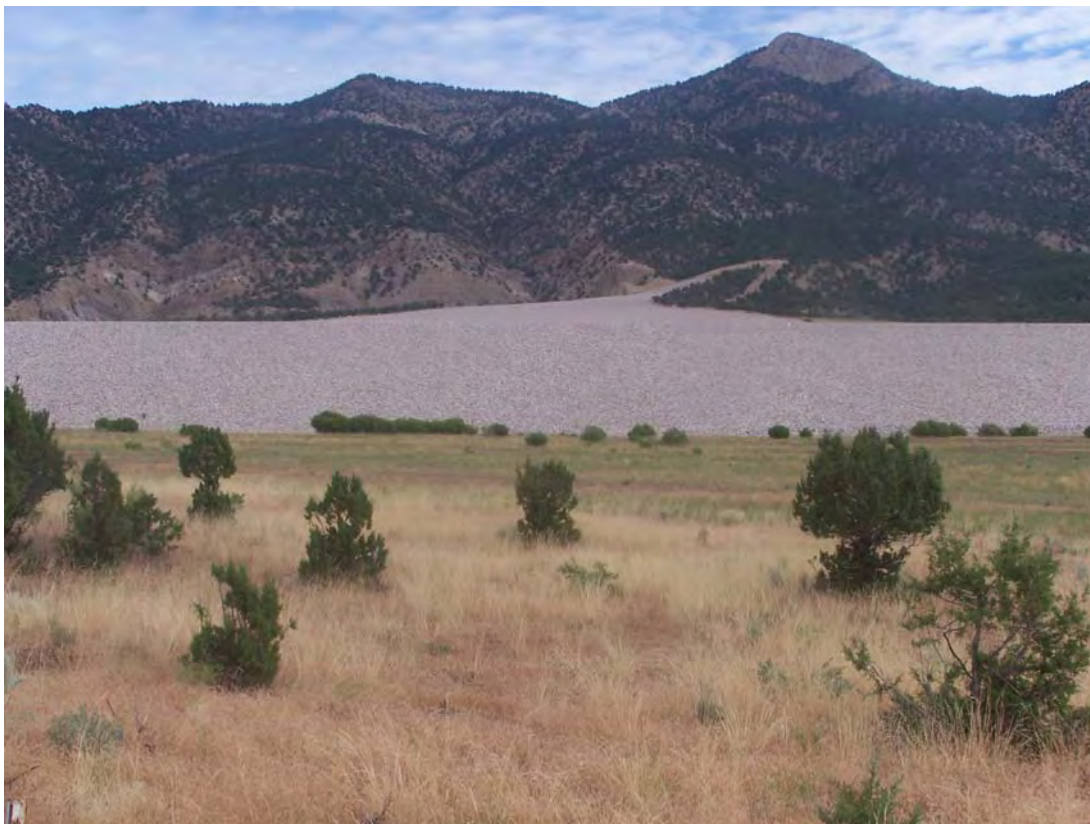
Disposal Cell and Interceptor Trench—Rock armor covers the 71-acre disposal cell, which was in excellent condition at the time of the inspection (PL-3). No evidence of subsidence, differential settling, or slumping was found. During the 2008 inspection, only small, isolated patches of annual weeds or annual grasses were found on the cell top.

RFL 8/2008. PL-3. View of the disposal cell.

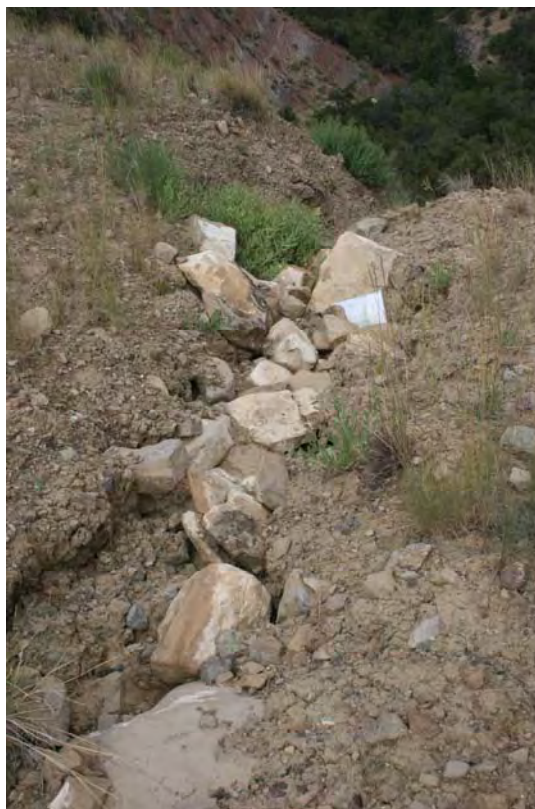
A revegetated interceptor trench was constructed at the top of the disposal cell to protect the cell from storm-water and snowmelt run-on. The trench diverts water to the arroyo west of the site. Significant erosion occurred during a major rain event in 2005, and repairs to the interceptor trench were performed in November 2005. Rocks were moved into the eroded channel, and the erosion was stabilized. No new erosion was evident in this area at the time of the 2008 inspection (PL-4). Monitoring of this trench will continue.

RFL 8/2008. PL-4. Armored gully at the base of the interceptor trench.

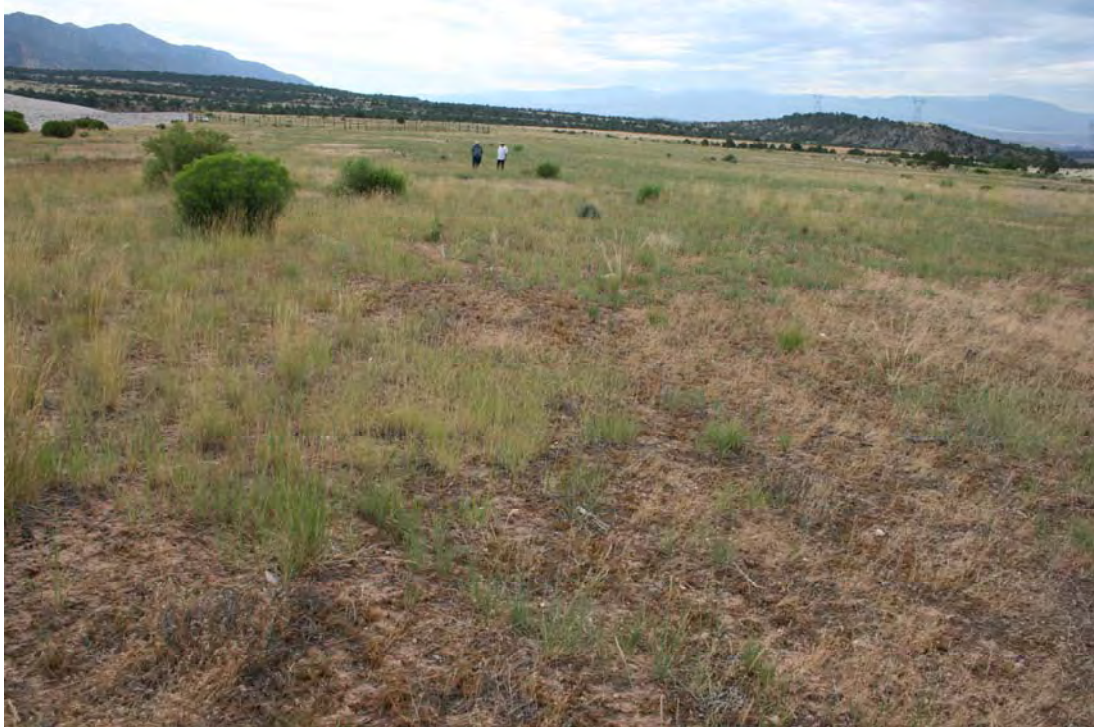
On-Site Reclaimed Areas—Disturbed areas around the edges and south of the disposal cell were reseeded in 1996 and, overall, have been successfully reclaimed. The vegetation, primarily grasses, is composed of desirable grasses and some undesirable cheatgrass and annual weeds. Over time, the number of undesirable species has steadily decreased. Although the vegetation was drought-stressed in 2006 and 2007, conditions in 2008 were not as dry, and the vegetation in these reclaimed areas was healthy and robust (PL-5). No evidence of cattle grazing within the site boundaries during the past year was observed. No noxious weeds were found in the onsite reclaimed areas during the 2008 inspection.

RFL 8/2008. PL-5. Reseeded reclaimed area inside fence and south of the disposal cell.
