13.0 Naturita, Colorado, Disposal Site

13.1 Compliance Summary

The Naturita, Colorado, Uranium Mill Tailings Radiation Control Act (UMTRCA) Title I Disposal Site was inspected on June 8, 2021. No changes were observed on the disposal cell or in the associated drainage features. Inspectors identified several minor maintenance needs but found no cause for a follow-up inspection.

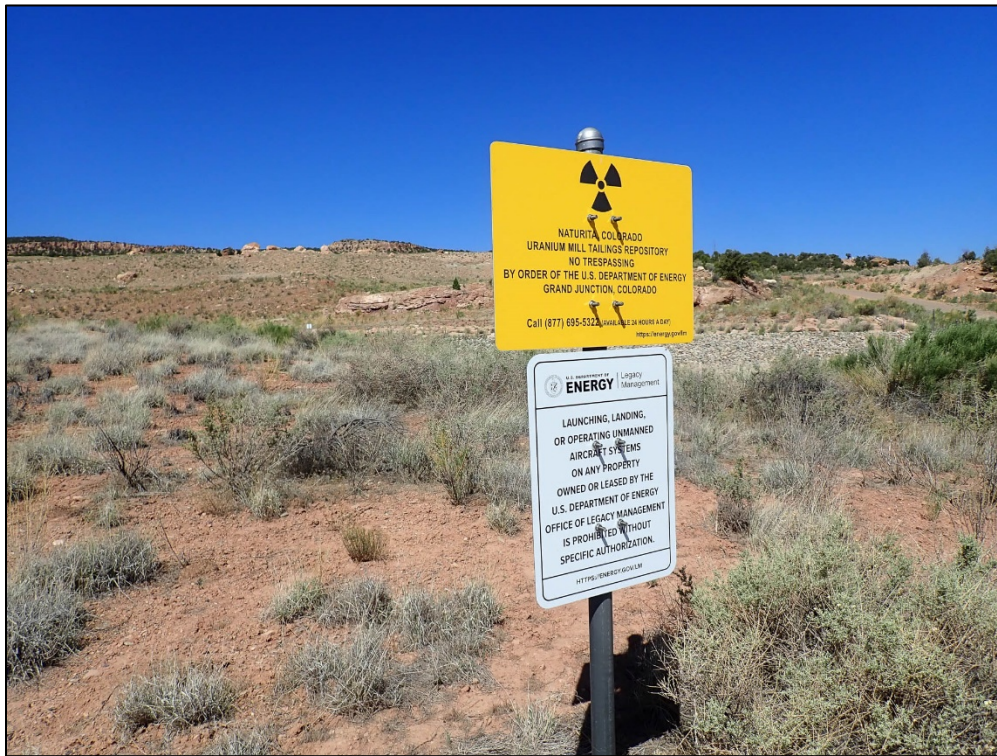
Access to the site is from Colorado Highway 141 to Montrose County Road EE22, which borders the northeast side of the site. Entrance to the site is through a locked steel gate directly off County Road EE22. The entrance sign is next to the entrance gate (PL-1). No maintenance needs were identified.

PL-1. Entrance Sign with Unmanned Aircraft System Sign

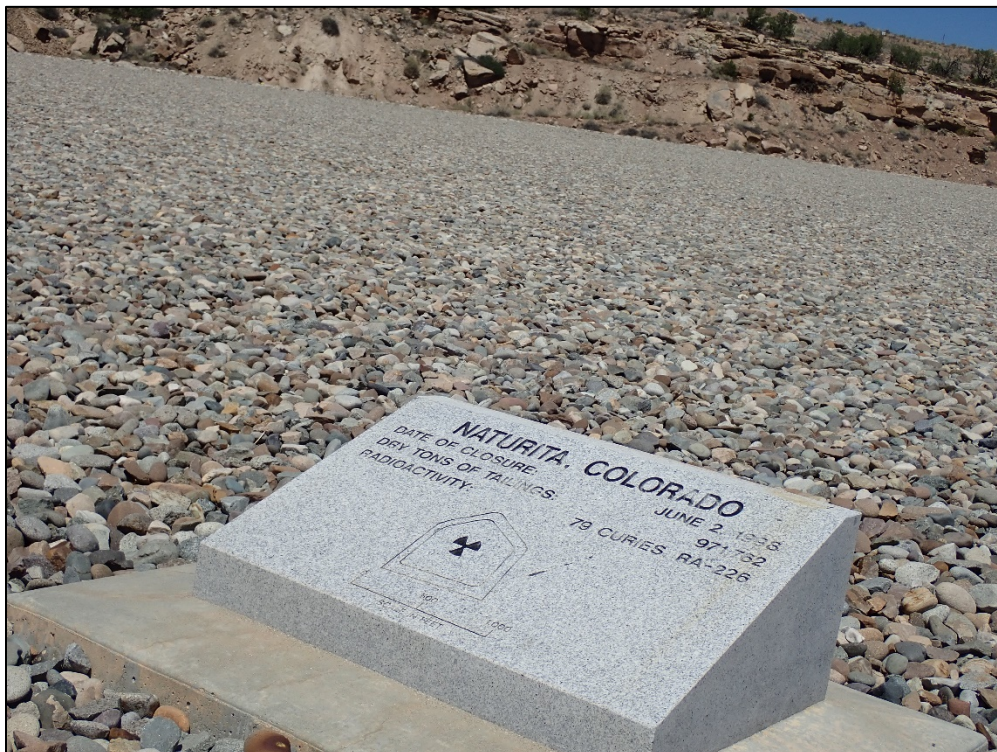
The site has two granite site markers. Site marker SMK-1 is just inside the entrance gate, and site marker SMK-2 (PL-2) is on the top slope of the disposal cell. No maintenance needs were identified.

PL-2. Site Marker on Disposal Cell Top

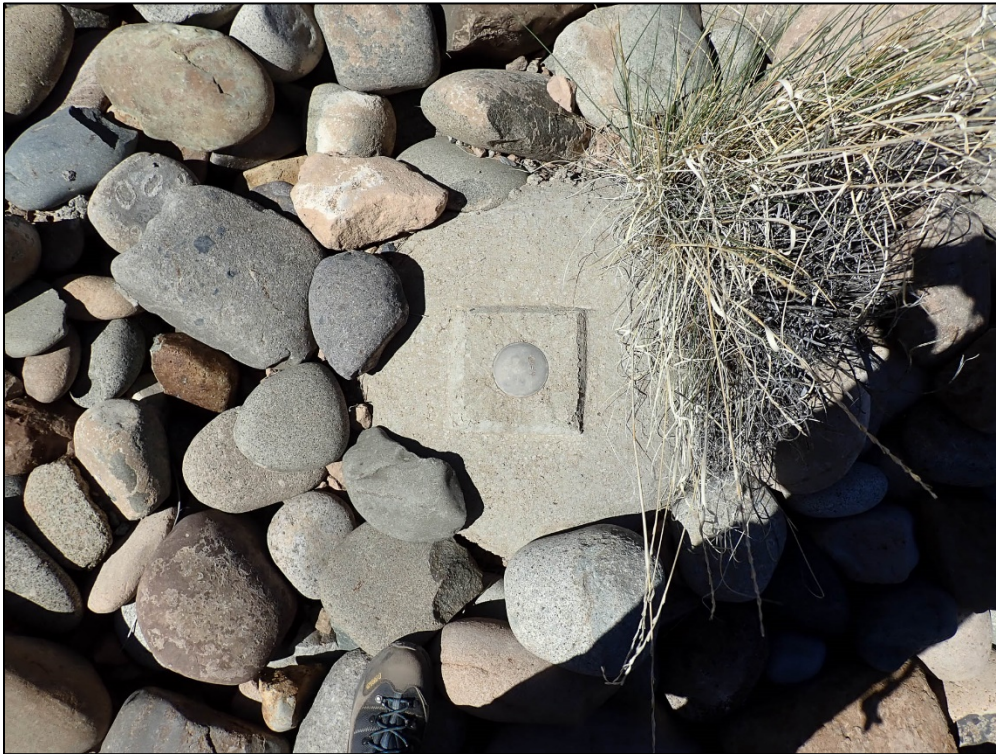
Three survey monuments and 14 boundary monuments delineate the property boundary. Boundary monuments BM-1 through BM-17 mark the property corners. Survey monuments SM-3, SM-4, and SM-11 represent boundary monuments BM-3, BM-4, and BM-11, respectively (PL-3). No maintenance needs were identified.

PL-3. Survey Monument SM-4

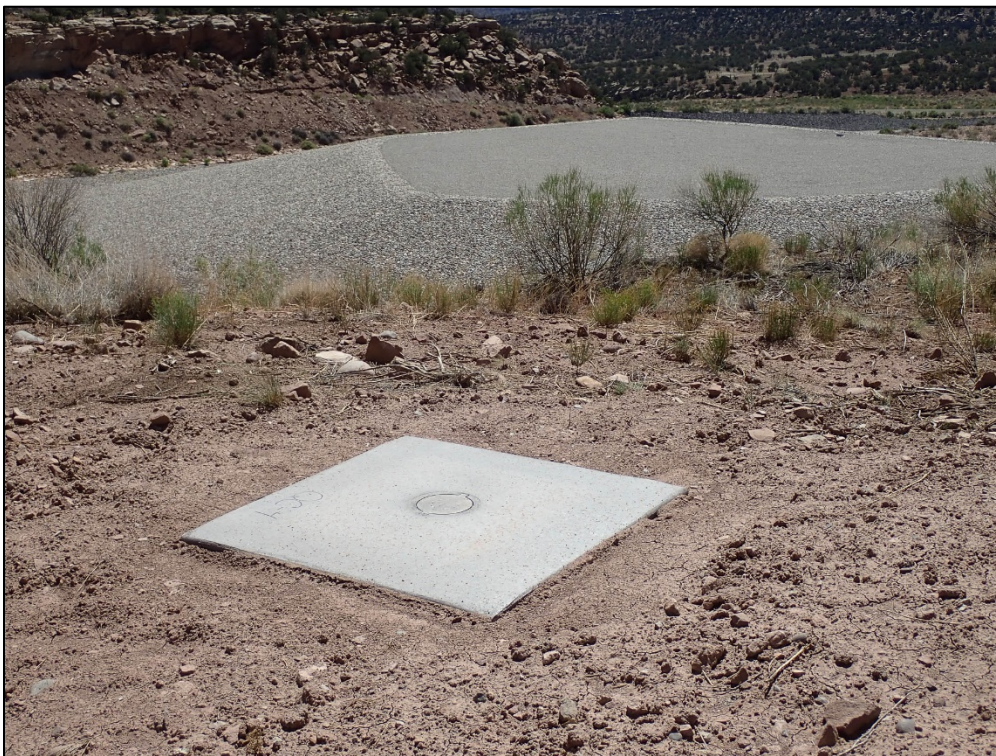
Four aerial survey quality control monuments were installed before the 2021 inspection (PL-4). No maintenance needs were identified.

PL-4. Aerial Survey Quality Control Monument QC-4

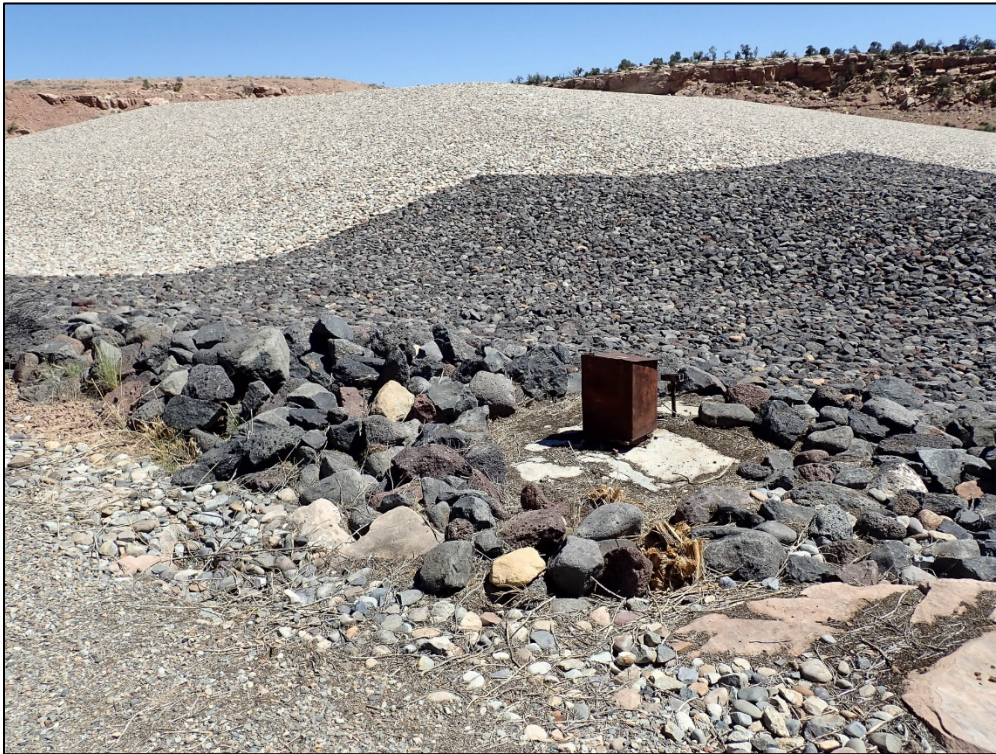
The site has five groundwater monitoring wells. The wellhead protectors were intact and locked (PL-5). Overgrown vegetation identified in the 2020 inspection around wells BR95-1, BR95-3, and CM93-1 was removed in preparation for well abandonment. No immediate maintenance needs were identified.

PL-5. Monitoring Well CM93-1

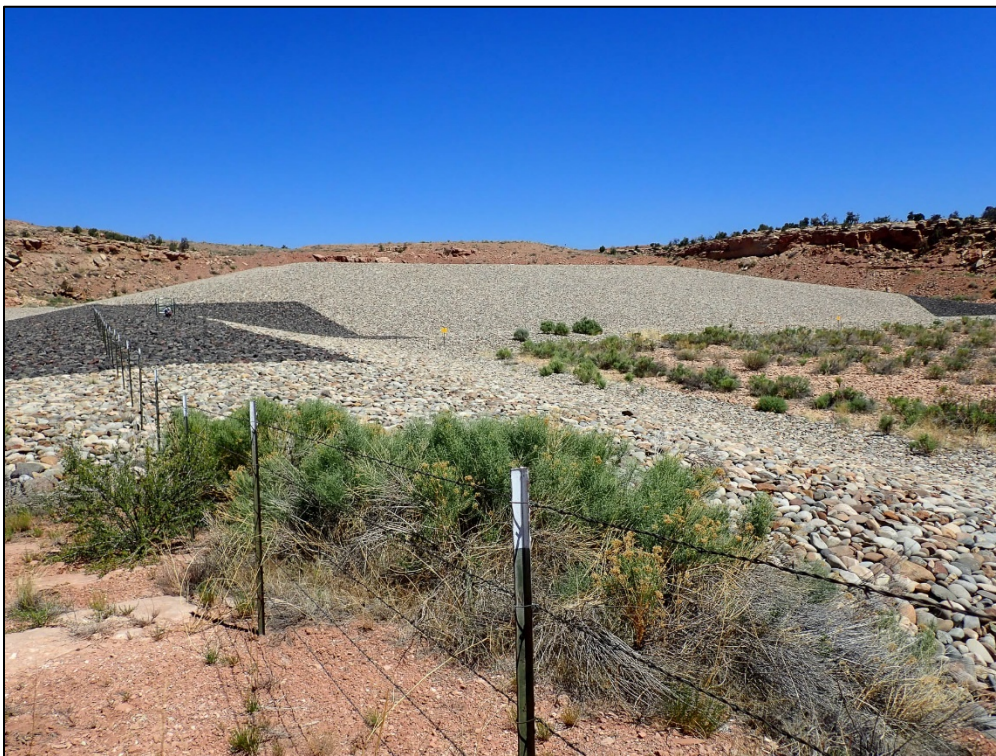
The disposal cell, completed in 1998, occupies 10 acres (PL-6). The disposal cell is armored with riprap to control erosion. The riprap is rounded, with larger diameter rock on the side slopes versus on the top slope. There was no evidence of settling, slumping, erosion, rock degradation, or other modifying processes that might affect the integrity of the disposal cell.

Irregularities in the riprap on the top slope of the disposal cell continue to be observed. The irregularities consist of slightly darker rock that are not lower than surrounding areas and have not changed over time. Another irregularity in the apron area on the west side of the disposal cell appears to be old vehicle tracks. The irregularity does not present a threat to the disposal cell or surrounding area. Inspectors will continue to monitor these areas for potential impacts. No maintenance needs were identified.

PL-6. Disposal Cell

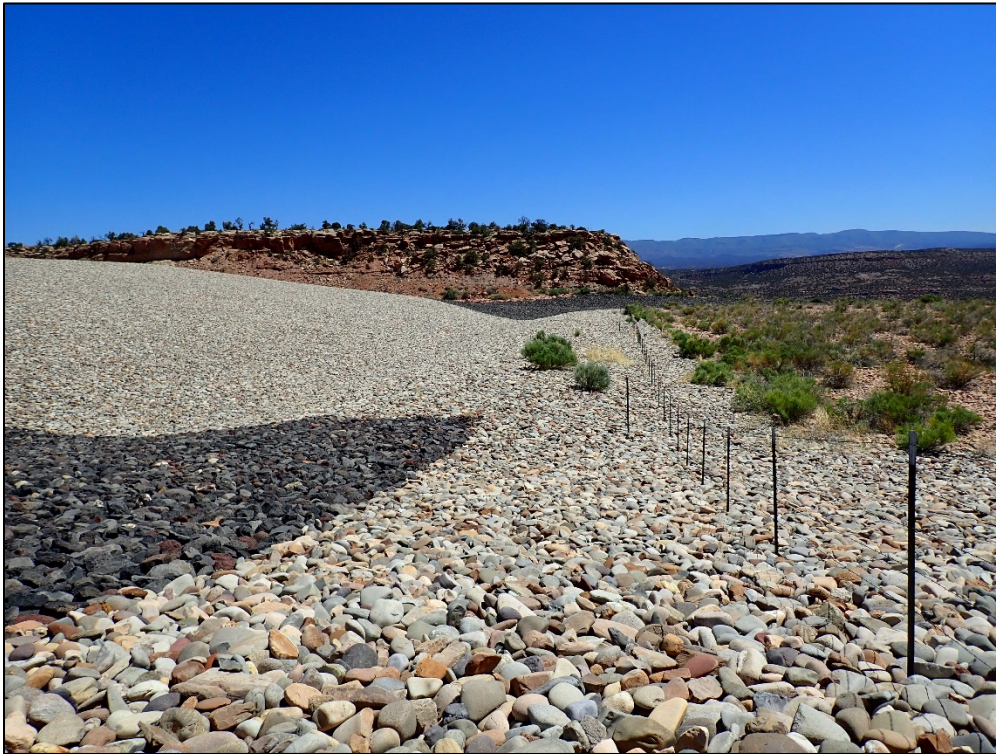
Woody vegetation is growing on the south side of the disposal cell between the apron and the site boundary fence line (PL-7). This vegetation is not impacting the disposal cell, but inspectors will continue to monitor this area.

PL-7. Vegetation Growing near Southern Fence Line

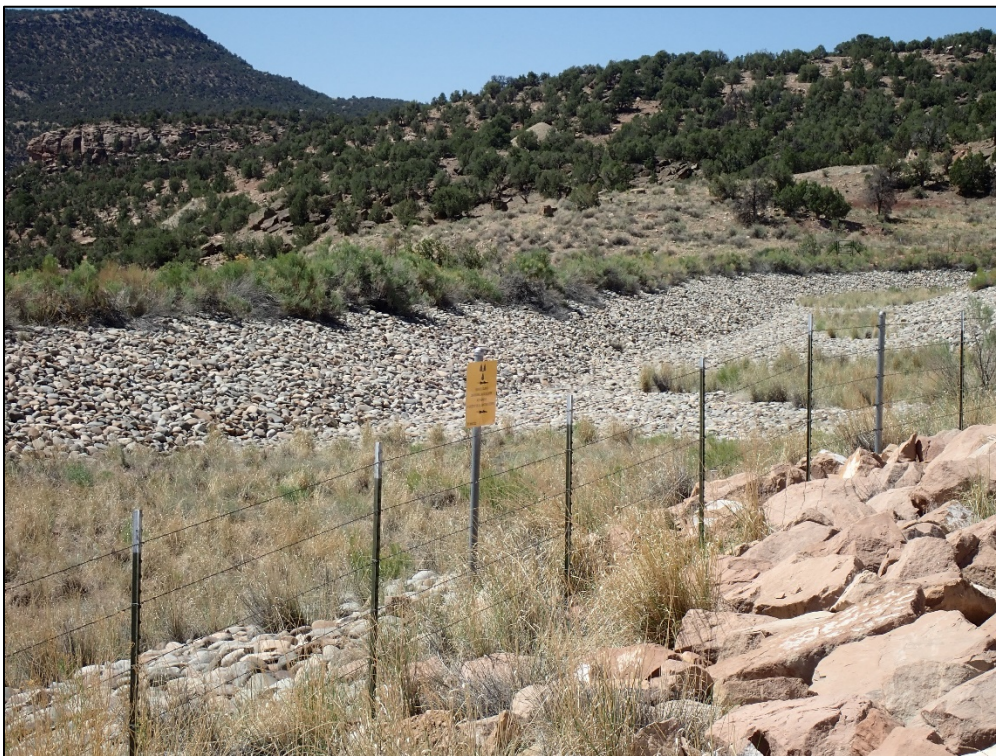
A riprap-armored interceptor channel, upgradient and northwest of the disposal cell, diverts stormwater and snowmelt runoff to the northeast under County Road EE22. Some sediment has eroded from the offsite area upslope from the channel and is being deposited in the channel. Sediment accumulation and associated vegetation have not adversely affected the performance of the interceptor channel (PL-8). Herbicide treatment of rabbitbrush plants is ongoing.

PL-8. Vegetation Growing in Interceptor Channel
