13.0 Naturita, Colorado, Disposal Site

13.1 Compliance Summary

The Naturita, Colorado, Uranium Mill Tailings Radiation Control Act (UMTRCA) Title I Disposal Site was inspected on May 4, 2022. No changes were observed on the disposal cell or in the associated drainage features. Inspectors identified several minor maintenance needs but found no cause for a follow-up inspection.

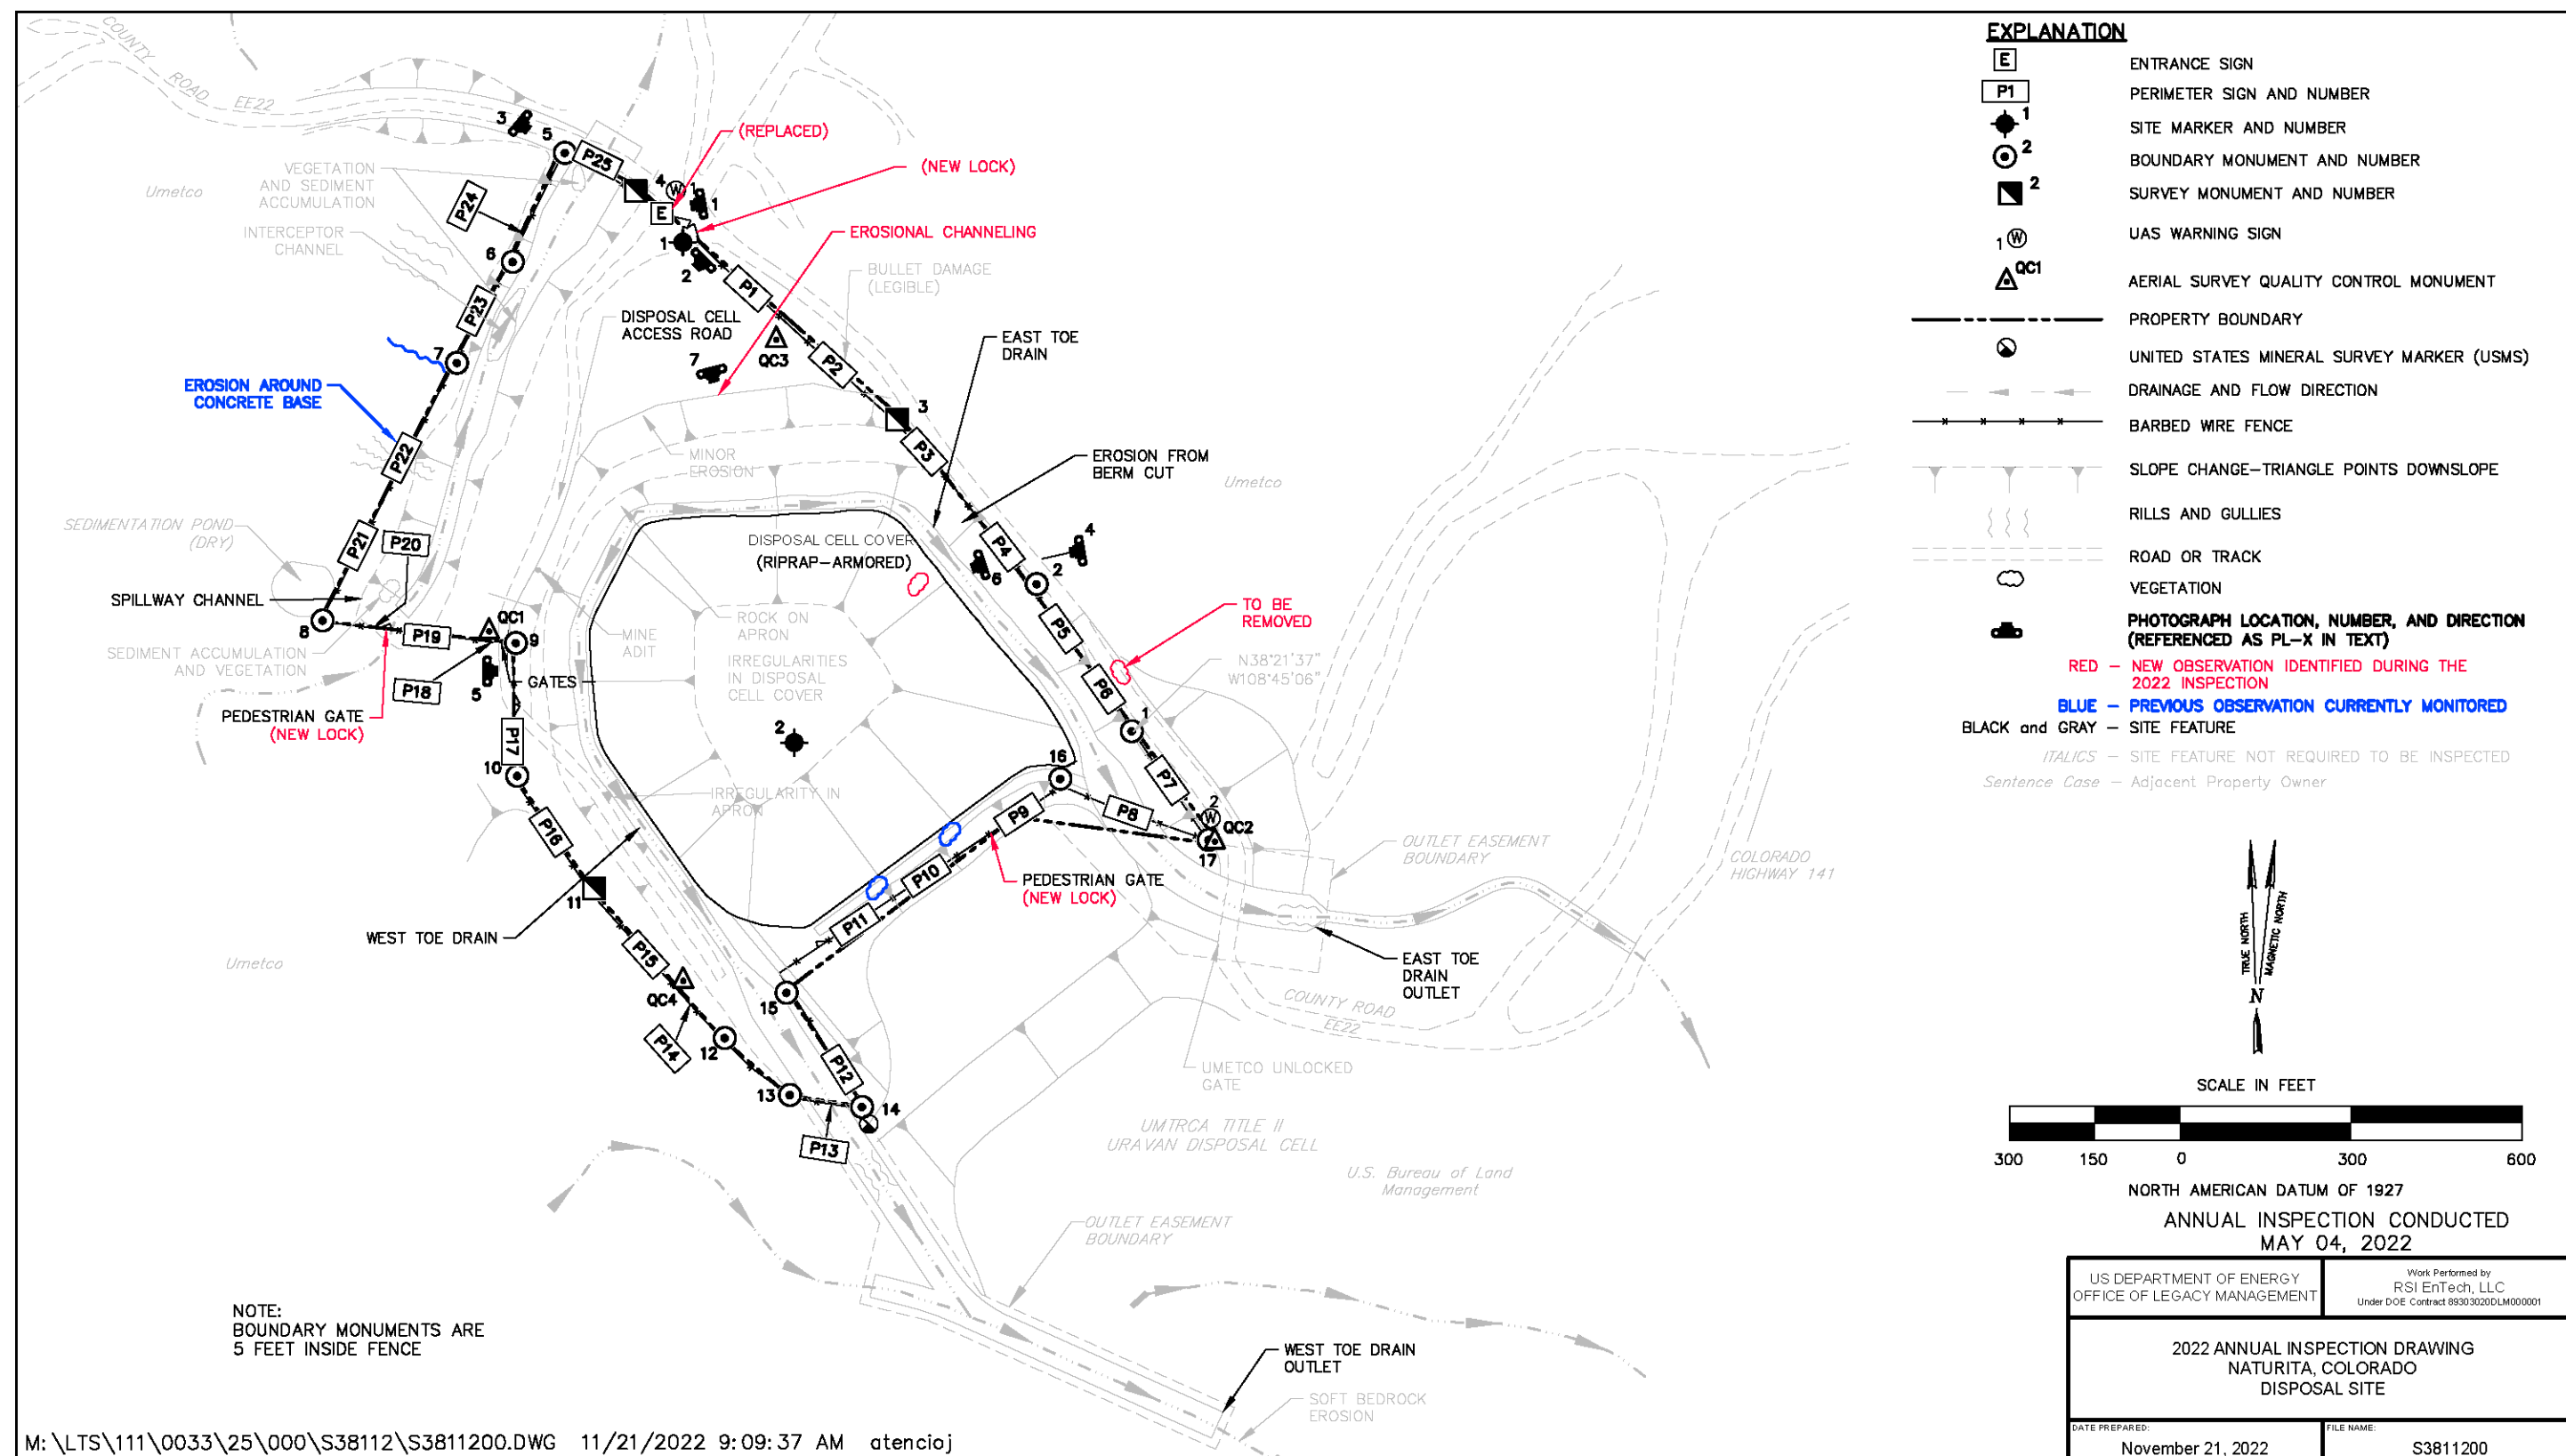
Figure 13-1. 2022 Annual Inspection Drawing for the Naturita, Colorado, Disposal Site

Figure 13-1 shows the locations of site features, including site surveillance features and inspection areas, in black and gray font. Some site features that are present but not required to be inspected are shown in italic font. Observations from previous inspections that are currently monitored are shown in blue, and new observations identified during the 2022 annual inspection are shown in red. Inspection results and recommended maintenance activities associated with site surveillance features are described in the following subsections. Photographs to support specific observations are noted in the text and in Figure 13-1 by photograph location (PL) numbers. The photographs and photograph log are presented in Section 13.10.

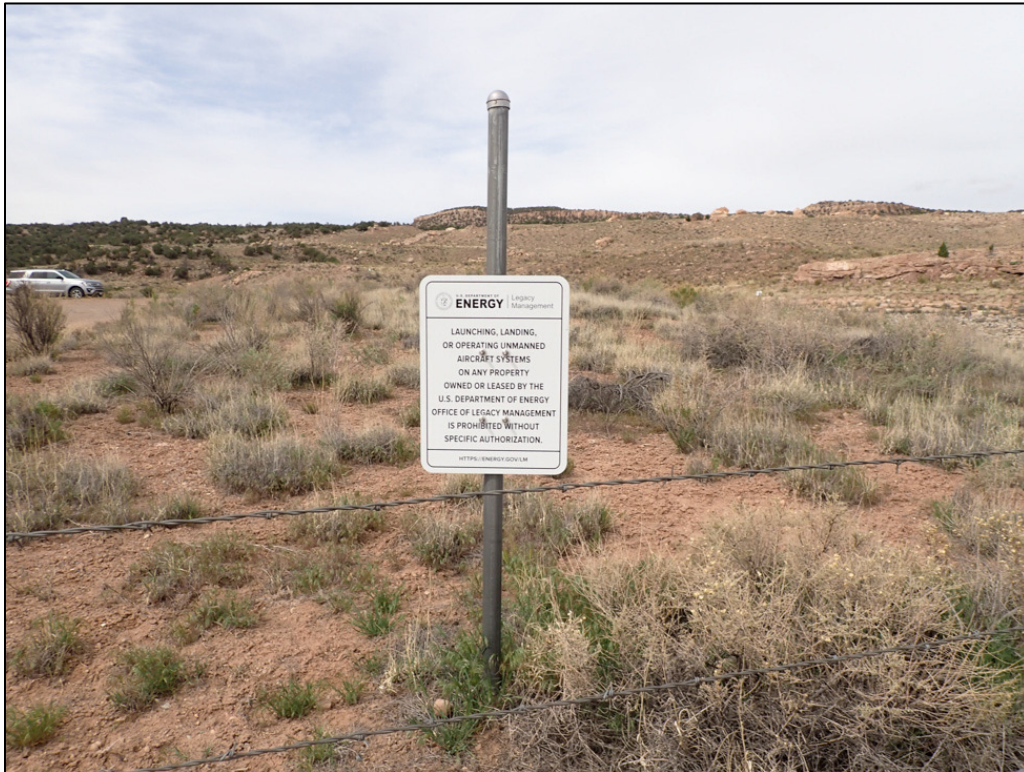
Access to the site is from Colorado Highway 141 to Montrose County Road EE22, which borders the northeast side of the site. The main entrance to the site is through a locked steel gate directly off County Road EE22. The entrance sign next to the entrance gate was missing and was replaced following the inspection (PL-1). New locks were placed at the entrance gate and two pedestrian gates. No other maintenance needs were identified.

PL-1. Entrance Area with Missing Entrance Sign

The entrance sign was replaced following the inspection. The vegetation growing in the fence line near perimeter sign P6 will be treated or removed before the next inspection. No other maintenance needs were identified.

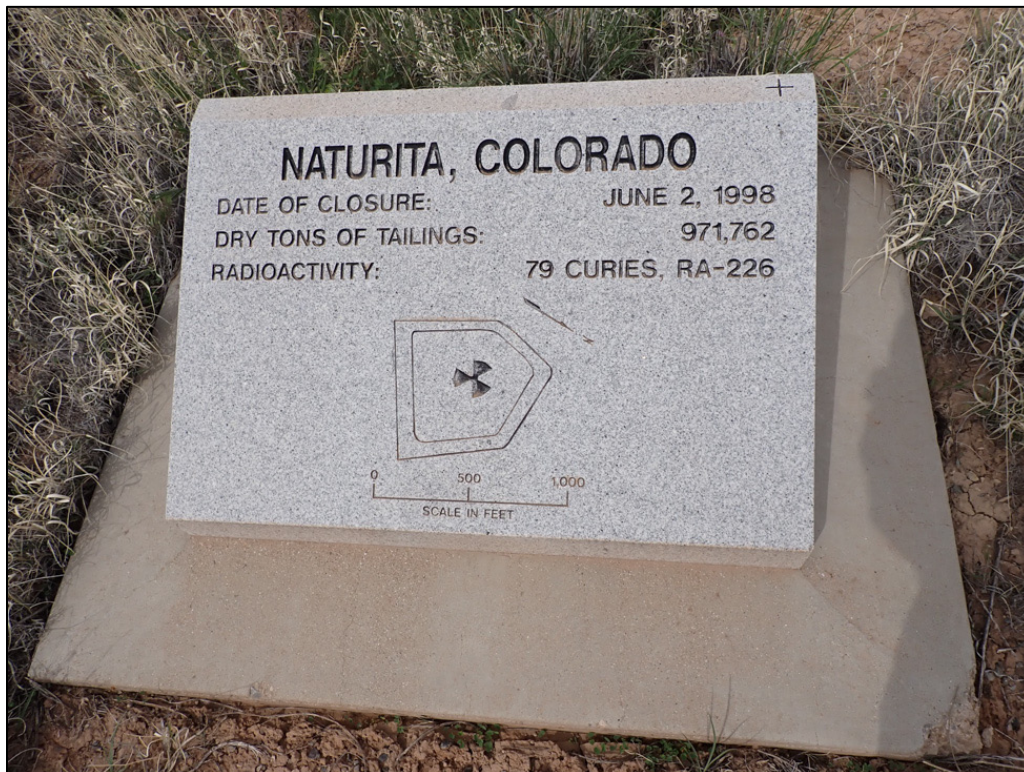
The site has two granite site markers. Site marker SMK-1 is just inside the entrance gate (PL-2), and site marker SMK-2 is on the top slope of the disposal cell. No maintenance needs were identified.

PL-2. Site Marker SMK-1 near Entrance Gate

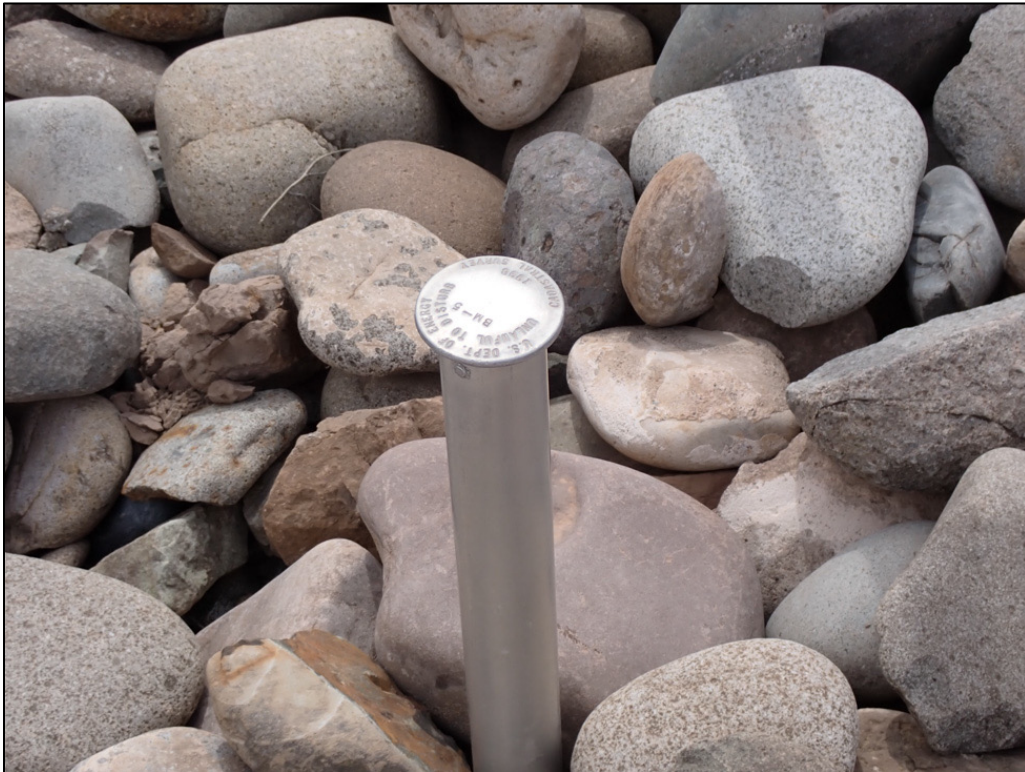
Three survey monuments and 14 boundary monuments delineate the property boundary. Boundary monuments BM-1 through BM-17 (PL-3) mark the property corners. Survey monuments SM-3, SM-4, and SM-11 are dual purpose monuments that represent boundary monuments BM-3, BM-4, and BM-11, respectively. No maintenance needs were identified.

PL-3. Boundary Monument BM-5

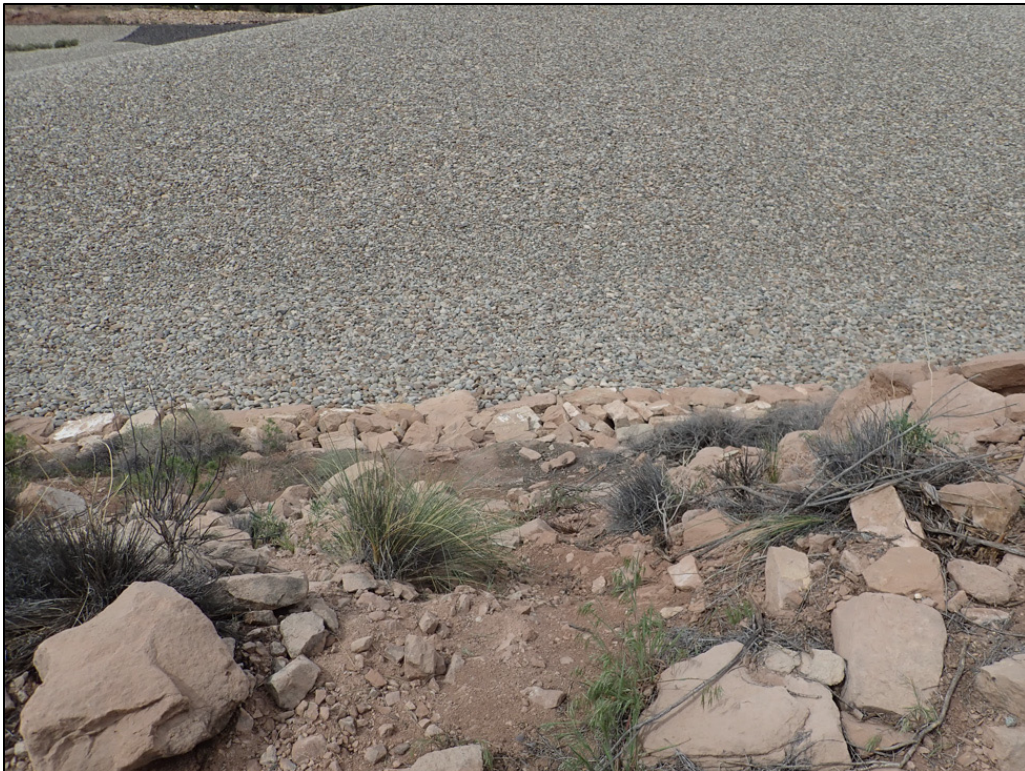
Before the inspection, five groundwater monitoring wells installed at the time of the disposal cell construction were abandoned in place according to Colorado state regulations (PL-4). LM requested concurrence from NRC to terminate groundwater monitoring at the site in 2013, and NRC concurred in a letter dated April 15, 2014 (DOE 2019).

PL-4. Previous Site of Monitoring Well BR95-1

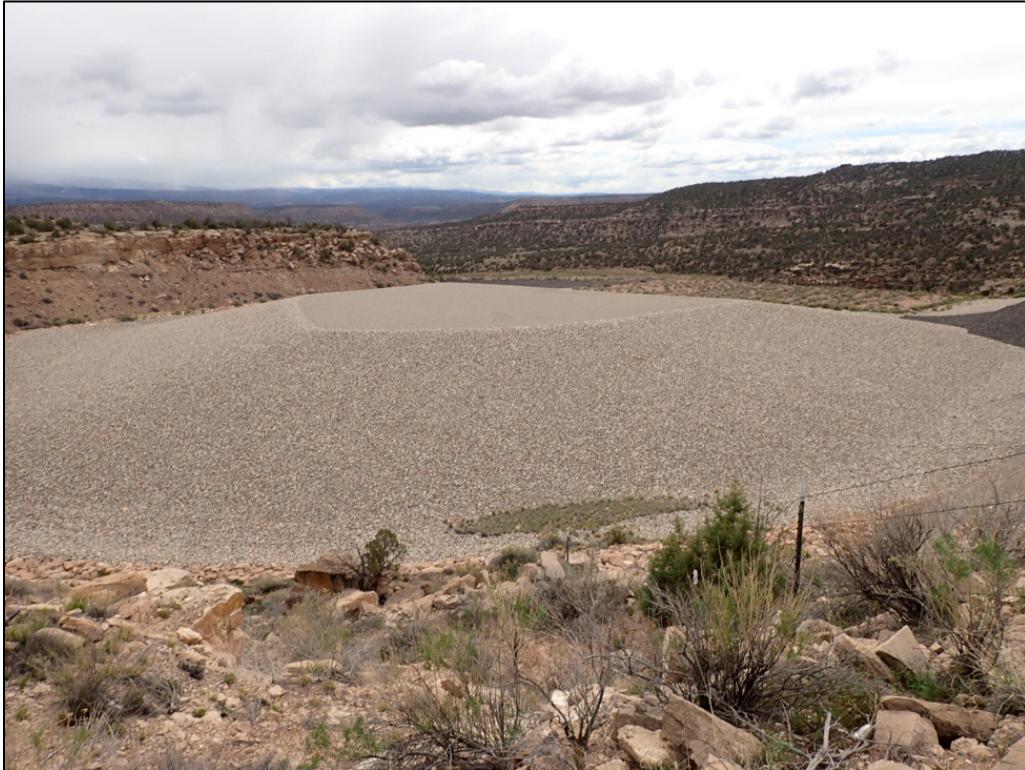
The disposal cell, completed in 1998, occupies 10 acres (PL-5). The disposal cell is armored with riprap to control erosion. The riprap is rounded, with larger diameter rock on the side slopes versus on the top slope. There was no evidence of settling, slumping, erosion, rock degradation, or other modifying processes that might affect the integrity of the disposal cell.

PL-5. Disposal Cell

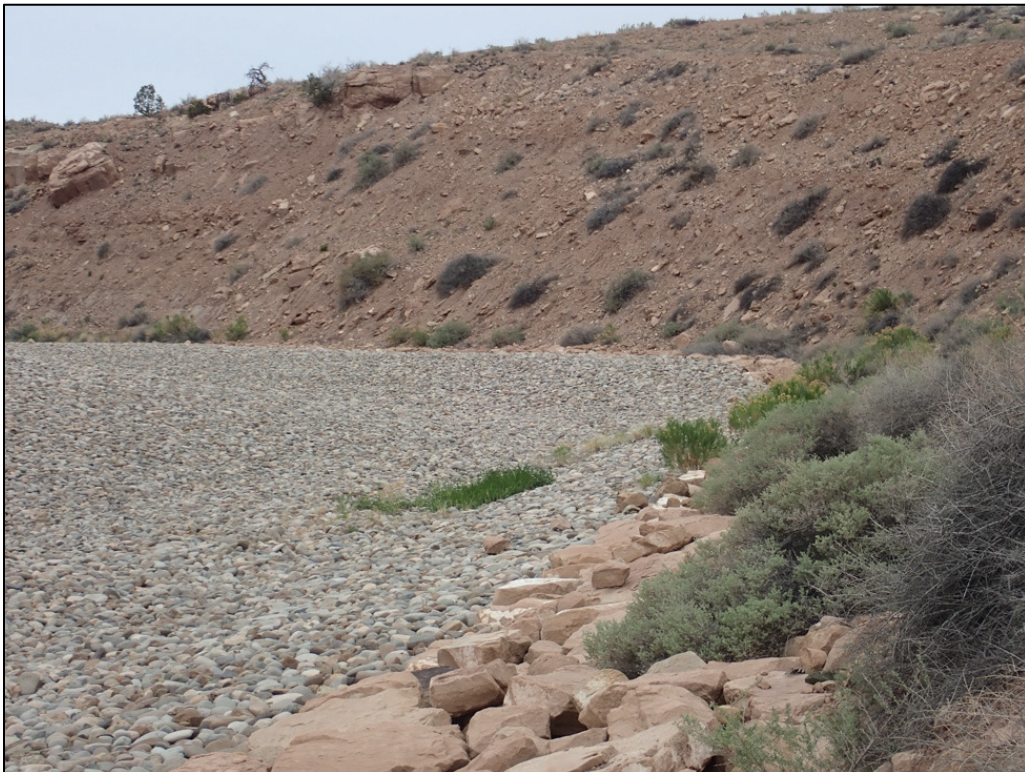
Sediment is accumulating in the apron on the northeast side of the disposal cell from erosion caused by the culvert break along County Road EE22. Vegetation is beginning to become established in this area (PL-6). No maintenance needs were identified.

PL-6. Vegetation Growing in Accumulated Sediment Downslope from Culvert Break

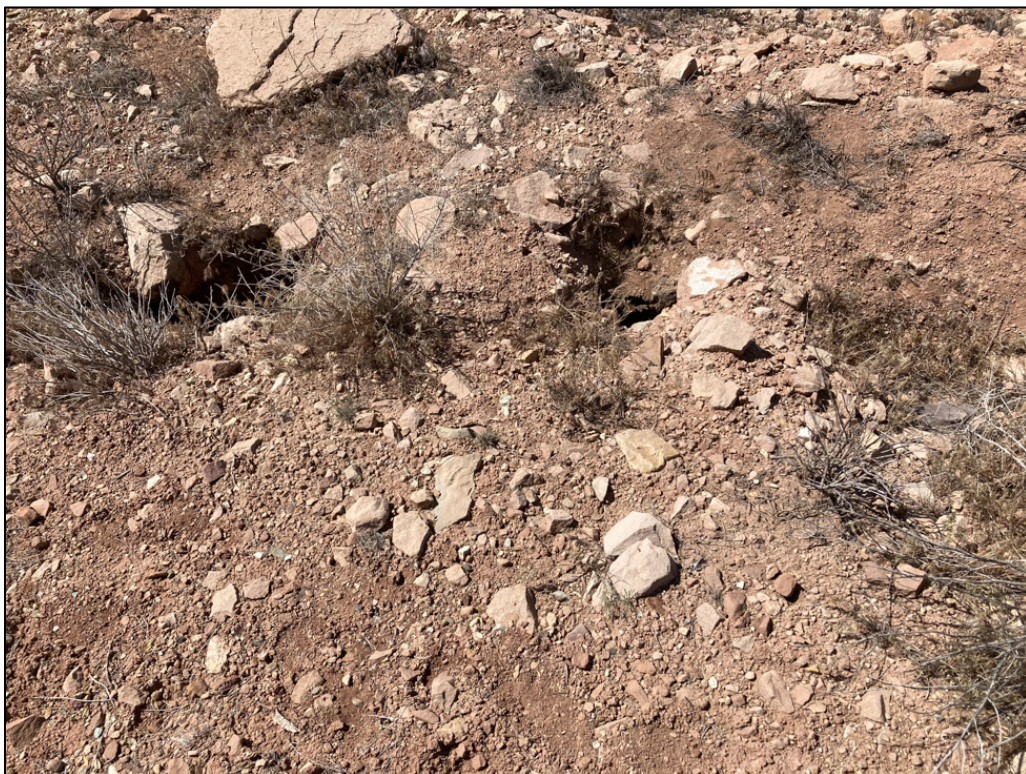
Inspectors noted small erosional channeling occurring along the cliff north of the disposal cell and flagged the area for safety reasons (PL-7). Inspectors will continue to monitor the area for further signs of erosion. No maintenance needs were identified.

PL-7. Erosional Channeling on Slope North of Disposal Cell
