13.0 Naturita, Colorado, Disposal Site

13.1 Compliance Summary

Figure 13-1. 2024 Annual Inspection Drawing for the Naturita, Colorado, Disposal Site

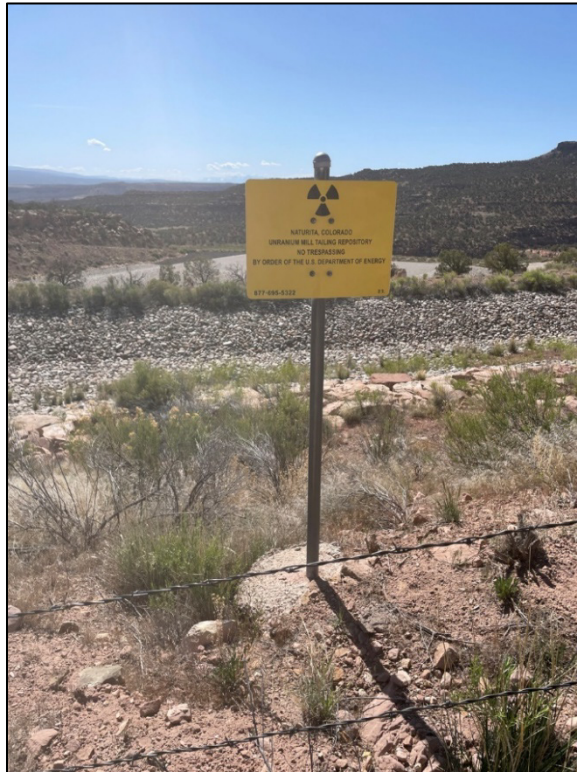
A barbed-wire perimeter fence encloses the site. There are 25 perimeter signs positioned along the perimeter fence that are attached to steel posts set in concrete and set back 5 feet from the property boundary. Erosion around the concrete base of perimeter sign P22 is continually present and will be monitored (PL-1). No other maintenance needs were identified.

PL-1. Erosion Around Concrete Base of Perimeter Sign P22

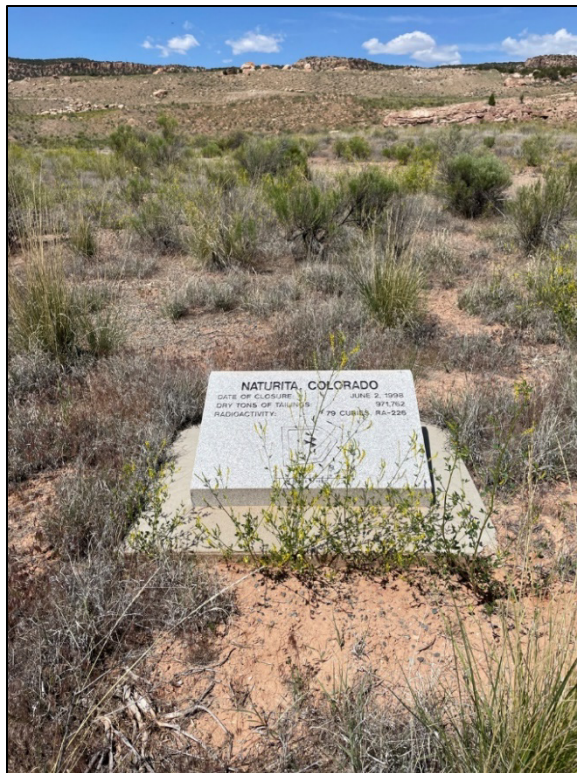
The site has two granite site markers. Site marker SMK-1 is just inside the entrance gate (PL-2), and site marker SMK-2 is on the top slope of the disposal cell. No maintenance needs were identified.

PL-2. Site Marker SMK-1

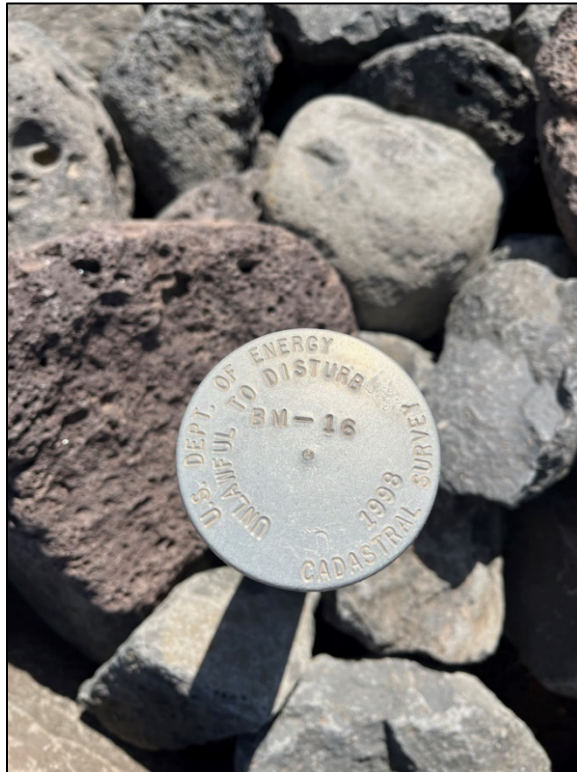
Three survey monuments and 14 boundary monuments delineate the property boundary (PL-3). Boundary monuments BM-3, BM-4, and BM-11 are dual-purpose monuments that also represent survey monuments SM-3, SM-4, and SM-11, respectively. No maintenance needs were identified.

PL-3. Boundary Monument BM-16

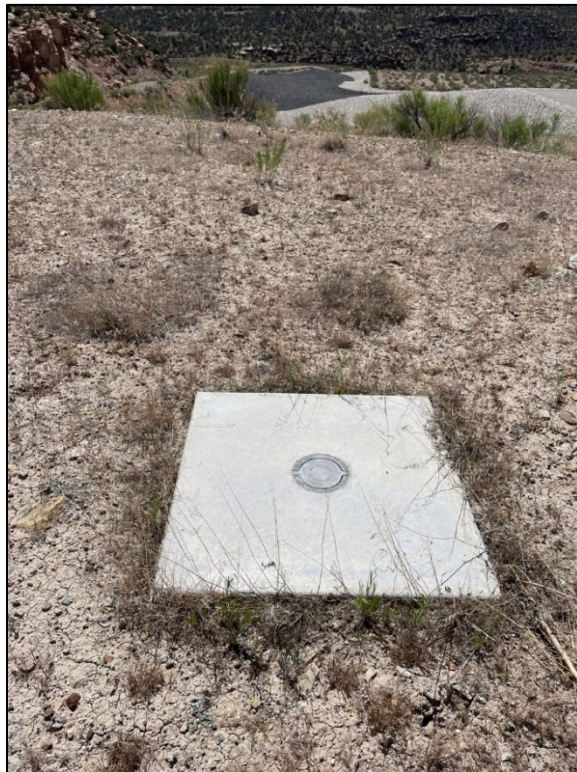
Four aerial survey quality control monuments used during aerial surveys for ground control were inspected (PL-4). No maintenance needs were identified.

PL-4. Aerial Survey Quality Control Monument QC-3

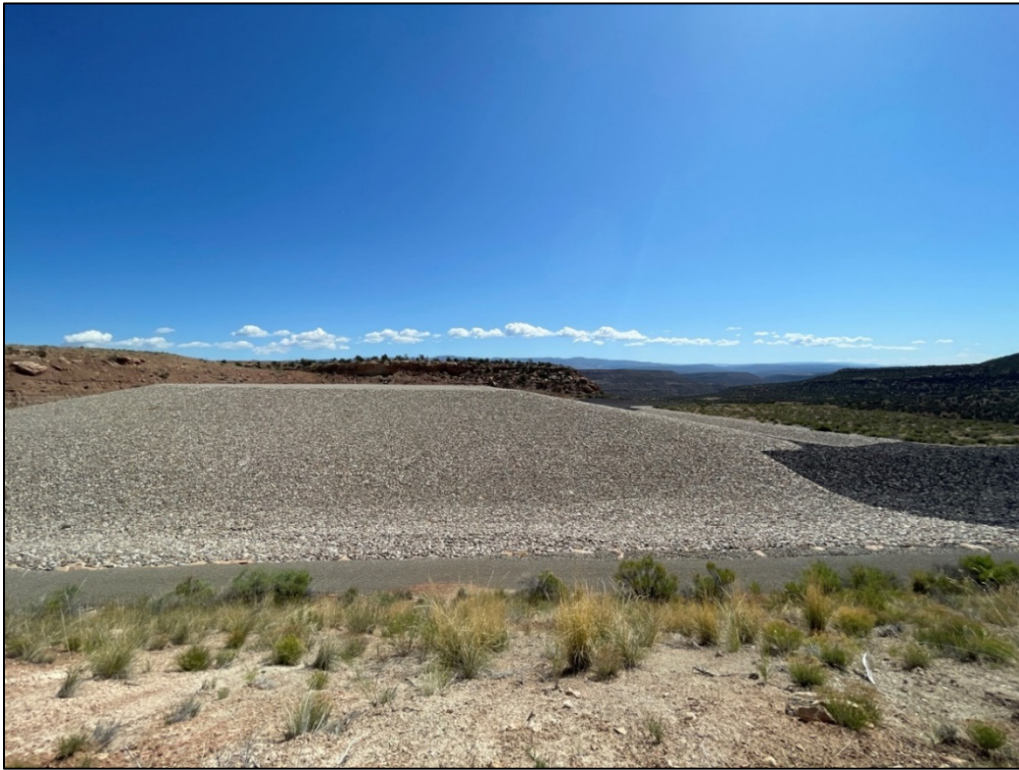
The disposal cell, completed in 1998, occupies 10 acres (PL-5). The disposal cell is armored with riprap to control erosion. The riprap is rounded, with larger diameter rock on the side slopes than on the top slope. There was no evidence of settling, slumping, erosion, rock degradation, or other modifying processes that might affect the integrity of the disposal cell.

PL-5. Disposal Cell

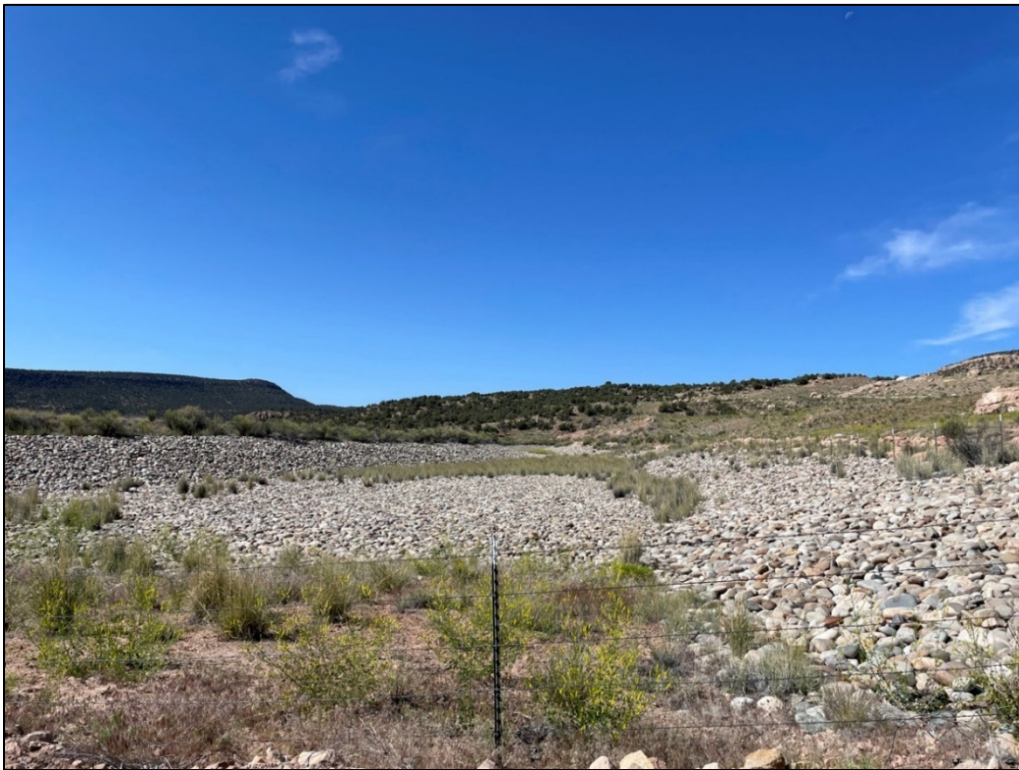
A riprap-armored interceptor channel, upgradient and northwest of the disposal cell, diverts stormwater and snowmelt runoff to the northeast under County Road EE22. Some sediment has eroded from the offsite area upslope from the channel and is being deposited in the channel. Sediment accumulation and associated vegetation have not adversely affected the performance of the interceptor channel (PL-6). Herbicide is applied to rabbitbrush plants when it is deemed necessary by LMS ecologists. Due to trace amounts of woody vegetation on the southeastern apron of the disposal cell, herbicide treatments are only performed intermittently.

PL-6. Interceptor Trench on North Side of Site

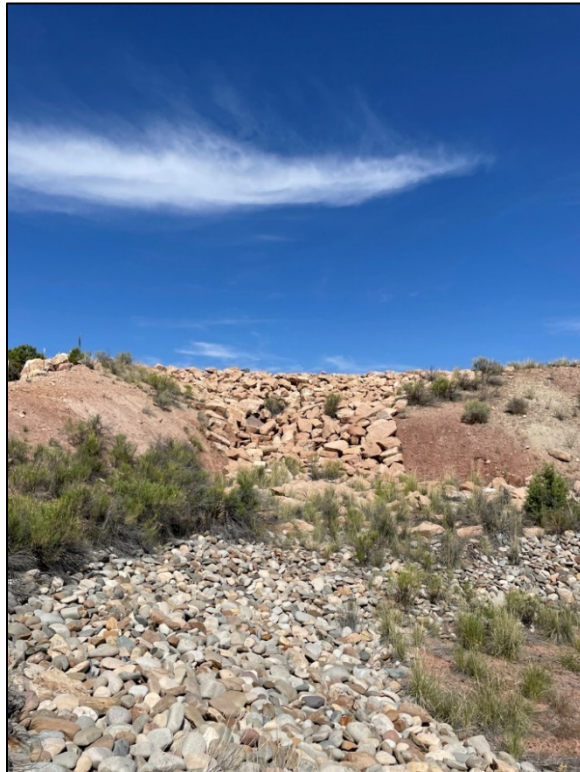
Headcutting erosion has been observed within the spillway channel below the sedimentation pond on the outlying area northwest of the site. Inspectors noted minor increases in rock slumping in this area during the 2023 inspection and will continue to monitor this area (PL-7).

PL-7. Rocks in Spillway

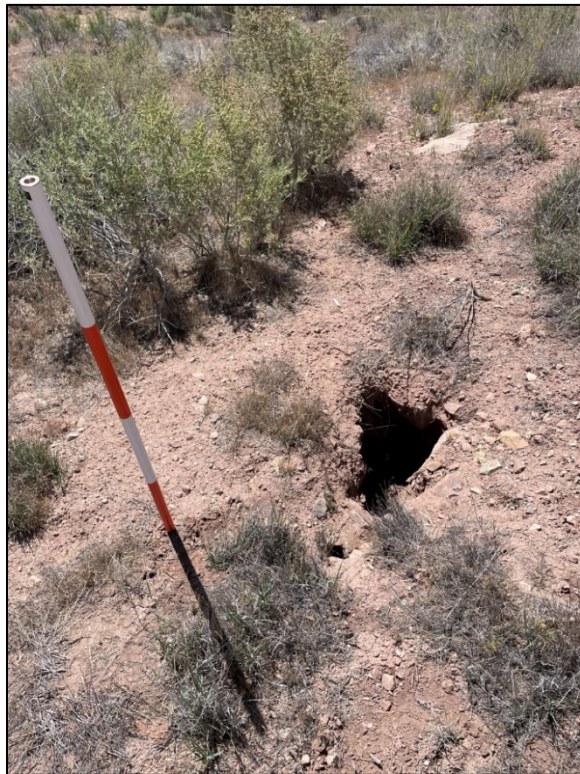
The disposal cell access road along the northwest side of the site descends through shale and sandstone units of the Salt Wash Member of the Morrison Formation. The road provides access to the disposal cell on the west side of the site. A vertical soil pipe is forming 60 feet west of the road on the upper bench of the site (PL-8). Although there are no current concerns, inspectors will continue to monitor this feature. The road surface was in good condition at the time of inspection and no maintenance needs were identified.

PL-8. Soil Piping West of Access Road

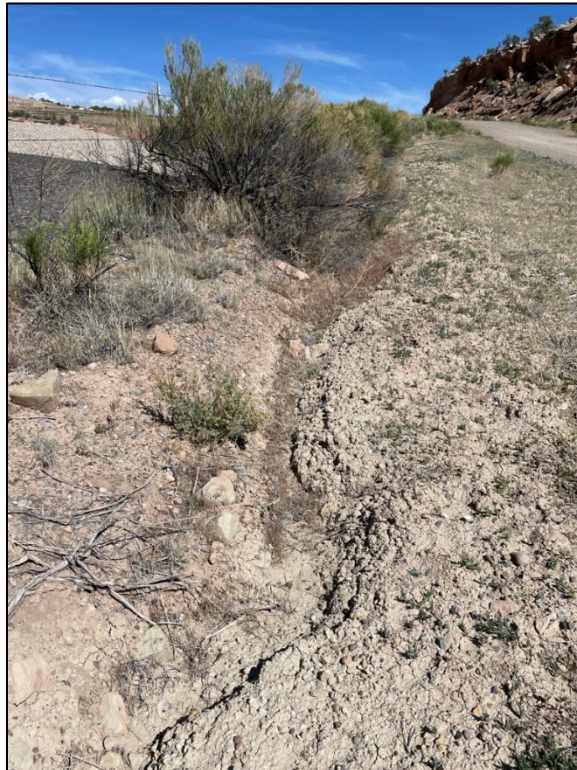
A gully has formed outside of and perpendicular to the fence near the southeast corner of the site (PL-9). Inspectors will continue to monitor to ensure that it does not cut under the fence line. No maintenance needs were identified.

PL-9. Gully near Southeast Fence Line

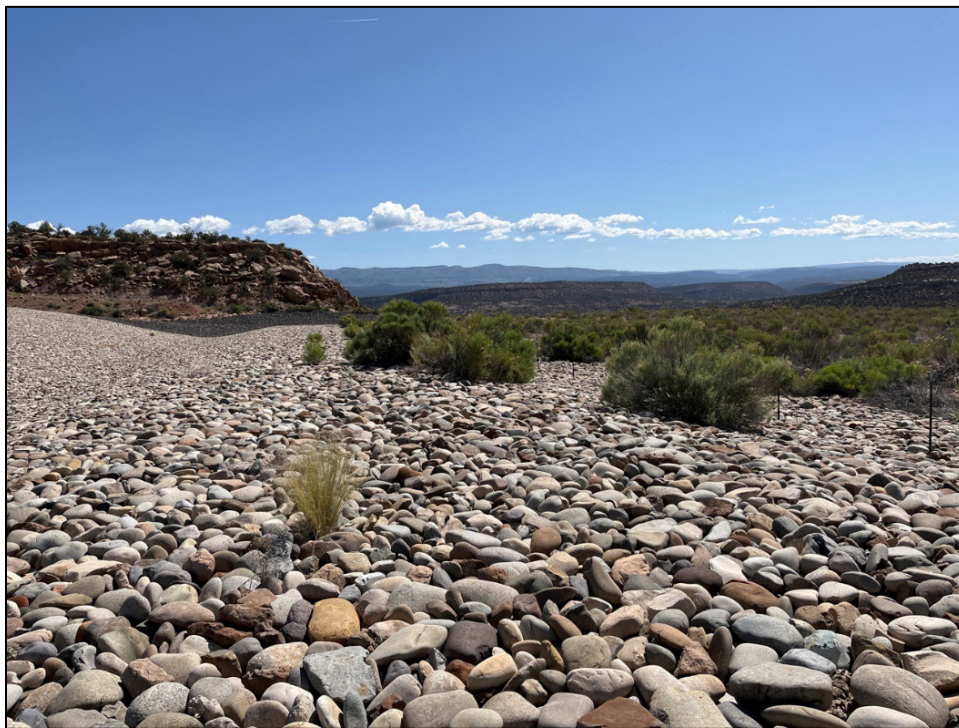
If volunteer plant growth or sedimentation becomes extreme enough to potentially degrade the function of engineered structures, LM will evaluate the potential impact and select appropriate responses. Woody vegetation (rabbitbrush) is beginning to grow on the southeast slope and apron (PL-10). This vegetation was treated after the inspection.

PL-10. Woody Vegetation Growth on Southeast Slopes of Disposal Cell

- Woody vegetation was treated on the southeast slope and apron of the disposal cell
