## 14.0 Rifle, Colorado, Disposal Site

### 14.1 Compliance Summary

Figure 14-1. 2021 Annual Inspection Drawing for the Rifle, Colorado, Disposal Site

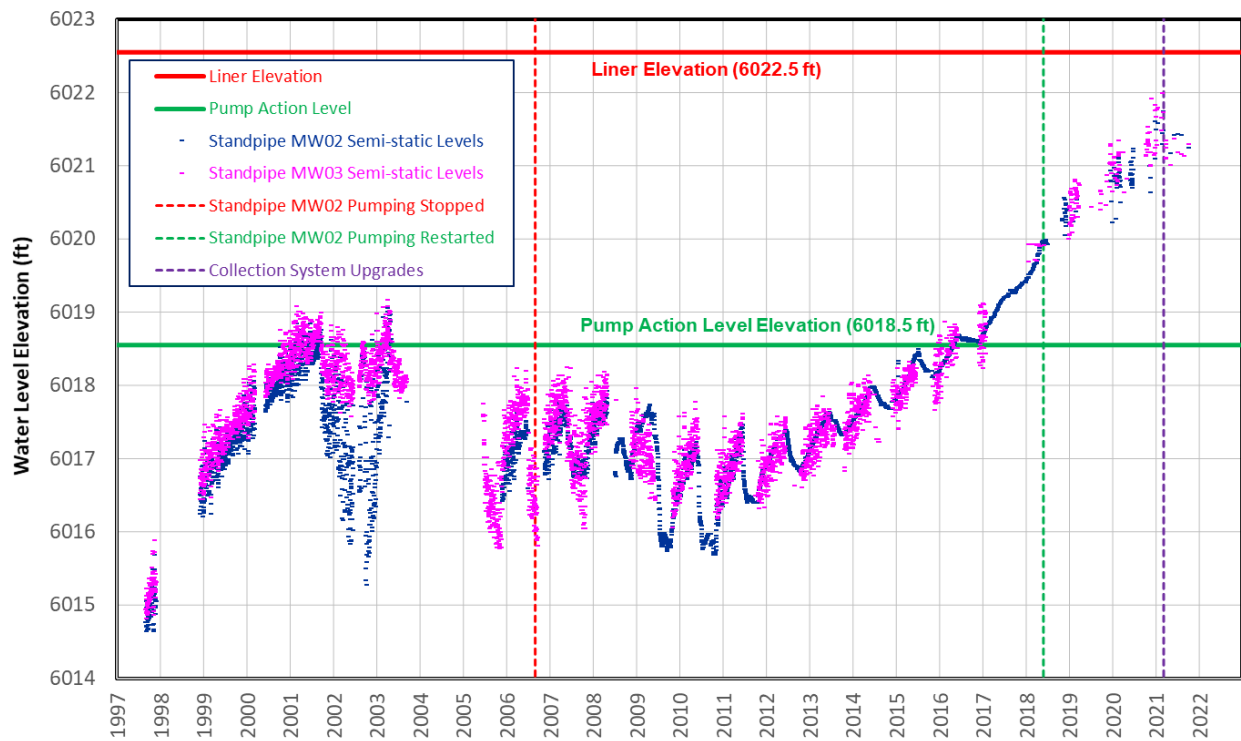
*Figure 14-2. Disposal Cell Pore-Water Levels in Standpipes SP-02 and SP-03 at the Rifle, Colorado, Disposal Site*

Despite the pumping efforts to dewater the cell since 2001, pore-water levels in the cell have not decreased as expected; instead, they have continued to increase to the recent maximum level of 6022.45 ft (6019.5 ft). While the 6018.55 ft (6016 ft) pump action level has been exceeded, pore-water levels in both standpipes SP-02 and SP-03 have been maintained below the top of the HDPE liner elevation. In compliance with requirements of the LTSP, pumping will continue until water levels in the standpipes stabilize at an elevation of 6016.55 ft (6014 ft) or lower. Studies are ongoing to determine (1) potential sources of pore water in the disposal cell other than tailings leachate and (2) potential pumping system upgrades to increase dewatering volumes. Table 14-2 lists total dewatering volumes.

Real-time disposal cell water elevations collected in 2018 (using pressure transducers and dataloggers) continued to indicate that daily maximum or semistatic pore-water levels in standpipes SP-02 and SP-03 exceed the 6018.55 ft (6016 ft) pump action level (see Figure 14-2). In 2019, LM modified the seasonal pumping regimen for year-round pumping while a long-term solution is evaluated and implemented.

Data fluctuations for both standpipes observed from 2018 to 2021 are the result of partial overnight recharge due to well inefficiencies, and nonstatic levels have been filtered from the dataset shown in Figure 14-2. Downhole video taken in 2020 for both standpipes revealed fouling in the perforated interval. Redevelopment of standpipe SP-02 to remove mineral scale and biofouling was completed in December 2020. Initial testing results indicate an increase in production volume from standpipe SP-02 of approximately 22%. Downhole video in standpipe SP-03 also identified approximately 7.6 ft of 6- to 10-inch diameter rock riprap at the bottom of the standpipe. Potential methods to remove the rock and redevelop the standpipe are being considered to increase production.

In March 2021, the solar-powered pumping system was upgraded to provide additional operation of the pumps by increasing electrical storage ability. By adding batteries to store solar-generated electricity, the pumps are able to operate throughout the night and on overcast days. This should yield a more consistent and lower pore-water elevation and increase annual dewatering volume. The pumping system will continue to have limited availability in winter because aboveground effluent lines are susceptible to freezing.

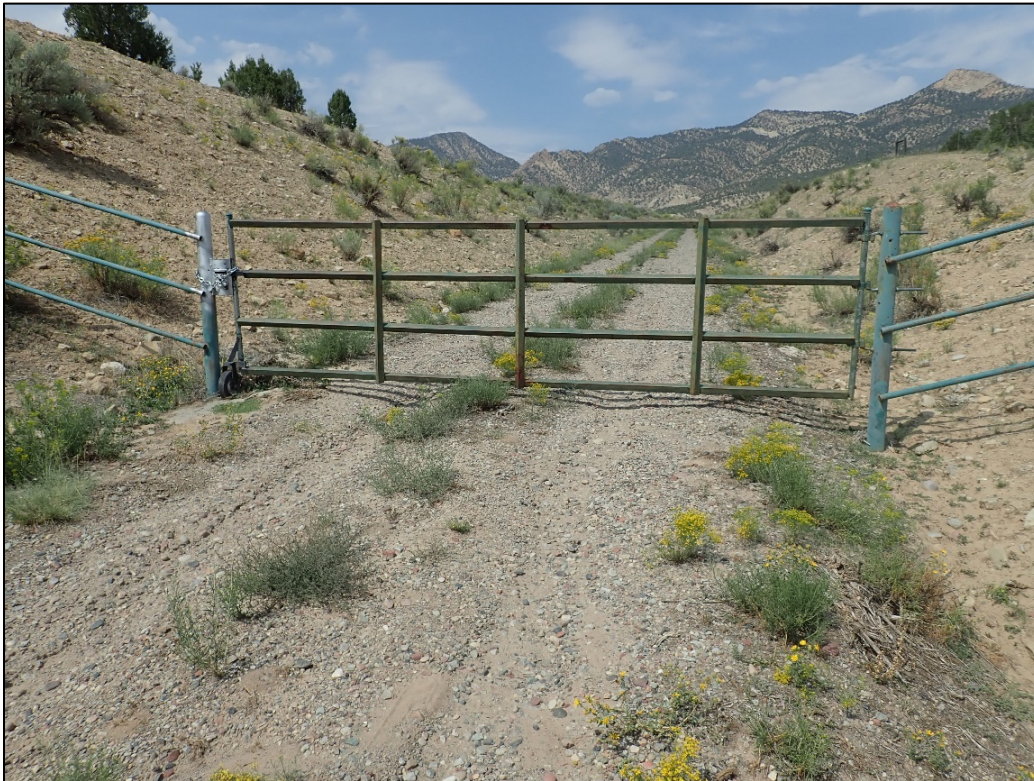
Access to the site is from an improved gravel road northeast of Colorado Highway 13. A perpetual right-of-way across U.S. Bureau of Land Management (BLM) property provides access to the site. Entrance to the site is through two locked gates on the access road: an outer reinforced metal gate about 1700 ft south of the site (PL-1) and an inner metal gate at the stock fence. The entrance sign, which is next to the inner gate, had minor cracks but remained legible. No other maintenance needs were identified.

*PL-1. Outer Entrance Gate*

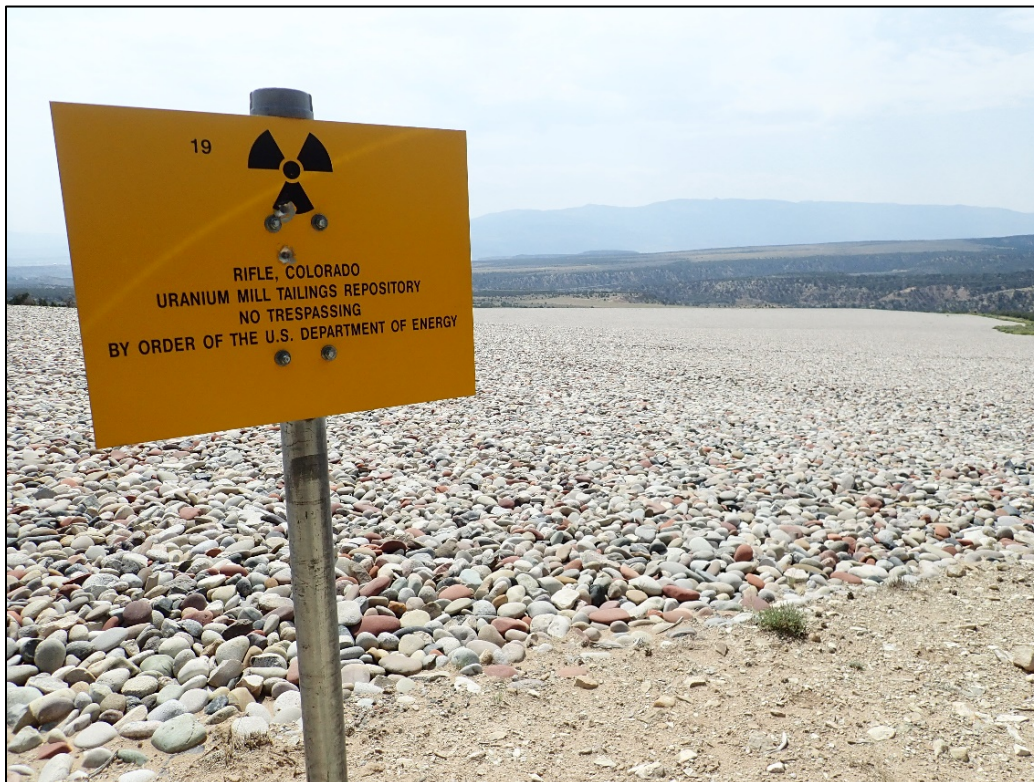
There are 27 perimeter signs positioned along the perimeter. Perimeter signs P0 through P11 are attached to the stock fence, and signs P12 through P26 are attached to steel posts set in concrete and set back 5 ft from the boundary (PL-2). Perimeter signs P15 and P19 have bullet damage, but remain legible and do not need to be replaced at this time. Perimeter sign P18 has shown minor cracks and peeling but remains legible. No other maintenance needs were identified.

*PL-2. Perimeter Sign P19*

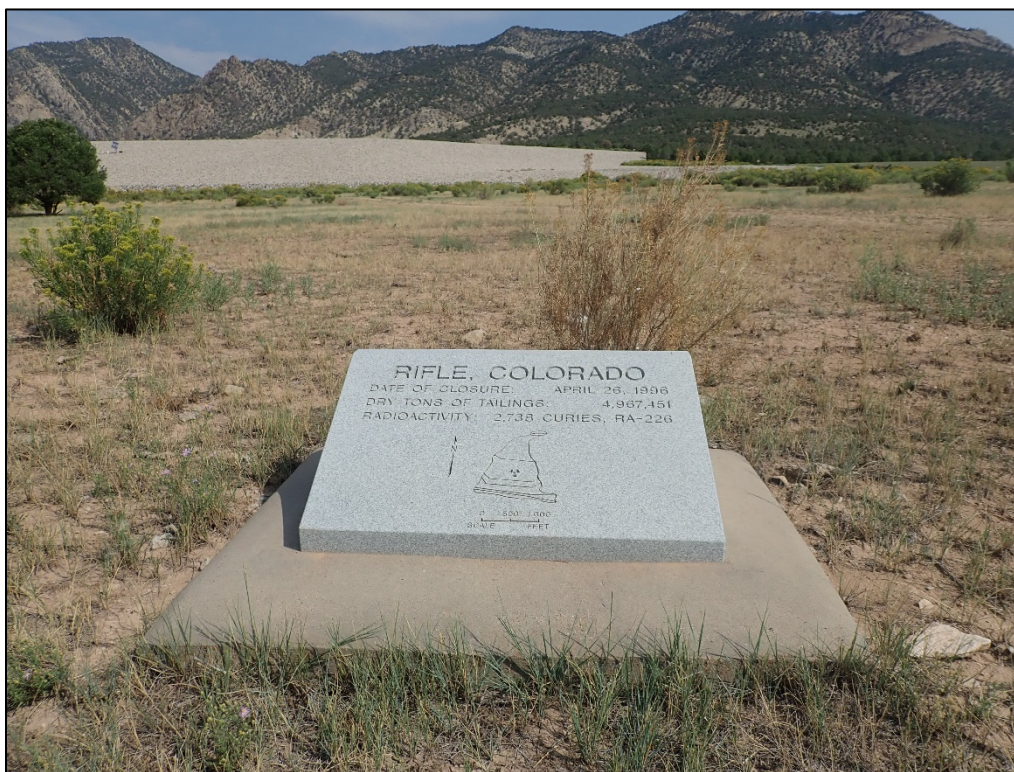
The site has two granite site markers. Site marker SMK-1 is just inside the inner entrance gate, and site marker SMK-2 is on the top slope of the disposal cell (PL-3). No maintenance needs were identified.

*PL-3. Site Marker SMK-1*

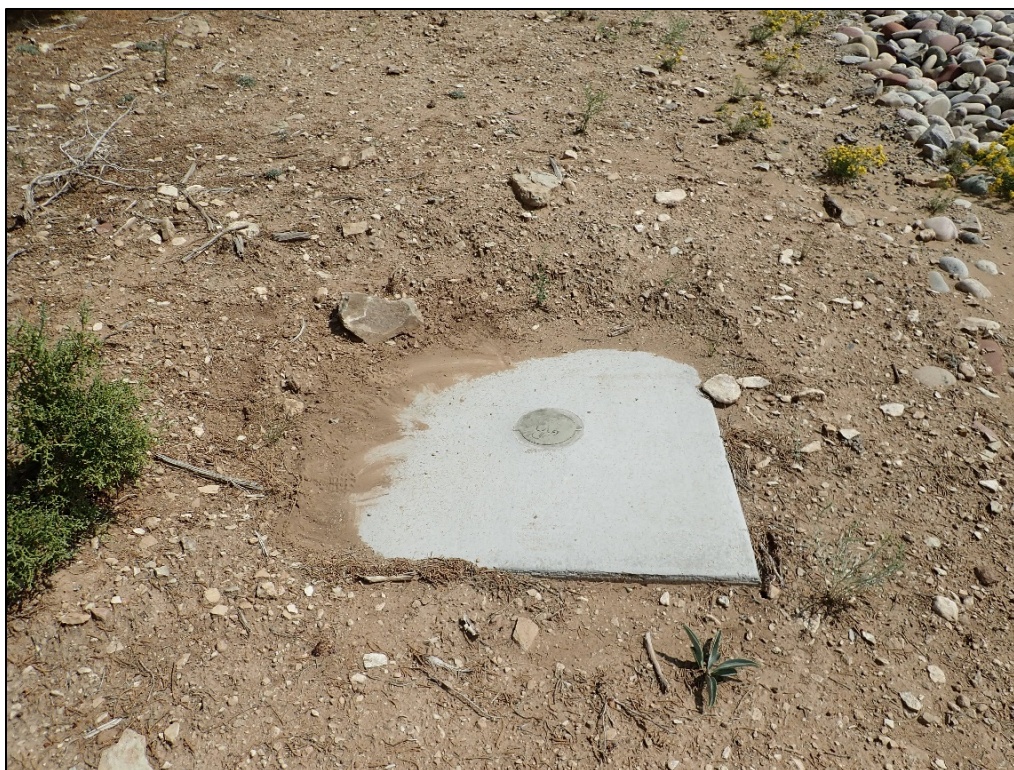
Nine aerial survey quality control monuments were inspected during the 2021 annual inspection. Inspectors noted minor sediment accumulation on quality control monuments QC-5 and QC-8 (PL-4). No maintenance needs were identified.

*PL-4. Quality Control Monument QC-5*

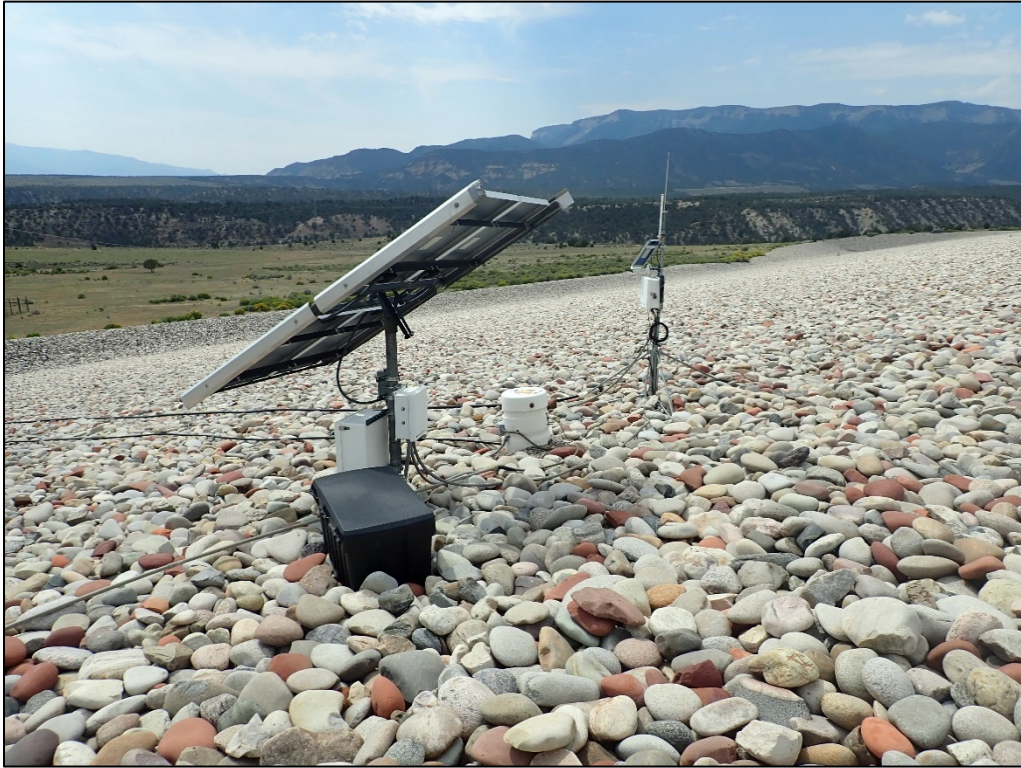
Three standpipes (SP-01, SP-02, and SP-03) on the south side slope of the disposal cell are used to monitor pore-water levels in the disposal cell (PL-5). At the time of the inspection, disposal cell pore water was being pumped from standpipes SP-02 and SP-03 (also known as monitoring wells 02 and 03, respectively) into the evaporation pond. Redevelopment of standpipe SP-02, consisting of mechanical and chemical cleaning to treat biofouling and debris removal, will be completed before the next inspection. No maintenance needs were identified.

*PL-5. Standpipe SP-02 and Instrumentation*

- Redevelopment of standpipe SP-02
- Treatment of the rabbitbrush on top of the disposal cell

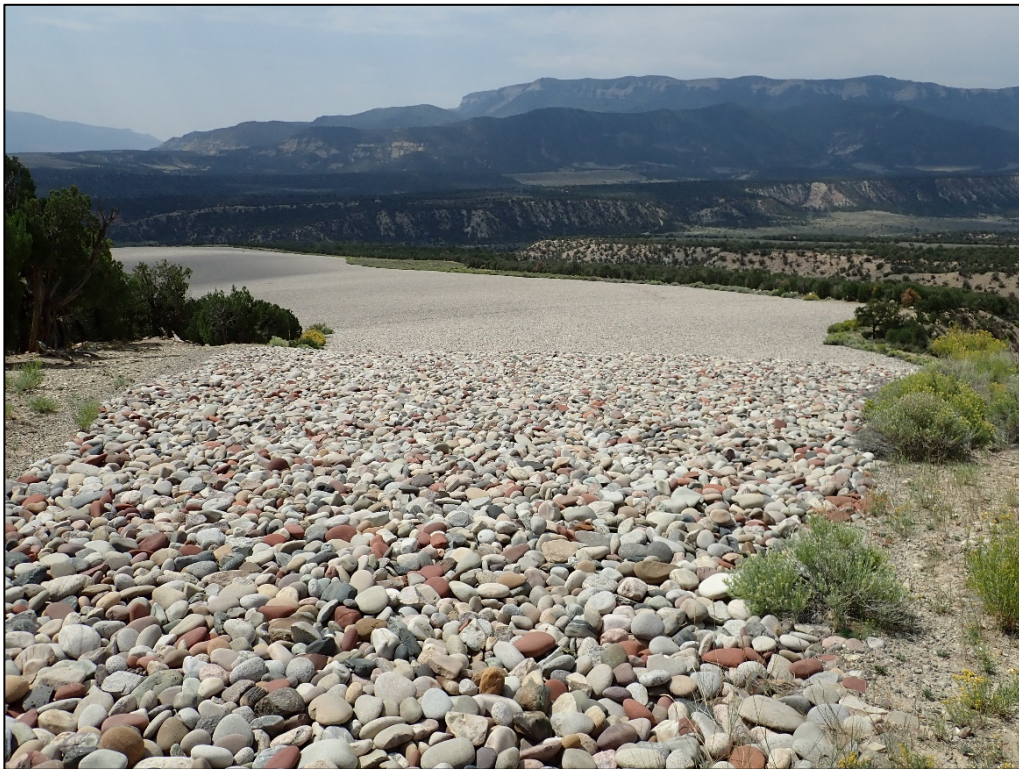
The disposal cell, completed in 1996, occupies 71 acres and is armored with riprap consisting of river cobbles and boulders to control erosion and deter animal and human intrusion. There was no evidence of erosion, settling, slumping, or other modifying processes that might affect the integrity of the disposal cell (PL-6). As in the past several inspections, inspectors noticed minor rock degradation on the disposal cell top slope, primarily in the form of cracking and spalling. Rock degradation does not present a concern at this time.

*PL-6. Disposal Cell Cover*

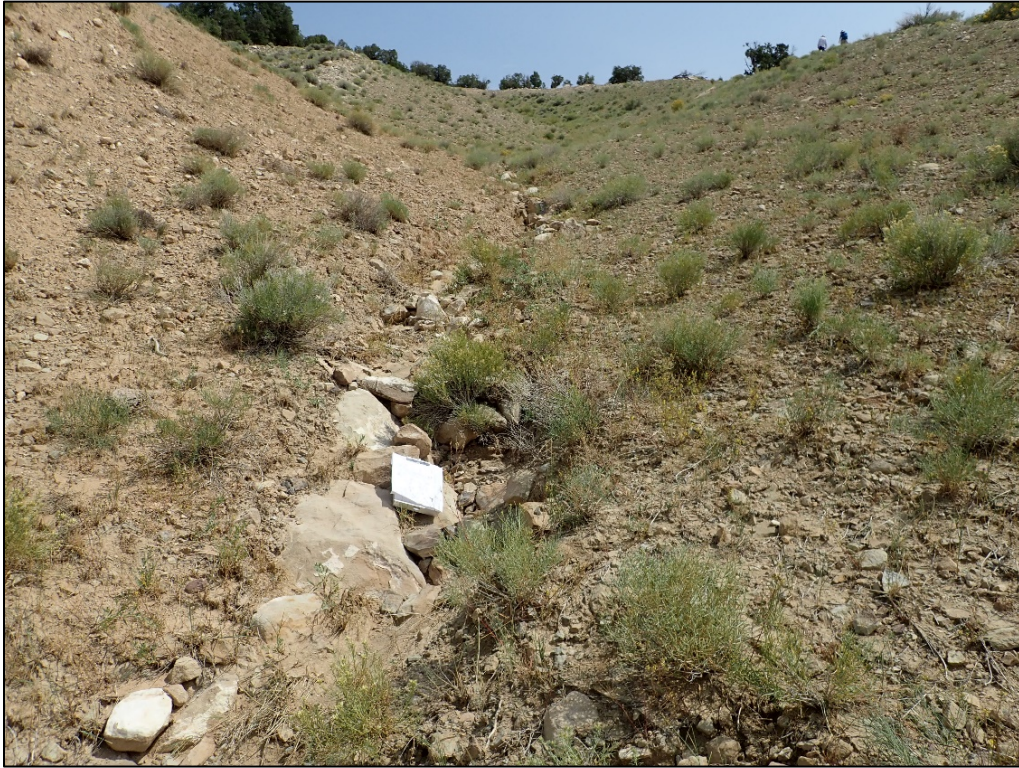
A vegetated interceptor trench was constructed at the top of the disposal cell to protect the disposal cell from stormwater and snowmelt runoff. The trench appeared to be functioning as designed, although minor gully erosion has been occurring in the lower portion of the trench. The gully did not appear to be increasing in depth or width (PL-7); the deepest downcut was approximately 18 inches deep and 24 inches wide. In the outfall area below the trench (down the steep-sided natural slope), stormwater runoff has formed a major gully to the north of the armoring riprap placed in this area in the early 2000s. The gully did not appear to be increasing in depth or width (PL-8) during the 2021 inspection. The outfall area will continue to be monitored to assess if additional riprap is needed on the slope to prevent upstream gully migration. No maintenance needs were identified.

*PL-7a. Gully Erosion in Interceptor Trench Outfall in 2021*

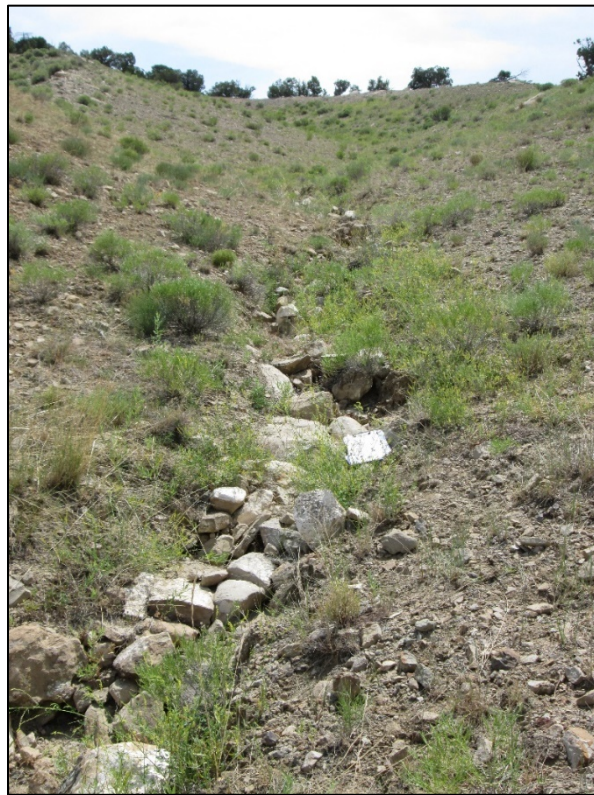
*PL-7b. Gully Erosion in Interceptor Trench Outfall in 2016—Photo for Comparison*

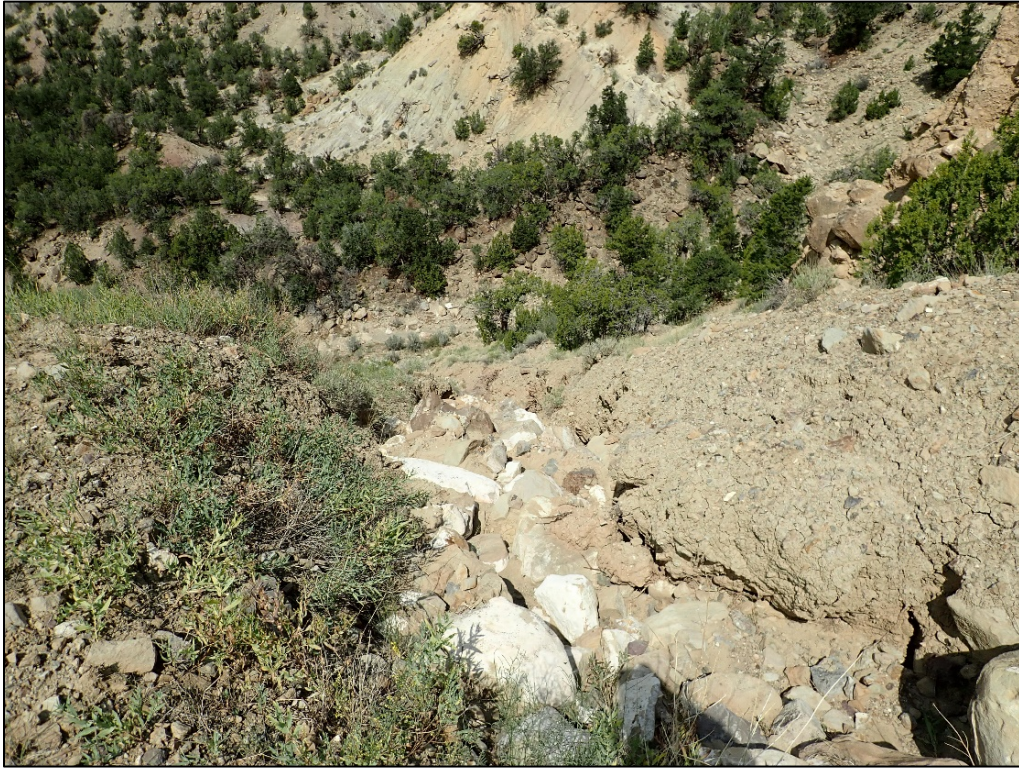
*PL-8a. Gully Erosion in Interceptor Trench Outfall in 2021*

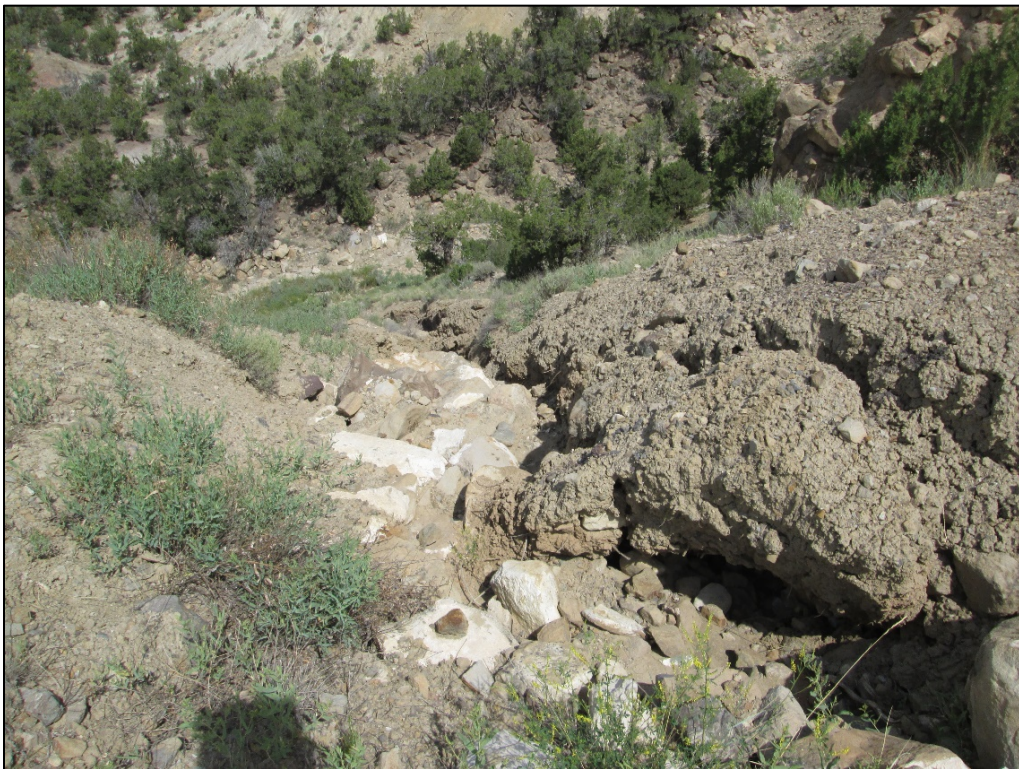
*PL-8b. Gully Erosion in Interceptor Trench Outfall in 2016—Photo for Comparison*

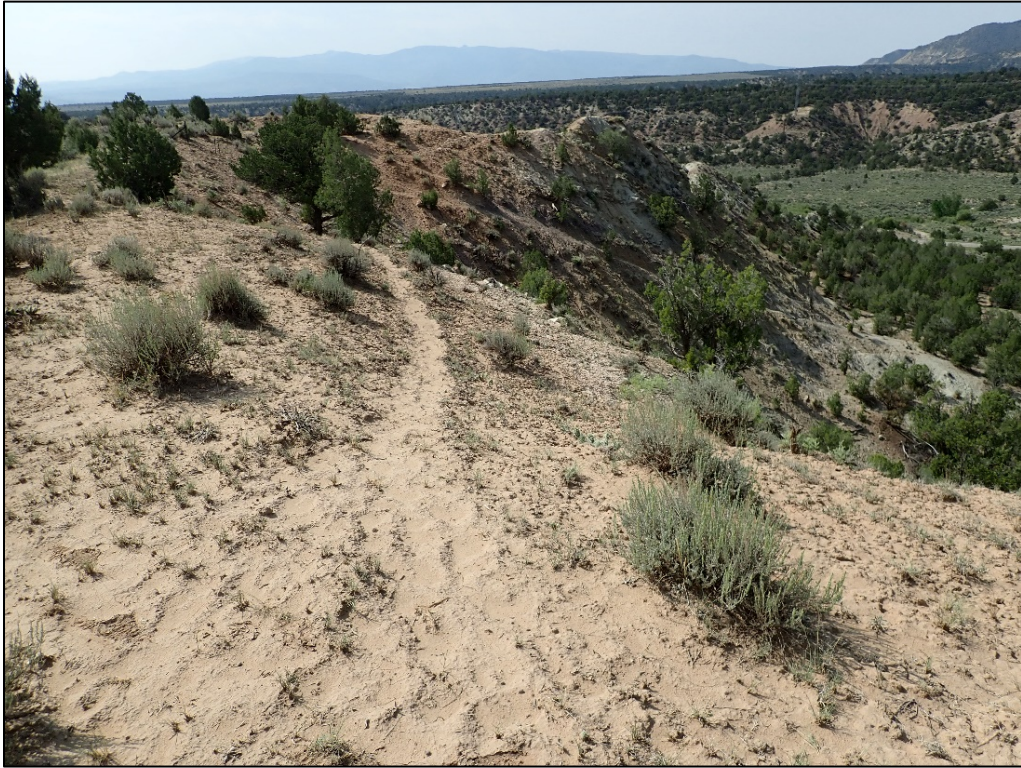
Disturbed areas around the edges and south of the disposal cell were reseeded in 1996 and, overall, have been successfully reclaimed. Before 2012, there was little evidence of grazing within the site boundaries. Since 2012, however, grazing by cattle has been regularly observed, and cattle trails have been identified meandering up the steep arroyos on the unfenced, southwest side of the site (PL-9). LM is evaluating additional fencing installation options on the southwest side of the site to prevent cattle access.

*PL-9. Cattle Trail on Southwest Side of Site*
