14.0 Rifle, Colorado, Disposal Site

14.1 Compliance Summary

The Rifle, Colorado, Uranium Mill Tailings Radiation Control Act (UMTRCA) Title I Disposal Site was inspected on August 11, 2022. Minor depressions or undulations were noted on the disposal cell cover, particularly on the western edge of the cell. These features will be verified with the light detection and ranging (lidar) data from the baseline aerial survey. No other changes were observed on the disposal cell. No changes were observed in the associated drainage features. Inspectors identified one minor maintenance need but found no cause for a follow-up inspection.

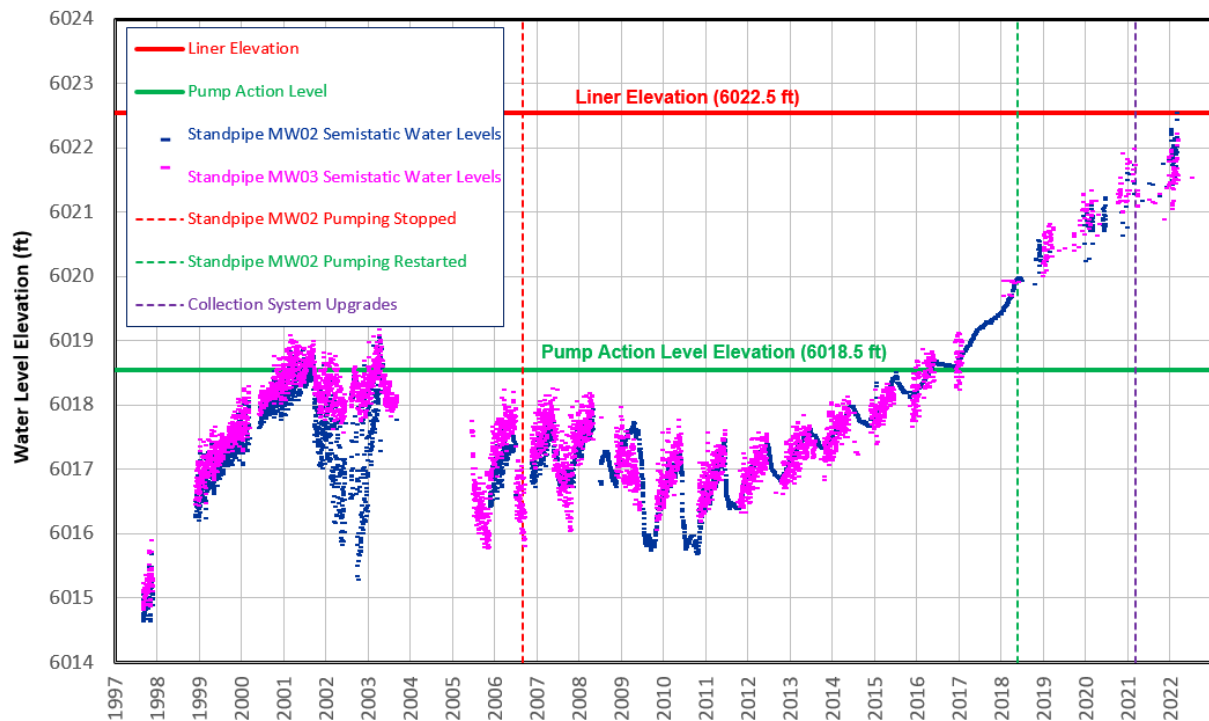
Figure 14-2. Disposal Cell Pore-Water Levels in Standpipes SP-02 and SP-03 at the Rifle, Colorado, Disposal Site

Despite the pumping efforts to dewater the cell since 2001, pore-water levels in the cell have not decreased; instead, they have continued to increase to the recent maximum level of 6022.42 ft. While the 6018.55 ft pump action level has been exceeded, pore-water levels in both standpipes SP-02 and SP-03 have been maintained below the top of the HDPE liner elevation. In compliance with requirements of the LTSP, pumping will continue until water levels in the standpipes stabilize at an elevation of 6016.55 ft or lower.

Real-time disposal cell water elevations collected in 2018 (using pressure transducers and dataloggers) continued to indicate that daily maximum or semistatic pore-water levels in standpipes SP-02 and SP-03 exceed the 6018.55 ft pump action level (see Figure 14-2). In 2019, LM modified the seasonal pumping regimen for year-round pumping while a long-term solution is evaluated and implemented.

Data fluctuations for both standpipes observed from 2018 to 2022 are the result of partial overnight recharge due to well inefficiencies. The nonstatic levels have been removed from the dataset shown in Figure 14-2. Downhole video taken in 2020 for both standpipes revealed fouling in the perforated interval. Redevelopment of standpipe SP-02 to remove mineral scale and biofouling was last completed in December 2020. Testing results indicated an increase in production volume from standpipe SP-02 of approximately 22%. Downhole video in standpipe SP-03 also identified approximately 7.6 ft of 6- to 10-inch diameter rock riprap at the bottom of the standpipe.

In March 2021, the solar-powered pumping system was upgraded to provide additional operation of the pumps by increasing electrical storage ability. By adding batteries to store solar-generated electricity, the pumps are able to operate throughout the night and on overcast days. This has yielded an increase in annual dewatering volume but does not appear to have decreased the pore-water level.

In July 2022, the leachate discharge pipes were replaced with 2-inch diameter pipes and insulated where the pipe crosses the toe ditch to protect against freezing and pipe bursting in the winter. These improvements should allow the pumping system to function at colder temperatures in the winter, increasing the annual dewatering volume.

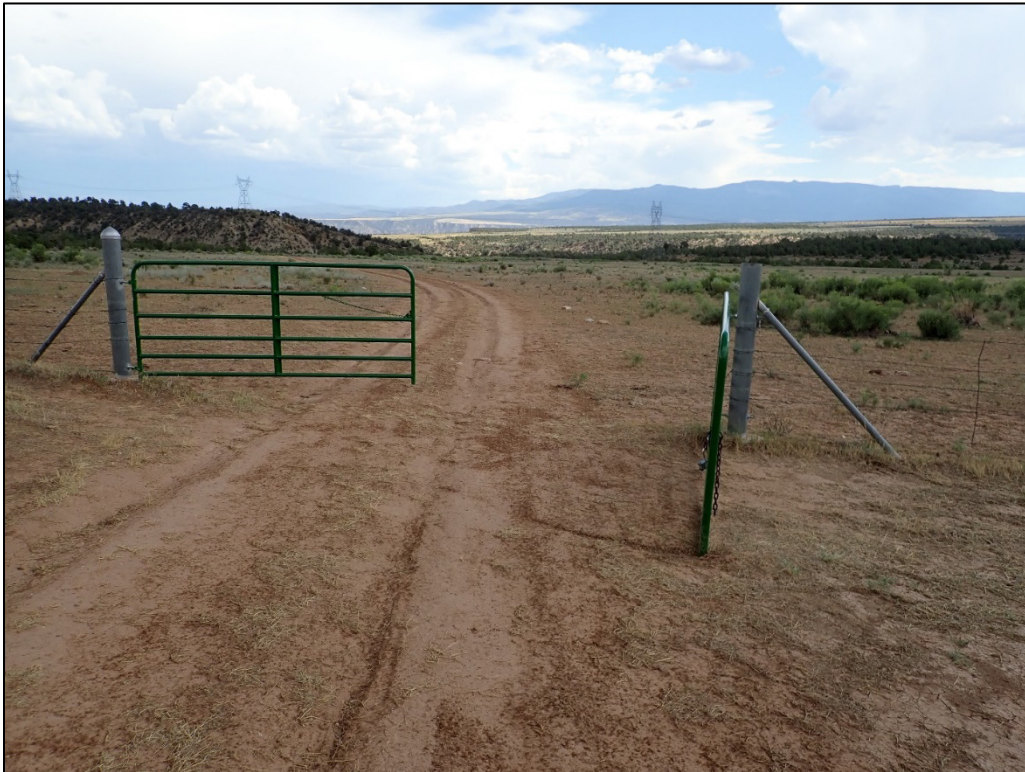
PL-1. Entrance Gate

Access to the site is from an improved gravel road northeast of Colorado Highway 13. A perpetual right-of-way across U.S. Bureau of Land Management (BLM) property provides access to the site. Entrance to the site is through two locked gates on the access road: an outer reinforced metal gate about 1700 feet (ft) south of the site and an inner metal gate at the stock fence (PL-1). The entrance sign, which is next to the inner gate, was faded and had minor cracks but remained legible. No maintenance needs were identified.

- Update the website address on the entrance sign
- Treat the rabbitbrush growing on the southeastern slope of the disposal cell and toe drain area

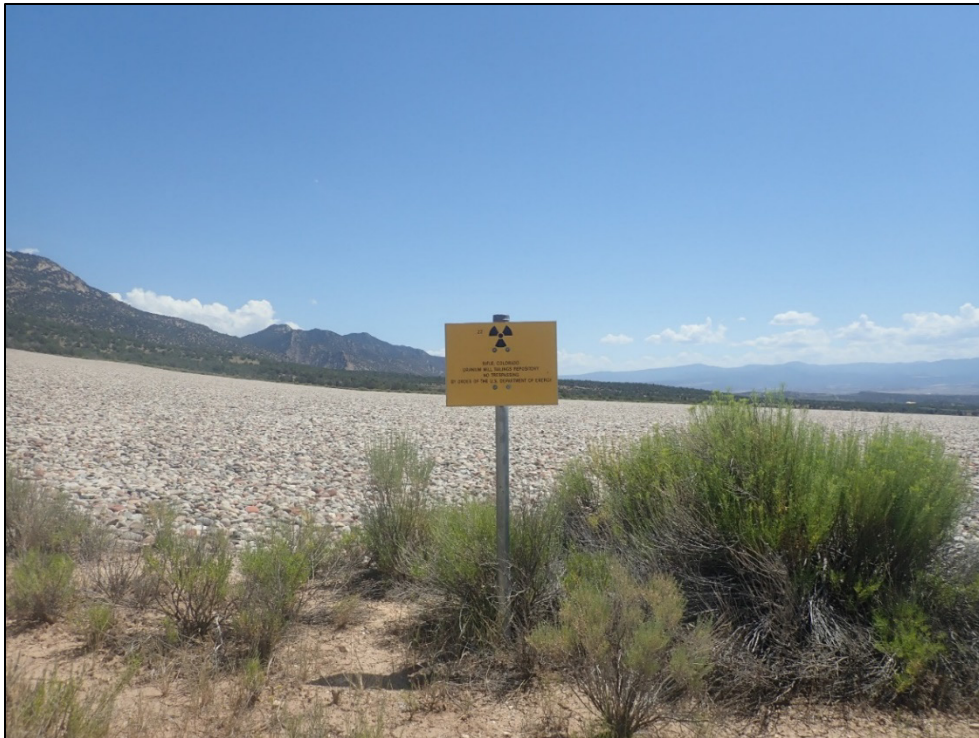
There are 27 perimeter signs positioned along the site perimeter. Perimeter signs P0 through P11 are attached to the stock fence, and signs P12 through P26 are attached to steel posts set in concrete and set back 5 ft from the boundary. Perimeter signs P15 and P19 have bullet damage but remain legible. Perimeter signs P1, P3, P16, P18, P22, P24, and P26 have minor cracks and peeling but remain legible (PL-2). No maintenance needs were identified.

PL-2. Perimeter Sign P22

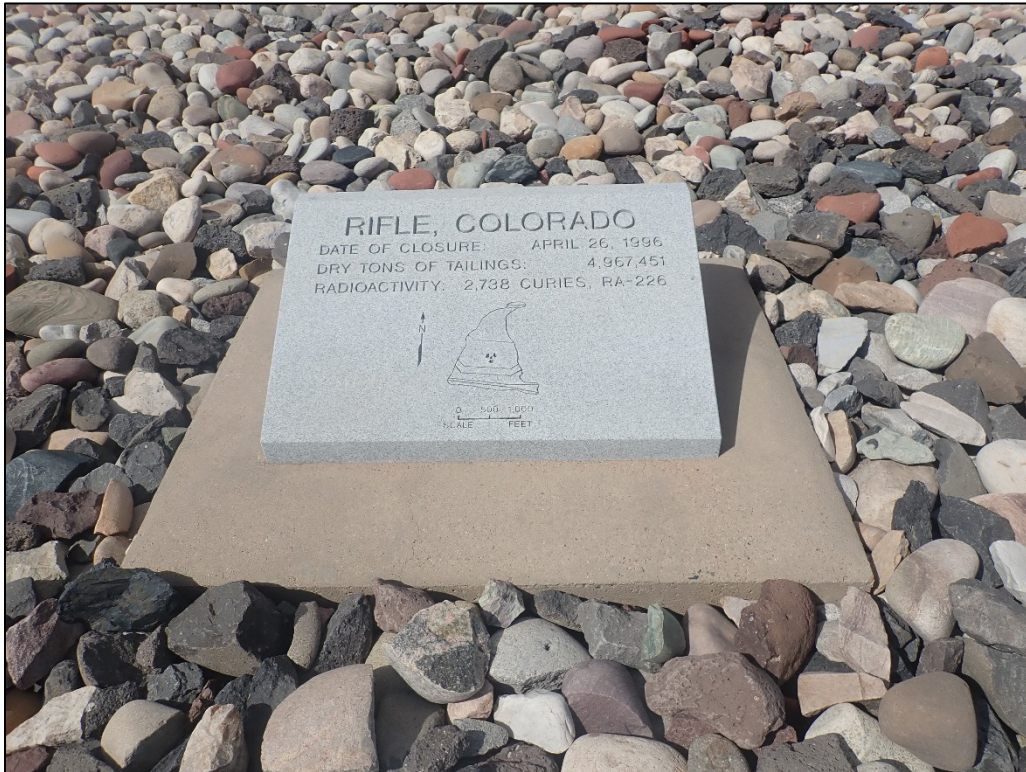
The site has two granite site markers. Site marker SMK-1 is just inside the inner entrance gate, and site marker SMK-2 is on the top slope of the disposal cell (PL-3). No maintenance needs were identified.

PL-3. Site Marker SMK-2

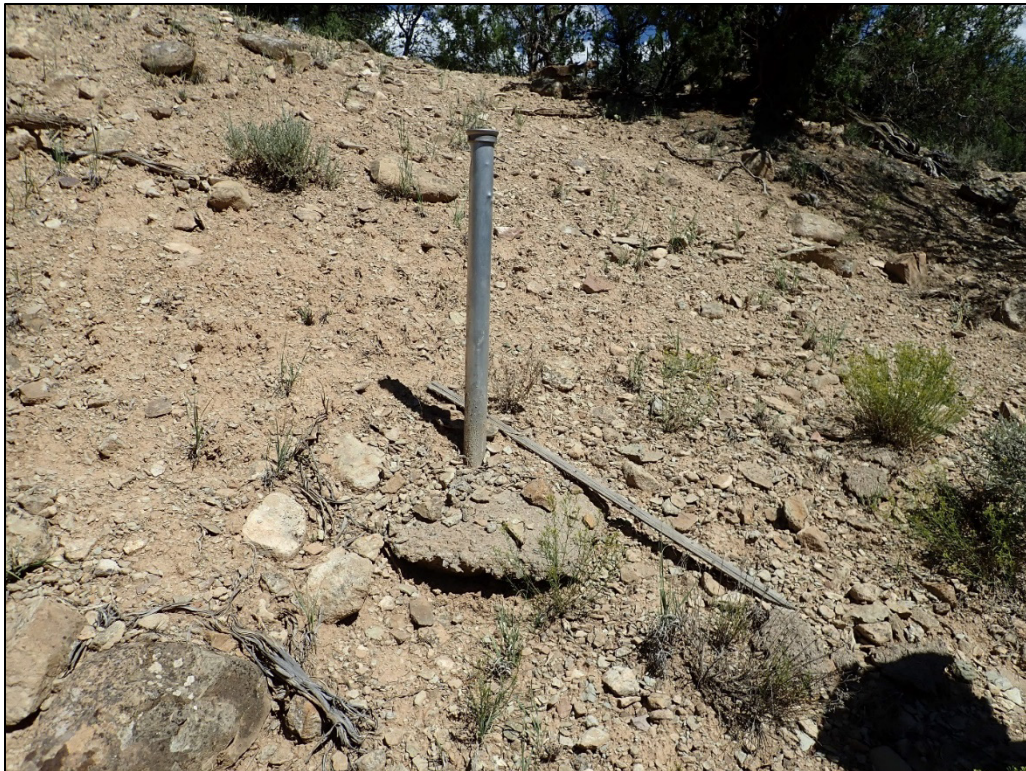
Three survey monuments and 15 boundary monuments delineate the property boundary. The boundary monuments are set at the corners of the irregular site boundary. Although the site boundary has 20 corners, only 15 are marked by boundary monuments because 5 of the corners are on extremely steep terrain that is not safely accessible. Consequently, boundary monuments BM-8, BM-9, BM-13, BM-17, and BM-20 were never installed. GPS is used to identify and inspect existing boundary monuments that are in hard-to-access areas. Boundary monument BM-2 has several bullet holes but remains intact. Boundary monuments BM-2 and BM-18 have undercutting at the ground surface but remain stable (PL-4). Survey monument SM-2 has slight cracking in the concrete, but the cracking does not affect the integrity of the survey monument. No maintenance needs were identified.

PL-4. Boundary Monument BM-2

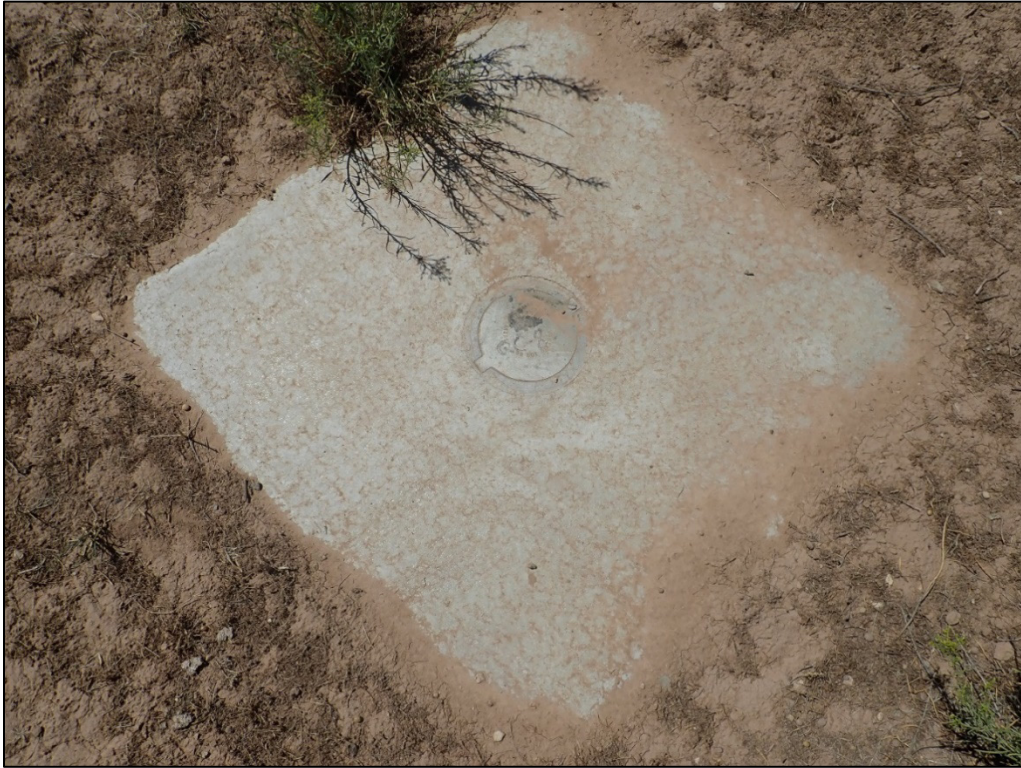
Nine aerial survey quality control monuments were inspected during the 2022 annual inspection. Inspectors noted minor sediment accumulation on quality control monuments QC-5 and QC-8 (PL-5). An aerial survey collected lidar data in July 2022. No maintenance needs were identified.

PL-5. Aerial Survey Quality Control Monument QC-8

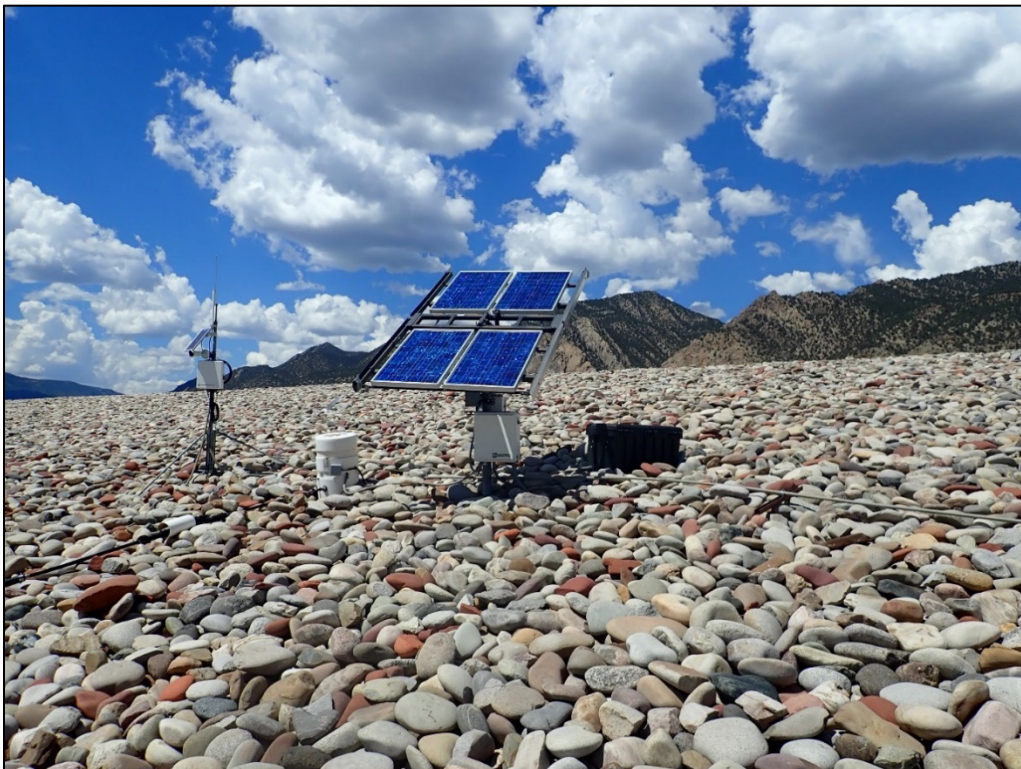
Three standpipes (SP-01, SP-02, and SP-03) on the south side slope of the disposal cell are used to monitor pore-water levels in the disposal cell (PL-6). At the time of the inspection, disposal cell pore water was being pumped from standpipes SP-02 and SP-03 (also known as monitoring wells 02 and 03, respectively) into the evaporation pond. No other maintenance needs were identified.

PL-6. Standpipe SP-02 and Instrumentation

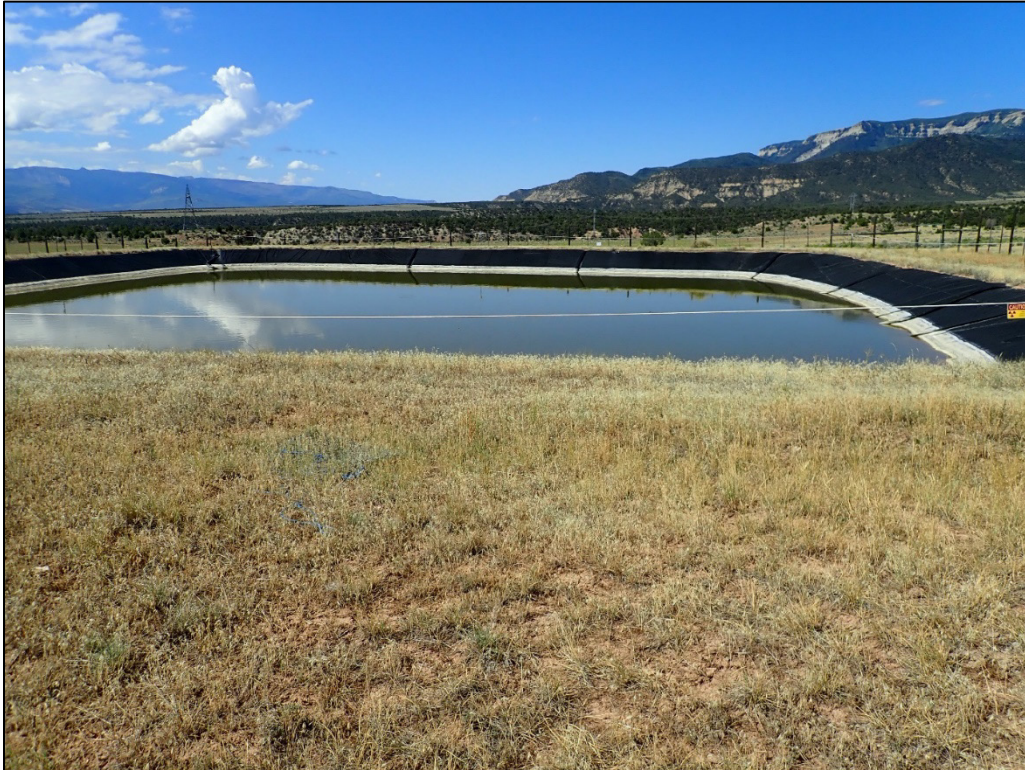
A lined evaporation pond was constructed adjacent to the disposal cell in 2001 to receive water pumped from standpipes SP-02 and SP-03. The pond contained water at the time of the inspection (PL-7). Evaluation of the pond liner's integrity was completed in fall 2020 by a professional geosynthetic liner installation and inspection company. Two minor holes, approximately 2 inches in diameter, were identified at the top slope of the liner and repaired in May 2021. Evaluation of the liner by a testing laboratory indicated that the liner is in good condition for its age. LM plans to replace the pond liner in fiscal year 2024, barring further damage that would necessitate earlier replacement. Inspectors will continue to monitor this before the planned liner preplacement.

PL-7. Evaporation Pond

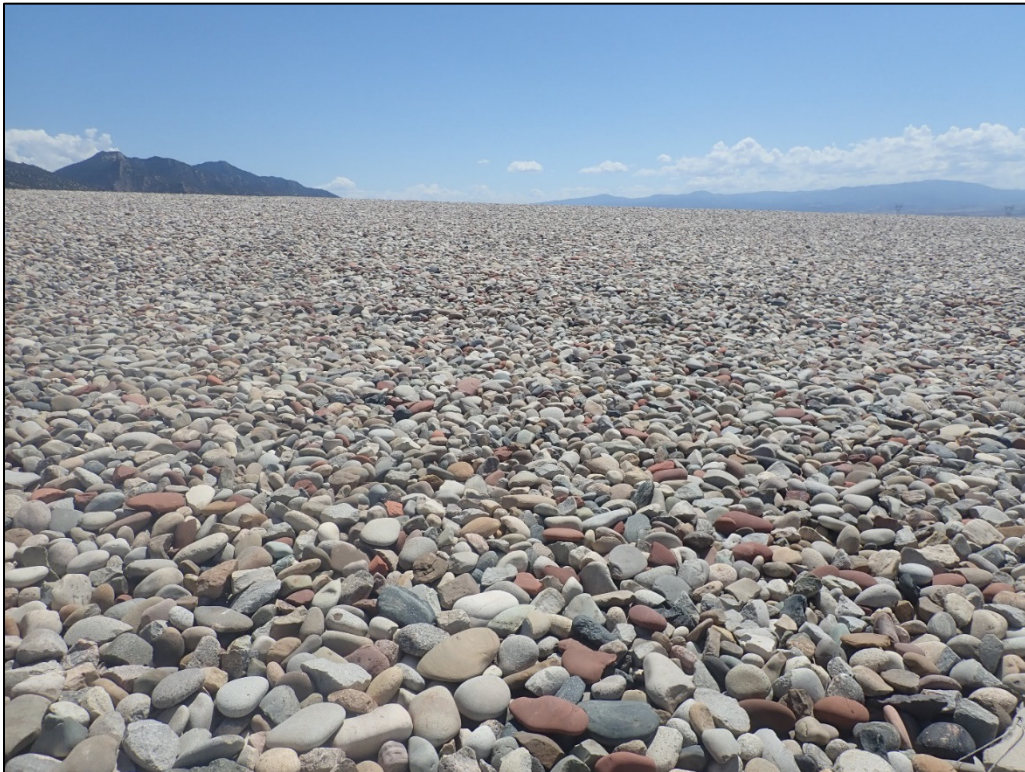
The disposal cell, completed in 1996, occupies 71 acres and is armored with riprap consisting of river cobbles and boulders to control erosion and deter animal and human intrusion. Three possible depressions or undulations were noted, primarily on the west edge of the disposal cell. The largest of these features was approximately 45 feet long × 5 feet wide × 6 inches deep (PL-8). The aerial survey lidar data collected in July 2022 will be used to verify these observed features. There was no evidence of erosion, settling, slumping, or other modifying processes that might affect the integrity of the disposal cell. As in the past several inspections, inspectors noticed minor rock degradation on the disposal cell top slope, primarily in the form of cracking and spalling. Rock degradation does not present a concern at this time.

PL-8. Potential Depression on Edge of Disposal Cell

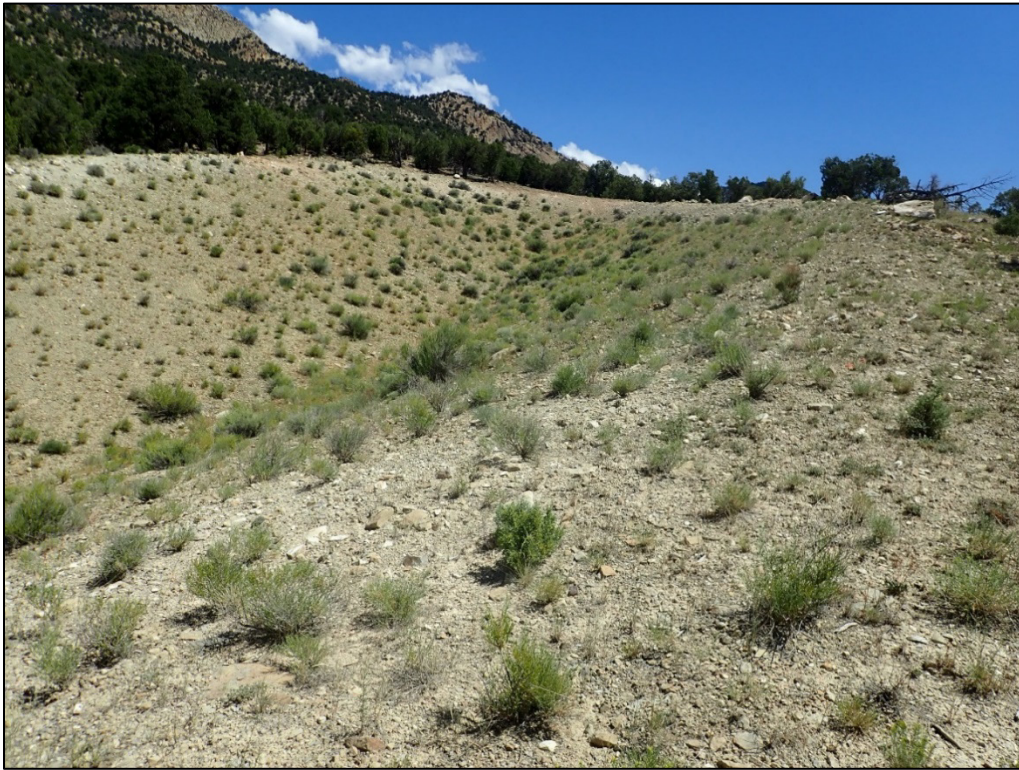
A vegetated interceptor trench was constructed at the top of the disposal cell to protect the disposal cell from stormwater and snowmelt runoff (PL-9). The trench appeared to be functioning as designed, although minor gully erosion has been occurring in the lower portion of the trench. The gully did not appear to be increasing in depth or width; the deepest downcut was approximately 18 inches deep and 24 inches wide. In the outfall area below the trench (down the steep-sided natural slope), stormwater runoff has formed a major gully to the north of the armoring riprap. The gully did not appear to be increasing in depth or width during the 2022 inspection. The outfall area will continue to be monitored to assess if additional riprap is needed on the slope to prevent upstream gully migration. No maintenance needs were identified.

PL-9. Interceptor Trench

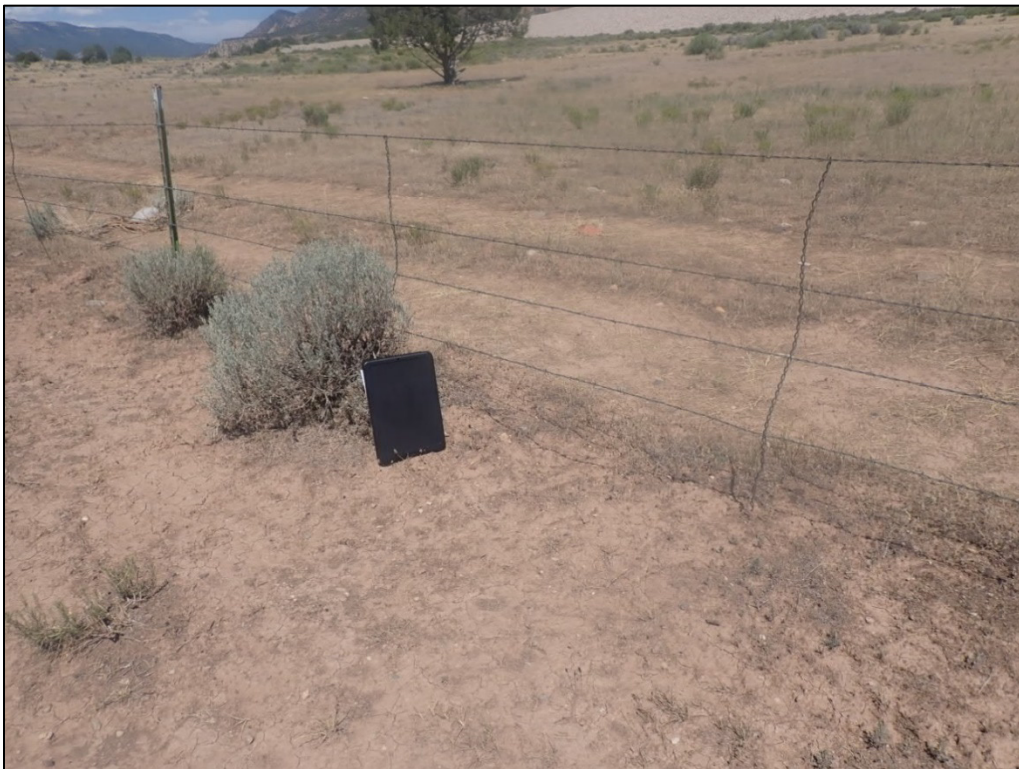
Disturbed areas around the edges and south of the disposal cell were reseeded in 1996 and, overall, have been successfully reclaimed. Before 2012, there was little evidence of grazing within the site boundaries. Since 2012, however, grazing by cattle has been regularly observed, and cattle trails have been identified meandering up the steep arroyos on the unfenced, southwest side of the site. LM is evaluating additional fencing installation options on the southwest side of the site to prevent cattle access. Animals are burrowing under the fence between perimeter signs P3 and P4 (PL-10). Inspectors will continue to monitor this area and conduct repairs when necessary.

PL-10. Signs of Animal Burrowing Under Fence
