14.0 Rifle, Colorado, Disposal Site

14.1 Compliance Summary

Figure 14-1. 2023 Annual Inspection Drawing for the Rifle, Colorado, Disposal Site

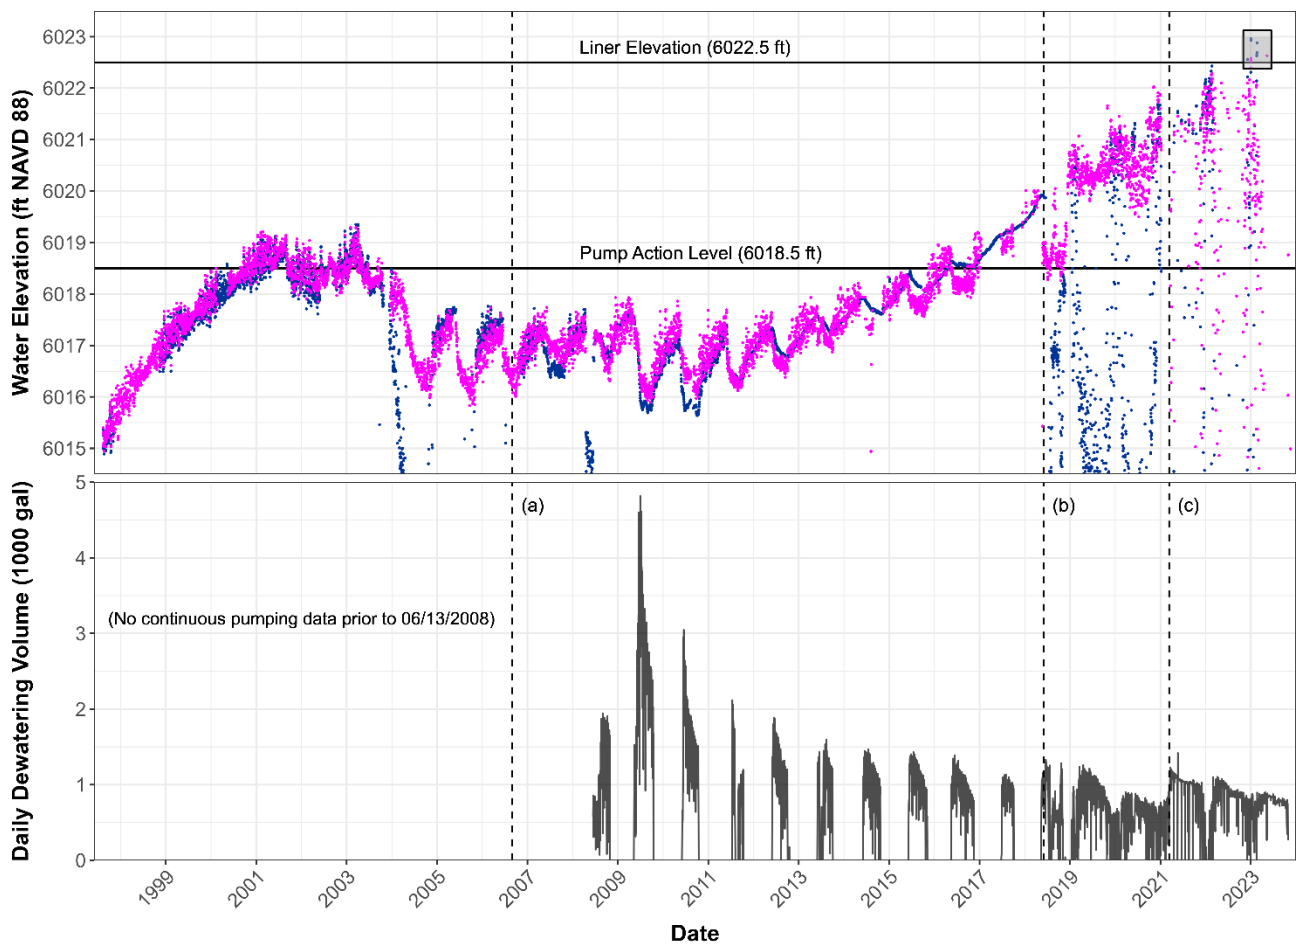
Figure 14-3. Disposal Cell Pore-Water Elevations in Standpipes MW02 and MW03 and Corresponding Dewatering Rates at the Rifle, Colorado, Disposal Site, 1997–2023

Figure 14-3 plots historical pore-water elevations in standpipes MW02 and MW03 and corresponding dewatering rates. The 6018.5 ft pump action level was first exceeded between 2001 and 2003, after which elevations declined. Starting in approximately 2012, water elevations in both standpipes began steadily increasing and the pump action level was again exceeded in 2016 (Figure 14-3). After an approximate 12-year shutdown, pumping at MW02 resumed in 2018. In response to the increasing water elevations, in 2019, LM began nearly continuous dewatering, a shift from the previous seasonal pumping regime evident in Figure 14-3.

In March 2021, the solar-powered pumping system was upgraded to provide additional operation of the pumps by increasing electrical storage ability. By adding batteries to store solar-generated electricity, the pumps can operate throughout the night and on overcast days. To allow the pumping system to function at colder temperatures in the winter, in July 2022, the leachate discharge pipes were replaced with 2-inch-diameter pipes and insulated where the pipe crosses the toe ditch to protect against freezing and pipe bursting. These upgrades resulted in an increase in annual dewatering volumes (Table 14-2) but do not appear to have decreased the pore-water level in the disposal cell. In fact, despite increased pumping, the maximum water level in both standpipes continues to rise (Figure 14-3).

To address the continued rise in pore-water levels, DOE has initiated planning to increase the extraction and pore-water handling capacity to dewater the disposal cell. This will include optimization of the existing pumping infrastructure and installation of additional extraction wells, power, and evaporation capacity. DOE plans to complete the work in FY 2024.

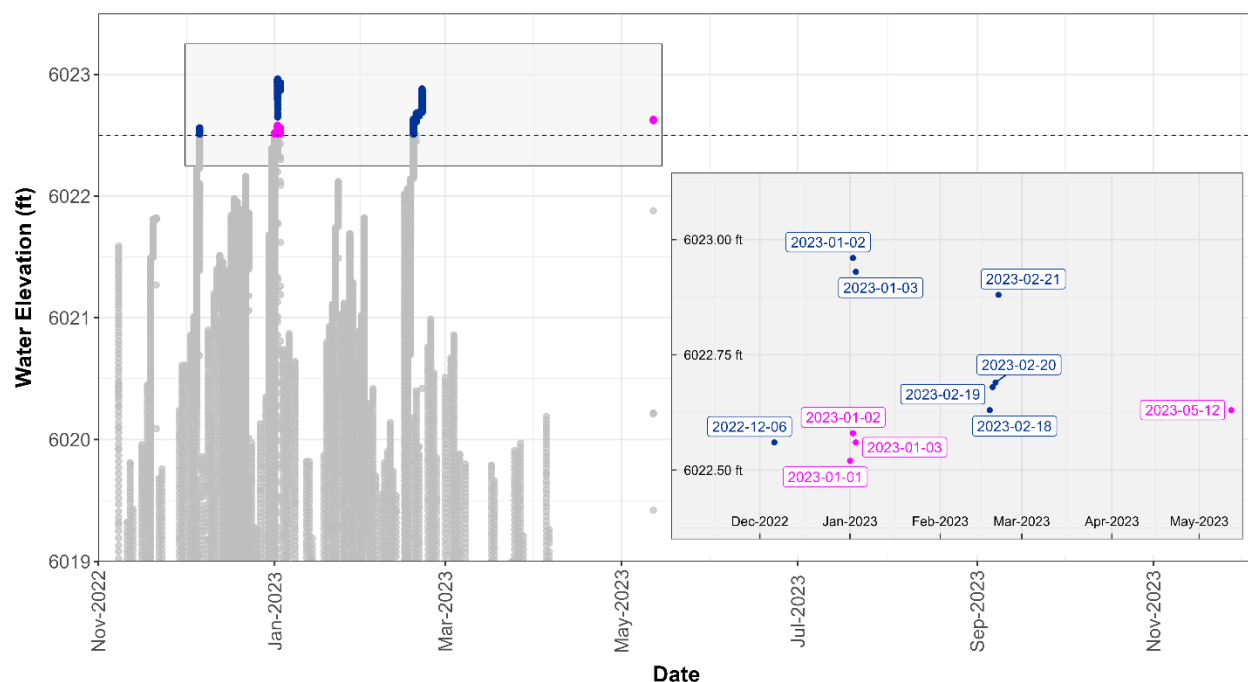
Figure 14-4. Zoom View of Pore-Water Elevations Exceeding the Top of Liner Elevation, December 2022 Through May 2023

Three unplanned system shutdowns occurred since the 2022 annual site inspection that caused the elevation of the pore water within the disposal cell to rise above the elevation of the top of the HDPE liner for short durations. A zoom view of these exceedances, showing only pore-water elevation measurements exceeding 6020.5 ft, is provided in Figure 14-4. These shutdowns are documented in the *Preliminary Assessment Report for Unplanned Pumping System Shutdown and Subsequent Pore-Water Level Rise Within the Rifle, Colorado, Disposal Site* (Young 2023a) and summarized below.

- December 6, 2022: The pore-water level in standpipe MW02 rose to an elevation of 6022.56 ft, the first documented exceedance of the top of liner elevation.
- January 1–3, 2023: Pore-water levels in standpipes MW02 and MW03 rose to maximum elevations of 6022.96 (maximum recorded elevation) and 6022.58 ft, respectively.
- May 12, 2023: The pore-water elevation in MW02 rose to 6022.63 ft.

In addition to the unplanned system shutdowns noted above, exceedances of the top of liner elevation also occurred for a brief period in February 2023 (February 18–21), associated with apparent malfunctions of the MW02 pump and flowmeter. During this period, water elevations in MW02 rose temporarily to levels ranging from 6022.63 to 6022.88 ft (Figure 14-4).

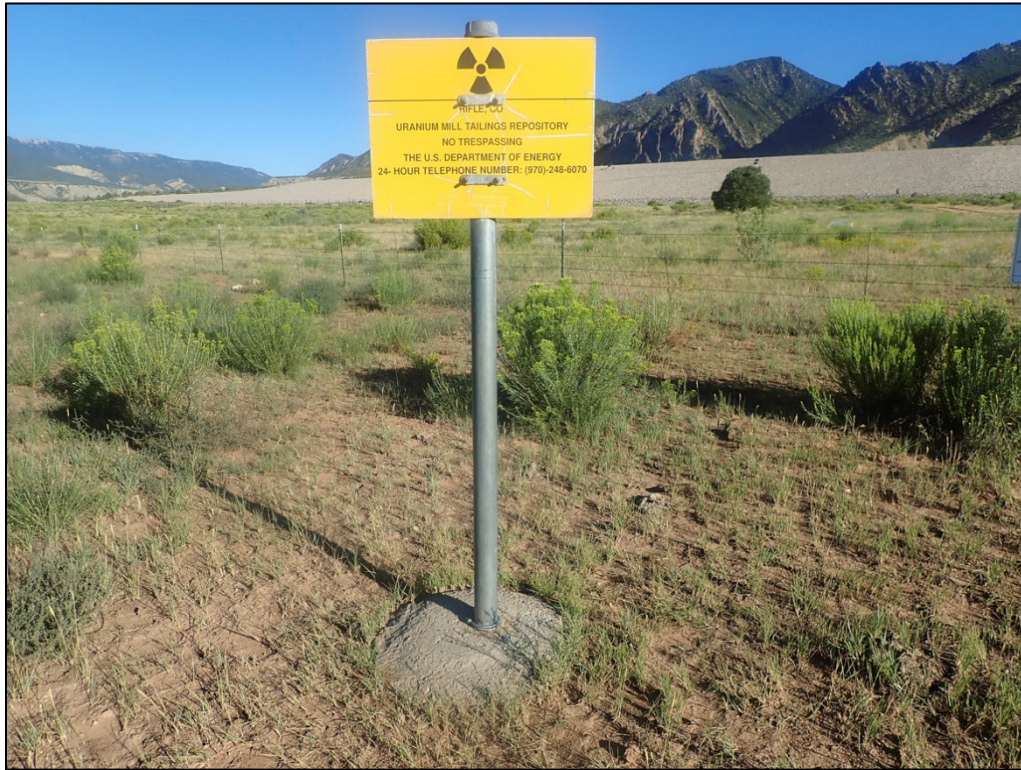
Access to the site is from an improved gravel road northeast of Colorado Highway 13. A perpetual right-of-way across U.S. Bureau of Land Management (BLM) property provides access to the site. Entrance to the site is through two locked gates on the access road: an outer reinforced metal gate about 1700 feet (ft) south of the site and an inner metal gate at the stock fence. The entrance sign, which is next to the inner gate, was faded and had minor cracks but remained legible (PL-1). The BLM section of the access road had several gullies approximately 6 to 12 inches deep, across and along the access road, from a precipitation event 5 days before the inspection that produced more than 1 inch of rain (PL-2). The access road was repaired following the inspection. No other maintenance needs were identified.

PL-1. Entrance Sign, Cracked and Faded but Legible

- Updating the website address on the entrance sign

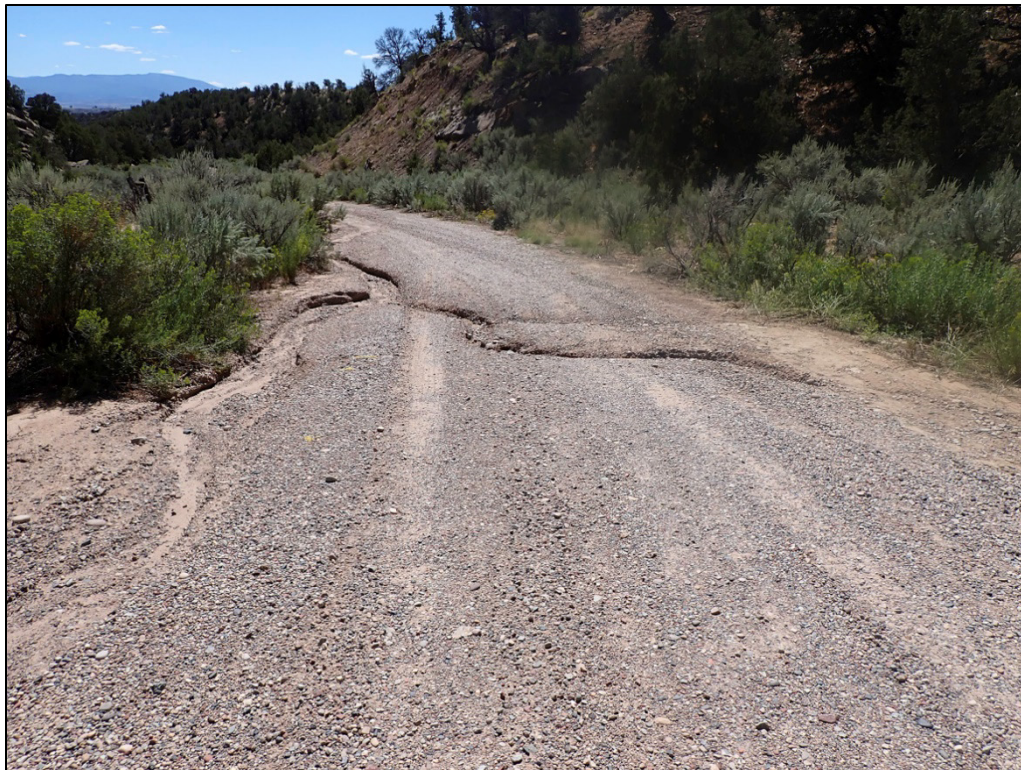
PL-2. Rutting and Erosion Along Access Road

- Treating the tamarisk growing in the toe drain
- Repairing the access road

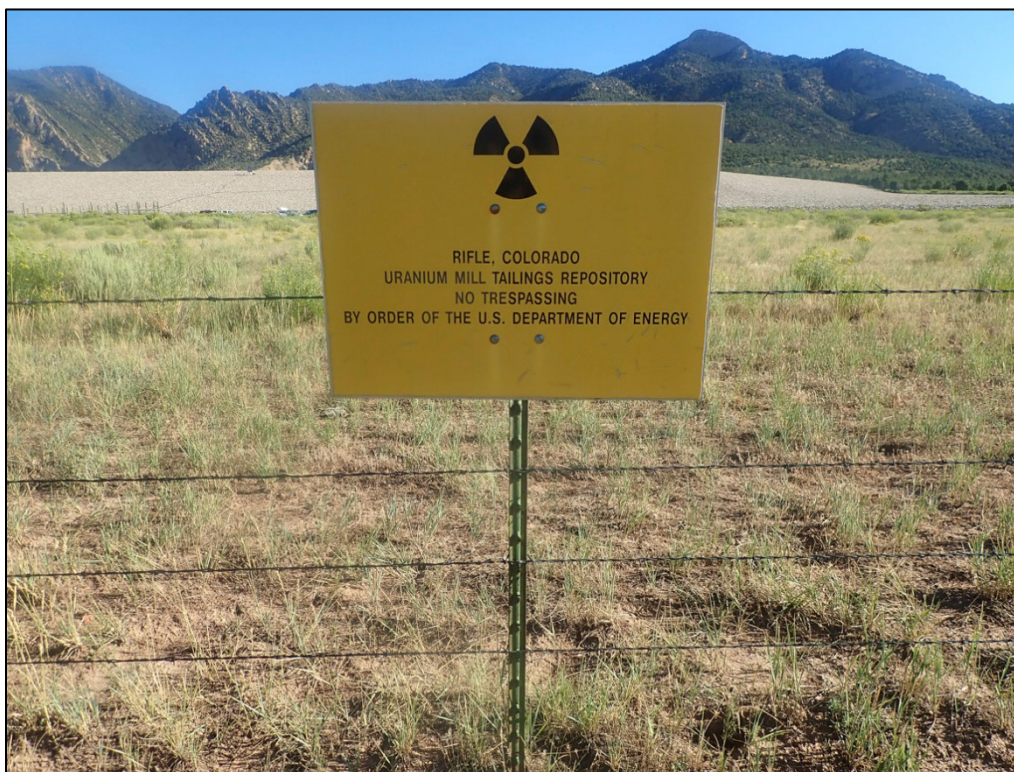
There are 27 perimeter signs positioned along the site perimeter. Perimeter signs P0 through P11 are attached to the stock fence, and perimeter signs P12 through P26 are attached to steel posts set in concrete and set back 5 ft from the boundary. Perimeter signs P15 and P19 have bullet damage but remain legible. Perimeter signs P1, P16, P18, P22, P24, and P26 have minor cracks and are peeling but remain legible. The sign number on perimeter sign P10 is faded, and the sign numbers on perimeter signs P8 and P9 are missing. Perimeter signs P0 through P7 are scratched but legible (PL-3). No maintenance needs were identified.

PL-3. Perimeter Sign P7, Scratched but Legible

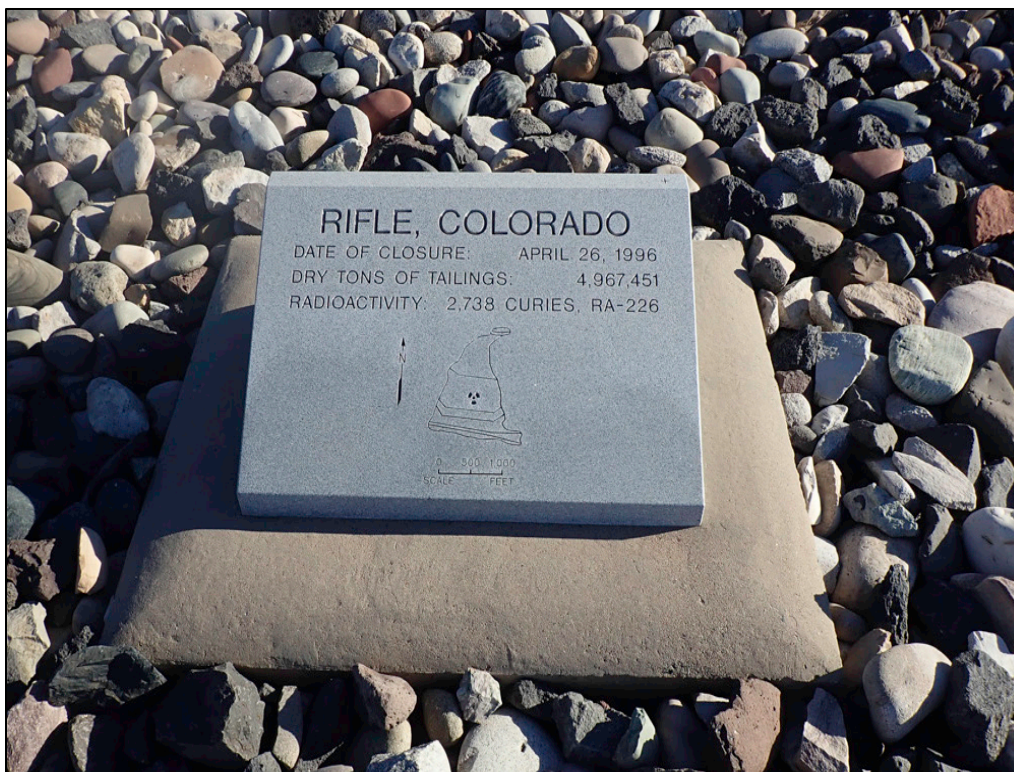
The site has two granite site markers. Site marker SMK-1 is just inside the inner entrance gate, and site marker SMK-2 is on the top slope of the disposal cell (PL-4). No maintenance needs were identified.

PL-4. Site Marker SMK-2

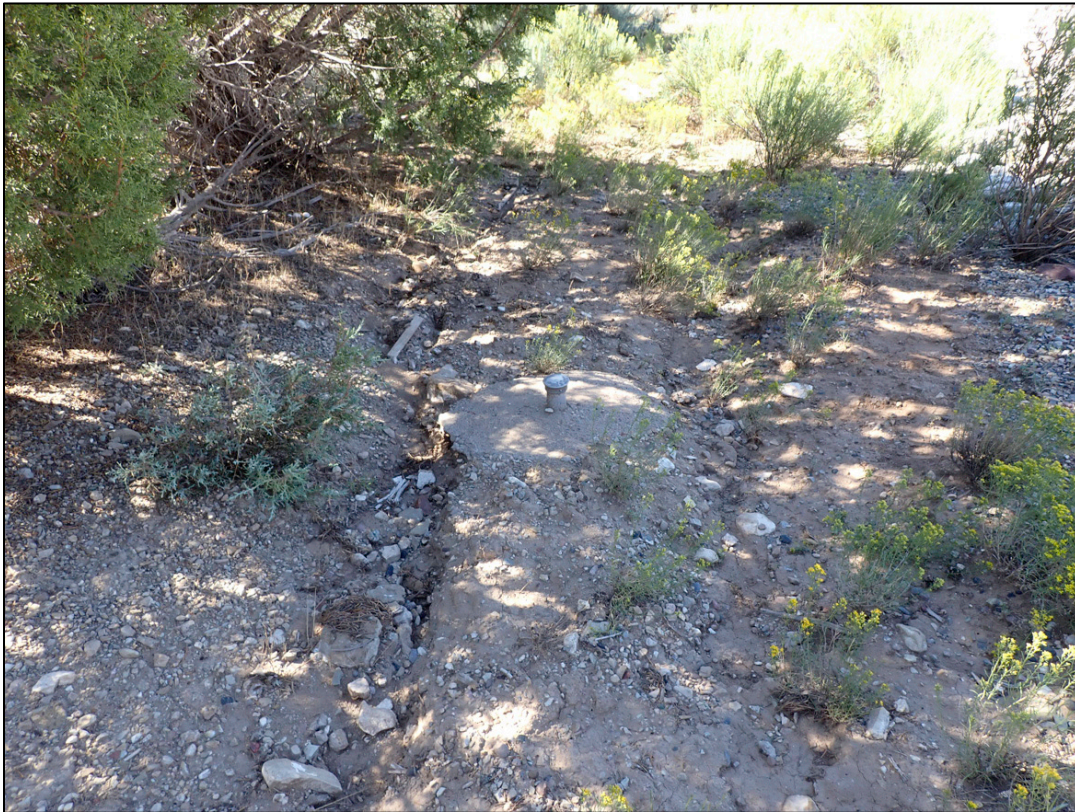
Three survey monuments and 15 boundary monuments delineate the property boundary. The boundary monuments are set at the corners of the irregular site boundary. Although the site boundary has 20 corners, only 15 are marked by boundary monuments because five of the corners are on extremely steep terrain that is not safely accessible. Consequently, boundary monuments BM-8, BM-9, BM-13, BM-17, and BM-20 were never installed. GPS is used to identify and inspect existing boundary monuments that are in hard-to-access areas. Boundary monument BM-2 has several bullet holes but remains intact. Boundary monuments BM-2 and BM-3 have undercutting at the ground surface but remain stable (PL-5). Boundary monument BM-18 was previously reported to have undercutting, but it was not inspected during the 2023 inspection because it was too difficult to access. Survey monument SM-2 has slight cracking in the concrete, but the cracking does not affect the integrity of the survey monument. No maintenance needs were identified.

PL-5. Boundary Monument BM-3 with Concrete Base Undercutting

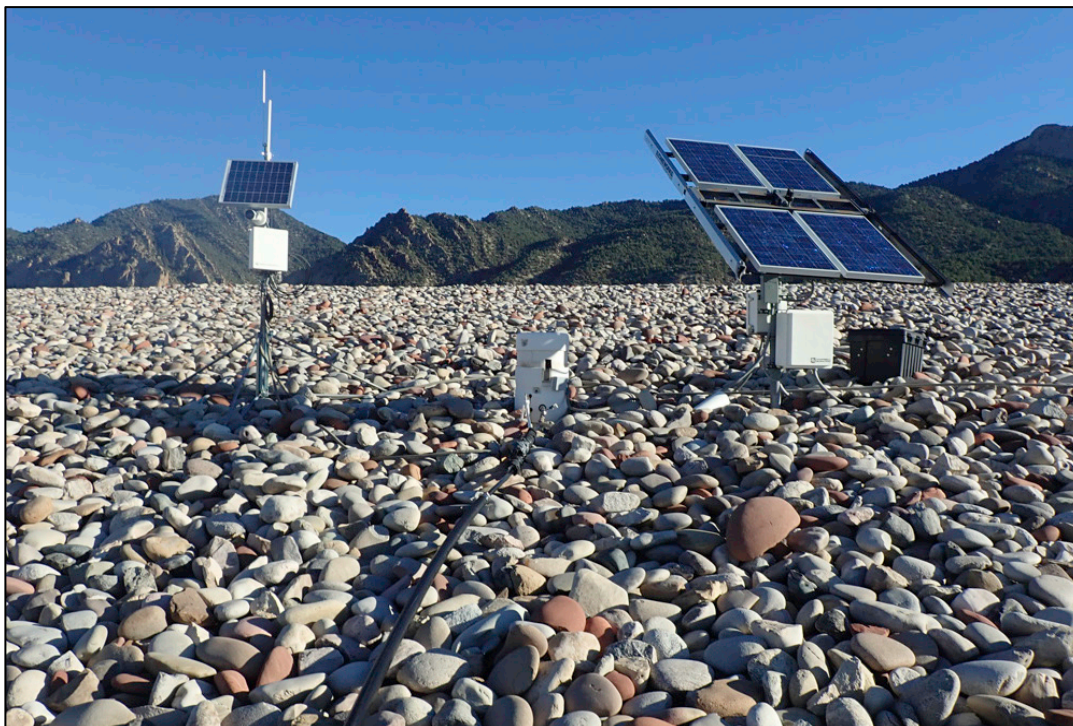
No routine maintenance needs were identified for the standpipes. However, in conjunction with the disposal cell pore-water level monitoring efforts (Section 14.8), the surface components for standpipes MW02 and MW03 were modified following the inspection by installing protective vaults over the standpipes and burial of the pipeline that transmits water to the evaporation pond.

PL-6. Standpipe MW02

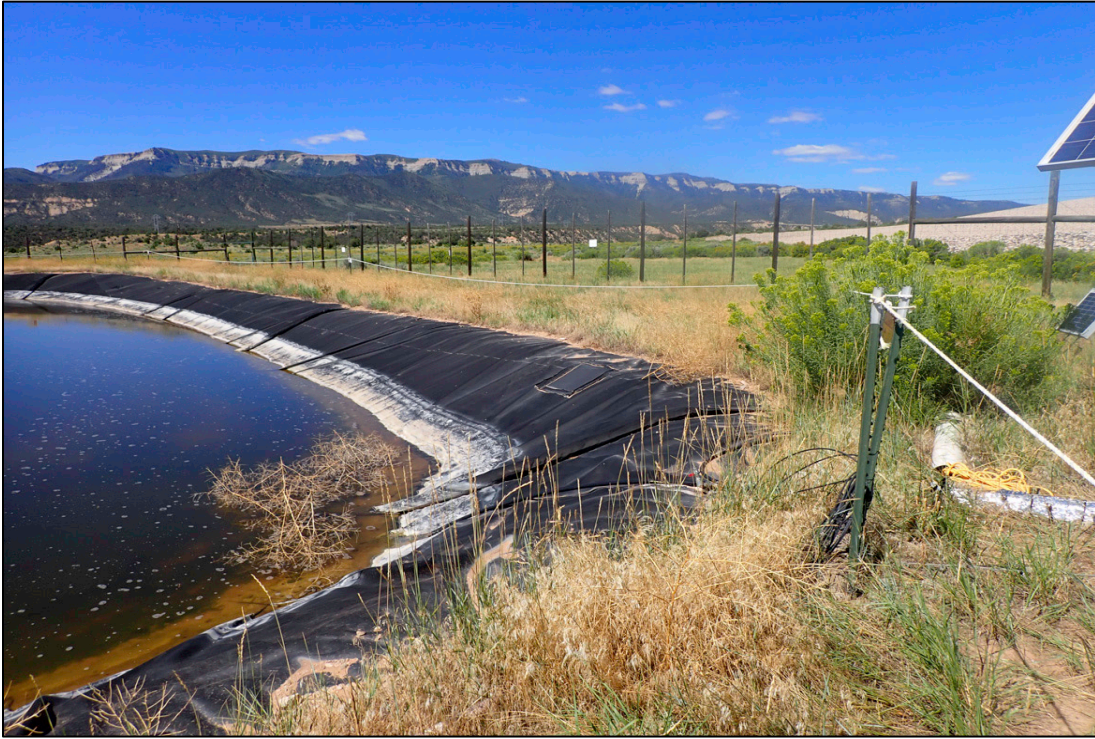
A lined evaporation pond was constructed adjacent to the disposal cell in 2001 to receive water pumped from standpipes MW02 and MW03. The pond contained water at the time of the inspection. Evaluation of the pond liner's integrity was completed in fall 2020 by a professional geosynthetic liner installation and inspection company. Two minor holes, approximately 2 inches in diameter, were identified at the top slope of the liner and repaired in May 2021. Inspectors noted that one of the patches placed on the top 1 foot of the pond liner in May 2021 was peeling on the top 1 foot of the liner near the northern corner of the evaporation pond (PL-7). LM plans to replace the pond liner in fiscal year (FY) 2025, barring further damage that would necessitate earlier replacement.

PL-7. Evaporation Pond Liner with Repair Patch on Northern Corner

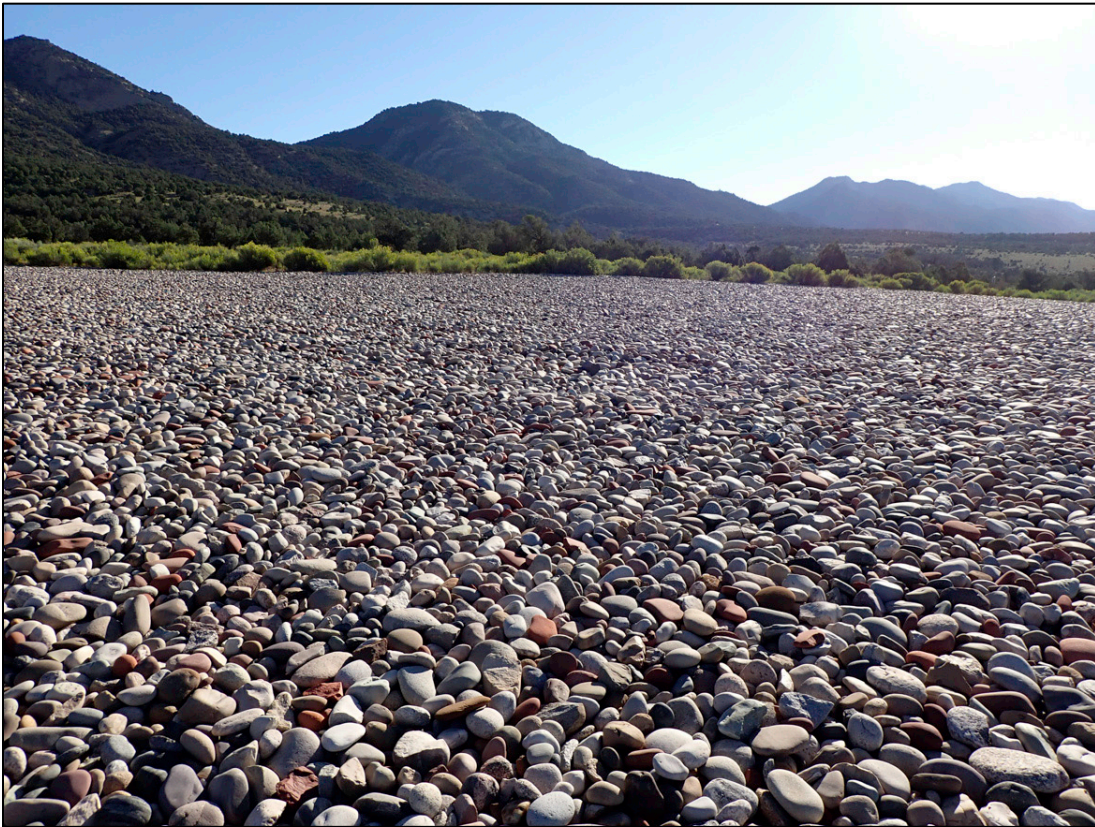
The disposal cell, completed in 1996, occupies 71 acres and is armored with riprap consisting of river cobbles and boulders to control erosion and deter animal and human intrusion. During the 2023 inspection, inspectors noted four depressions on the southeast side of the top of the cell. The largest was approximately 16 ft × 6 ft × 3 inches (PL-8). There was no other evidence of erosion, settling, slumping, or other modifying processes that might affect the integrity of the disposal cell. As in the past several inspections, inspectors noticed minor rock degradation on the disposal cell top slope, primarily in the form of cracking and spalling. Rock degradation is not currently a concern.

PL-8. Depression on Top Slope in Southeast Area of Disposal Cell

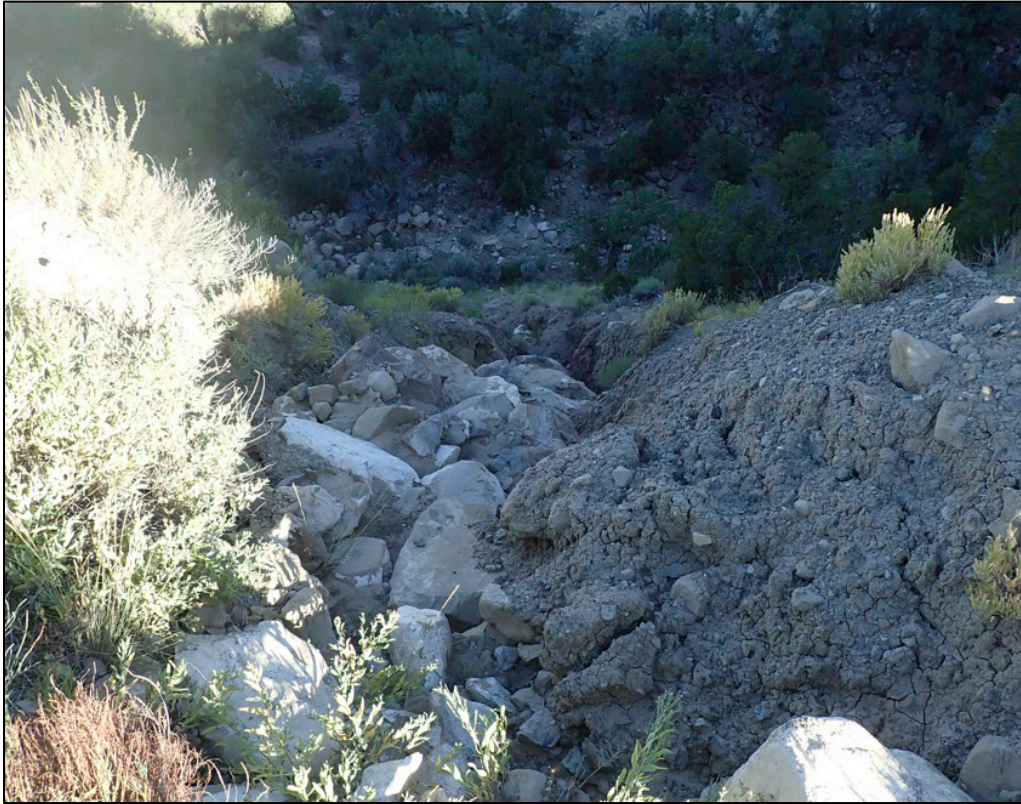
A vegetated interceptor trench was constructed at the top of the disposal cell to protect it from stormwater and snowmelt runoff (PL-9). The trench appeared to be functioning as designed, although minor gully erosion has been occurring in the lower portion of the trench. The gully did not appear to be increasing significantly in depth or width. In the outfall area below the trench (down the steep-sided natural slope), stormwater runoff has formed a major gully to the north of the armoring riprap. The gully did not appear to be increasing in depth or width during the 2023 inspection. The outfall area will continue to be monitored to assess if additional riprap is needed on the slope to prevent upstream gully migration. No maintenance needs were identified.

PL-9. Gully at Toe of Interceptor Trench

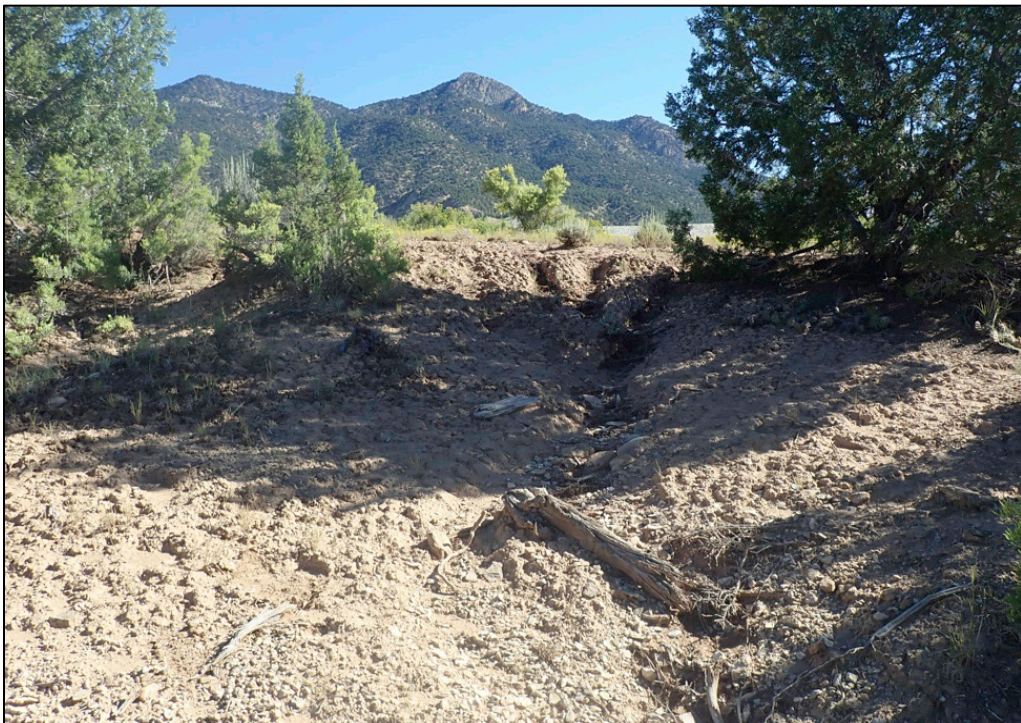
A small gully has formed adjacent to the disposal cell near perimeter sign P26 (PL-10). It will continue to be monitored.

PL-10. Erosion near Perimeter Sign P26
