15.0 Salt Lake City, Utah, Disposal Site

15.4 Inspection Results

Figure 15-1. 2021 Annual Inspection Drawing for the Salt Lake City, Utah, Disposal Site

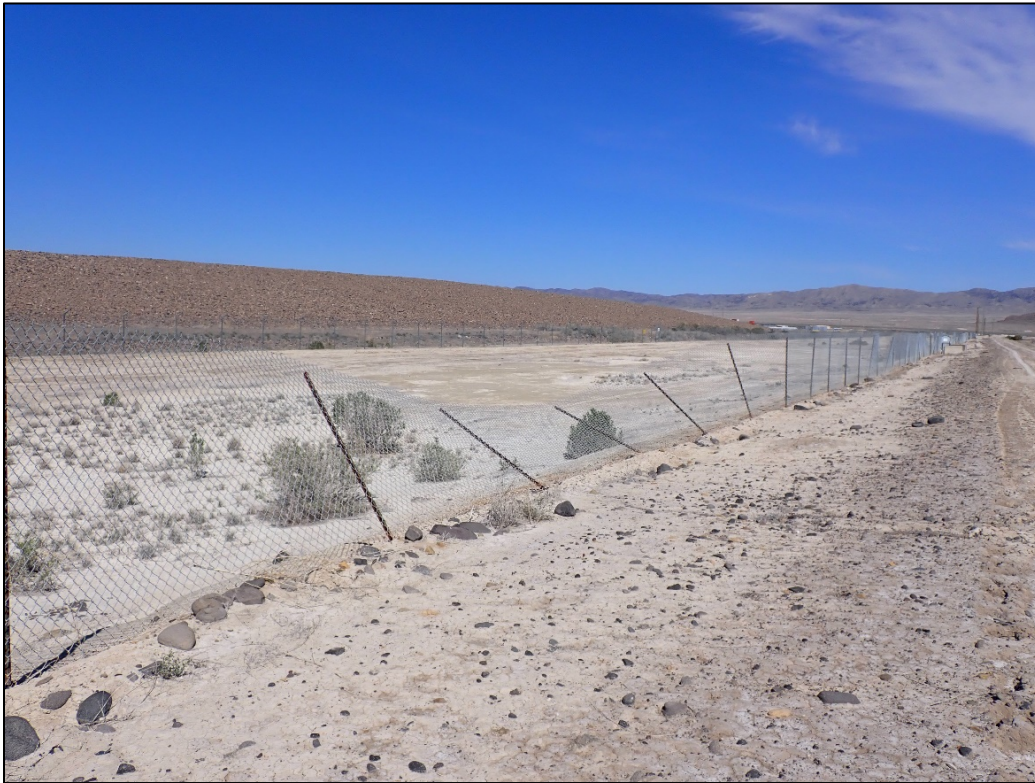
The site has two chainlink fences: the exterior EnergySolutions perimeter fence along the property boundary and the interior LM security fence that encloses the disposal cell and surface water diversion channels. There are 19 perimeter signs attached to the LM security fence. Inspectors identified two new sections of the outer chainlink fence east of Gate 64 that had blown down (PL-1). Repairs to the fence will be completed before the next inspection.

PL-1. Down Fence Along South Side of Cell

- Repair downed fence east of Gate 64
- Remove vegetation growing in the access road on the south and west side of the disposal cell.

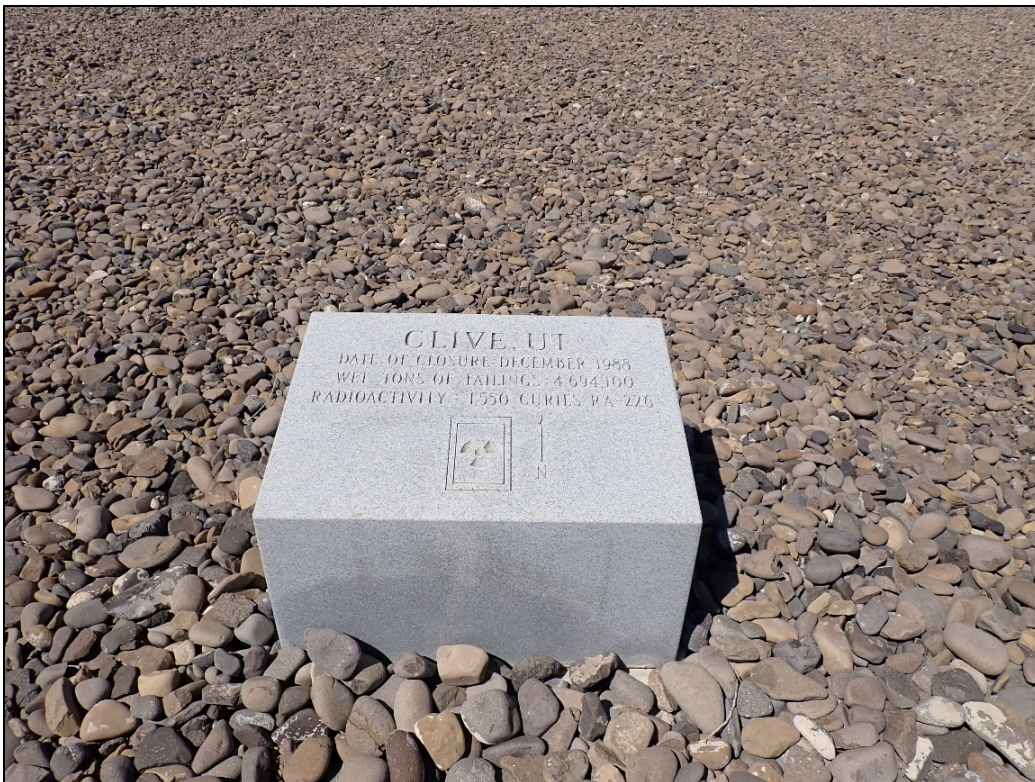
The site has two granite site markers. Site marker SMK-1 is just inside Gate 87 in the northwest corner of the site. Site marker SMK-2 is on the top slope of the disposal cell (PL-2). No maintenance needs were identified.

PL-2. Site Marker SMK-2

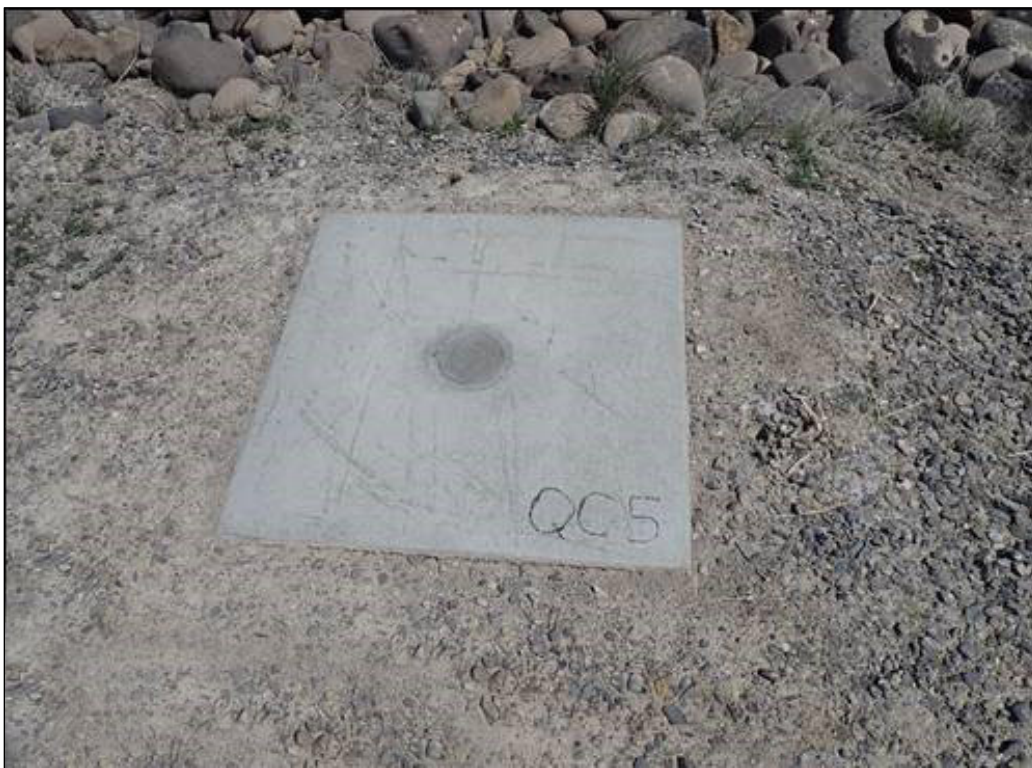
Eight aerial survey quality control monuments were installed before the 2021 inspection (PL-3). No maintenance needs were identified.

PL-3. Baseline Aerial Survey Quality Control Monument

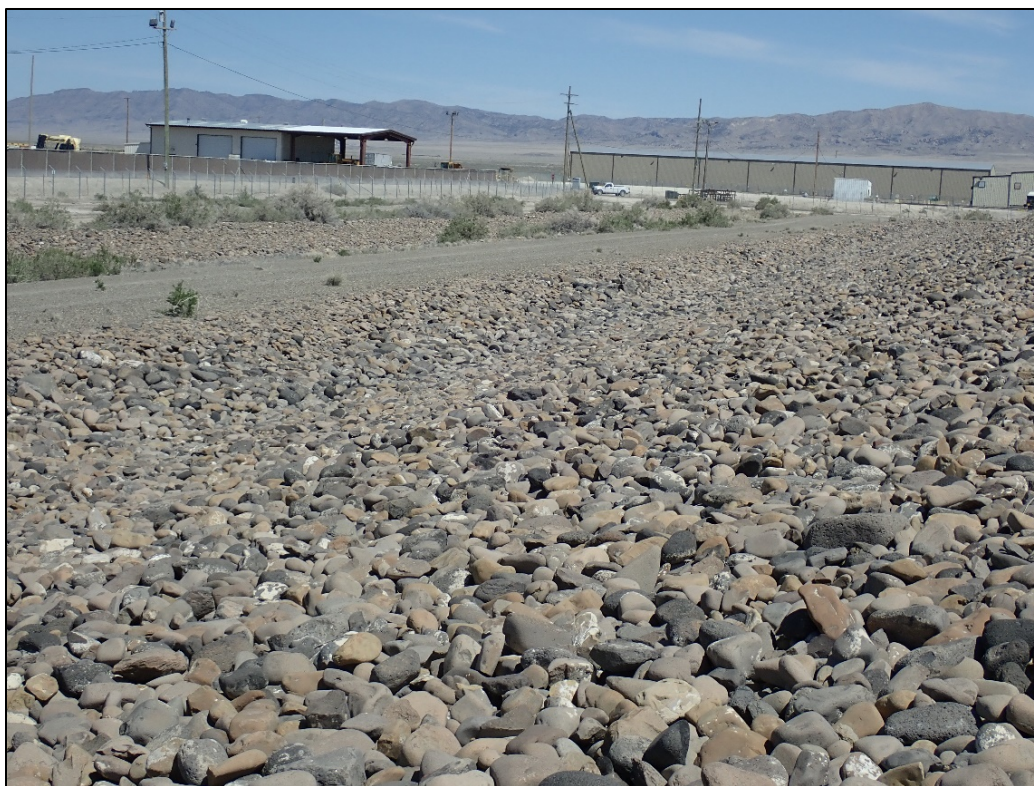
The disposal cell, completed in 1988, occupies 54 acres. The disposal cell is armored with riprap to control erosion (PL-4). There were noticeable vehicle tracks on the east side slope of the disposal cell, but there was no evidence of erosion, settling, slumping, or other modifying processes that might affect the integrity of the disposal cell. No maintenance needs were identified.

PL-4. North Side Cell Slope

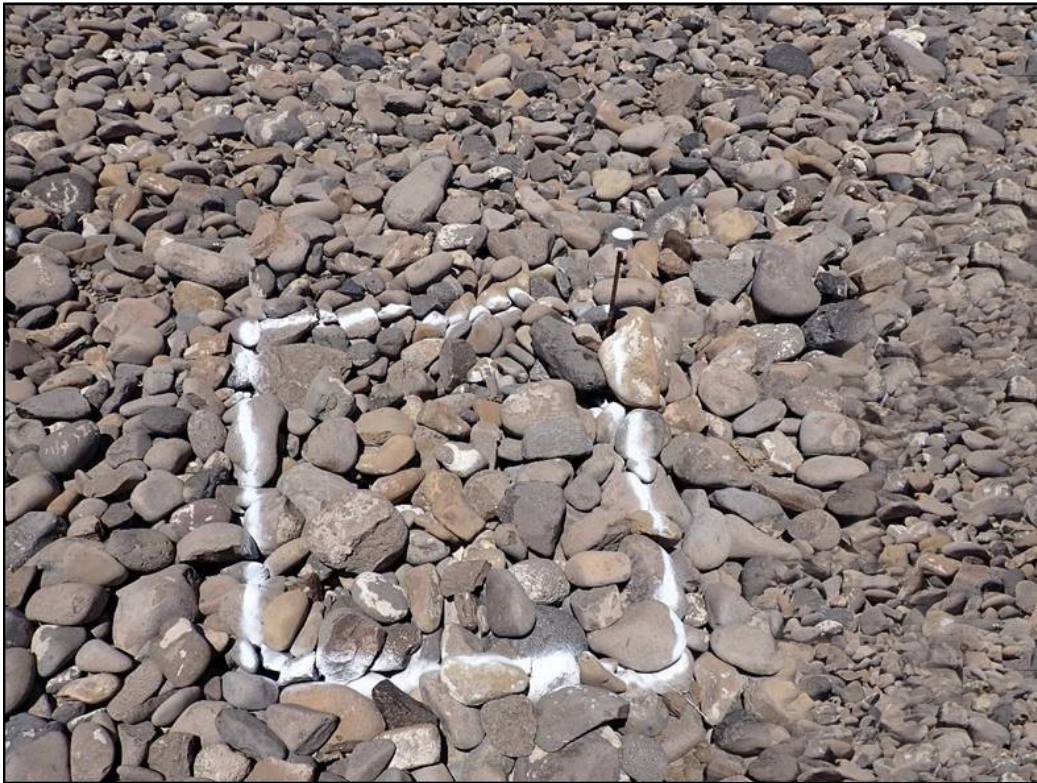
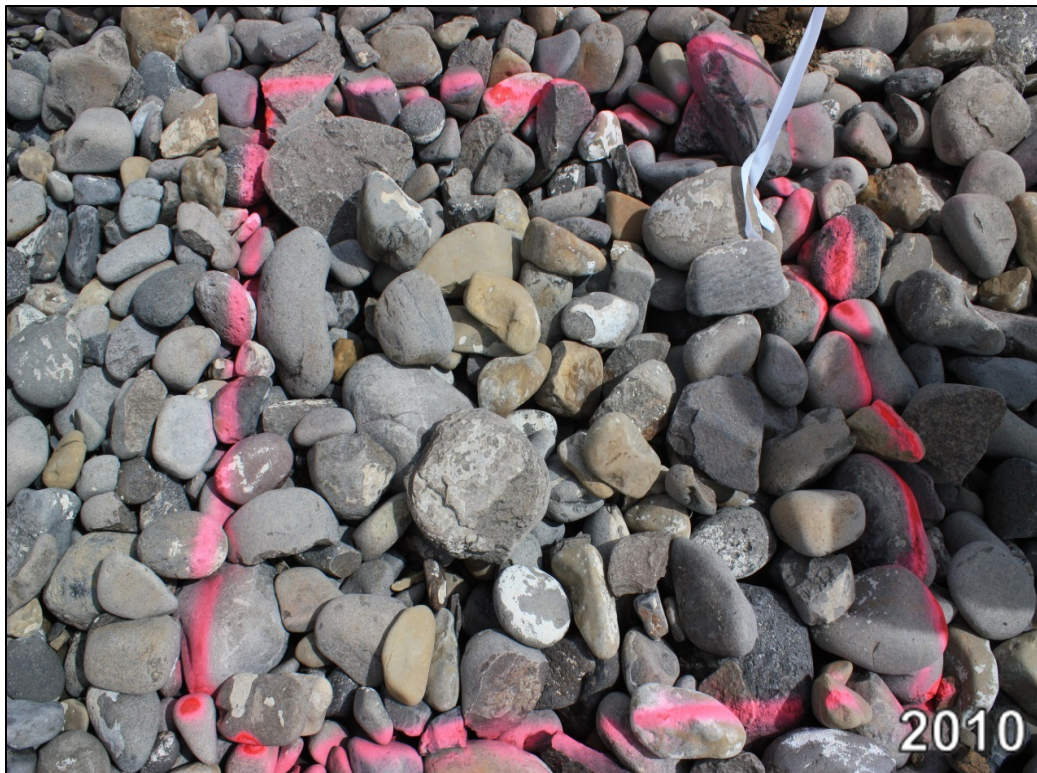
One of several types of rock used for the disposal cell erosion-protection riprap layer has exhibited minor degradation since the disposal cell was constructed. As a result, eight rock-quality monitoring plots, each measuring 1 square meter (indicated by Roman numerals I–VIII in Figure 15-1), were established in 2010 to monitor for continued rock degradation.

The rock type exhibiting degradation constitutes approximately 1%–10% of the riprap material; degradation of this less competent rock is thought to result from freeze-thaw weathering. Rock-quality monitoring plots are visually monitored and documented annually with photographs. Approximately 1%–10% of the rock in the plots exhibited signs of weathering during the 2021 annual inspection (PL-5 through PL-7), with no significant changes from the 2020 annual inspection. Comparisons to the initial 2010 rock-quality plot photographs indicate very little (if any) additional rock degradation since monitoring began. The minimal rock degradation observed to date has not reduced the effectiveness of the riprap cover. Rock-quality monitoring plots will continue to be visually monitored and documented annually with photographs to ensure that the riprap continues to protect the integrity of the disposal cell.

PL-5. (a) Rock Quality Plot No. 1—2021

PL-5. (b) Rock Quality Plot No. 1—2010 Photo for Comparison

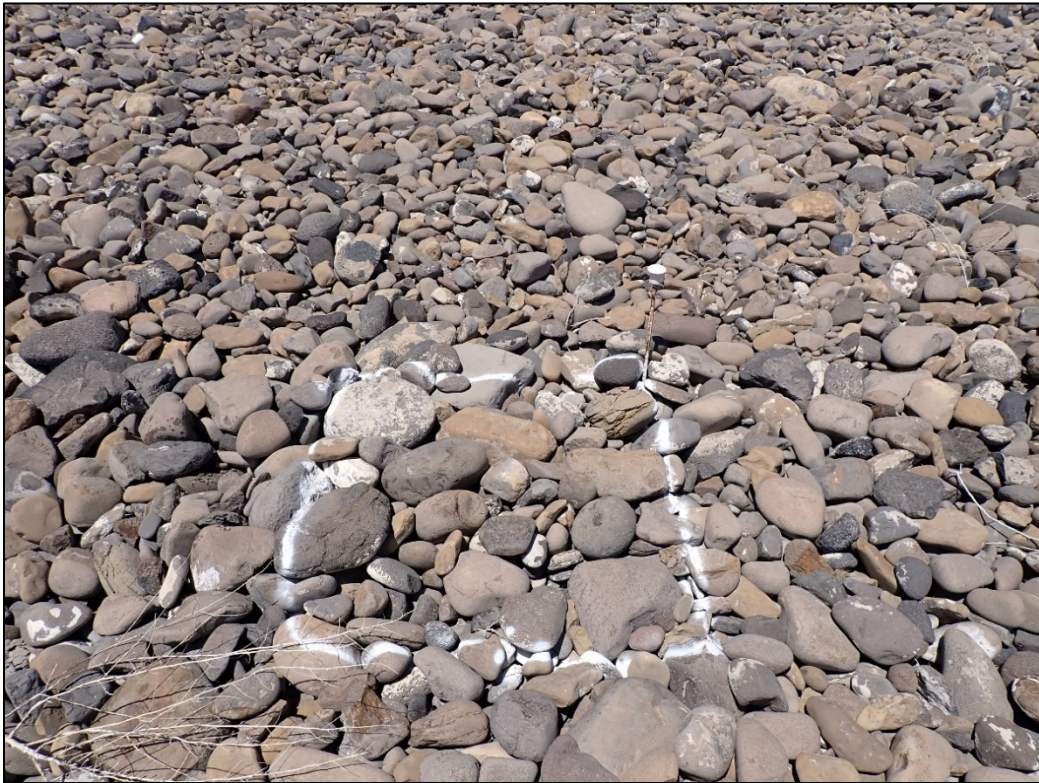
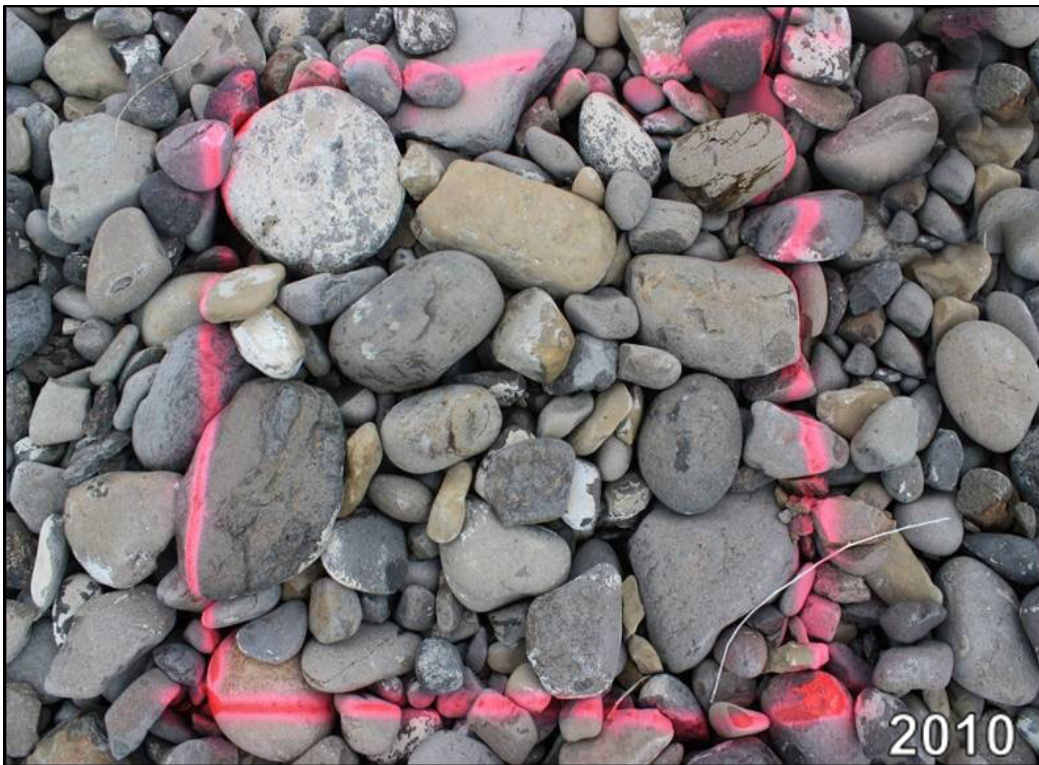
PL-6. (a) Rock Quality Plot No. II—2021

PL-6. (b) Rock Quality Plot No. II—2010 Photo for Comparison

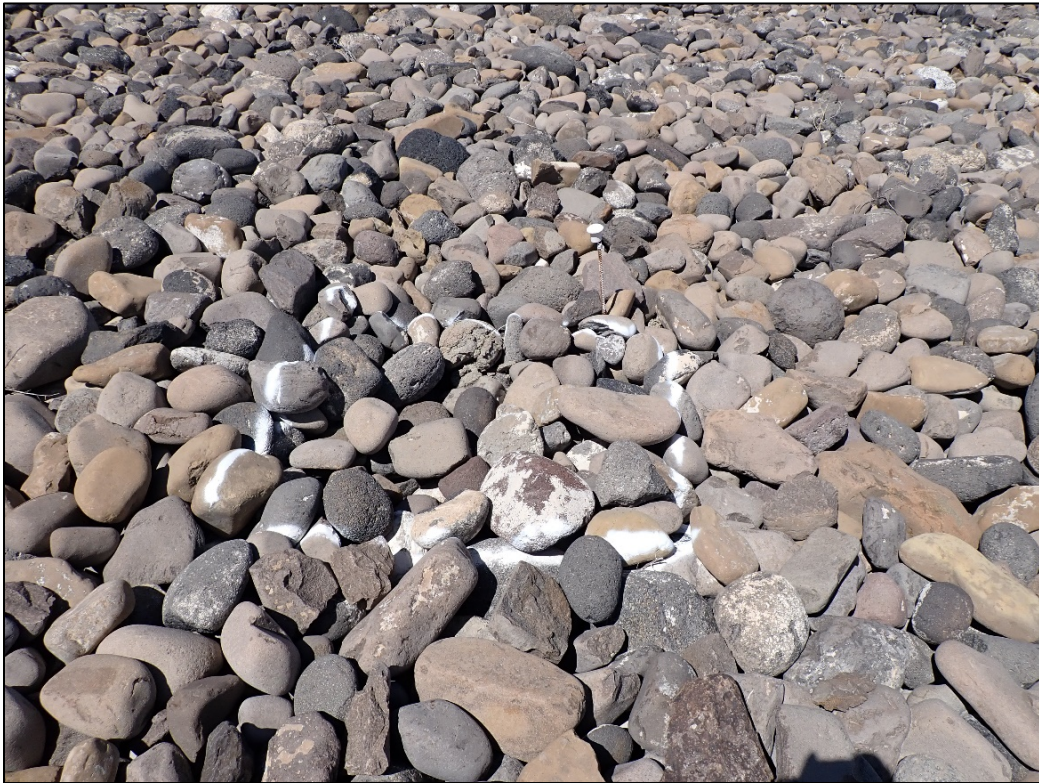
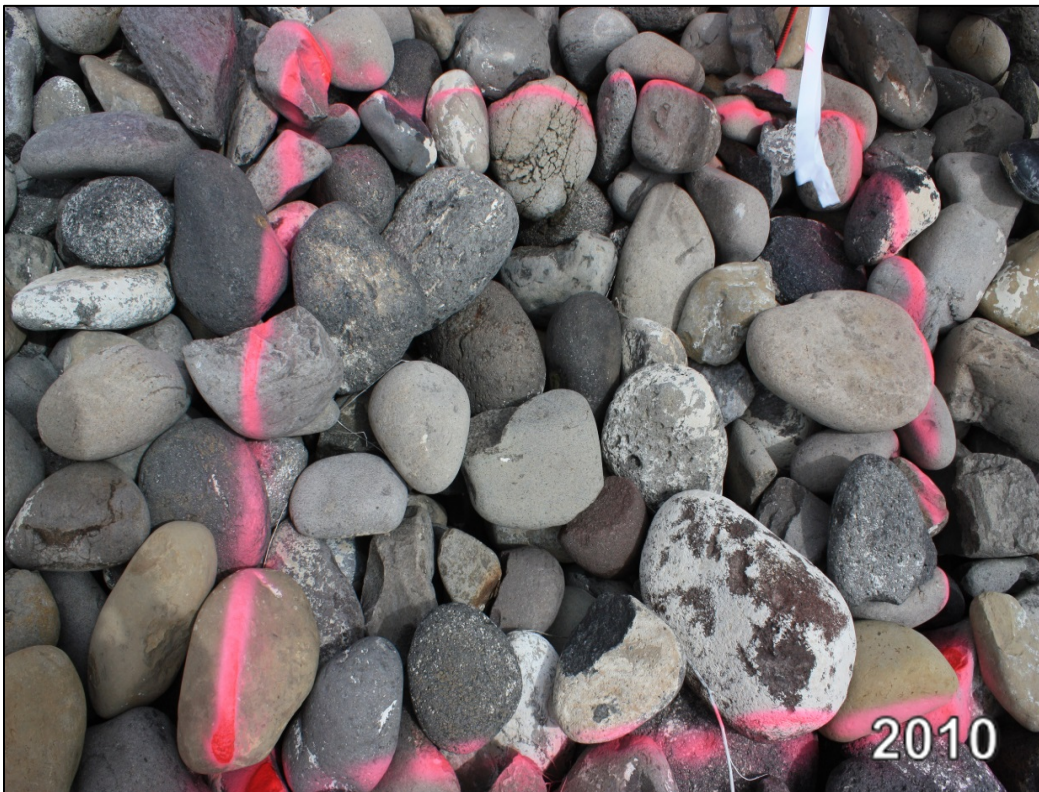
PL-7. (a) Rock Quality Plot No. III—2021

PL-7. (b) Rock Quality Plot No. III—2010 Photo for Comparison

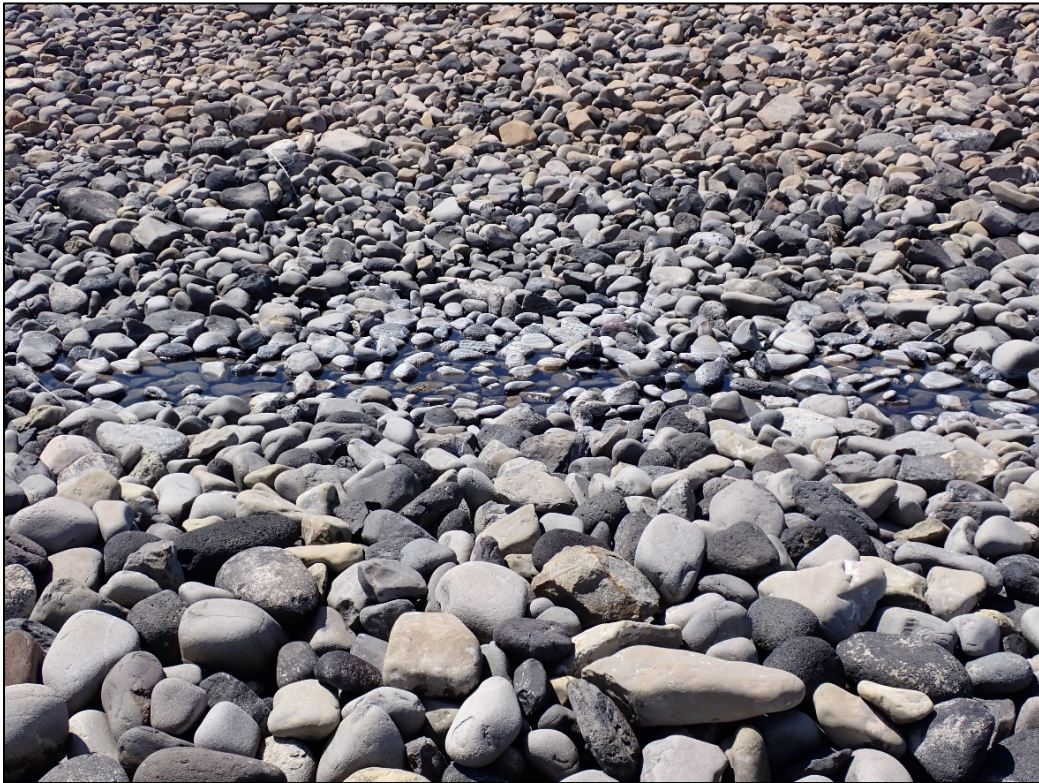
Although areas of the disposal cell have continued to have minor perennial grass growth, no deep-rooted plants were present on the disposal cell. Standing water from stormwater runoff was observed in the apron at the base of the east side slope of the disposal cell toe drainage (PL-8); no adverse impacts to the disposal cell were noted or expected as a result of this standing water. No other maintenance needs were identified.

PL-8. Standing Water in Southeast Cell Toe Drainage
