## 15.0 Salt Lake City, Utah, Disposal Site

### 15.1 Compliance Summary

The Salt Lake City, Utah, Uranium Mill Tailings Radiation Control Act (UMTRCA) Title I Disposal Site was inspected on April 19, 2022. No changes were observed on the disposal cell or in associated drainage features. Observations of rock-quality monitoring plots indicated no significant change from the previous year. Inspectors identified one routine maintenance need but found no cause for a follow-up inspection. Minor maintenance needs were identified and will be completed before the next inspection. Groundwater monitoring is not required.

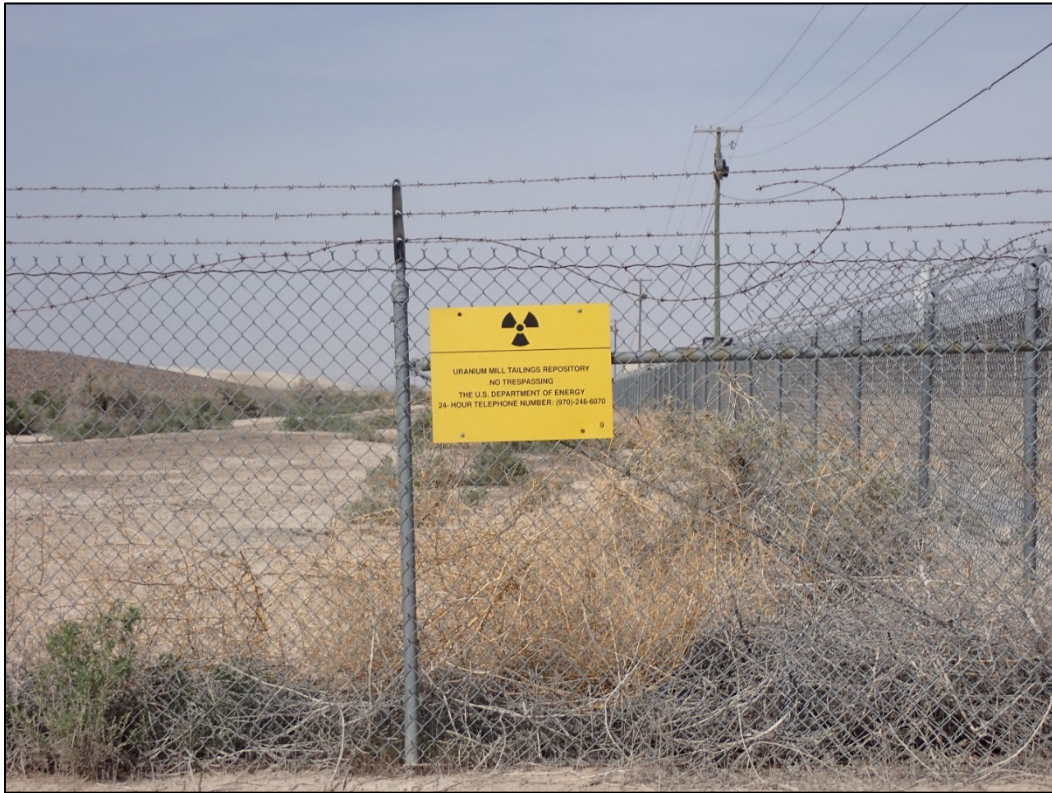
*PL-1. Perimeter Sign P9*

The site has two chainlink fences: the exterior EnergySolutions perimeter fence along the property boundary and the interior LM security fence that encloses the disposal cell and surface water diversion channels. There are 19 perimeter signs attached to the LM security fence; all 19 perimeter signs were present and in good condition (PL-1). Inspectors noted vegetation growing along the east fence line that will be addressed before the next annual site inspection. The EnergySolutions fence was partially buried in sand and pushed over in areas along the north side of the site. This non LM-owned asset does not require maintenance at this time. No other maintenance needs were identified.

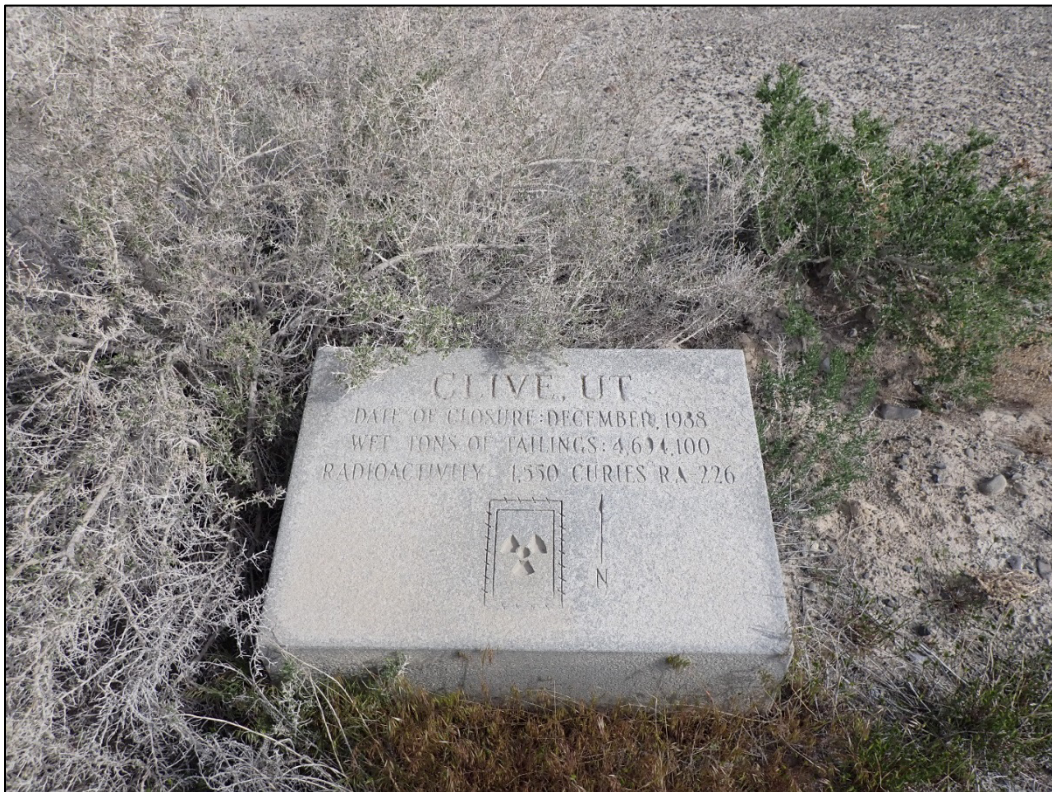
*PL-2. Site Marker SMK-1*

The site has two granite site markers. Site marker SMK-1 (PL-2) is just inside Gate 87 in the northwest corner of the site. Site marker SMK-2 is on the top slope of the disposal cell. No maintenance needs were identified.

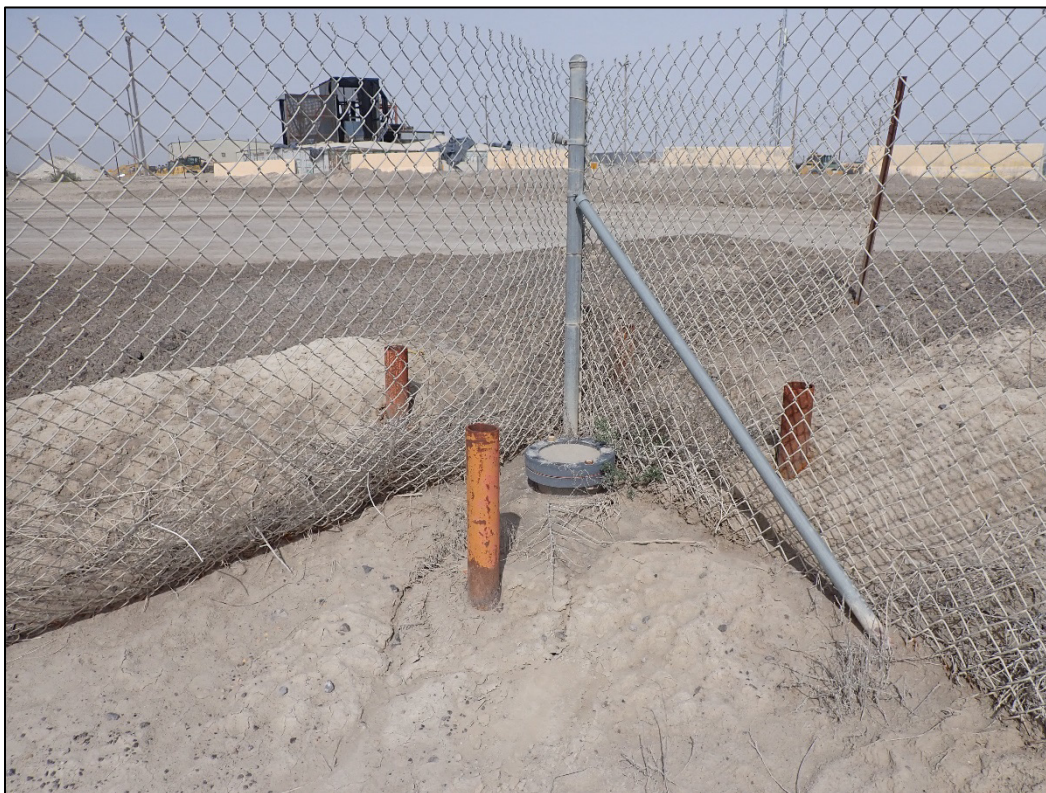
*PL-3. Boundary Monument BM-1 with Protective Cover and Nearby Bollards*

Four boundary monuments delineate the corners of the property boundary (boundary monuments BM-1 [PL-3] to BM-4). Protective casings that EnergySolutions installed over each boundary monument continue to protect the boundary monuments from damage by surrounding earthmoving activities. No maintenance needs were identified.

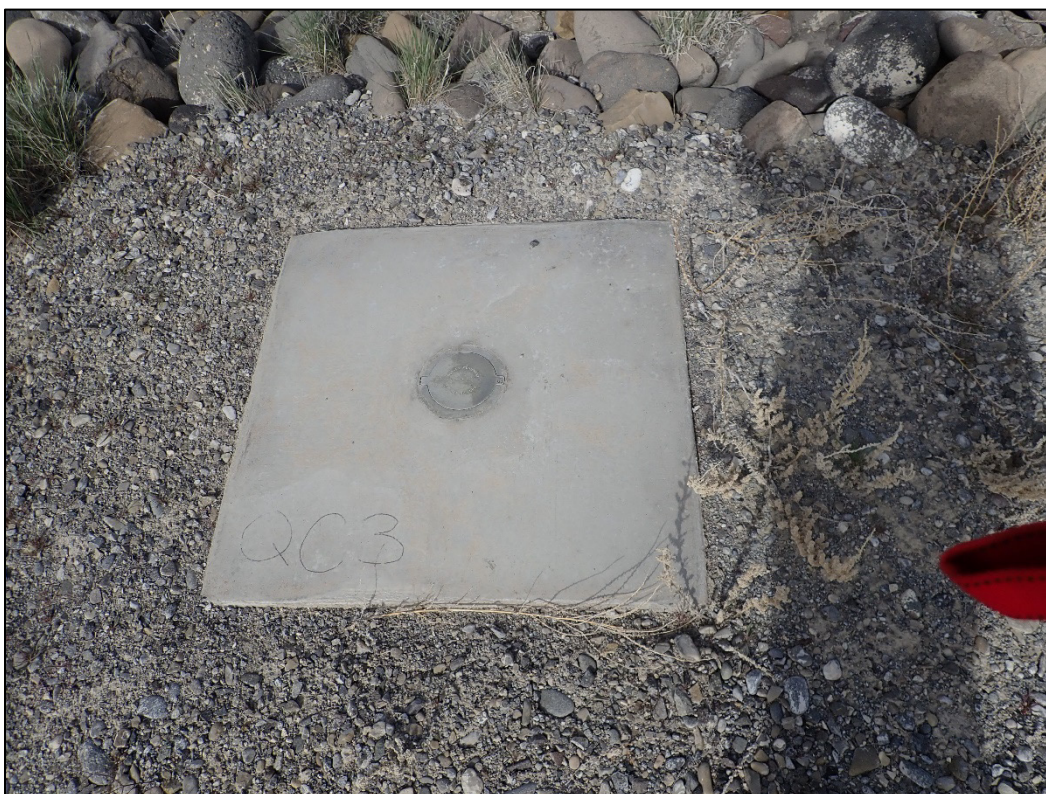
*PL-4. Quality Control Monument QC-3*

Eight aerial survey quality control monuments were installed before the 2022 inspection (PL-4). All aerial survey monuments were in good condition and no maintenance needs were identified.

Repairs to the chainlink fence on the south side of the site were performed, and aerial survey quality control monuments were installed before the 2022 inspection.

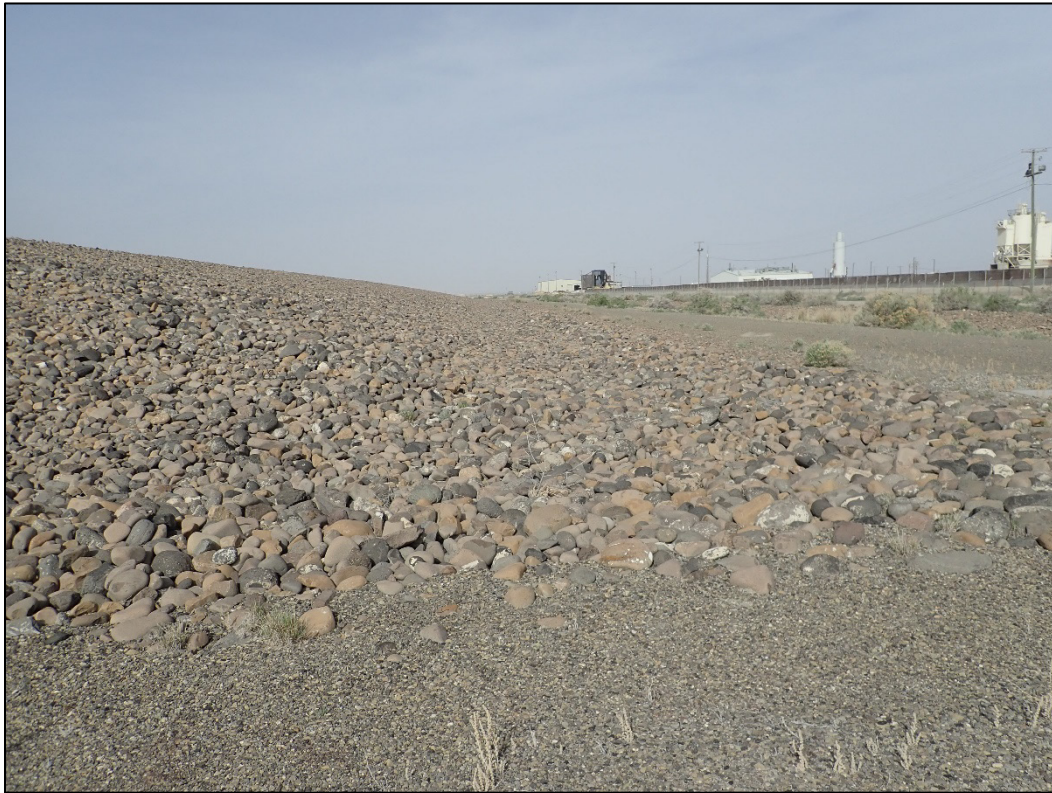
*PL-5. Northern Cell Side Slope*

The disposal cell, completed in 1988, occupies 54 acres. The disposal cell is armored with riprap to control erosion (PL-5). There were noticeable vehicle tracks on the east side slope of the disposal cell, but there was no evidence of erosion, settling, slumping, or other modifying processes that might affect the integrity of the disposal cell. Vehicle use on disposal cells is prohibited without consent from DOE. No maintenance needs were identified.

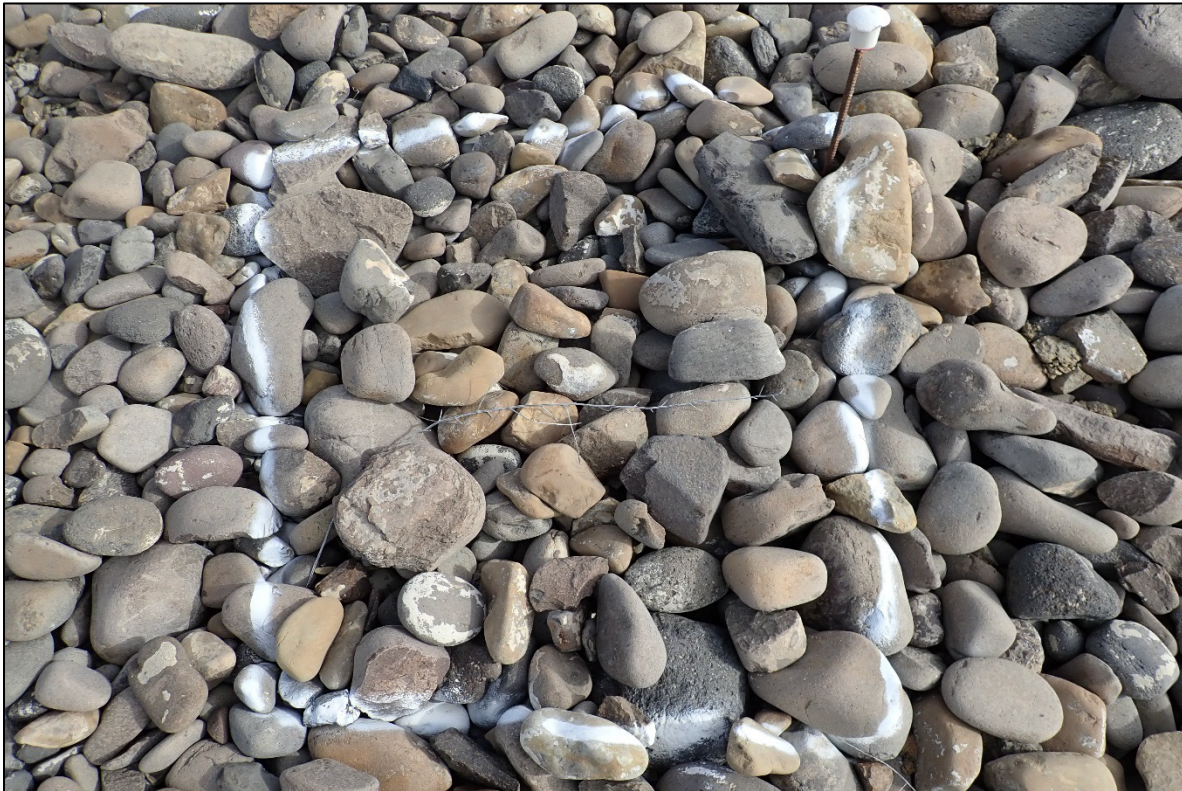
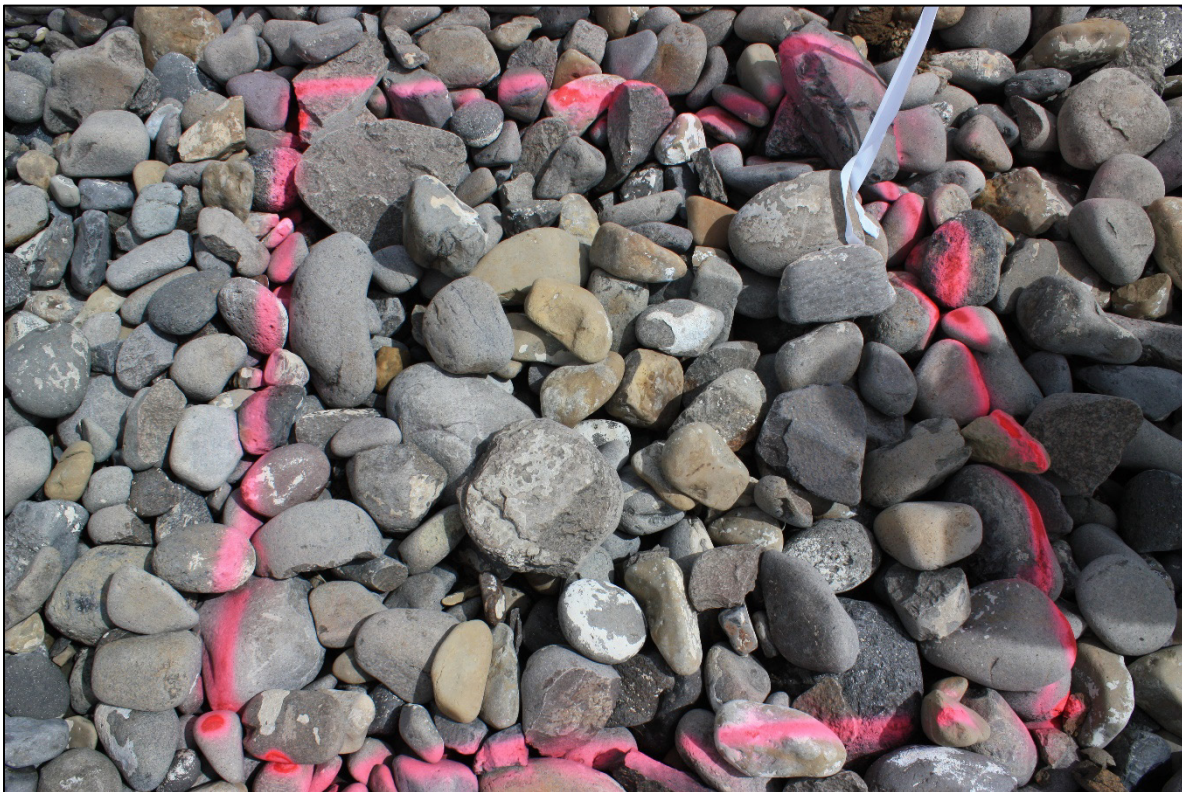
*PL-6a. Rock Quality Plot No. I—2022*

One of several types of rock found within the mix used for the disposal cell erosion-protection riprap layer has exhibited minor degradation since the disposal cell was constructed.

The type of rock exhibiting degradation constitutes approximately 1%–10% of the riprap material; observed rock degradation is thought to result from freeze-thaw weathering. Rock-quality monitoring plots are visually monitored and documented annually with photographs. Based on visual monitoring of the rock in the plots (PL-6 through PL-9), there have been no significant changes from the 2021 annual inspection. Comparisons to the initial 2010 rock-quality plot photographs indicate very little (if any) additional rock degradation since monitoring began (PL-6a through PL-9a). The extent of rock degradation observed to date has not reduced the effectiveness of the riprap cover. Rock-quality monitoring plots will continue to be visually monitored and documented annually with photographs to ensure that the riprap continues to protect the integrity of the disposal cell. Inadvertently, no photos were taken of rock-quality plots VI and VII during the 2022 inspection. The condition of these rock quality plots will be documented by photograph during a site visit later in the year to correct the oversight.
