15.0 Salt Lake City, Utah, Disposal Site

15.1 Compliance Summary

The Salt Lake City, Utah, Uranium Mill Tailings Radiation Control Act (UMTRCA) Title I Disposal Site was inspected on June 22, 2023. Due to an abnormally wet spring in the region around the site, inspectors observed ponded water in drainage channels and increased vegetation around the disposal cell. Observations of rock-quality monitoring plots indicated no significant change from the previous year. Inspectors did not find any routine maintenance needs and found no cause for a follow-up inspection. Maintenance needs that could be addressed during the inspection were completed by inspectors. Groundwater monitoring is not required.

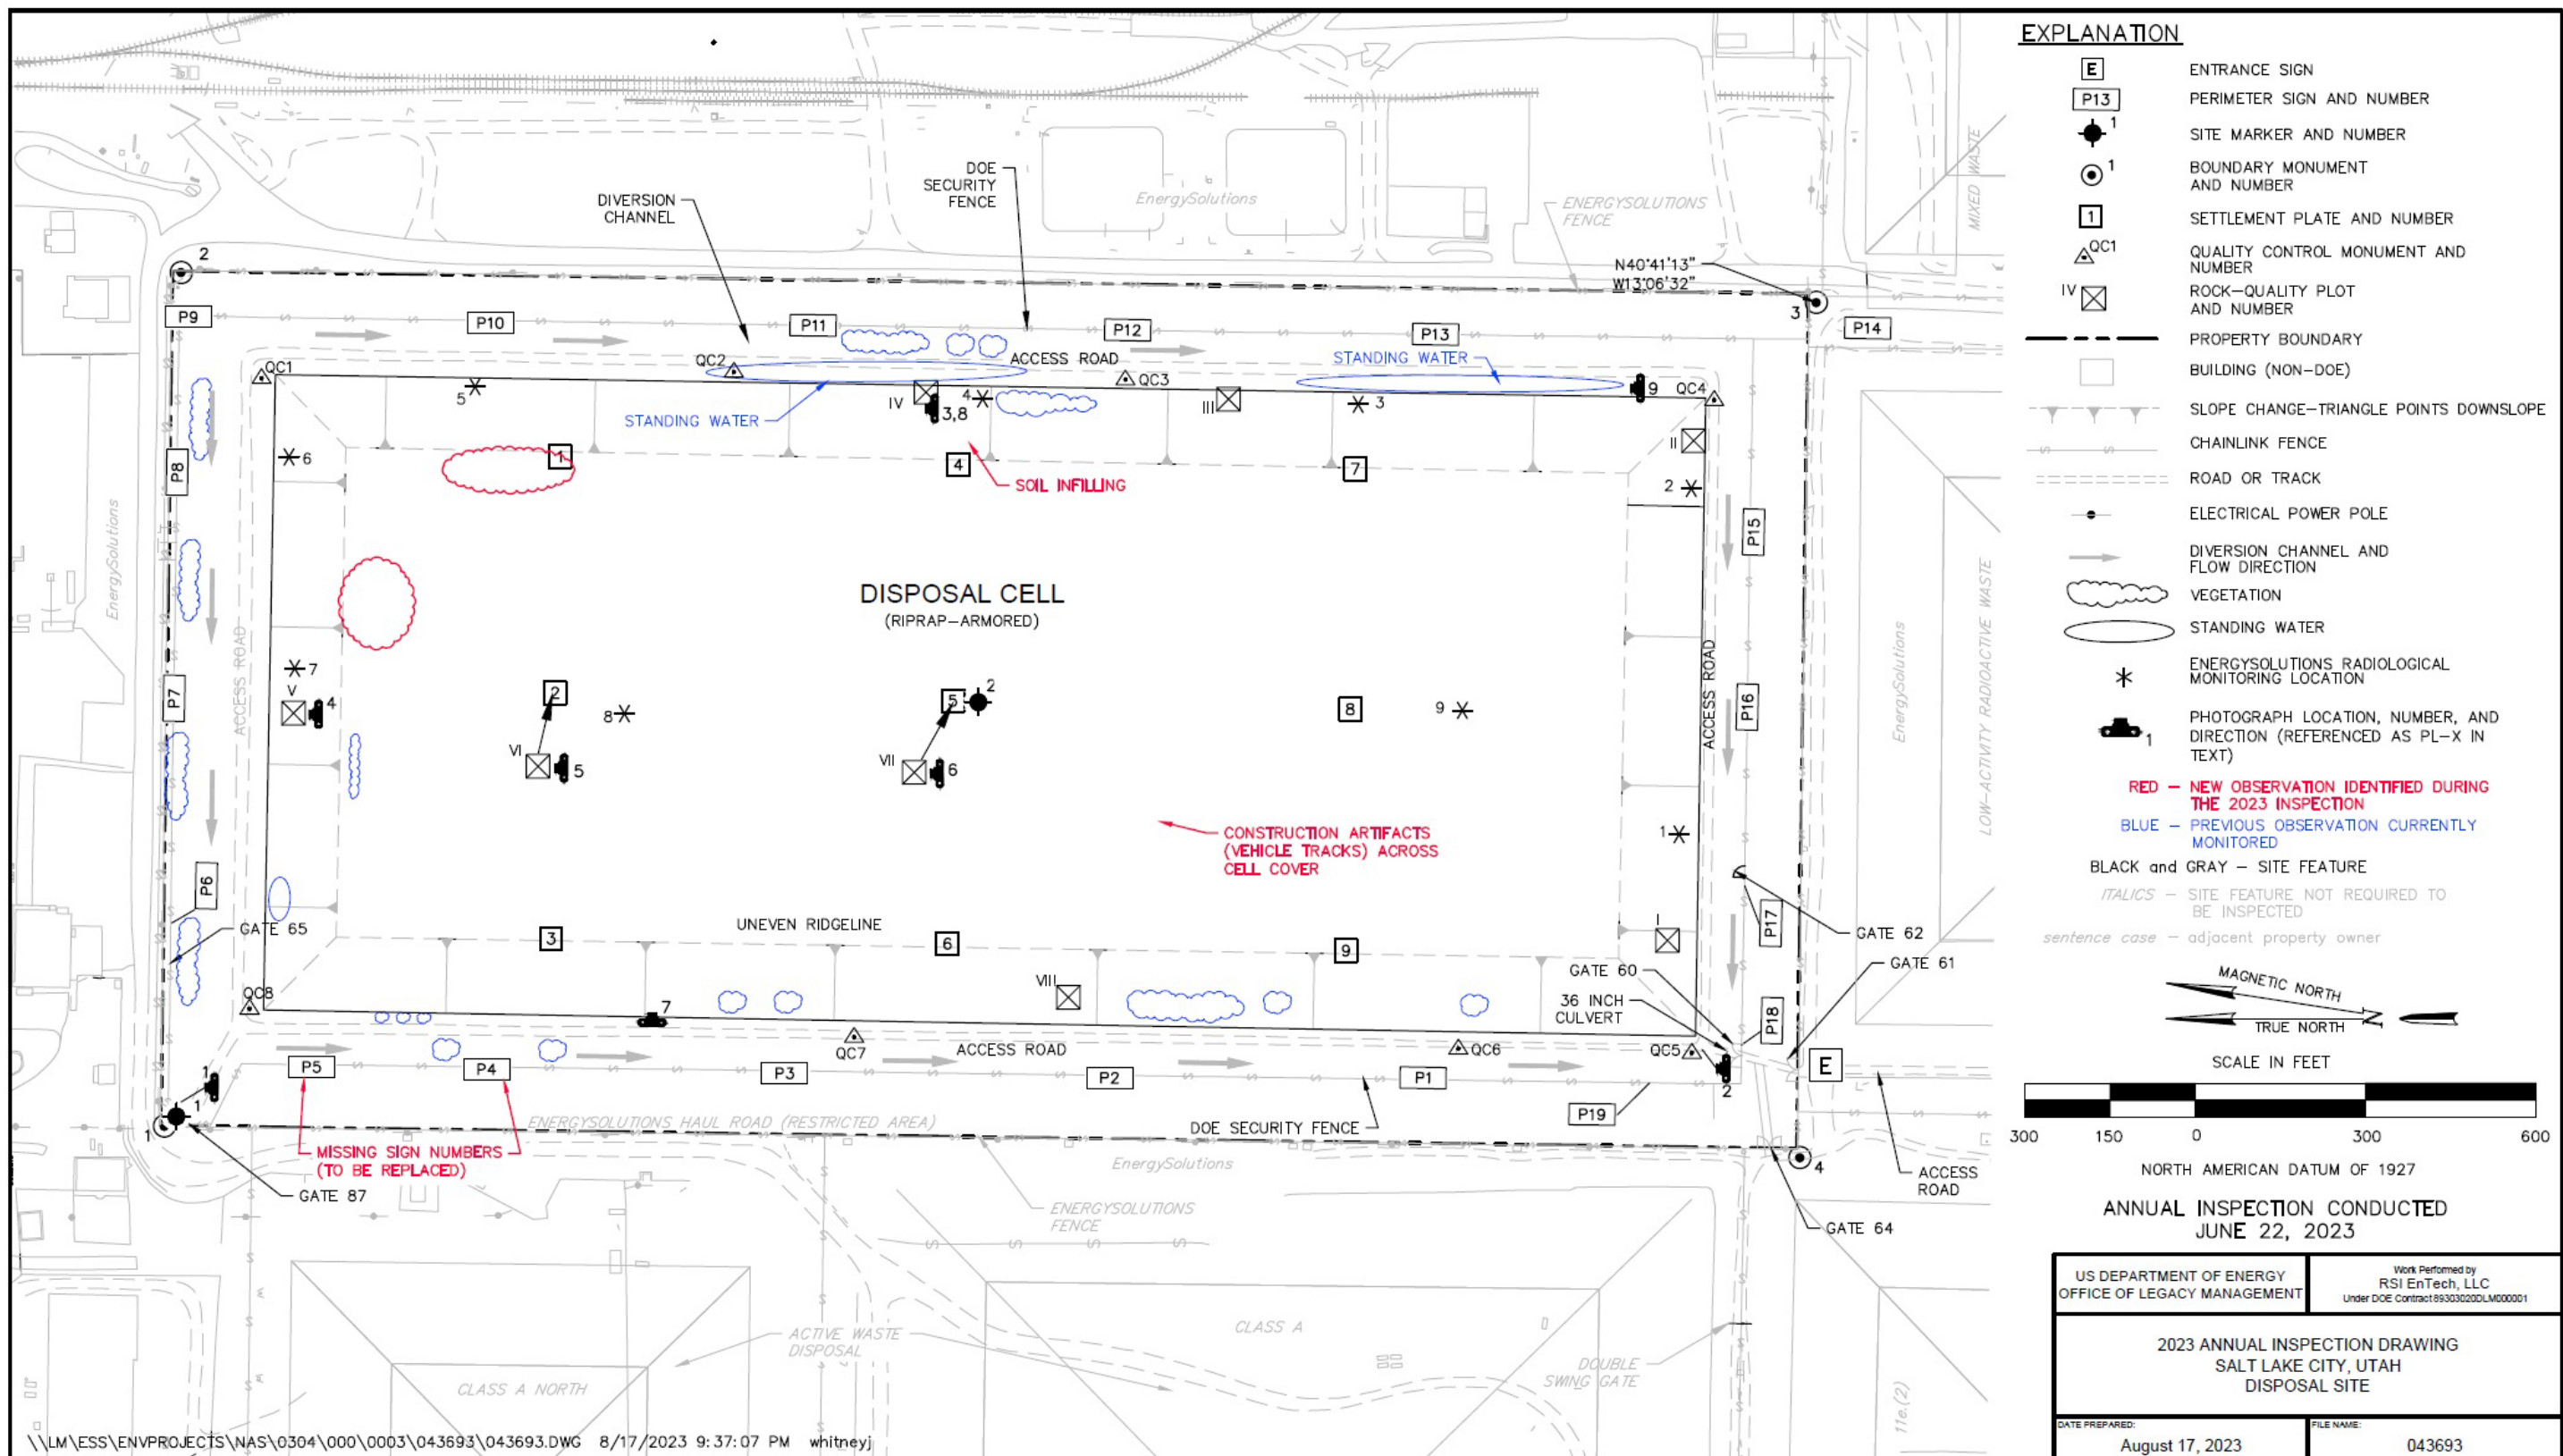
Figure 15-1. 2023 Annual Inspection Drawing for the Salt Lake City, Utah, Disposal Site

Figure 15-1 shows the locations of site features, including site surveillance features and inspection areas, in black and gray font. Some site features that are present but not required to be inspected are shown in italic font. Observations from previous inspections that are currently monitored are shown in blue, and new observations identified during the 2023 annual inspection are shown in red. Inspection results and recommended maintenance activities associated with site surveillance features are described in the following subsections. Photographs to support specific observations are noted in the text and in Figure 15-1 by photograph location (PL) numbers. The photographs and photograph log are presented in Section 15.10.

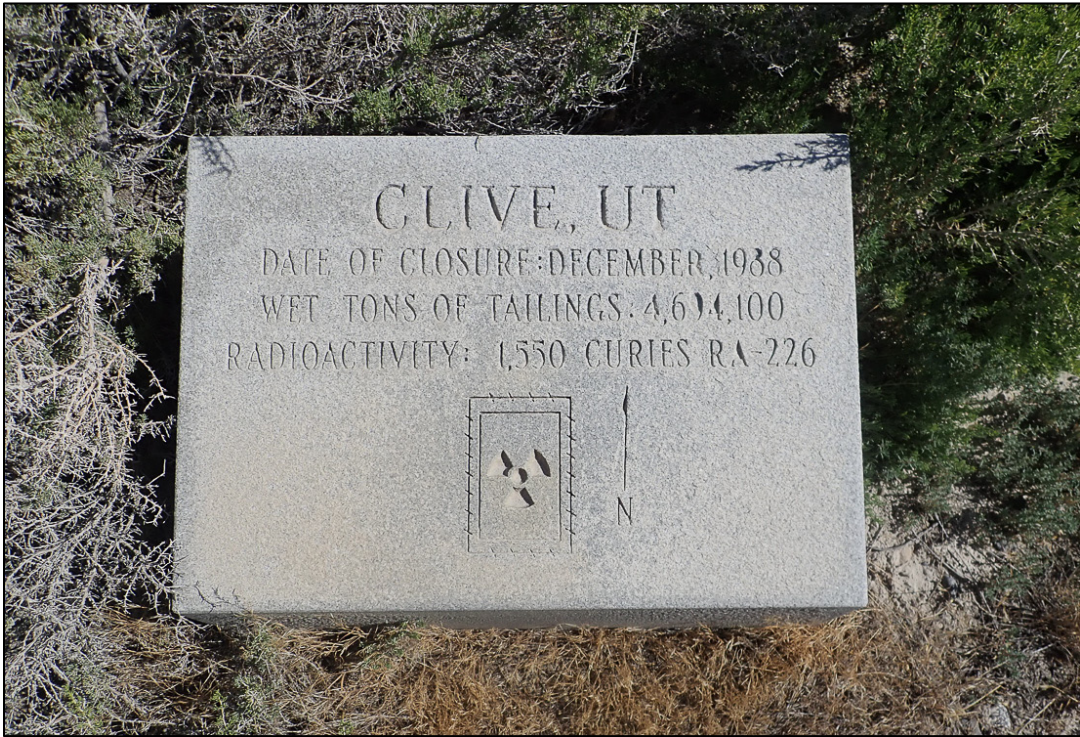
The site has two granite site markers. Site marker SMK-1 (PL-1) is just inside Gate 87 in the northwest corner of the site. Site marker SMK-2 is on the top slope of the disposal cell. No maintenance needs were identified.

PL-1. Site Marker SMK-1

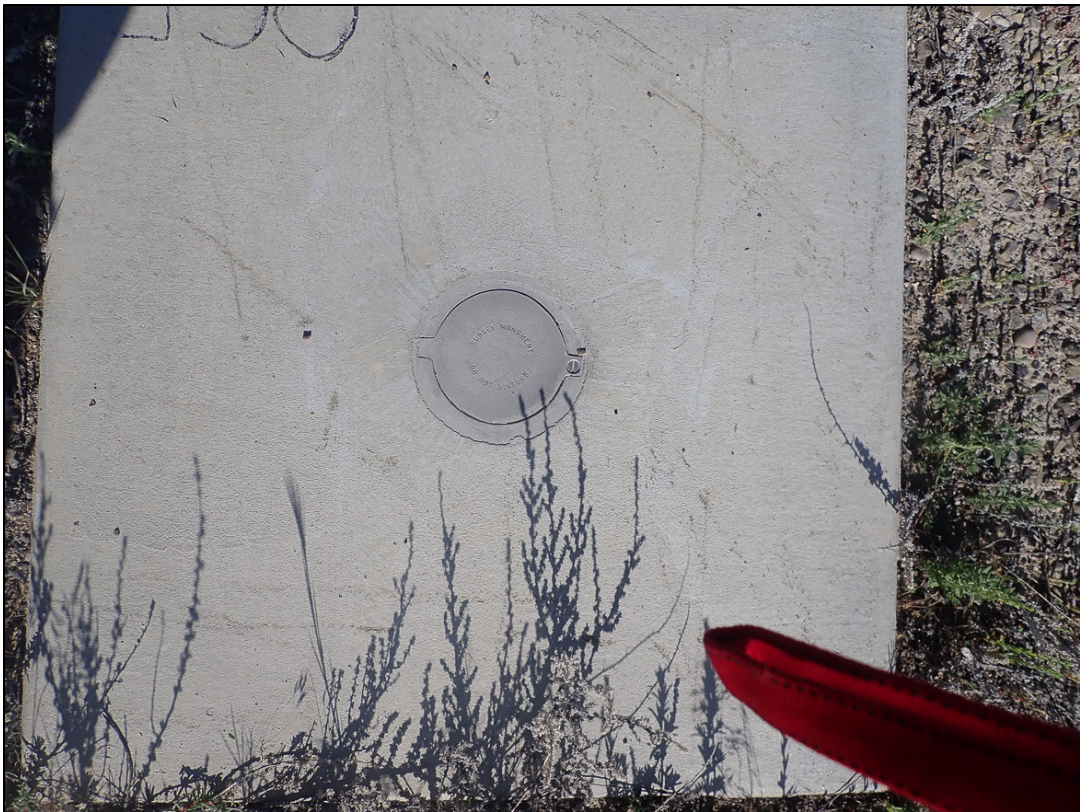
Eight aerial survey quality control monuments (PL-2) were in good condition and no maintenance needs were identified.

PL-2. Aerial Survey Quality Control Monument QC-5

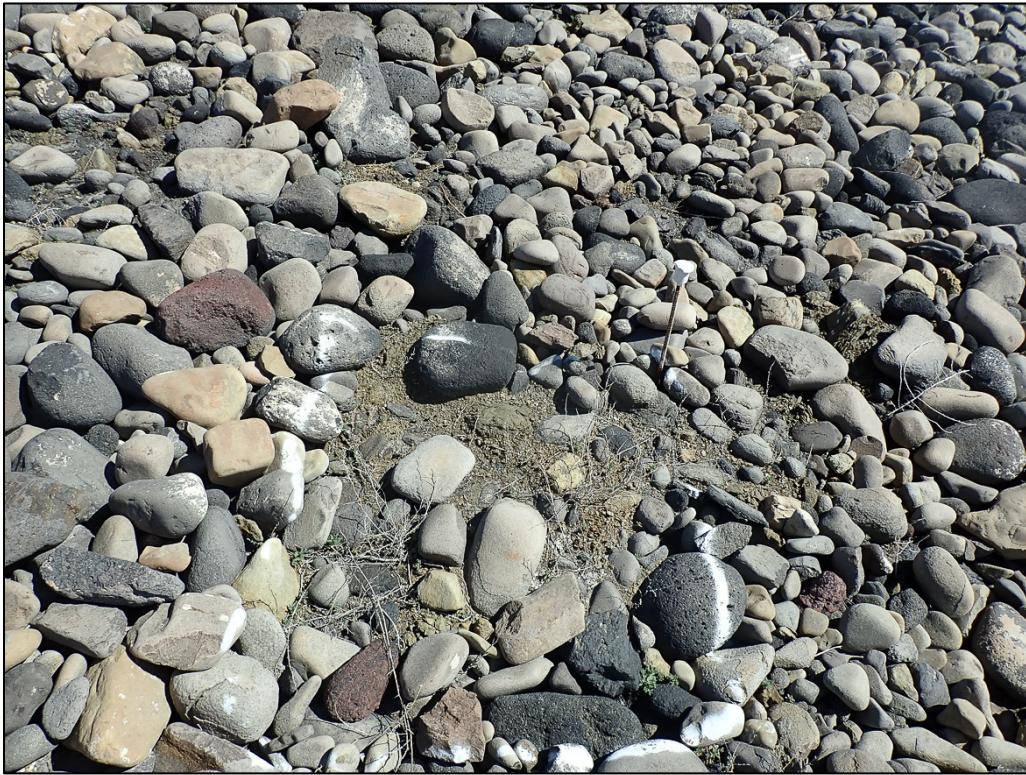
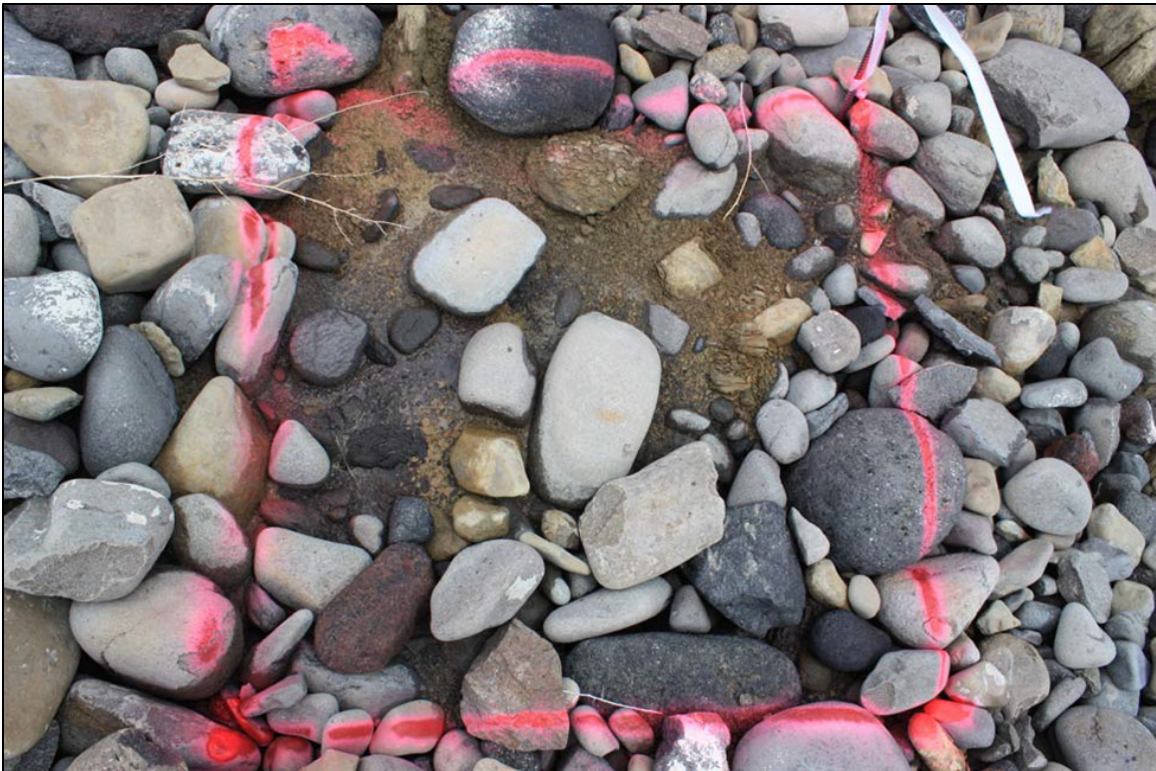
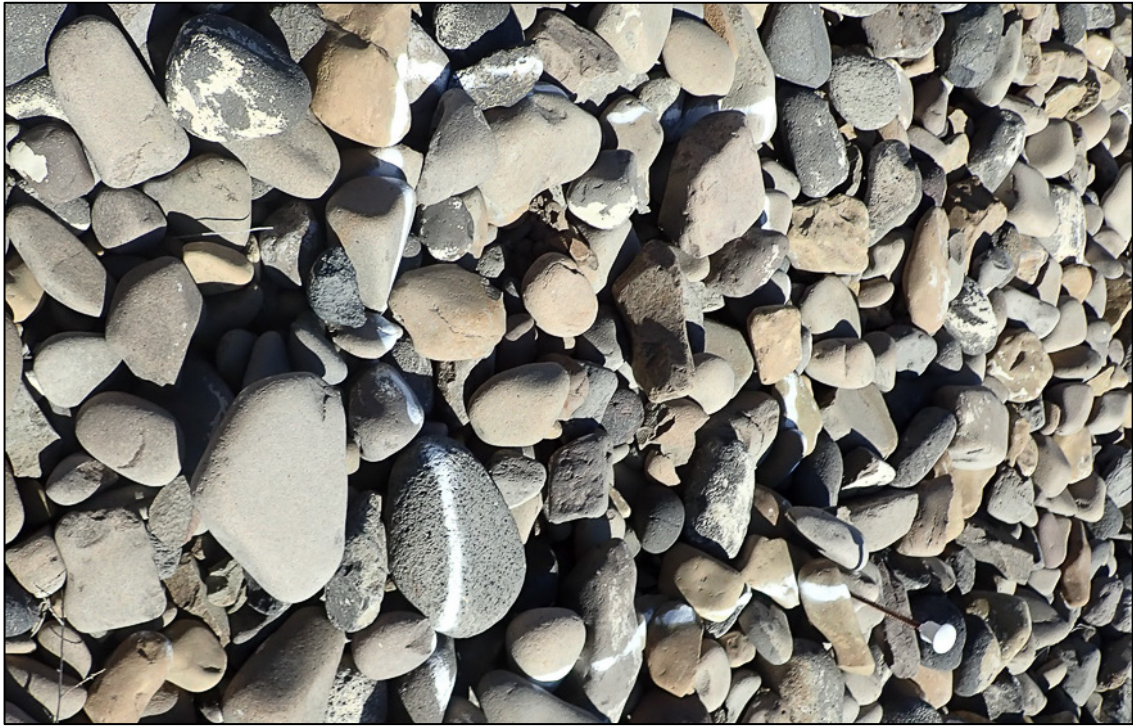
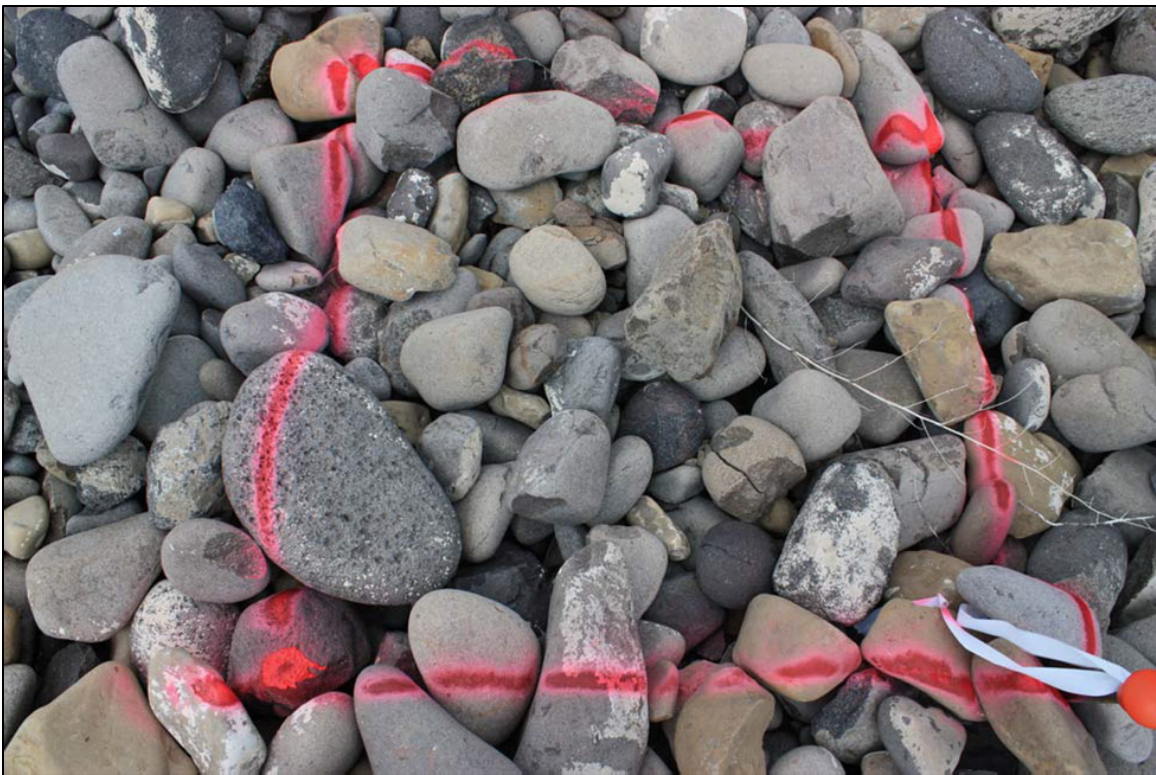
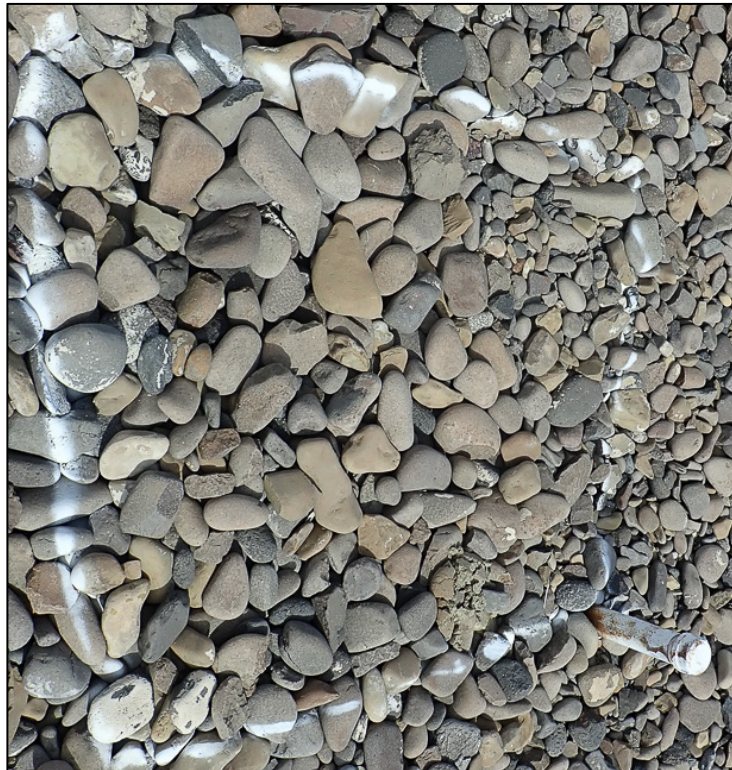
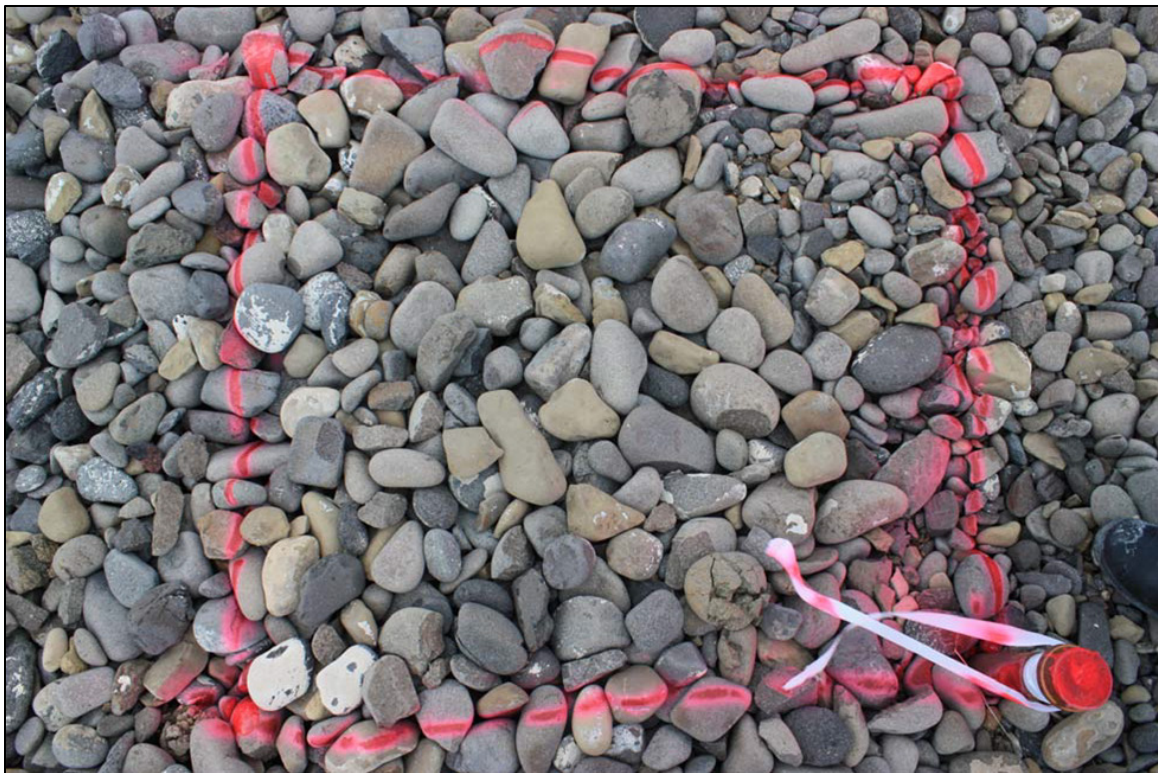
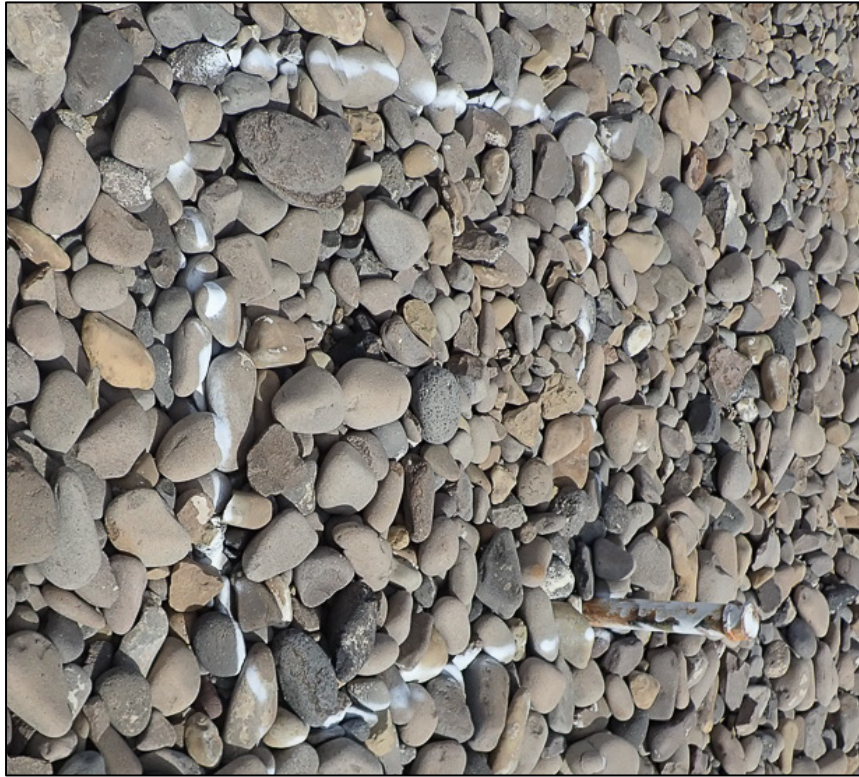
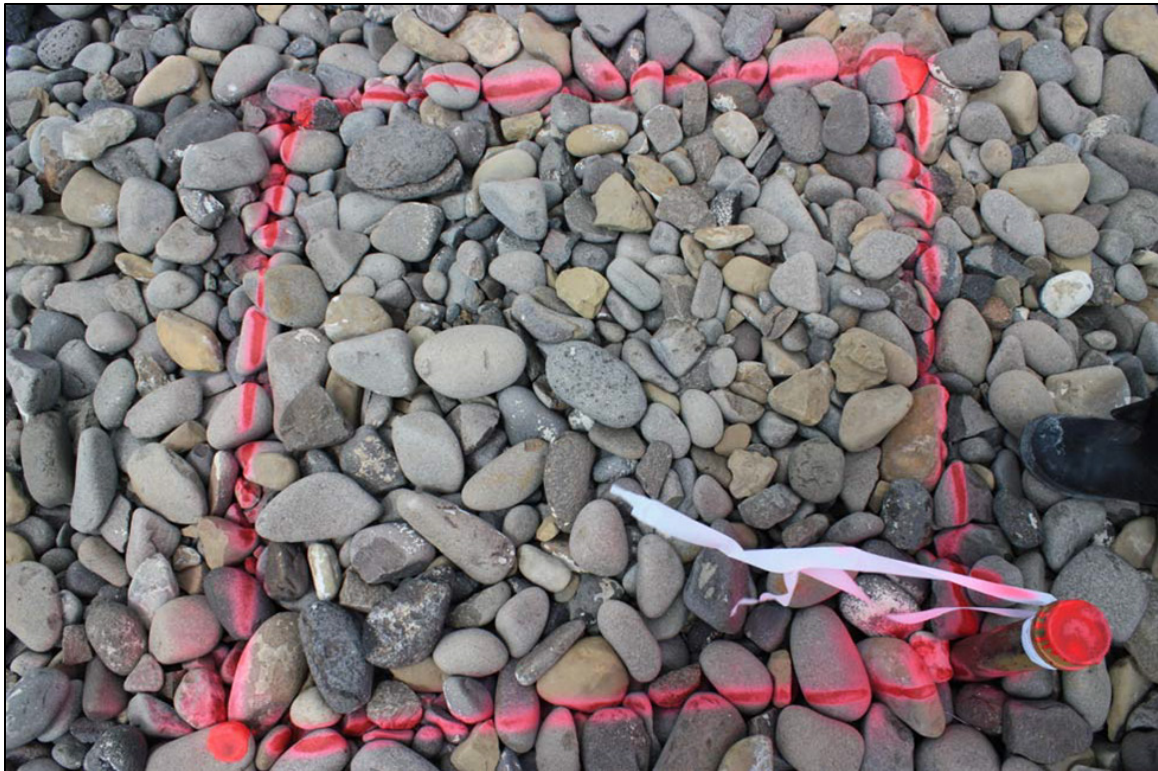
One of several types of rock found within the mix used for the disposal cell erosion-protection riprap layer has exhibited minor degradation since the disposal cell was constructed. Eight rock-quality monitoring plots, each measuring 1 square meter (indicated by Roman numerals I–VIII in Figure 15-1), were established in 2010 to monitor for continued rock degradation.

The type of rock exhibiting degradation constitutes approximately 1%–10% of the riprap material; observed rock degradation is thought to result from freeze-thaw weathering. Rock-quality monitoring plots are visually monitored and documented annually with photographs. Photographs of plots IV, V, VI, and VII (PL-3 through PL-6) have been included in the report as representative of the rock-quality monitoring plots. Based on visual monitoring of the rock in the plots, there have been no significant changes from the 2022 annual inspection. Comparisons to the initial 2010 rock-quality plot photographs indicate very little (if any) additional rock degradation since monitoring began (PL-3 through PL-6). The extent of rock degradation observed to date has not reduced the effectiveness of the riprap cover, and, at this time, there is no concern that cover integrity will be affected in the future. Rock-quality monitoring plots will continue to be visually monitored and documented annually with photographs to ensure that the riprap continues to protect the integrity of the disposal cell.

PL-3a. Rock-Quality Monitoring Plot IV—2023

PL-3b. Rock-Quality Monitoring Plot IV—2010 Photo for Comparison

PL-4a. Rock-Quality Monitoring Plot V—2023

PL-4b. Rock-Quality Monitoring Plot V—2010 Photo for Comparison

PL-5a. Rock-Quality Monitoring Plot VI—2023

PL-5b. Rock-Quality Monitoring Plot VI—2010 Photo for Comparison

PL-6a. Rock-Quality Monitoring Plot VII—2023

PL-6b. Rock-Quality Monitoring Plot VII—2010 Photo for Comparison

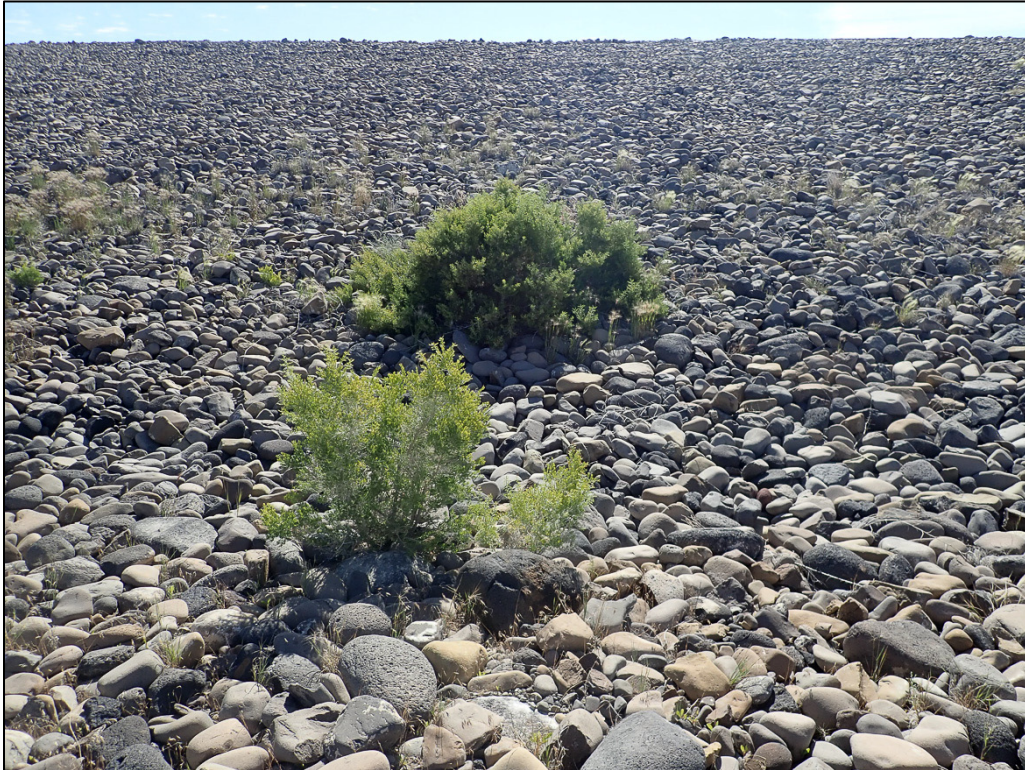
Although areas of the disposal cell have continued to have minor perennial grass growth, no deep-rooted plants were present on the disposal cell. Two small weedy plants were found growing on the west side slope (PL-7), and two areas near the northeast corner of the top slope had minor vegetation growth. Soil infilling and some minor settling was observed along the east side slope (PL-8). No immediate maintenance is required, but this area will be monitored in the future for further settling, slumping, and infilling. No other maintenance needs were identified.

PL-7. Vegetation on West Side Slope

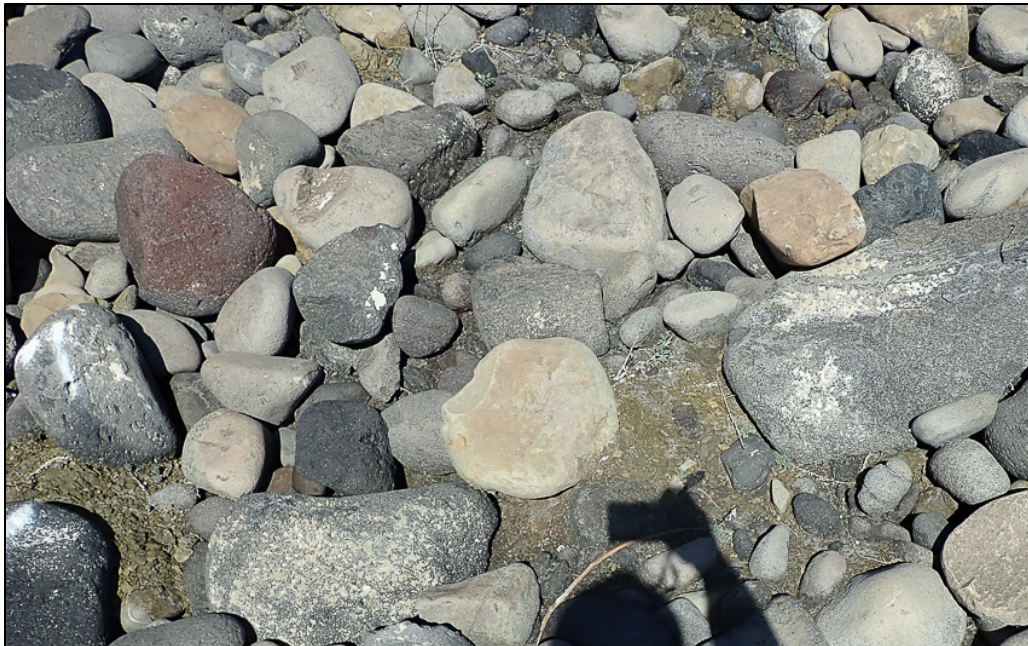
PL-8. Infilled Soil in Rock-Quality Monitoring Plot IV

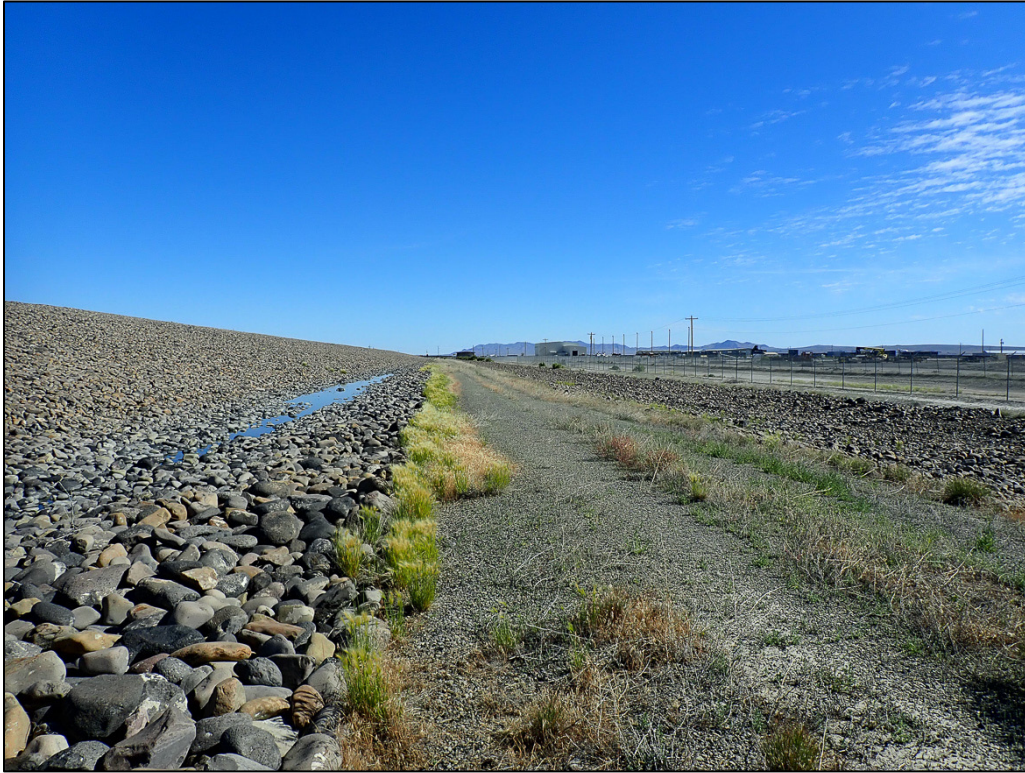
The surface water diversion channels were functioning as designed. Ponded water and vegetation growth were observed in and along these diversion channels (PL-9) but are not impeding stormwater runoff.

PL-9. Ponded Water in Toe Drain near Southeast Corner of Disposal Cell
