## 16.0 Shiprock, New Mexico, Disposal Site

### 16.1 Compliance Summary

The Shiprock, New Mexico, Uranium Mill Tailings Radiation Control Act (UMTRCA) Title I Disposal Site was inspected on June 8, 2021. No changes were observed on the disposal cell or in the associated diversion channels. Inspectors identified several minor maintenance needs but found no cause for a follow-up inspection. Groundwater monitoring to evaluate disposal cell performance is not required.

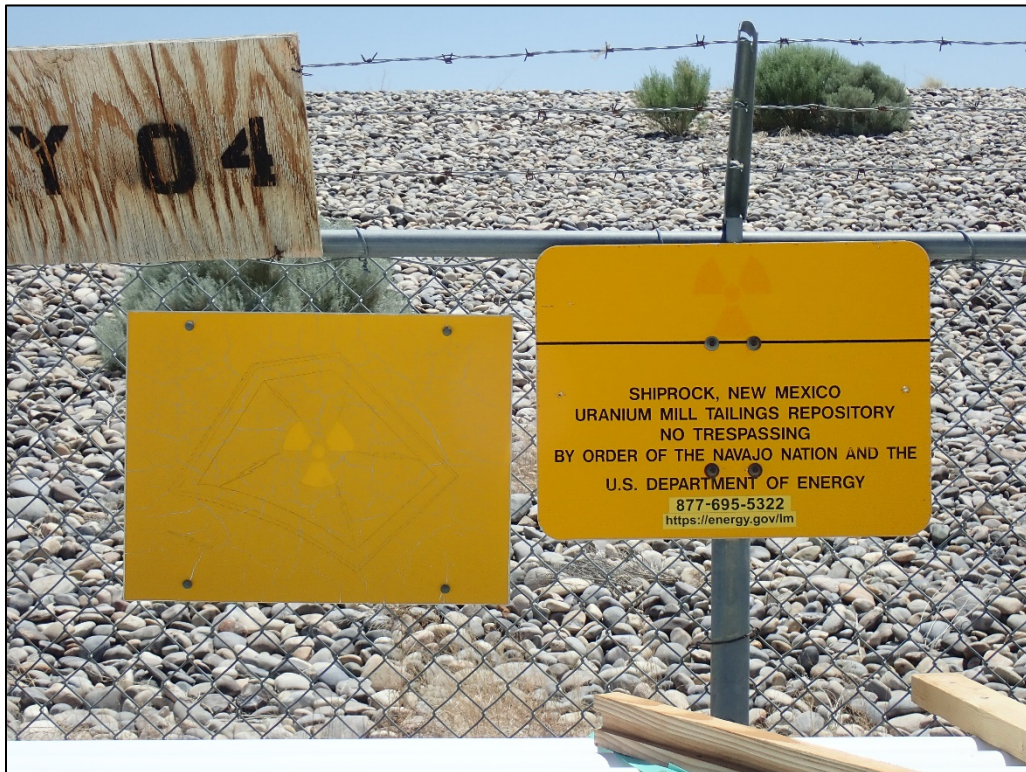
A chainlink perimeter fence encloses the disposal cell and drainage features. Regular maintenance to keep the perimeter fence free of trash, tumbleweeds, and other debris is ongoing. Seventeen pairs of perimeter signs, designated P1 through P17 (each pair consisting of one pictorial and one textual sign), are positioned along the perimeter fence.<sup>1</sup> Pictorial signs P1, P12, and P13 were faded and in need of replacement (PL-1), the radiation symbols on several signs were faded and the website information on perimeter sign P3 was faded. Faded signs and symbols will be replaced before the next inspection. No other maintenance needs were identified.

*PL-1. Faded Pictorial Sign and Radiation Symbol on Perimeter Sign P12*

- Replacing faded pictorial and information on perimeter signs
- Continuing to remove trash and debris (including tumbleweeds) along the perimeter fence
- Sealing the cracks and repairing erosion at the base of site marker SMK-1
- Treating deep-rooted woody shrubs on the top and side slopes of the disposal cell
- Assessing torn areas in erosion control fabric on the northwest end of the outflow channel

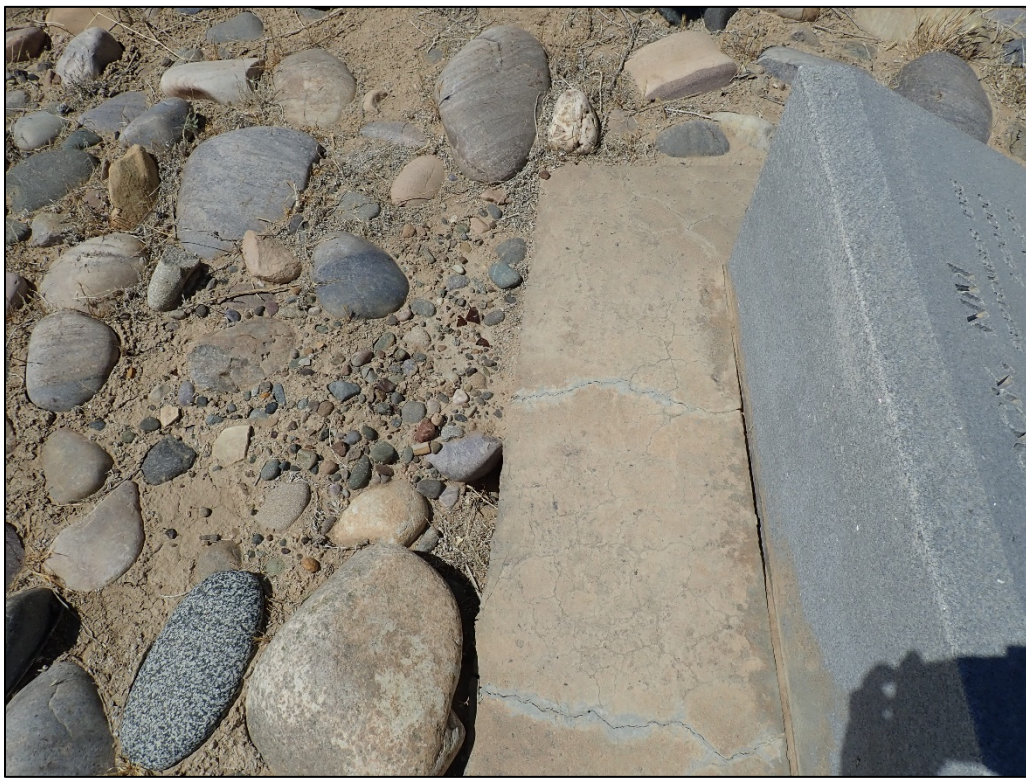
The site has two granite site markers. Site marker SMK-1 is just inside the west gate and contains minor cracks in its concrete base. Although the cracks were sealed in 2018, they are beginning to open and will start to deteriorate (PL-2). Inspectors also noted that a minor amount of soil had eroded from the north side of the concrete base. Both of these items will be repaired before the next inspection. Site marker SMK-2 is on the top slope of the disposal cell and is stable and legible (PL-3).

*PL-2. Cracks and Erosion in Concrete Base of Site Marker SMK-1*

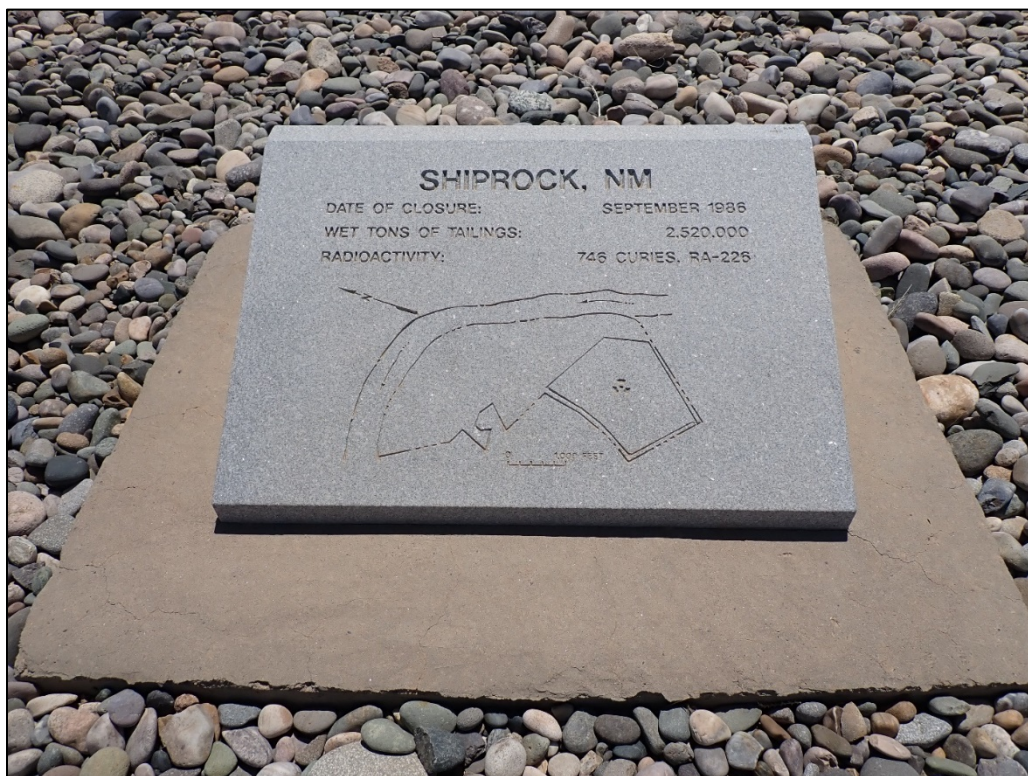
*PL-3. Site Marker SMK-2 on Cell Top*

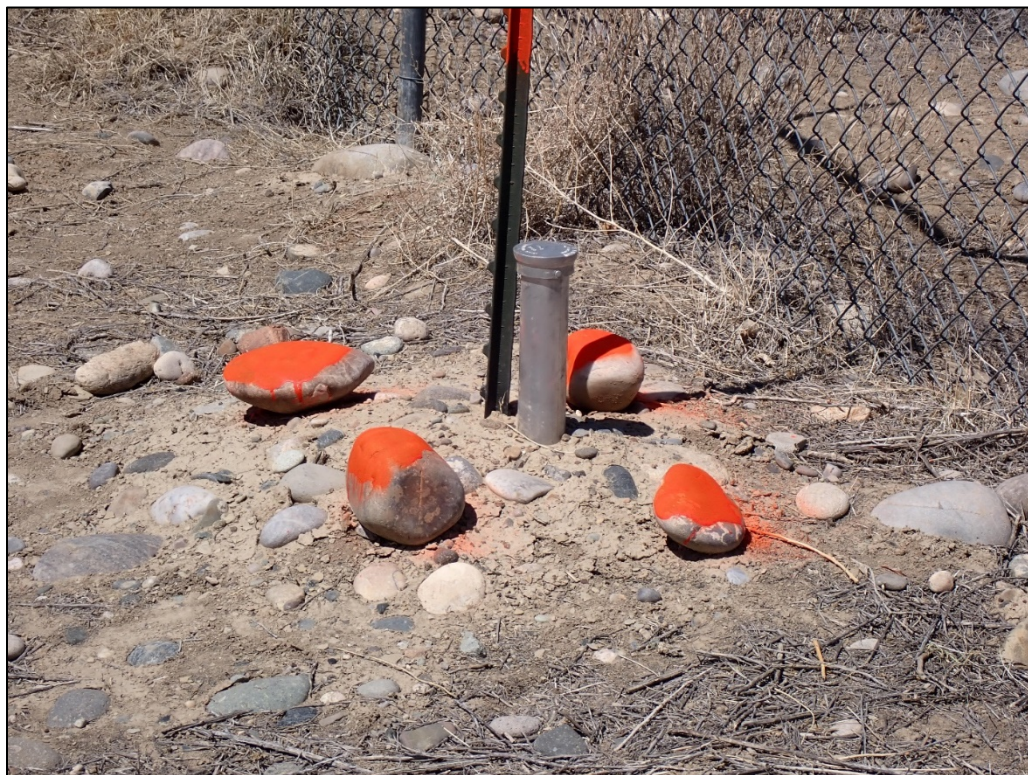
*PL-4. Boundary Monument BM-1*

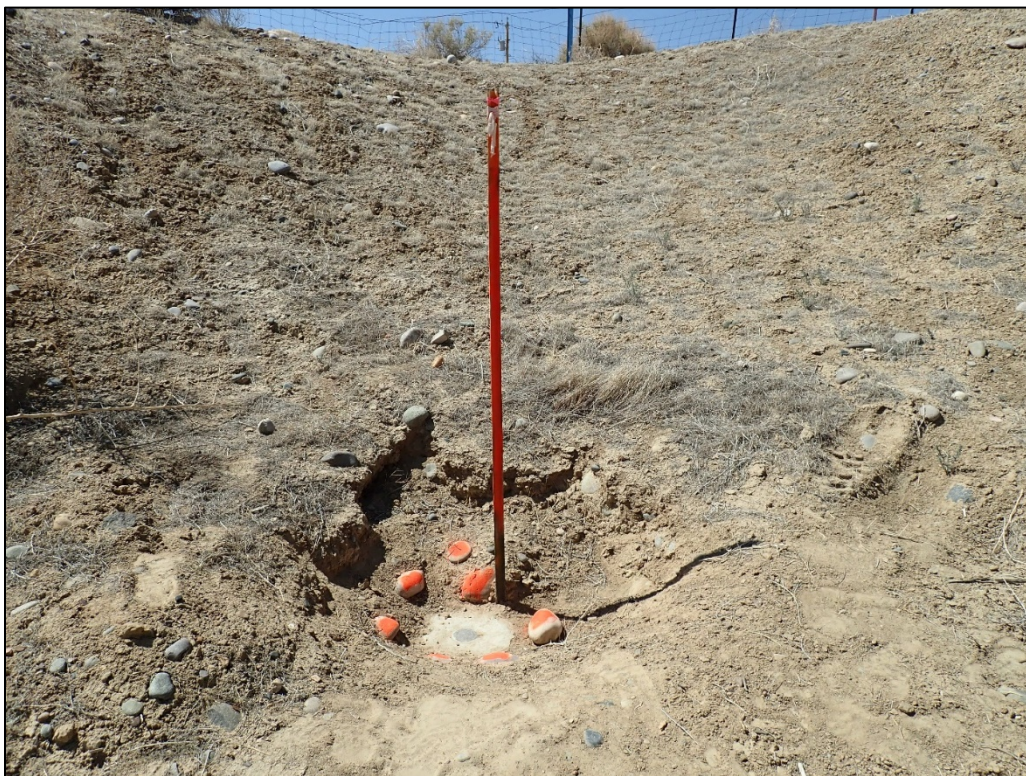
Three survey monuments and six boundary monuments delineate the property boundary. Two additional boundary monuments are offsite; monitoring of these offsite monuments was discontinued in 2003. In 2002, boundary monument BM-1 was destroyed or removed by an adjacent landowner. It was replaced, and two reference monuments (RM-1 and RM-2) were installed next to it in 2003. Steel T-posts were installed next to all boundary monuments to make them more visible and help inspectors locate them. The concrete at survey monument SM-1 is cracked, but the crack does not threaten the integrity of the marker. All survey and boundary monuments were observed to be clear of vegetation and were either visible (PL-4) or uncovered with a shovel (PL-5 and PL-6) during the 2021 inspection. No maintenance needs were identified.

*PL-5. Boundary Monument BM-5*

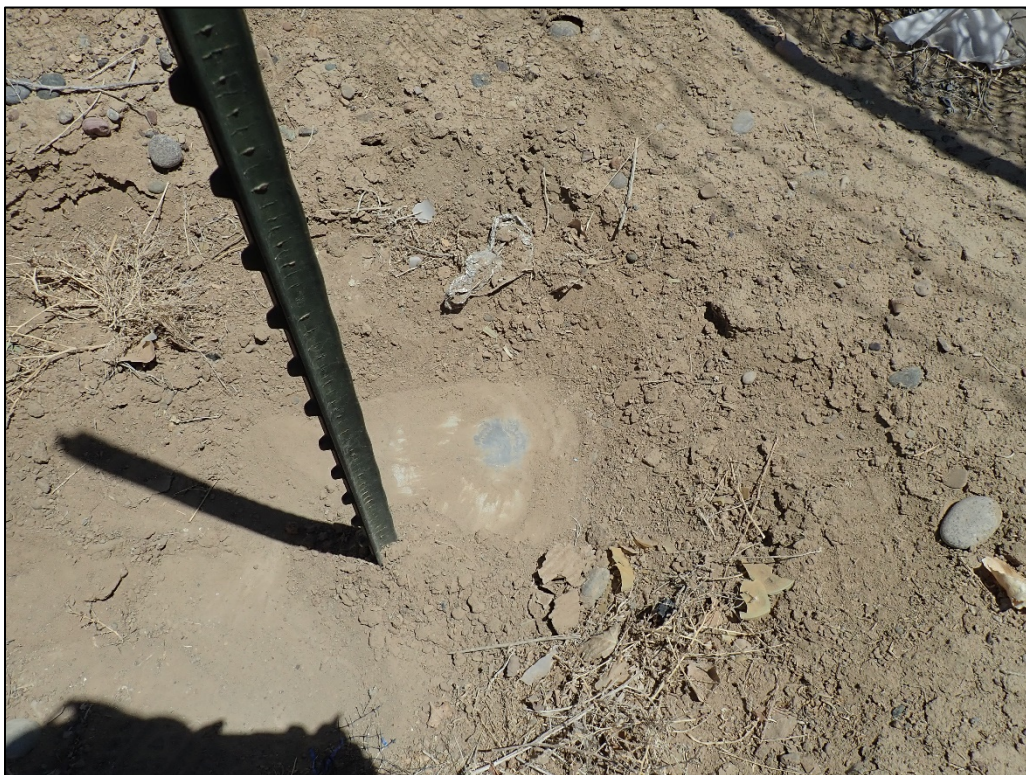
*PL-6. Boundary Monument BM-3*

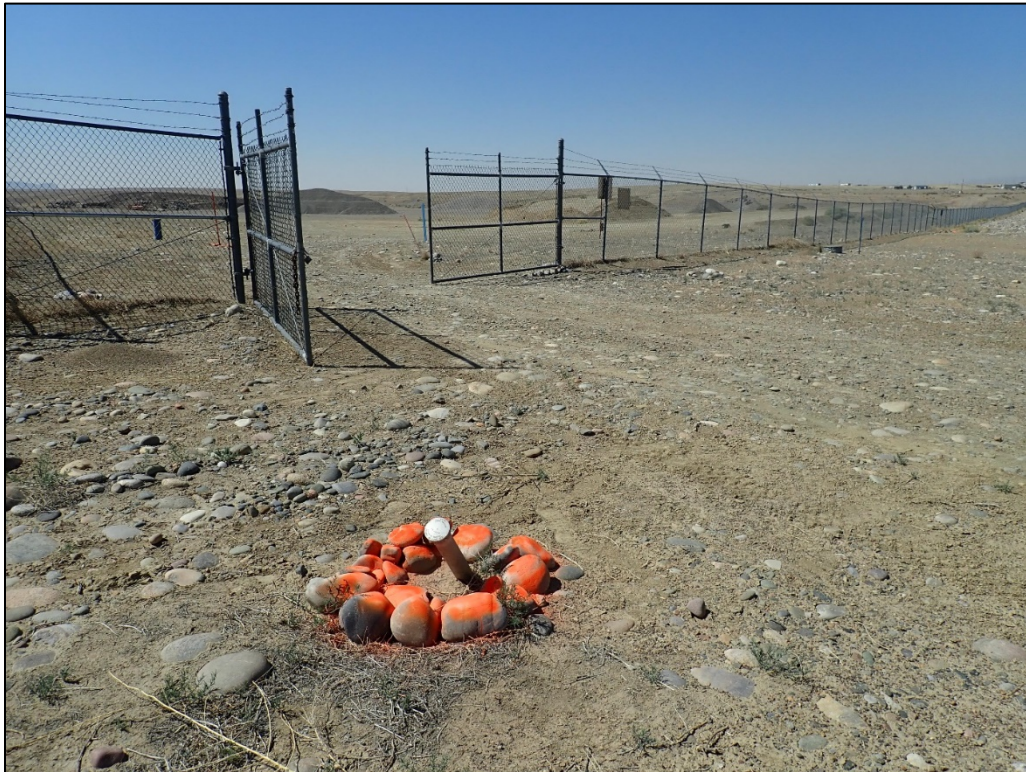
The site has four pairs of erosion control markers (1/1A, 2/2A, 3/3A, and 5/5A) (PL-4) along the edge of the terrace escarpment. Erosion control markers 4 and 4A are not inspected; they were installed on the terrace east of the site in the gravel pit. Erosion control marker 5A, near the east entrance gate, was previously bent by a vehicle (PL-7), but it is functional and does not require repair. No maintenance needs were identified.

*PL-7. Erosion Control Marker 5A*

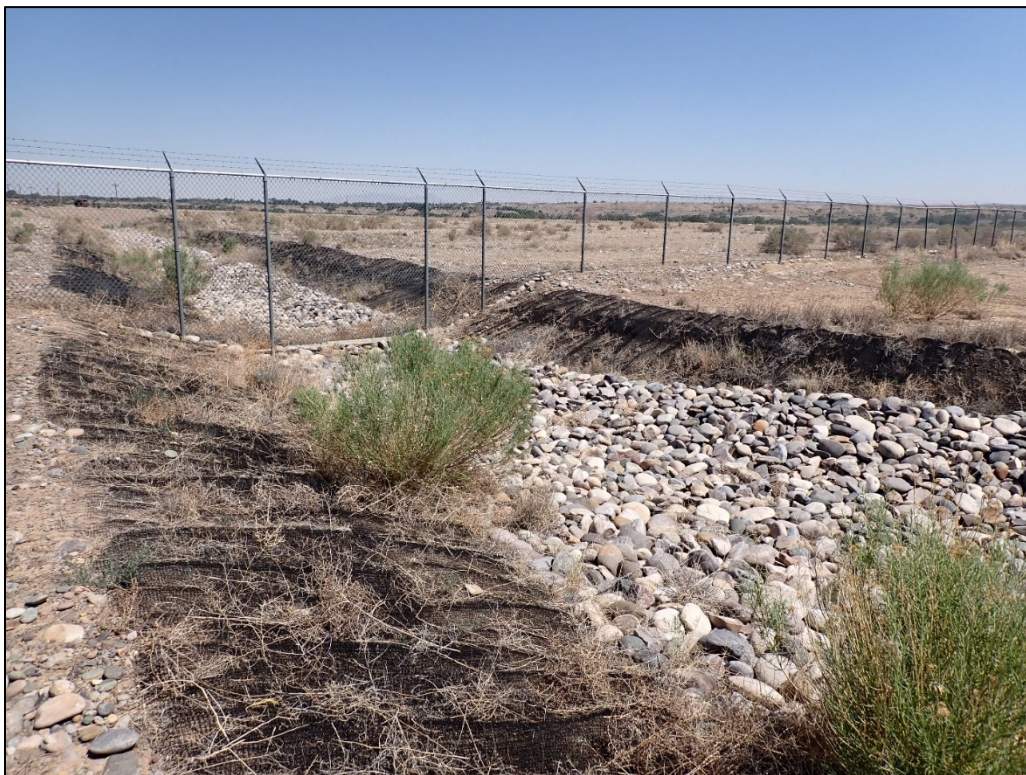
*PL-8. Outflow Channel at North Perimeter Fence*

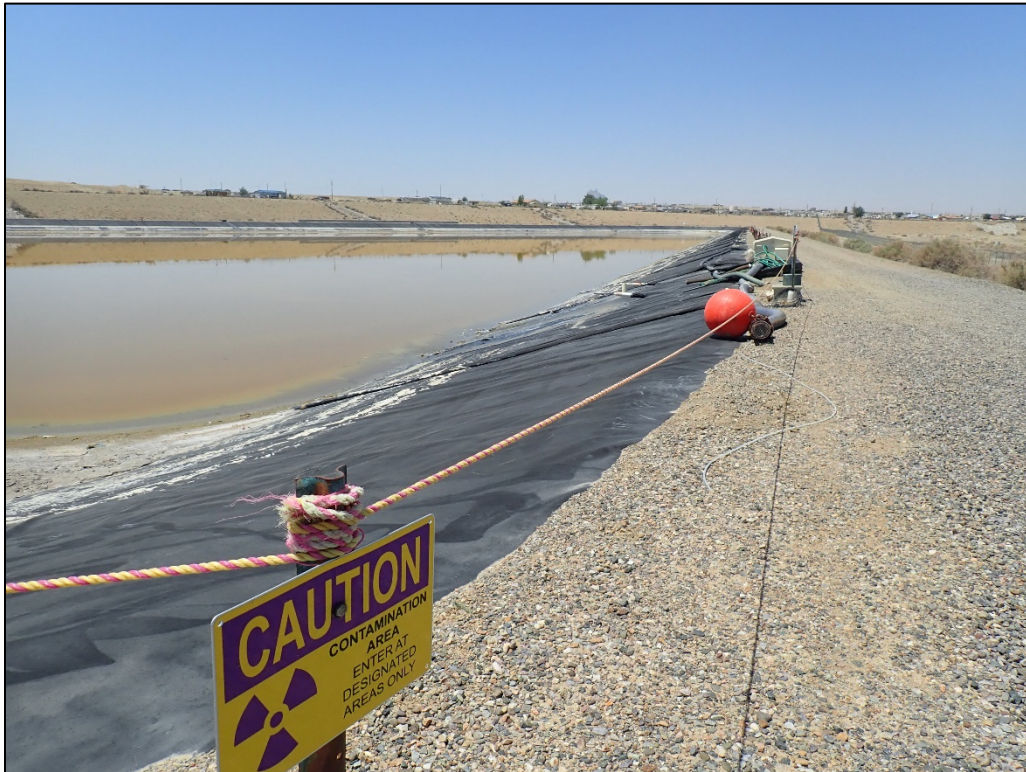
In 2002, LM constructed an 11-acre lined evaporation pond near the disposal cell as part of the groundwater compliance strategy. The pond, surrounded by a chainlink security fence, is maintained under the groundwater compliance program. Both the security fence and pond were intact and functional at the time of the inspection (PL-9). The informational sign at the pond contained outdated information. Updates to the sign will be made before the next inspection.

*PL-9. Evaporation Pond*

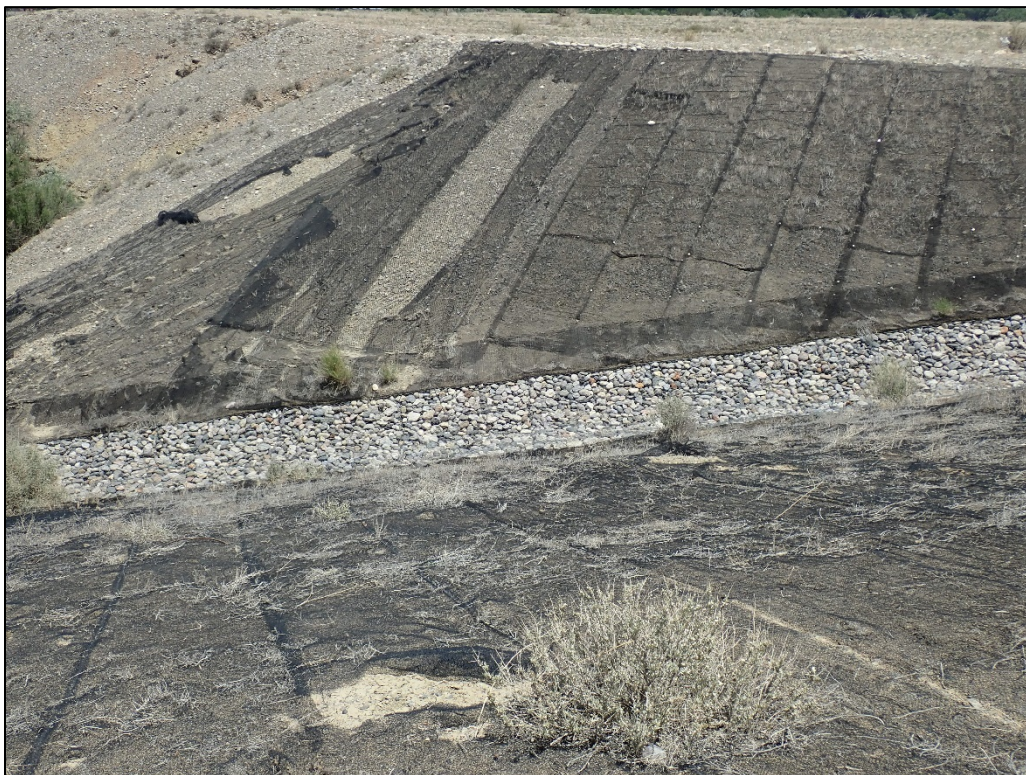
Inspectors noted three new torn areas in the erosion control fabric on the banks of the lower outflow channel, one of which was considered significant (PL-10). The tears will be assessed in 2022 once travel restrictions are lifted.

*PL-10. Torn Areas in Erosion Control Fabric on Northwest End of Outflow Channel*
