16.0 Shiprock, New Mexico, Disposal Site

16.1 Compliance Summary

The Shiprock, New Mexico, Uranium Mill Tailings Radiation Control Act (UMTRCA) Title I Disposal Site was inspected on June 22, 2022. No changes were observed on the disposal cell or in the associated diversion channels. Inspectors identified several minor maintenance needs but found no cause for a follow-up inspection. Groundwater monitoring to evaluate disposal cell performance is not required.

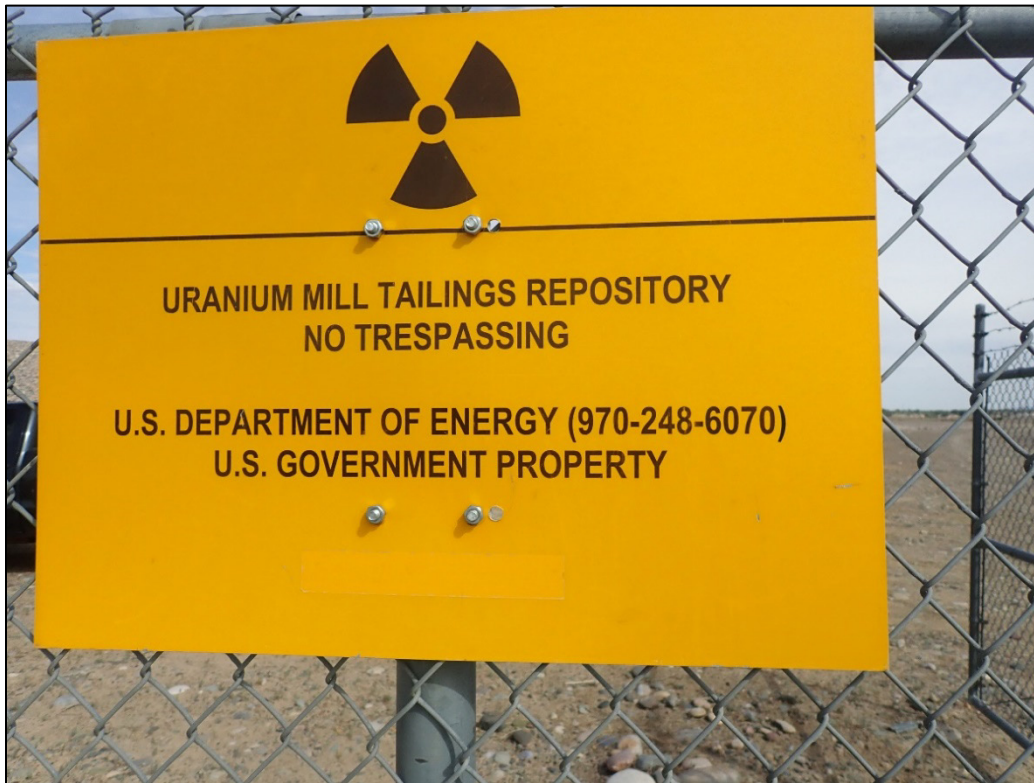
PL-1. Perimeter Sign P3

A chainlink perimeter fence encloses the disposal cell and drainage features. Regular maintenance to keep the perimeter fence free of trash, tumbleweeds, and other debris is ongoing. Seventeen pairs of perimeter signs, designated P1 through P17 (each pair consisting of one pictorial and one textual sign), are positioned along the perimeter fence¹ (PL-1). Perimeter sign P10 is beginning to crack and perimeter sign P14's radiation symbol is faded. Cracked signs and signs with faded symbols will be replaced before the next inspection. No other maintenance needs were identified.

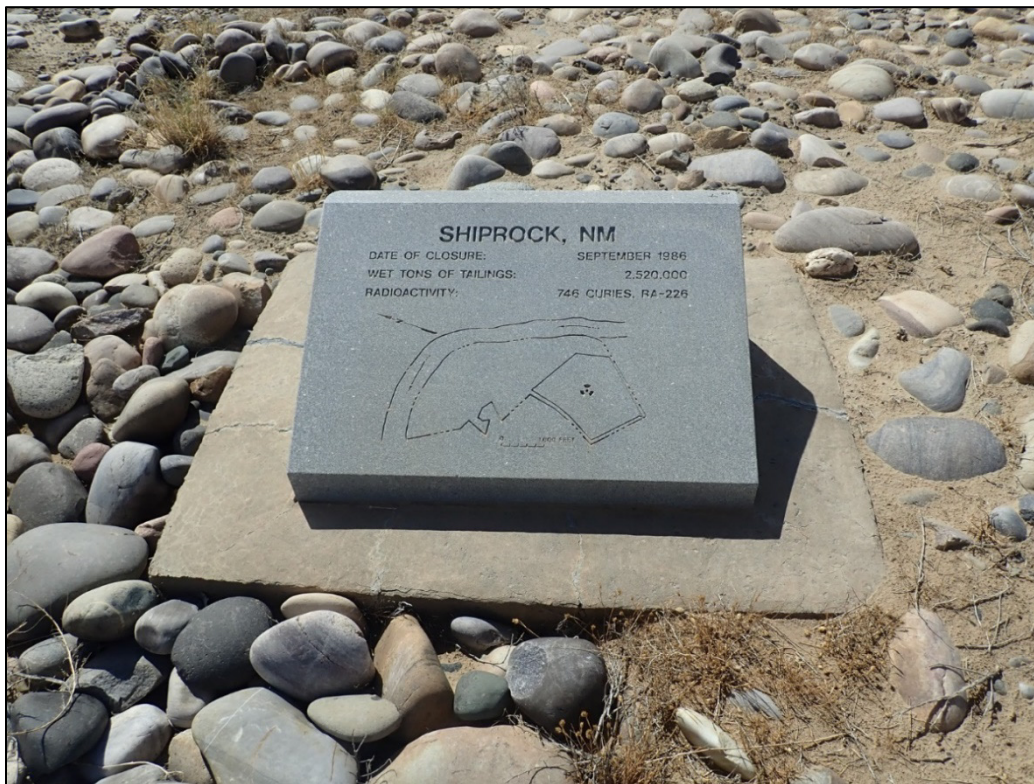
PL-2. Site Marker SMK-1

The site has two granite site markers. Site marker SMK-1 is just inside the west gate and contains minor cracks in its concrete base. Although the cracks were sealed in 2018, they are beginning to open and will be repaired before the next inspection (PL-2). Site marker SMK-2 is on the top slope of the disposal cell and is stable and legible (PL-3). No other maintenance needs were identified.

- Replacing faded pictorial signs and updating information on perimeter signs
- Continuing to remove trash and debris (including tumbleweeds) along the perimeter fence
- Sealing the cracks and repairing erosion at the base of site marker SMK-1
- Treating deep-rooted woody shrubs on the top and side slopes of the disposal cell
- Assessing torn areas in the erosion control fabric on the northwest end of the outflow channel

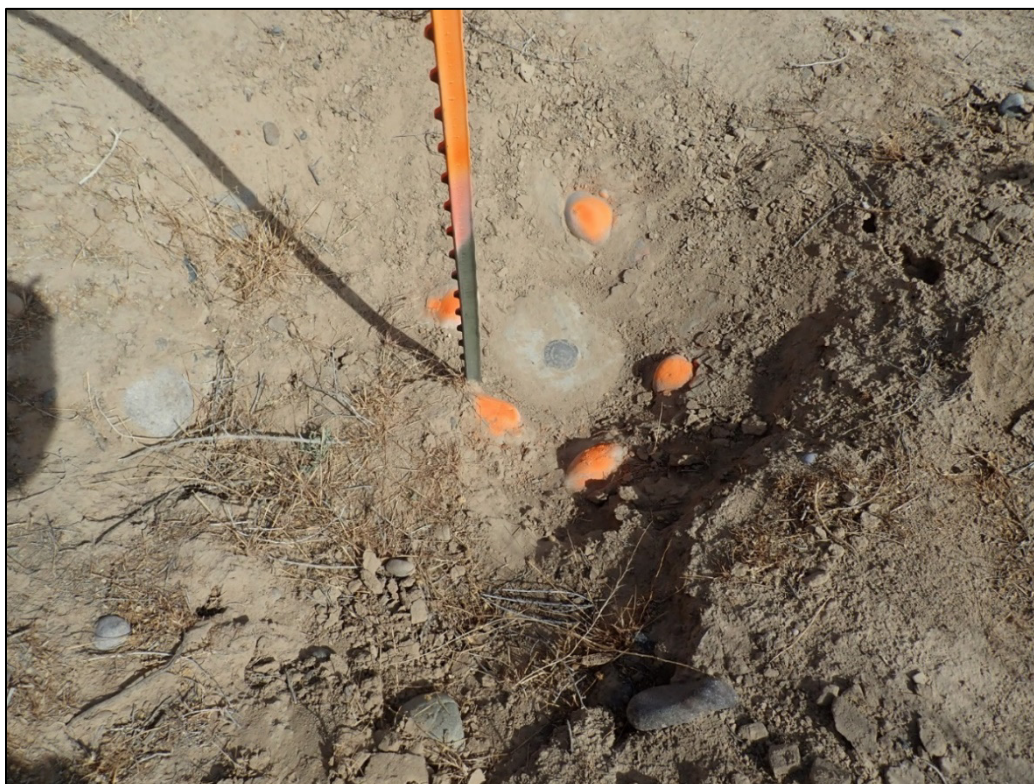
PL-4. Boundary Monument BM-5

Three survey monuments and six boundary monuments delineate the property boundary. Two additional boundary monuments are offsite; monitoring of these offsite monuments was discontinued in 2003. In 2002, boundary monument BM-1 was destroyed or removed by an adjacent landowner. It was replaced, and two reference monuments (RM-1 and RM-2) were installed next to it in 2003. Steel T-posts were installed next to all boundary monuments, as well as spray-painted rocks, to make them more visible and help inspectors locate them. The concrete at survey monument SM-1 is cracked, and the sides eroded. This will be repaired before the next inspection. All survey and boundary monuments were observed to be clear of vegetation and were either visible or uncovered with a shovel (PL-4) during the 2022 inspection. No other maintenance needs were identified.

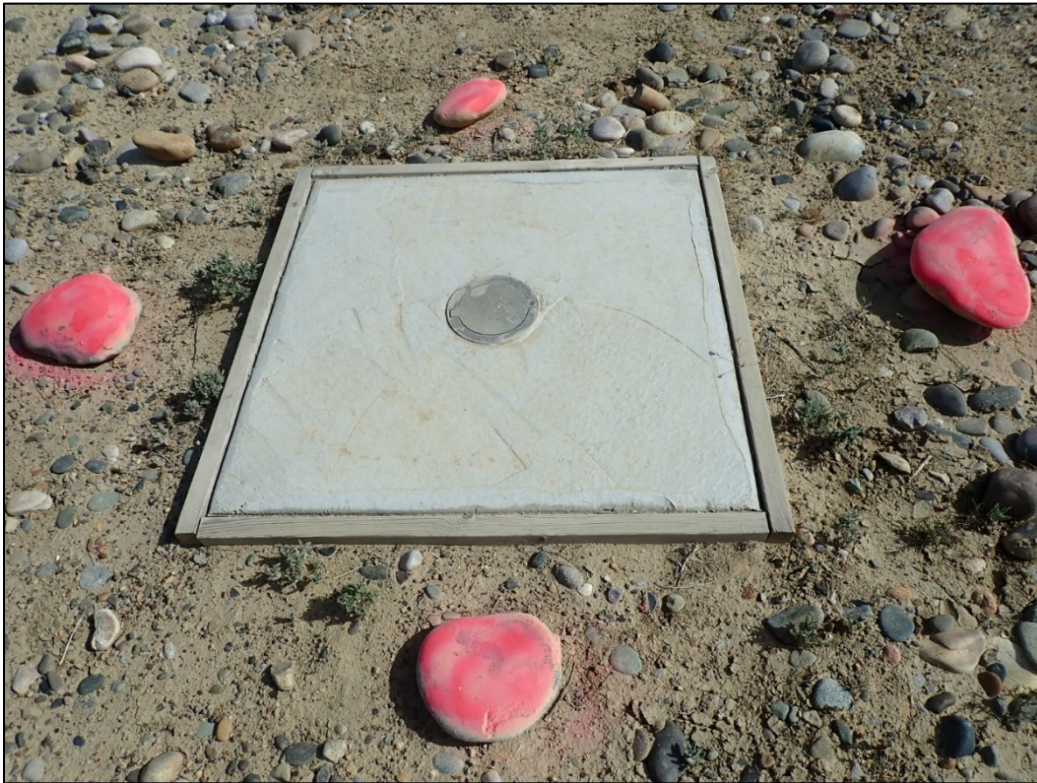
PL-5. Aerial Survey Quality Control Monument QC-2

Two aerial survey quality control monuments are present at the site and were inspected during the 2022 annual inspection (PL-5). No maintenance needs were identified.

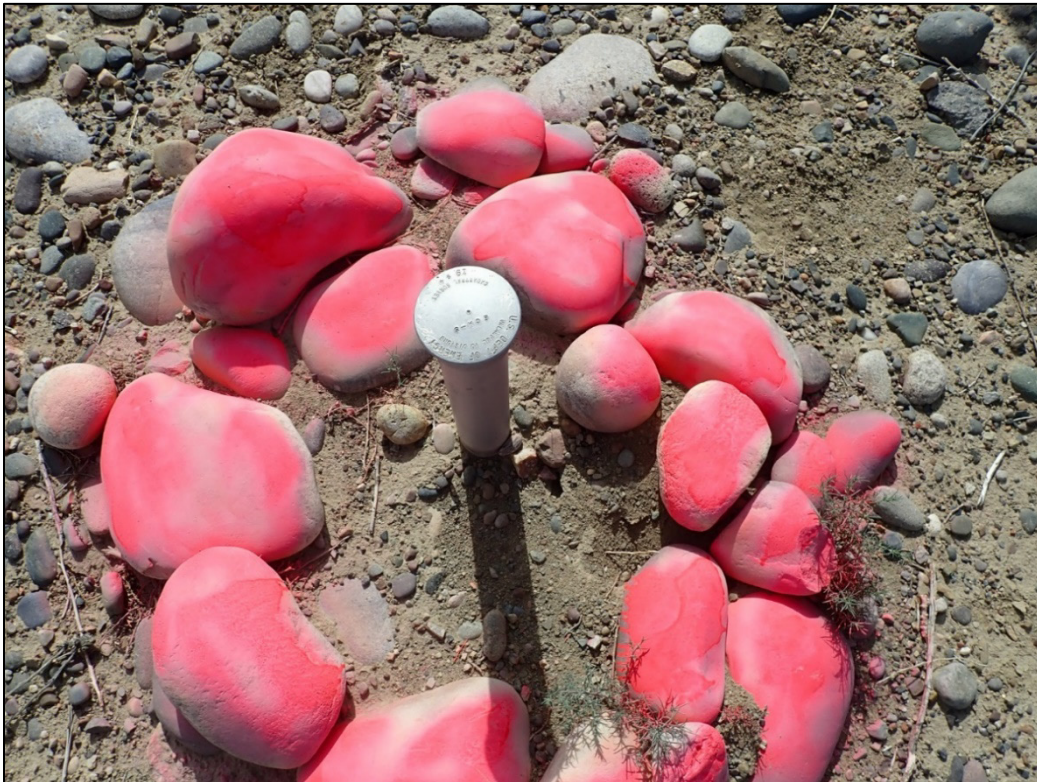
PL-6. Erosion Control Marker ECM-5

The site has pairs of erosion control markers (1/1A, 2/2A, 3/3A, and 5/5A) (PL-6) along the edge of the terrace escarpment. Erosion control markers 4 and 4A are not inspected; they were installed on the terrace east of the site in the gravel pit. Erosion control marker 5A, which is near the east entrance gate, was previously bent by a vehicle, but it is functional and does not require repair. No maintenance needs were identified.

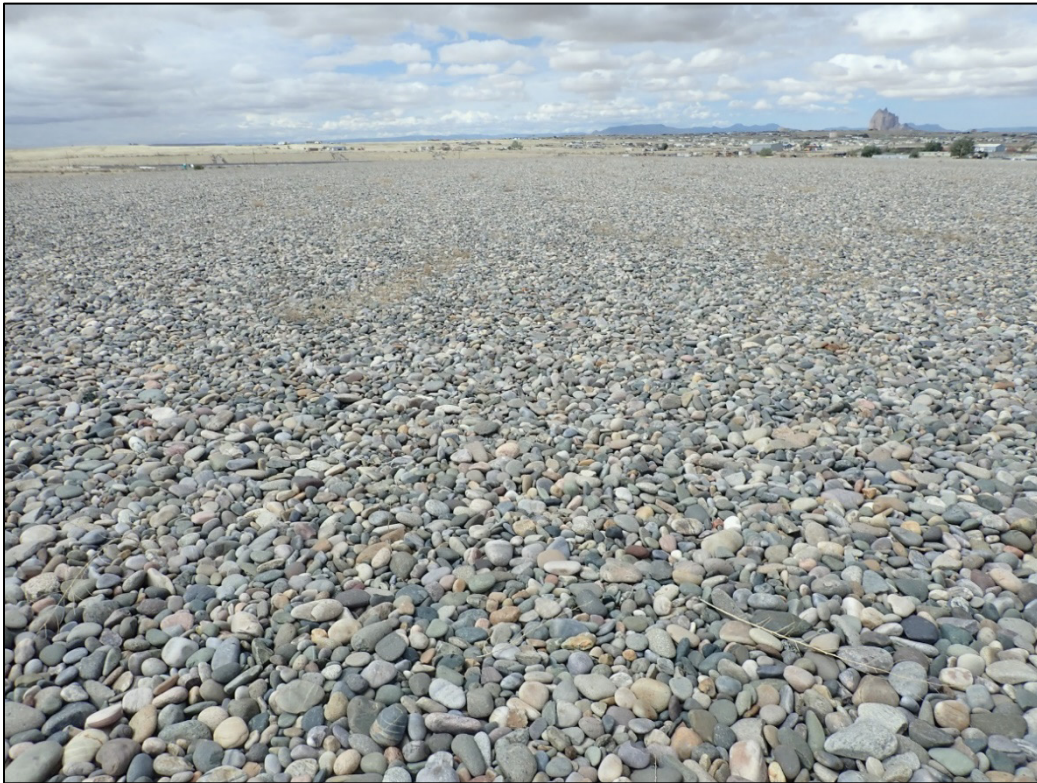
PL-7. Top Slope of Disposal Cell

The disposal cell, completed in 1986, occupies 77 acres and is armored in riprap to control erosion and deter animal and human intrusion. There was no evidence of erosion, settling,

slumping, rock degradation, or other modifying processes that might affect the integrity of the disposal cell (PL-7). Piezocones installed on the disposal cell cover that were associated with a research project are no longer in use. Some of the filled piezocone pits have subsided slightly or were never completely backfilled, which resulted in shallow conical depressions in the cover. As reported in previous site inspection reports, the surface of the disposal cell has numerous ruts associated with past vehicle traffic. An area where smaller riprap is exposed along the northern ridge of the disposal cell is monitored each year to detect possible changes that might indicate erosion or degradation of the cover. The inspectors observed no changes in this area in 2022. The condition of other depressions and vehicle ruts is monitored annually and has not changed significantly since the 2014 inspection.

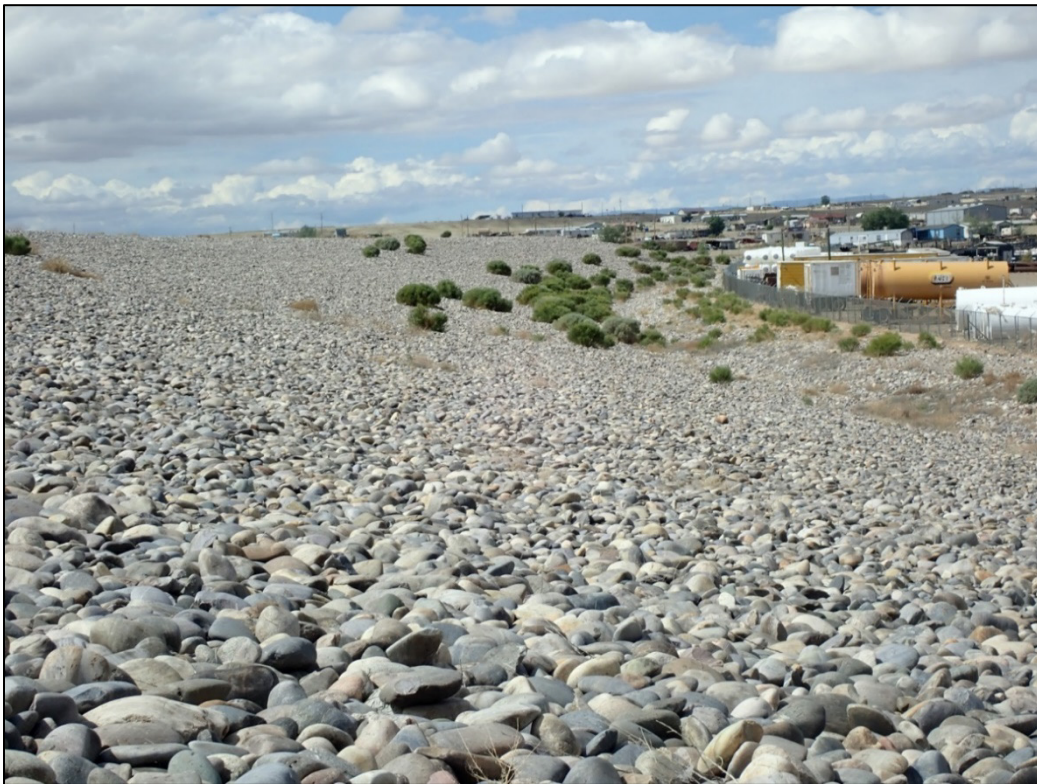
PL-8. West Side Slope of Disposal Cell

Windblown sediment has accumulated in the rock cover in several places. In accordance with the LTSP, woody, deep-rooted shrubs are controlled. Several woody shrubs were found on the top and side slopes of the disposal cell and will be treated before the next inspection (PL-8).

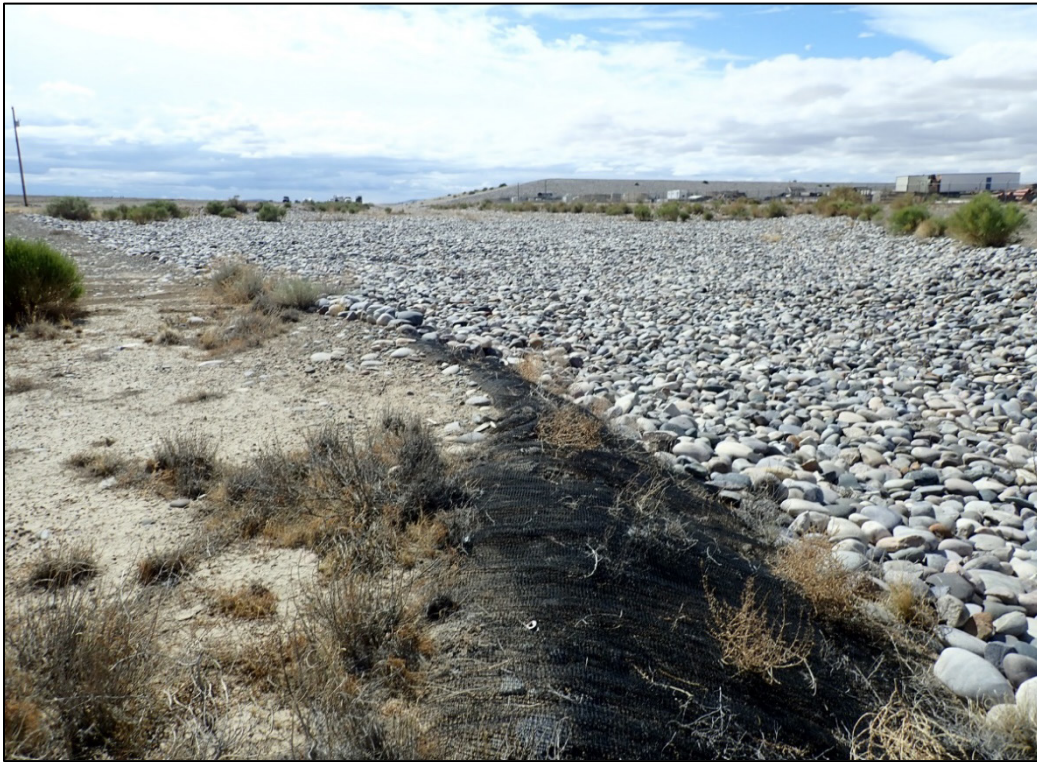
PL-9. Northwest Drainage Channel

Diversion channels around the base of the disposal cell contained scattered vegetation, including several woody shrubs. The channel along the southwestern side of the disposal cell has accumulated sediment, and a significant amount of vegetation has grown. Inspectors noted that nonwoody plants were growing within the outflow channel, and woody vegetation was growing on the banks of the outflow channel (PL-9). Vegetation growth does not adversely affect the performance of any of these channels at this time and is not a concern; however, inspectors will continue to monitor this area. No other maintenance needs were identified.

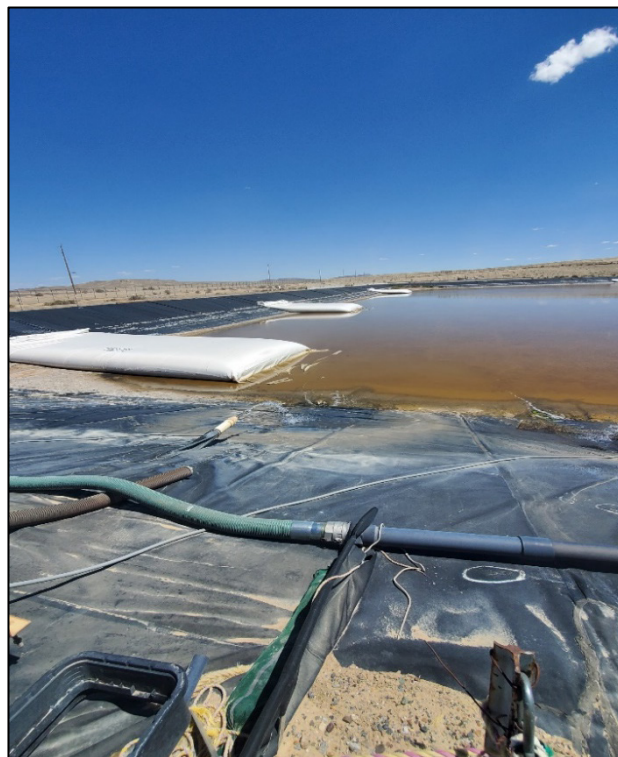
In 2002, LM constructed an 11-acre lined evaporation pond near the disposal cell as part of the groundwater compliance strategy. The pond, surrounded by a chainlink security fence, is maintained under the groundwater compliance program. The security fence was intact and functional at the time of the inspection. A pond liner leak test showed that the liner has five locations where liner performance has been compromised due to the age of the liner, resulting in breaches from pin sized holes to ½". To mitigate seepage from the pond at these locations LM

place five water-filled hydrologic barriers over the areas in question. The hydrologic barriers function as pressure patches to eliminate unplanned seepage. A quarterly pond liner inspection is conducted by a geotechnical engineer to identify any other potential issues that may arise. Water levels are monitored during the work week to determine whether any actions need to be taken (PL-10).

PL-10. Evaporation Pond with Hydrologic Barriers Deployed to Mitigate Seepage
