16.0 Shiprock, New Mexico, Disposal Site

16.1 Compliance Summary

The Shiprock, New Mexico, Uranium Mill Tailings Radiation Control Act (UMTRCA) Title I Disposal Site was inspected on June 21, 2023. No changes were observed on the disposal cell or in the associated diversion channels. Inspectors identified several minor maintenance needs but found no cause for a follow-up inspection. Groundwater monitoring to evaluate disposal cell performance is not required.

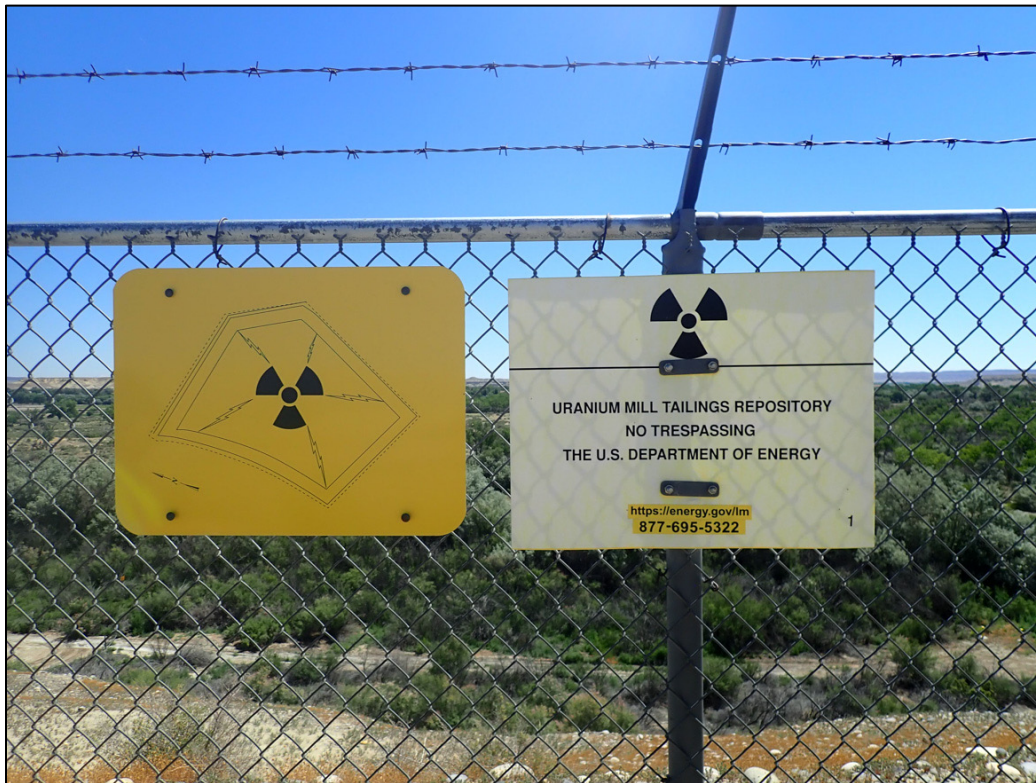
A chainlink perimeter fence encloses the disposal cell and drainage features. Regular maintenance to keep the perimeter fence free of trash, tumbleweeds, and other debris is ongoing. Seventeen pairs of perimeter signs, designated P1 through P17 (each pair consisting of one pictorial and one textual sign), are positioned along the perimeter fence¹ (PL-1). Perimeter sign P10 was replaced after the inspection. The radiation symbol on perimeter sign P14 needs to be replaced. Cracked signs and signs with faded symbols will be replaced before the next inspection. No other maintenance needs were identified.

PL-1. Perimeter Sign P1

- Replacing faded pictorial signs and updating information on perimeter signs

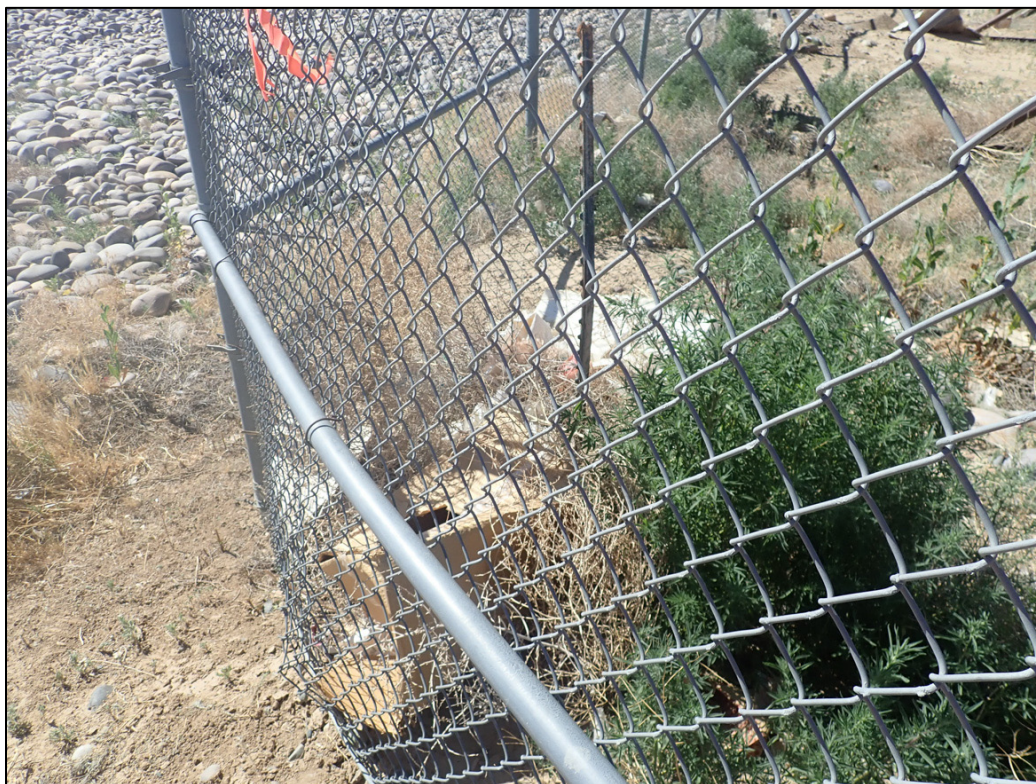
Three survey monuments and six boundary monuments delineate the property boundary. Two additional boundary monuments are offsite; monitoring of these offsite monuments was discontinued in 2003. In 2002, boundary monument BM-1 was destroyed or removed by an adjacent landowner. It was replaced, and two reference monuments (RM-1 and RM-2) were installed next to it in 2003. Steel T-posts were installed next to all boundary monuments, as well as spray-painted rocks, to make them more visible and help inspectors locate them. The concrete at survey monument SM-1 was repaired. All survey and most boundary monuments were observed to be clear of vegetation and trash. Boundary monument BM-2 was cleared of vegetation and trash following the inspection (PL-2). No other maintenance needs were identified.

PL-2. Boundary Monument BM-2 with Vegetation and Trash

- Boundary monument BM-2 cleared of vegetation and trash

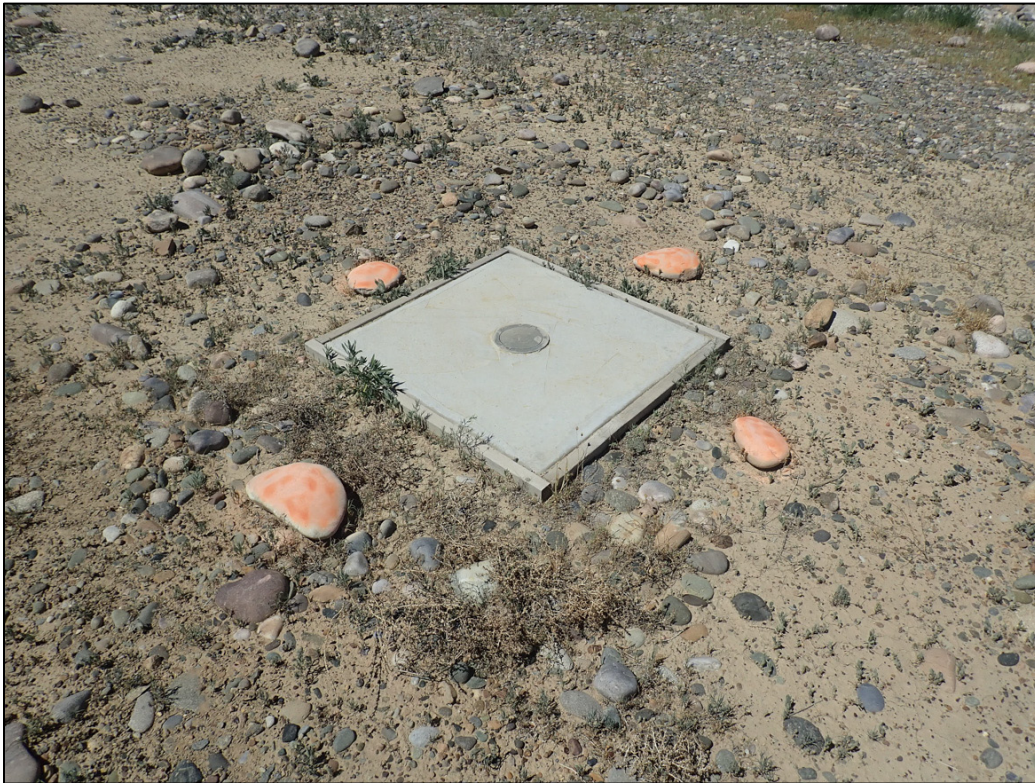
Two aerial survey quality control monuments are present at the site and were inspected during the 2023 annual inspection (PL-3). No maintenance needs were identified.

PL-3. Quality Control Monument QC-2

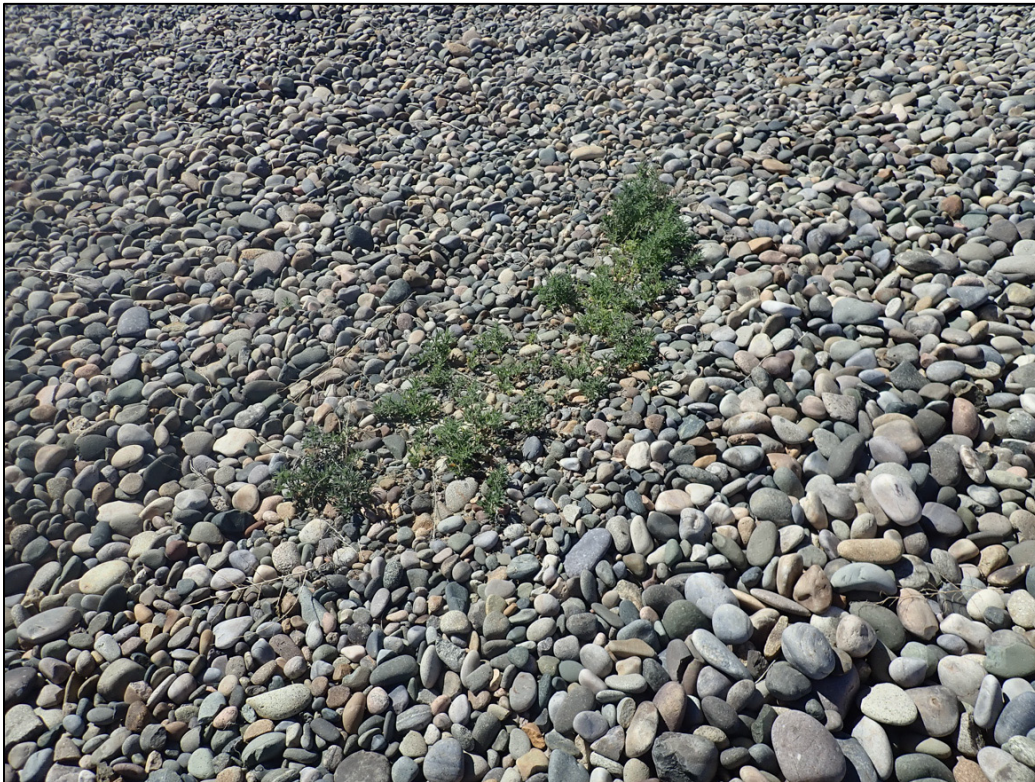
slumping, rock degradation, or other modifying processes that might affect the integrity of the disposal cell. Piezocones installed on the disposal cell cover that were associated with a research project are no longer in use. Some of the filled piezocone pits have subsided slightly or were never completely backfilled, which resulted in shallow conical depressions in the cover. As reported in previous site inspection reports, the surface of the disposal cell has numerous ruts associated with past vehicle traffic. An area where smaller riprap is exposed along the northern ridge of the disposal cell is monitored each year to detect possible changes that might indicate erosion or degradation of the cover (PL-4). The inspectors observed no changes in this area in 2023. The condition of other depressions and vehicle ruts is monitored annually and has not changed significantly since the 2014 inspection.

PL-4. Smaller Riprap Exposed Along Northern Ridge of Disposal Cell Top Slope

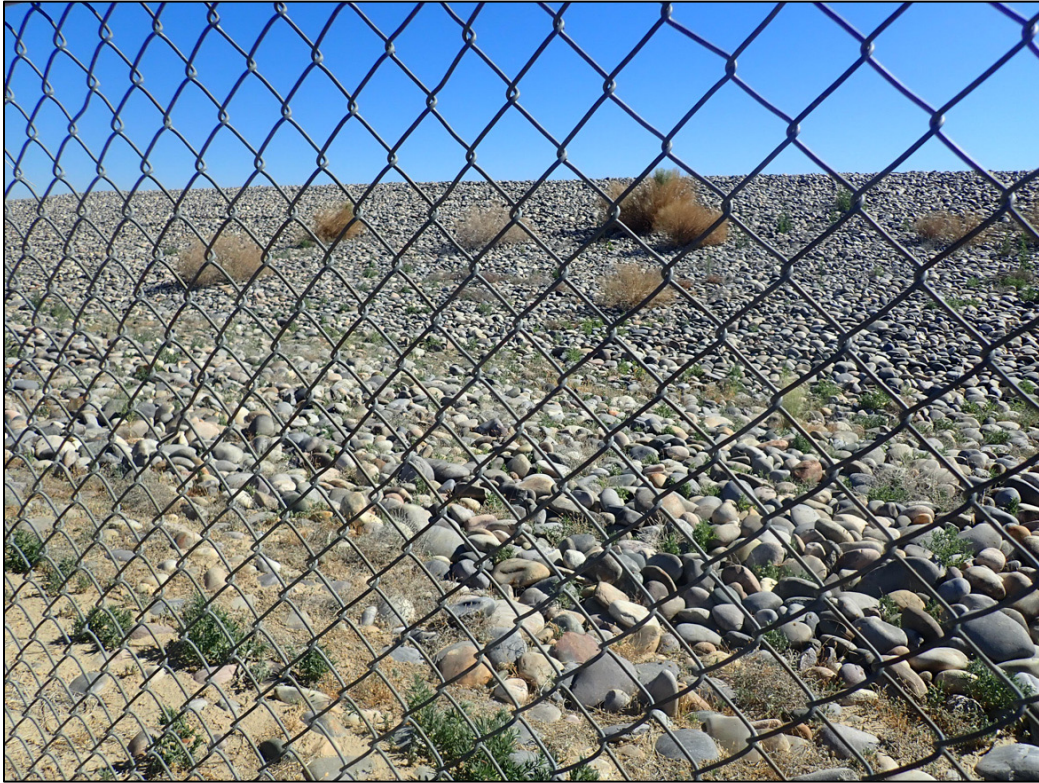
Windblown sediment has accumulated in the rock cover in several places. In accordance with the LTSP, woody, deep-rooted shrubs are controlled. Several woody shrubs found on the top and side slopes of the disposal cell were treated (PL-5).

PL-5. Treated Vegetation on Side Slope

- Continuing to remove trash and debris (including tumbleweeds) along the perimeter fence
- Treating deep-rooted woody shrubs on the top and side slopes of the disposal cell

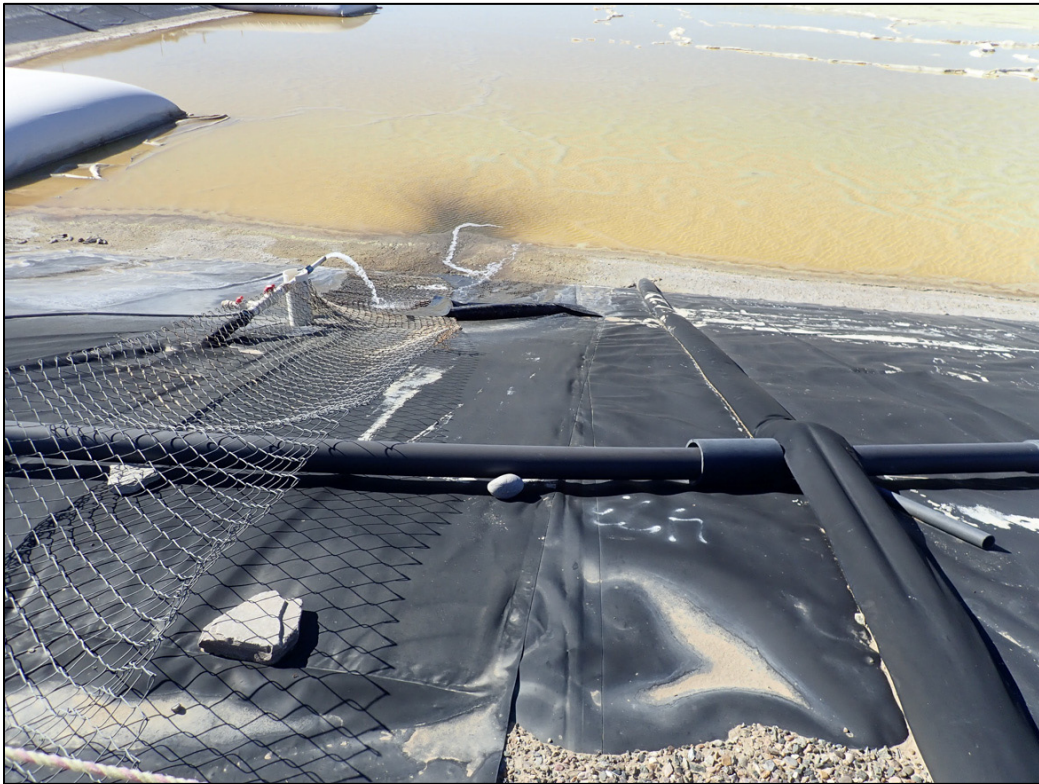
In 2002, LM constructed an 11-acre lined evaporation pond near the disposal cell as part of the groundwater compliance strategy. The pond, surrounded by a chainlink security fence, is maintained under the groundwater compliance program. The security fence was intact and functional at the time of the inspection. A quarterly inspection of the pond liner is conducted by a geotechnical engineer to identify any other potential issues that may arise. Water levels are monitored during the workweek to determine whether any actions need to be taken (PL-6). Torn

PL-6. Evaporation Pond Liner

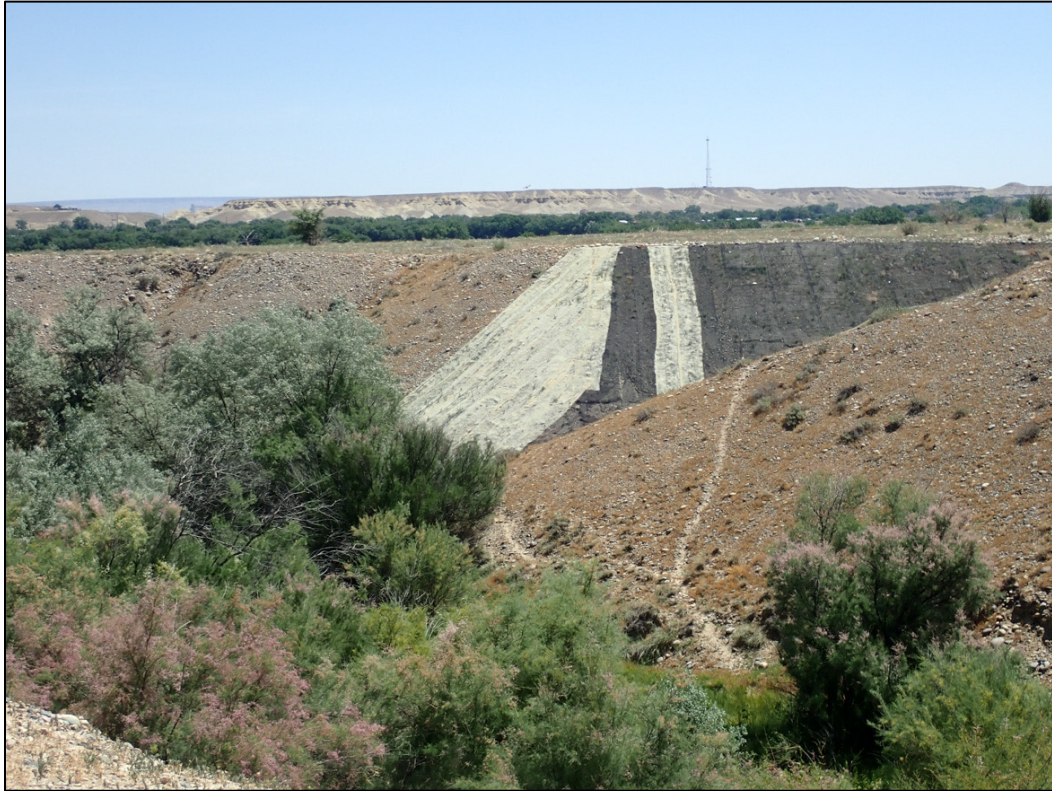
areas in the erosion control fabric on the banks of the lower outflow channel were repaired prior to the inspection (PL-7).

PL-7. Repaired Erosion Control Fabric
