## 16.0 Shiprock, New Mexico, Disposal Site

### 16.1 Compliance Summary

The Shiprock, New Mexico, Uranium Mill Tailings Radiation Control Act (UMTRCA) Title I Disposal Site was inspected on June 6, 2024. No changes were observed on the disposal cell or in the associated diversion channels. Inspectors identified several minor maintenance needs but found no cause for a follow-up inspection. Groundwater monitoring to evaluate the disposal cell performance is not required.

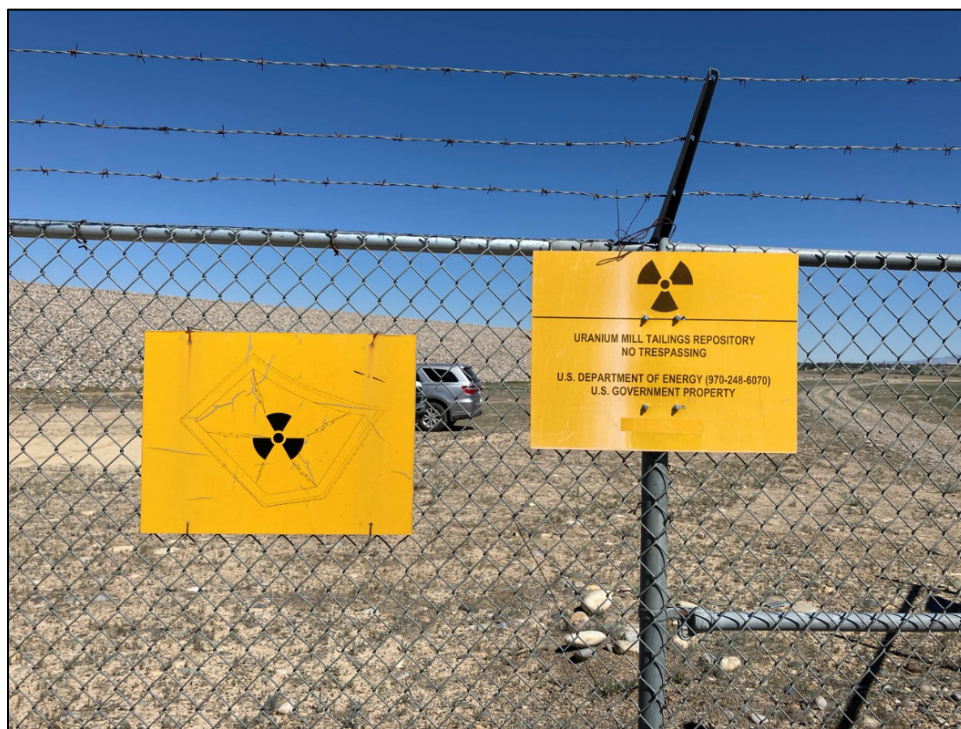
Access to the site is from a gravel road off U.S. Highway 491. Three gates allow access to the site through the perimeter fence: the east gate (the current main entrance gate near the terrace escarpment [PL-1]), the north gate (an auxiliary access gate to the floodplain area of site), and the west gate (the former main entrance gate). Access to the main entrance gate is on the road adjacent to the Navajo Engineering and Construction Authority (NECA) gravel pit. The three gates were locked and functional. Pairs of entrance signs—one pictorial and one textual—are present near each gate. One pair is present at the east and north gates, and two pairs are present at the west gate. Contact information on the evaporation pond entrance sign was verified and is up to date. No maintenance needs were identified.

*PL-1. Entrance Sign*

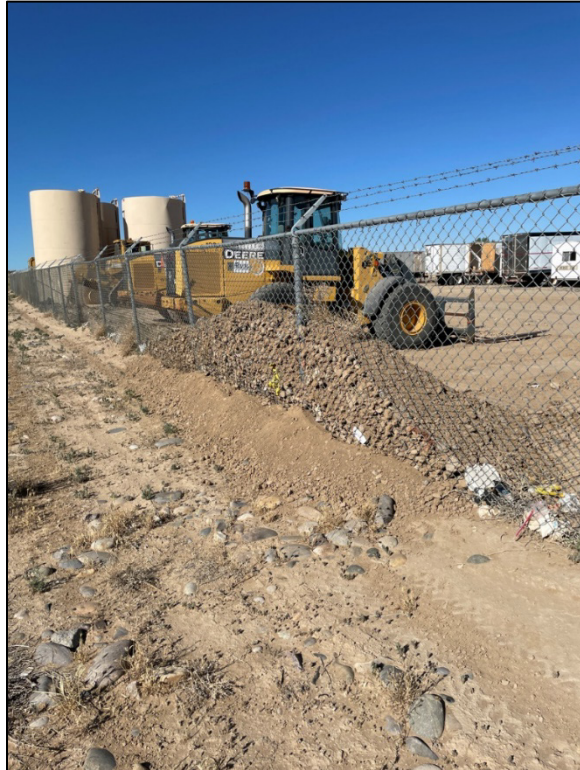
A chainlink perimeter fence encloses the disposal cell and drainage features. Regular maintenance is ongoing to keep the perimeter fence free of trash, tumbleweeds, and other debris. The northwestern fence that is shared between NECA and DOE had several dirt piles that had been pushed up on the fence from the NECA side (PL-2). At one point, the ground under the fence had eroded, creating a gap (PL-3), which will require maintenance.

*PL-2. Dirt Piled on Fence*

- Remove aerial survey quality control monuments targets
- Ask NECA to remove dirt pushed up on the fence
- Replace outflow channel erosion control matting
- Treat deep-rooted woody shrubs on the top and side slopes of the disposal cell
- Clean dirt off the top of boundary monument BM-3

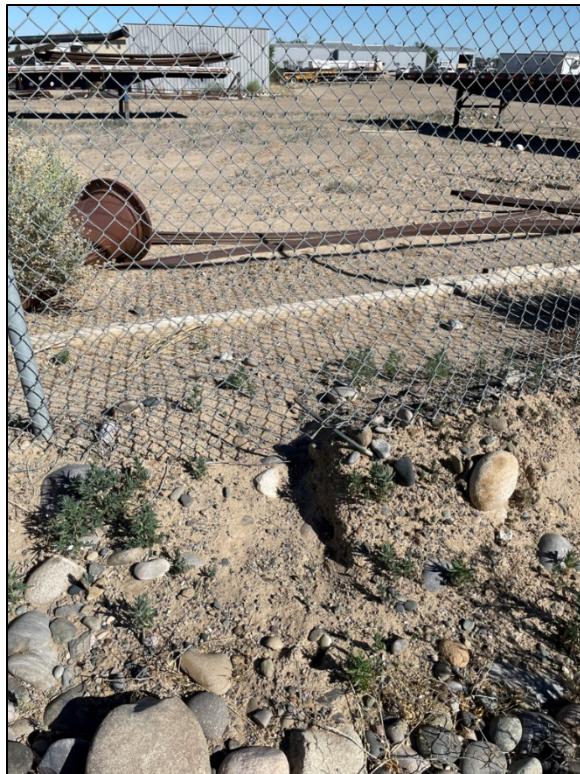
*PL-3. Gap Under Fence*

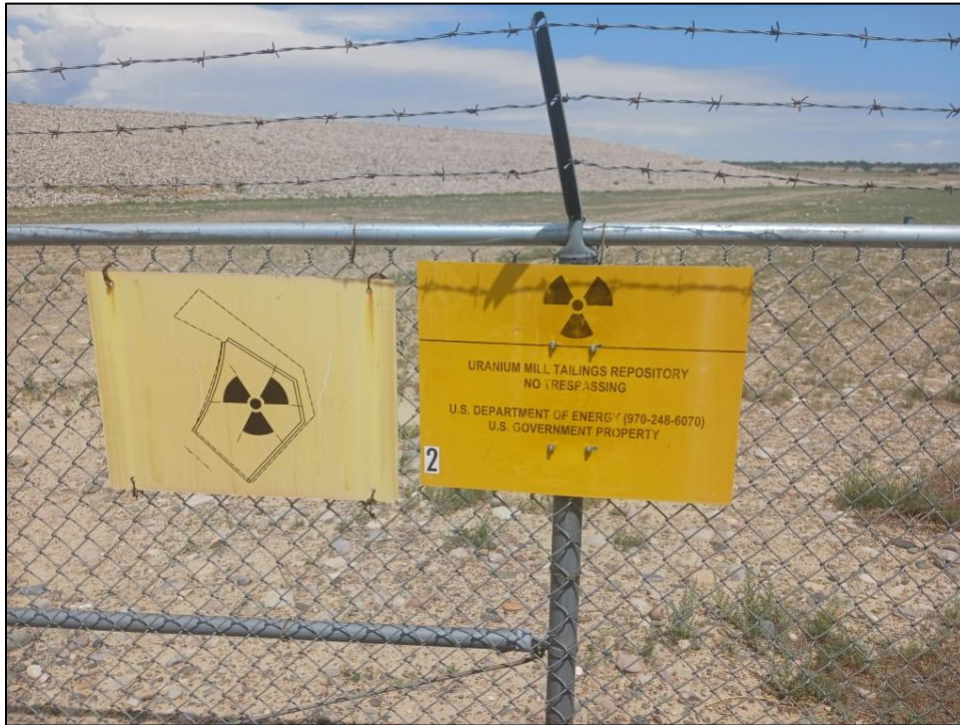
Seventeen pairs of perimeter signs, designated P1 through P17 (each pair consisting of one pictorial and one textual sign), are positioned along the perimeter fence<sup>1</sup> (PL-4). Perimeter sign P14, which was found faded during the 2023 inspection, was not able to be replaced due to

*PL-4. Perimeter Sign Pair*

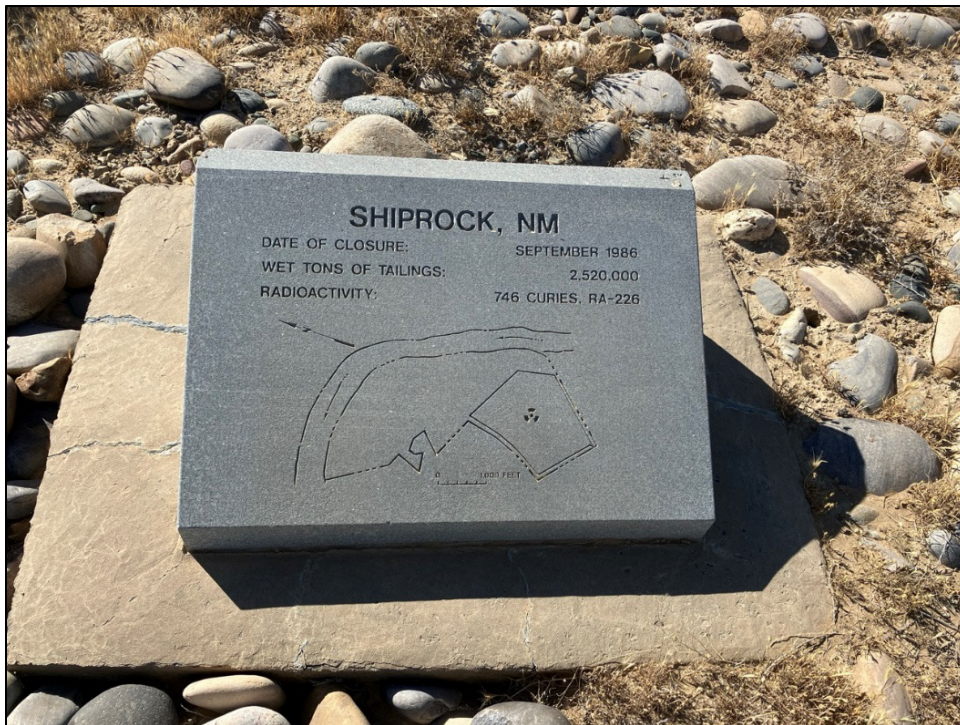
The site has two granite site markers. Site marker SMK-1 (PL-5) is just inside the west gate and contains minor cracks in its concrete base. Site marker SMK-1 cracks were sealed in 2023. Site marker SMK-2 on the top slope of the disposal cell is stable and legible. No maintenance needs were identified.

*PL-5. Site Marker SMK-1*

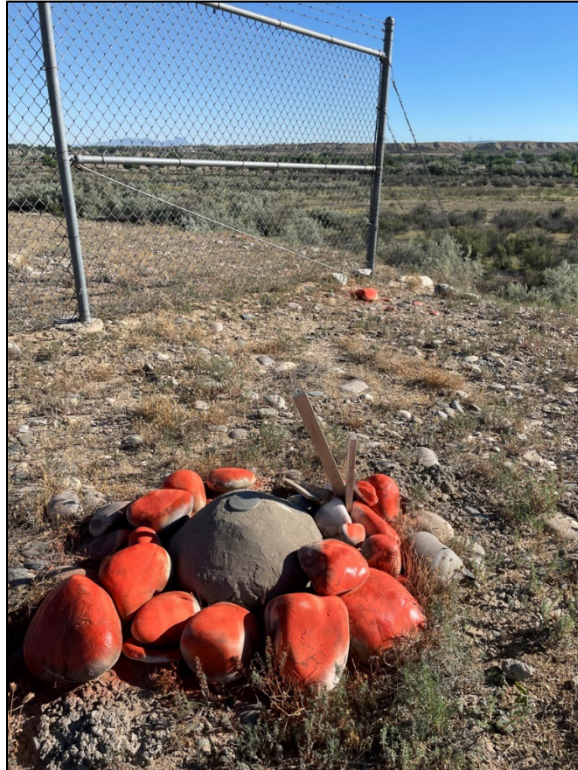
*PL-6. Survey Monument SM-1*

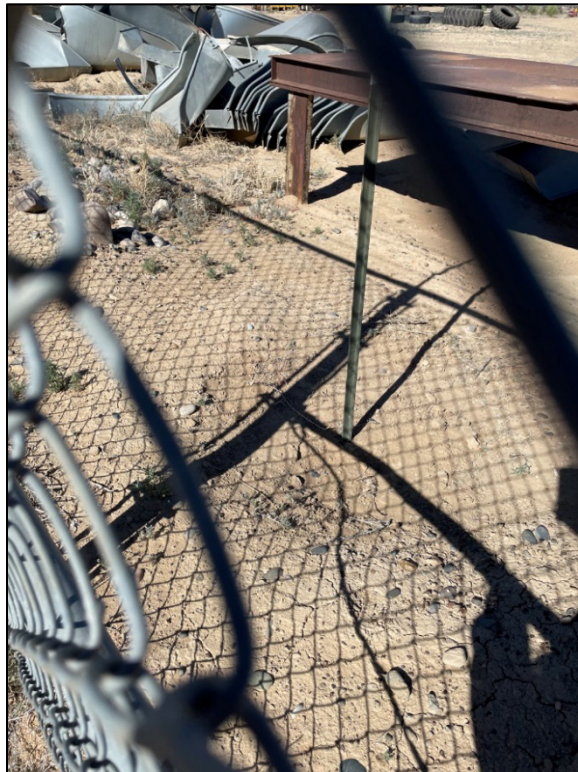
Three survey monuments and six boundary monuments delineate the property boundary. Two additional boundary monuments are offsite; monitoring of these offsite monuments was discontinued in 2003. In 2002, boundary monument BM-1 was destroyed or removed by an adjacent landowner. It was replaced, and two reference monuments (RM-1 and RM-2) were installed next to it in 2003. Steel T-posts were installed next to all boundary monuments, as well as spray-painted rocks, to make them more visible and help inspectors locate them. The concrete at survey monument SM-1 (PL-6) was repaired. All survey and most boundary monuments were observed to be clear of vegetation and trash. Boundary monument BM-3 needs to have accumulated dirt cleaned off the top (PL-7). Boundary monument BM-2 was cleared of vegetation and trash following the inspection. No other maintenance needs were identified.

*PL-7. Boundary Monument BM-3 (Covered with Rocks)*

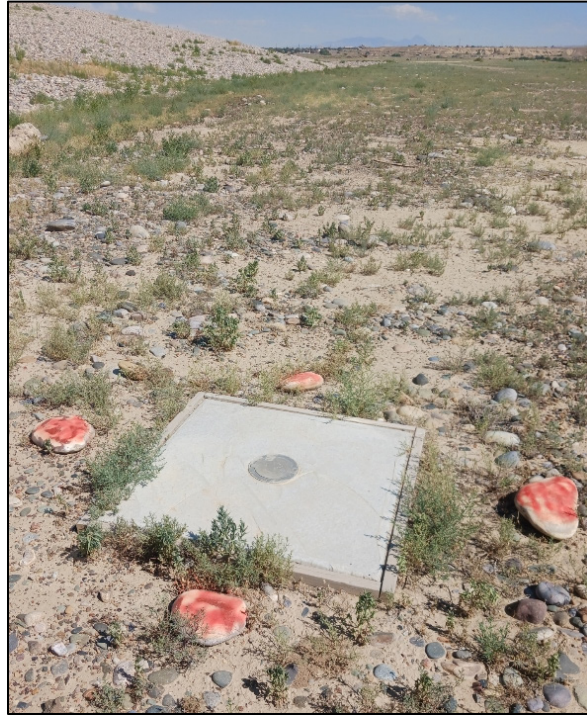
Two aerial survey quality control monuments (PL-8) are present at the site and were inspected during the 2024 annual inspection. Two aerial targets located at the site were identified as not needed and will be removed before the next annual inspection (PL-9).

*PL-8. Quality Control Monument QC-2*

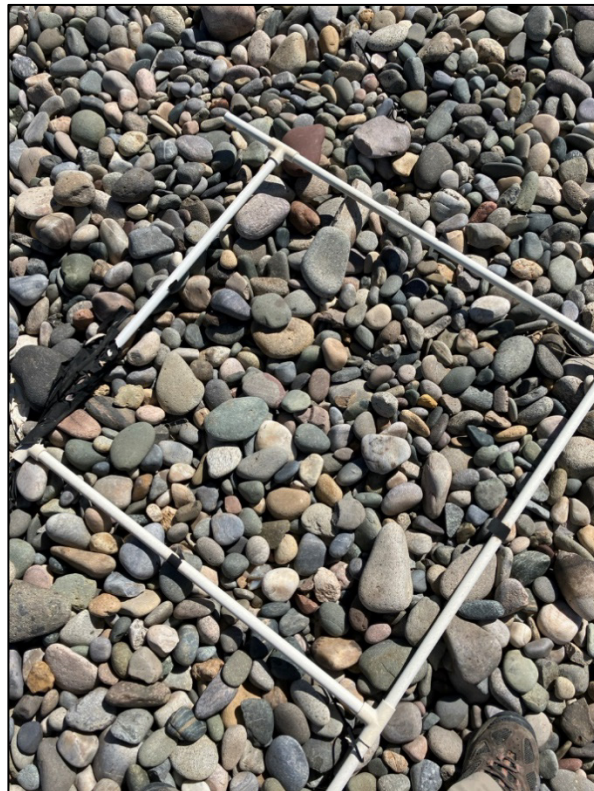
*PL-9. Aerial Survey Targets*

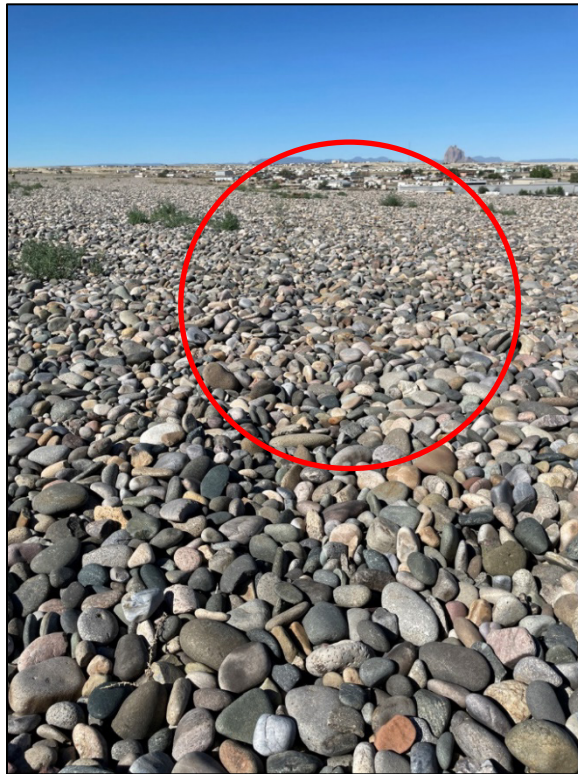
The disposal cell, completed in 1986, occupies 77 acres and is armored in riprap to control erosion and deter animal and human intrusion. There was no evidence of erosion, settling, slumping, rock degradation, or other modifying processes that might affect the integrity of the disposal cell. Piezocones installed on the disposal cell cover that were associated with a research project are no longer in use. Some of the filled piezocone pits have subsided slightly or were never completely backfilled, which resulted in shallow conical depressions on the cover. As reported in previous site inspection reports, the surface of the disposal cell has numerous ruts associated with past vehicle traffic (PL-11). An area where smaller riprap is exposed along the northern ridge of the disposal cell is monitored each year to detect possible changes that might indicate erosion or degradation of the cover. The inspectors observed no changes in this area in 2024. The condition of other depressions and vehicle ruts is monitored annually and has not changed significantly since the 2014 inspection.

*PL-11. Vehicle Ruts*

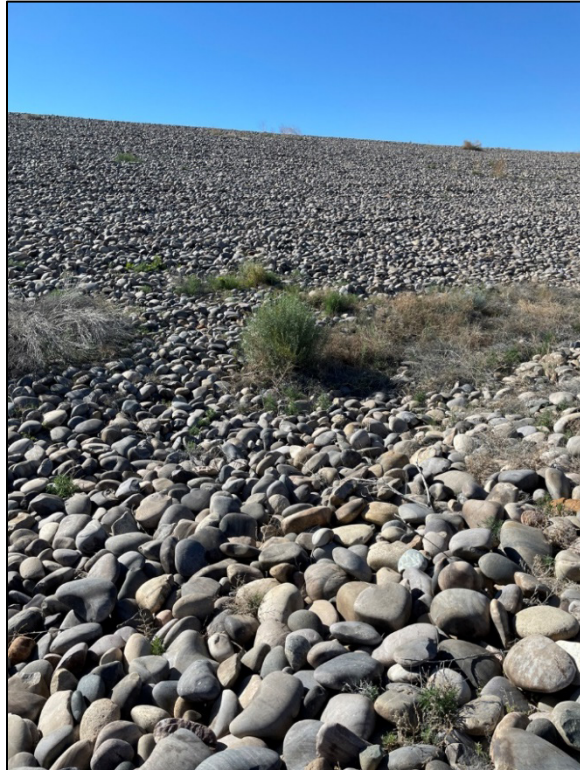
Windblown sediment has accumulated in the rock cover in several places. Woody, deep-rooted shrubs are controlled in accordance with the LTSP. Several woody shrubs found on the top and side slopes of the disposal cell were treated (PL-12).

*PL-12. Woody Shrubs*

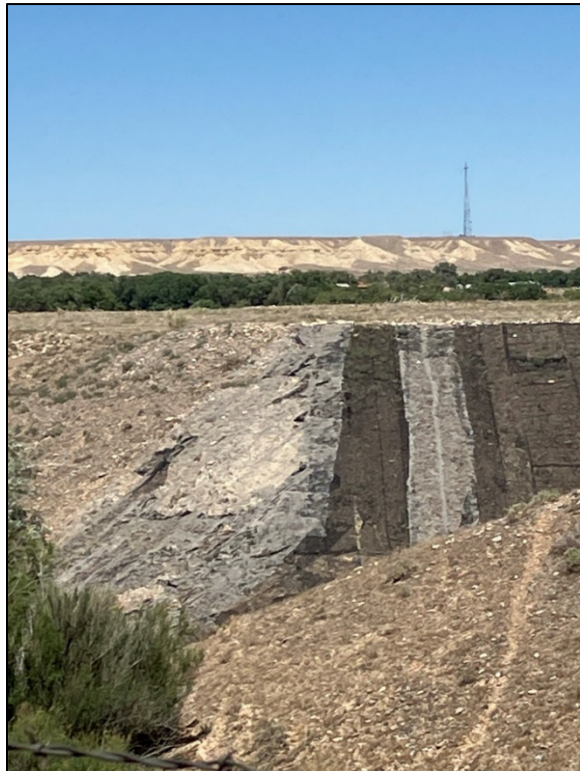
The erosion control fabric on the outflow channel has deteriorated to the point that it needs to be repaired (PL-13).

*PL-13. Deteriorated Fabric in Outflow Channel*
