Department of Energy  
Office of Legacy Management

SUBJECT: Status Report of Steps Taken Regarding Monitoring Results at Surface Water Point of Evaluation (POE) SW027

# **Report of Steps Taken Regarding Monitoring Results at Surface Water Point of Evaluation (POE) SW027**

## **August 31, 2010**

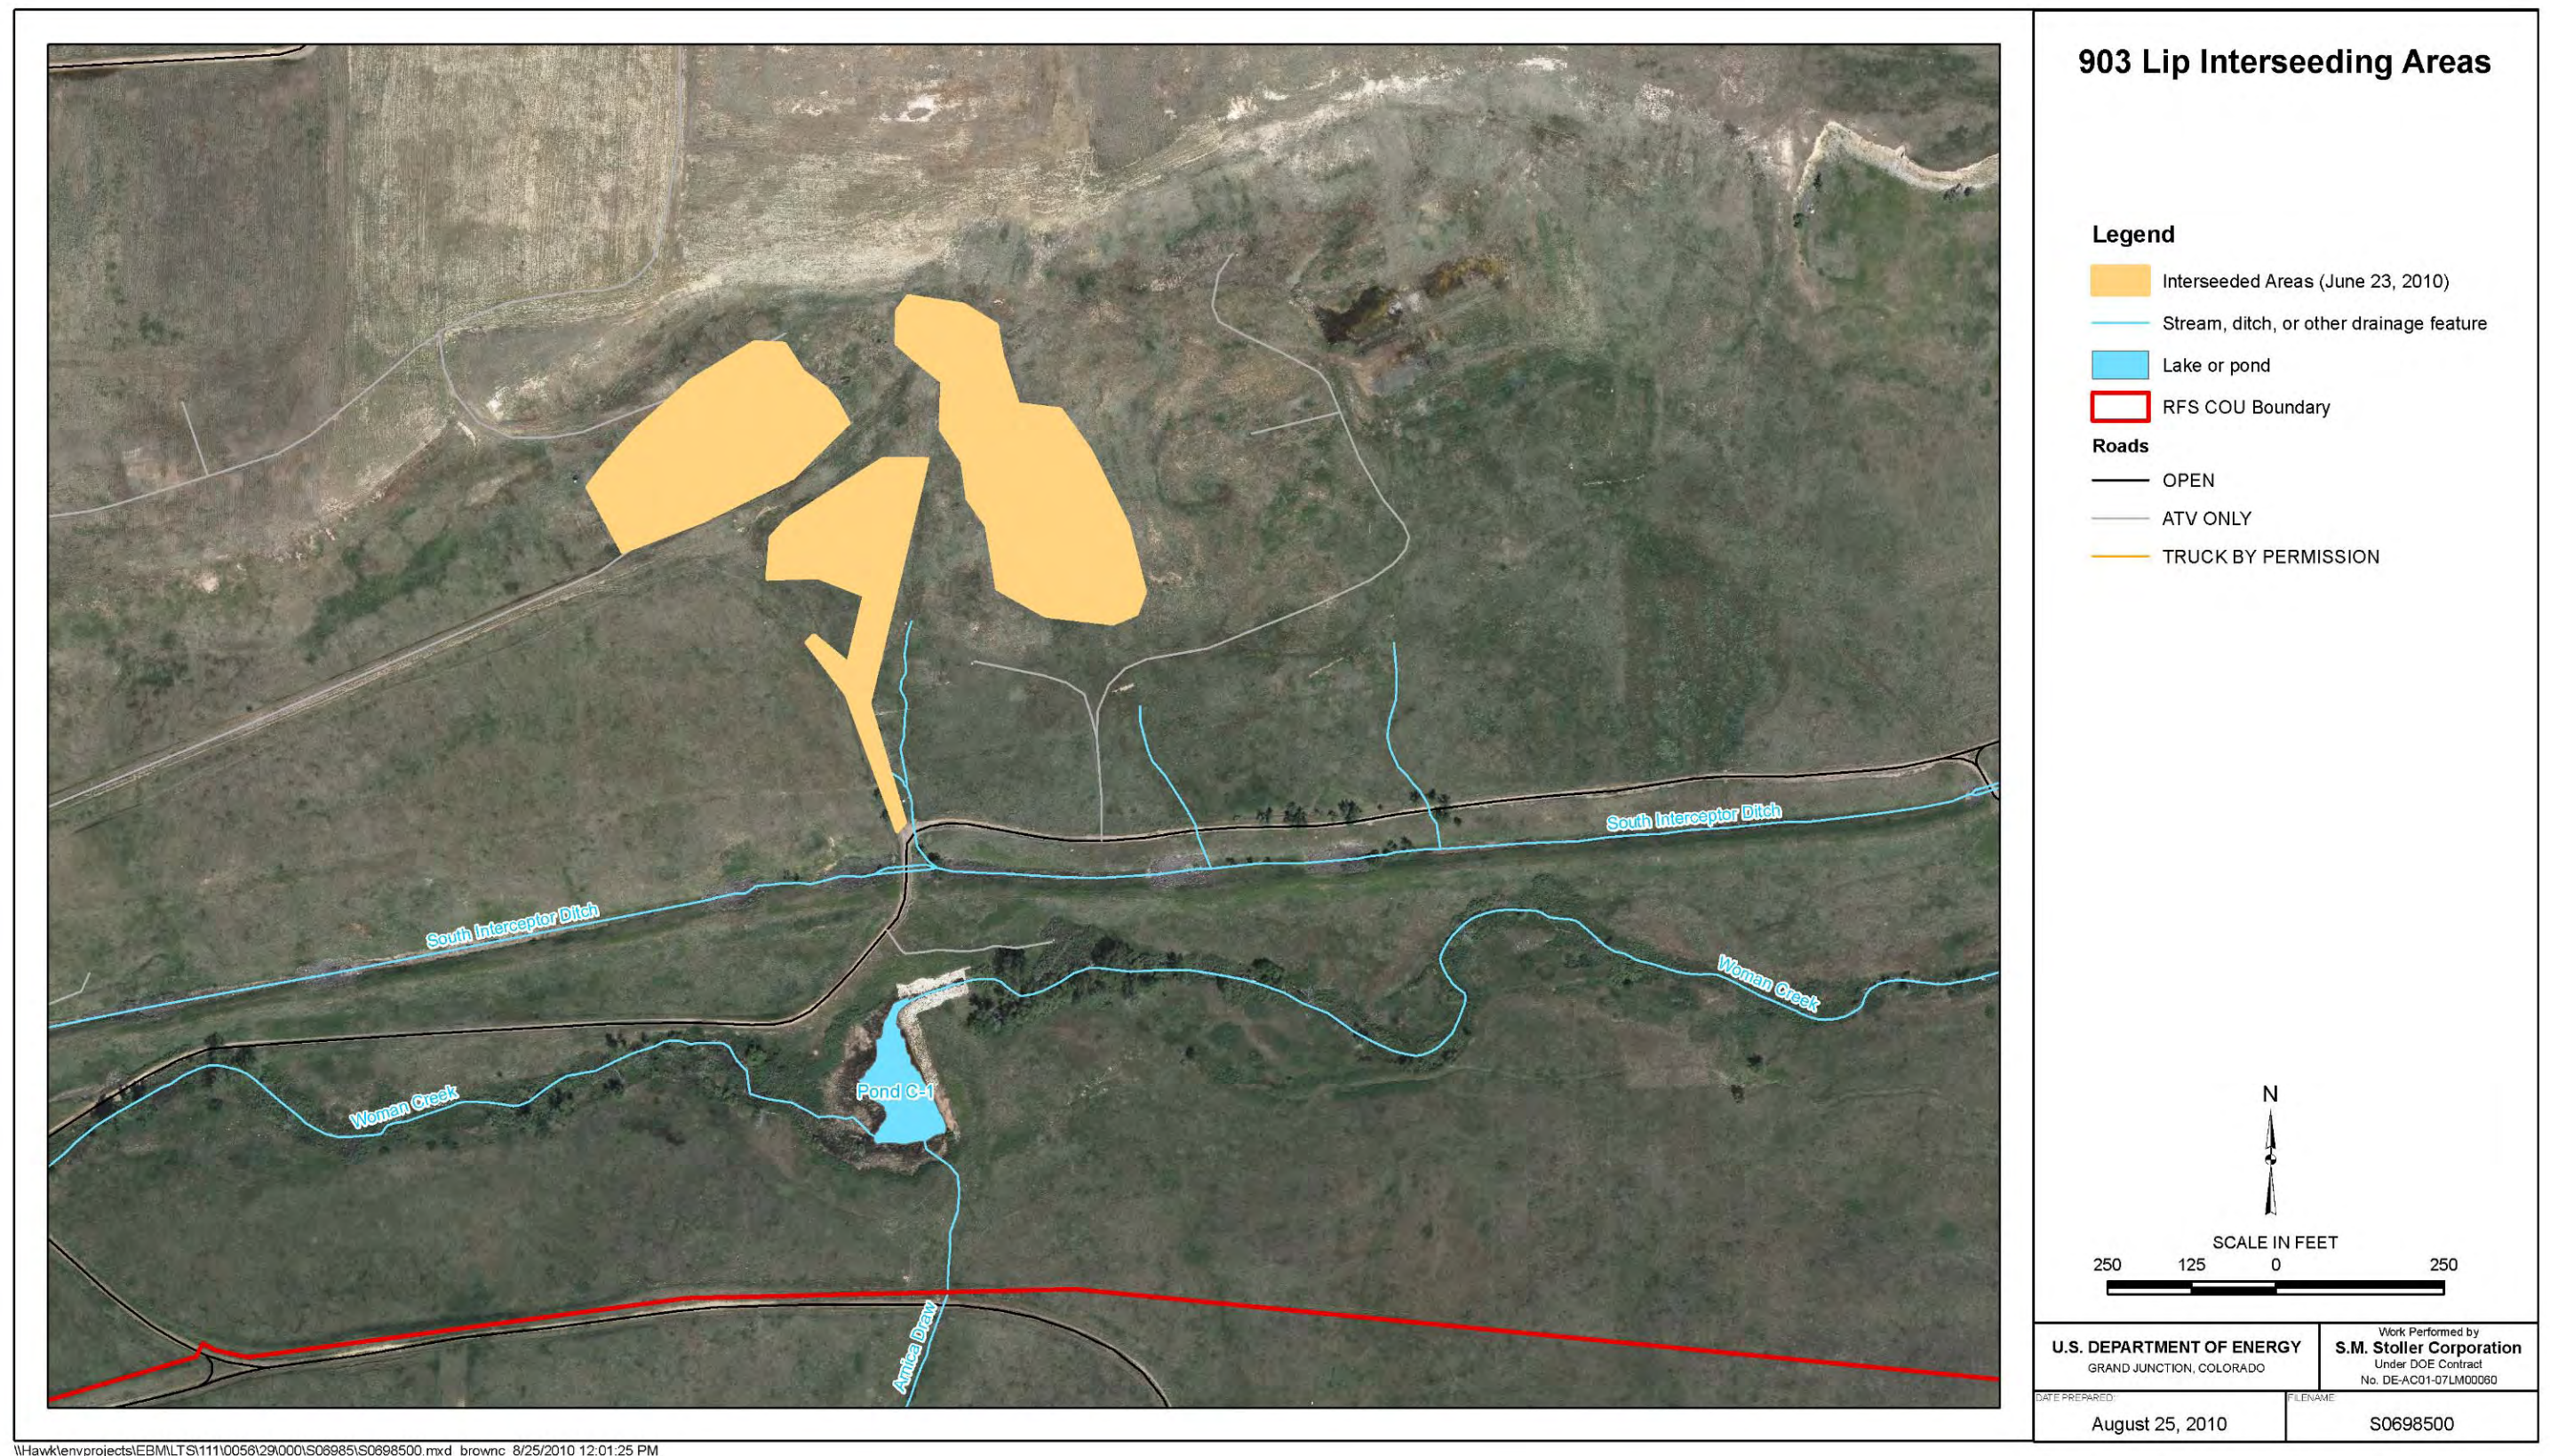
Figure 3. Interseeding Areas

Steps to improve vegetation cover will take time to be effective. Implementation of these steps began on June 23, 2010, when several areas were interseeded, as shown on Figure 3. Figure 4 shows potential locations for additional wattles.

- Install wattles as shown on Figure 3.

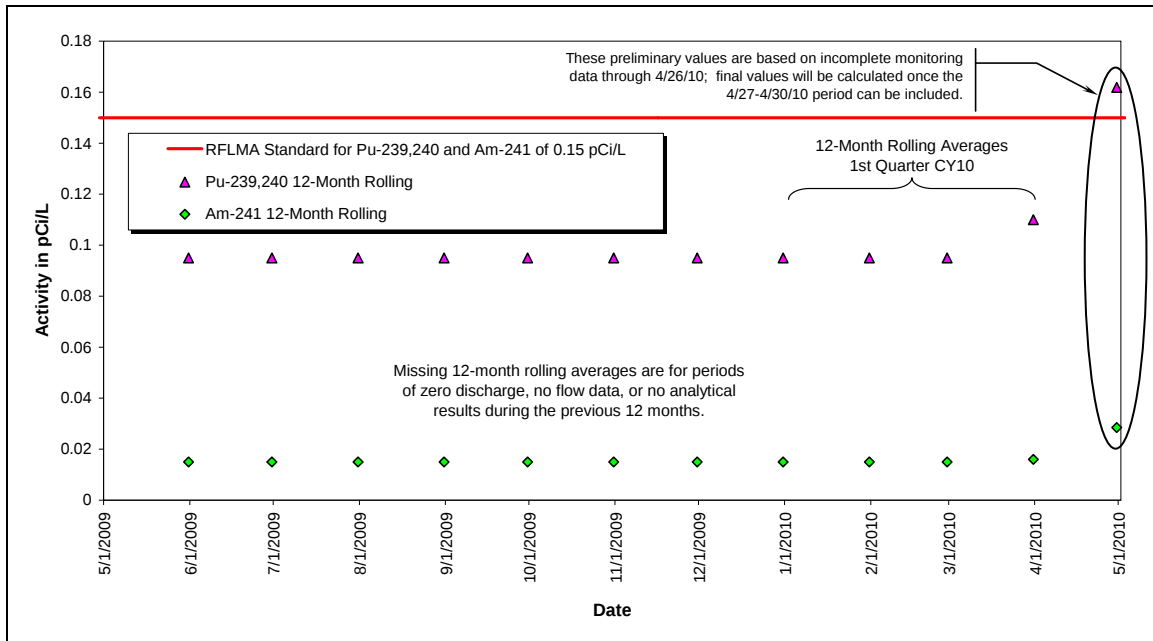
Figure 6. Data for SW027

Although there is normally no water flowing at SW027, heavy runoff during late April 2010 generated the two highest analytical results. Plutonium concentration in a subsequent sample collected April 26, 2010, was 0.029 pCi/L, which indicates that Pu levels have decreased. Sampling at SW027 is accomplished using automated samplers that collect continuous flow-paced composites; the composites are filled based on the availability of water flow. The SW027 composite that was started on April 27, 2010, is still in progress as of August 31, because the composite bottle does not yet contain enough sample volume to conduct a valid analysis. Therefore, the 12-month rolling average for the end of April 2010 cannot be calculated at this time. However, based on the results available through April 26, 2010, DOE has made preliminary notification that the April 2010 12-month rolling average for Pu is expected to be just above the 0.15 pCi/L standard. Figure 6 shows the 12-month rolling average calculated for SW027 with sample results up to April 26, 2010.

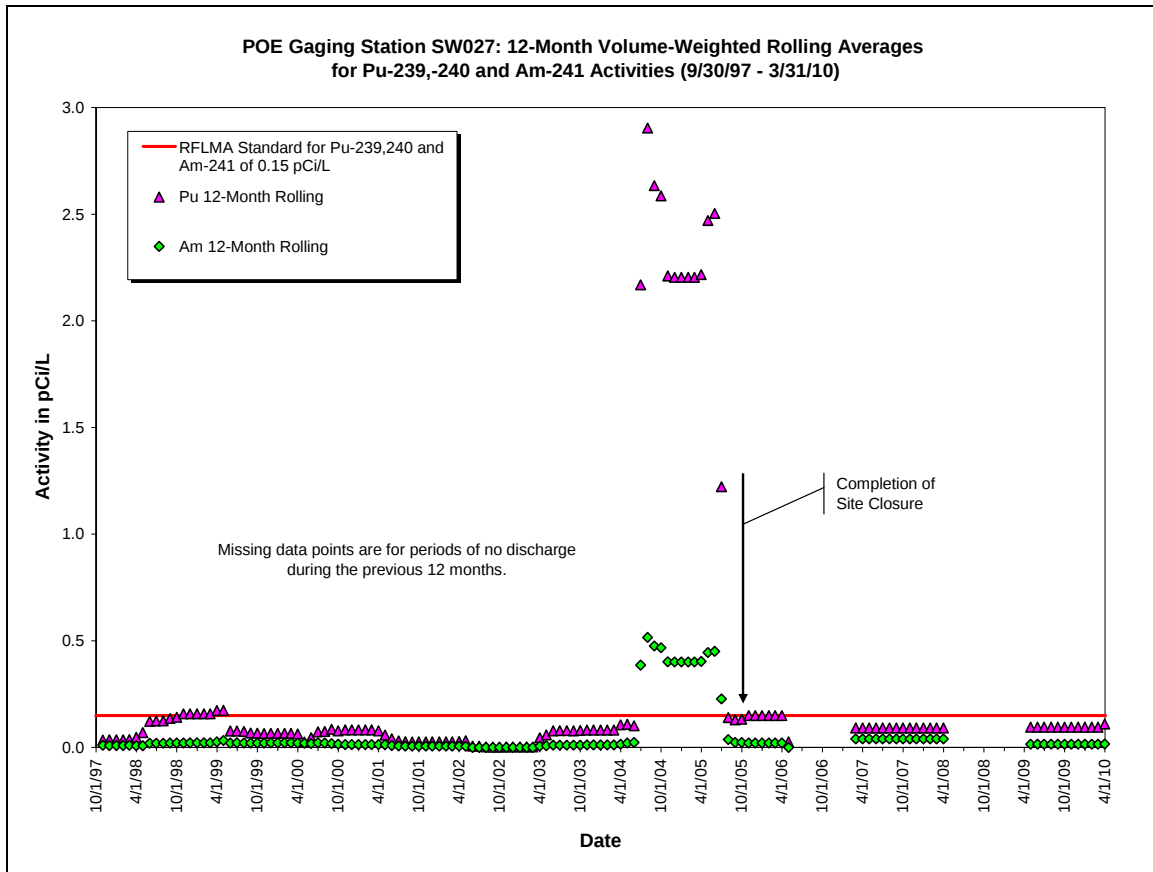
*Figure 8. 12-Month Rolling Averages at SW027*

Figure 7 shows discharge volumes at SW027, and Figure 8 shows 12-month rolling average results at SW027. While the recent SW027 results indicate that the RFLMA standard for Pu will be exceeded when the April 2010, 12-month rolling average can be calculated, these results are within historical variability and do not indicate a previously unknown source or transport mechanism.

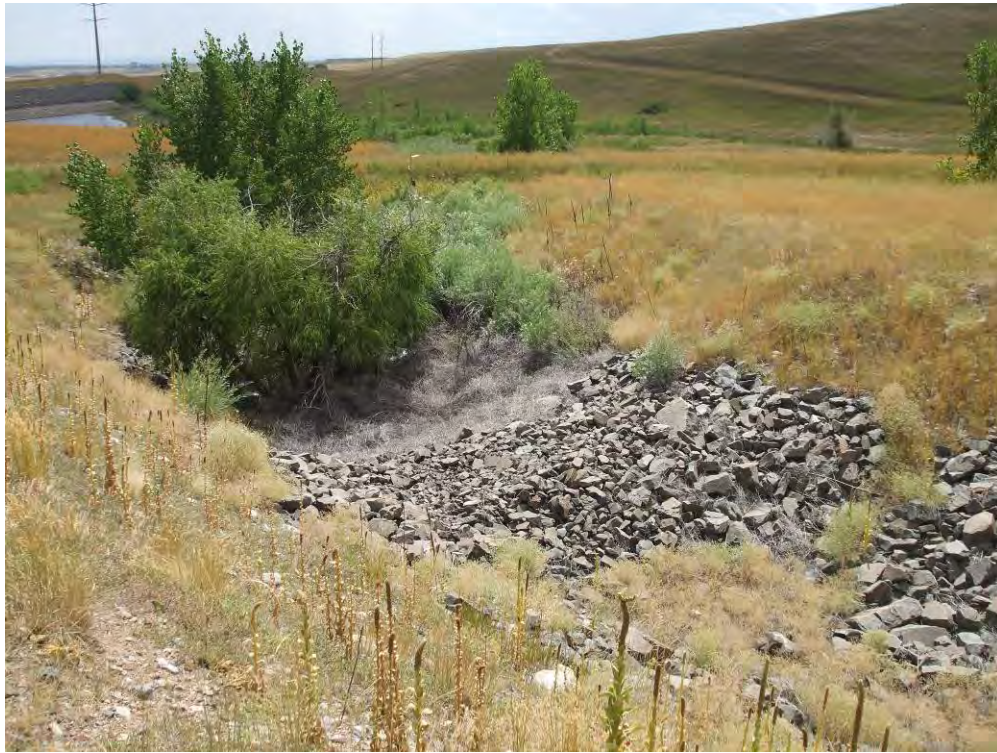
Much of the litter and the riprap, which has litter in the spaces between the rocks, appear to form natural erosion matting. Site personnel are evaluating where additional erosion controls, such as reseeding or installation of permanent erosion matting, might be used for localized areas in the SID and are evaluating the approach to installing these items, where recommended.

*Figure 9. SID Photopoint Location 1—Riprap and Vegetation Litter*

- Install erosion matting and interseeding in localized areas where vegetation cover is sparse.
- Reseed in localized areas in the SID where wetland vegetation no longer thrives.
- Evaluate placement of erosion matting in localized areas of the SID and install any recommended matting when conditions are appropriate (likely in late winter or early spring 2011).

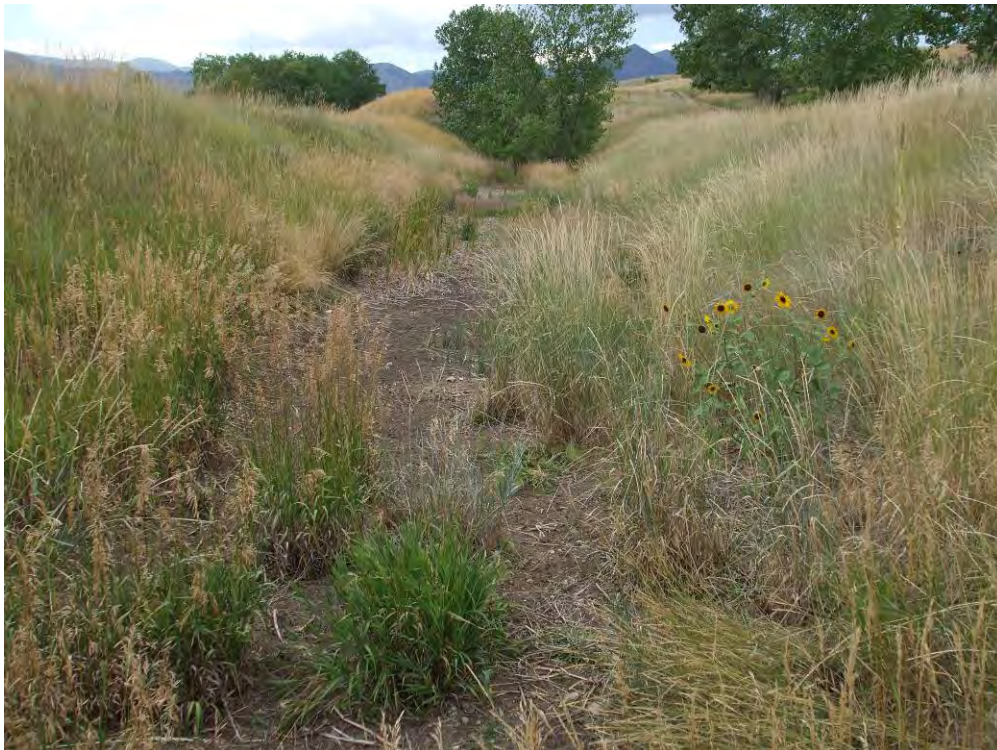
*Figure 10. SID Photopoint Location 6—Minimal Cover in Channel*

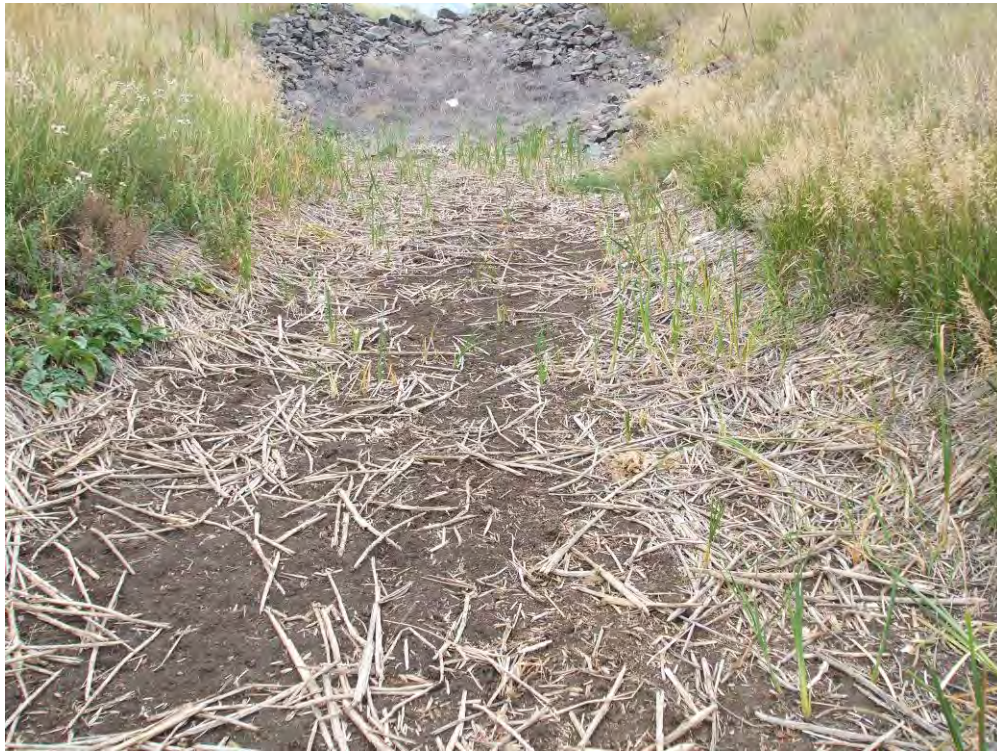
The generally reduced flow of water in the SID relative to pre-closure conditions was apparent in areas that previously supported wetland-type vegetation. The wetland plants are no longer thriving, and dead stands and litter now occupy these locations. These areas will be reseeded at the appropriate times with vegetation more suitable to the drier conditions.

*Figure 11. SID Photopoint Location 15—Dead Wetland Vegetation Litter*
