17.0 Slick Rock, Colorado, Disposal Site

17.1 Compliance Summary

Figure 17-1. 2021 Annual Inspection Drawing for the Slick Rock, Colorado, Disposal Site

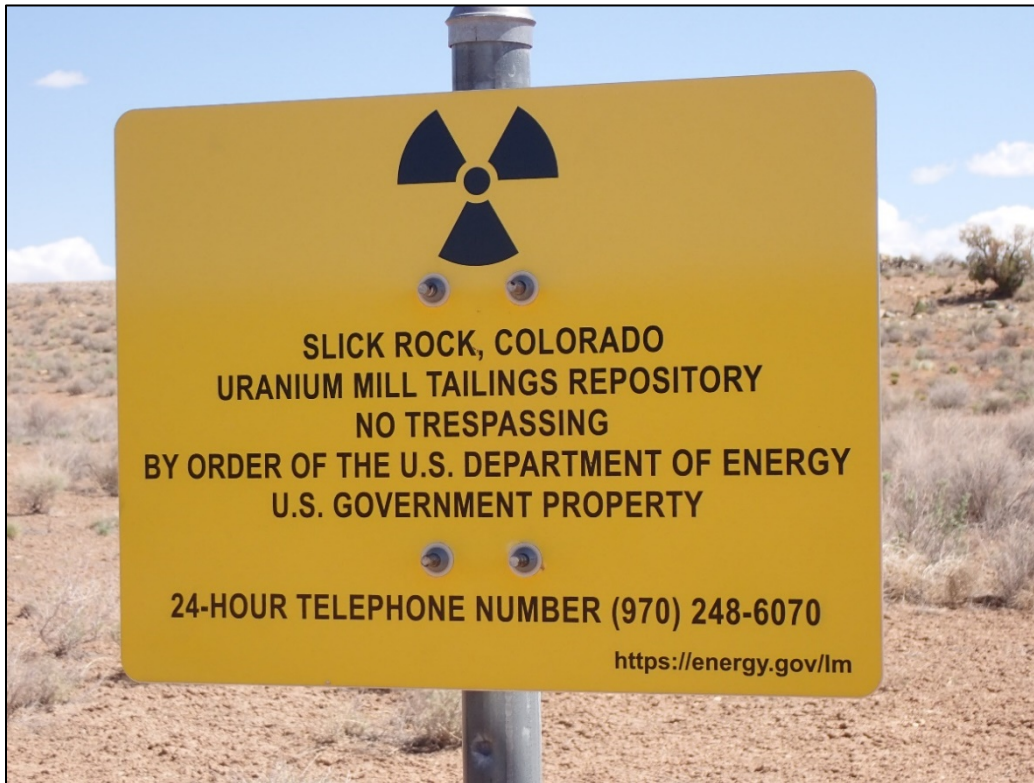
PL-1. Entrance Sign

Access to the site is from San Miguel County Road T11. Entrance to the site is through a chained and locked gate. The entrance gate was locked and is worn but remains functional. The entrance sign is next to the gate (PL-1). No maintenance needs were identified.

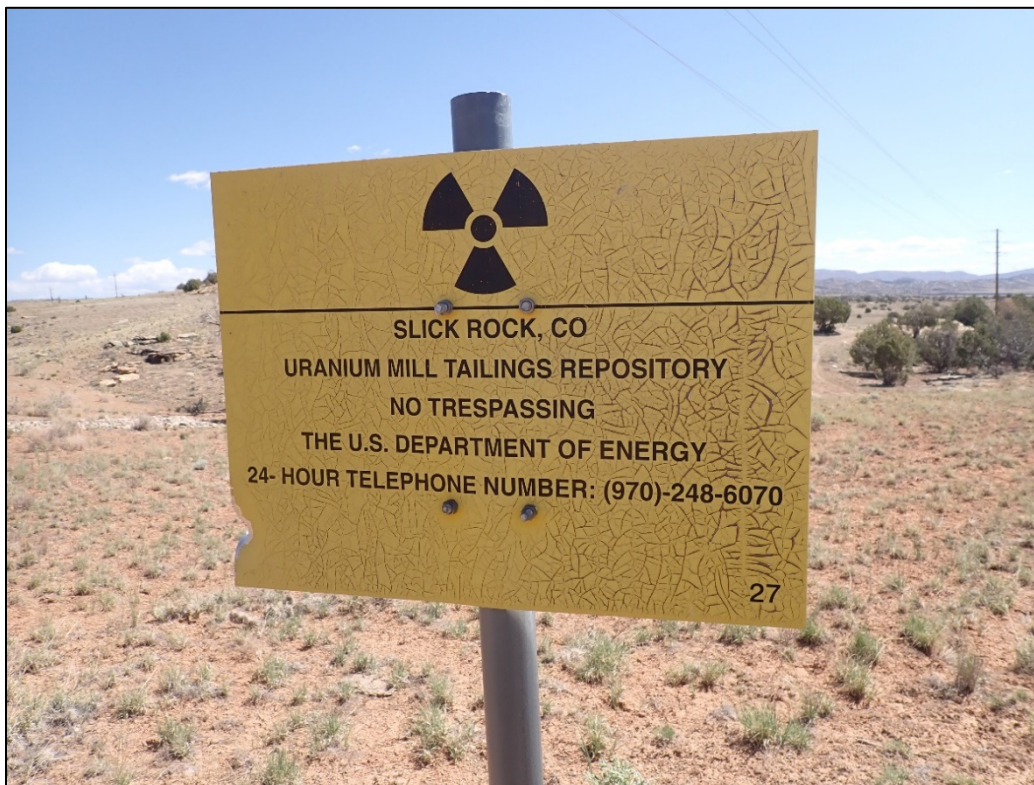
PL-2. Cracked Overlay on Perimeter Sign P27

There are 32 perimeter signs, attached to steel posts set in concrete, positioned along the property boundary; they are set back 5 feet (ft) from the boundary and cut in at the southwest corner. The printed overlay is cracked on several signs (PL-2), and several signs still display bullet damage, but all remain legible. The concrete bases on perimeter signs P14 and P15 are slightly undercut by erosion but remain stable. No maintenance needs were identified.

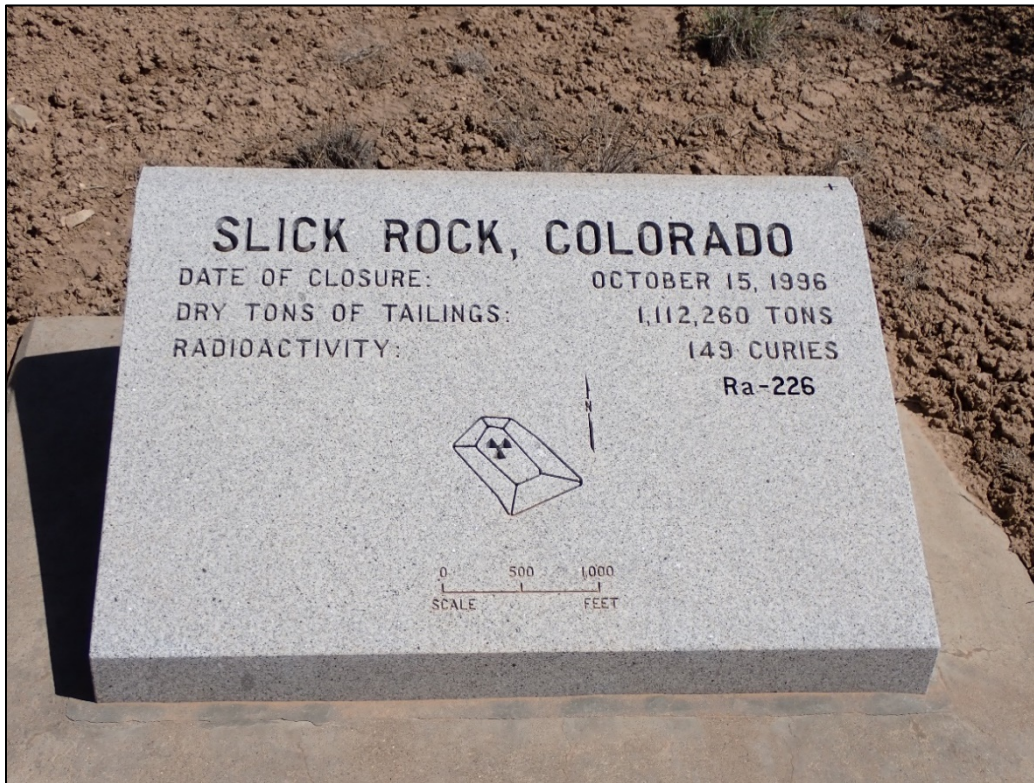
PL-3. Site Marker SMK-1

The site has two granite site markers. Site marker SMK-1 is just inside the entrance gate (PL-3), and site marker SMK-2 is on top of the disposal cell. No maintenance needs were identified.

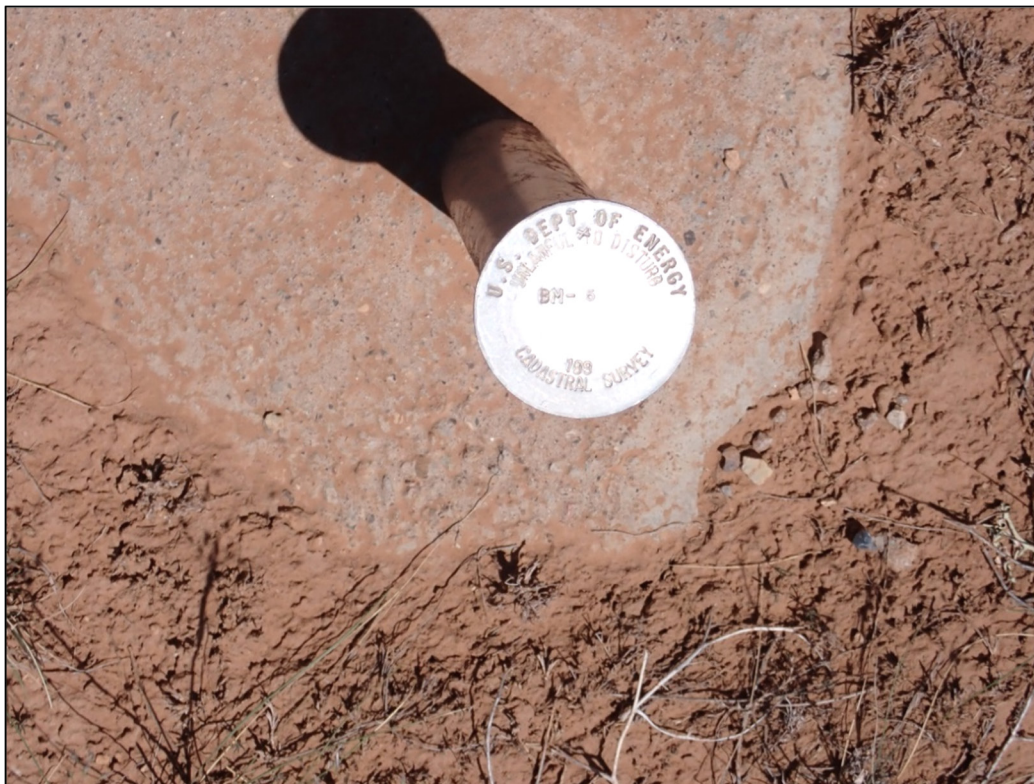
PL-4. Boundary Monument BM-1

The site has three survey monuments. Survey monument SM-2 was set in a low area and is frequently covered by several inches of soil. A T-post and rocks have been placed next to the monument to assist in locating this feature. Six boundary monuments delineate the corners of the site boundary (PL-4). No maintenance needs were identified.

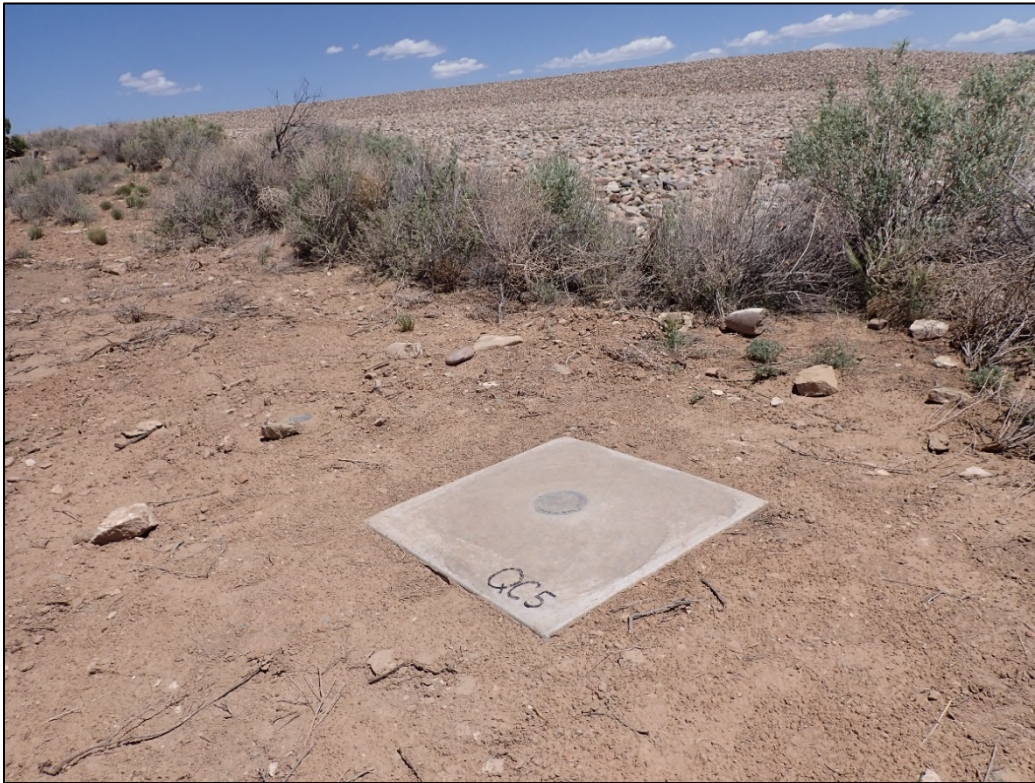
PL-5. Quality Control Monument QC-5

Five aerial survey quality control monuments were installed before the 2021 inspection. No maintenance needs were identified during the inspection (PL-5).

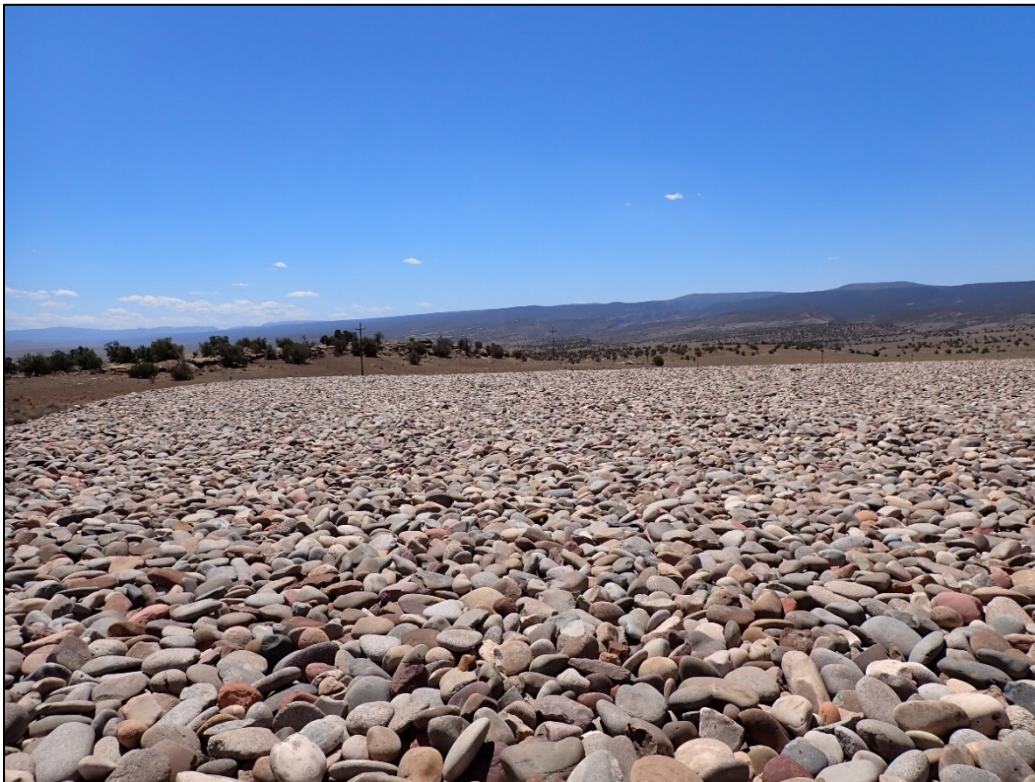
PL-6. Disposal Cell Cover

The disposal cell, completed in 1996, occupies 12.9 acres and is armored with riprap, consisting of rounded, cobble-sized river rock, to control erosion and deter animal and human intrusion (PL-6). The inspection found no evidence of erosion, settling, slumping, rock degradation, or other modifying processes that might affect the integrity of the disposal cell. Several bunches of grass are growing on the top of the disposal cell but do not require treatment at this time (PL-7). No other maintenance needs were identified.

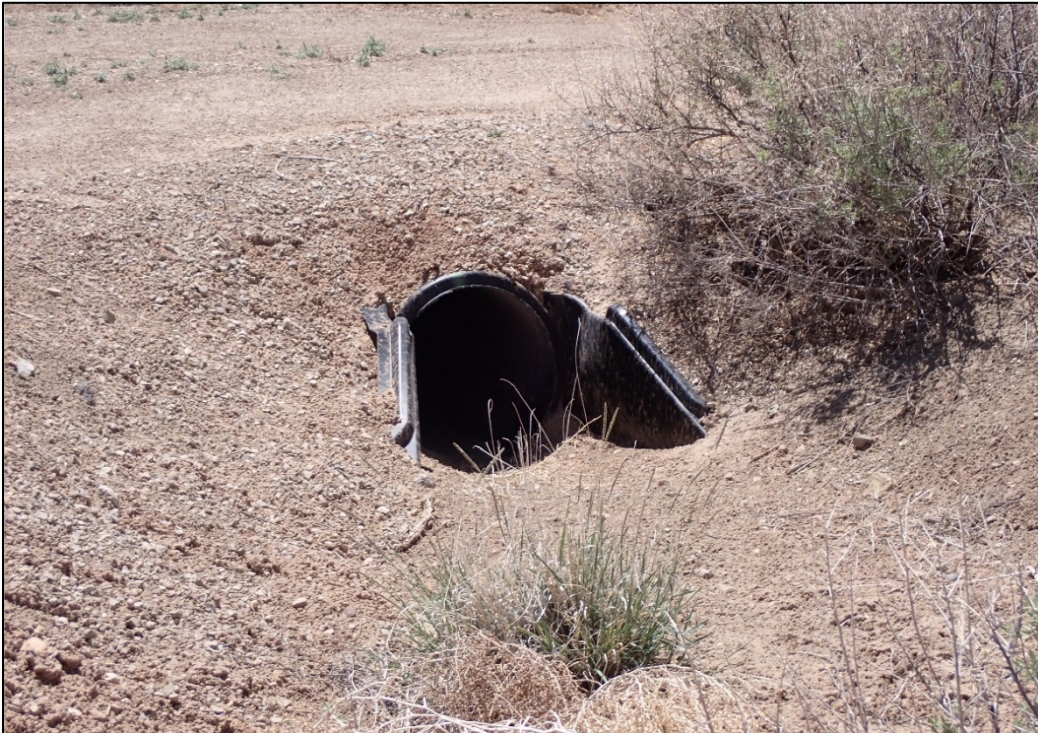
PL-8. North Side of Culvert Under Access Road Inside Gate

The two occluded culverts identified in the 2019 inspection, and subsequently cleaned out, have stabilized (PL-8). No other maintenance needs were identified.
