17.0 Slick Rock, Colorado, Disposal Site

17.1 Compliance Summary

Figure 17-1. 2022 Annual Inspection Drawing for the Slick Rock, Colorado, Disposal Site

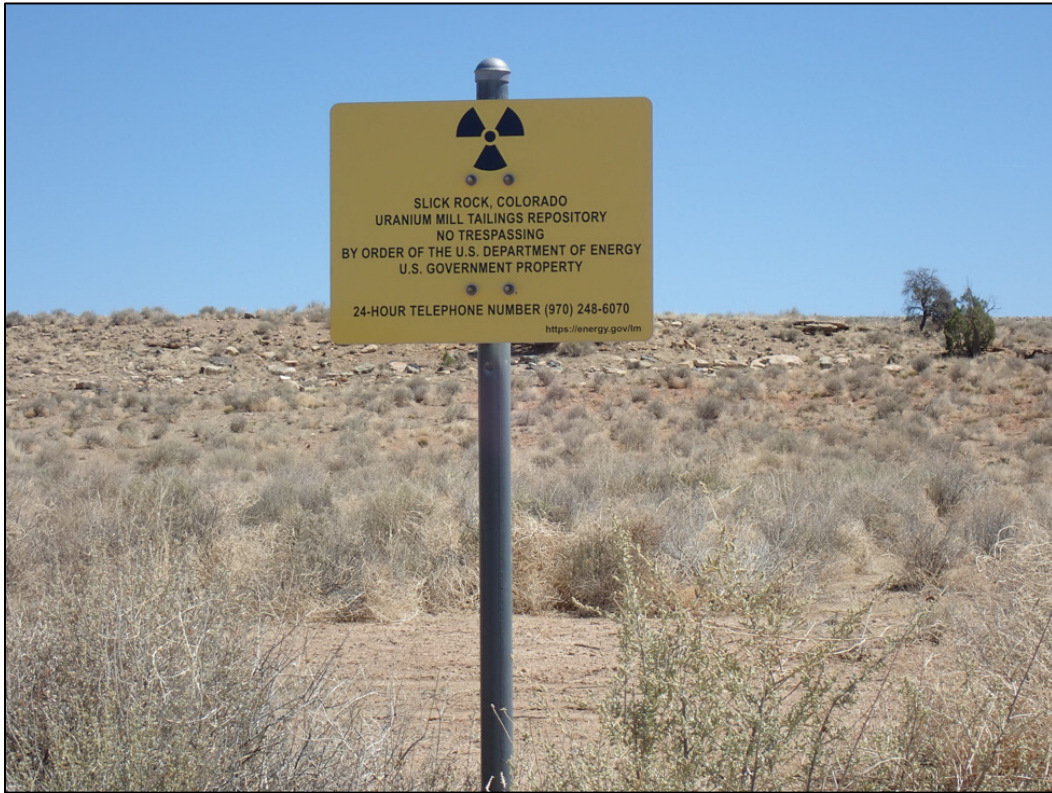
Access to the site is from San Miguel County Road T11. Entrance to the site is through a chained and locked gate. The entrance gate was locked and is worn but remains functional. The entrance sign is next to the gate (PL-1). No maintenance needs were identified.

PL-1. Entrance Sign

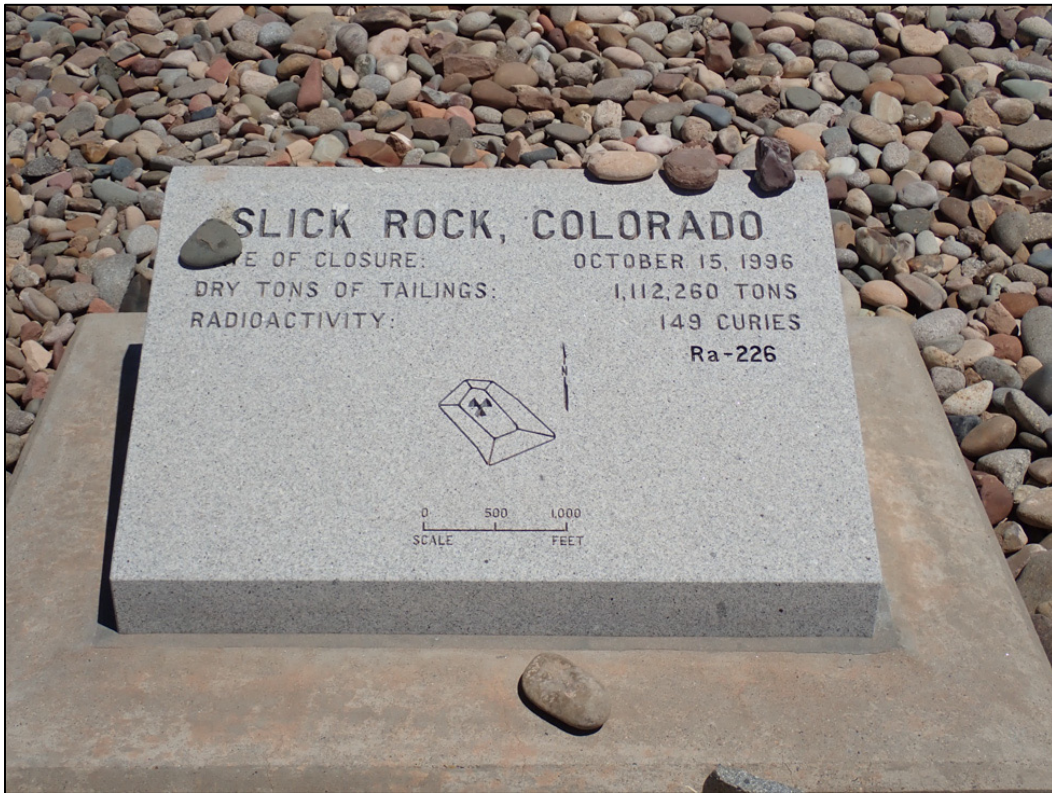
The site has two granite site markers. Site marker SMK-1 is just inside the entrance gate, and site marker SMK-2 is on top of the disposal cell (PL-2). No maintenance needs were identified.

PL-2. Site Marker SMK-2

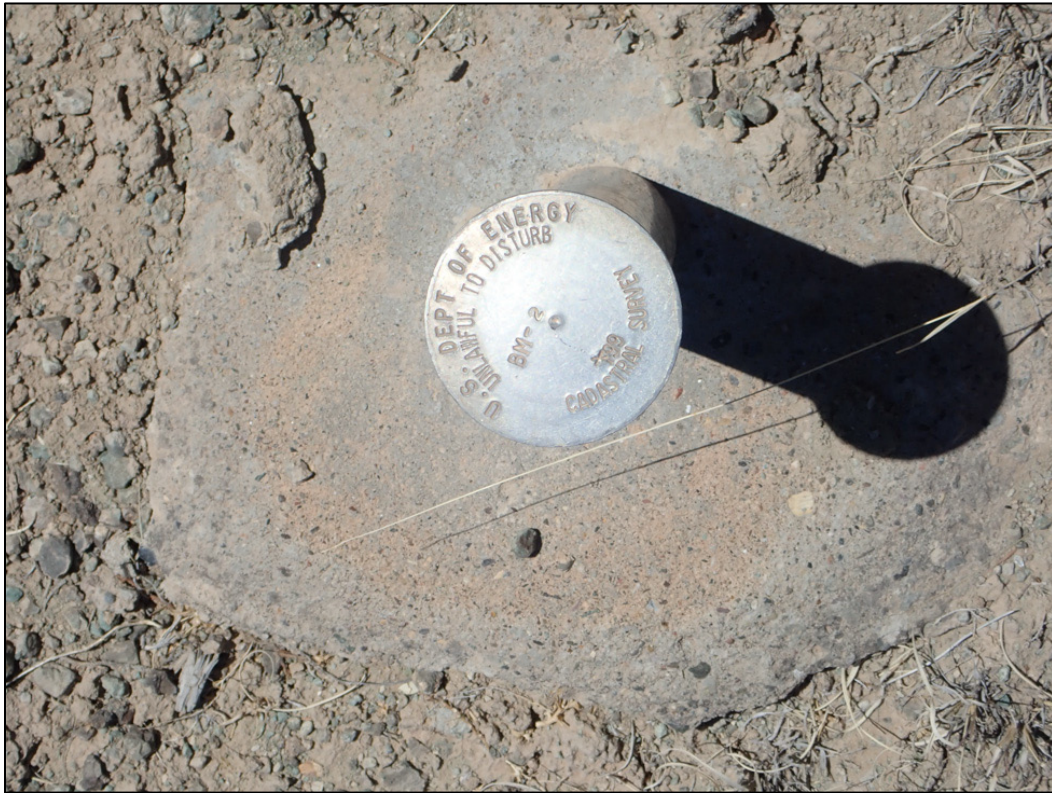
The site has three survey monuments. Six boundary monuments delineate the corners of the site boundary (PL-3). No maintenance needs were identified.

PL-3. Boundary Monument BM-2

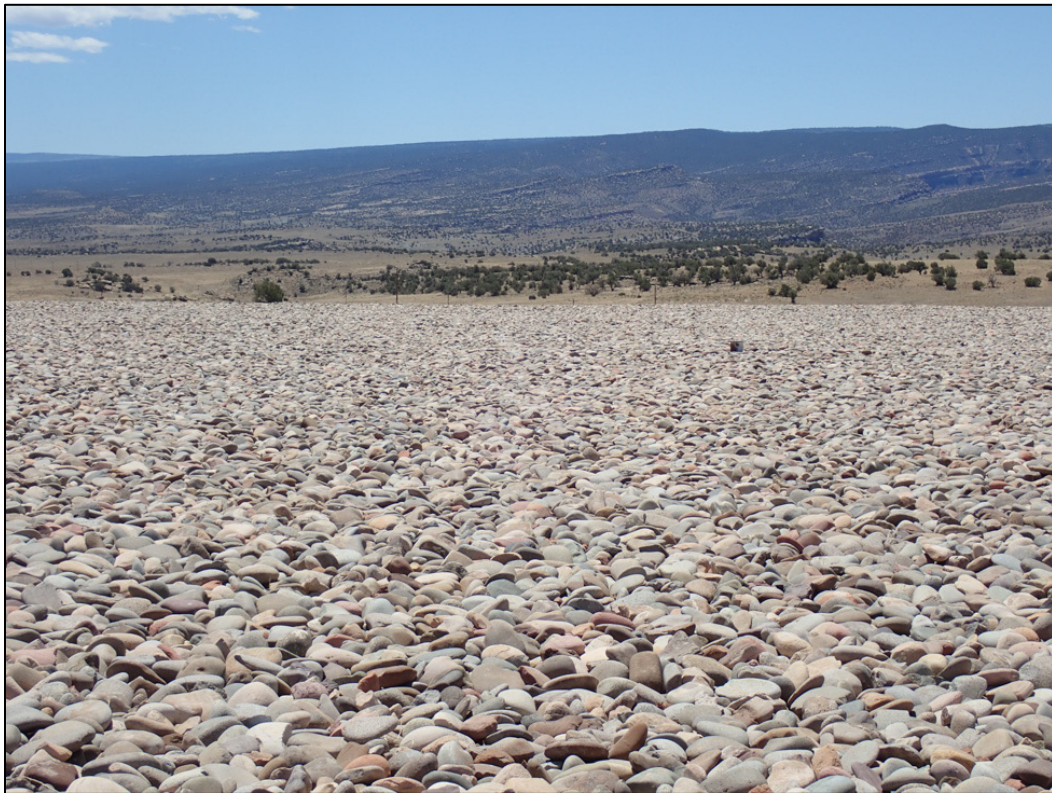
The disposal cell, completed in 1996, occupies 12.9 acres and is armored with riprap, consisting of rounded, cobble-sized river rock, to control erosion and deter animal and human intrusion (PL-4). The inspection found no evidence of erosion, settling, slumping, rock degradation, or other modifying processes that might affect the integrity of the disposal cell. Several bunches of grass are growing on the top of the disposal cell but do not require treatment at this time. No other maintenance needs were identified.

PL-4. Disposal Cell Top Slope

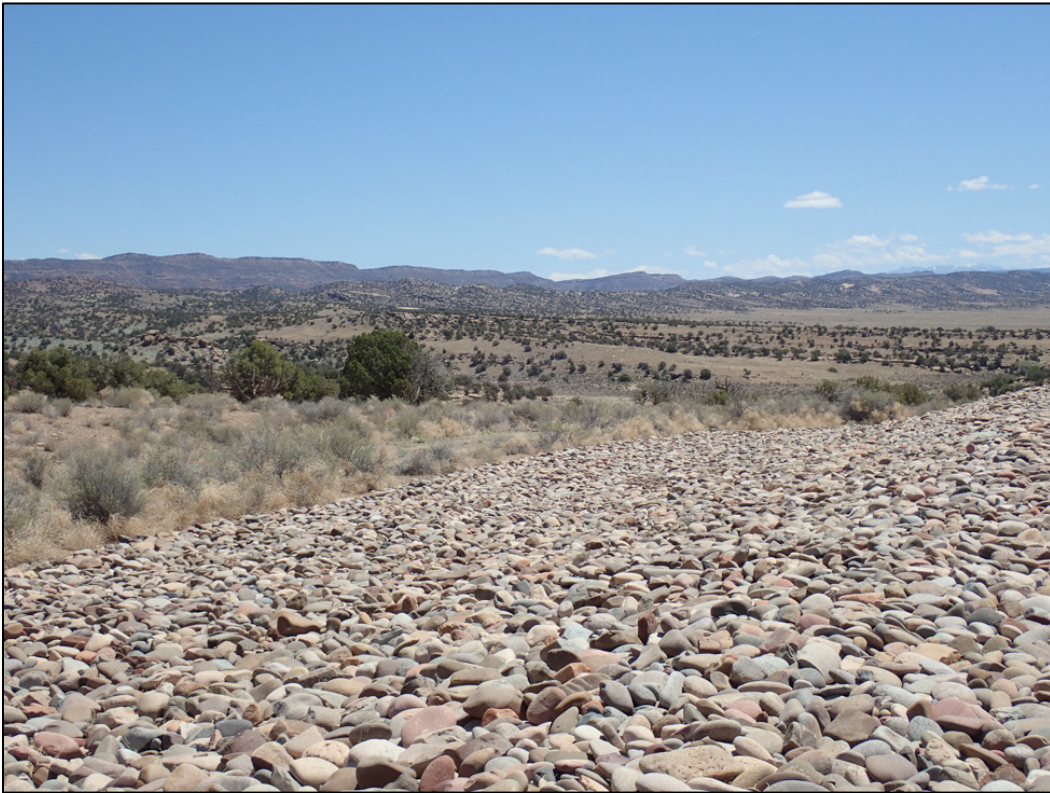
At the toe of the disposal cell side slopes is a key trench that encloses the disposal cell (PL-5). The key trench, designed to convey stormwater runoff away from the disposal cell, is approximately 5 ft deep and 20 ft wide and filled with rock. Stormwater runoff from the key trench discharges to an apron at the south (downslope) corner of the disposal cell. The apron extends 50 to 200 ft beyond the key trench. The key trench and apron are covered with rounded cobble- and pebble-sized river rock. Willows (a deep-rooted species) are growing on a portion of the apron but are not considered detrimental to the integrity of the disposal cell (PL-6). No maintenance needs were identified.

PL-5. Key Trench on East Side Slope

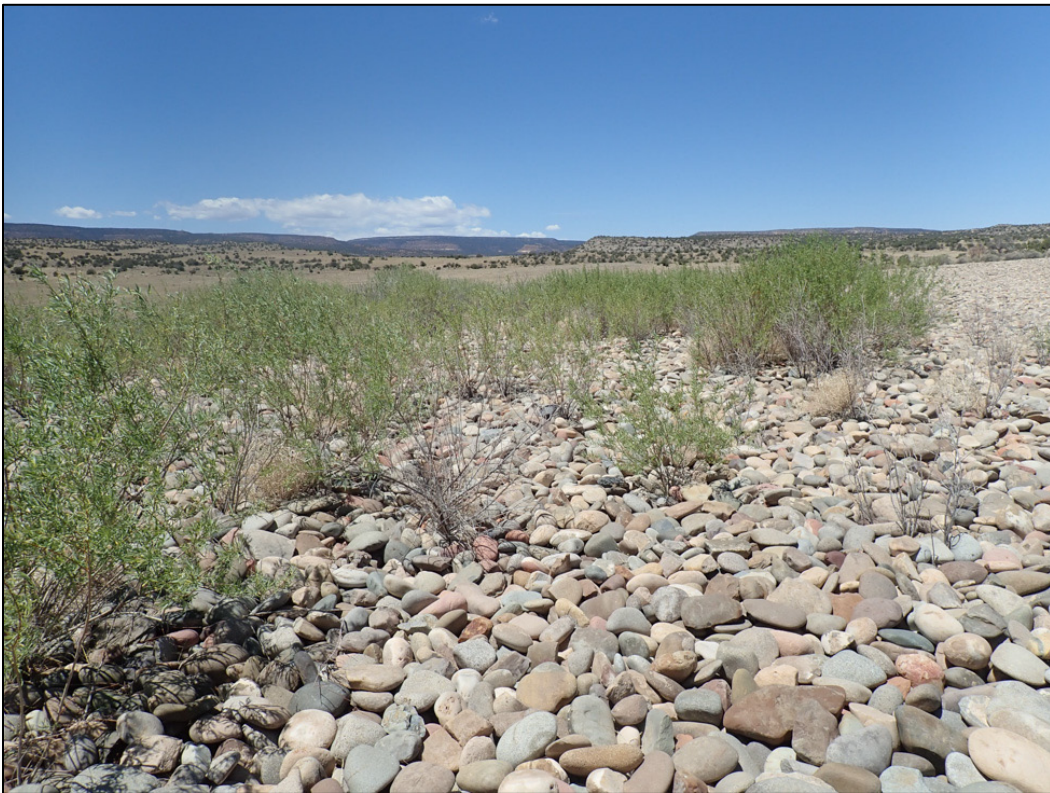
PL-6. Willows Growing in Apron

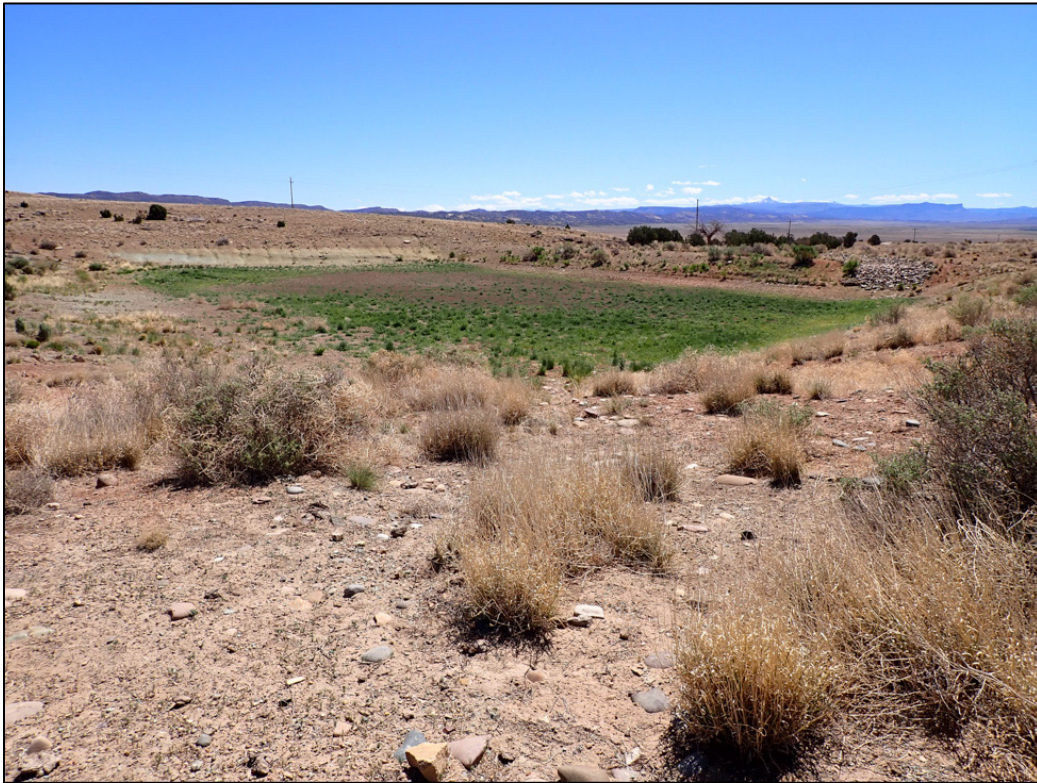
The area around the disposal cell includes a stormwater retention pond (PL-7). Surface drainage from the disposal cell flows south from the apron into the retention pond, which is constructed in a channel tributary that drains to Joe Davis Canyon. An outflow channel below the pond is lined with rounded riprap for a short distance. The pond was dry at the time of inspection.

PL-7. Retention Pond

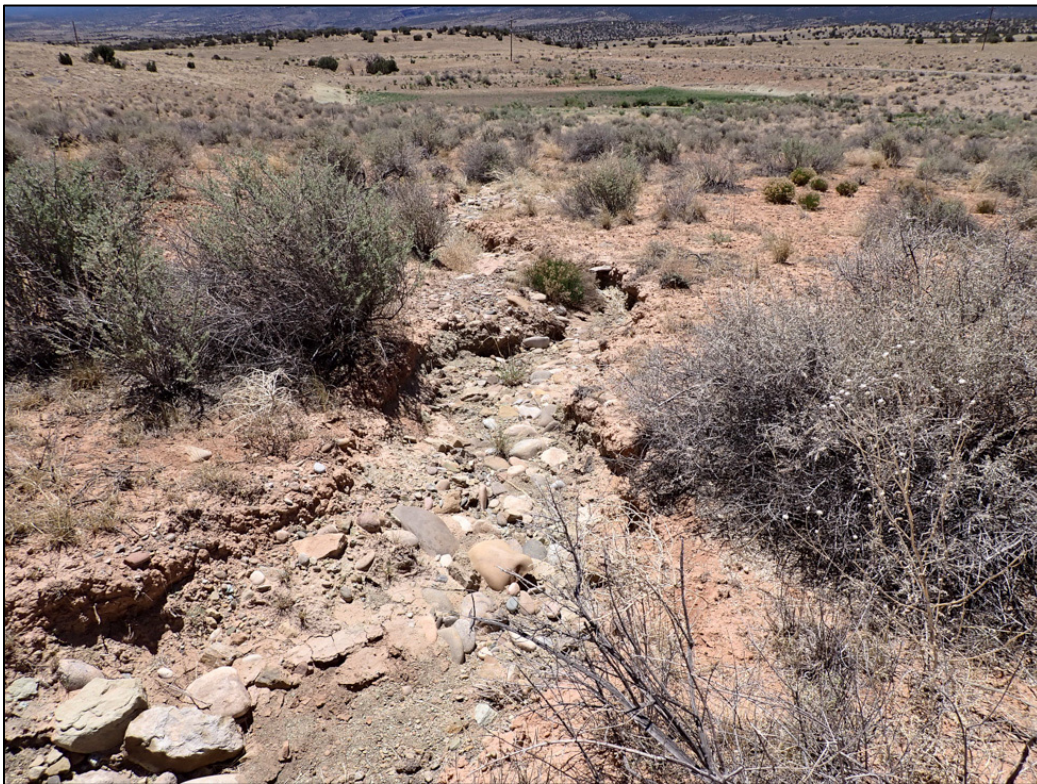
Inspectors noticed rills and gullies expanding on the southwest side of the site from the apron area extending to the fence line between perimeter signs P30 and P32. The gullies and rills terminate into the culvert along San Miguel County Road T11. Consequently, the fence posts along that fence line are undercut by the erosion and are unstable. Stabilization of the fence posts will be completed before the next inspection, and if mitigation to the erosional features will be required, it will be completed in the future. No other maintenance needs were identified.

The site was originally graded for sheet flow from the apron to the retention pond. Rills have been developing since 1998 on the northwest side of the retention pond and now are 3 ft deep or deeper adjacent to the pond and shallower farther upslope. Most of the rills have stabilized or are stabilizing. Deeper gullies identified in the 2020 inspection have not grown significantly since the previous inspection and do not threaten the integrity of the disposal cell (PL-8). Erosional gullies on the southwest side of the apron area have grown to affect the fence posts along San Miguel County Road T11. This erosional area will be evaluated for mitigation but does not currently affect the integrity of the disposal cell. Inspectors will continue to monitor this area. No maintenance needs were identified.

PL-8. Gullies on South Area Between Disposal Cell and Site Boundary

Stabilization of the fence posts between perimeter signs P30 to P32 will be completed before the next inspection. If determined to be necessary, the erosional features downslope from the cell and apron extending to San Miguel County Road T11 between perimeter signs P30 and P32 will be evaluated and possibly mitigated in the future. No other maintenance needs were identified.
