17.0 Slick Rock, Colorado, Disposal Site

17.1 Compliance Summary

The Slick Rock, Colorado, Uranium Mill Tailings Radiation Control Act (UMTRCA) Title I Disposal Site was inspected on May 22, 2024. No changes were observed on the disposal cell or in the associated drainage features. Inspectors identified routine maintenance needs but found no cause for a follow-up or contingency inspection. Groundwater monitoring is not required.

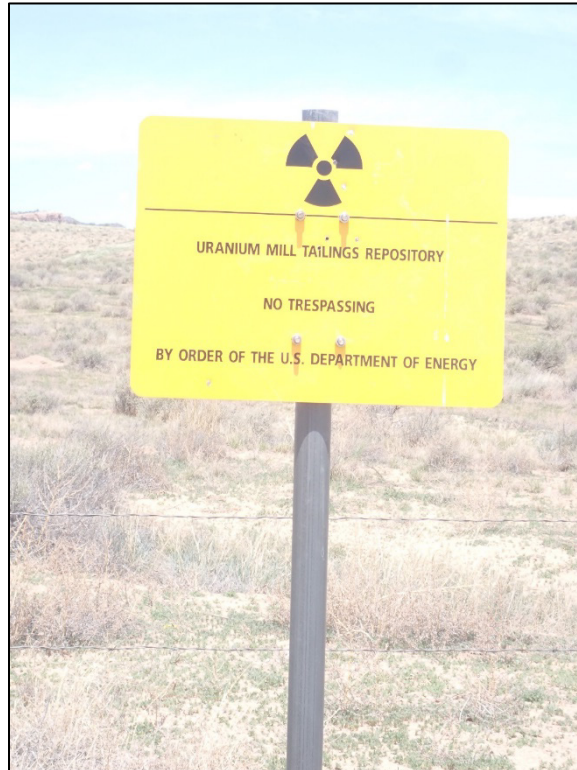
PL-1. Perimeter Sign P19

There are 32 perimeter signs, attached to steel posts set in concrete, positioned along the property boundary. The perimeter signs are set back 5 feet (ft) from the site boundary line with the exception of the southwest corner where they are along the fence line (PL-1). Erosion found during the 2023 inspection around the base of perimeter sign P6 was repaired following this inspection. The printed overlay on perimeter sign P7 was cracked and was replaced following the inspection. The concrete base on perimeter sign P14 (PL-2) was moderately undercut by erosion but was repaired after the inspection. The concrete base on perimeter sign P15 is slightly undercut and remains stable. No other maintenance needs were identified.

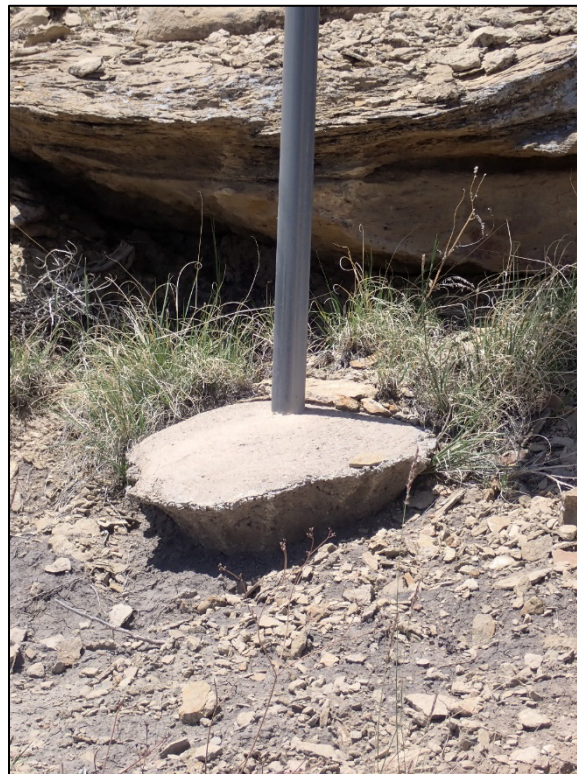
PL-2. Erosion Undercut at Concrete Base of Perimeter Sign P14

- Replace perimeter sign P7
- Backfill undercutting at perimeter sign P14
- Backfill erosion at perimeter sign P6, near perimeter sign P3, and between perimeter signs P31 and P32

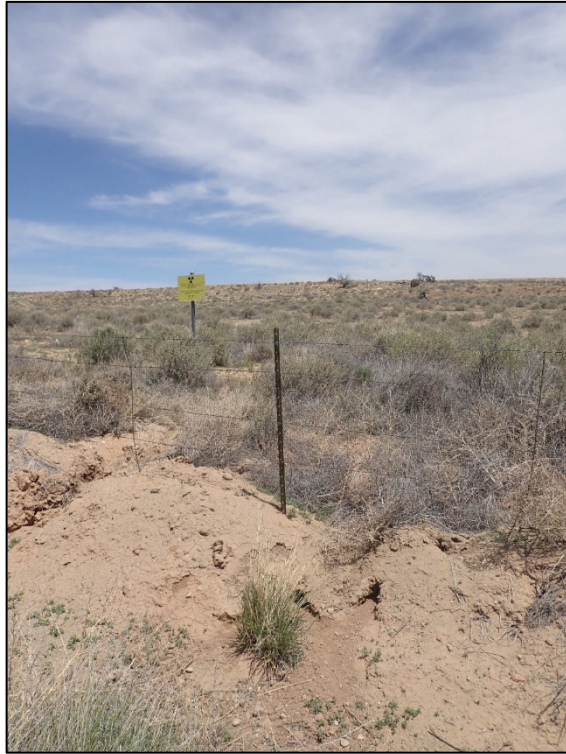
A four-strand wire perimeter fence encloses the disposal cell, drainage structures, and much of the site. The top and bottom strands are smooth wire to allow wildlife to pass over and under, and the middle two strands are barbed wire. Erosional features were identified between perimeter signs P31 and P32 during the 2023 inspection and were repaired during the pothole and rill repair in 2024 (PL-3). Erosion identified during the 2023 inspection from a gully near perimeter sign P3 was repaired following this inspection.

PL-3. Erosion at Fence Line Between Perimeter Signs P31 and P32

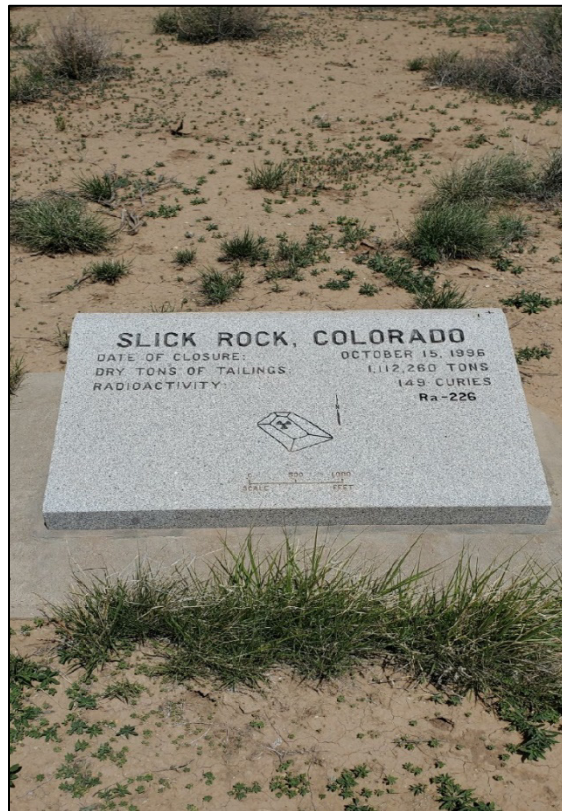
PL-4. Site Marker SMK-1

The site has two granite site markers. Site marker SMK-1 (PL-4) is just inside the entrance gate, and site marker SMK-2 is on top of the disposal cell. No maintenance needs were identified.

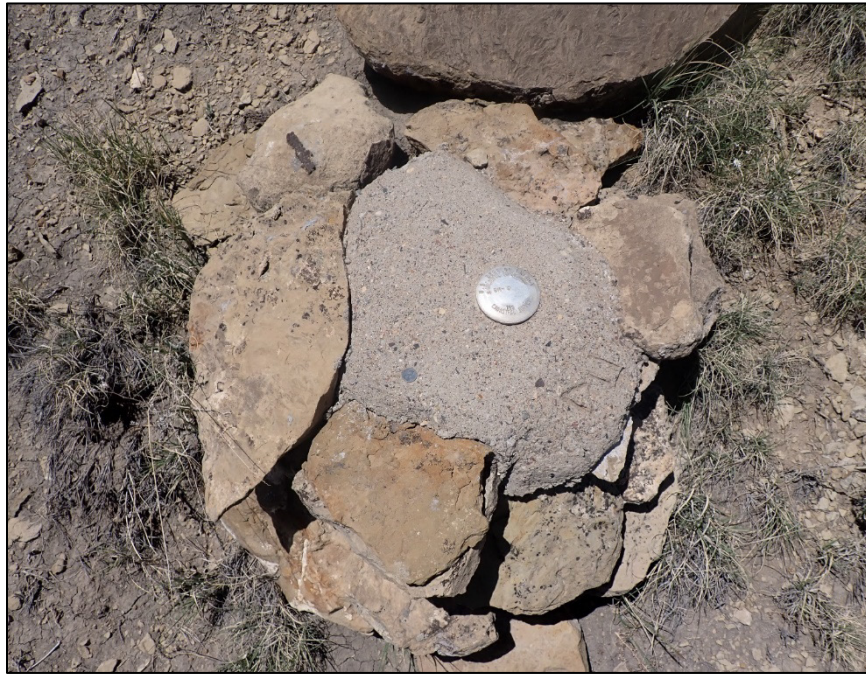
PL-5. Boundary Monument BM-3

The site has three survey monuments. Six boundary monuments delineate the corners of the site boundary (PL-5). No maintenance needs were identified.

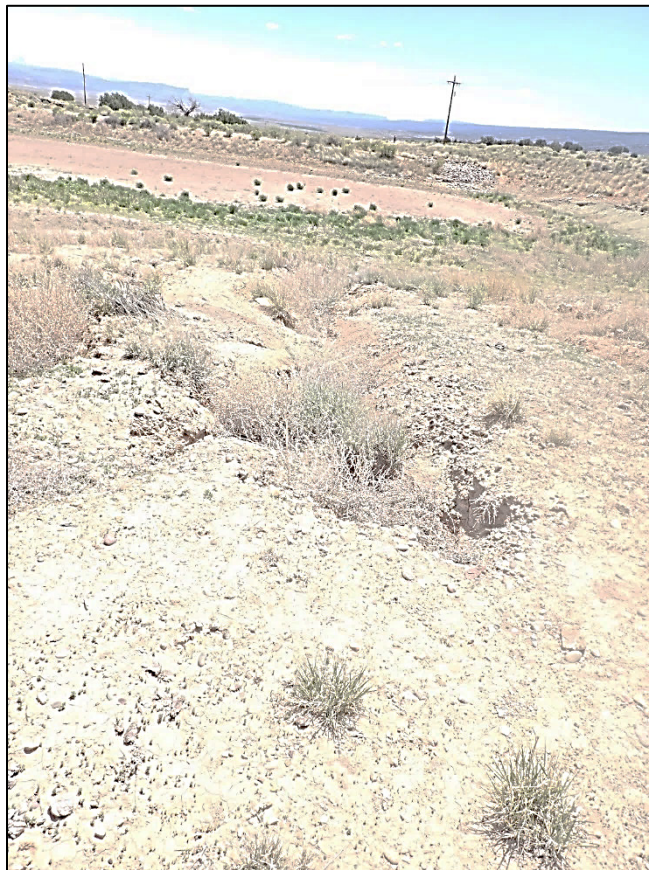
The site was originally graded for sheet flow from the apron to the retention pond. Gullies have been developing since 1998 on the northwest side of the retention pond and now are 3 or more feet deep adjacent to the pond and shallower farther upslope (PL-6). Most of the gullies have

stabilized or are stabilizing. Deeper gullies identified in the 2023 inspection have grown significantly since the previous inspection but do not threaten the integrity of the disposal cell. Deferred maintenance needs (backfilling the gullies) were identified and will be addressed in fiscal year 2025.

PL-6. Gully North of Retention Pond

- Backfill erosion north of the retention pond
